**1986
KOOTENAY LAKE
SOUTH ARM
STREAM
INVENTORY**

CRESTON VALLEY ROD AND GUN CLUB

Ministry of
Environment

Fish and Wildlife
Branch

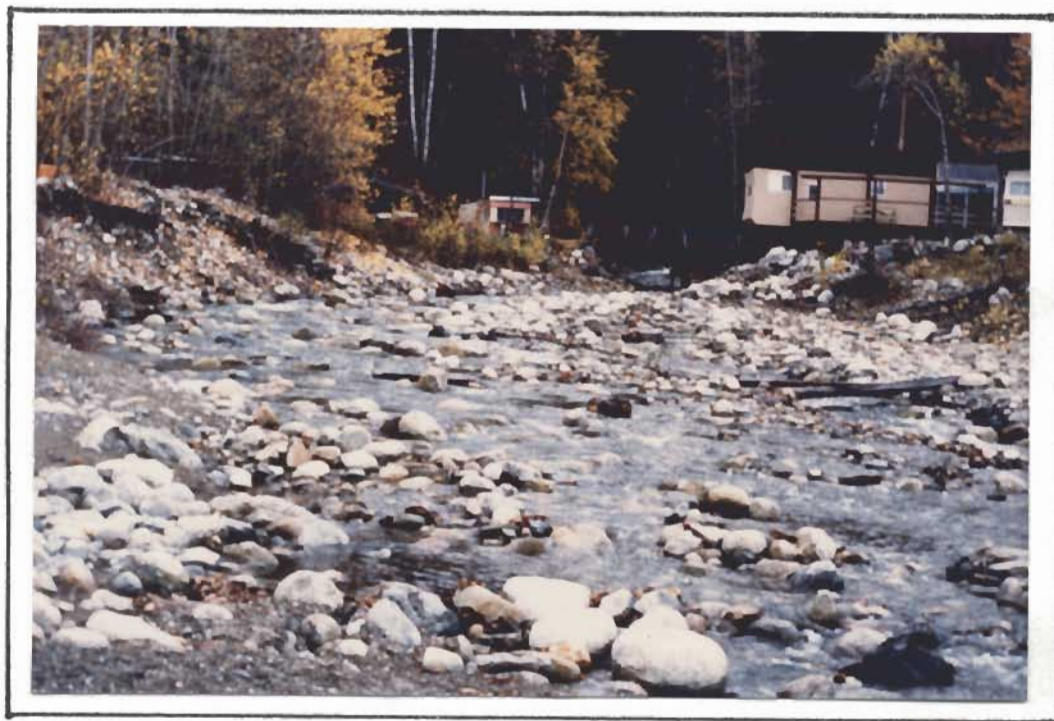
①

Photo#1 Typical Reach looking upstream

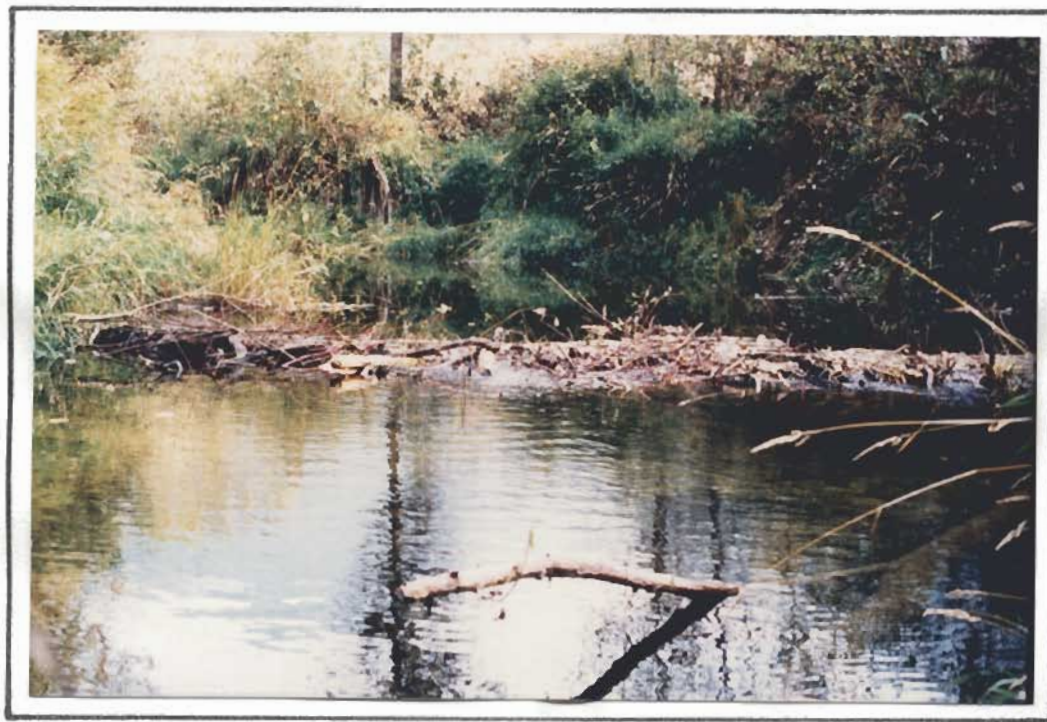
①

Photo #1 Beaver Dam

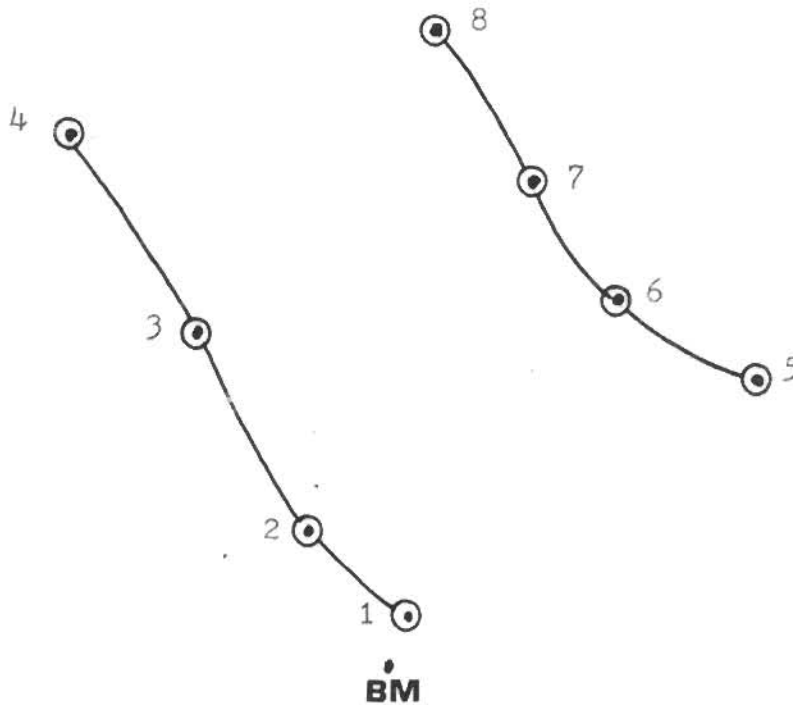
Comments: Well channelized. During spawning run, no Kokanee observed below 1/2 kilometer from Highway bridge. Lower 75% silt/clay bottom. No substantial stream bank cover. One massive log jam, approximately 40 meters by 1.5 kilometers.

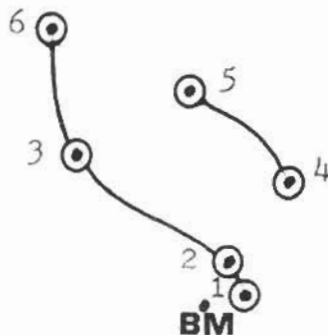
Stream Name: INDIAN CREEK

Comments: Tributary of south braid of Goat River. Deeply channelized clay. Stream bank cover predominantly grasses. Less than 200 square meters gravel. Very slow flow. Chub and suckers observed.

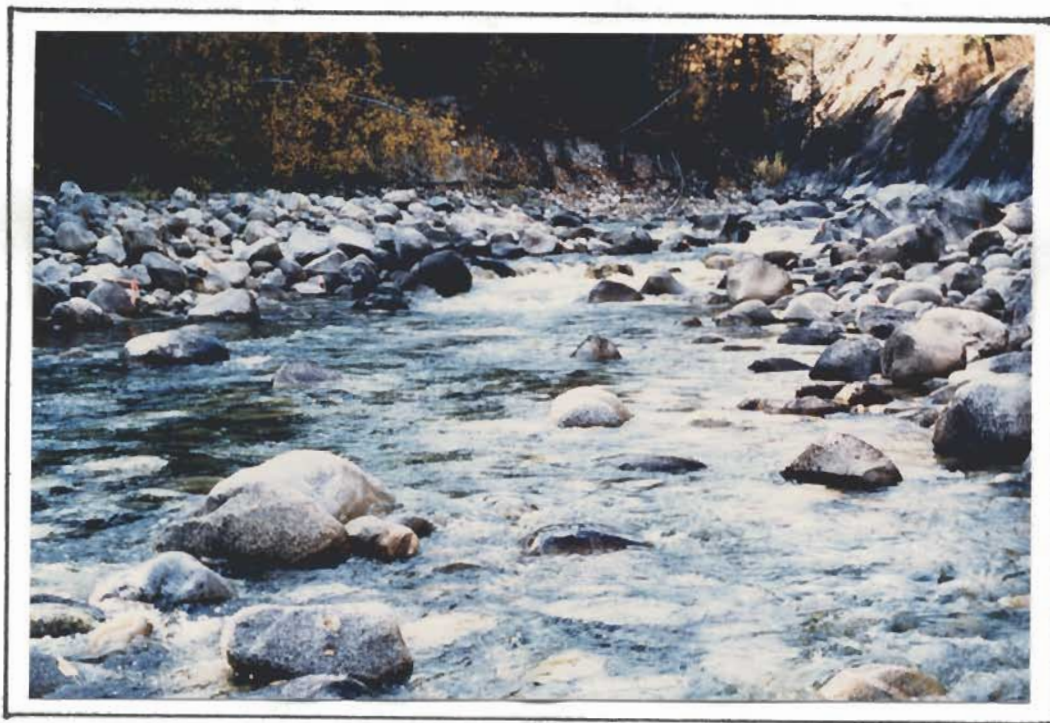
①

- Photo #1 Typical Reach looking upstream
- #2 Typical Reach looking downstream
- #3 Barrier (aerial)
- #4 Confluence (aerial)

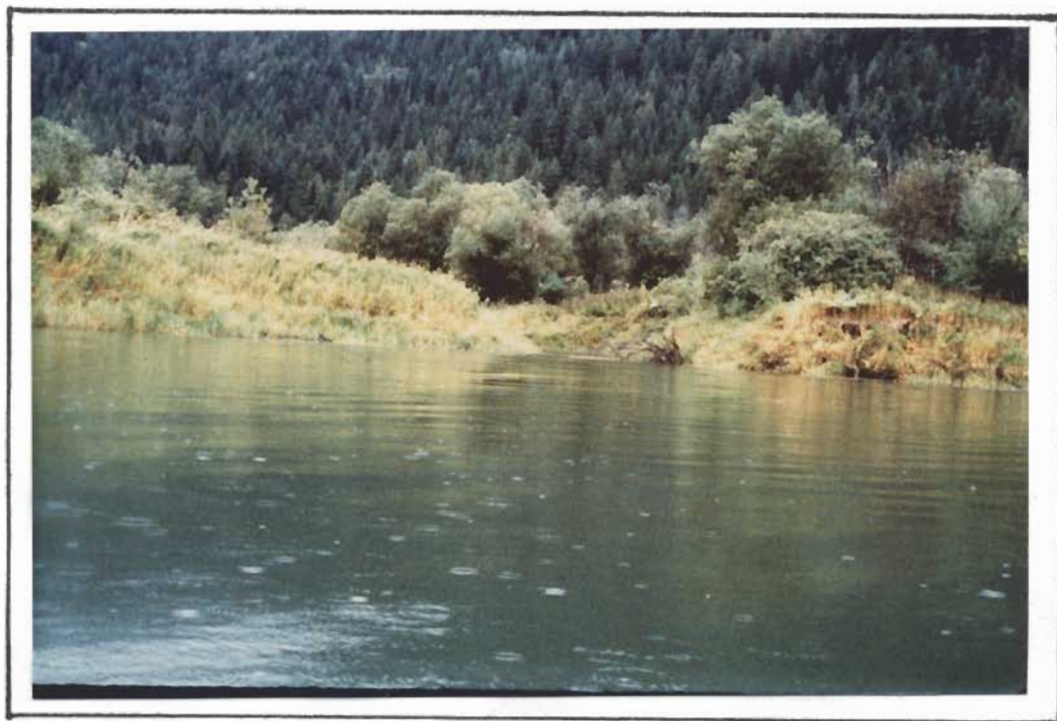
①

- Photo #1 Confluence
- #2 Midgely Meadow (aerial)
- #3 Widest area just above confluence
- #4 Typical Reach through meadow

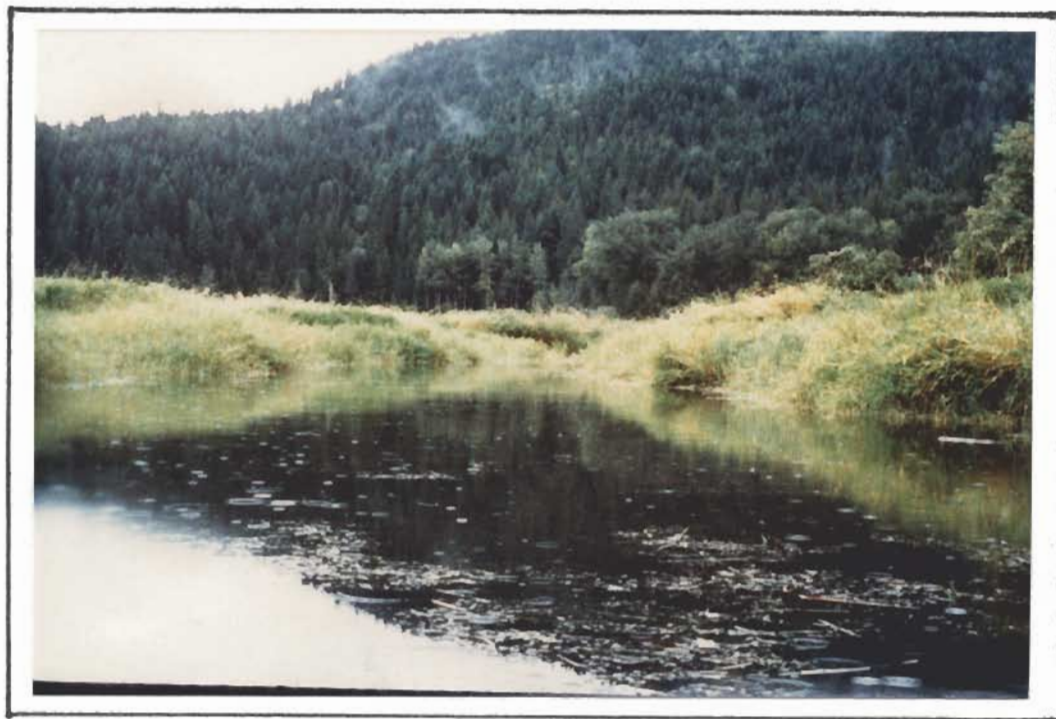
③

Comments: Because the volume of water and the accessible streambed did not appear to be sufficient to support a spawning run of Kokanee, we did not deem it necessary to survey a typical reach. Photo # 3 is 100% clay bottom. Photo # 4 shows middle reach which is 12-14 cm. deep and less than 1 metre average width.

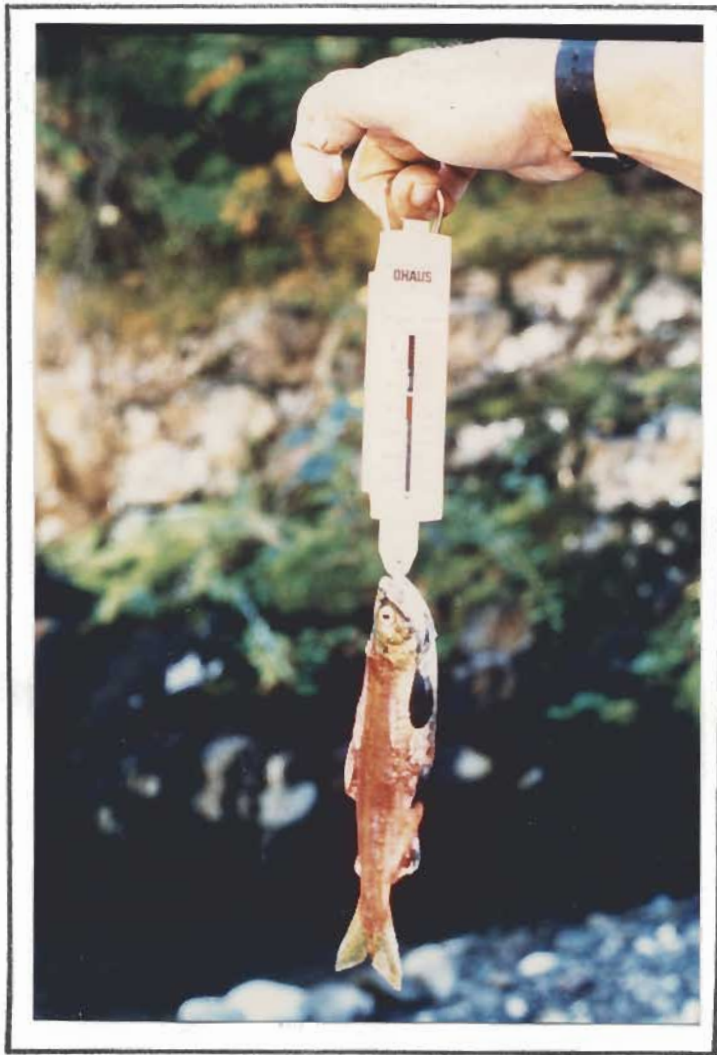
Typical ♂, 7 3/4" - 2.47 oz. (19.7 cm. - 65 gm.)

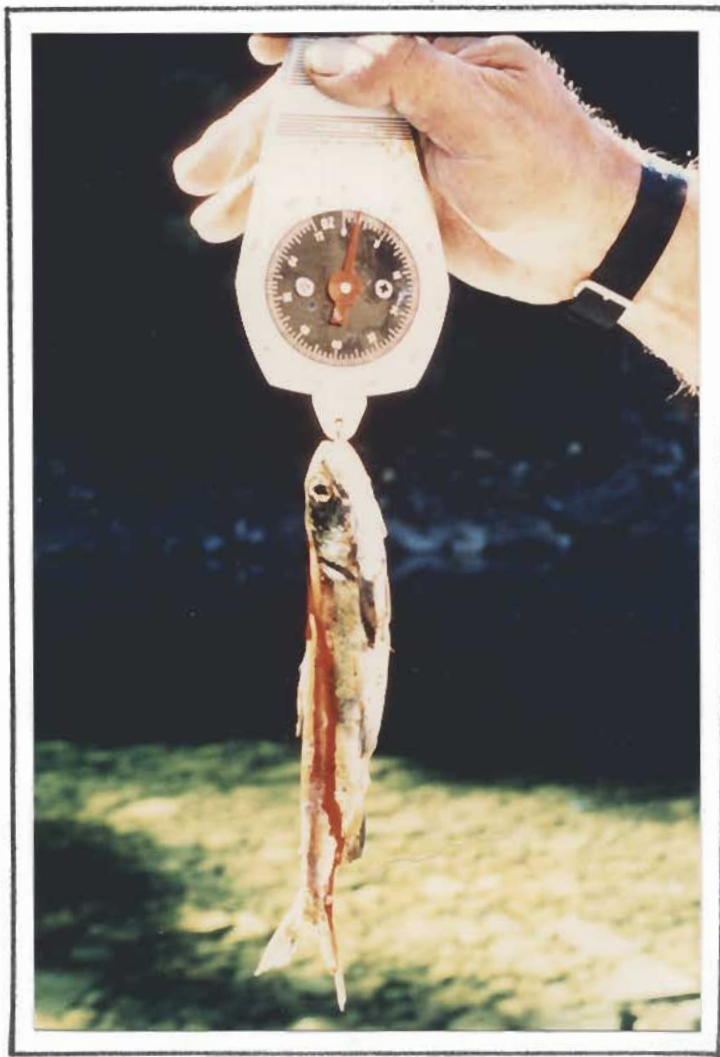
Typical ♀ , 7 1/2" - 3.36 oz. (19 cm. - 55 gm.)

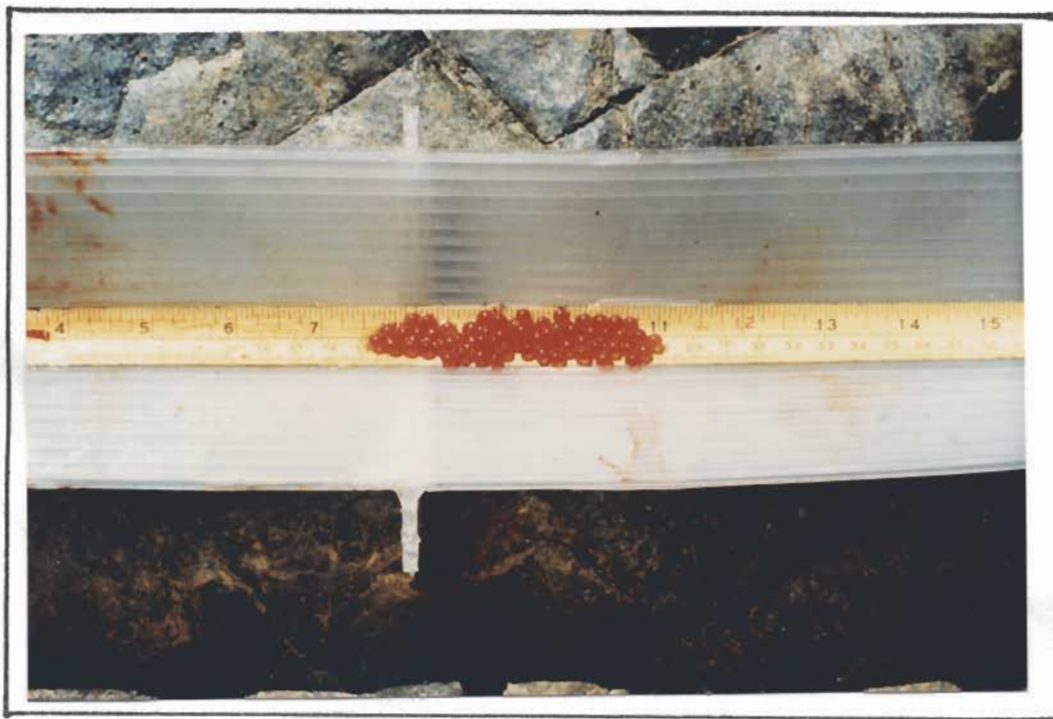
Eggs from fish #17, Goat River.

Typical ♂/♀ comparison.

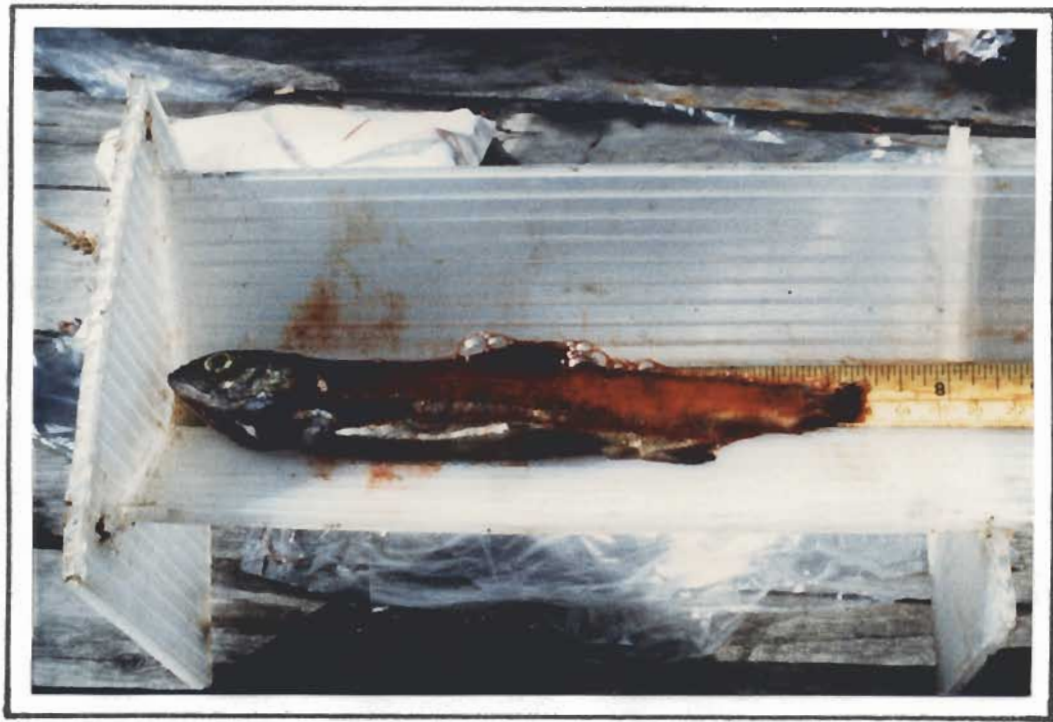
Gray Creek #1 Length

Gray Creek # 1 Weight

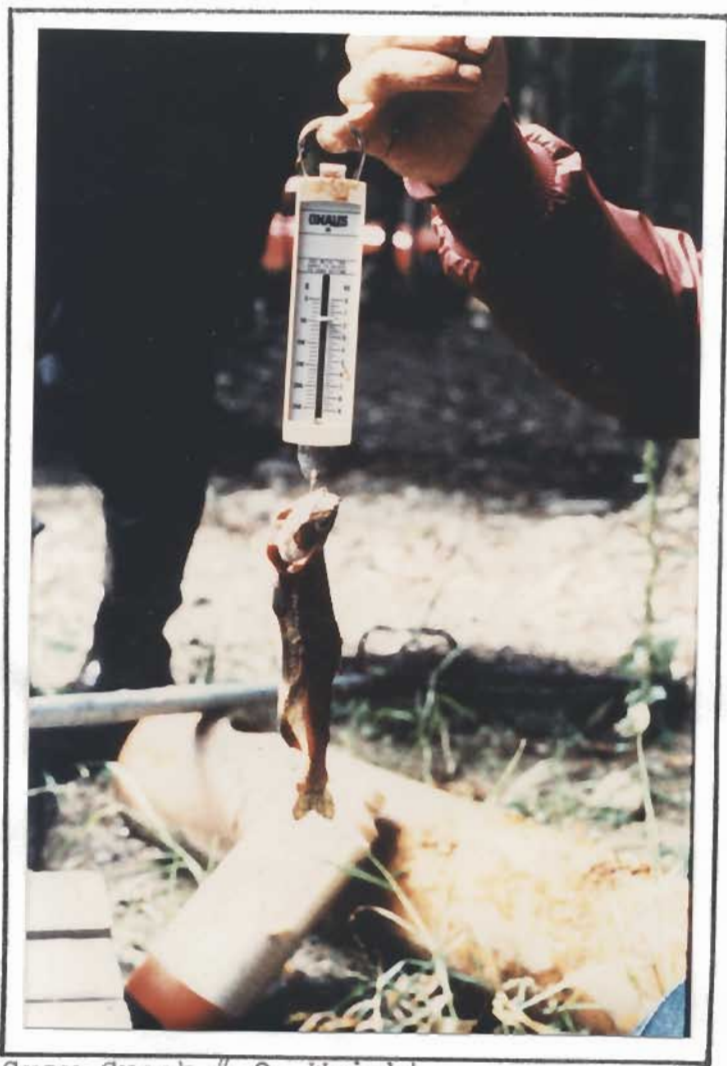
Gray Creek # 2 Weight

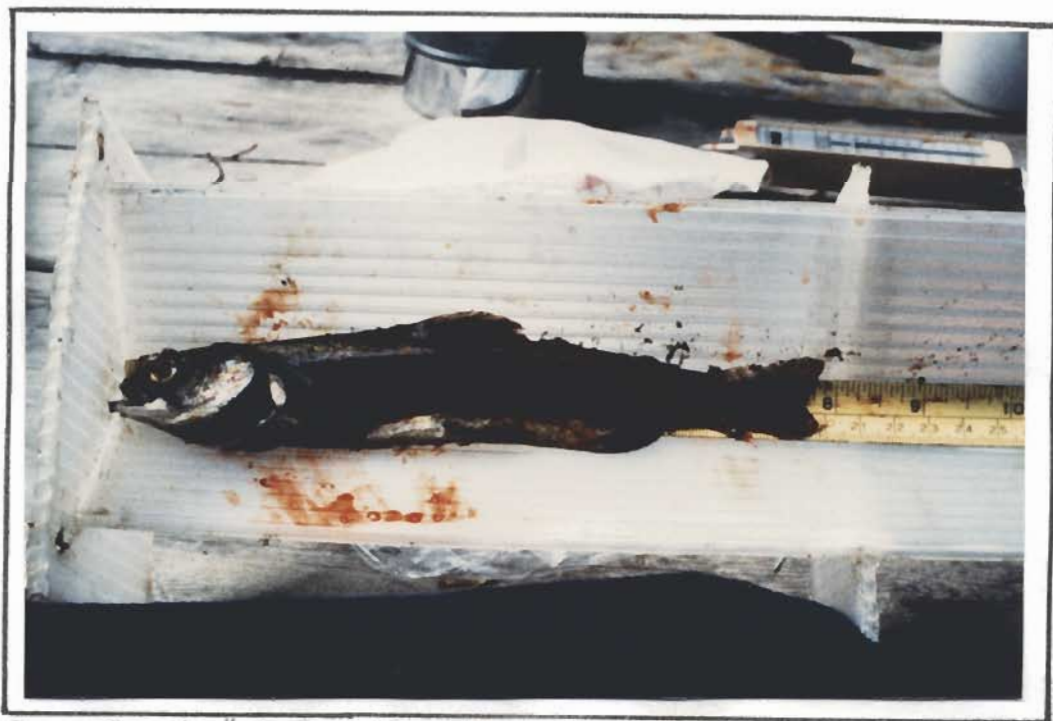
Gray Creek # 2 Length No Eggs Present

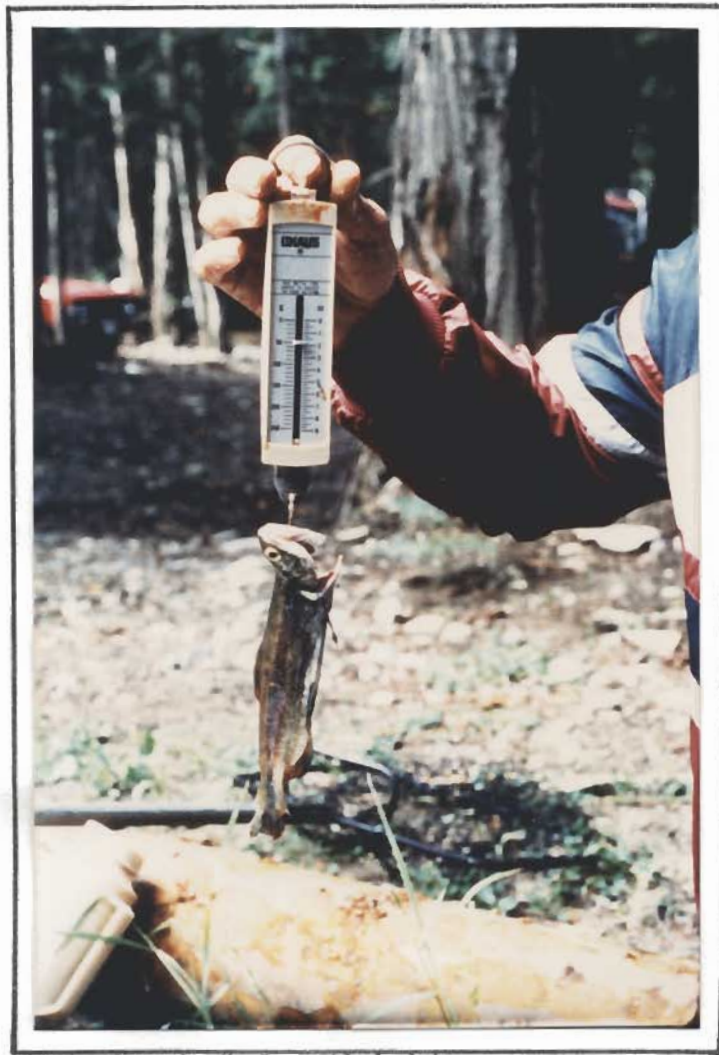
Gray Creek # 3 Weight

Gray Creek # 3 Length

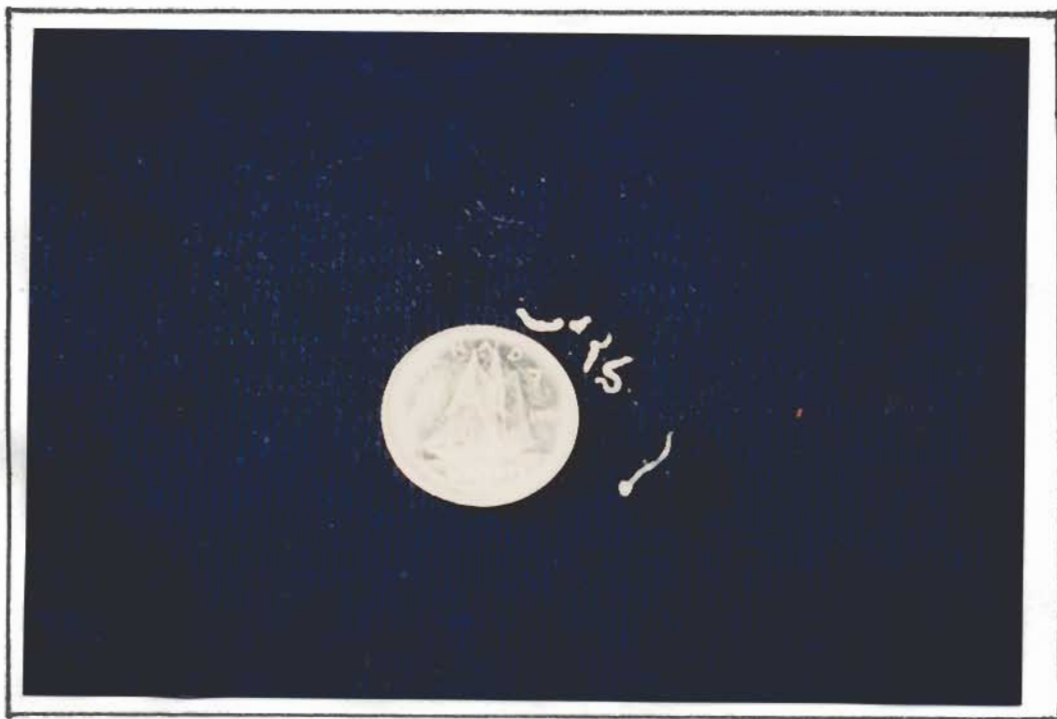
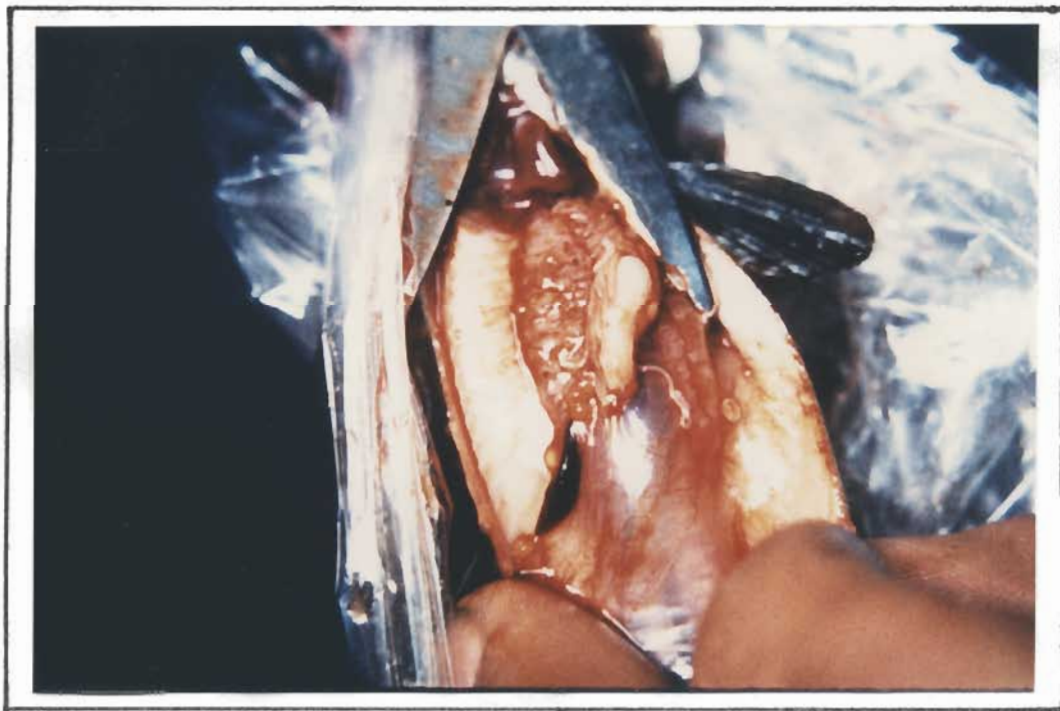
Parasites, found in several ♀ Kokanee.

Parasites, and undeveloped skeins.

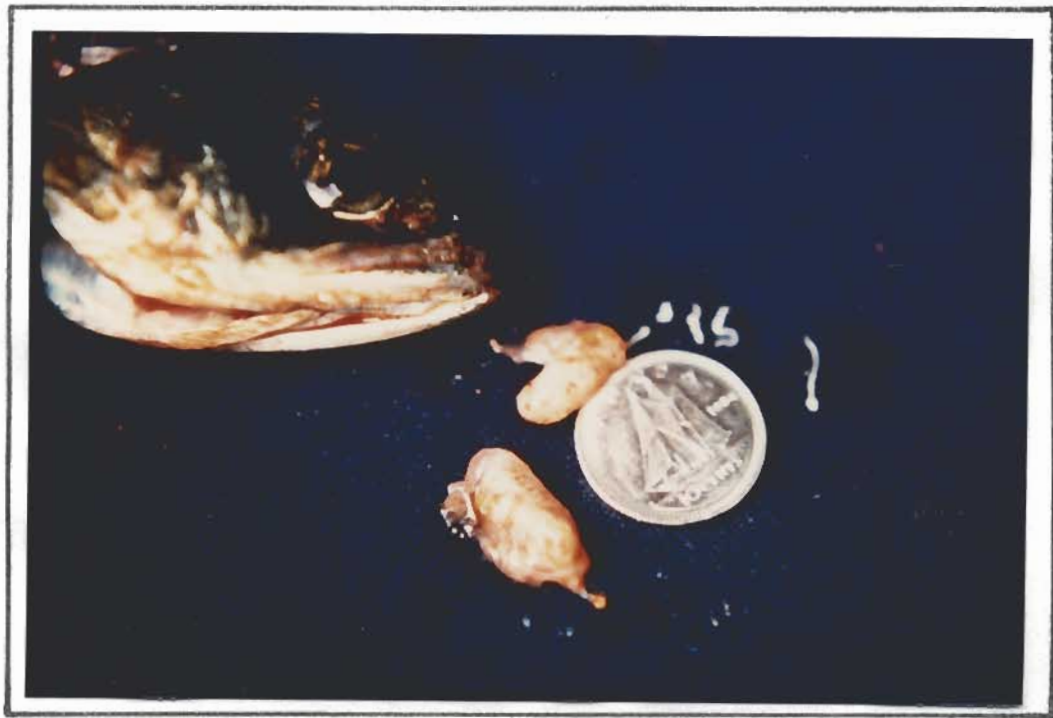
Comparison, undeveloped skeins and parasites.

Gray Creek, #3, eggs & undeveloped skeins.
