**FALLS RIVER HYDRO DAM  
Fisheries Restoration Feasibility Study**

prepared for  
**BC HYDRO FISH AND WILDLIFE BRIDGE COASTAL  
RESTORATION PROGRAM**

prepared by  
**Lana Miller, Don Hjorth and Jaison Van Tine  
Fisheries and Oceans Canada - North Coast Resource Restoration Unit**

**November, 2002**

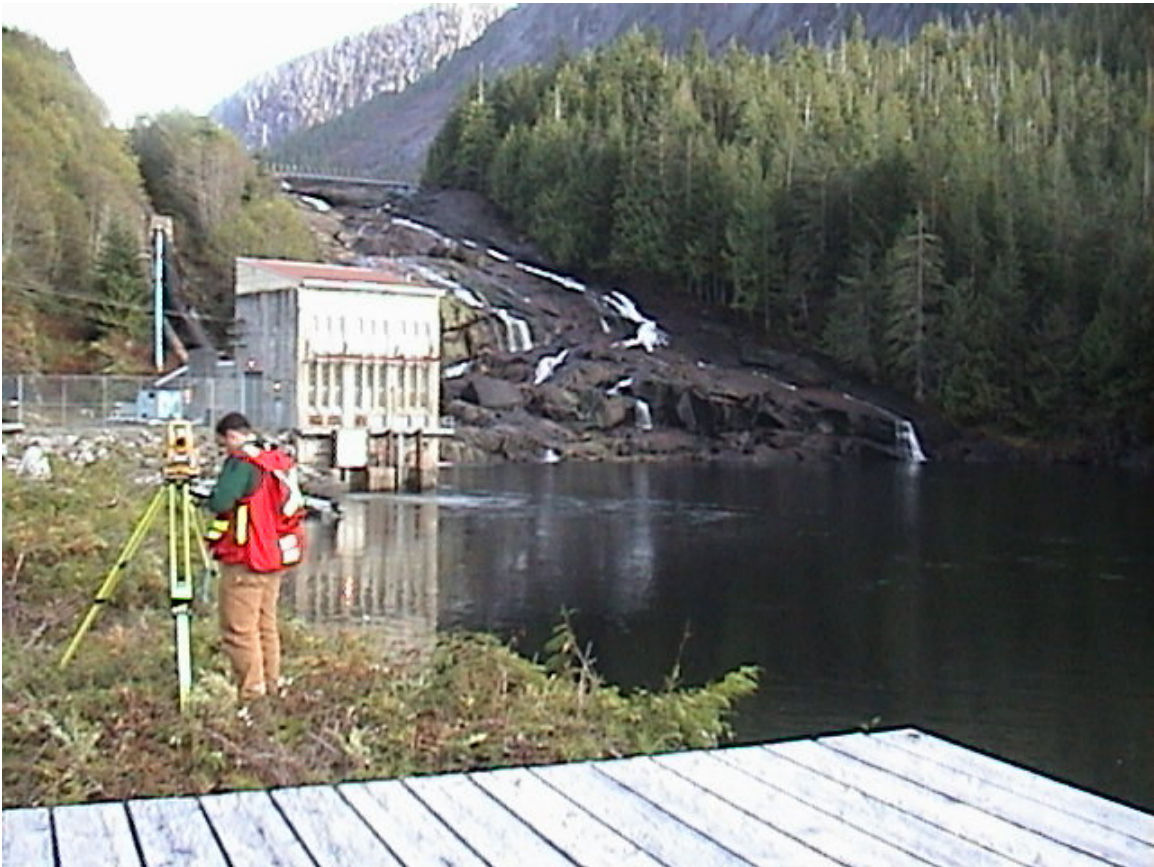
**Figure 3: Jaison Van Tine surveys the Falls River tail water pond**

A detailed topographic survey of the tail water pond and lower falls was completed using a total station, geographic positioning system (GPS), depth sounder and computer correction software (see figure 3 below).

The total station was used to collect topographic data above the water line and some specific points in shallow areas of the tail water pond. Most of the tail water pond was mapped for its topography with the use of the GPS, depth sounder, and computer correction software working together as a single unit.

Control points were established for both surveys so that the two sets of data could be combined.

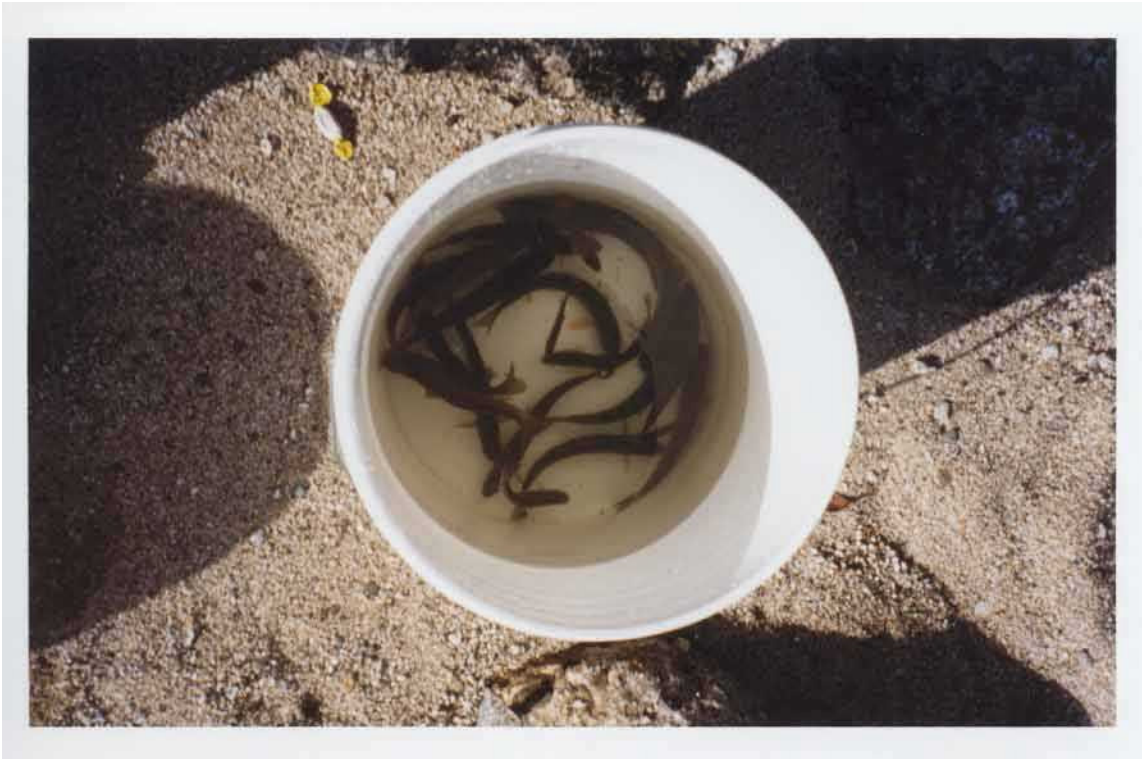
In general, Dolly Varden were found in traps placed at the base of the upper falls where water tends to be deep and fast. Coho were found in greater abundance in traps on the rip rapped right bank where the water is relatively shallow. Chinook juveniles were found in greater percentages in traps located in the middle of the tailpond and on the left bank, which is characterised by bedrock banks, deeper water and greater water velocities. See Figure 4 on page 13 illustrates fish captured near the base of the larger falls.

**Figure 4: Juvenile Fish Sampling**  
**Dolly Varden, coho and chinook in bucket**
