A. Project Number and Name 05-CH-02 Central Channel Estuary Restoration

D. Final Report Prepared by Edith B. Tobe,
May 25th, 2006

Final Report

05 CH 02
May 25th, 2006

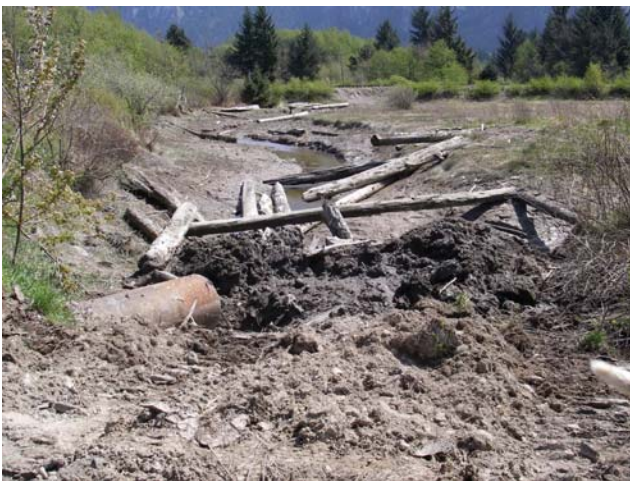
photo of last years (2004) project clearly showing culvert which will be removed. (facing east towards railway spur line along restoration channel)

As this project is phased, the next stage will be to put a secondary bridge across the former sewage outfall trail and remove a portion of the sewage pipe that has been decommissioned.

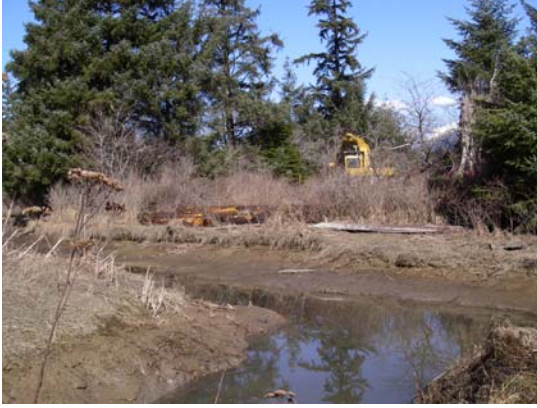
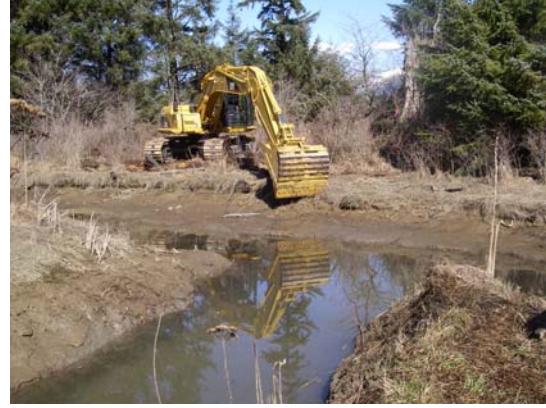
Initial clearing to connect with existing tidal channel

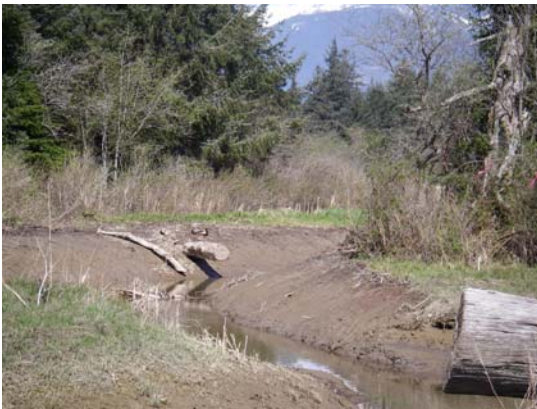
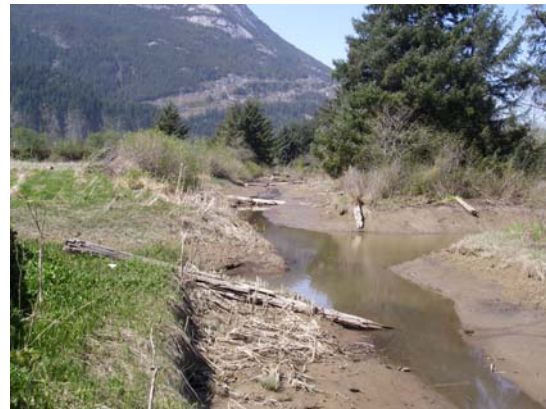
Low tide after Phase I complete

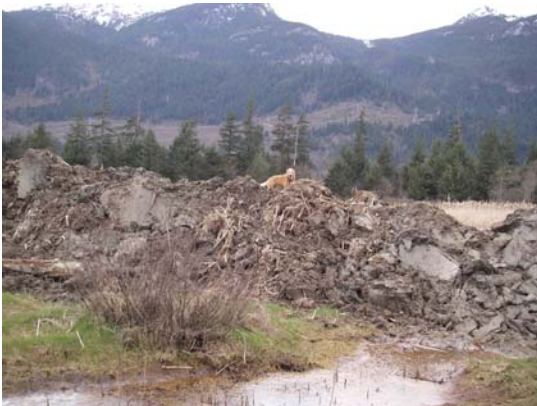
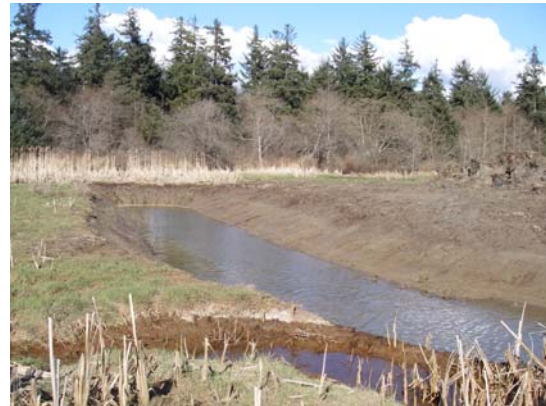
Sidecast pile before being flattened

And after

The contractor took special care to minimize any disturbance to the area and was able to construct the channels in a manner that the side cast material was less than a metre in elevation above grade. The side cast material was immediately seeded and planted up with native vegetation and shrubs to prevent any invasive species from growing. Care will be taken over the next few years to weed out any invasive species and maintain the estuarine meadow habitat. In order to minimize impacts, the contractor, John Hunter and Company, moved the excavator along a conveyor of logs that supported the weight of the unit and were moved along with the excavator. Although a somewhat slow and cumbersome technique the result is extremely limited impact on the estuary and any flattened vegetation inevitably returned to normal growth once the machinery was removed.

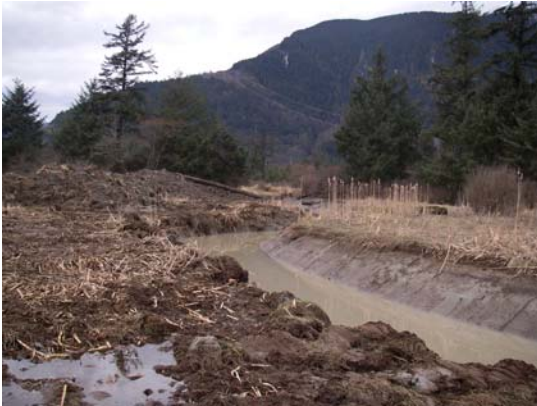
Facing south towards above shots

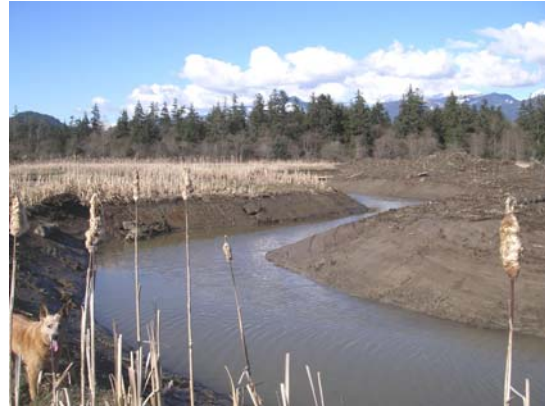
reaching completion

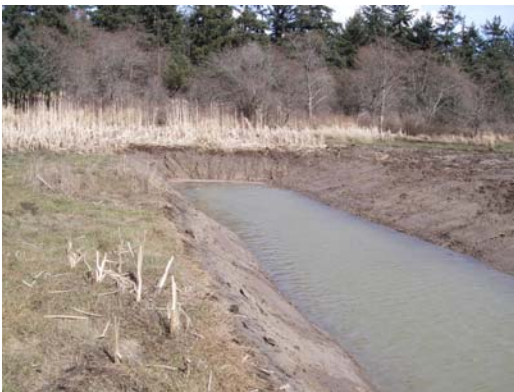
upper end (north) of phase I

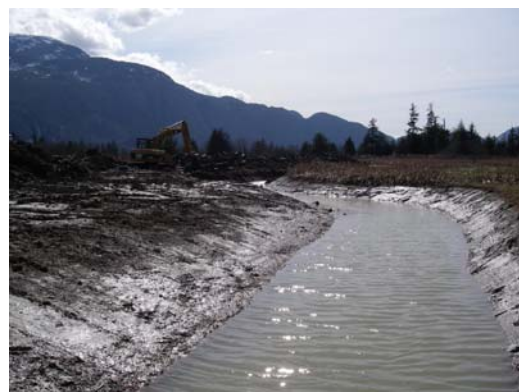
lower end (south)

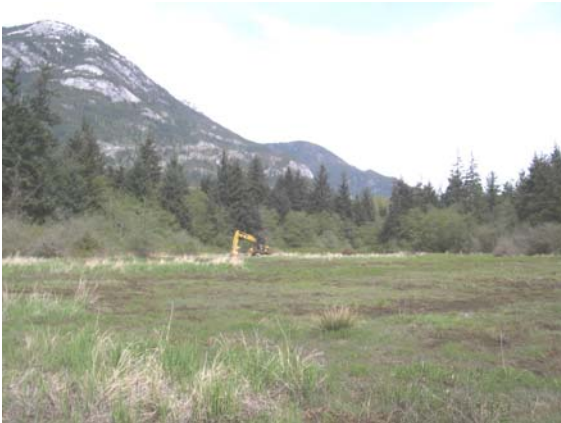
Getting started (north end of Site “A”)

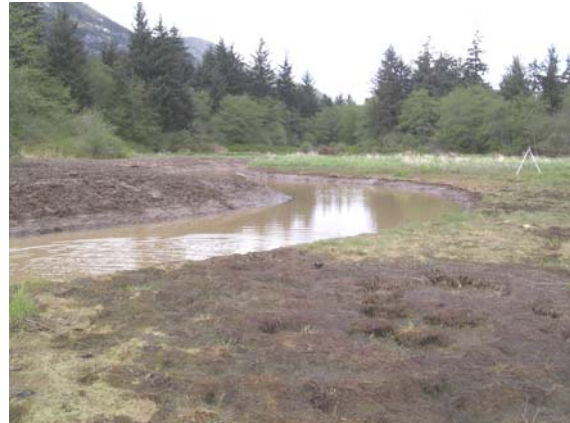
Later that week

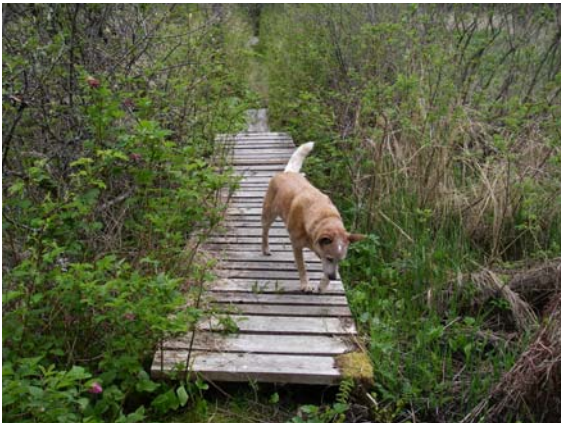
old bridge

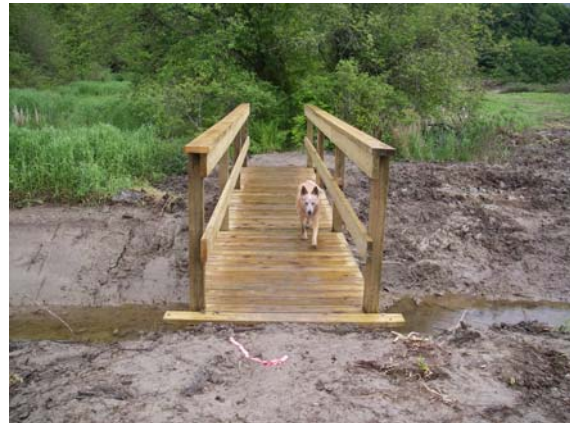
new bridge (with newly connected channel)

Over 2,000 linear metres or approximately 6,000 m² of new habitat was constructed to provide habitat for migratory and resident fish including Chinook and coho salmon that would have spawned in the upper Squamish watershed including the Cheakamus River. Signage was placed at key locations to identify the project and alert the public for any temporary disruptions to trail access. A new bridge was constructed along what is called the North Loop Trail.

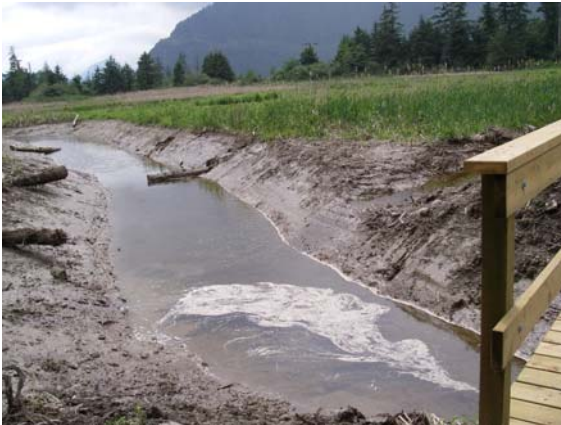
Downstream of new bridge – note how channel now connects with phase I

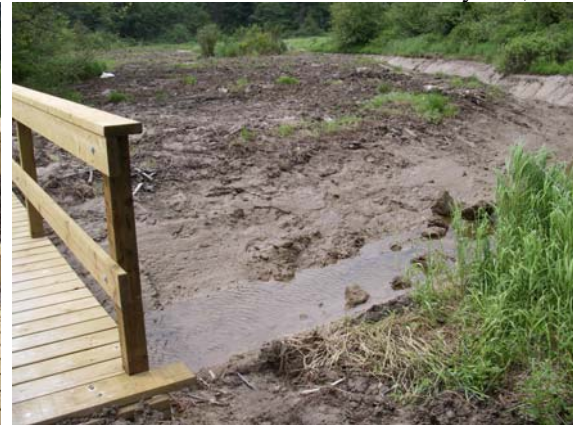
Upstream of new bridge

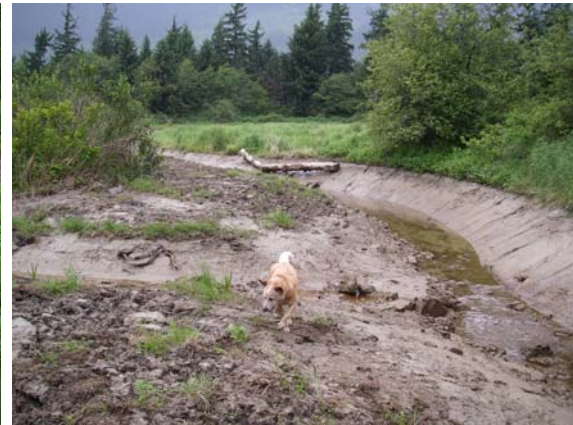
New channel facing west

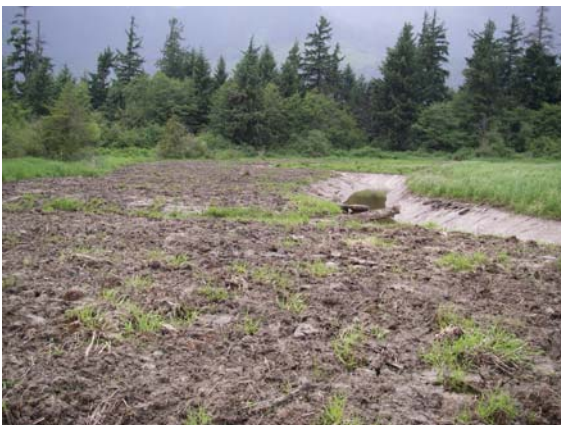
Wide angle view of Phase II channel

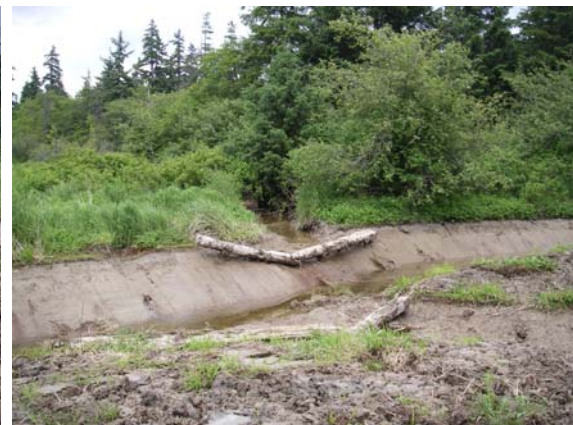
New tributary feeding into main

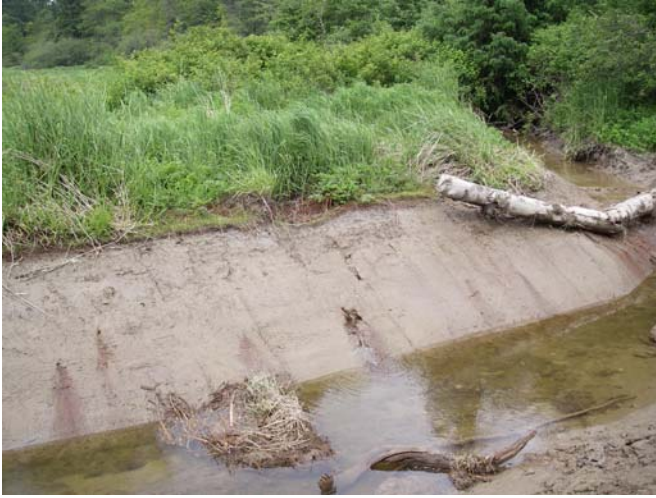
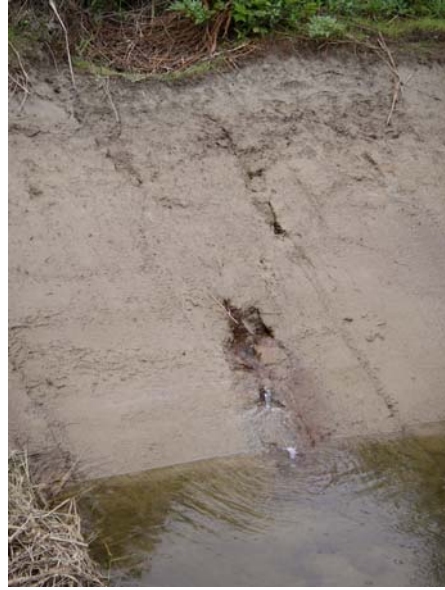
Notice piping (submerged channels) that allow seepage (right photo is close up)

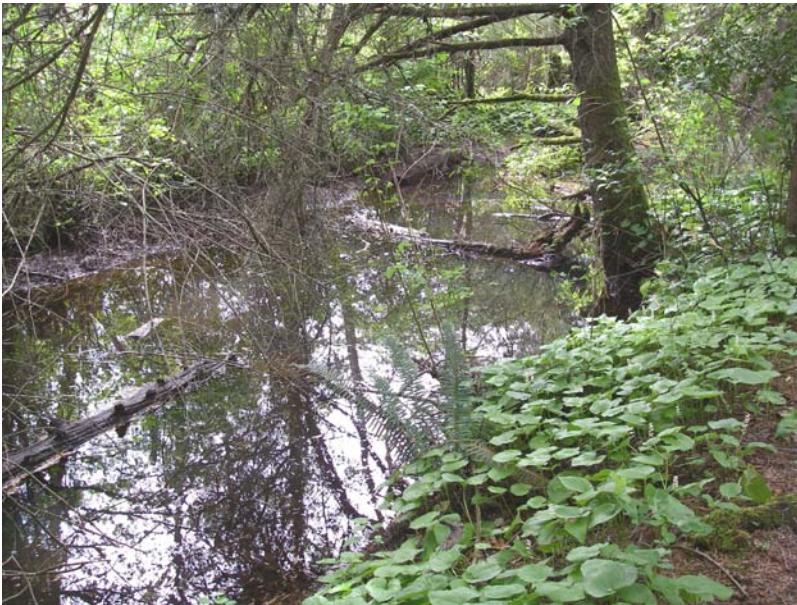
Current isolated channel (as seen from North Loop trail) which will be connected up to this years channel works in the future to permit fish access.

The recommendations are to continue to reconnect the isolated channels within this portion of the estuary and to establish permanent interpretive signage. Squamish Nation has begun a pilot project to place educational signage at specific fishing sites. The hope is to incorporate these style of signs in the estuary. Furthermore, the estuary is becoming an increasingly important destination for pedestrian traffic and residents and visitors and looking for nature hikes and peaceful sites to visit. The tidal salmon channels help to provide such a destination and are being well received by the community as a whole.
