## A Reconnaissance Survey Of Spring Lake

M. J. Hunter  
March 1997

**A RECONNAISSANCE SURVEY OF  
SPRING LAKE**

**WATERSHED:** Williston Reservoir (Parsnip Reach)  
**DATE OF SURVEY:** July 12 - 13, 1996  
**FIELD CREW LEADER:** Mark Hunter  
**FIELD ASSISTANT:** Karin Mathias  
**REPORT PREPARED BY:** Mark Hunter

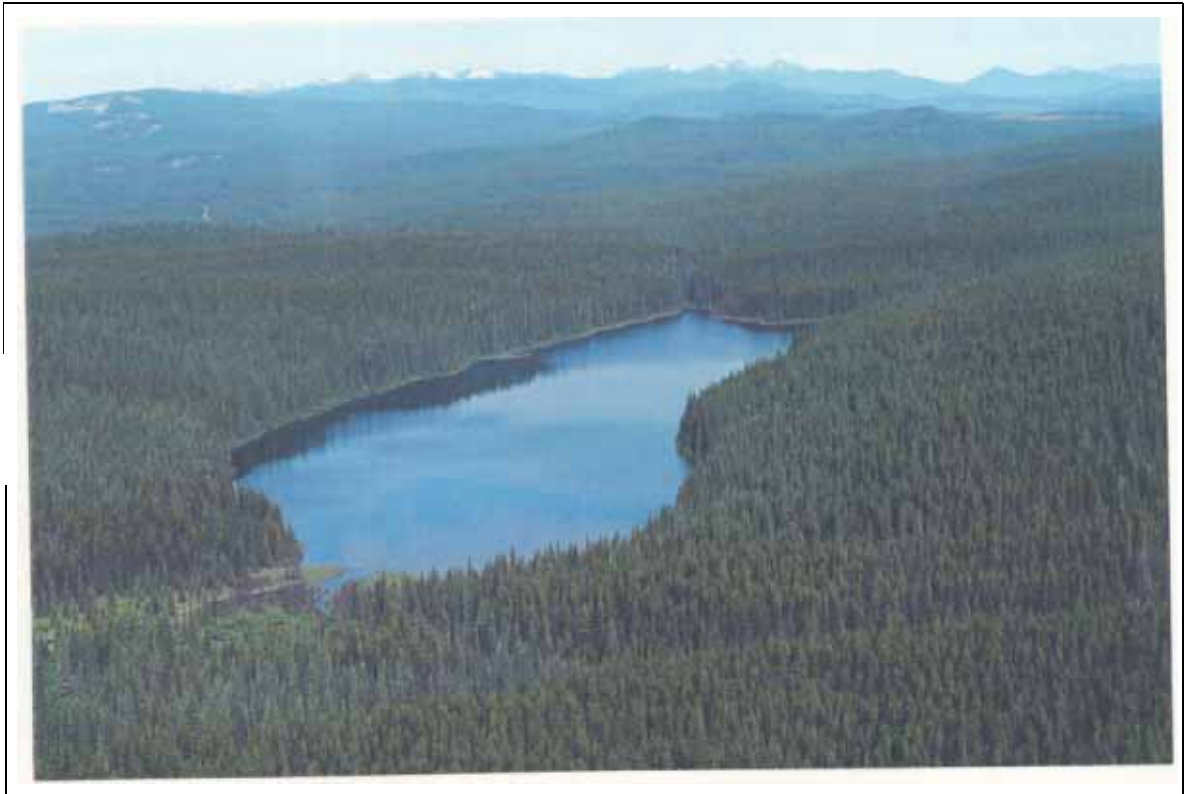
**LAKE: Spring Lake**

**Plate # 1:** Aerial view of Spring Lake looking northwest.

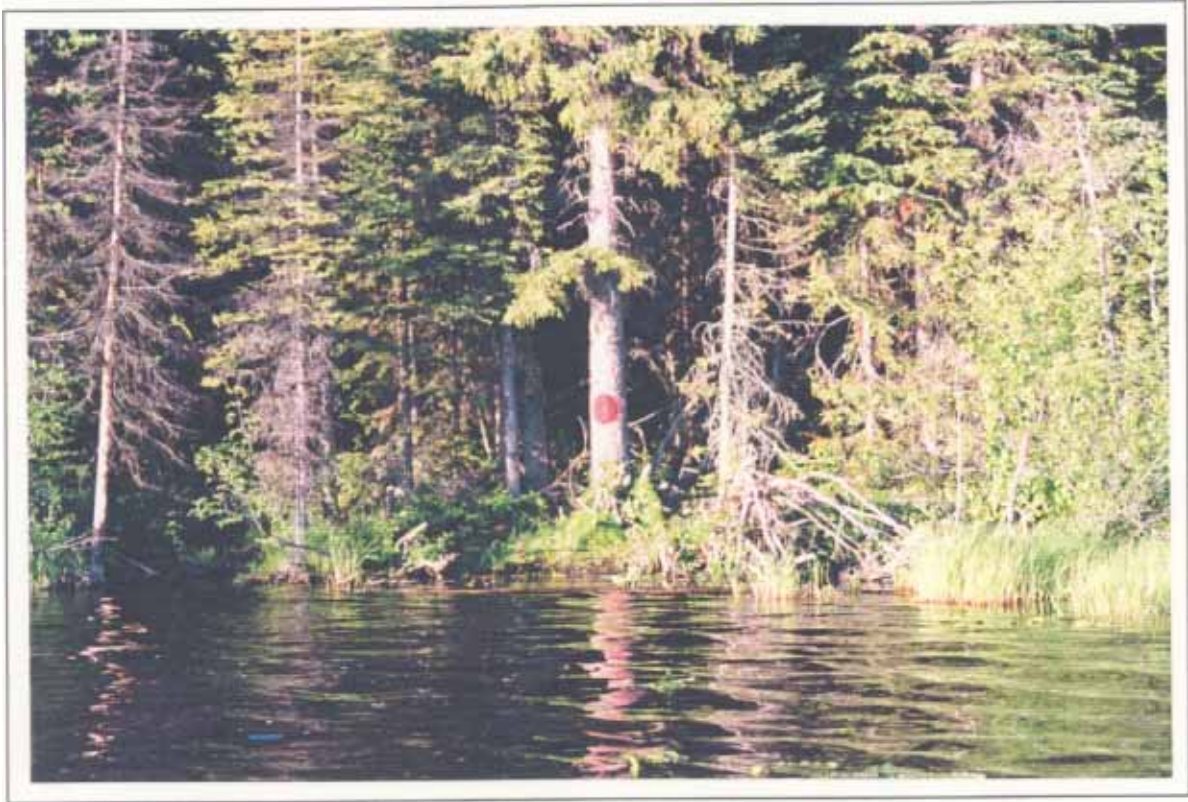
(Iron spike, center of red circle) located 2.0 m above present water level in a 31 cm diameter spruce tree that is 2.6 m from the present water's edge and located approximately 90 m northeast of Inlet # I (Plate # 4).

**Plate # 4:** View of the benchmark located 2.0 m above present water level in a 31 cm diameter spruce tree that is 2.6 m from the present water's edge and located approximately 90 in northeast of Inlet # 1.

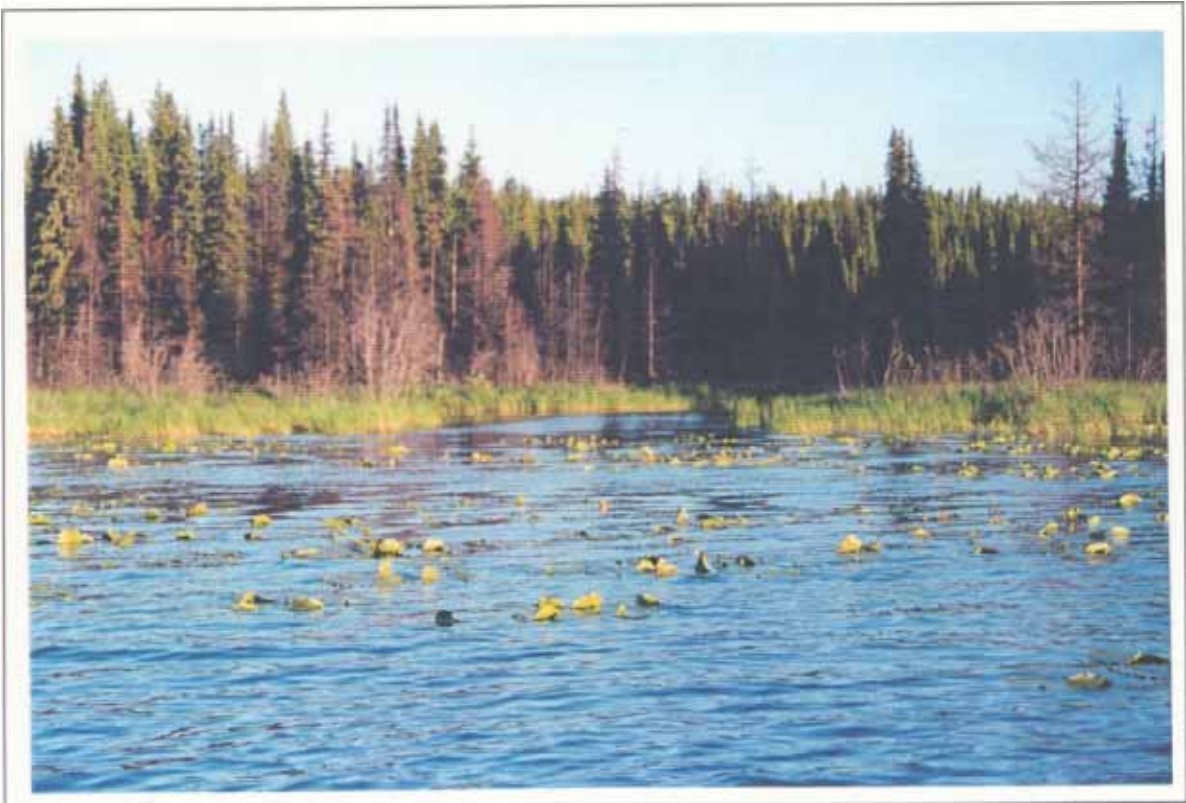
The large bed of yellow waterlily (Nuphar sp.) found in the southeast end of the lake is difficult for motor boats to pass through without the propeller becoming wrapped in weeds (Plate # 5).

Inlet # 1 enters Spring Lake in the southeast end of the lake through the swamp (Plate # 5). The first 40 m has an average wetted width of 1.3 m and depth of 0.6 m. The channel becomes braided approximately 40 m upstream from the lake. Approximately 80 m upstream of the lake, there is a beaver dam that is 0.75 m high and roughly 100 m long. Water flows over the top of the dam in many spots to feed the different braids of the creek; however, there was probably not enough flow over the top of the dam to allow for upstream fish passage at the time of survey. Upstream of the dam, there are two channels that converged.

**Plate # 5:** View of the mouth on Inlet # 1 where it enters Spring Lake in the east end of the lake. Note the large bed of Yellow Waterlilies (Nuphar sp.).

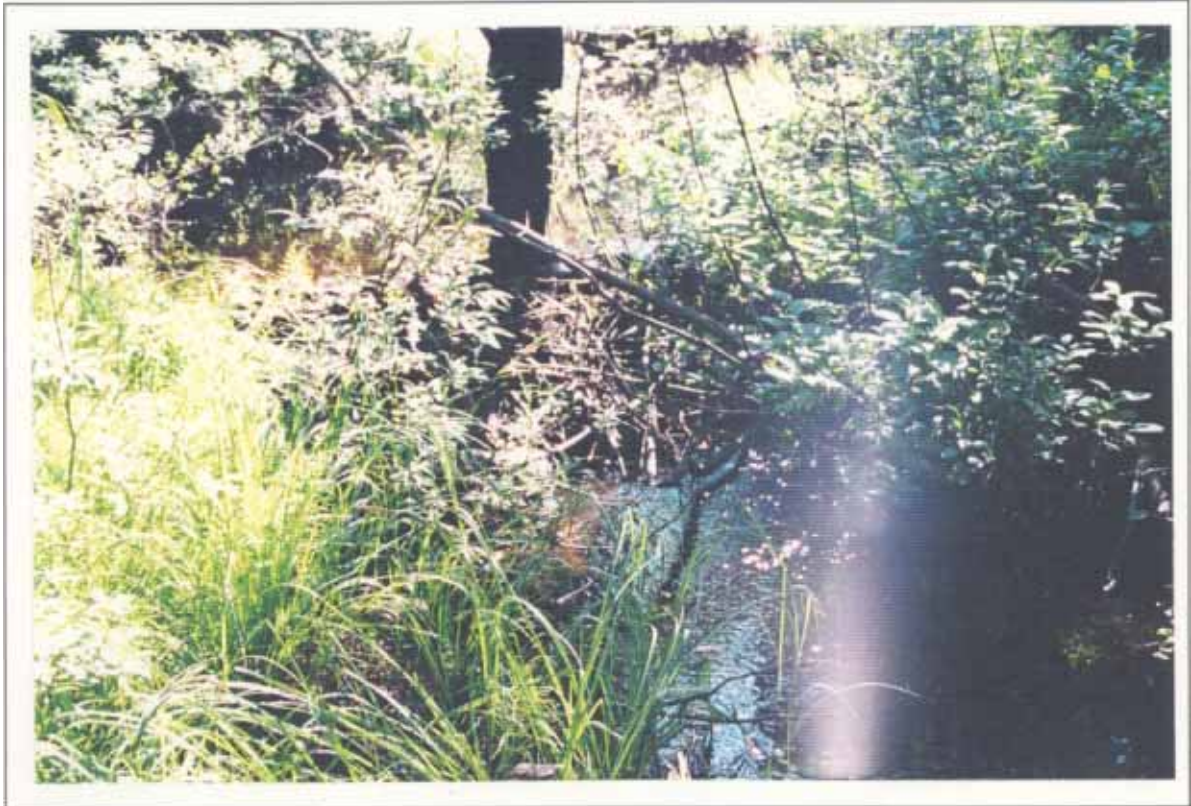
Channel # 2 flows from the east into the swamp. Approximately 110 m upstream from the lake, there is a 0.4 m high and 25 m long beaver dam with a beaver hut built on it. Redside shiners were seen in the pool on the upstream side of the dam. Approximately 140 m upstream from the lake, there is a 0.6 m high and 5 m long beaver dam (Plate # 6). The substrate of the pool on the upstream side of the dam is gravels and small cobble covered by silts and organics. Some rainbow trout (approximately 10 cm long) and redside shiners were seen in this pool. Approximately 170 m upstream from Spring Lake, there is good to excellent rainbow trout spawning substrate (small and large gravels) in a channel that has an average wetted width of 1.3 m and depth of 0.2 m. Further upstream, there are three debris jams located approximately 190 m, 225 m and

**Plate # 6:** Upstream view of beaver dam # 3 on Channel # 2 of Inlet # 1, located approximately 140 m upstream of Spring Lake.

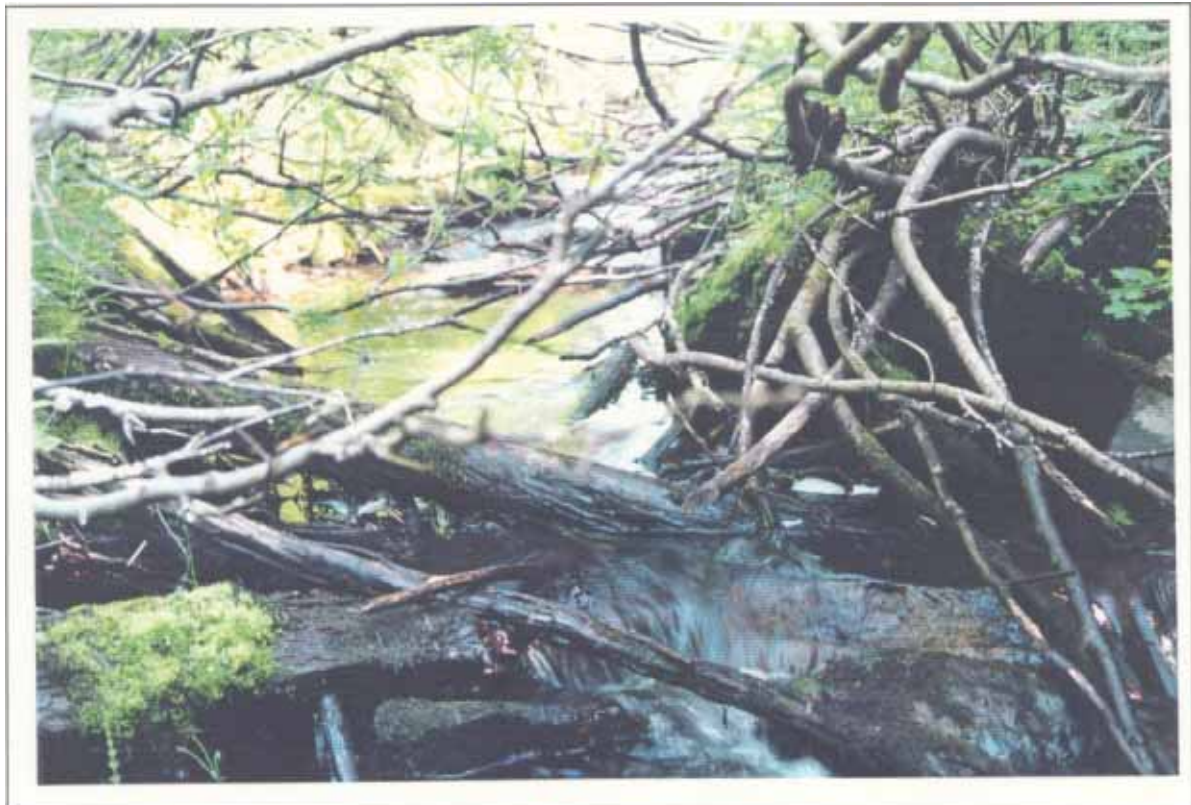
A Stream Survey card was completed for a sample site located approximately 230 m upstream from Spring Lake (Plates # 7 - # 8). The average wetted width is 1.8 m and the average maximum riffle depth is 0.14 m. The substrate is comprised of gravels (45%), fines (40%), cobbles (10%) and boulders (5%). The fines are located mainly on the sides of the channel, and the gravels and cobbles are in the middle. The creek morphology is mainly riffle and run (40% each). The water temperature was 15°C at the time of survey. For additional information, refer to Appendix B.

**Plate # 7:** Upstream view of the sample site on Channel # 2 of Inlet # 1, taken approximately 220 m upstream of Spring Lake.

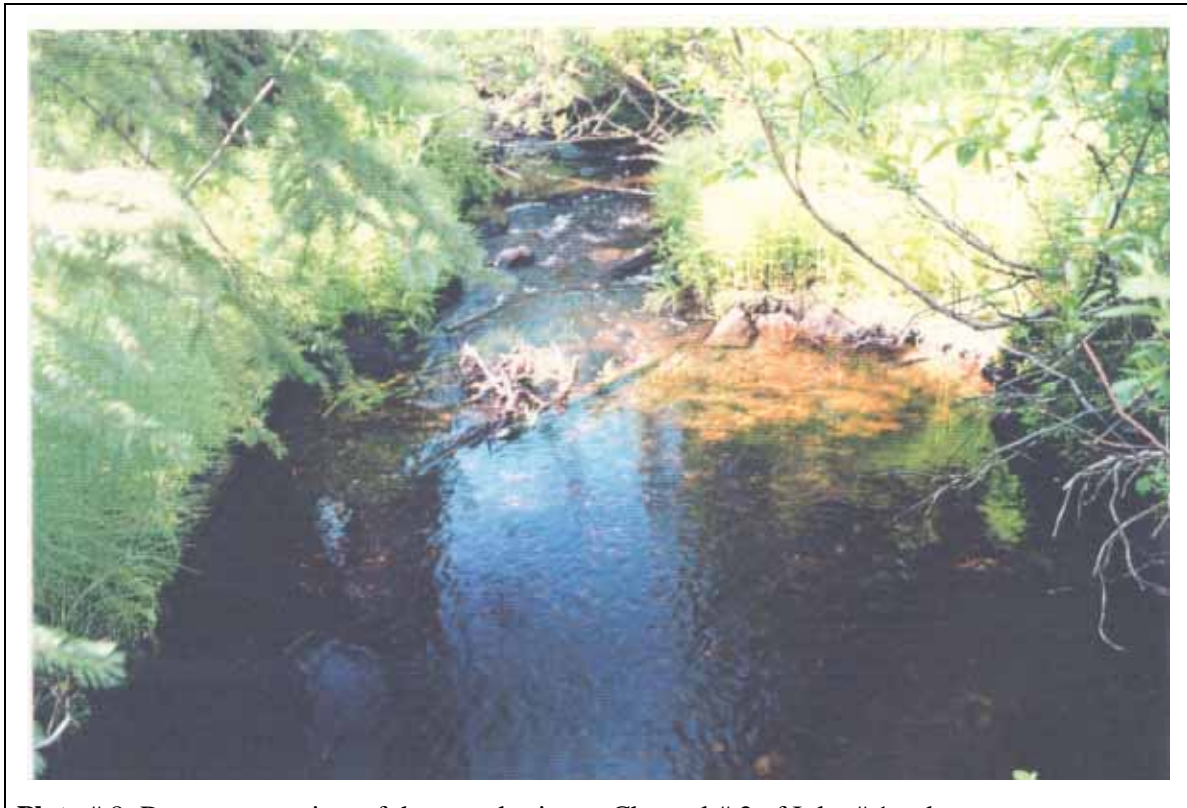
**Plate # 8:** Downstream view of the sample site on Channel # 2 of Inlet # 1, taken approximately 230 m upstream of Spring Lake.

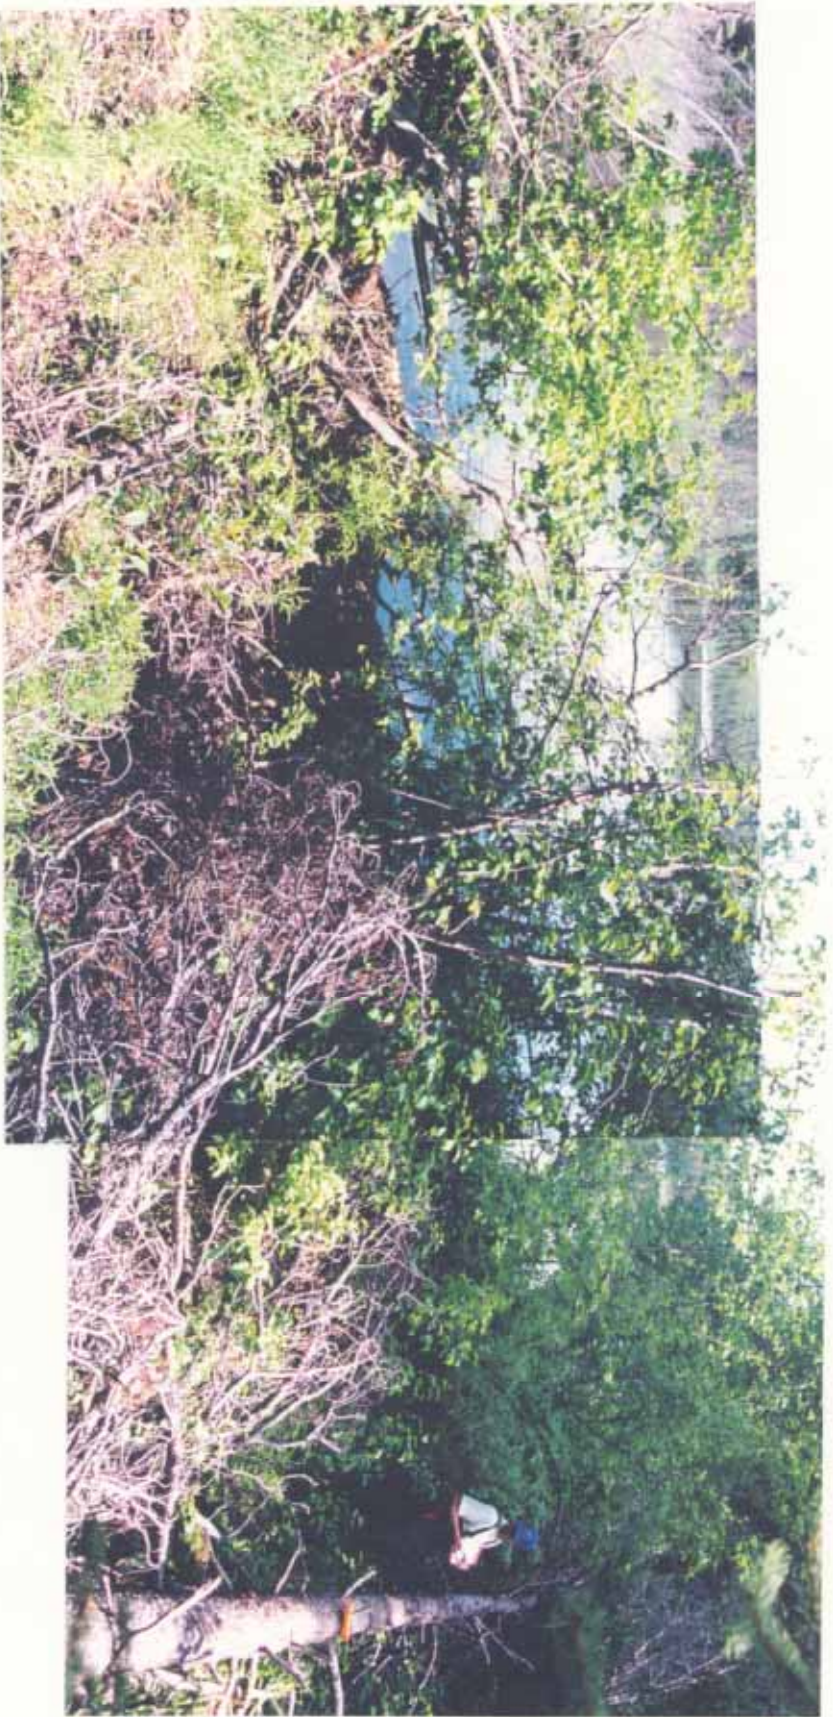
The outlet creek flows through a 1.1 m high and 20 m long beaver dam that is located at the lake's edge (Plate # 9). Willows and alders have become well established on the top of the dam, and there is no flow over the top of the beaver dam. Approximately 30 m downstream from the lake, there is a 0.1 m high debris jam. Approximately 50 m downstream from the lake, there is a second debris jam that is 0.2 m high. Approximately 90 m downstream from Spring Lake, three small rainbow trout (approximately 10 cm long) were seen feeding on the surface; some redbreast shiners were also seen here. Approximately 115 m downstream from the lake, a small inlet enters the outlet creek on the right side (looking upstream). The channel is overgrown by a moderately thick growth of alders and there is a large amount of blowdown over the creek.

**Plate # 9:** Upstream view of beaver dam # 1 on the outlet. The dam is 1.1 m high and is located at the mouth of the outlet.

Spring Lake sustains a moderately sized population of rainbow trout that could support a low use fishery. Putting a partial breach in the beaver dam located at the mouth of the outlet would allow for access to the spawning substrate in the outlet creek for the rainbow trout in Spring Lake. At the moment, downstream passage is probably not possible because water flows through the beaver dam, not over it. If access was made possible to more spawning habitat, the rainbow trout population may grow, and then the lake may be able to support a higher use fishery. Oxygen and pH levels were sufficient throughout the entire water column for supporting a fish population.

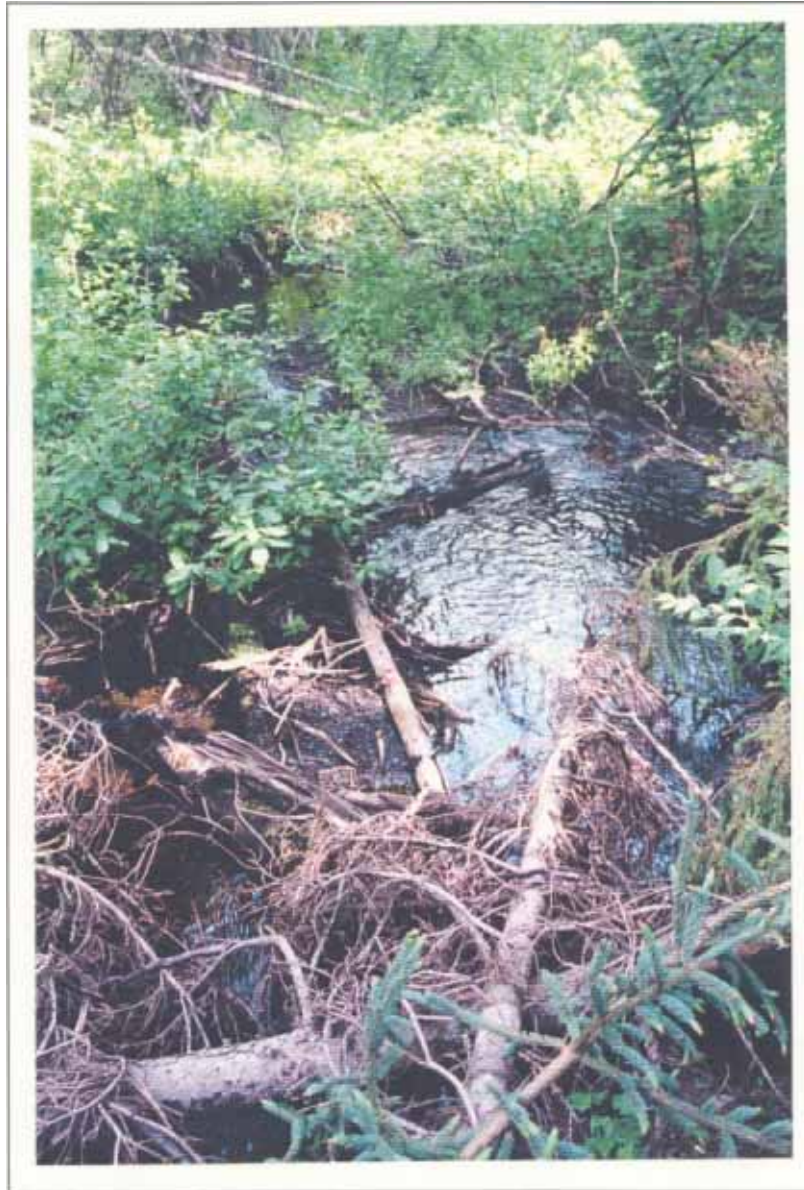
A Stream Survey card was complete for a sample site located approximately 120 m downstream from the lake (Plates # 10 - # 11) . The average wetted width is 3 m and the average maximum riffle depth is 0.22 m. The substrate is comprised of gravels (60%) and fines (40%), and offers areas of good spawning habitat (Plate # 12). The creek morphology is mainly run (45%) and riffle (40%). The water temperature was 18°C at the time of the survey. For additional information, refer to Appendix B.

**Plate # 10:** Upstream view of the sample site on the outlet, taken approximately 130 m downstream of Spring Lake.

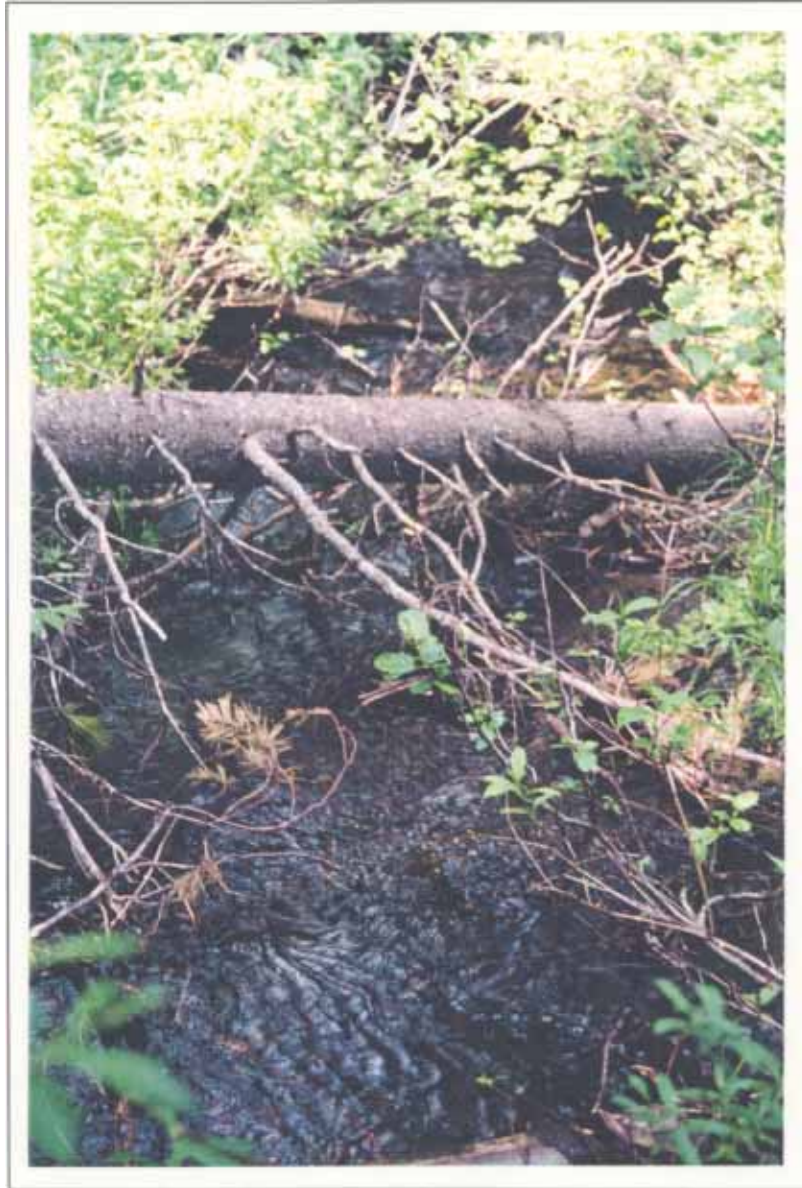
**Plate # 11:** Downstream view of the sample site on the outlet, taken approximately 110 m downstream of Spring Lake.

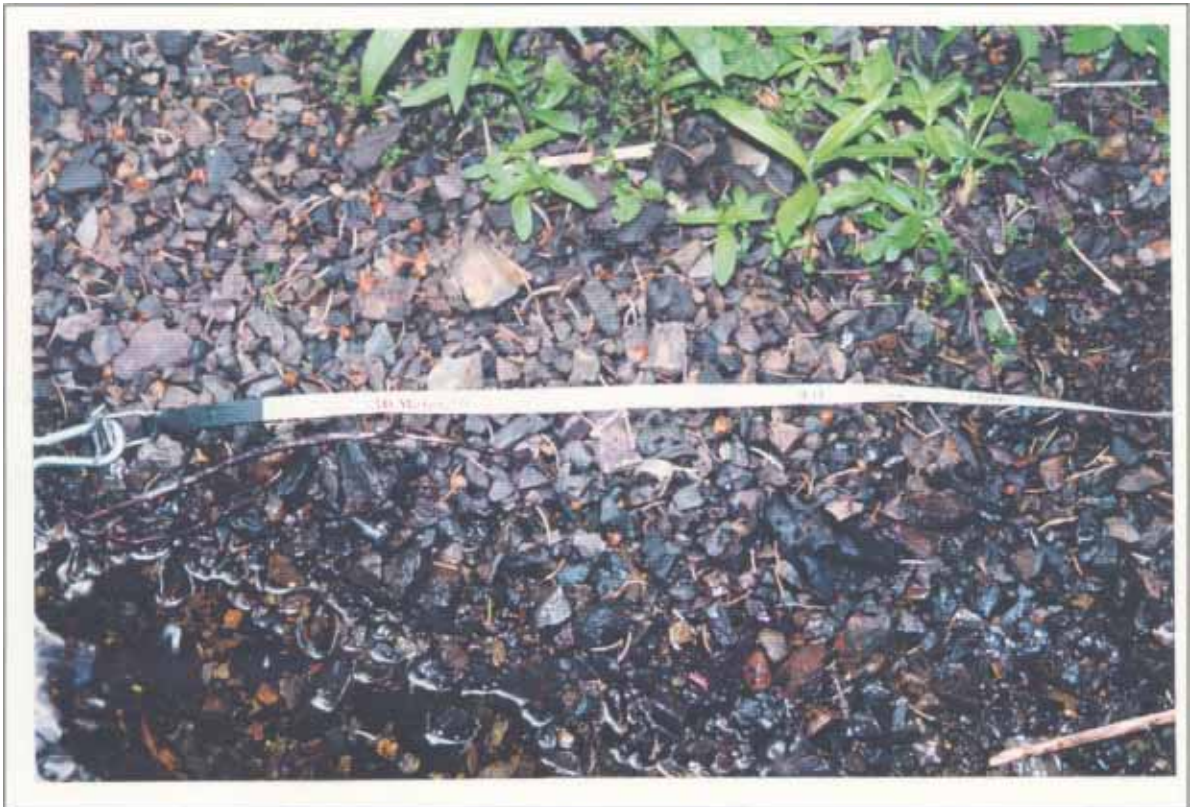
**Plate # 12:** View of the typical gravel substrate found in the sample site on the outlet.

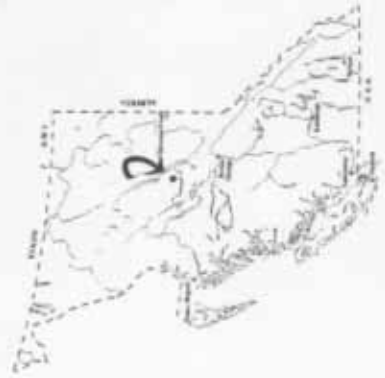
**BATHYMETRIC MAP**

NOTES: 1 - Depths are in meters. 2 - Inverted Bench Mark. 3 - Not intended for navigational use. Uncharted rocks and shoals may exist.
