Stave River Spawning Habitat Restoration Project Final Report

BCRP Project # 07.SFN.01

March 20, 2008

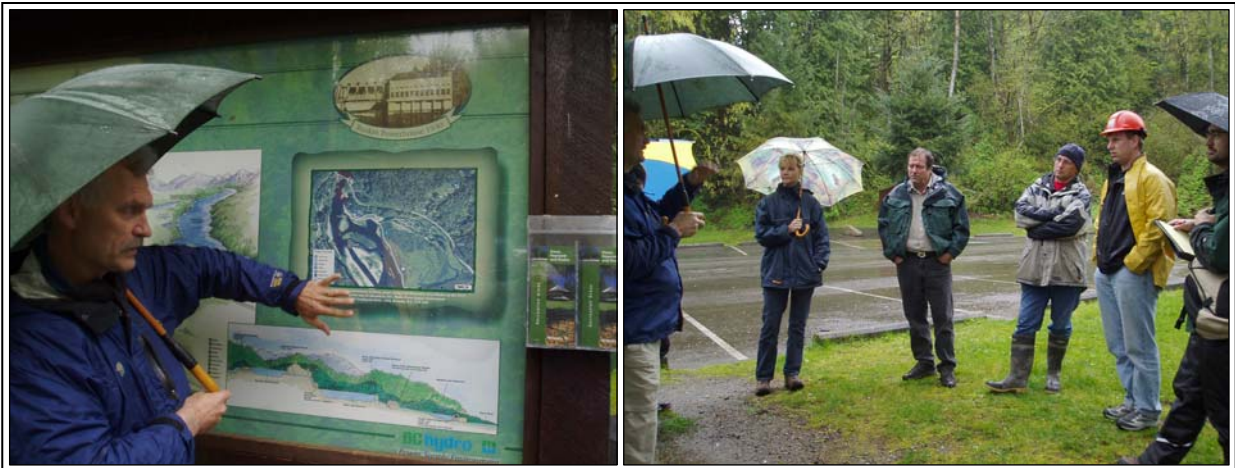
Figure 2. Site meetings and project planning (April 2007)

Project planning was initiated in April 2007 (Figure 2) with a site meeting involving the FVRWC, DFO, BC Hydro, and the Kwantlen First Nation. The restoration strategies shown to be effective on the lower Stave River by Fisheries and Oceans and BC Hydro in 2006 involved the use of heavy construction equipment to move gravel from within the existing floodplain to areas where they are useful to spawning salmon and to where they provide a protective barrier against erosive water flows. The gravel bed of the river is then contoured such that any water released from the dam flows evenly across all of the spawning grounds. Due to the successful efforts in 2006, the same approach was planned for 2007.

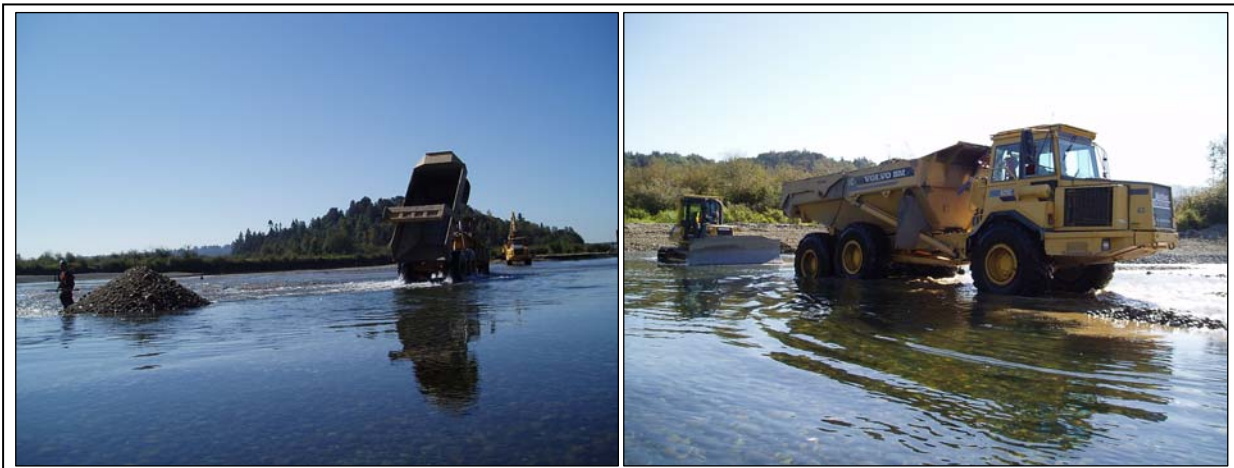
Figure 3. Project construction (September 2007)

Due to high water levels in the Fraser River throughout the month of August, the project was delayed for over two weeks until water levels receded sufficiently to allow in-stream works to be safely conducted in the project area. Consequently, project surveying to determine stream bed and gravel bar elevations, and final project design, was not able to commence until September 7. Project construction (Figure 3) began on September 10 and proceeded until September 19.

Unfortunately, due to the original project delay resulting from high Fraser River water levels, project construction was limited both in the number of hours per day and the number of days because of shorter daylight available and uncooperative tidal periods, as well as the presence of salmon beginning to return to the system to spawn. This resulted in the project coming in significantly under budget due to the reduced machine time used on the project.

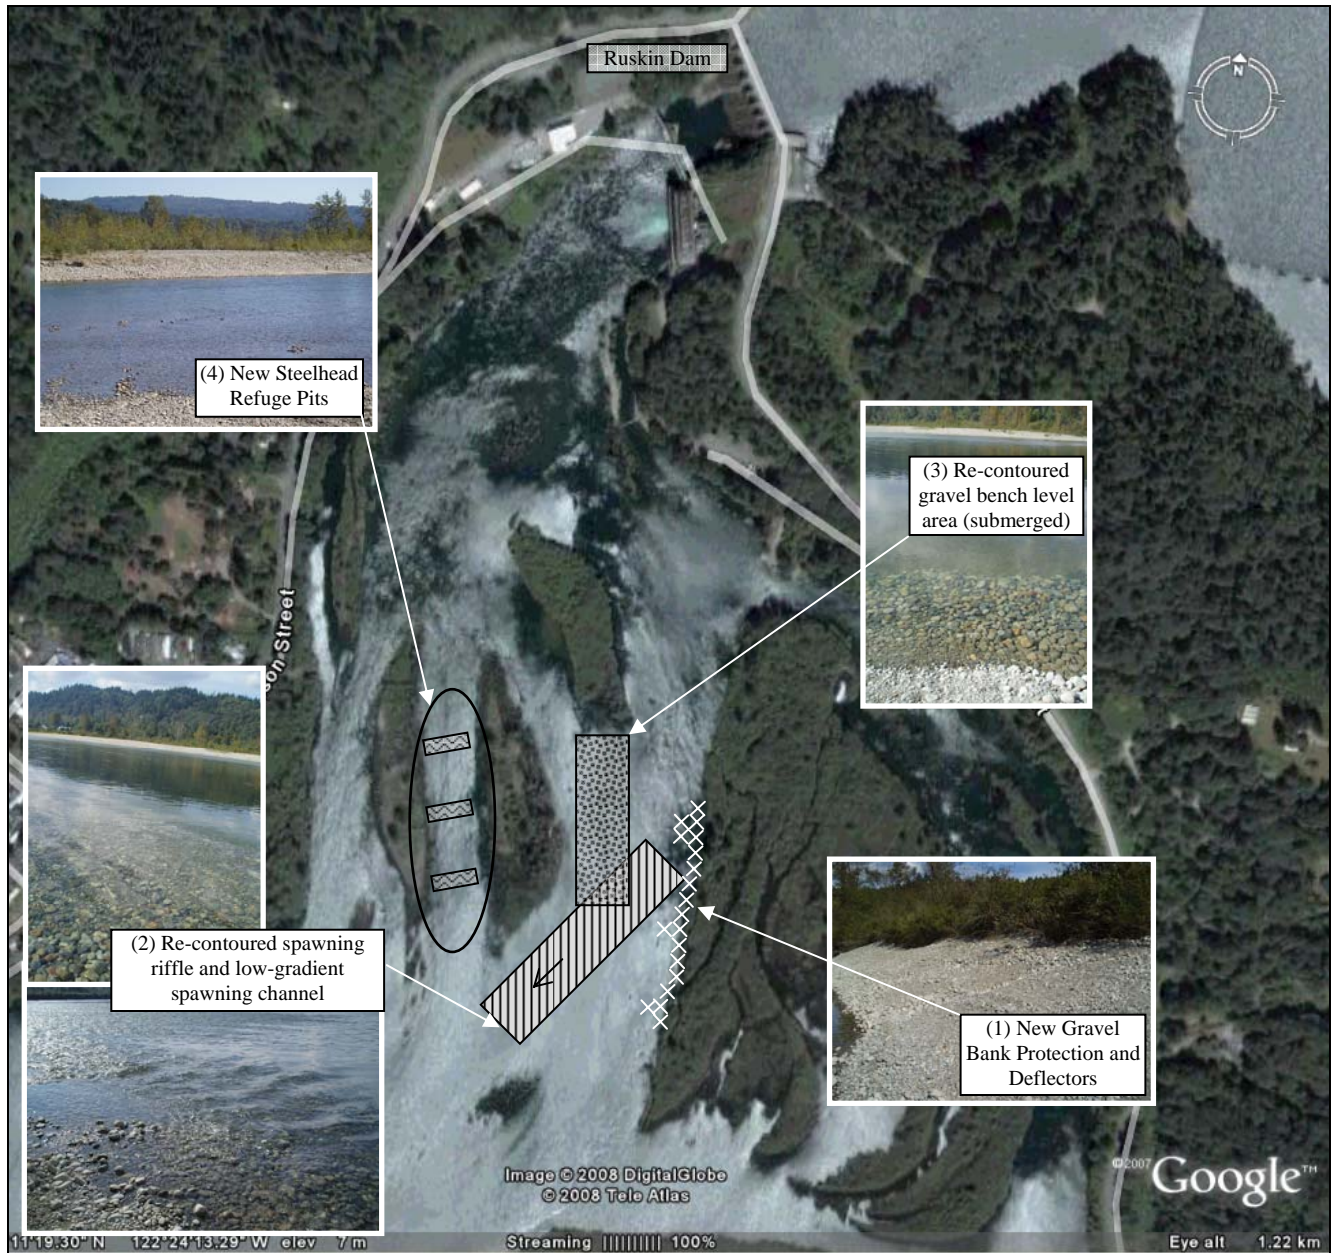
- (1) Substantial shoreline protection (~175 m) along the eastern bank using on-site gravel, to help protect the bank from further erosion resulting in siltation of spawning beds and risking damage to important cultural and archaeological sites and artifacts;
- (2) Recontouring of streambed gravel to create 150 m long spawning riffle and 120 m long spawning channel in the eastern channel;
- (3) ~150 m long spawning bench, also in the eastern channel;
- (4) Three deep water trenches perpendicular to stream flows in the central channel, creating refuge pits for steelhead and other salmonids during h flows.

Figure 5. Final project results and locational map of (1) bank protection, (2) re-contoured spawning riffle/channel, (3) gravel bench, and (4) new steelhead refuge pits

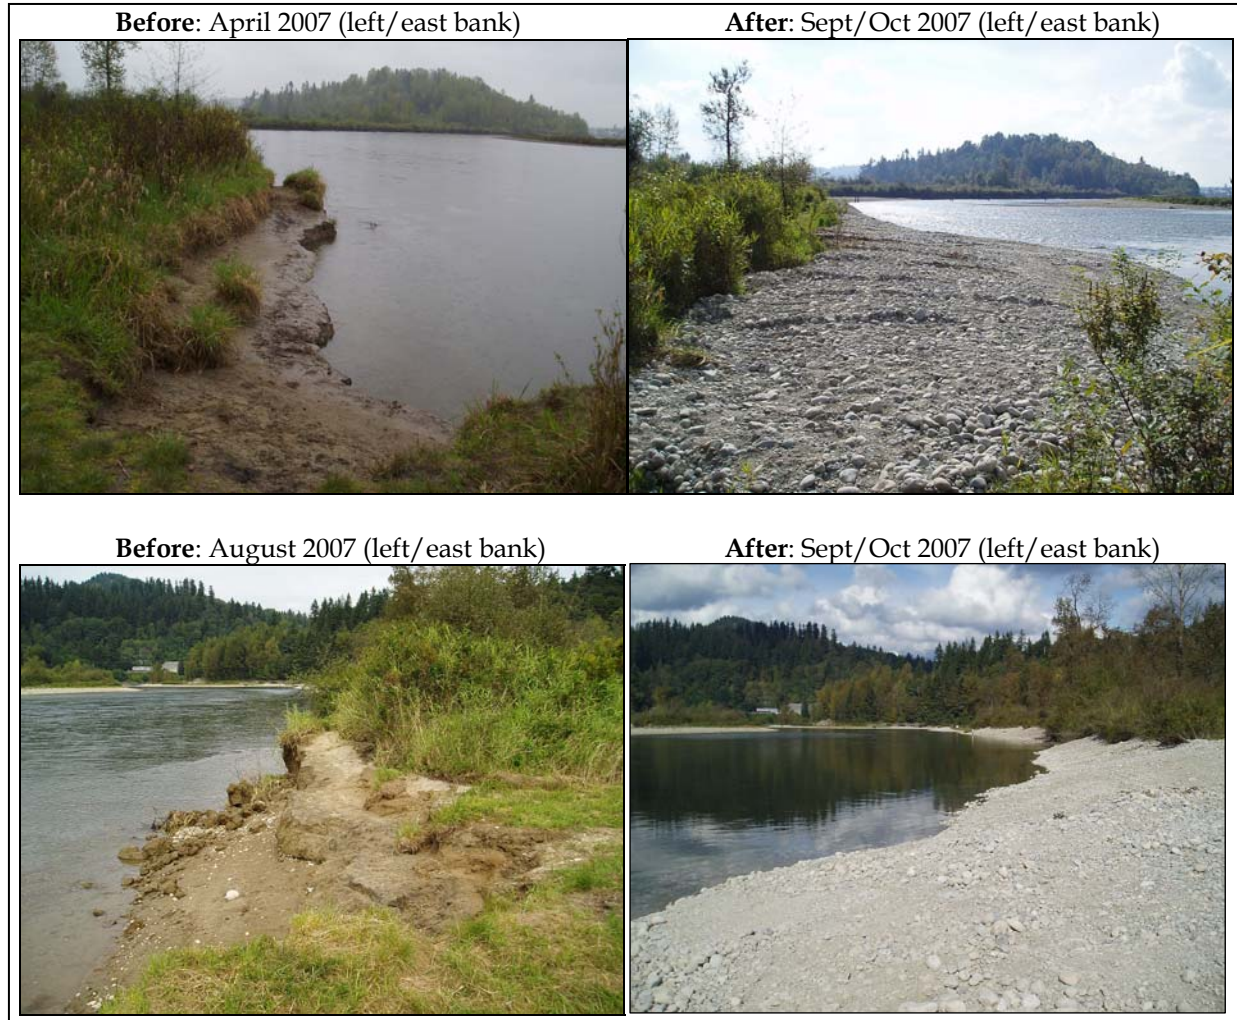
Figure 6. Photos of the eroding (east) bank comparing pre- and post-project conditions

Figure 6 shows photos of the east (left) bank before and after the project, showing the bank protection provided to these previously-eroding sites as a result of the project. The gravel used to stabilize the bank was taken from elsewhere on the site while recontouring the streambed to allow for improved spawning habitat conditions.

(2) Stabilize the east bank from further erosion	Gravel from the streambed was pushed towards the eastern bank, protecting the shoreline from further erosion and protecting the cultural and archaeological value of the site. <i>Conclusion: Successful</i>
