**CLAYTON FALLS SPAWNING CHANNEL
ENVIRONMENTAL ASSESSMENT**

OCTOBER 2004

Prepared by
Sigma Engineering Ltd.
1444 Alberni Street, Vancouver BC. V6G 2Z4

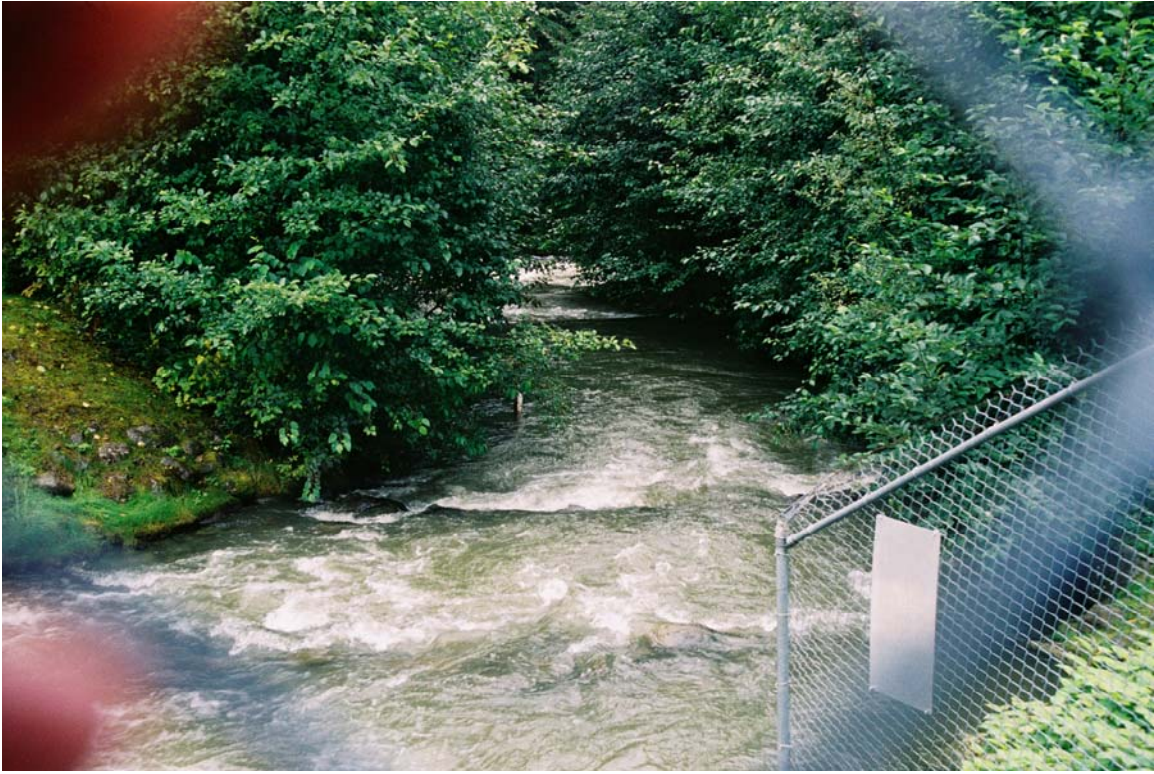
Photo #1 Tailrace

Part of the Clayton Falls project included a salmon spawning channel as a component of the tailrace see photo #1. Since the inauguration of the facility no environmental review of the spawning channel or its significance to the fishery has ever been completed. This survey evaluates the success of this enhancement project and reports to BCRP with a summary of the findings and recommendations for future studies or endeavors.

There are two prime areas of interest: the first is the tailrace (photo #1) which is approximately 55m by 6m or 330m², the second is the main channel (photo #2) below the Falls which is approximately 200m by 12m or 2400m² for a total maximum spawning area of 2730m². Since the required area for spawning pair is about 0.6m², the maximum number of spawning fish in these two areas (provided the entire area was usable) could be as many as 9000 fish or 4550 redds. The count for this year to date was approximately 4000 fish. More 200 pinks were counted in the Tailrace area (photo #3) waiting for reduced flows and velocities.

Two 10mx10m sections of the tailrace were selected and the redds were attempted to be enumerated, after several counts it was estimated the redd count was one redd per 1.5m² or about half capacity within the tailrace. Spawning starts in mid August and ends mid September. The substrate habitat in the tailrace was 5-130mm smooth gravel rock to maximum depth of about 0.12m. Water depth was ½ m.

- 1) Due to low recruitment, gravel should be added to the tailrace to increase egg survival. A BC Hydro or DFO fisheries or habitat biologist should be contacted for timing and gravel size.

- 2) Stream complexing could be added to the tailrace with the addition of several large boulders placed in mid-stream.
- 3) No signage is evident. There is evidence of cougars, coyote and grizzly bears in the area and tourists should be aware. As well, signage is required to keep people out of the creek from August through March each year to protect egg incubation.

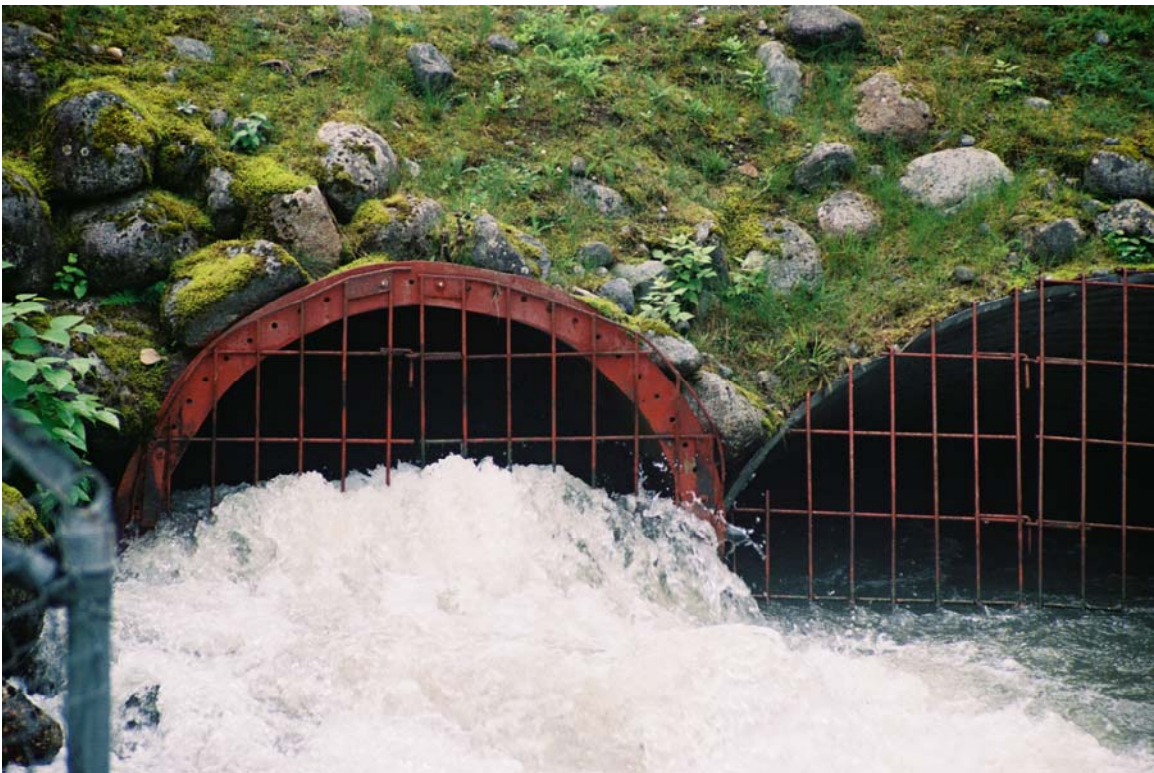
Photo #4 Water exit draft tubes

- 4) Several pink salmon were observed below the floor of the powerhouse, directly beneath the turbine (draft tube area?). They obviously swam up the draft tubes at lower flows and were now trapped. It is recommended that a new gate with smaller openings be installed in front of the draft tube opening, see photo #4.
