DOWNTON RESERVOIR FISH PASSAGE CULVERT INSPECTION
BCRP PROJECT # 05.BR.01

BRIDGE COASTAL RESTORATION PROGRAM

SIGMA ENGINEERING LTD.

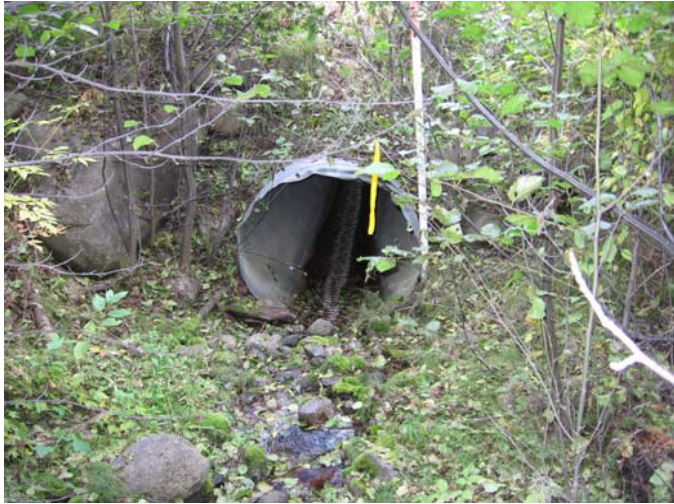
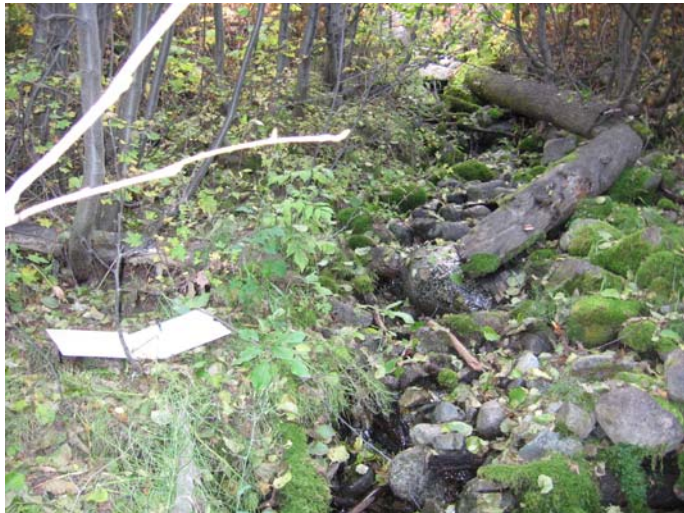
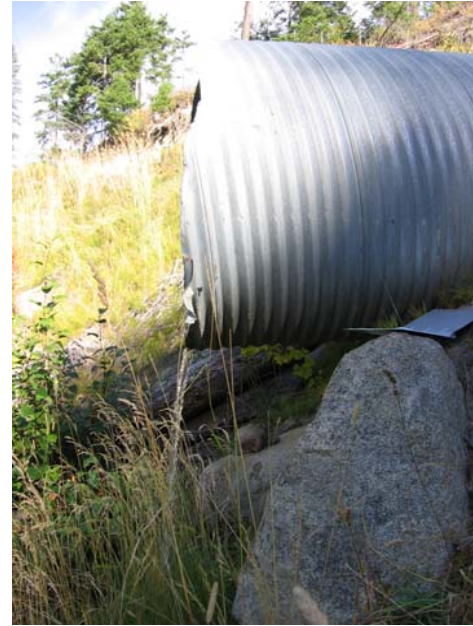
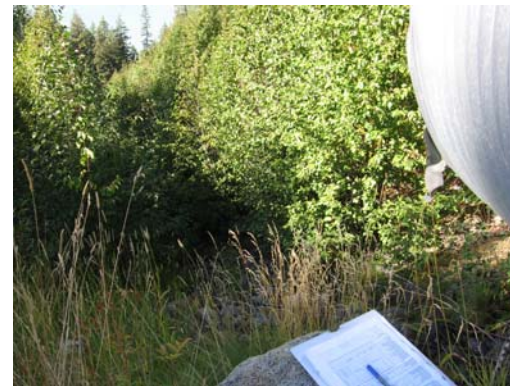
Site 1 Culvert Assessment

Site 1 is located on an unnamed creek at 2.3 km along the Bridge River Forest Service Road. The culvert is a round, 1400 mm diameter corrugated steel pipe, 21 m long, with a gradient of 3%. Water depth in the inlet was 4 cm and wetted width was 30 cm: higher flows, indicated by rust stains at the culvert inlet, frequently reach a depth of 30 cm. The culvert outfall drop was 170 cm and no plunge pool was present. This would make it a full barrier to fish migration, since it is above the jumping abilities of adult trout. Restoration of fish passage at this site is not recommended, however, based on the stream characteristics above and below the culvert. The step-pool boulder habitat does not provide any spawning or rearing areas and the reach would be classified as non-fish bearing based on gradient (30% downstream and 28% upstream).

Photo 001 Downstream view of inlet

Photo 002 Channel upstream of inlet

Photo 003 Outfall drop

Photo 004 Channel downstream of outfall.

Four of the five sites were assessed as being full or partial barriers but no prescriptions or recommendations for restoration work is recommended due to the topography of the watershed: the high gradient slopes and step-pool morphology of the creeks do not provide suitable spawning or rearing habitat above the culverts.

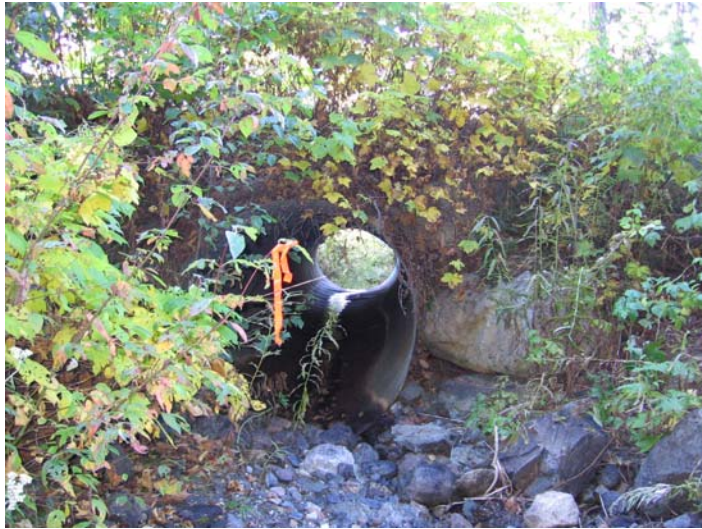
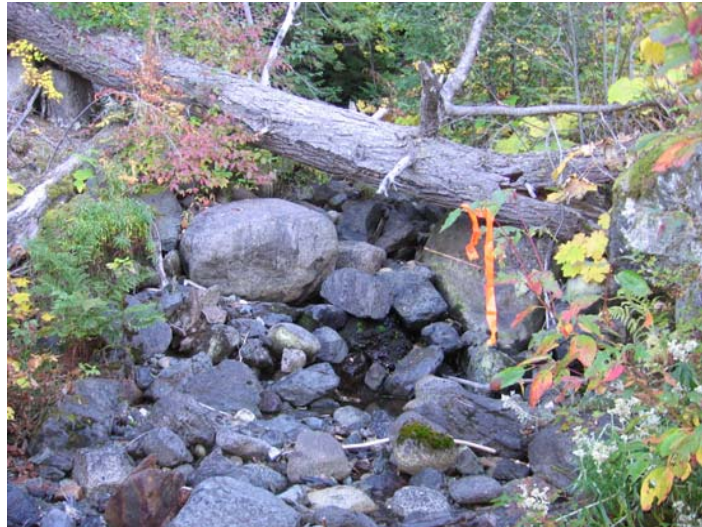
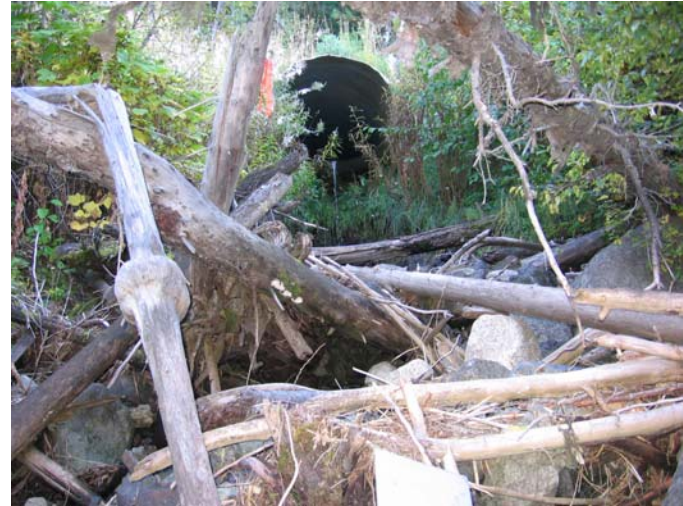
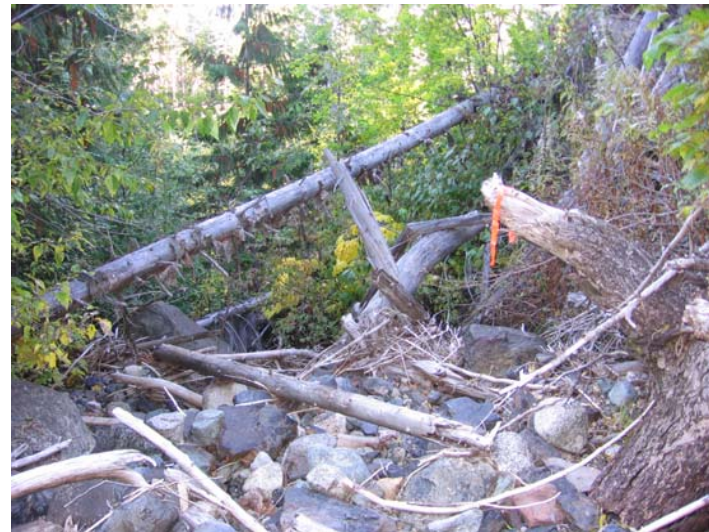
Site 2 Culvert Assessment

Site 2 is located on Gwyneth Creek at 3.46 km along the Bridge River Forest Service Road. The culvert is a round, 1200 mm diameter corrugated steel pipe, 14.7 m long with a gradient of 2%. Water depth in the culvert was 2 cm and wetted width was 30 cm: the high water mark was 30 cm, indicated by the rust stains in the culvert. The 40 cm outfall drop at the time of the survey is a partial barrier: at higher flows the culvert would be under water. The creek has cascade habitat downstream of the culvert (gradient 45%) and step-pool boulder habitat upstream (gradient 31%), with a 1.2 m falls located approximately 30 m upstream of the culvert. The average bankfull width is 4 m below the culvert and 3.5 m above the culvert. Water depth was 6 cm below the culvert (with sections dewatered) and 8.7 cm above: average bankfull depth (vertical height from waters edge to the bankfull depth) was estimated as 53 cm upstream and 51 cm downstream.

Photo 006 Inlet upstream photo

Photo 007 Inlet downstream photo

Photo 008 Outlet upstream photo

Photo 009 Outlet downstream photo

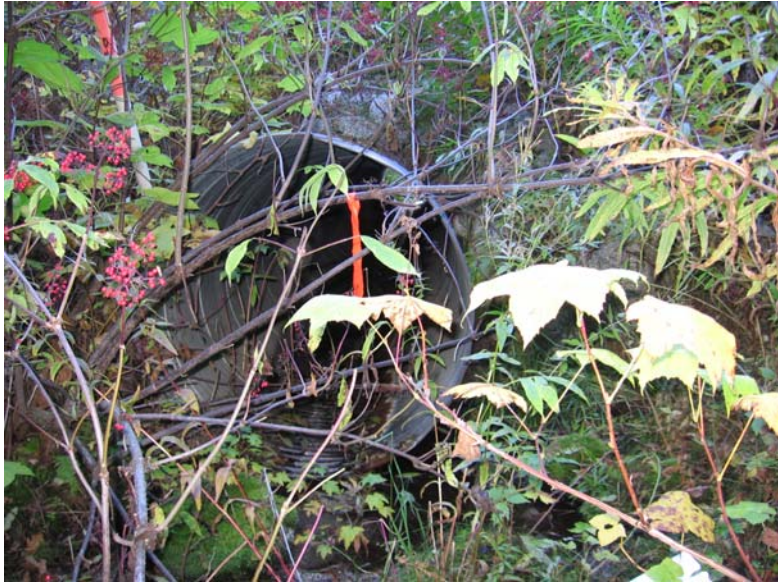
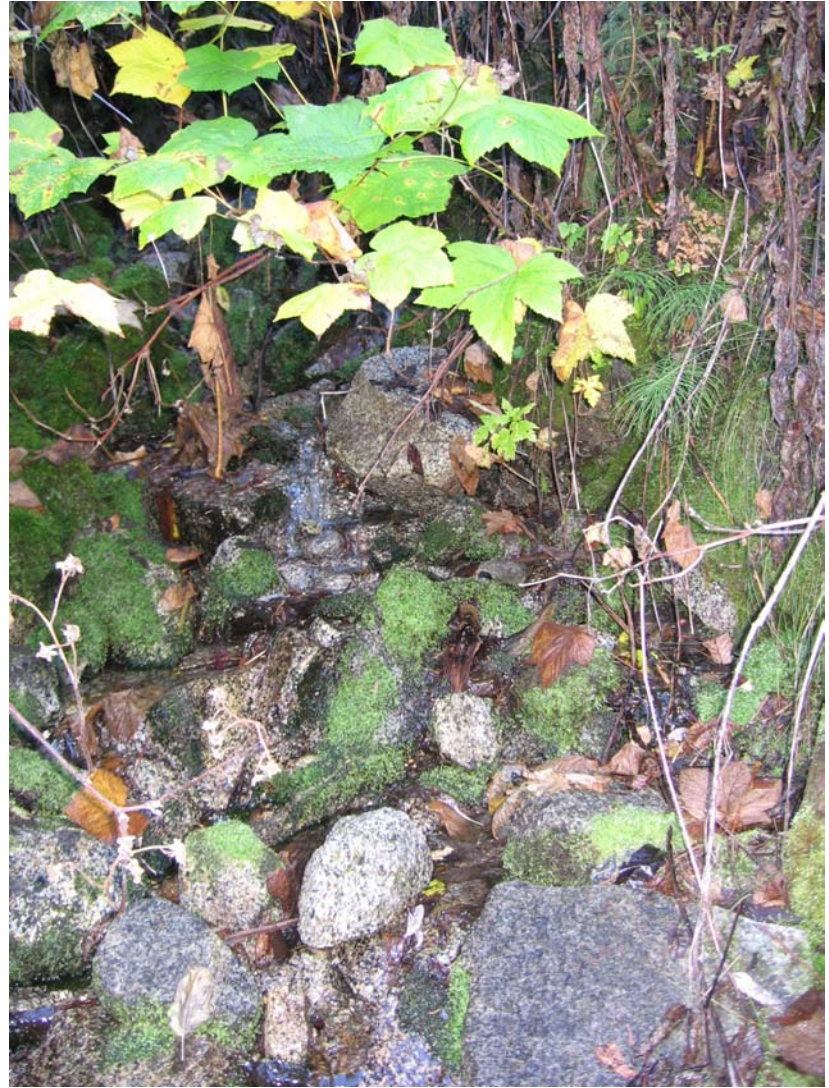
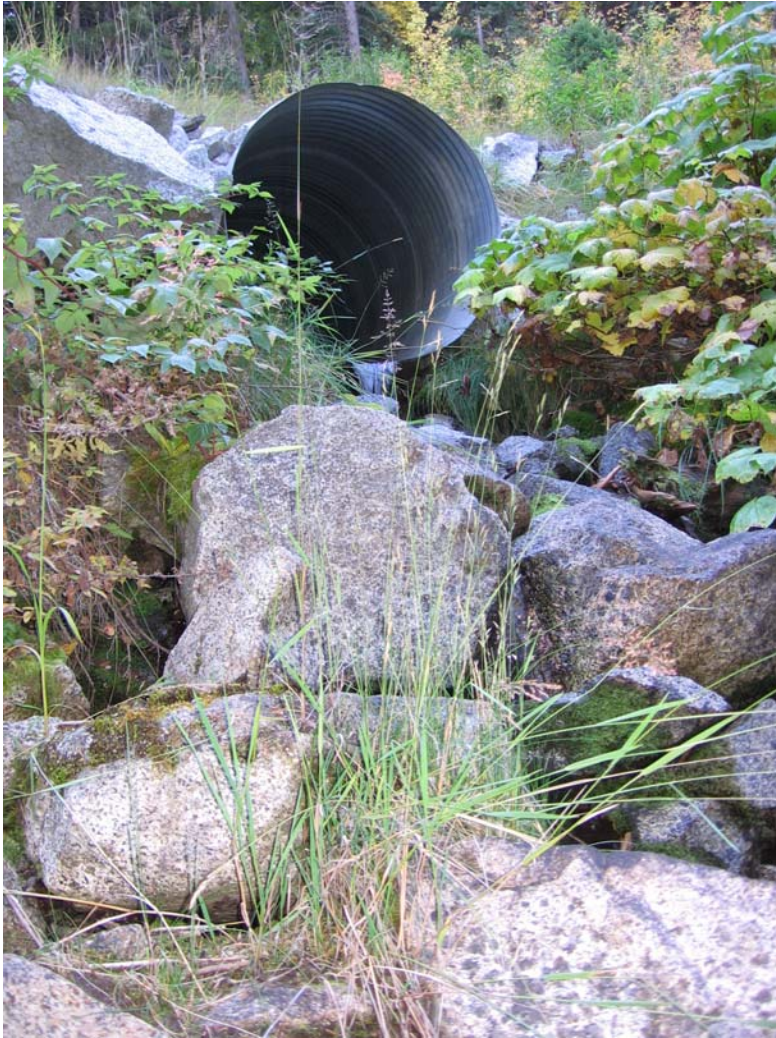
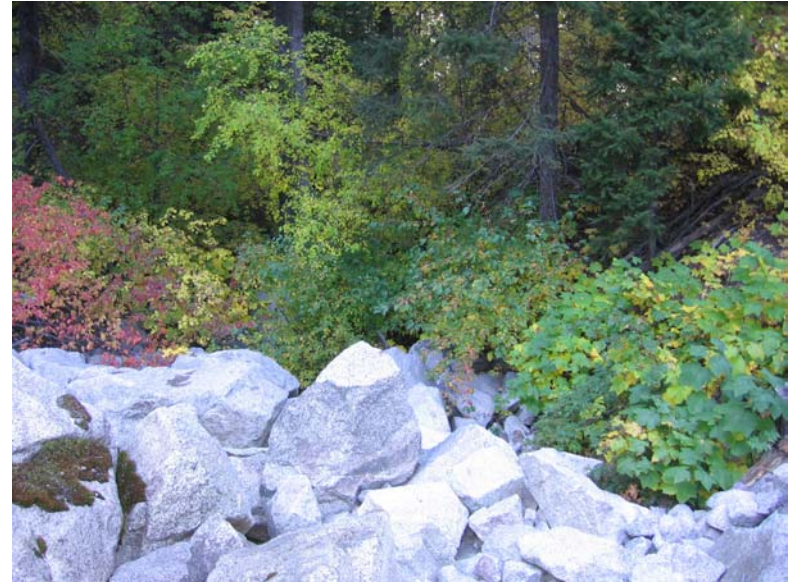
Site 3 Culvert Assessment

Site 3 is located on an unnamed creek 20.7 km along the Bridge River Forest Service Road. The culvert is a round, 1450 mm diameter corrugated steel pipe with a gradient of 4%. Water depth at the inlet was 3 cm and wetted width was 30 cm: the high water mark was 10 cm, indicated by the rust stains in the culvert. The culvert had an outfall drop of 36 cm and is a full barrier due to the lack of plunge pool at the outfall. No natural fish habitat exists downstream of the culvert: water from the outfall drops onto large, angular rip-rap and flows subsurface down a 45% slope until the natural channel resumes 20-30 m away. The channel remains natural upstream of the culvert but does not provide

any fish spawning or rearing habitat: the 55% gradient had an average wetted width of 74 cm and bankfull width of 120 cm during normal flows. Average depth at the time of the survey was 5.2 cm and bankfull depth was estimated as 25 cm.

Photo 030 Inlet downstream photo

Photo 031 Inlet upstream photo

Photo 032 Outlet upstream photo

Photo 033 Outlet downstream photo

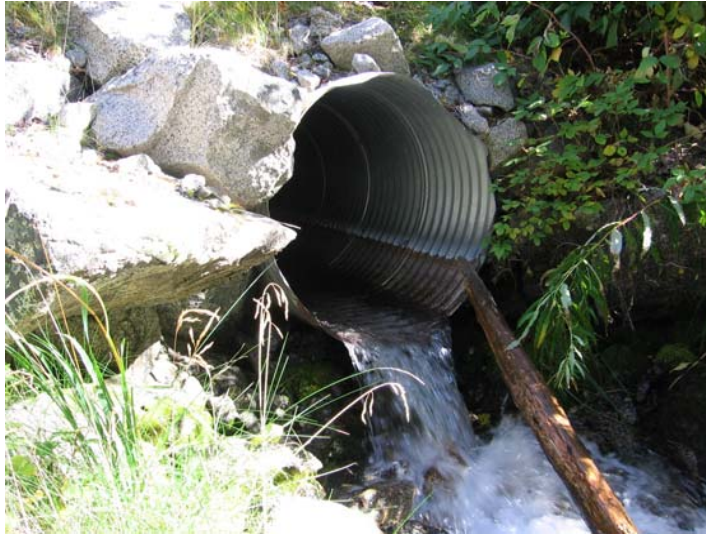
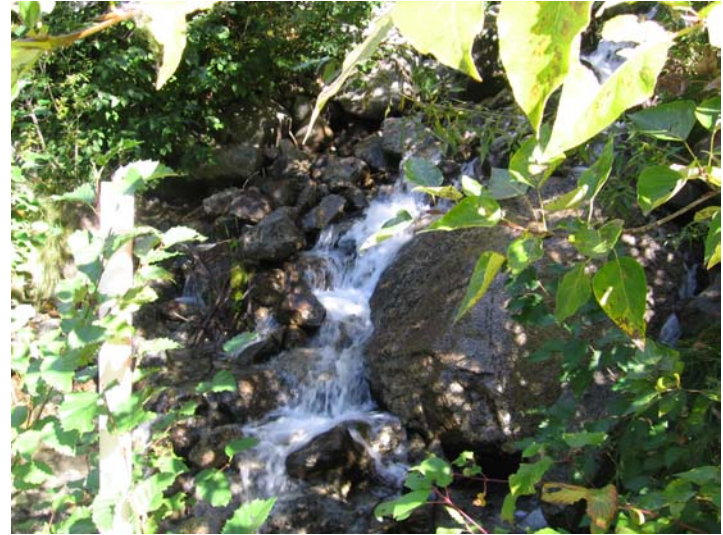
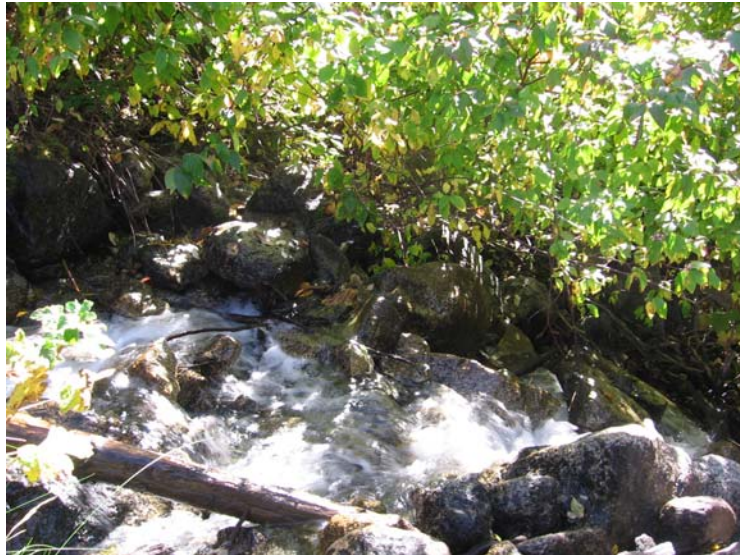
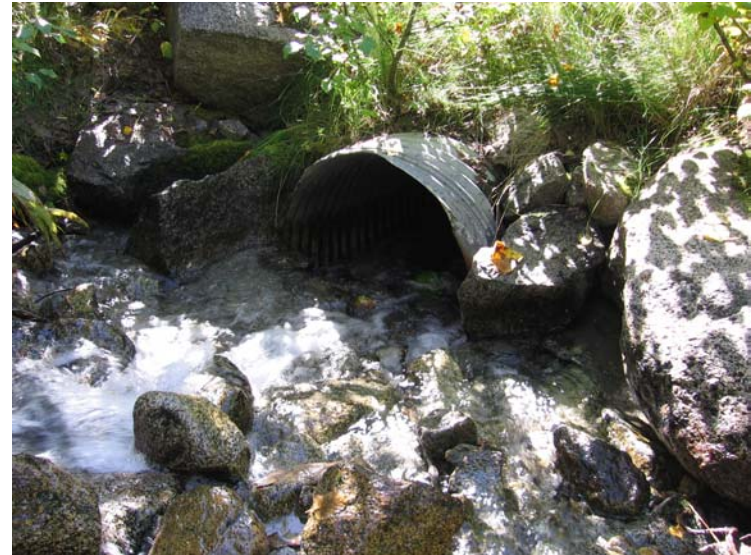
Site 4 Culvert Assessment

Site 4 is on an unnamed tributary with a watershed code of 100-241900-75800 at 22.6 km along the Bridge River FSR. The culvert is a round, 900 mm diameter corrugated steel pipe with a gradient of 1%. Water depth in the culvert was 14 cm and wetted width was 80 cm at the inlet: the high water mark was 40 cm, indicated by the rust stains in the culvert. The 42 cm outfall drops onto boulder and cobble substrate: the culvert is a barrier at current flows due to the lack of a plunge pool, but would be submerged at high flows. However, it would likely be a velocity barrier at higher flows, since velocity was measured at 1 m/s at the time of the survey during low flows. A short section (~15 m) of creek upstream of the culvert provides good rearing habitat, being low gradient riffle habitat with abundant riparian vegetation and instream cobbles and boulders for cover, but the channel upstream of this becomes a high gradient (32%) cascade. Downstream of the culvert the channel is boulder step-pool with a 45% gradient slope; 23-30 m downstream of this the channel becomes braided and flows overland in sections.

Photo 035 Outfall upstream photo

Photo 037 Inlet upstream photo

Photo 036 Outfall downstream photo

Photo 038 Inlet downstream photo

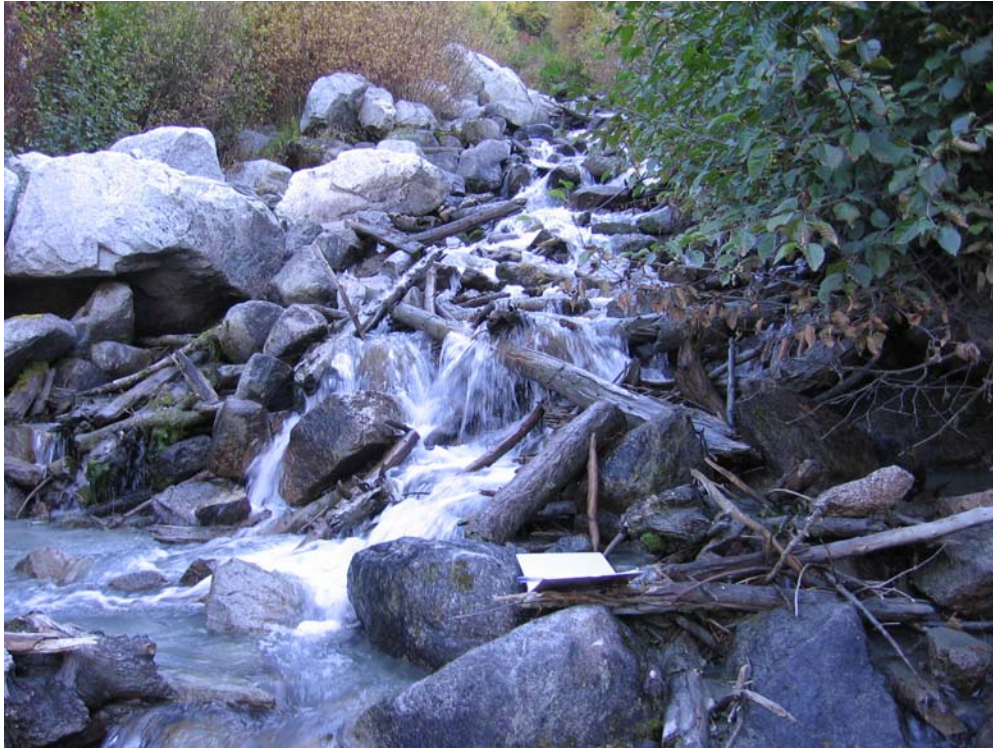
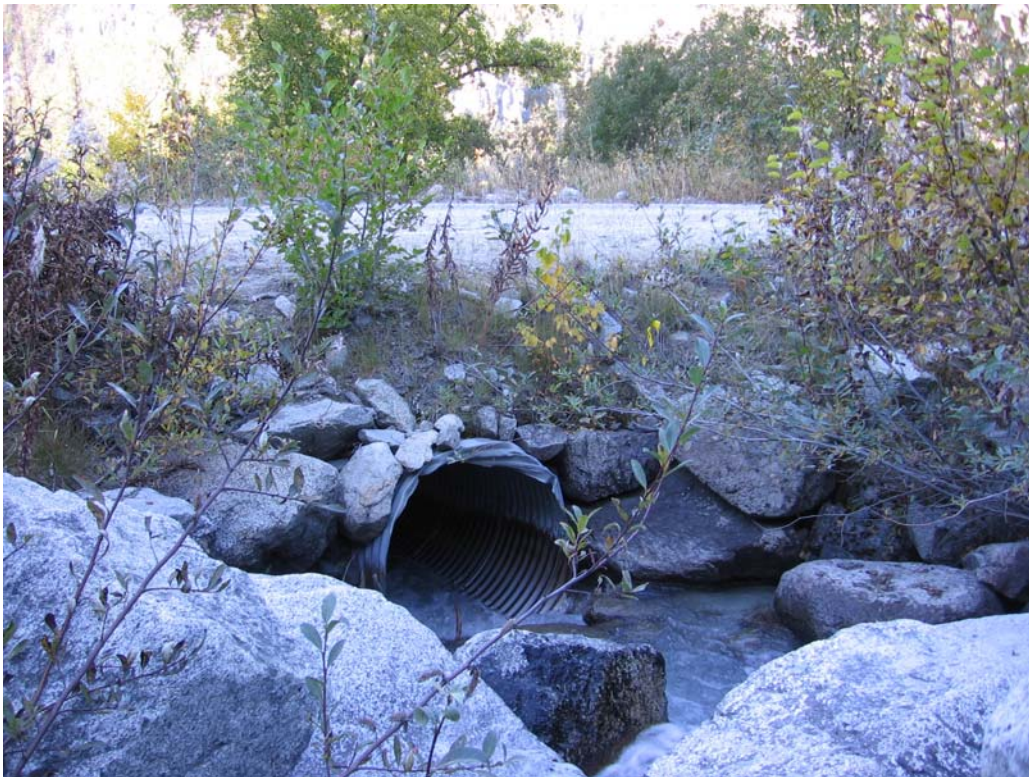
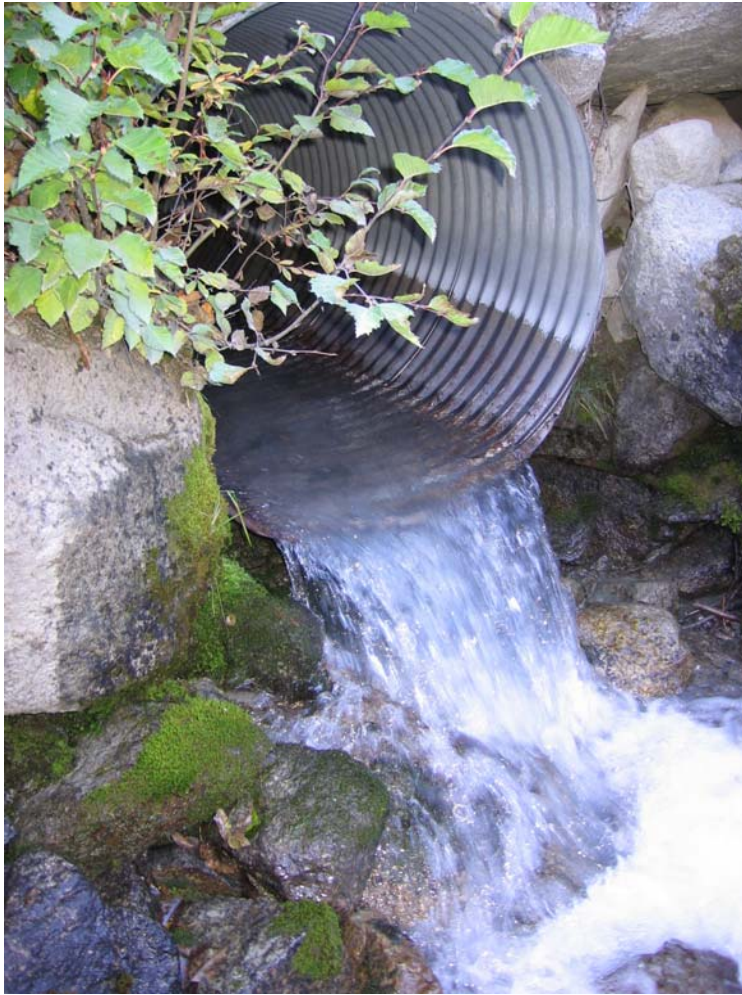
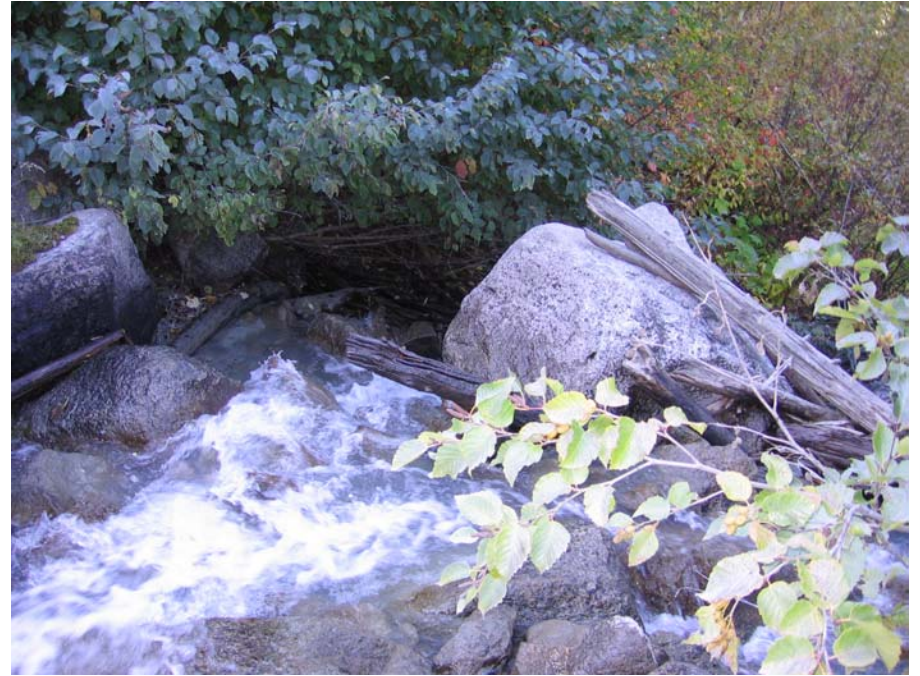
Site 5 Culvert Assessment

Site 5 is on an unnamed tributary with a watershed code of 100-241900-76400 at 22.6 km along the Bridge River FSR. The culvert is a round, 1200 mm diameter corrugated steel pipe with a gradient of 1.5%. Water depth in the inlet was 18 cm and wetted width was 75 cm at the inlet: the high water mark was 44 cm, indicated by the rust stains in the culvert. The outfall drop is 35 cm and falls onto boulder and riprap with no plunge pool. Abundant LWD and SWD parallel to the flow in the cascade upstream of the culvert indicate high flows have occurred historically: the inlet of the culvert has sustained some damage, possibly from the debris in high flow events. The average wetted width below the culvert is 4 m and the average bankfull width was estimated as 4.25 m, with a bankfull depth of 30 cm. This culvert is not a barrier to fish passage.

Photo 039 Inlet upstream photo

Photo 040 Inlet downstream photo

Photo 041 Outfall upstream photo

Photo 042 Outfall downstream photo

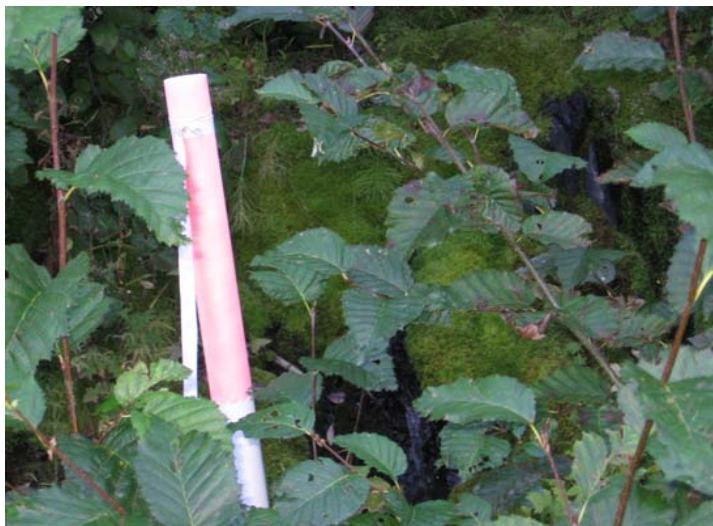
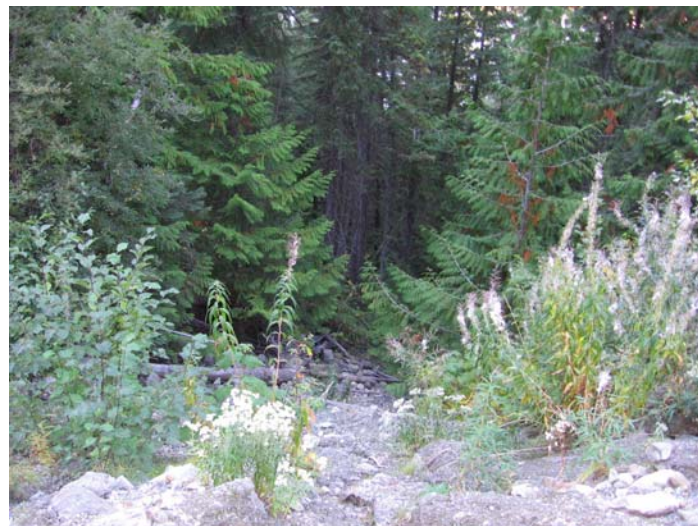
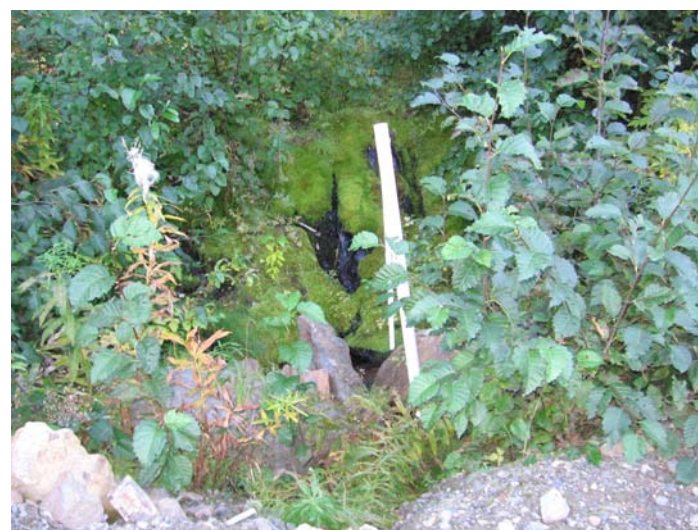
WP 005 – Sites Not Assessed

Photo 010 Upstream of inlet – vertical seep.

Photo 011 Downstream view of outlet.

Photo 012 Downstream of outfall – no channel.

Photo 013 Upstream of inlet – close up of vertical seep.

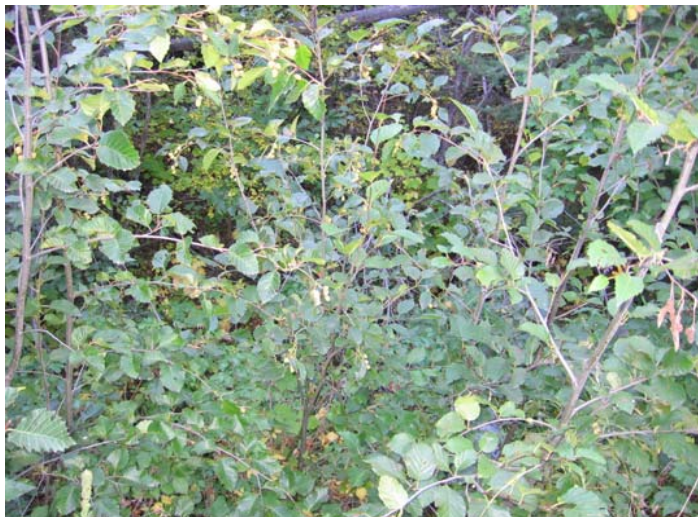
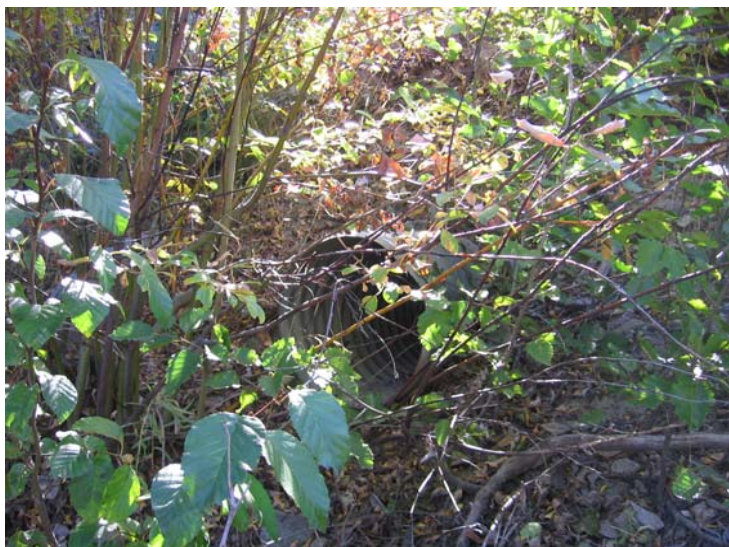
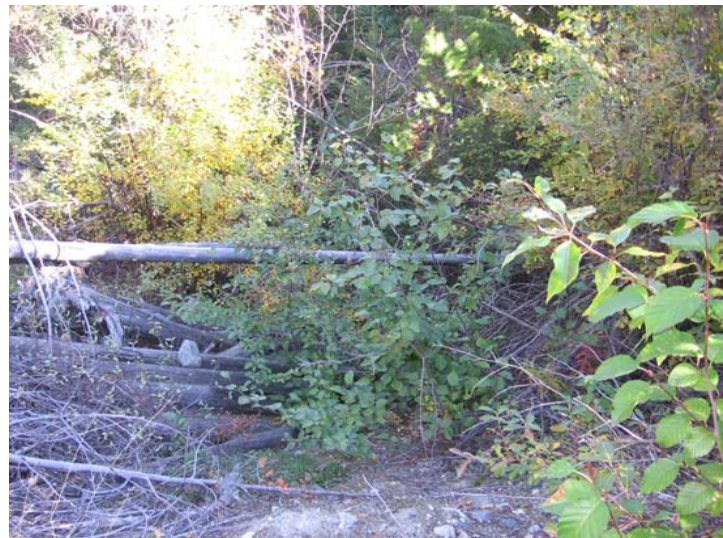
WP 016 – Sites Not Assessed

Photo 016 Upstream of culvert – no channel.

Photo 017 Culvert outfall.

Photo 018 Downstream of outfall – no channel.

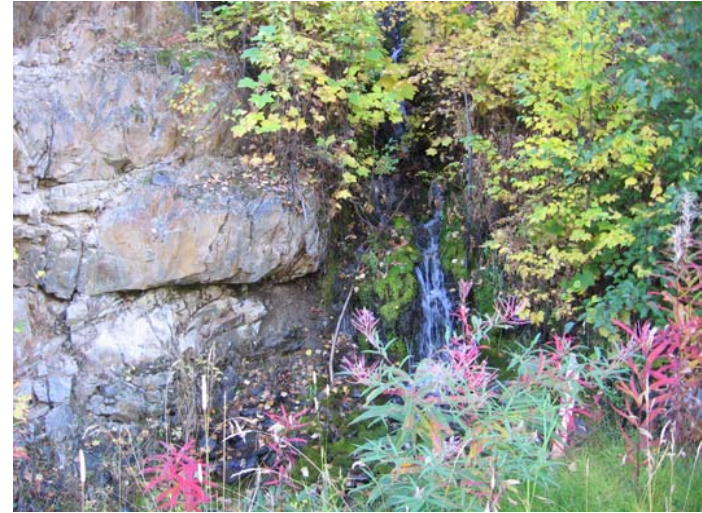
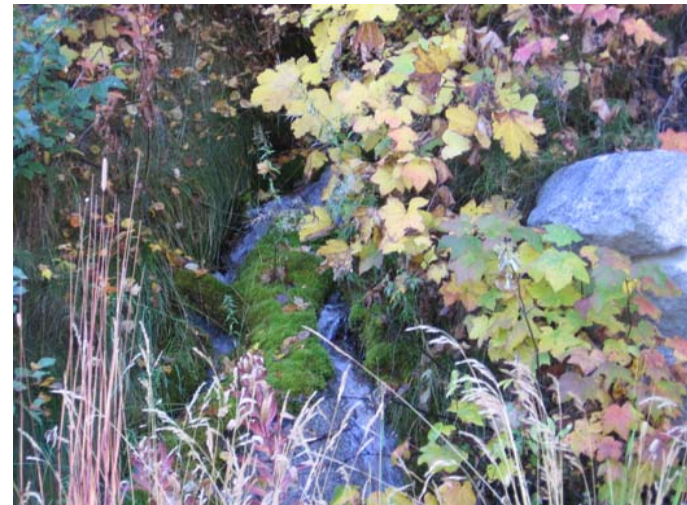
WP 018 & WP 019 – Sites Not Assessed

Photo 019 WP 018 Upstream of culvert – bedrock falls – no fish habitat

Photo 020 Upstream of Culvert 12.1 km along Bridge River FSR - no fish habitat.

Photo 021 WP 019 Upstream of culvert.

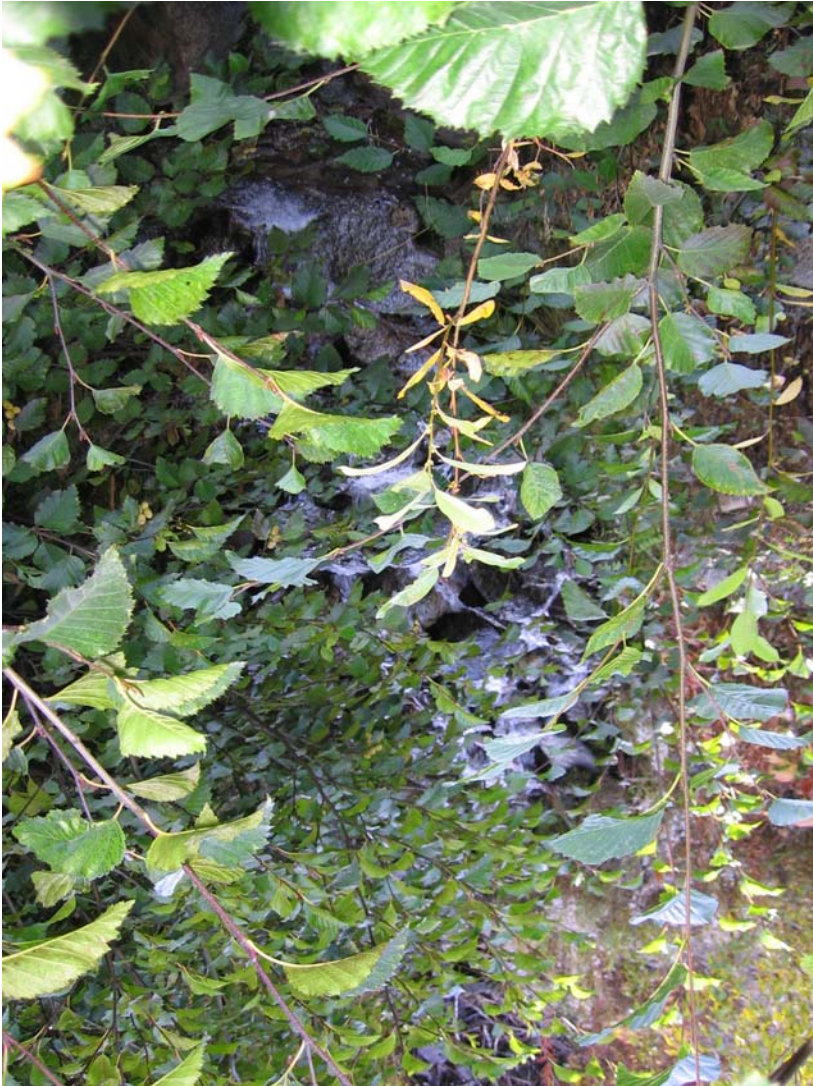
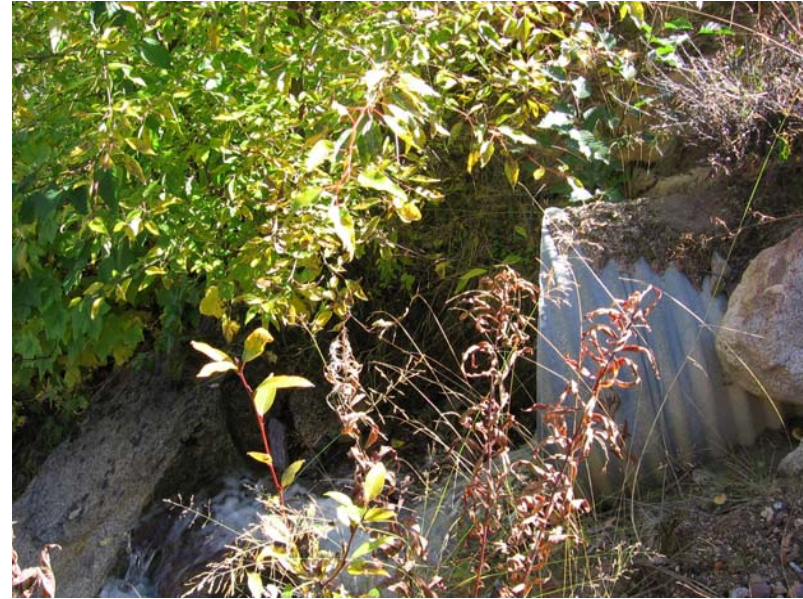
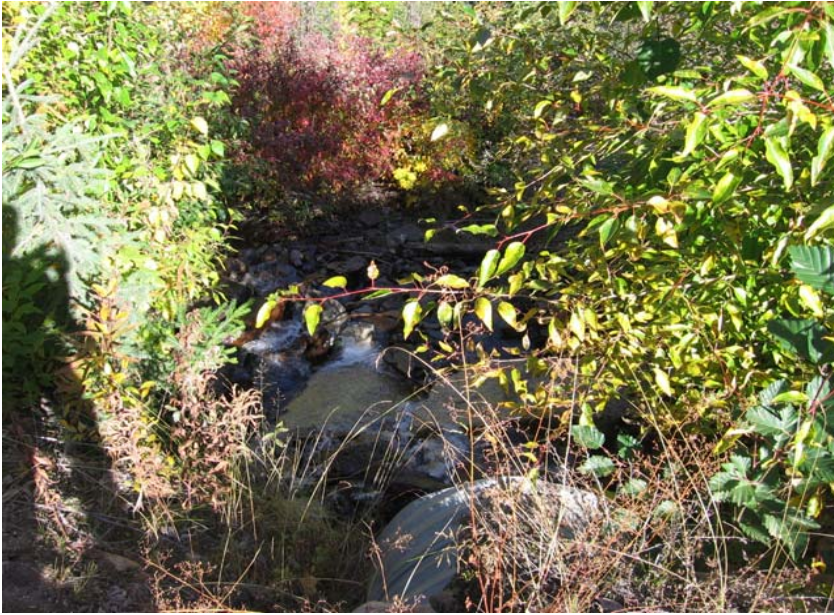
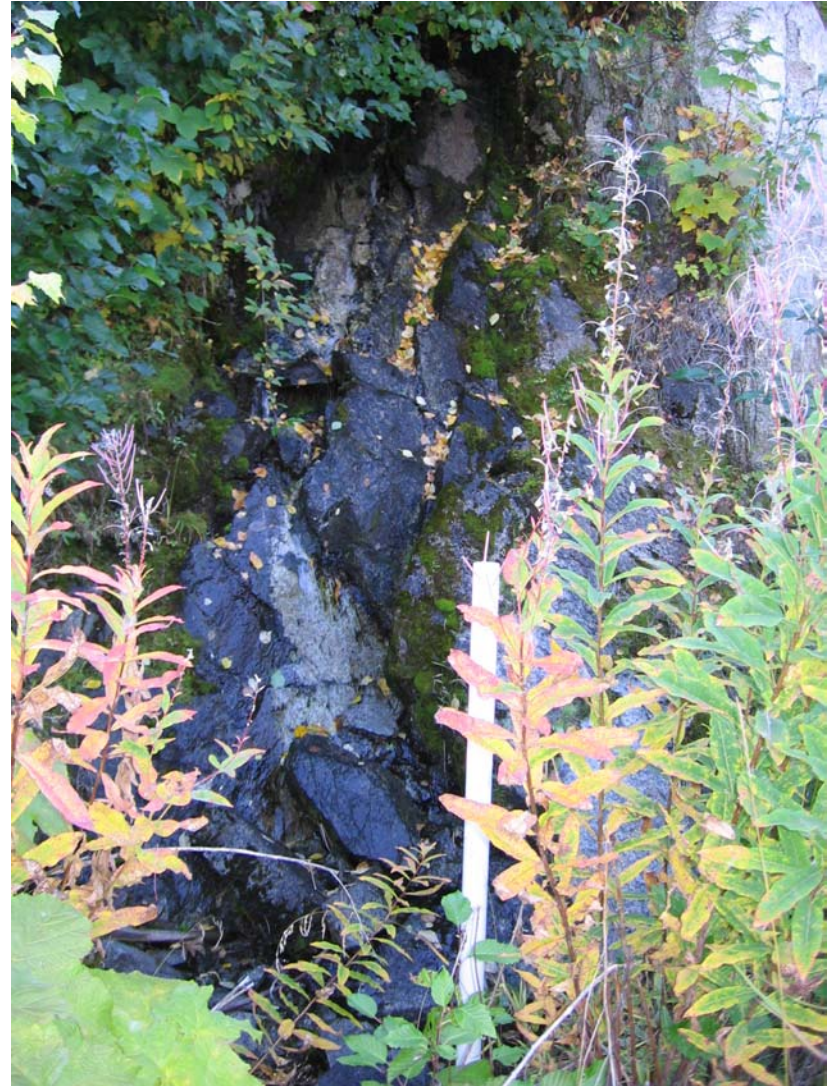
WP 020 & WP 022 – Sites Not Assessed

Photo 023 WP 020 Upstream view of channel above inlet-step-pool habitat, high gradient.

Photo 024 WP 020 View of culvert from side showing outfall drop.

Photo 025 WP 020 Channel downstream of outlet – high gradient boulder cascade.

Photo 026 WP 022 Bedrock seep upstream of inlet.
