**ELK RIVER
2005 CHANNEL STABILIZATION PROJECT
AND YEAR 2 MONITORING REPORT**

Project # 05CA02

I.D. REDDEN, A.Sc.T.
STREAMLINE ENVIRONMENTAL CONSULTING LTD.
786 Quilchena Cr., Nanaimo, BC V9T 1P6
Phone: (250) 758-7980

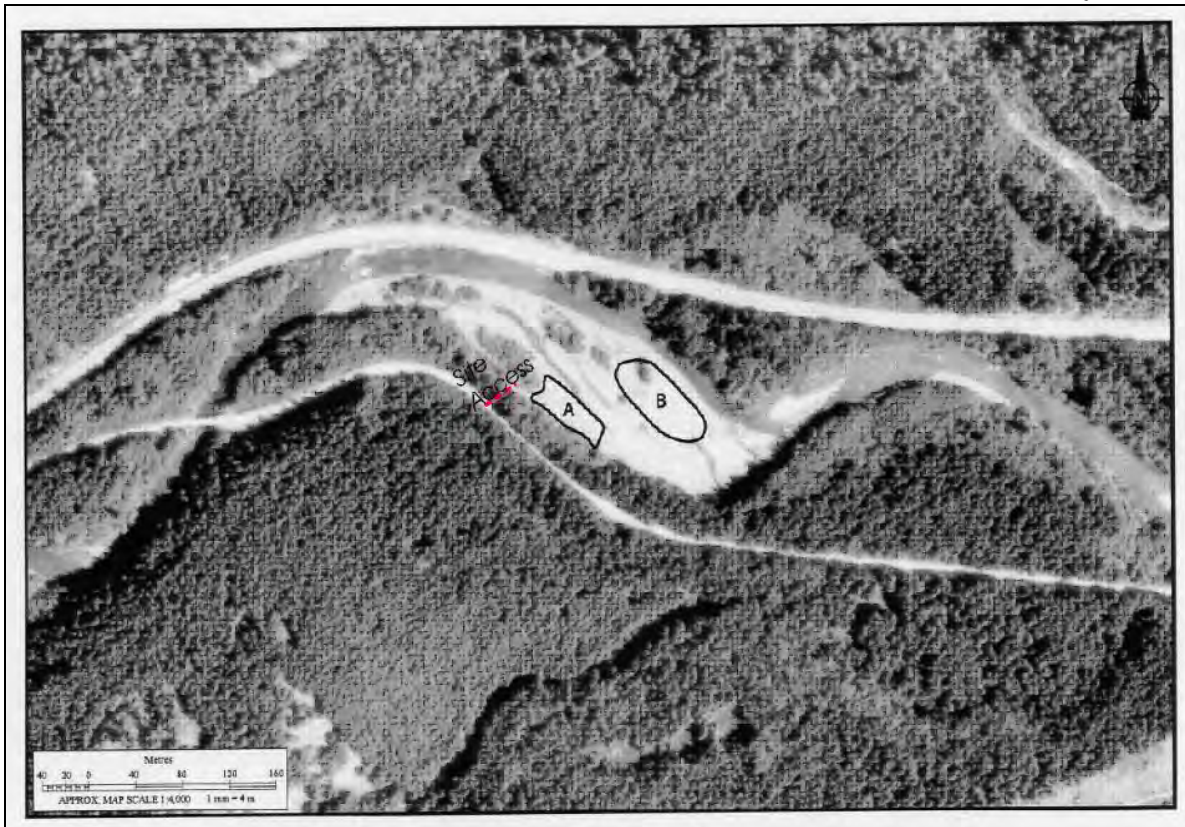
Figure 2. 1995 Airphoto of Treatment Site 2

Sites 2, 3 and 6A which were planted in 2004 are located at 9.8, 8.4 and 3.8 km upstream from the river mouth, respectively. Air photographs with approximate delineations of the sites are provided below in Figures 2, 3 and 4. Maps of the planted sites are provided in Appendix IV. Site 6B is located adjacent to site 6A and can also be seen in Figure 4.

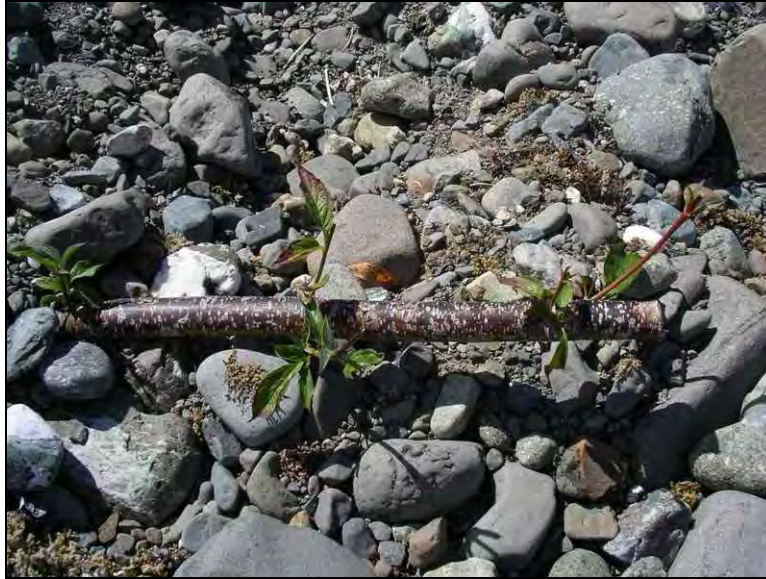
The live stakes had a high rate of survival (90 %). The survival rate of the willow was highest (96 %), and red-osier dogwood had lowest survival rate (62 %). Due to the unknown number of cottonwood planted in 2004 their survival rate could not be calculated, however, observations indicated that it was high. It was anticipated that there would be significant mortality to the stakes due to browsing from deer and elk. The results indicate that the preferred browse species was red-osier dogwood at 71 % browsed followed by cottonwood at 27 % browsed and finally willow at only 3% browsed (Figure 5). Field observations and monitoring data showed that the mix of species benefited the willow, as the elk and deer focused on the other species allowing the willow flourish. The willow did experience some mortality due to an infestation of what is believed to be willow leaf beetle (*Plagioder a versicolora*). The defoliating beetle was more abundant at Site 2 than the other sites. Generally these beetles are not known to cause tree mortality however it is believed that because the live stakes were newly established the stress caused by the beetles may have led to some mortality. The beetle larvae and the damage it caused the live stakes is shown in Figure 6.

Figure 5. Browsed Red-Osier Dogwood.

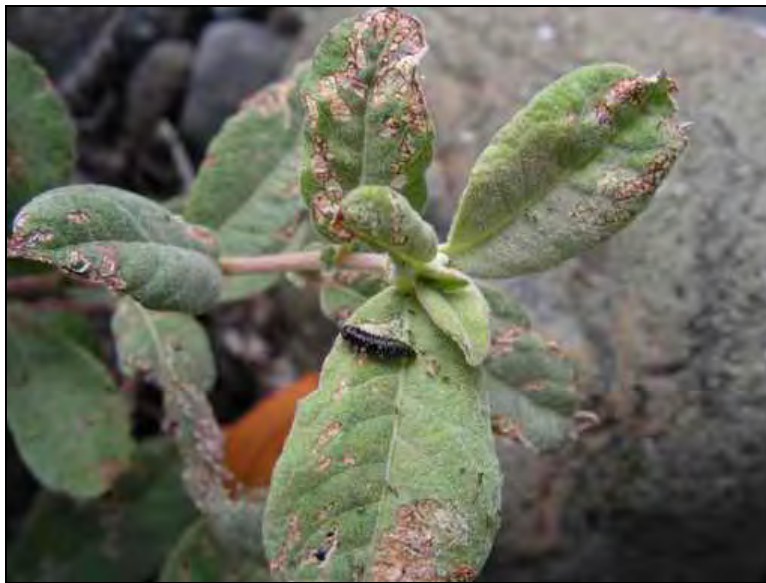
Figure 6. Beetle larvae and damage to willow tree.

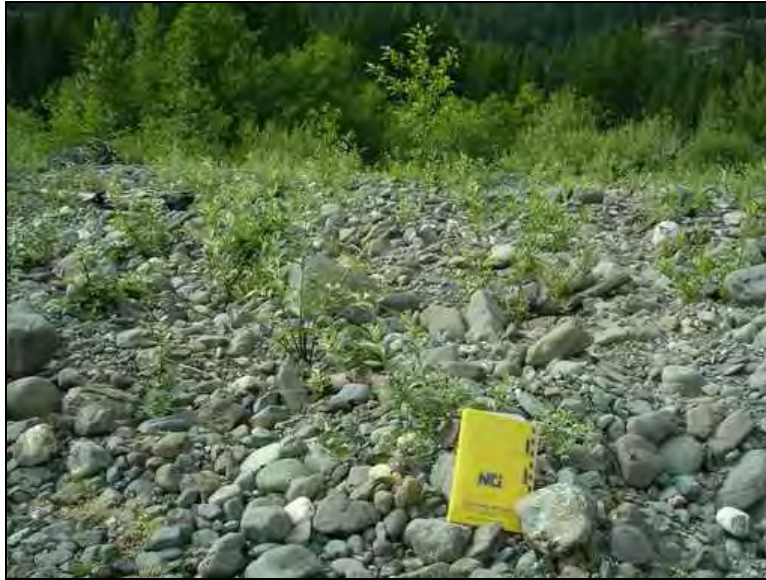
dogwood did not perform as well, with 96 % of the stakes having between 1 to 5 shoots growing per stake. Photographs of the live stakes performance are provided in Figures 7 and 8. These photos were taken on June 29th, 2005 nearly a month before the vegetation surveys were completed.

Figure 7. Site 3 Live Stake Growth June 29, 2005.

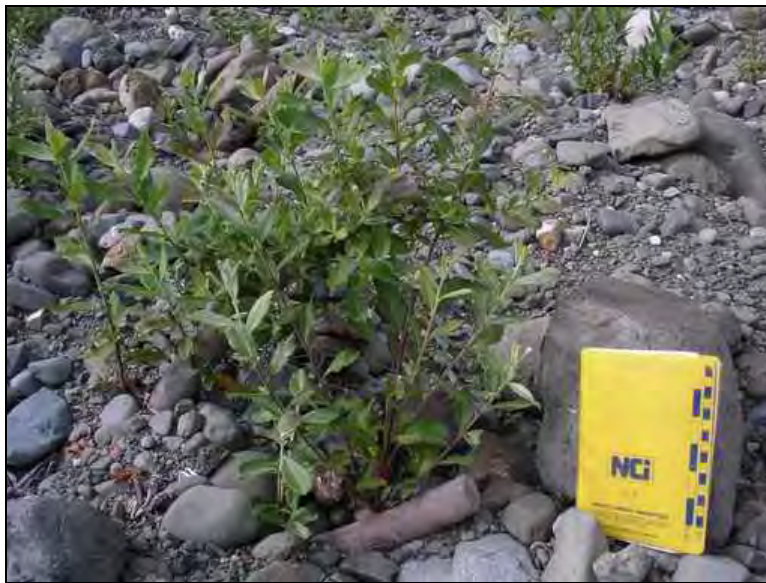
Figure 8. Site 3 Willow Live Stake Growth June 29, 2005.

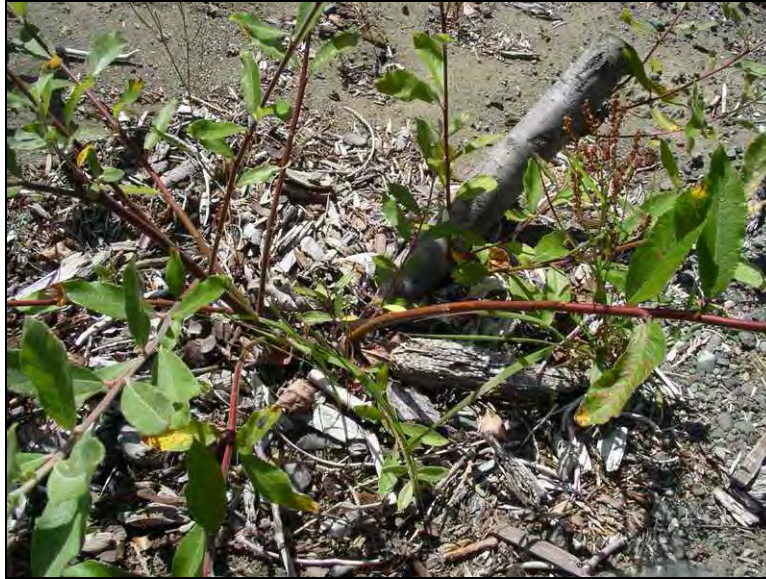
It was expected that as the live stakes grow they will slow the water during peak flow events, causing fine sediments and organics to be deposited, resulting in a gradual shift in the surficial substrate from coarse gravel to finer materials. Baseline 2004 substrate photographs were taken at 16 of the research plots. This consisted of photo-documenting three 0.5 m² sub-plots from each of the 16 plots. The random sub-plots were established 2.5 m from the center pin of each of the plots at bearings of 120⁰, 240⁰ and 360⁰. The substrate photos were duplicated during the June 2005 site visit. The comparison photos are included in Appendix VII. Analysis of the photos indicates that there was generally little change in the substrate composition. While the photos did not show large changes in composition, evidence of sediment deposition and trapping of small organic debris was found in areas throughout the sites (Figures 9). This was most evident in Sites 2B, lower Site 3 (nearest the river) and throughout Site 6. This indicates that these areas were inundated by peak flows and the live stakes performed as expected.

Figure 9. Fine sediment and small organic debris collecting around live stake.

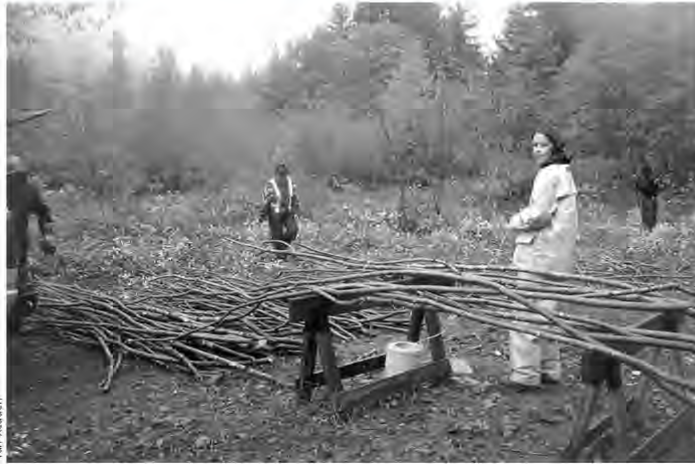
Figure 2. Assembling limbed poles into bundles.

collected, topped, and limbed the cut trees. Using high quality, relatively expensive pruning and lopping shears was invaluable, as smaller shears tended to break, disrupting production. The topped and limbed "poles," which ranged from 2 to 4 m in length, were then placed on sawhorses and tied with biodegradable sisal baling twine into bundles of 7–10 stems (Figure 2). Flagging tape was attached to each bundle, with a different colour used for each day. When the weather conditions were cool and wet, bundles were loaded into trucks and taken to the soaking site at the end of each day. During warmer, sunny weather, bundles were taken to the soaking sites throughout the day to prevent desiccation (wilting) and death. The use of a Silva cool-tarp to cover the bundles during collection would have been beneficial during hot, dry weather. Production averaged 2840 stakes per day for a seven-person crew.

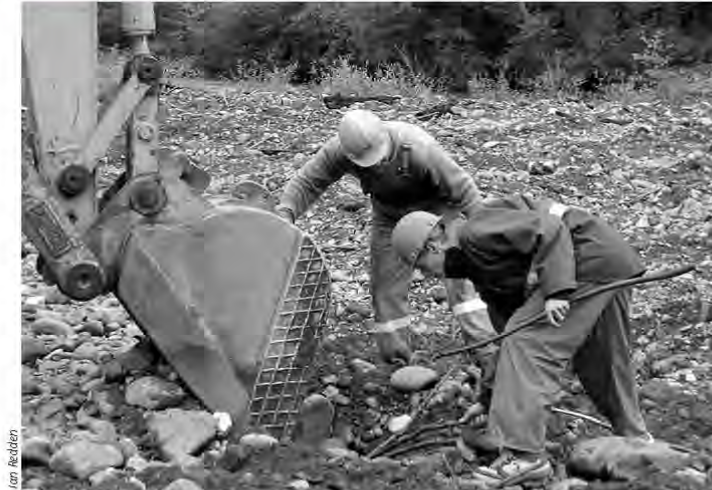
Figure 3. Crew member instructing student on planting stakes.

hand (Figure 3). The excavator then withdrew its bucket allowing the gravel to settle back in place. The stakes were planted with about three-quarters of their length in the gravel at a 45° or greater downstream angle (Figure 4). Four large stakes and three to five undersized stakes, if available, were placed into each opening, taking about one minute for each opening. While the undersized stakes may not flourish as well as the large stakes, they significantly increased the overall number of stakes planted, which should improve the chances of the project in overcoming mortality due to elk browse.

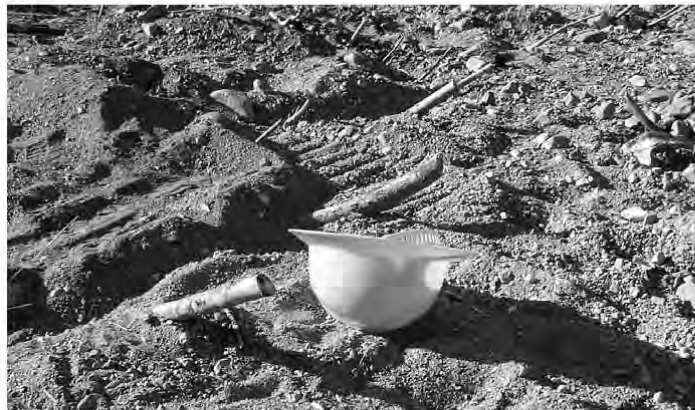
Figure 4. Planted stakes.
