**Puntledge River Impoundment
and Diversion Dam Fishway Assessment 2006**

06Pun.05

April 2007

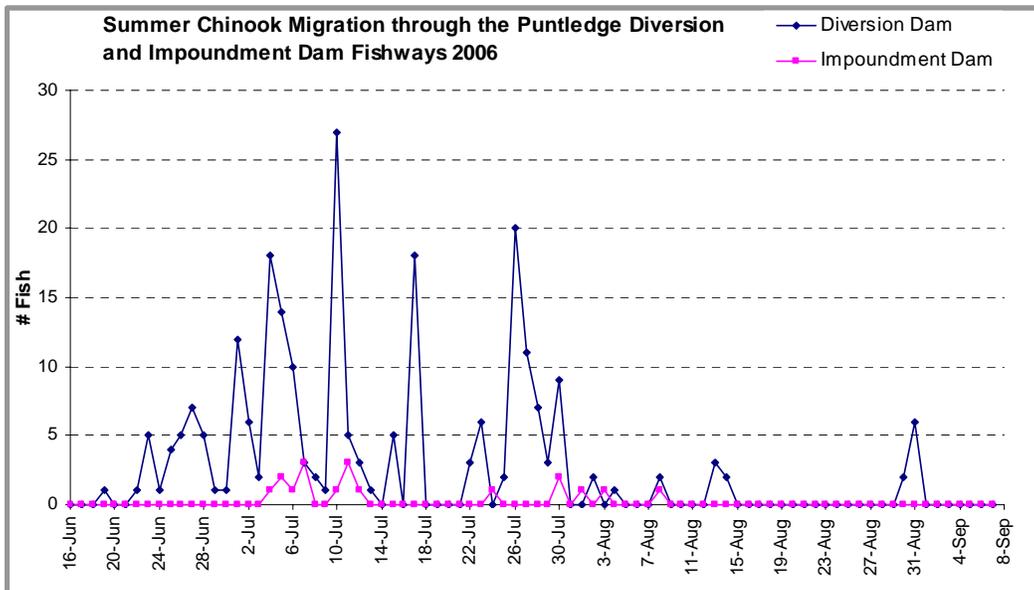
Figure 2. Movement of summer chinook salmon through the diversion and impoundment dam fishways as recorded by underwater video surveillance, June 16 – Sept. 8, 2006.

From June 16th to September 7th, a total of 237 summer chinook and 3 steelhead were counted by the camera entering the headpond through the diversion dam fishway (Figure 2). The diversion dam fishway was closed Sept 7th to prevent fall chinook access into the headpond. It was reopened in November for coho migration and remained open throughout the winter. During this time 249 coho were counted entering the headpond. Fishway operations and video surveillance schedules are summarized in Table 1.

Between June 16th and August 8th the camera recorded approximately 18 summer chinook passing through the tunnel into Comox Lake. No fish were observed using the fishway between August 9th and November 3rd until coho migration commenced in November. Thirty-five coho were counted passing through the tunnel into the lake between Nov 3rd and Nov 19th. Video monitoring was terminated on January 10th and no other fish were observed by the camera during this period. Figure 3 compares total numbers of chinook observed migrating into the headpond (through the diversion dam fishway) versus the total number of fish that migrated into Comox Lake. Images captured by the video equipment with the modified tunnel were clear throughout the entire monitoring period.

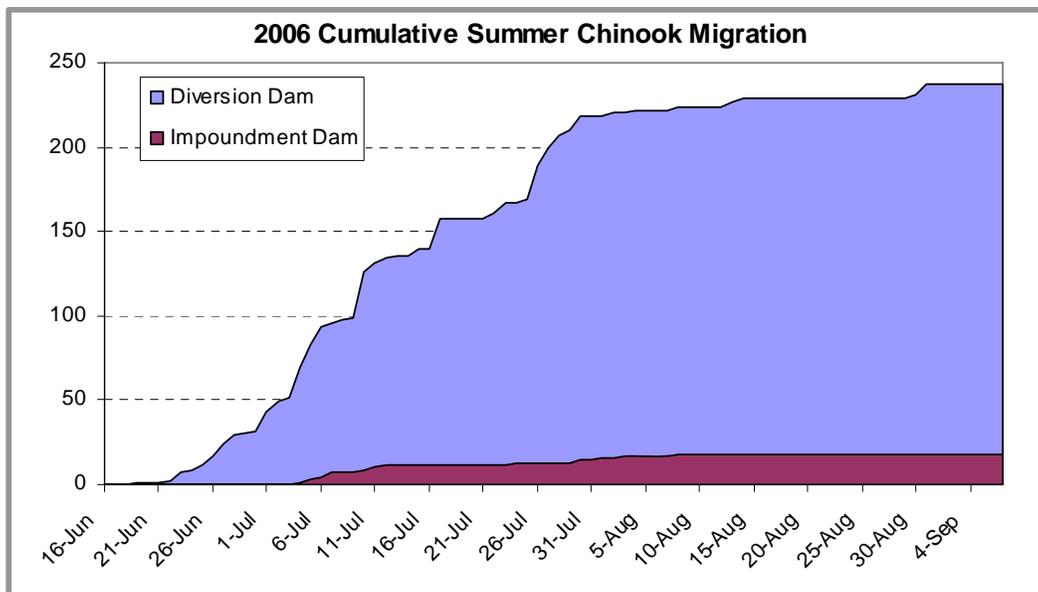
Figure 3. Cumulative summer run chinook migration through the diversion and impoundment dam fishways between June 16 and Sept. 8, 2006.

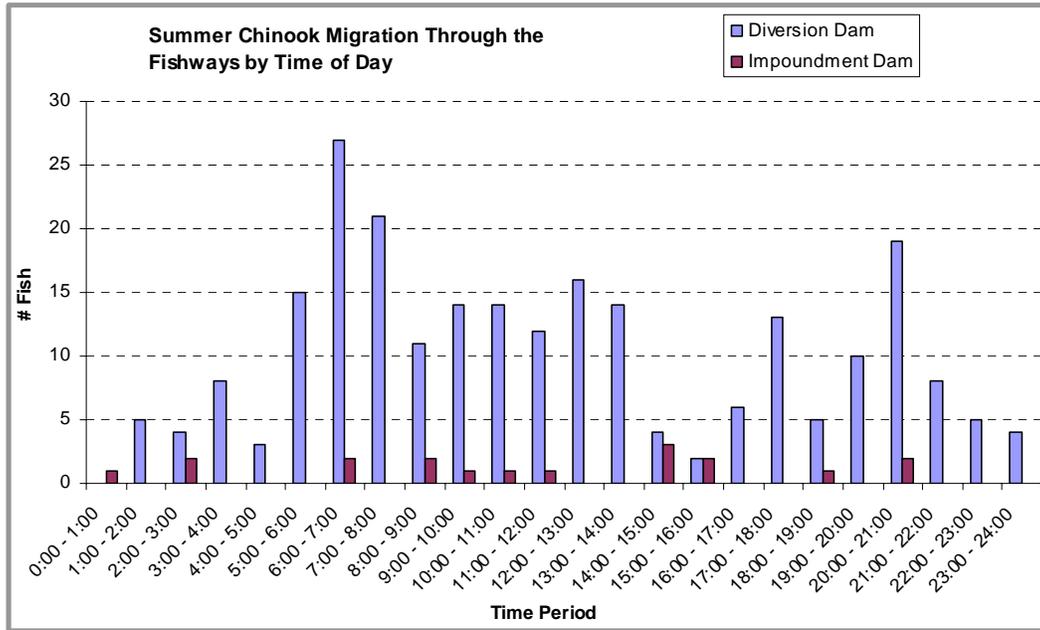
Figure 4. Daily migration patterns of summer chinook through the diversion and impoundment dam fishways, June – September 2006.

At the diversion dam, fish migrated through the tunnel during all hours of the day, but appeared to be more active between 5:00 and 21:00hrs. Likewise, the few fish that migrated through the Comox dam fishway were active during all hours (Figure 4).

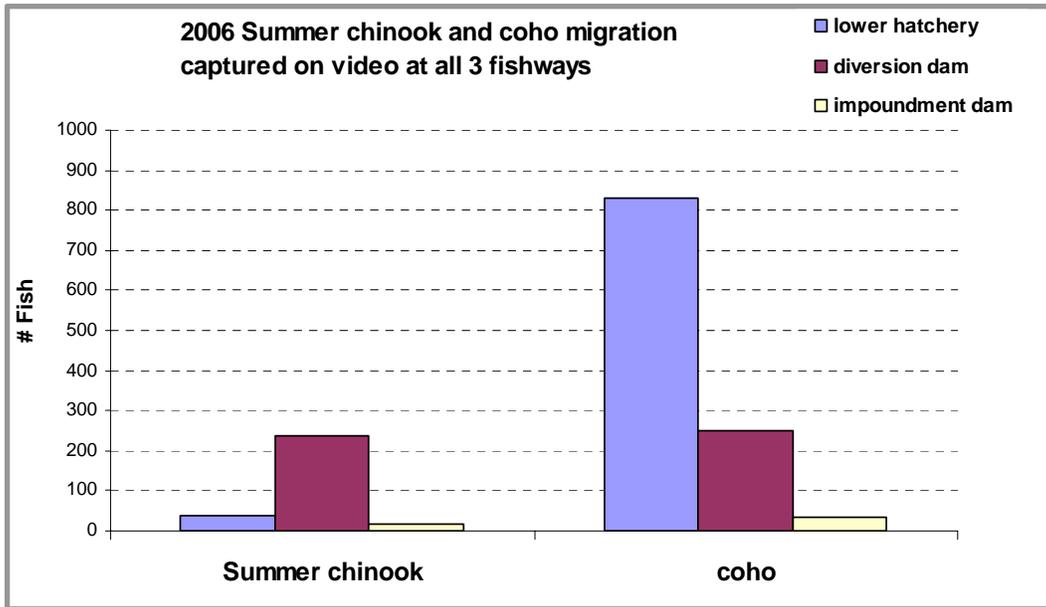
Figure 5. Summer run chinook and coho migration recorded at all 3 video monitoring stations in the Puntledge River fishways between May 5, 2006 and January 10, 2007.

Video surveillance commenced at the lower hatchery on May 5, 2006 and recorded 37 summer chinook passing through the tunnel to access the reach above the barrier fence until the by-pass was closed on June 9th. From June 9th until September 14th, the by-pass was closed, and all fish were diverted into the lower hatchery for broodstock collection. When the by-pass to the upper river was re-opened on the 14th, video surveillance resumed and within an eight day period (Sept 14th – Sept 22nd) 5247 fall chinook and 832 coho salmon were counted passing the camera. Figure 5 summarizes total numbers of summer chinook and coho salmon counted at all fishway cameras during the entire monitoring period.

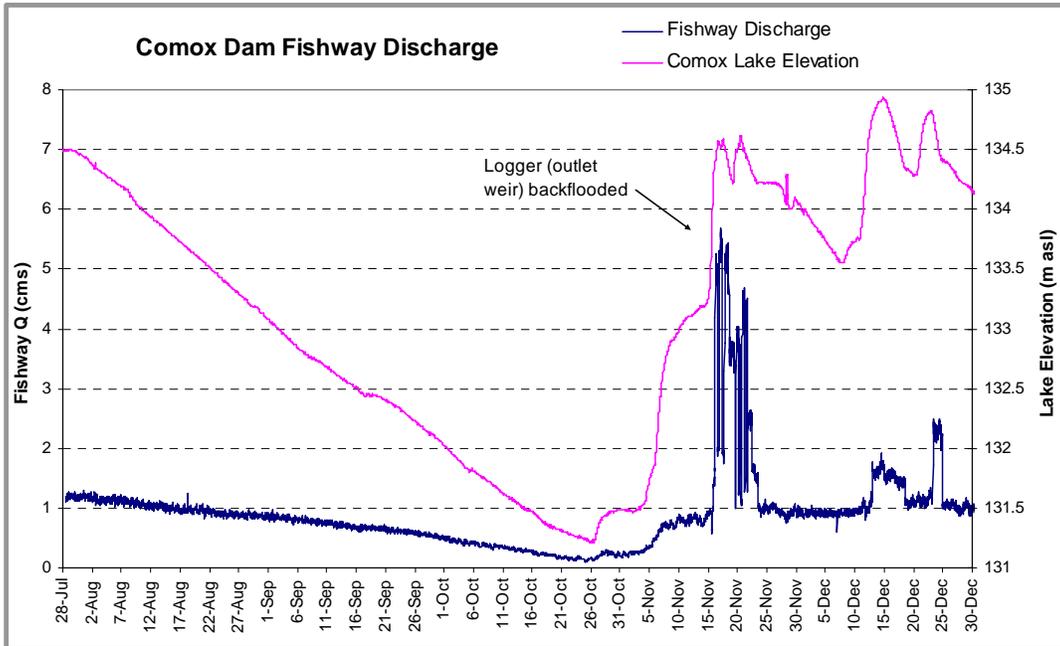
Figure 6. Discharge recorded through the Comox impoundment dam fishway between July 28 and Dec 31, 2006 with Comox Lake elevation.

Discharge through the fishway at the Comox impoundment dam ranged from a maximum of 1.3 cms (45.5 cfs) in the early summer when Comox Lake was near full pool (~134.5 m), to a minimum of 0.094 cms (3.3 cfs) in late October when Comox Lake was at 131.21, its lowest recorded level in 2006 (Figure 6). A relationship between lake elevation and fishway discharge has been developed (Figure 7). It should be noted that the above relationship is for operation of the fishway without making any adjustments to the stop logs in the fishway cells. In 2005, all of the stop logs on the two cells upstream of the outlet weir were removed, (i.e. 5 stop logs from the cell immediately upstream of the last weir, and 6 from the next cell upstream). This left only the steel plates in these cells with approximately 8 inches of water flowing over each plate at the time (August 26, 2005), slightly increasing fishway discharge and providing fish two options for upstream passage. It is uncertain whether these stop logs were replaced when flows in the fishway increased above 0.85 cms (30 cfs) as recommended (M. Sheng, pers. comm.).

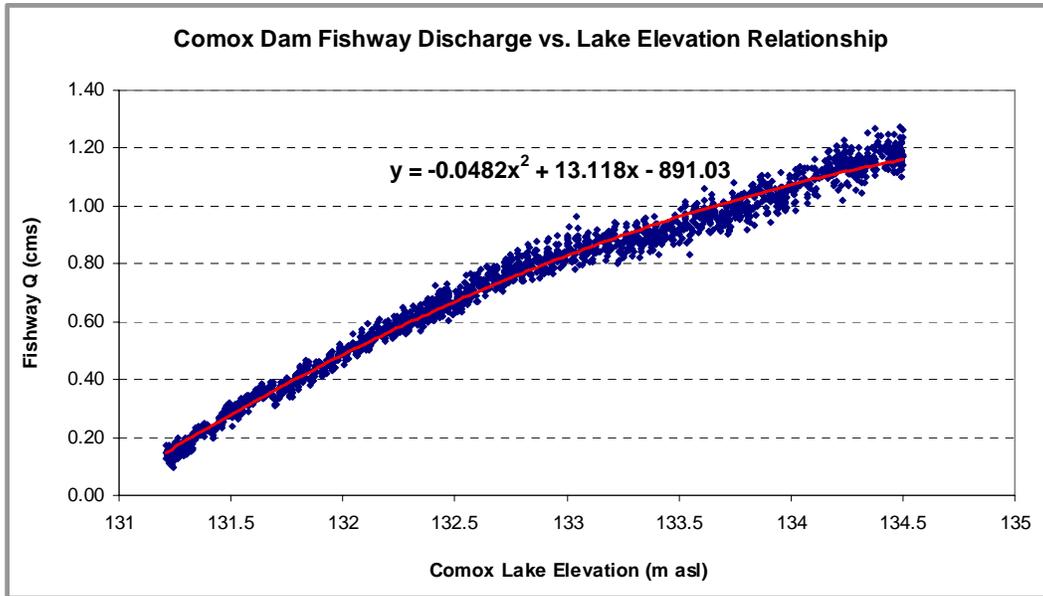
Figure 7. Discharge / Lake elevation relationship developed for the fishway at the Comox Lake impoundment dam.

A Solinst water level data logger was installed at the outlet weir of the fishway on July 28, 2006 to measure discharge through the fishway as lake levels declined. A discharge curve was developed showing the relationship between lake level and fishway discharge. This information was used to determine whether fish negotiated the fishway at low flows. Records of discharge at Gauge 6 below the diversion dam (WSC Gauge No. 08HB084), Comox Lake levels, and Comox dam sluice gate height and discharge were obtained from BC Hydro.

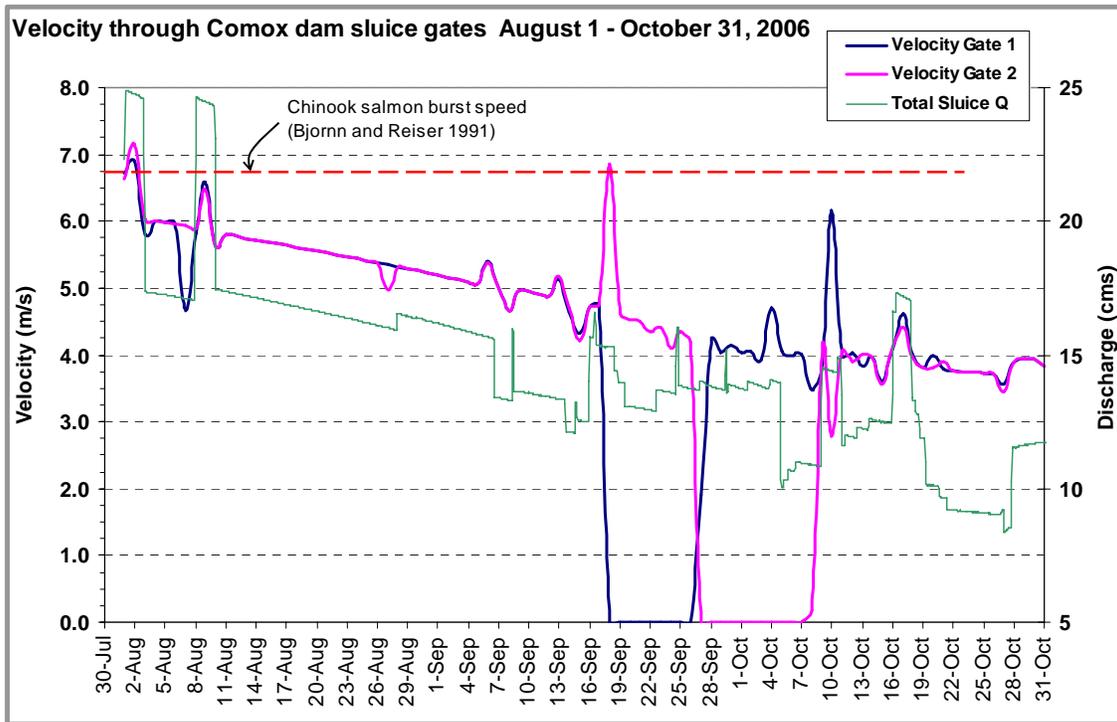
Figure 8. Average velocity through the Comox impoundment dam sluice gates, August 1 to October 31, 2006.

It is more probable that the other 119 or so chinook accessed Comox Lake directly through the sluice gates. It is assumed that chinook could potentially swim through the gates when velocity through the gates is < 6.83 m/s (22.4 ft/s) based on the burst speed of chinook (Bjornn and Reiser 1991). Records of gate height and discharge for each of the sluice gates at the Comox Dam were provided by BC Hydro for the period August 1 to October 31, 2007. Using this information, the velocity through each gate was calculated and results indicate that chinook salmon may have been capable of passing through the gates at the dam as early as August 1st. Figure 8 displays the average velocity through each gate. Water velocity under the gate is affected by friction caused by the edges of the submerged opening. Since velocity is greater in the centre of the opening compared to around the edges, suitable velocities for fish access may have been underestimated. Nonetheless, based on a maximum burst speed of 6.83 m/s, the average velocity calculated through the gates roughly coincides with the date that summer chinook were last observed passing through the camera tunnel (August 8th). It is assumed that the fishway would have been operating effectively at this time with a discharge of around 1 cms (~35 cfs). Since gate height and discharge data for earlier periods were not examined, chinook access through the sluice gates before August 1st can not be ruled out.

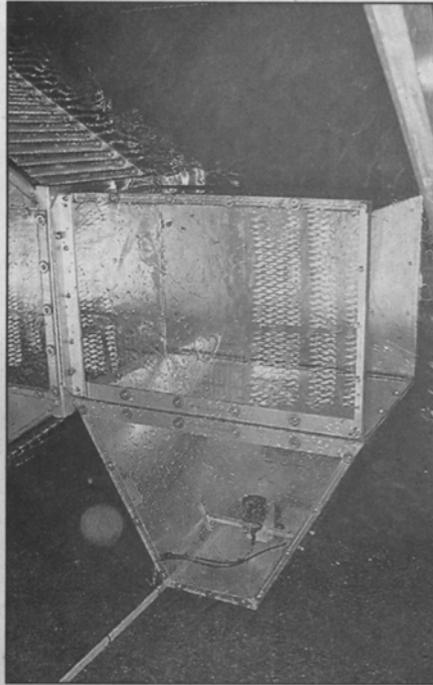
AN UNDERWATER CAMERA at left photographs fish moving up the Puntledge River.

to a square opening of about two and a half feet where the camera is stationed. The camera is completely waterproof and sits behind a plexiglass window in a compartment to the side of the enclosure.

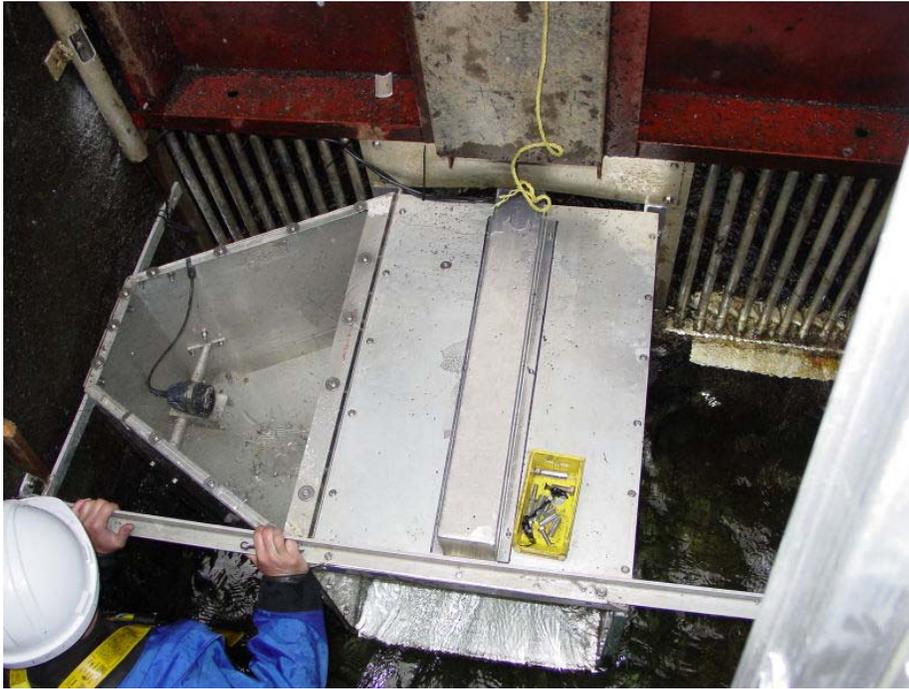
Photo 1. Modified tunnel assembly in the Comox Lake impoundment dam fishway showing separate chamber on left side of tunnel with camera installed

Aluminum tunnels designed and installed in the fishways for the 2005 video surveillance project (Guimond 2006) were left in place over the winter except at the Comox dam fishway. At this site the tunnel and camera box were removed prior to the winter so that modifications could be made before installation in 2006. The aluminum picket fence screen was left in place in the fishway weir orifice. The Comox dam fishway tunnel camera box was modified to operate as a "side-view" system similar to installations at the diversion dam and lower hatchery fishways (Appendix D; Photos 1&2). This improves image view and reduced maintenance requirements. Details of the tunnel design are described in Guimond 2006. A new environmental enclosure was installed at the Comox dam to house the video monitoring equipment (Appendix D; Photo 3).

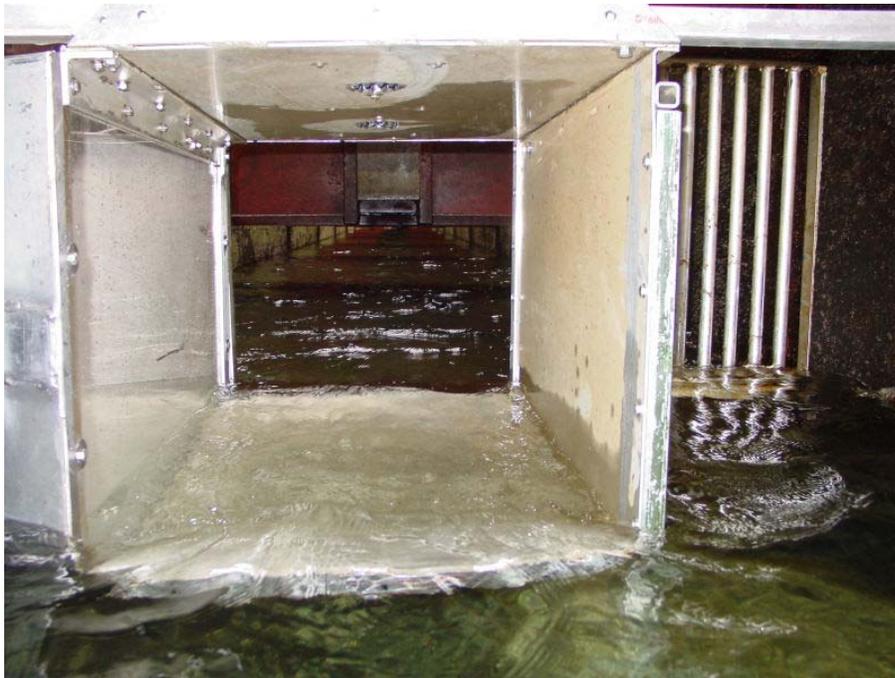
Photo 2. Tunnel assembly in the Comox Lake impoundment dam fishway showing new lighting system (top of tunnel) for improved night recording. Photo looking downstream at (submerged) fishway orifices.

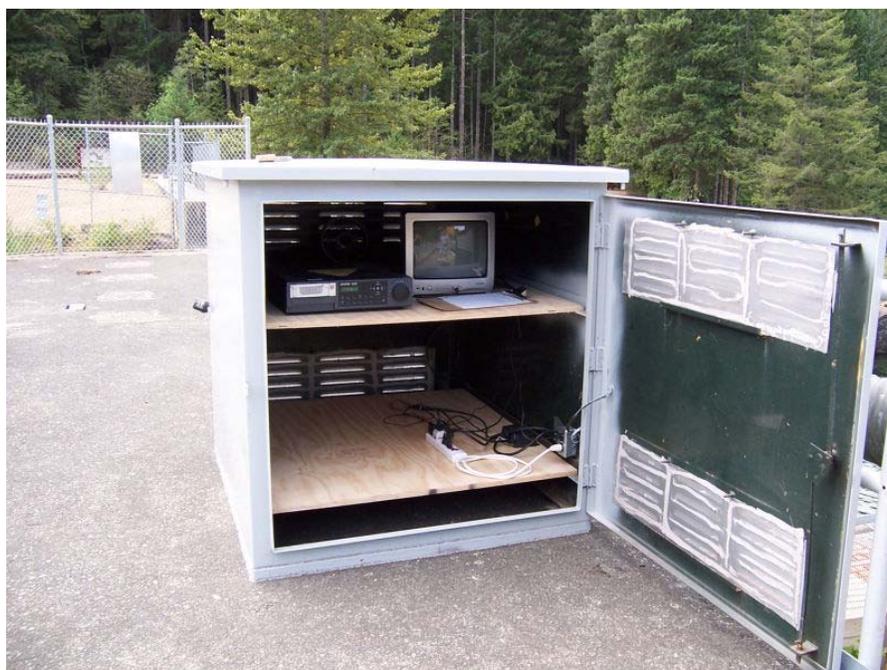
Photo 3. Installation of new protective shelter for DVMS digital recording equipment at Comox Dam, July 2006.

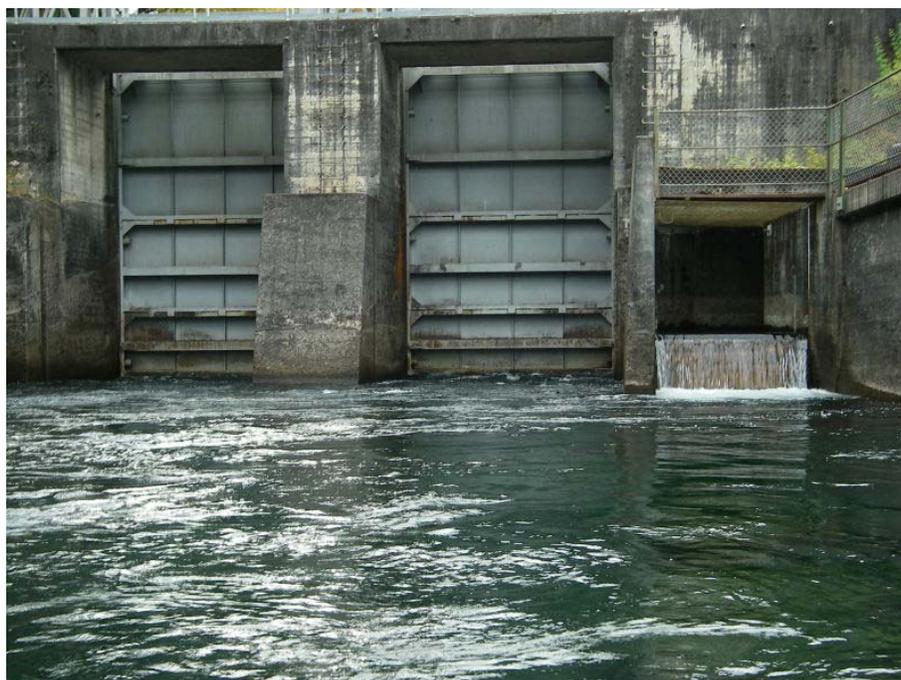
Photo 4. Comox impoundment dam sluice gates and tailrace pool, and fishway entrance, October 24, 2006. Sluice gate $Q = 9.1$ cms; fishway $Q = 0.15$ cms.

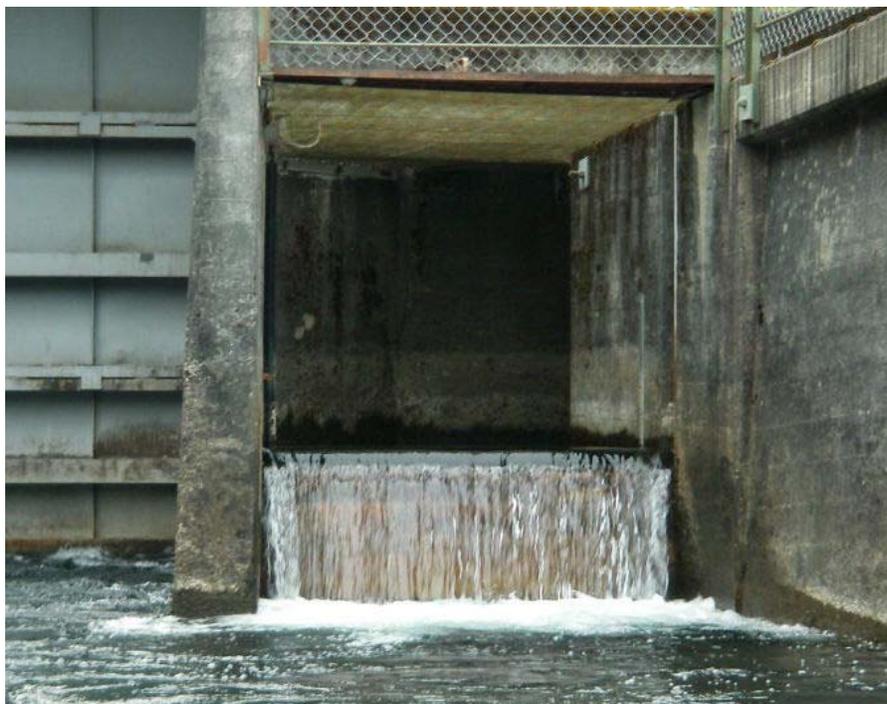
Photo 5. Comox Dam fishway entrance, October 24, 2006. Water level logger located in black PVC pipe on left of fishway outlet. Fishway $Q = 0.15$ cms (13 cm water flowing over weir).

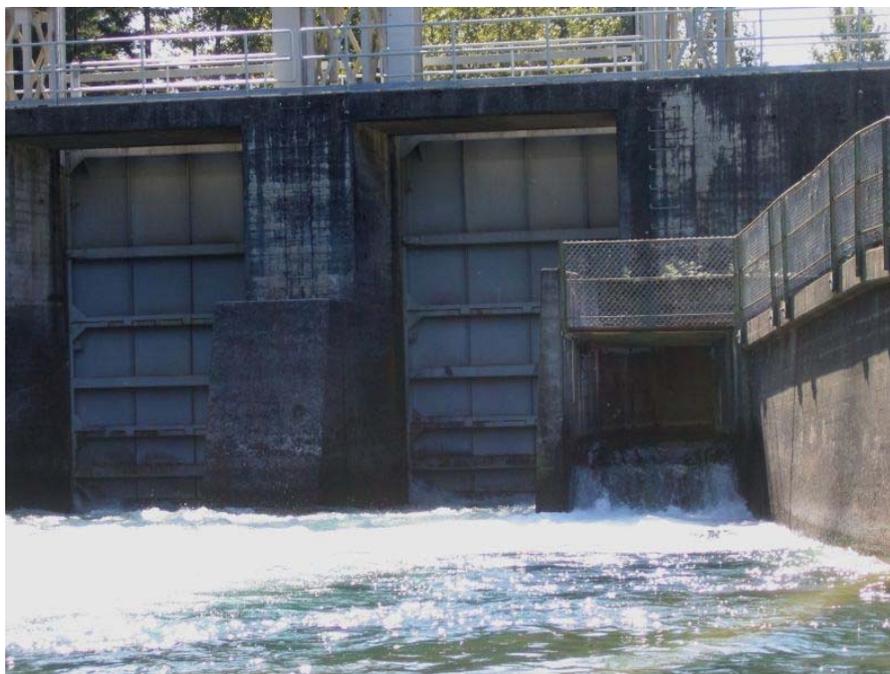
Photo 6. Entrance to fishway showing approximately 35 cms discharge over outlet weir.

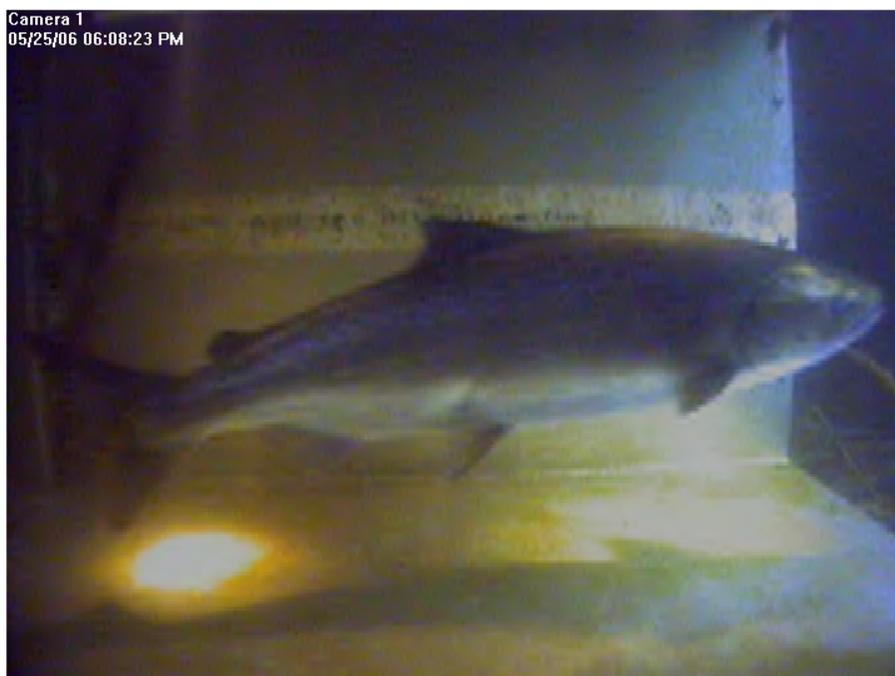
Photo 7. Image of summer chinook passing through the tunnel at the Lower Puntledge Hatchery, May 25, 2006 @ 1800 hrs.
