Salmon River Adult Fish Passage Assessment
Study
Project #07.CBR.04

Prepared by
Shannon Anderson
Fisheries & Oceans Canada

For
BCHydro
Bridge Coastal Fish and Wildlife Restoration Program
June 16, 2009

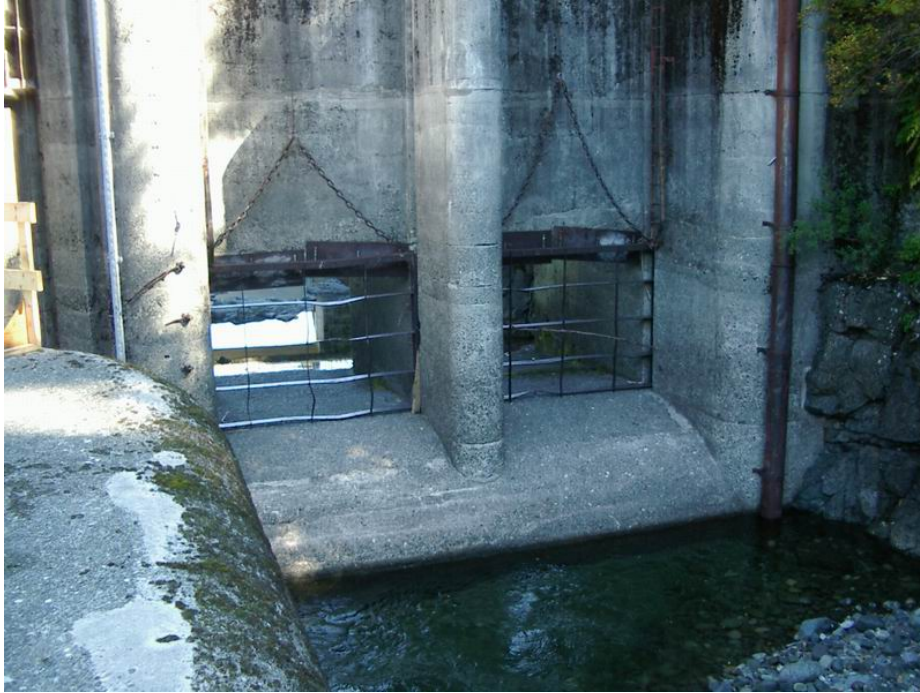
Figure 5. Upstream entrance to the diversion canal, looking downstream. Mainstem discharge ($1.7\text{m}^3/\text{sec}$ in this photo) all carried through undersluice (1m open) to the left of photo. Shows relative sill height of canal entrance and trash rack on canal.

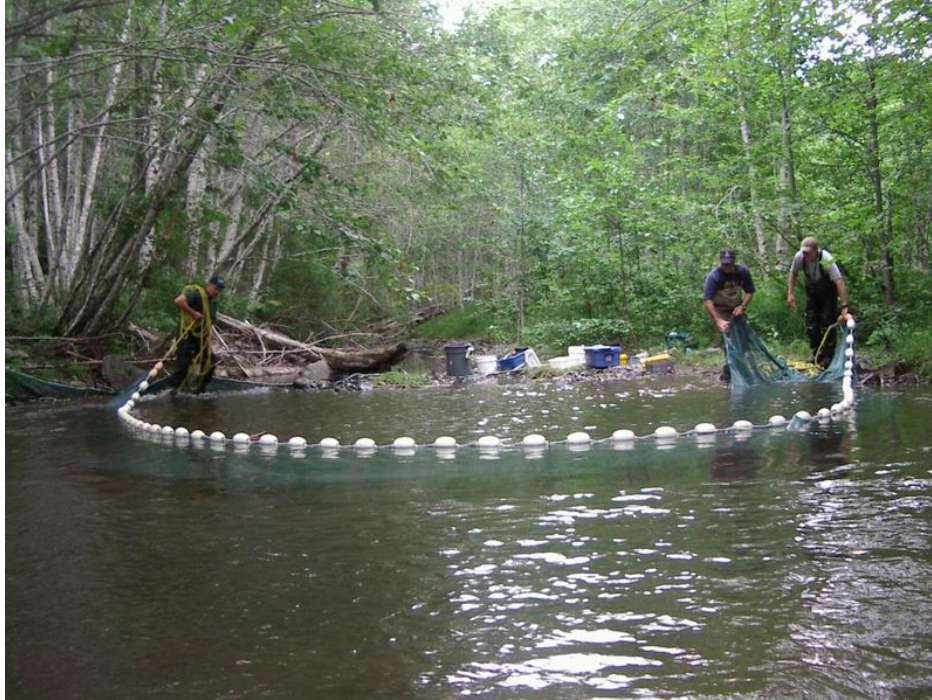
Figure 7. DFO staff beachseining for juveniles on Grilse Creek Tributary - G02 August 08.

In late August and September 2008 DFO staff undertook 3 days of a juvenile survey in the Salmon River watershed based on sites sampled and reported in a previous report surveying potential habitat of Coho salmon in the upper Salmon River Watershed (Craig et al. 1998). Four sites upstream of the diversion and 2 downstream were established and sampled using beach and pole seine removal methods, sampling the juveniles for length, weight and scale samples, (Appendix A, Fig.6) to add to the understanding of the productivity from available habitat, densities, biomass and life history. Each site was sketched and position recorded on GPS. All Coho were measured (mm) and up to 3 of each length were damp blotted and weighed (0.01g) using an Ohaus Scout Pro, model SP202 (Fig. 7 & 8).

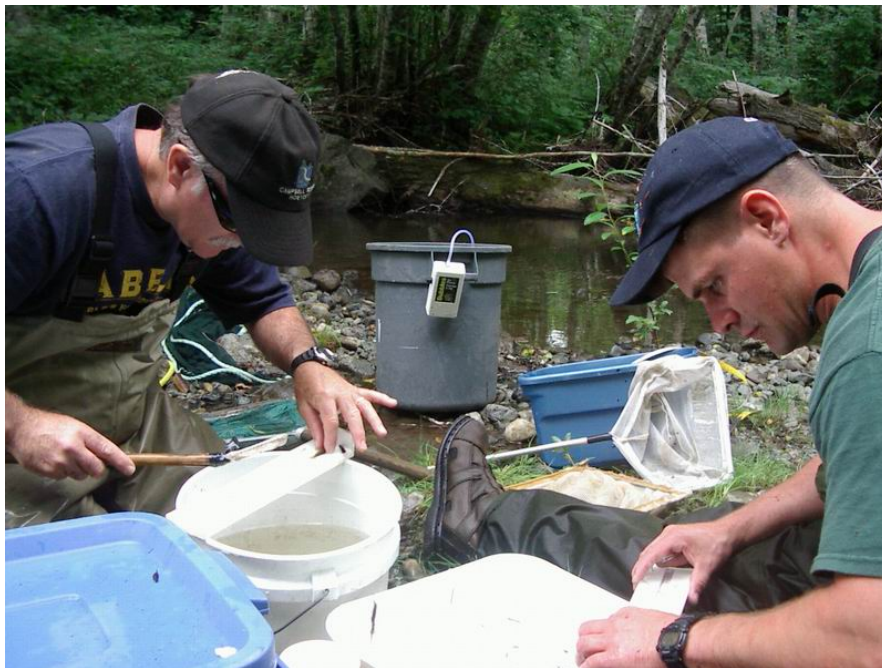
Figure 8. DFO staff - David Ewart and Pieter van Will sampling Coho fry at Grilse Creek tributary August 08

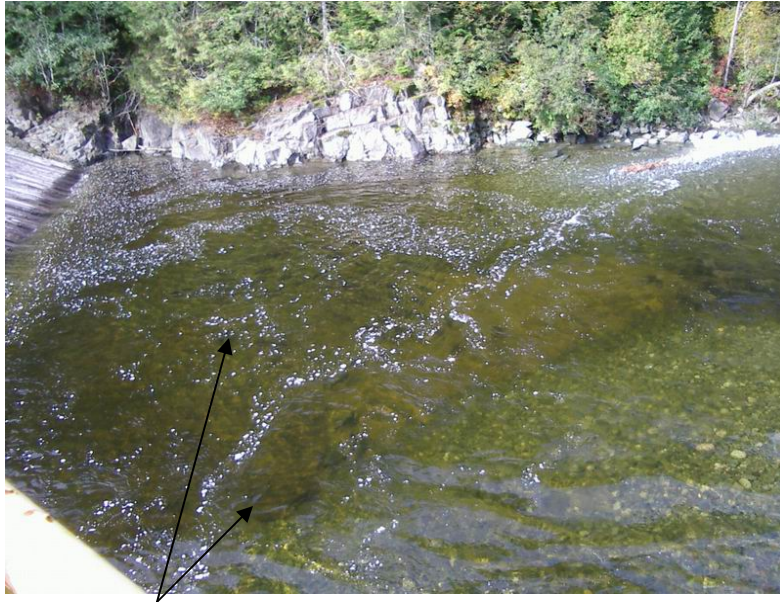
Figure 9. Coho adults - dark shapes - holding at the diversion dam pool. October 8, 2008. Discharge $16\text{m}^3/\text{sec}$, undersluice open 0.91m.

Early (October 8) flows of $16 \text{ m}^3/\text{sec}$ brought Coho to the diversion pool, 75-100 were observed holding, the undersluice at this time was still open to nearly 1.0m. A week later there were no fish in the diversion pool, and a few under the logging road bridge. During this period the diversion canal was closed, river discharge had dropped to $7 \text{ m}^3/\text{sec}$, and the undersluice remained open 0.91m until October 15/16 when it was reduced to 0.15m. Generally the gate setting is decreased in anticipation of the higher fall flows that bring large debris that can get jammed in the gate. Adult Coho were observed continually at either the diversion pool site or at the logging bridge from early October until November 28 when there were still 20 fish at the diversion dam pool. During higher flows visibility was decreased at both the diversion dam pool and the bridge pool.

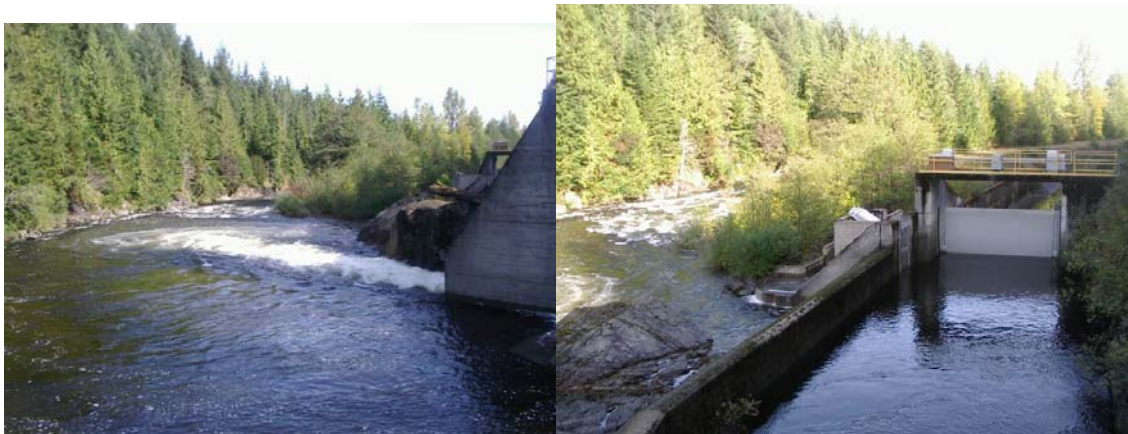
Figure 10. October 8, 2008- undersluice open 0.91m. $16\text{m}^3/\text{sec}$ all through undersluice and fishway, no diversion flow.

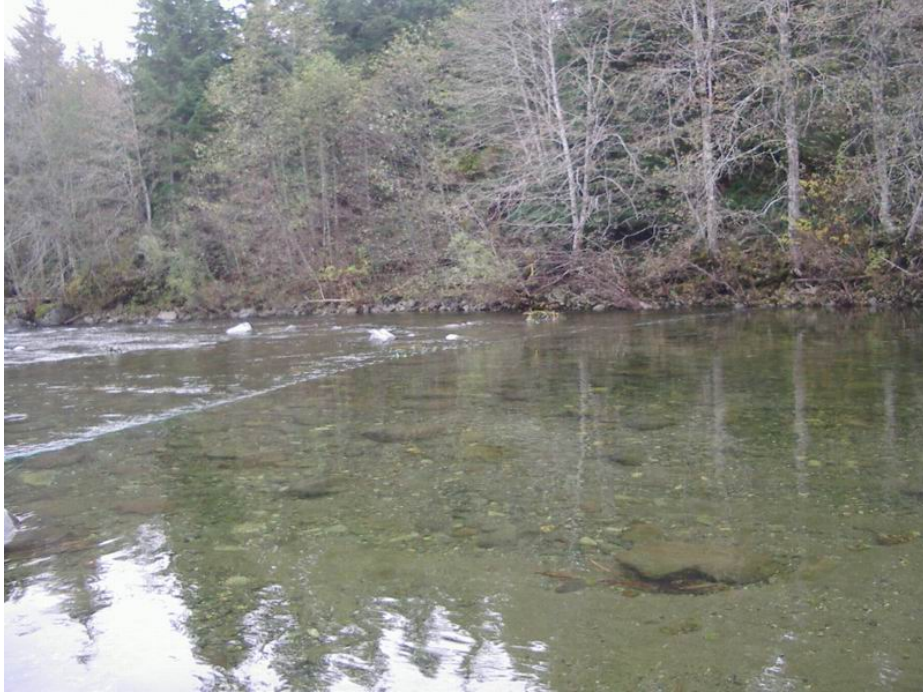
Figure 12. Tangle net spanning riffle downstream of Coho capture site, October 28 2008.

On October 28th five staff from DFO and Mainstream Biological Consulting (MBC), captured 14 Coho adults using a beachseine (61m long x 6m deep, 14cm mesh) and two sinking tangle nets, (15m x 2.4m with 14cm mesh). Discharge in the river was 5m³/sec with no flow through the diversion canal. The tangle nets were joined together and strung across the mainstem at a riffle site about 100m downstream of the logging bridge (Fig. 12). The beachseine was set using a small inflatable raft with one person aboard and two ashore at the top end holding the upstream end of the net. A rope from the other end of the net was walked downstream on the left bank then midway across the river to pull the raft downstream, launching the net from the raft. The raft was then pulled to shore about 30m downstream of the original launch site, the upper crew walking down the left bank to close off the net (Fig. 13). Large boulders at the upstream end caused some delays in deploying the net; however the tangle net at the downstream end was very effective in catching the fish. Eleven males and 3 females were caught and placed in a net pen for tagging (Fig. 14). All 14 fish were in very good condition, coloured up but with no visible fungus or injuries (Fig. 15-16).

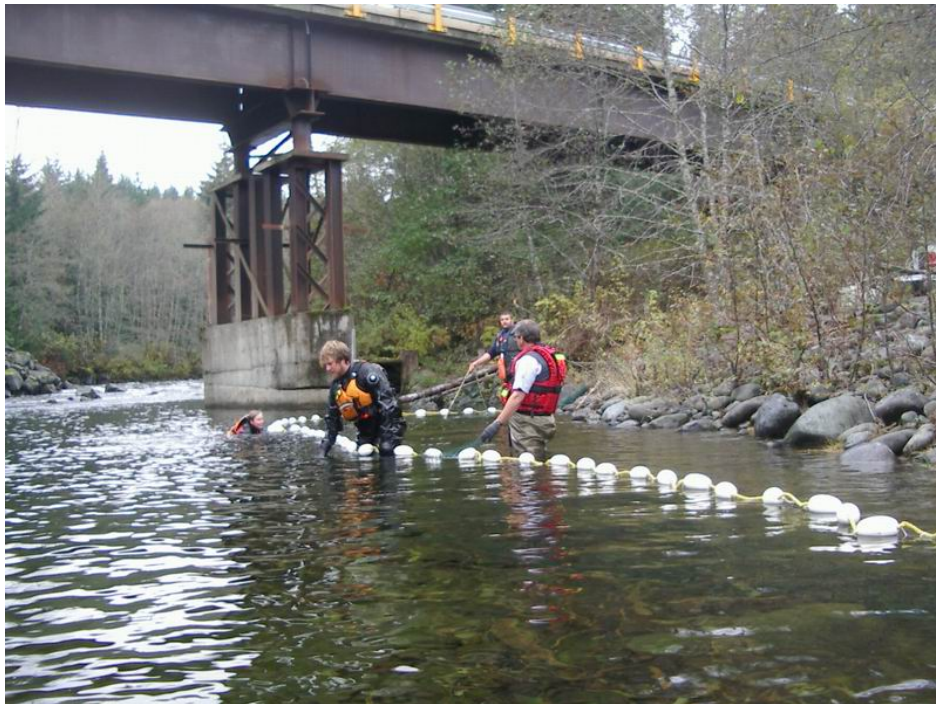
Figure 13. Closing up the Beachseine, October 28th, during capture of adult Coho for marking

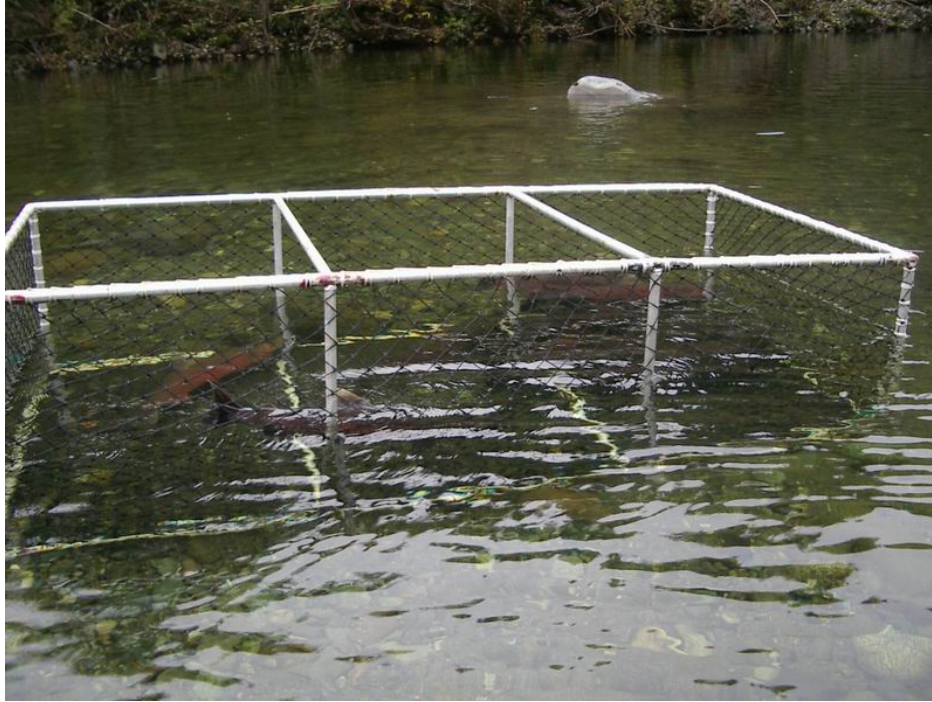
Figure 14. Captured Coho waiting tagging in net pen (S. Anderson photo)

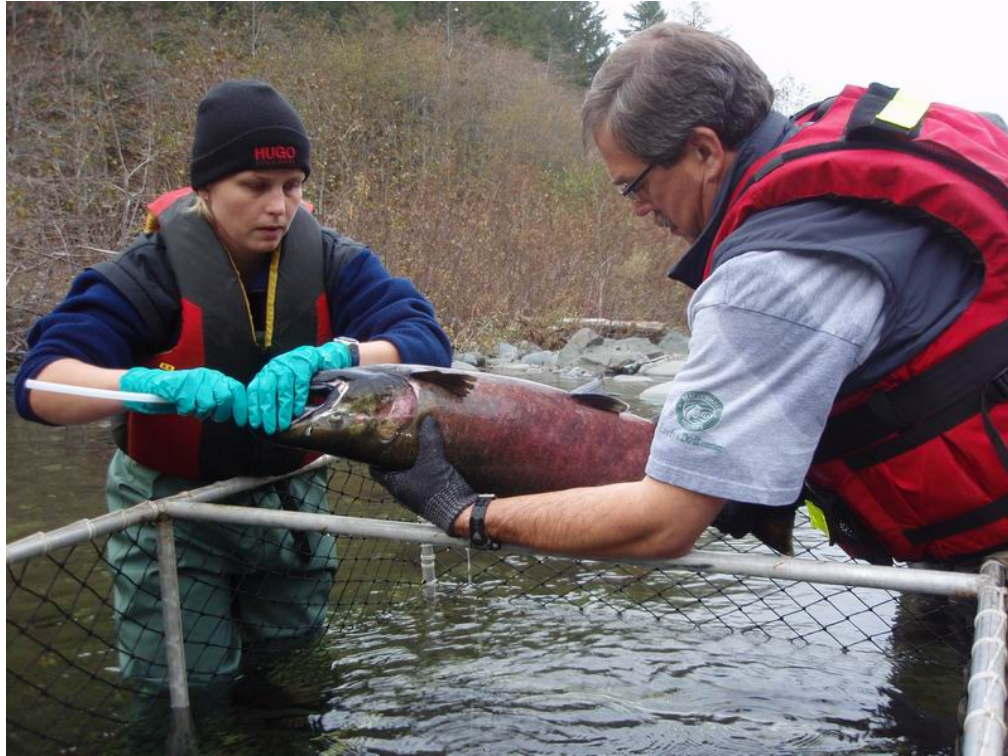
Figure 17. Heidi Lydersen of Kintama Research inserting acoustic tag. Fish held by Barry Peters DFO. (Mainstream Biological Consulting photo)

The application of the acoustic tags was done right at the net pens with no anesthetic applied (see Appendix E for explanation). The cool water (5C) kept the fish fairly docile, and efficient handling times of less than one minute per fish streamlined the operation. Each fish was taken out of the net pen and the nose-fork length, sex and the tag number were recorded. The fish was held belly-side up and the V13-1L tag was quickly inserted down the esophagus, through to the stomach using a food grade, flexible plastic tube and plunger (Fig. 17). The fish were then placed into individual broodstock holding bags for 30-60 minutes to monitor for regurgitation of the tags, then released at the capture site. Receivers were removed and downloaded in early December 2008.

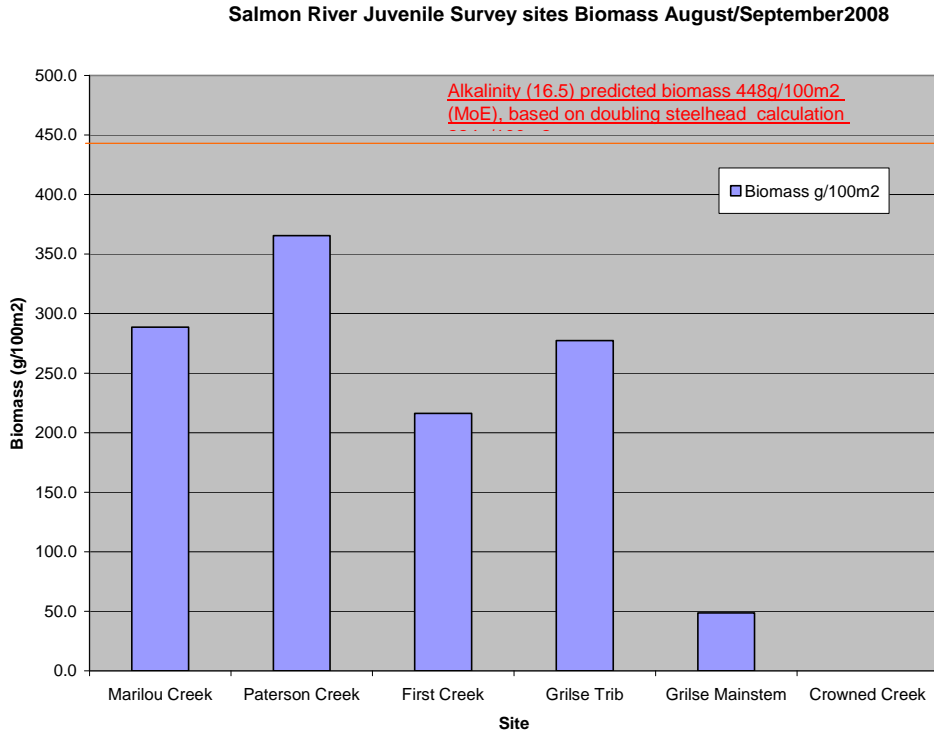
Figure 18. Biomass/100m2 for Salmon River juvenile survey sites, with biomass predicted by alkalinity of 16.5mg/l=224.5g/100m² times 2 for coho fry= 448g/100m². (MoE)

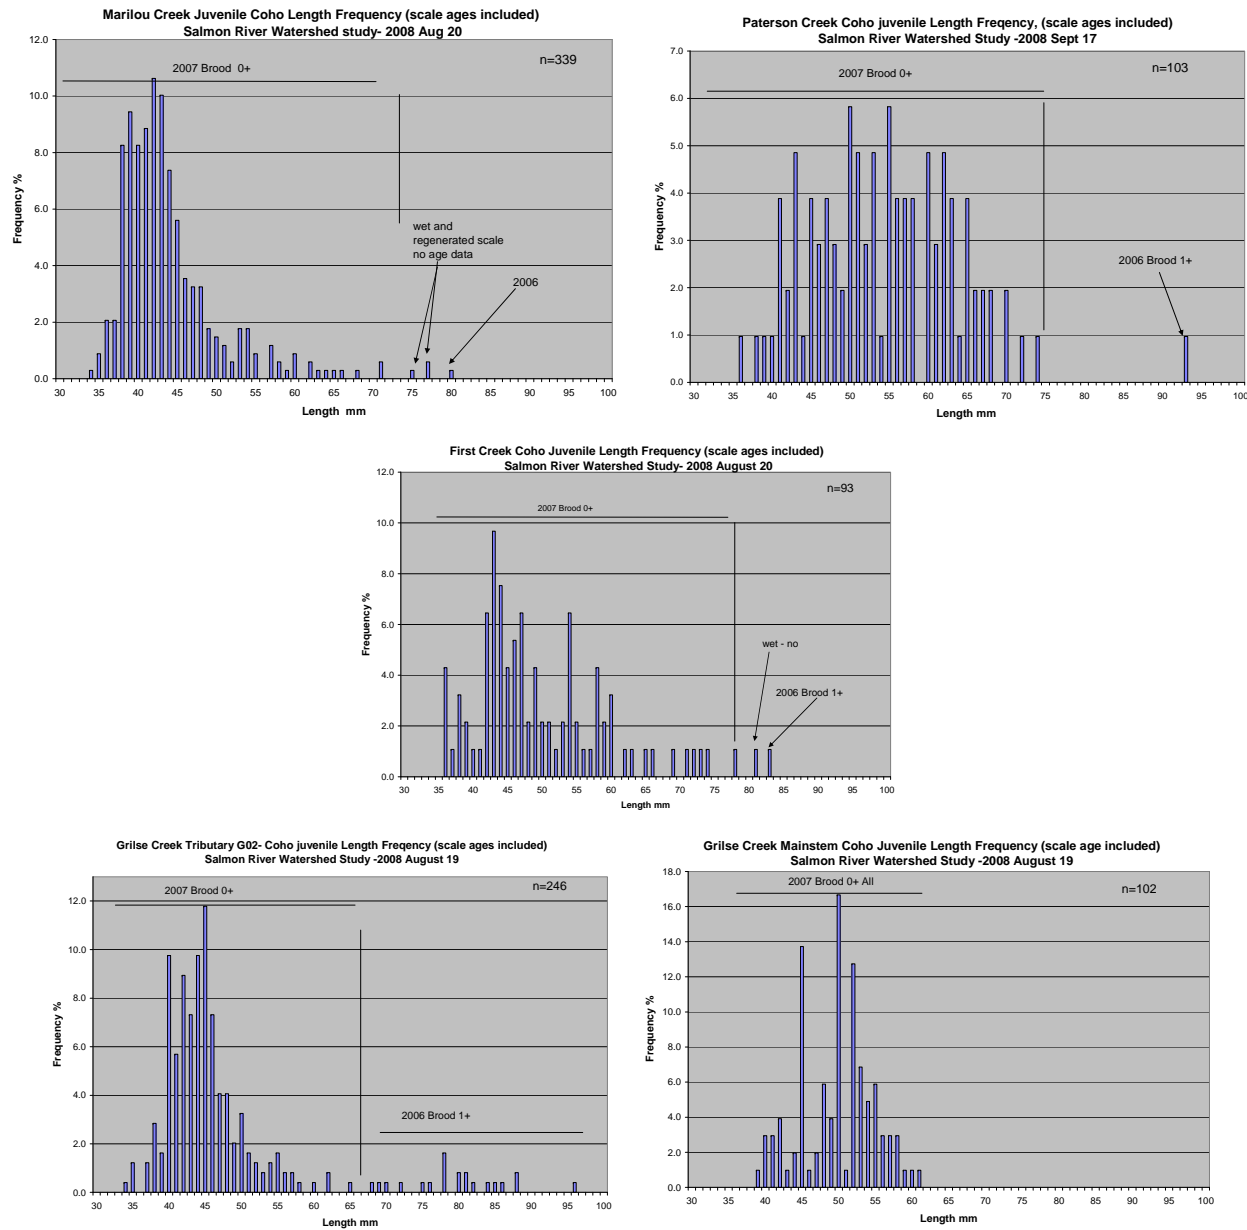
Figure 19. Frequency distribution of Coho juvenile length for the 5 sites sampled, 2008. Top 2 charts are sites below the diversion, 3 lower sites above.

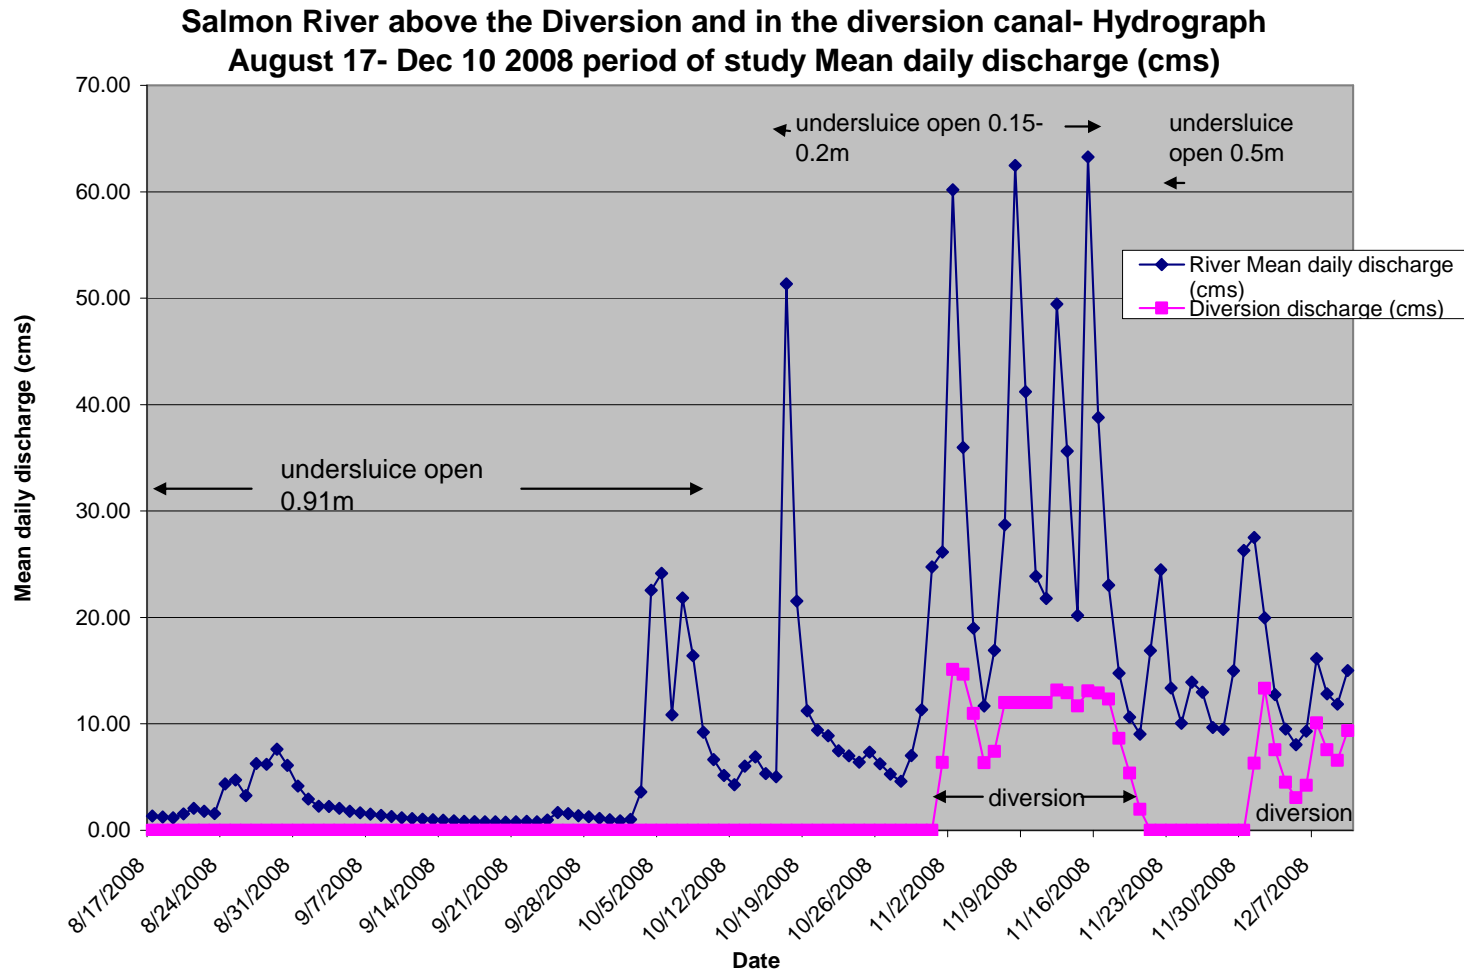
Figure 20. Environment Canada Water Survey of Canada Discharge data for Salmon River mainstem upstream of the diversion and the diversion canal (08HD015 and 08HD020) August 17- December 10, 2008, period of study and undersluice gate openings recorded. Note steep increases in response to rain events

DFO and BCHydro personnel reported observations and activities at the Salmon River diversion site on the provided template form, contributing valuable information on the conditions, timing of adult migration and reconnaissance for fish capture and tagging opportunities. This diary information is included in Table 3. Undersluice gate settings, discharge and diversion operation over the period of the study is reported in Fig. 20.

The diversion canal was opened November 1-20, closed for a period, then reopened December 1st (refer to Fig. 20 above). Discharge curves were adjusted to account for the amount of water left in the mainstem river (WSC 08HD015 – WSC 08HD020), and fish passage related to this number ((Fig. 26- 27). Although mainstem attraction flow is less there is the still head pressure at the top of the fishway with the diverted flows.

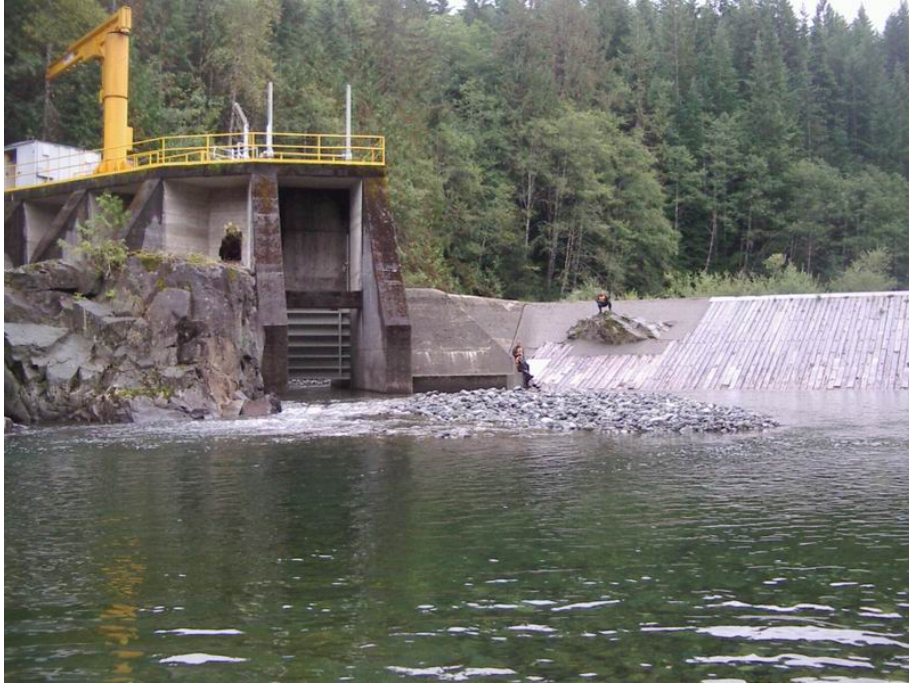
Figure 21. Salmon River diversion structure looking upstream - undersluice gate open to 0.9m September 24 2008, mainstem flow less than $1\text{m}^3/\text{sec}$. All of the river flow is passing through the undersluice.

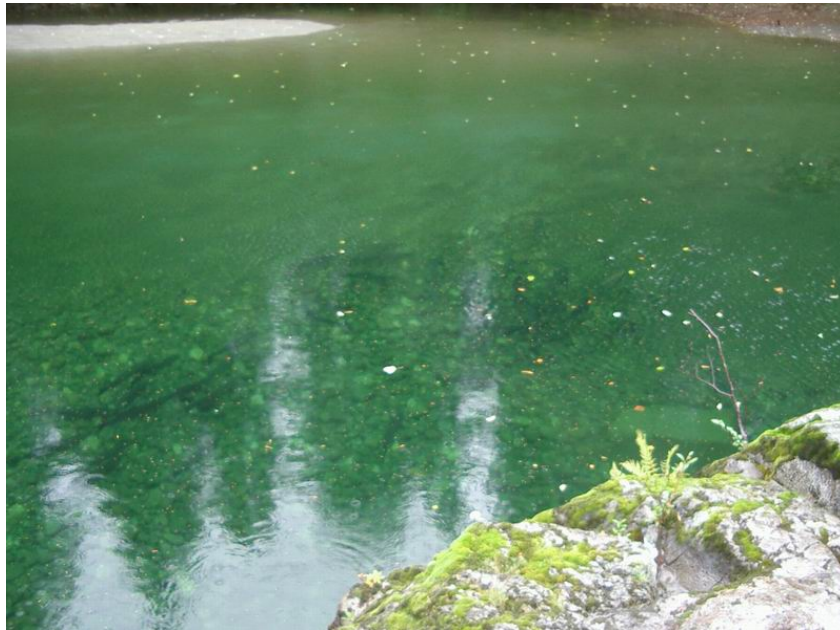
Figure 22. Coho adults observed in the WSC pool upstream of the diversion dam September 24, 08. Undersluice open to 0.91m, mainstem river flow $0.9\text{m}^3/\text{sec}$

The discharge for the Salmon River near the diversion, for most of the summer months is around $1 \text{ m}^3/\text{sec}$, quite low for a river of this size, and easily flowing through the undersluice gate when it is open about one meter (Fig. 21). Coho were observed holding in the lower river near Sayward in early September. A storm in late August bumped the Salmon mainstem flow to $7 \text{ m}^3/\text{sec}$ likely drawing these fish upstream as an estimated 40 Coho were observed in the pool upstream of the diversion on September 24th indicating the adults move up early on quite low water (Fig. 22).

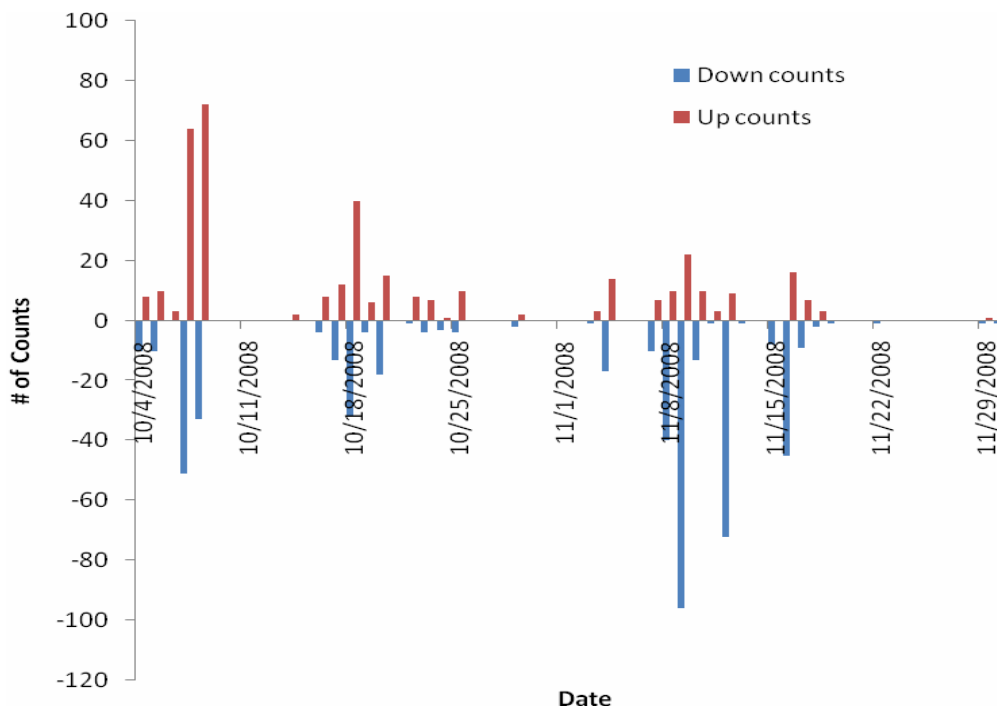
Figure 23. Daily up and down counts as recorded by the resistivity fish counter on the Salmon River fishway, fall October – December 2008 (McCubbing 2009, see Appendix D)

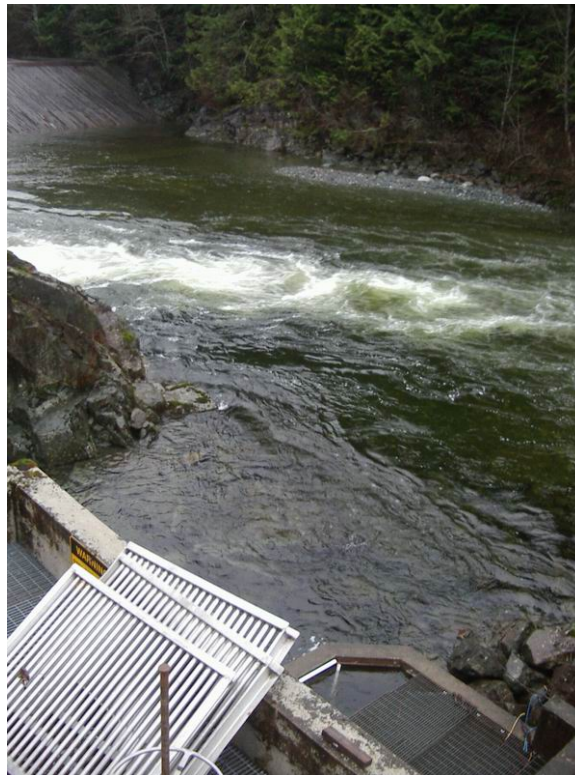
Figure 25. View of entrance to Salmon River fishway with mainstem in background. Screen is off lowest cell of fishway, where Coho could have bypassed resistivity counter both up and down.

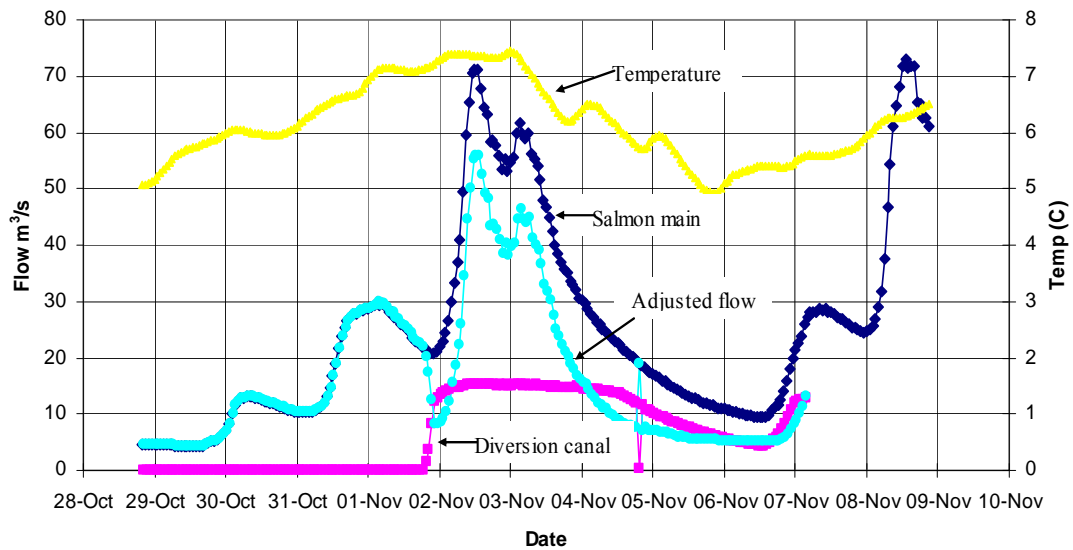
Figure 28. Discharge summary of the Salmon River. Flow (m^3/s) and temperature (C) in the Salmon River and Diversion Canal during the period tagged Coho were detected near the BC Hydro Diversion Dam. There is a gap in the flow data for the diversion canal between the 7 Nov (3:22) and the 12 Nov (20:32). “Salmon main” refers to the flow above the dam and “Adjusted flow” is an approximation of the flow in the river below dam. The first hydrometric reading from the diversion canal, indicating flow, was on the 1 Nov 2008 at 19:32. . (Lydersen et al 2009 Appendix E)

The hydrographs, summarizing flows in the mainstem Salmon River above the diversion, in the diversion canal, the net flow downstream to the mainstem and water temperature, are shown in Figure 28 for the period after Coho were tagged to the date of the last detection (October 28- November 9, 2008).

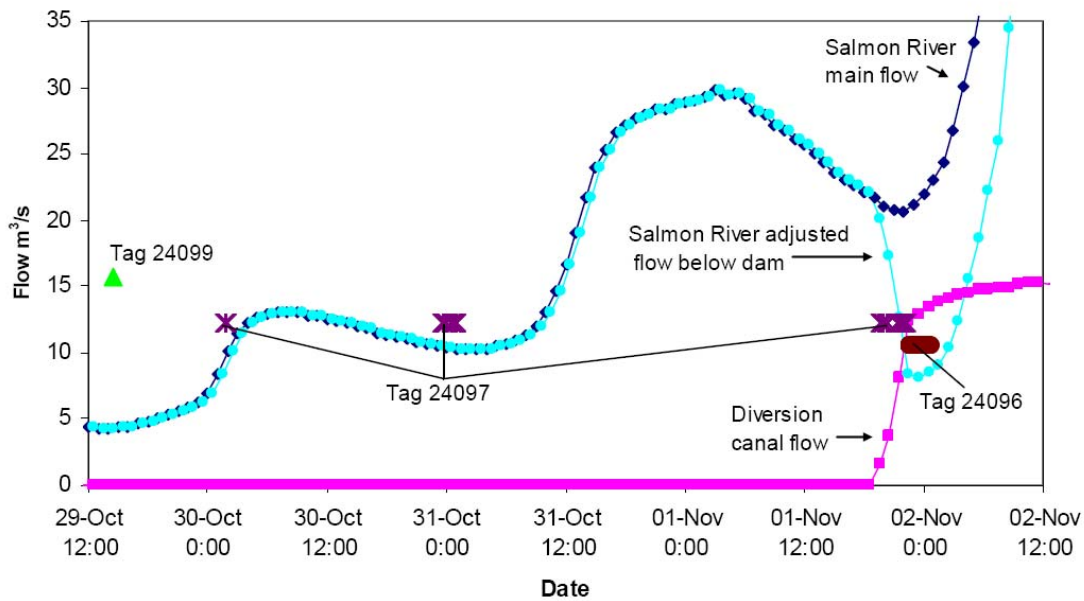
Figure 29. From Appendix E - (Lydersen et al. 2009) A close-up showing the flow in the Salmon River, diversion canal and adjusted flow in river below dam during the time adult Coho were detected in the fish ladder. Fish 24099 was only detected once and subsequently heard downstream. Fish 24096 had one period of continuous detection in the fish ladder. Each tag is shown as a different symbol

Only 3 tagged fish were detected in the fishway (Fig. 29), all at flows of 10-15 m^3/sec to the river downstream.

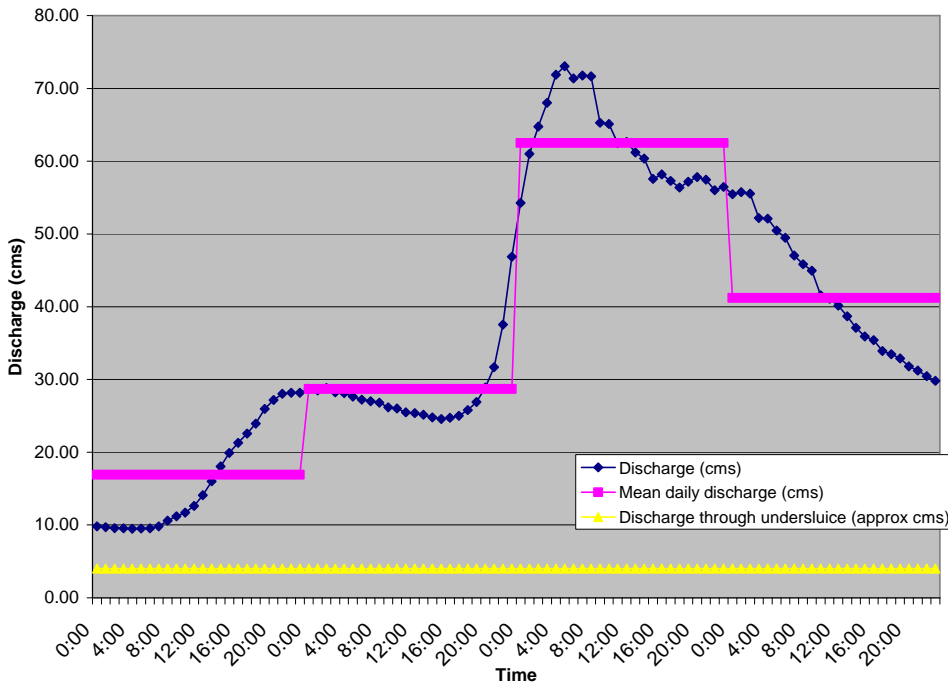
Salmon River discharge (cms) hourly vs daily average November 6-9, 2008. Includes undersluice estimate at 0.20m opening.

Figure 30. Salmon River discharge showing the hourly and daily averages, as well as the undersluice gate settings discharge estimates for 2 periods. a) October 4-6 and b) November 6-9 2008

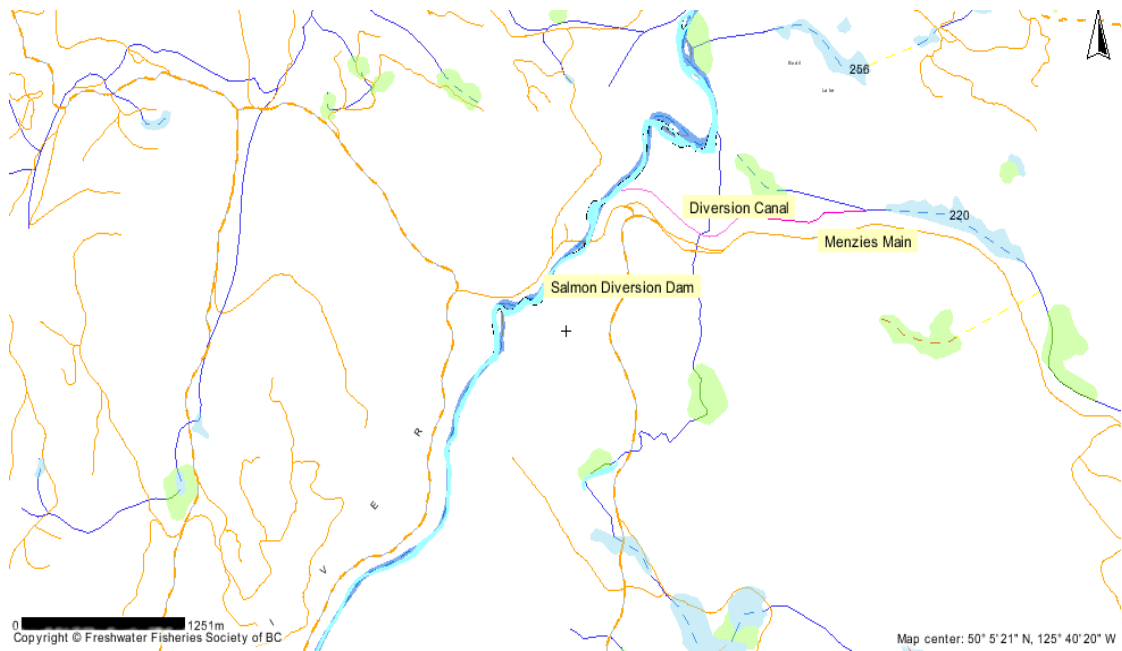
Figure 1. Location of Salmon River Diversion.

BC Hydro operate a water diversion canal on the upper Salmon River during high water periods, typically in the spring during snow melt and for shorter periods in the fall during rain or rain on snow storm events (Ladell and McCubbing 2005). The diversion canal entrance is located at the BC Hydro (BCH) diversion dam and accessed along the Menzies Mainline of ~~Weyerhaeuser Ltd., North Island Timberlands~~, north of Campbell River (Figure 1).

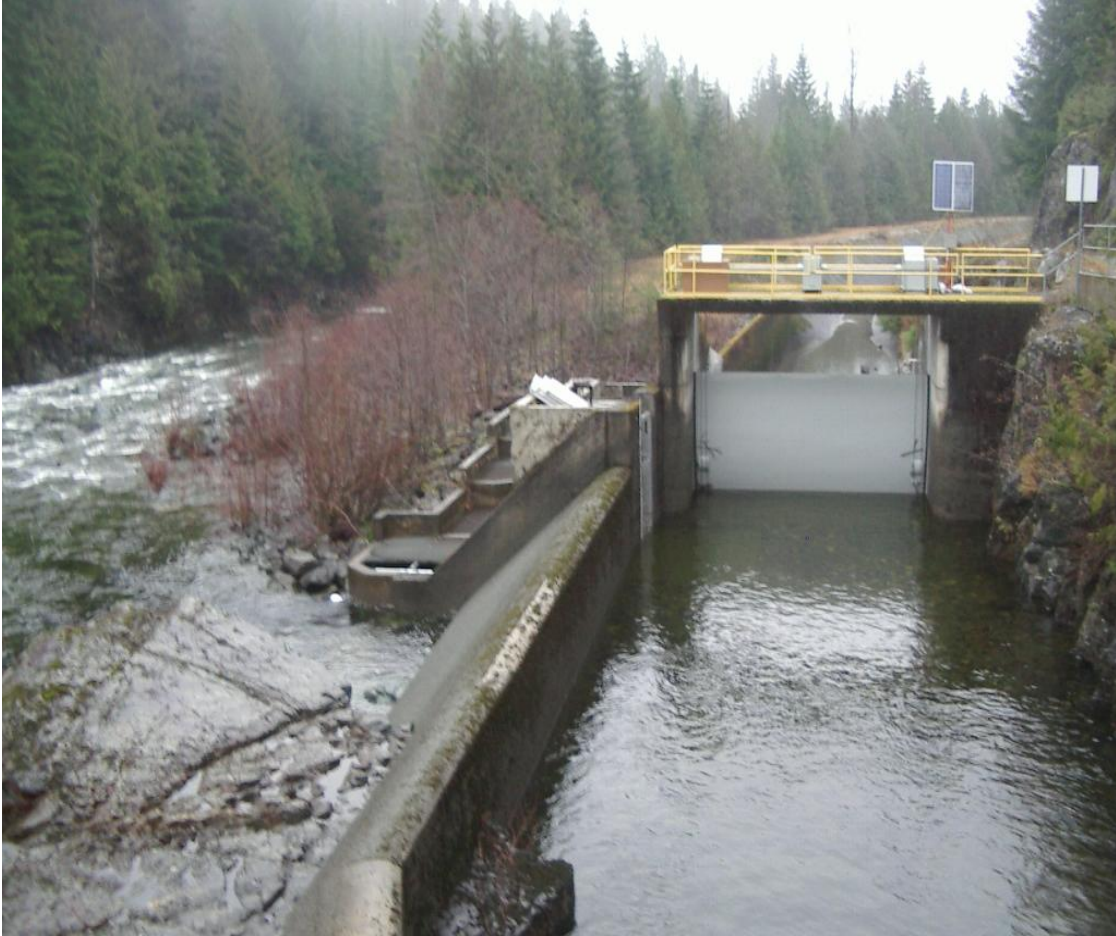
Figure 2. Downstream view of the diversion fishway, radial arm gate and Salmon River during fall 2008 at approximately 9CMS flow with the diversion closed (photo by S.Anderson).

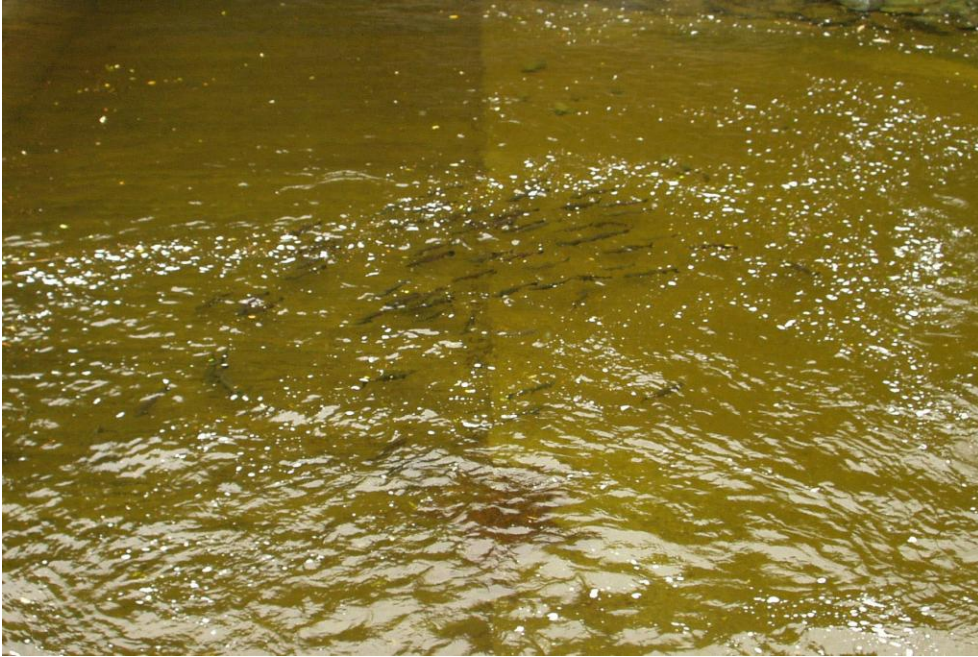
Figure 4. Coho salmon holding below the diversion dam under low flow conditions, October 10th 2003 (Photo from IFR archives).

Observations of fish passage past the diversion structures and fish holding below the dam have been made by InStream Fisheries Staff between 2003 and 2008 during routine maintenance of the horizontal screen. These include passage of coho salmon through the fishway at below canal full capacity, likely passage of fish over the main diversion dam under high flow conditions, and conditions which appear suitable for fish passage via the undersluice gate on low flow with the gate out of the river flow. Observations of steelhead and coho holding below the dam (Figure 4) were also routinely recorded in operations reports (Troffe and McCubbing 2003, Ladell and McCubbing 2004 - 2008) although in many cases these were transient and the fate of holding fish ultimately unknown.

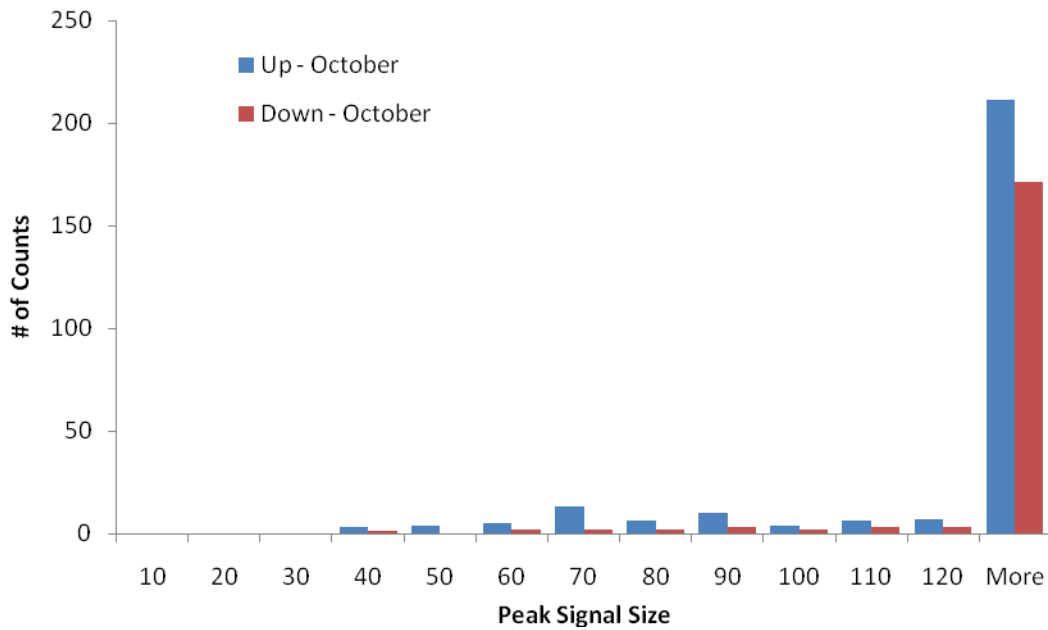
Figure 5. Peak signal size of fish enumerated at the Salmon River fishway, October 2008, gain set at 300.

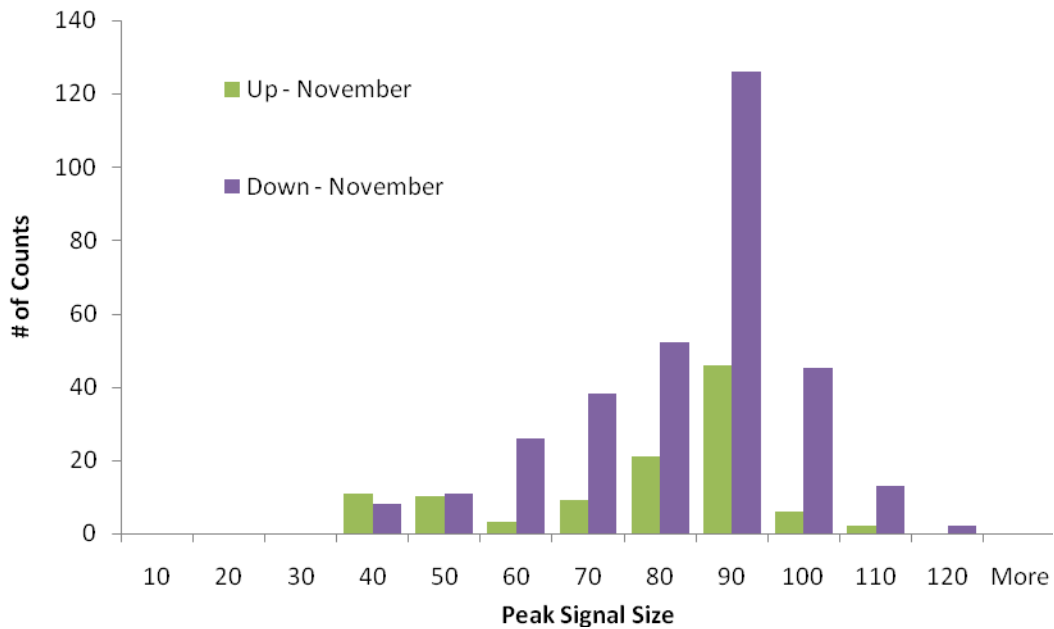
Figure 6. Peak signal size of fish enumerated at the Salmon River fishway, November 2008, gain set at 100.

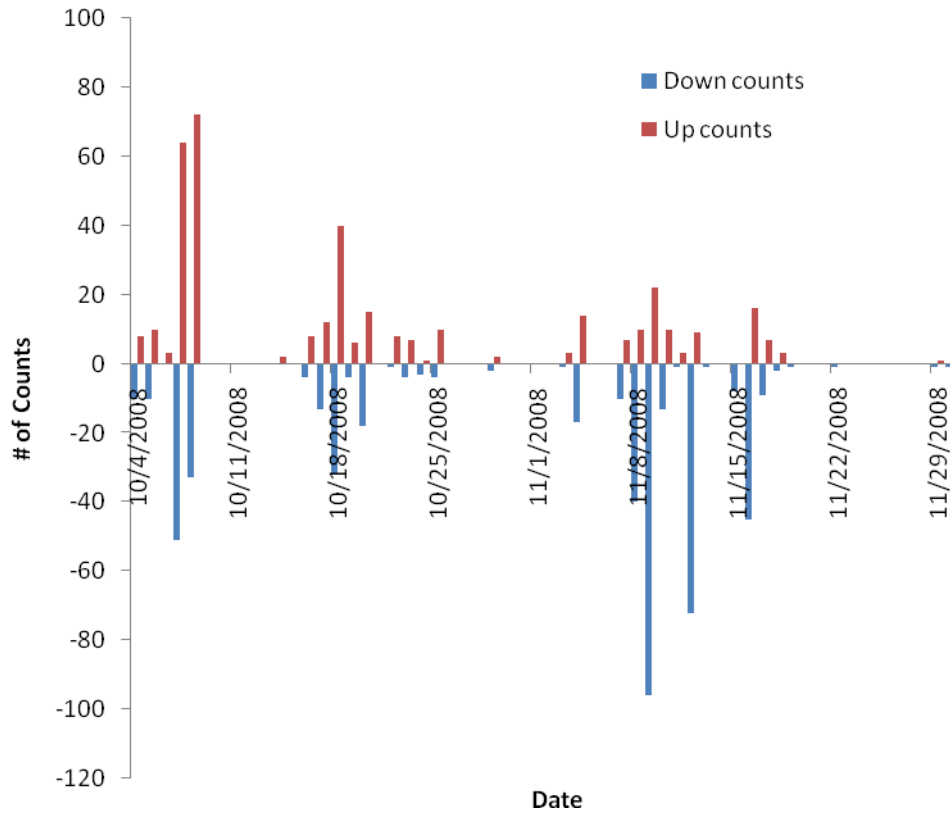
Figure 7. Daily up and down counts as recorded by the resistivity fish counter on the Salmon River fishway, fall 2008.

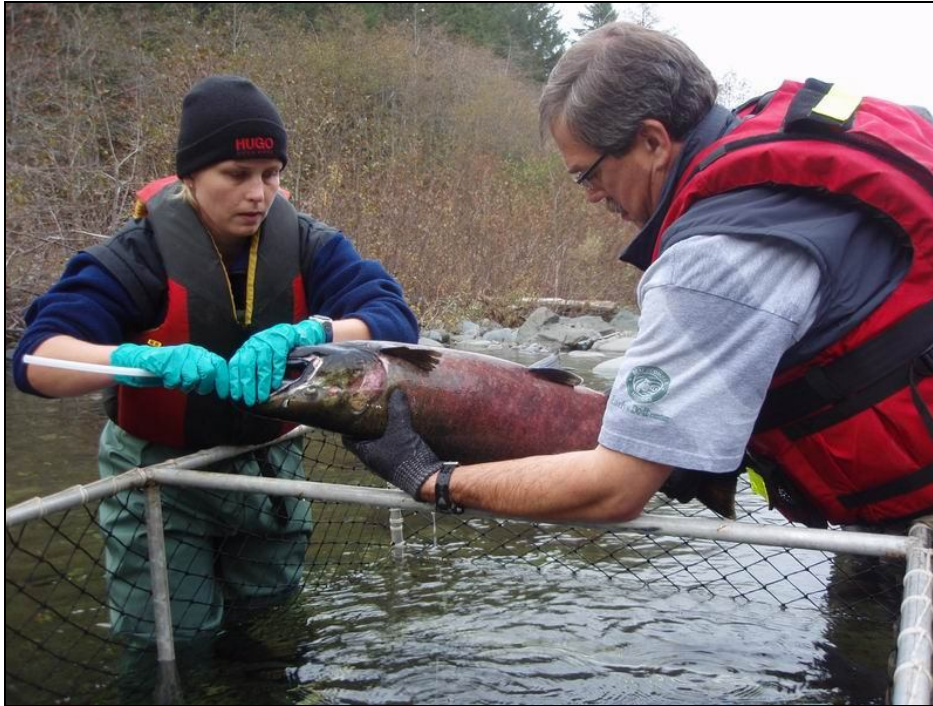
Figure 4. Gastric implantation of acoustic tag in adult coho by Heidi Lydersen (Kintama Research) and Barry Peters (DFO; Photo courtesy of Mainstream Biological Consulting Inc).

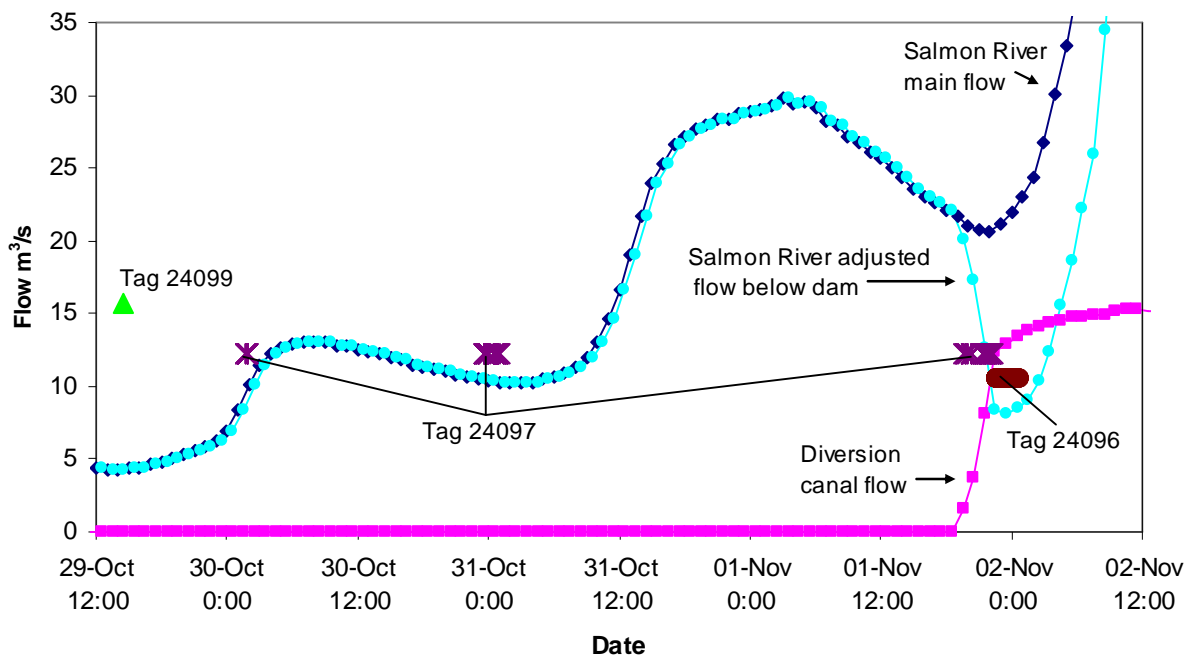
Figure 11. A close-up showing the flow in the Salmon River, diversion canal, and adjusted flow in river below dam during the time adult coho were detected in the fish ladder. Fish 24099 was only detected once and subsequently heard downstream. Fish 24097 had four periods of detection in the fish ladder at approximately equal flow rates. Fish 24096 had one period of continuous detection in the fish ladder. Each tag is shown as a different symbol.
