# **Puntledge River Impoundment and Diversion Dam Fishway Assessment 2007**

**07.Pun.02**

**BC Hydro Bridge Coastal Fish and Wildlife  
Restoration Program**

**March 2008**

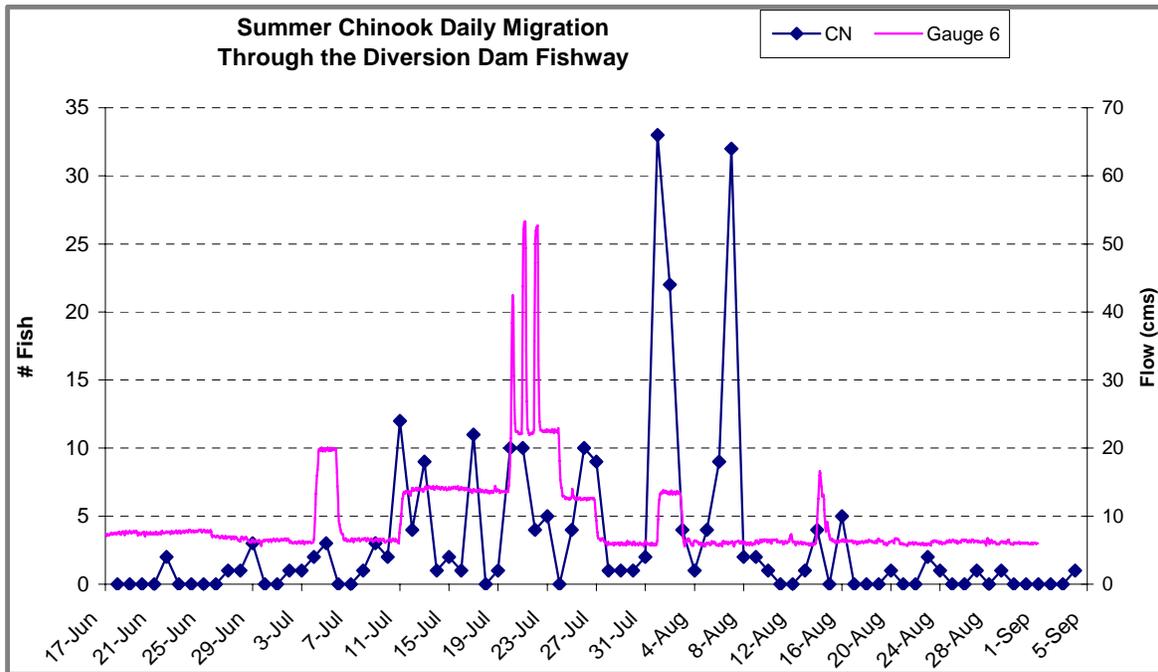
**Figure 2.** Movement of summer chinook salmon (CN) through the diversion fishway as recorded by underwater video surveillance, June 12 – Sept 6, 2007 plotted with discharge in Reach C recorded at BC Hydro Gauge 6.

The camera at the diversion dam fishway operated from June 12 to September 6 with a brief outage (June 16-18) when the camera was removed for repair. A total of 245 summer chinook, 4 steelhead and 9 trout were counted by the camera entering the headpond through the diversion dam fishway during this period (Figure 2).

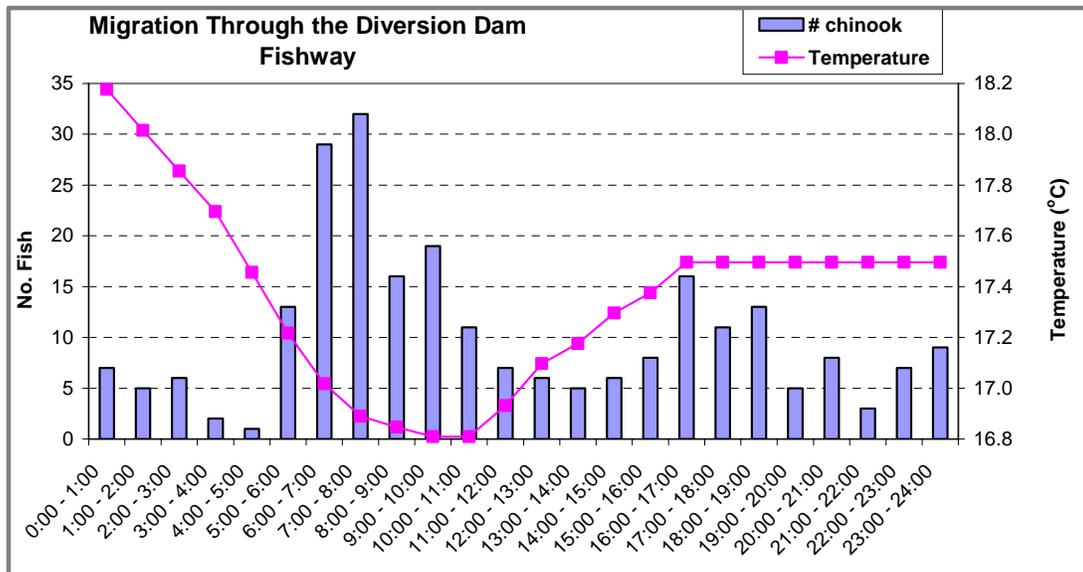
**Figure 3.** Daily migration patterns of summer chinook through the diversion dam fishway, June – September 2007, and hourly average diurnal temperature (from T. Sweeten, DFO) as measured on July 27, 2007.

At the diversion dam, fish migrated through the tunnel during all hours of the day, but peak migration through the fishway occurred between the hours of 05:00 and 12:00 with a smaller period of activity from 16:00 – 20:00 (Figure 3). The diurnal pattern of movement through the fishway (peak migration) seems to coincide with the coolest part of the day. The urge to migrate may also be influenced by increasing (or decreasing) light intensity in the tunnel or the pool below the fishway entrance.

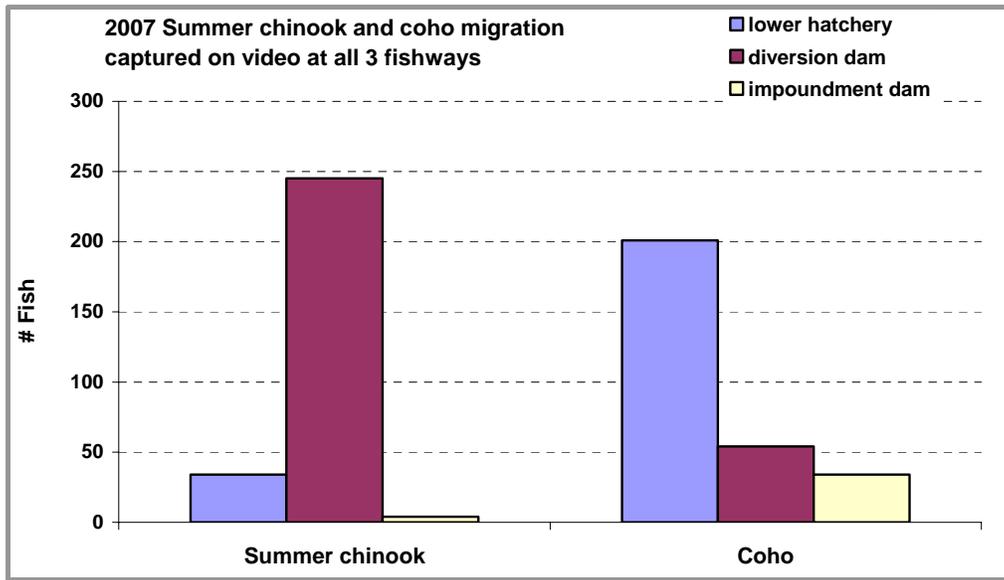
**Figure 4.** Summer run chinook and coho migration recorded at all 3 video monitoring stations in the Puntledge River fishways between March 1 and December 7, 2007.

From June 18 until September 1, the by-pass was closed, and all fish were diverted into the lower hatchery for broodstock collection. The lower hatchery bypass was reopened concurrently with the hatchery fishway for Fall chinook migration and broodstock collection on September 1. Video surveillance resumed and a total of 2541 Fall chinook, 787 pink and 201 coho salmon were recorded passing through the fishway until September 27. Figure 4 summarizes total numbers of summer chinook and coho salmon counted at all fishway cameras during the entire monitoring period.

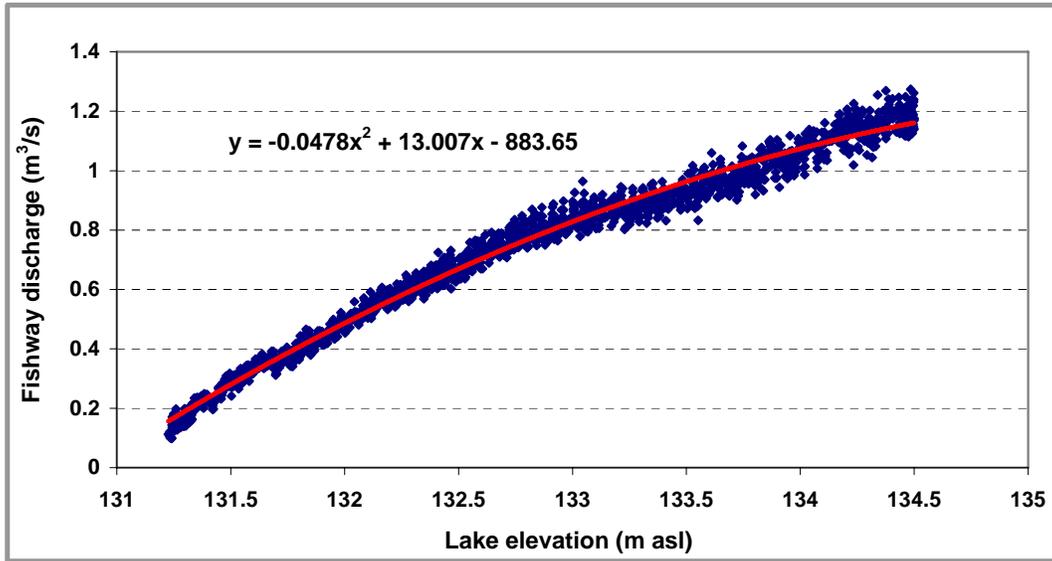
**Figure 5.** Revised discharge / lake elevation relationship developed for the fishway at the Comox Lake impoundment dam from data collected in 2006.

In 2006, a relationship between lake elevation and fishway discharge was developed using water level data collected at the fishway outlet and lake elevation between July and October 2006. Re-examination of the data used in developing this relationship found a small error. A new relationship is illustrated in Figure 5. Discharge at the fishway was not measured in 2007, however, using this discharge / lake elevation relationship, discharge through the fishway can be calculated (Figure 6). Discharge through the fishway at the Comox impoundment dam between July 1 - August 31, 2007 ranged from 0.95 to 1.14 m<sup>3</sup>/s (Figure 6). It is assumed that chinook would have no difficulty negotiating the fishway under these flows. Velocities through the two sluice gates during this period were below the chinook salmon burst speed (6.83 m/s) from Bjornn and Reiser 1991.

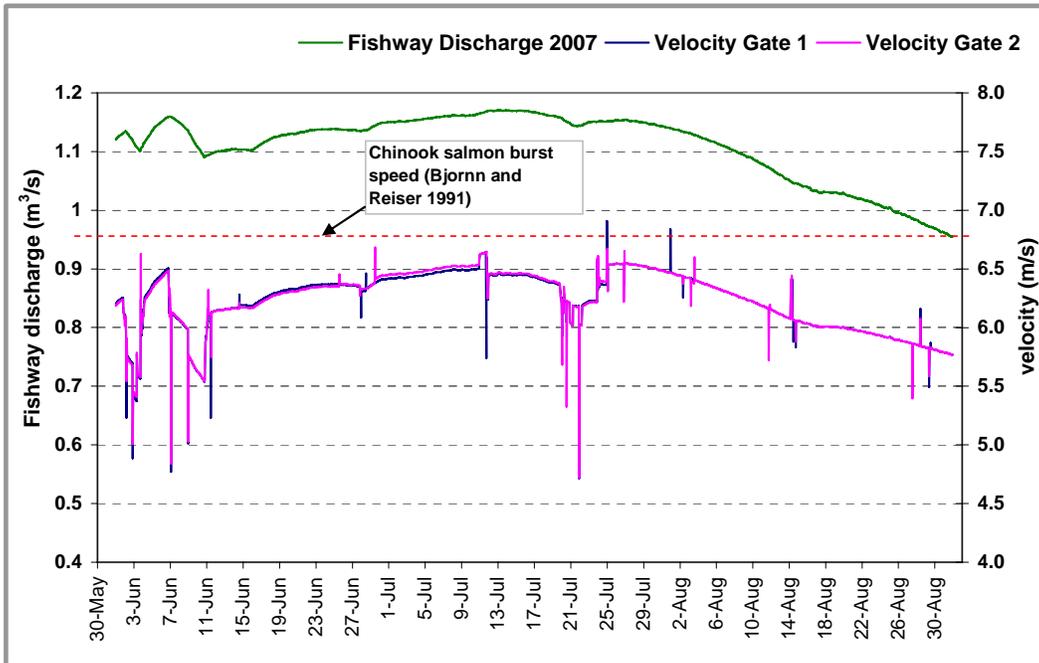
**Figure 6.** Discharge through the Comox impoundment dam fishway between June 1 and Aug 31, 2007 calculated from a discharge / lake elevation relationship developed in 2006. Velocity through the sluice gates during this period is calculated from BC Hydro data.

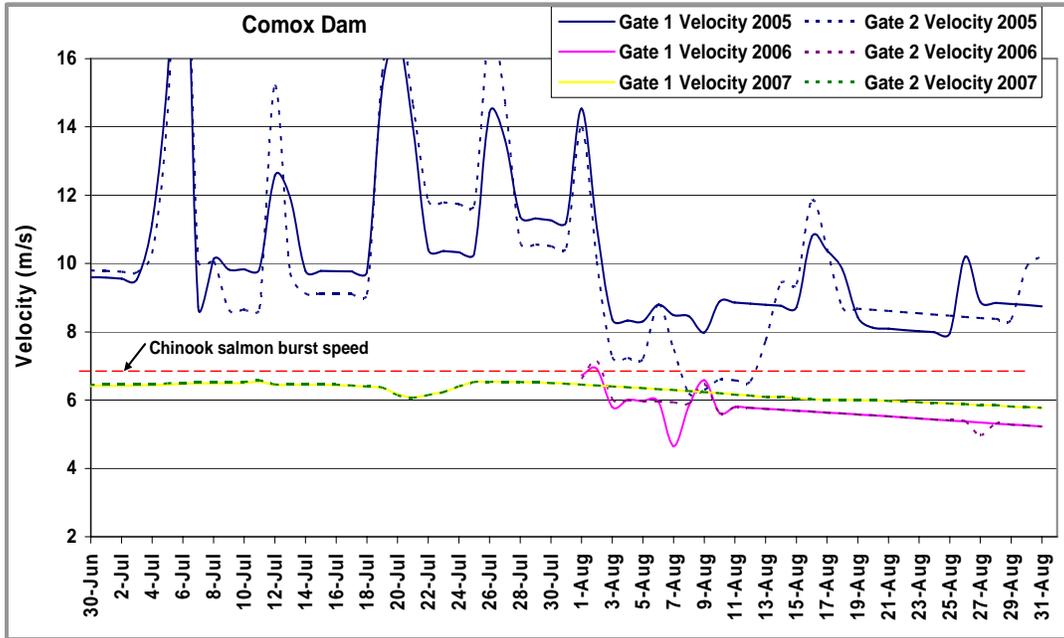
**Figure 7.** Comparison of the calculated daily average velocity through sluice gates 1 & 2 at the Comox Dam for monitoring years 2005-2007 in relation to the chinook salmon burst speed from Bjornn and Reiser, 1991.

the sluice gates are unfavorable. Although total sluice discharge and lake levels were lower in 2005 than 2007, the calculated daily average velocities through the dam were higher likely forcing fish to use the fishway (Figure 8). However, this behaviour has not been confirmed. Of the 5 radio tagged fish that migrated into the headpond during the 2007 WUP Telemetry study, none successfully accessed the lake.

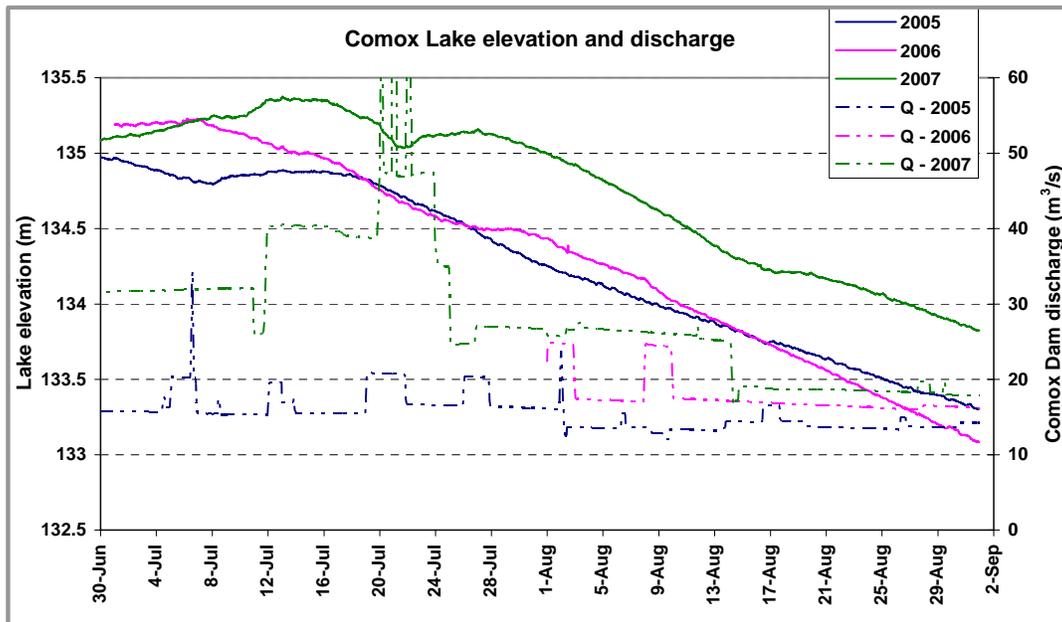
**Figure 8.** Comparison of the total discharge at Comox Dam and Comox Lake elevation for monitoring years 2005-2007 (hourly average data from BC Hydro records).

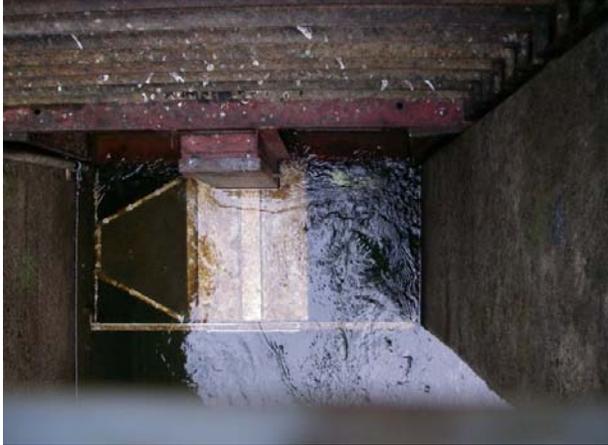
**Photo 1.** View of the camera tunnel from the top of the Comox dam fishway during low lake elevations (131.2 m), February 20, 2008.

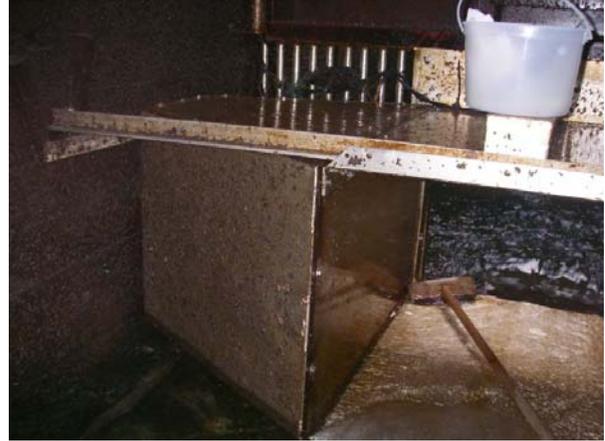
**Photo 3.** Camera tunnel installation in the Comox Dam fishway before cleaning, February 20, 2008. Plexiglass wall of tunnel is completely covered in sludge and macroinvertebrate growth.

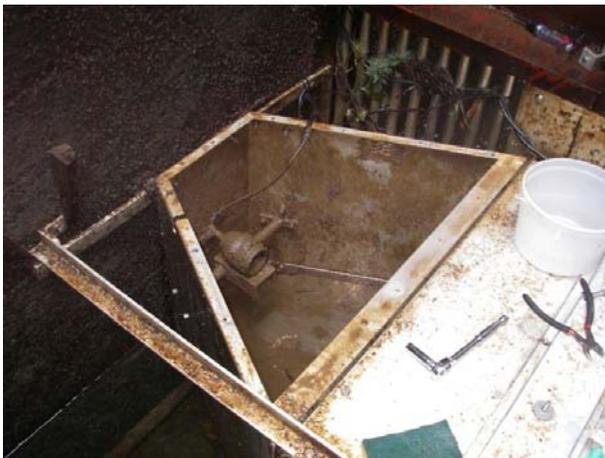
**Photo 2.** Camera tunnel installation in the Comox Dam fishway before cleaning, February 20, 2008.

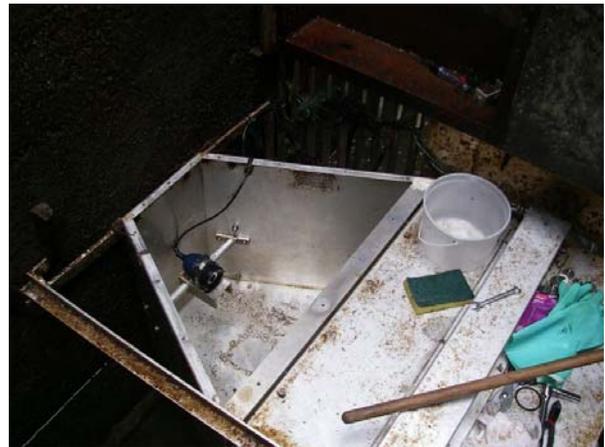
**Photo 4.** Camera tunnel installation in the Comox Dam fishway after cleaning, February 20, 2008.
