Puntledge River Stotan Falls - Improvement for Adult Summer Chinook Migration

07.Pun.03

March 2008

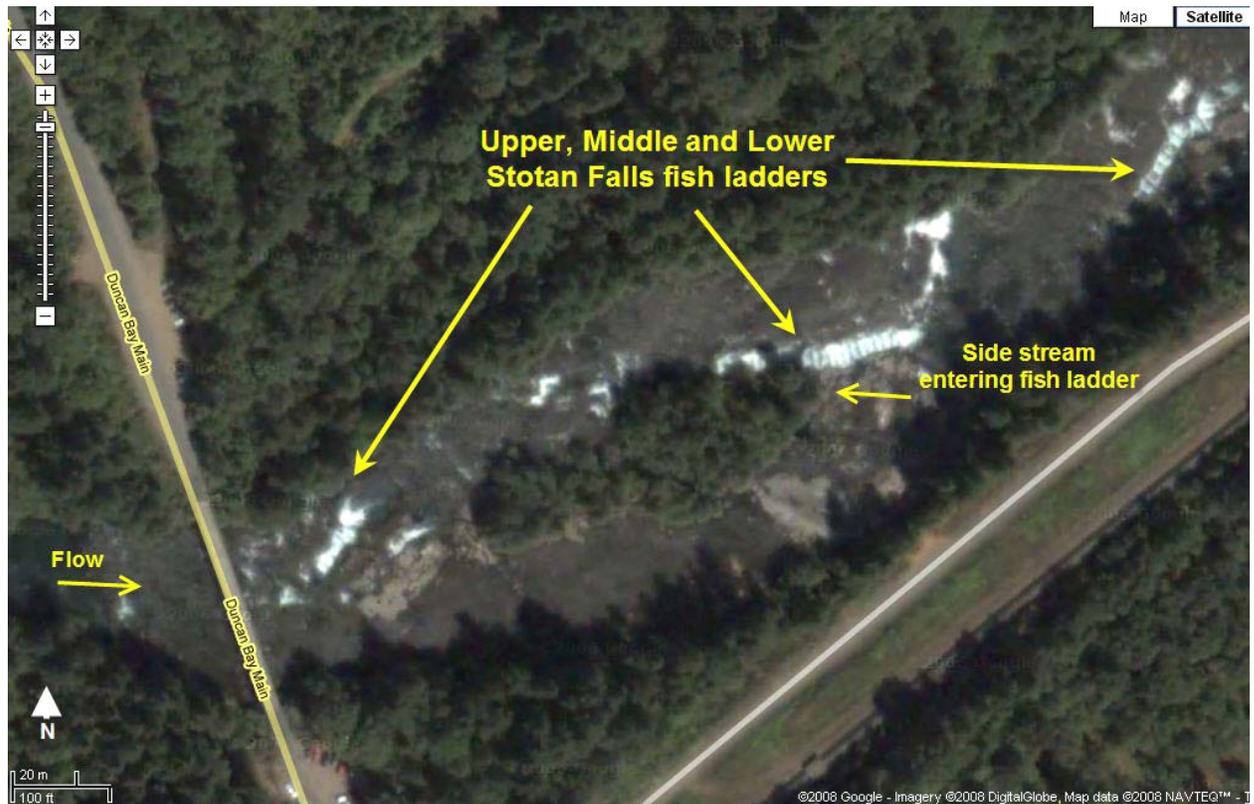
Figure 2. Location of the Stotan Falls area showing fish ladders and location of attraction flow into middle fish ladder.

In 2005, BC Hydro initiated the Puntledge River Water Use Plan. One of the key recommendations was the release of 5 pulse flows in Reach C during the months of July and August to improve chinook and steelhead migration. During these pulse flows, discharge through Reach C is increased from 5.7 m³/s to 12 m³/s for a period of 48 hours to stimulate summer chinook and steelhead and facilitate migration upstream. Following a pulse flow event, BC Hydro staff observed several adult chinook stranded at the Stotan Falls area in potholes and on the bedrock shelf on the right side of the river below the Duncan Bay Mainline bridge. Staff later observed that adult summer chinook swimming up the middle Stotan Falls fishway were being attracted to a side-channel that flowed into the fishway half-way up the ladder (Figure 2; Appendix D: Photo 1). During a pulse flow, flow from the side-channel increased and attracted adults into the side-channel which opened to the right side of the river. This side of the river, which is composed of a wide bedrock shelf, only normally has a thin .05-.07 m veneer of water flowing over it and shallow pockets (potholes) are scattered throughout the shelf. When the pulse flow recedes, fish migrating up this side of the river often become stranded.

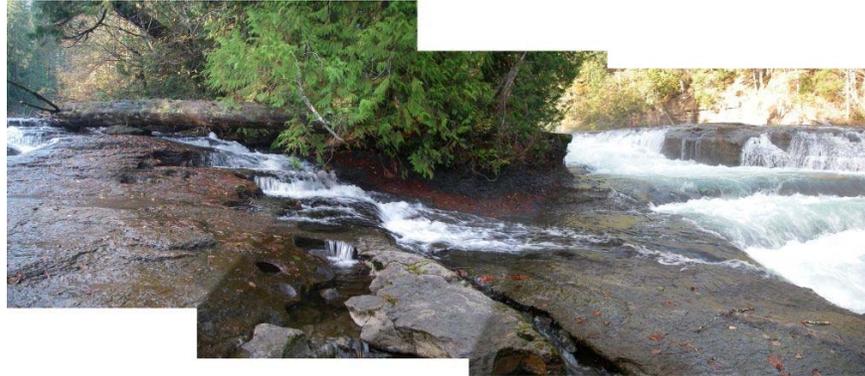
Photo 1. Confluence of problem side-channel with the middle fish ladder in Stotan Falls during a flow of $\sim 8 \text{ m}^3/\text{s}$ (from BC Hydro website Gauge 6) November 9, 2006.

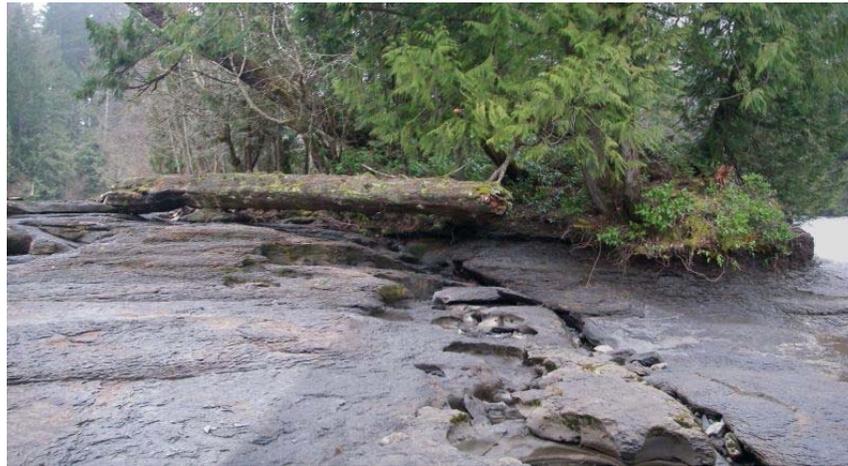
Photo 2. Location of the side-channel confluence with the middle fish ladder after construction of the diversion channel, at a pulse flow of $\sim 12 \text{ m}^3/\text{s}$ (from BC Hydro website Gauge 6) February 8, 2008. Note entire area previously wetted is now dry.

Flow from the side-channel has been completely diverted from the middle fish ladder during typical pulse flow discharges (12-13 m³/s). At higher river discharges, some side-channel flow may enter the ladder but it is unlikely to attract fish, compared to flows in the ladder at high river discharges.

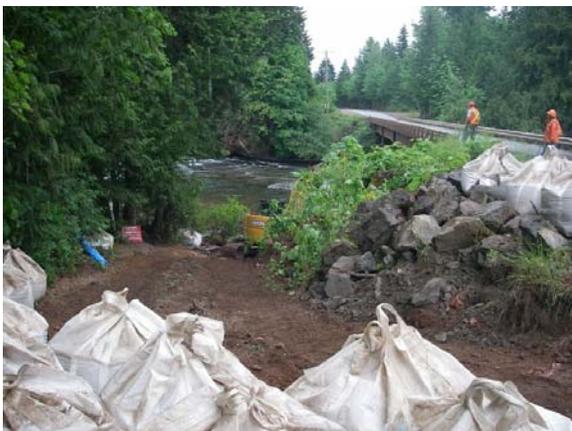
Photo 3. Existing access ramp to Puntledge River located on upstream side of Duncan Bay Mainline Bridge, beside Bevan Creek confluence (left of photo).

An existing access ramp to the Puntledge River, located on the upstream side of the Duncan Bay Mainline Bridge and adjacent to the Bevan Creek confluence, was used to access the river and work site. This site was chosen over a second undeveloped opportunity located on the downstream side of the logging bridge, because there was no disturbance to the riparian zone and it did not require any additional clearing or ballasting. A hydro pole anchor cable near the ramp entrance was temporarily removed by BC Hydro to safely allow equipment to access a road ramp to the river. Once at the river, equipment could access the work site by traveling downstream for 200 m on smooth bedrock along the right side of the river. Traffic control was setup at the ramp entrance on the Duncan Bay Mainline for the duration of the project.

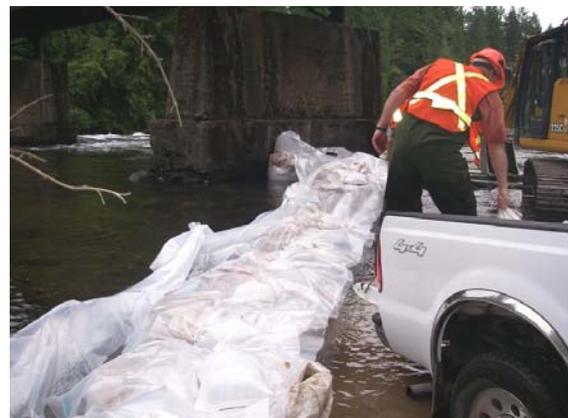
Photo 4. Placement of pre-filled mega bags, plastic sheeting and sandbags for coffer dam construction at upper end of equipment access route.

The coffer dam was constructed from the right bank just upstream of the ramp access, and downstream of the Bevan Creek confluence, and extended into the river to the first

instream bridge abutment. It continued further across the river from the opposite side of the abutment, for a total length of approximately 30 m. In addition, flow from a small channel cutting through the island adjacent the work site was pumped around the work zone using a 3 inch trash pump. While the right side of the river slowly dewatered, the effected downstream area was fry salvaged. Potholes that remained wetted were fished with dipnets and pole seines. Access for machinery was on solid bedrock. Potholes around the work site were easily avoided. Although the area dewatered covered a large area (~7000 m²), only 2 dozen salmonids were removed from the area. This was indicative of the very poor rearing habitat in this reach. Many of the fish salvaged were recent Upper Puntledge Hatchery chinook smolt releases.

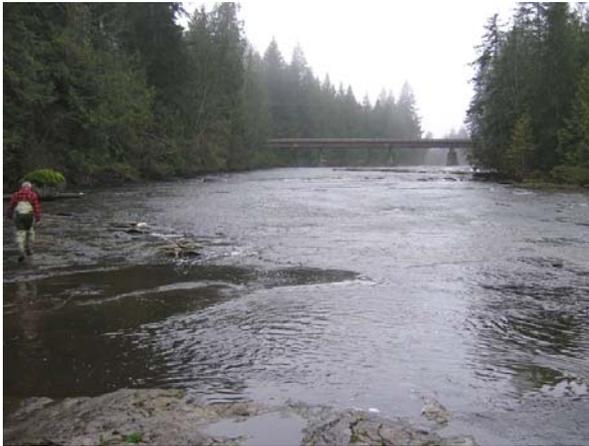
Photo 5. Access route for equipment on right side of river between Duncan Bay Mainline Bridge and work site ~200 m downstream. Photo taken during base flow conditions (5.7 m³/s) looking upstream from proposed work site.

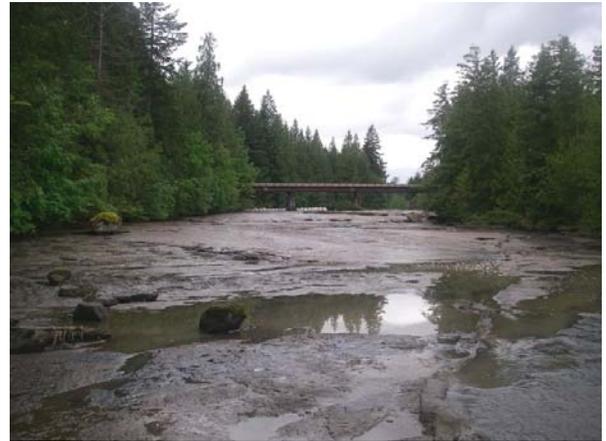
Photo 6. Access route for equipment on right side of river after site isolation measures, June 4, 2007. Cofferdam visible at bridge.

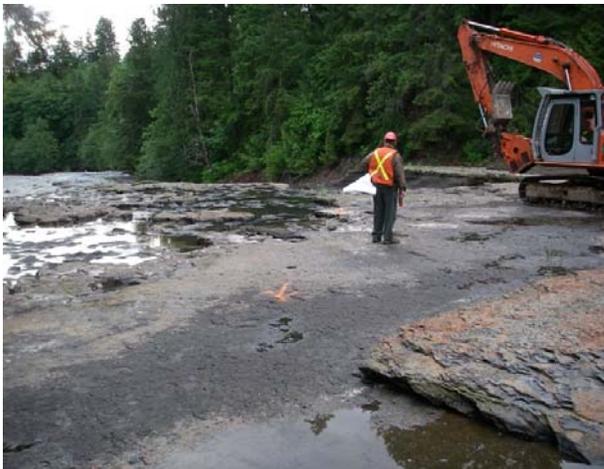
Photo 7. Location of proposed diversion channel looking downstream before excavation work, June 5, 2007.

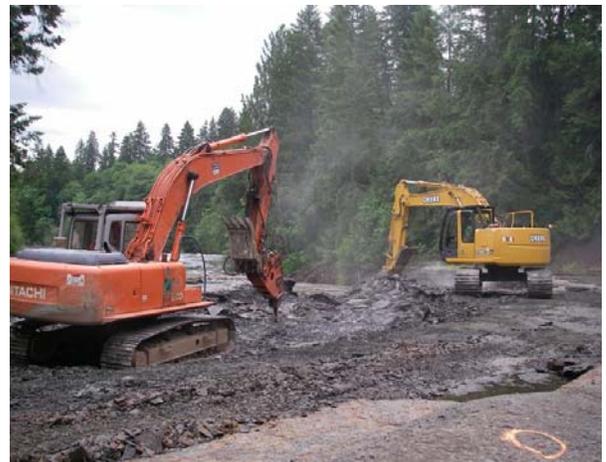
Photo 8. Commencement of channel excavation work looking downstream, June 5, 2007.

A Hitachi EX200 with a hydraulic hammer built the diversion channel by breaking out a rock trench in the streambed as per the engineered design (DFO) while a Deere EX225C LC cleared the broken material and stockpiled it for loading into a Volvo 6WD off-road truck. The streambed at the work site was predominantly shale with some sandstone, and was easily broken. The rock was removed from the river and hauled to a spoil site at Comox Timber Ltd.'s property (Hancock Forest Management) on the south west side of the river (location of the BCRP 2006/07 Forbidden Side-channel project) only 0.5 km from the work site. Approximately 19 truck loads of broken rock (~15 m³/load) were removed from the river. Rock breaking and removal was completed by late afternoon on the second day of the project. The coffer dam was then dismantled, bulk bags were loaded into the Volvo and delivered to a disposal site on Duncan Bay Mainline. A summary of equipment used, duration and quantity of material removed form the river is outlined in Table 1.

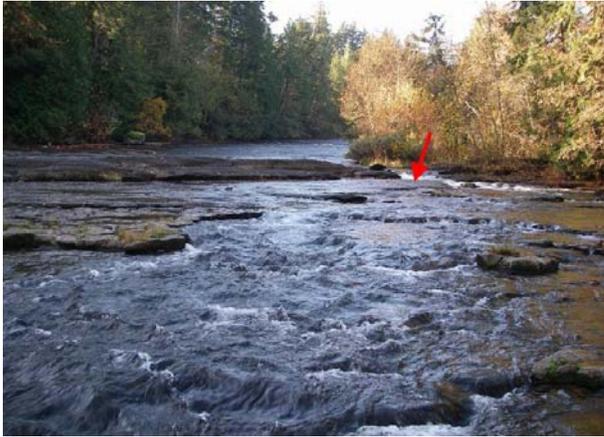
Photo 9. Upstream view of the location of the proposed diversion channel before excavation work November 9, 2006. Arrow indicates the upstream end of the channel.

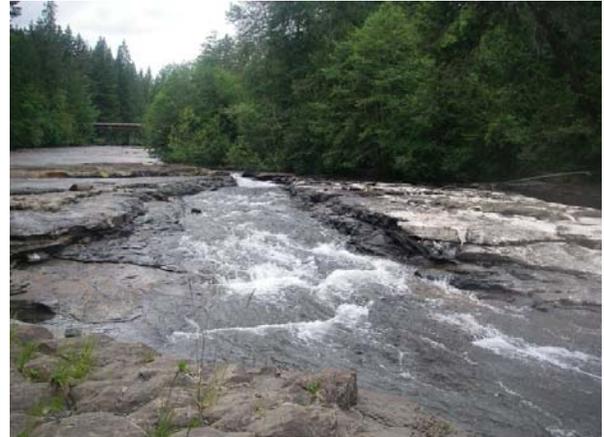
Photo 10. Upstream view of the diversion channel after completion June 19, 2007. Gauge 6 discharge = $7.5 \text{ m}^3/\text{s}$.

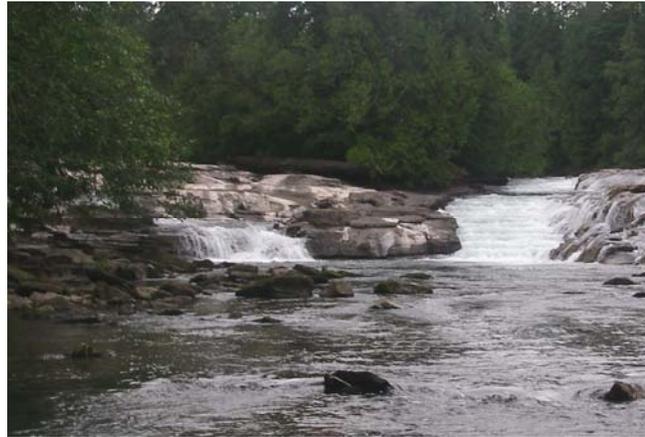
Photo 11. Stotan Falls looking upstream towards the middle fish ladder (right) and the outlet flow from the new diversion channel (left), June 19, 2007. Gauge 6 discharge = $7.5 \text{ m}^3/\text{s}$.

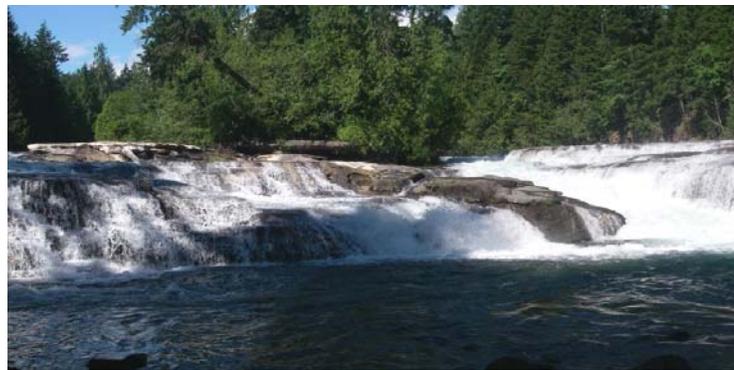
Photo 12. Stotan Falls looking upstream towards the middle fish ladder (far right) and the outlet flow from the new diversion channel (centre), July 4, 2007. Gauge 6 discharge = $19.7 \text{ m}^3/\text{s}$.
