CAMPBELL RIVER
ELK FALLS 3 SIDE CHANNEL
MONITORING 2009/10

BCRP Project Number: 09.CBR.07

March 2010

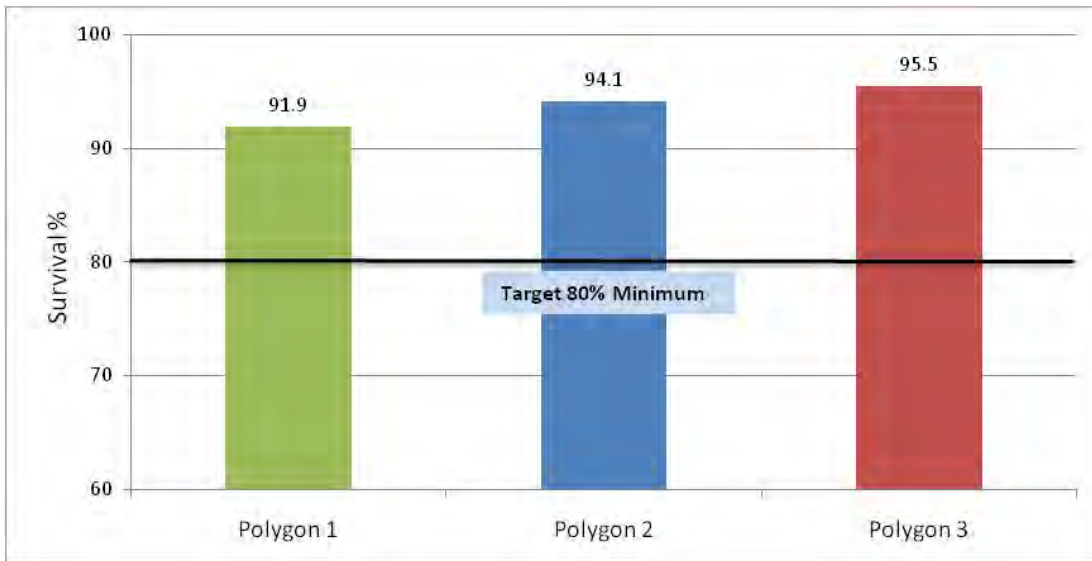
Figure 5. Approximate locations of Bioinventory Polygons (blue rectangles) of Elk Falls III Side Channel Ecosystem Monitoring Program (Sept. 01, 2009)

The EMP evaluates riparian restoration success based on Department of Fisheries & Oceans target 80% survival within three (10x20m) established representative polygons (Figure 5). Monitoring data includes an evaluation of biophysical performance of planted stream bank riparian stock by recording plant species, quantity, average growth of indicator species, and percent survival. In addition, summaries of plant recruitment, invasive species, indicator plant growth, soil bioengineering, wildlife trees, and channel morphology are included. Three polygons, each measuring 10 by 20 m, were established within the stream's riparian area to assess the survival of planted vegetation one year after construction. Each polygon was divided down its centre by the stream's wetted width creating a 5 by 20 m polygon on either side (Figure 4). The polygons were established with the 20 m length parallel to the water's edge and the 5 m width ascending the slope of the bank. Growth data for observed riparian vegetation stock within each polygon is summarized. As the Department of Fisheries and Oceans (DFO) minimum target percentage for planted riparian vegetation survival is 80% this quantity is plotted against survey results. Indicator species are used to estimate growth in representative polygons since installation of plants in October 2008.

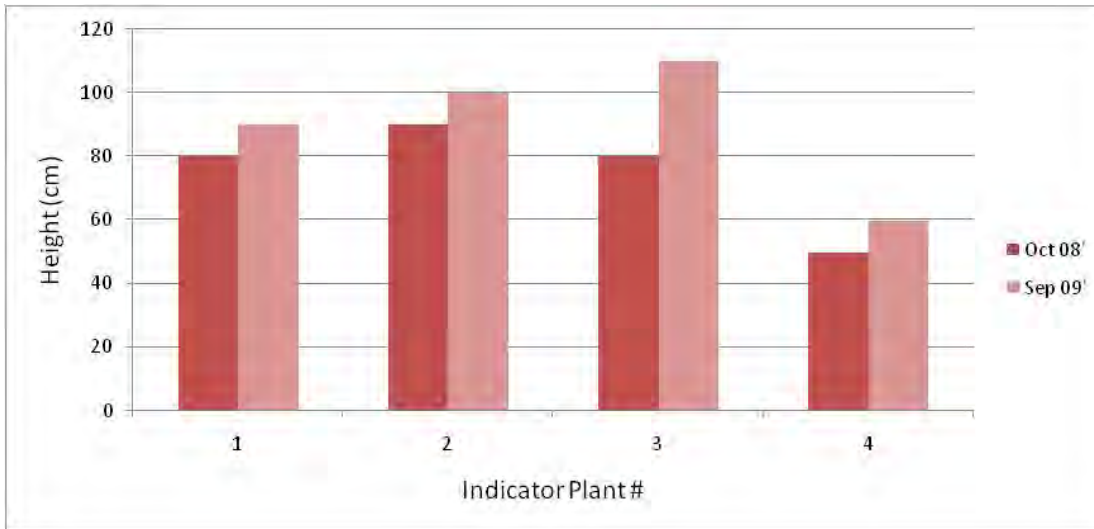
Figure 7. Polygon 1 indicator plant growth of *Thuja plicata* from Oct. '08 to Sep. '09.

Mammal browsing activity did not result in plant mortality but had an observable impact on the growth of affected plants as represented by indicator plant #3 (Figure 7, Photo 8 & 9). A possible limiting factor to mammal browsing impacts is the abundance of alternative options in existing riparian vegetation. Desiccation leading to plant mortality was likely the result of installation at an incompatible site, insufficient burial depth or lack of mulch application. Conversely, survival of hydrophytes within wetland terraces built in Polygon 2 was poor with the most probable cause being that the terraces are too low in elevation relative to the operating water depth (Photo 10).

In general, deciduous indicator plant species *Salix spp.* & *Cornus stolonifera* and coniferous species *Thuja plicata* & *Picea sitchensis* in Polygons 1 & 3 showed positive growth rates (Figure 7 - 9). An exception to positive growth was observed in Indicator #3 (*Thuja plicata*) in Polygon 1 as a result of beaver browse (Figure 8). *Cornus stolonifera* is the only indicator species recorded in Polygon 2 as *Thuja plicata* & *Picea sitchensis* were not planted in Segment C where the moisture regime is not favorable.
