THE SPATSIZI AND STIKINE RIVERS:
MAINSTEM SYSTEM EVALUATIONS OF
FISHERY AND RECREATION VALUES.

Environmental Management Division
B. C. Parks Branch

October, 1977.

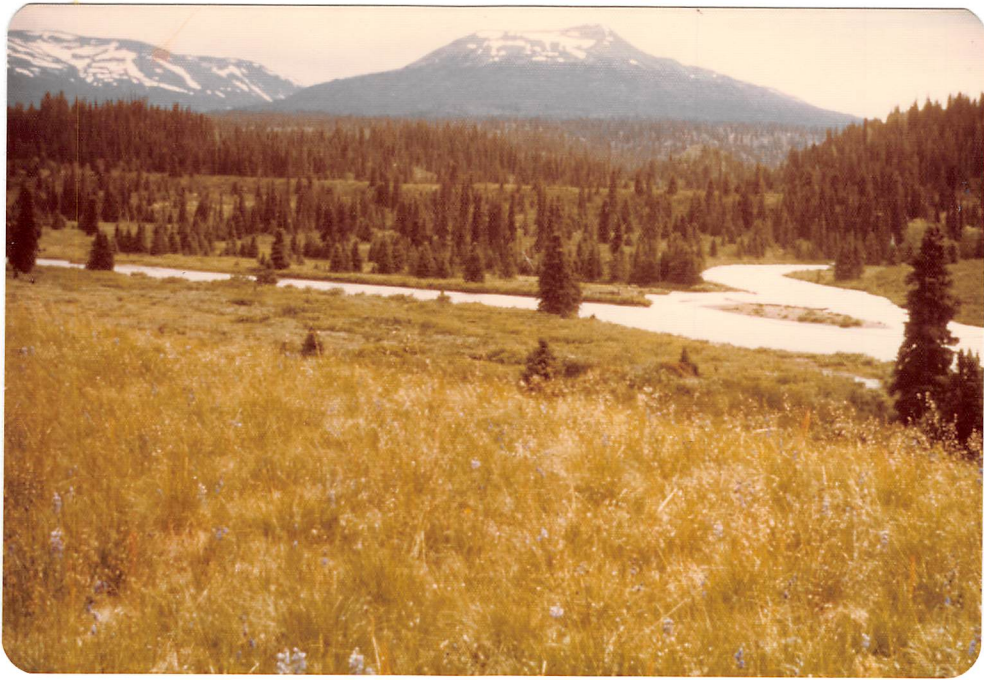
View from a grassy terrace overlooking the confluence of Kluayetz creek and the Spatsizi river. This is the practical head of navigation on the river.

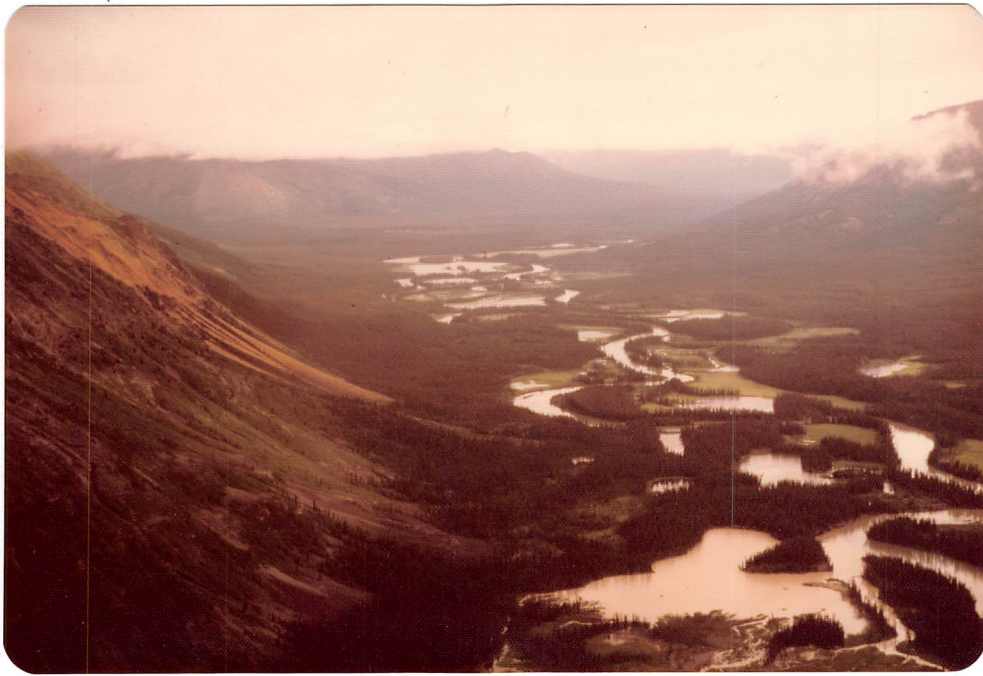
Spatsizi mountain overlooks a deposition area of the river with many meanders, oxbow lakes and low marshy areas. Mink creek and Kliweguh creek respectively enter the valley from the left.

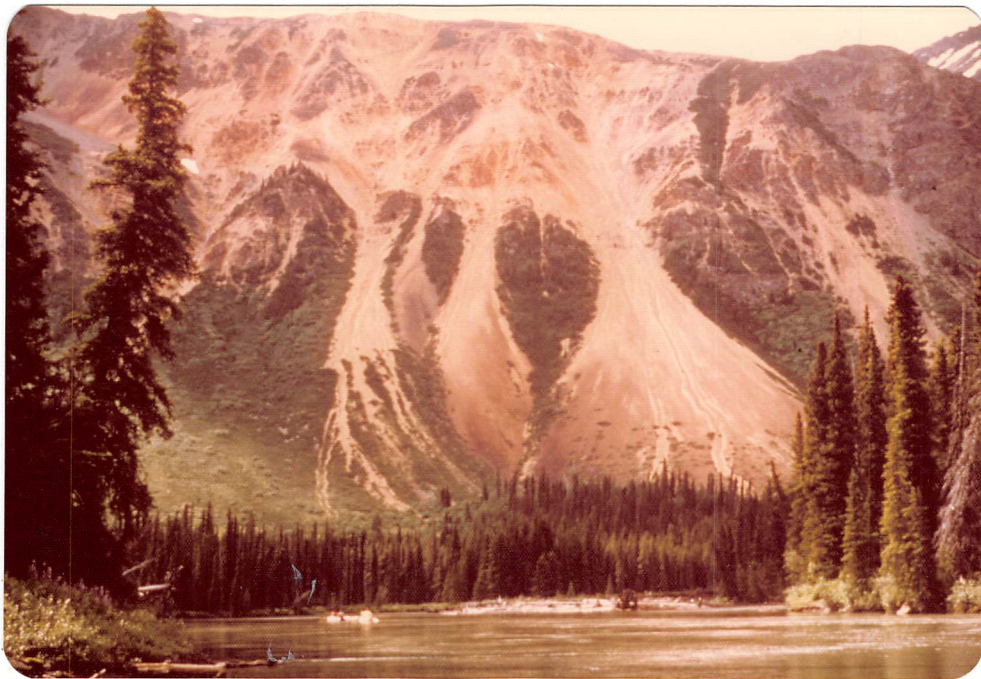
A frontal view of Spatsizi mountain from a meander of the river.

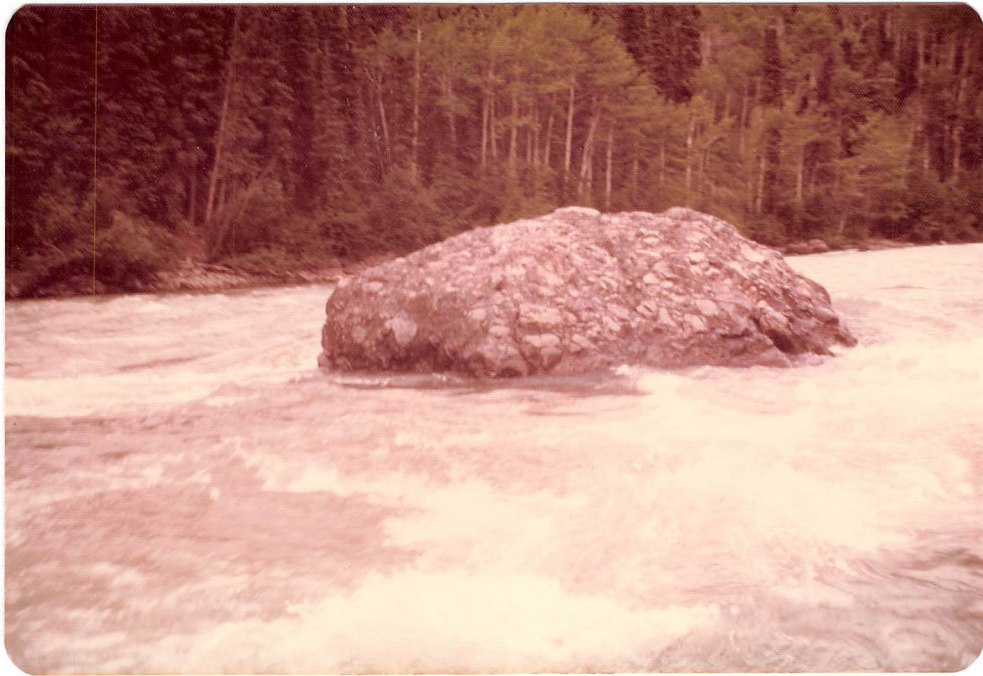
Large glacial erratics in the Stikine river make Jewel rapids a hazardous passage.

This rapid is challenging canoeing which changes considerably with water levels. Routes are confined by boulders many of which are submerged and barely visible from upstream. Standing and breaking waves are liable to swamp open canoes. Water is rated as class IV and scouting from shore is recommended.

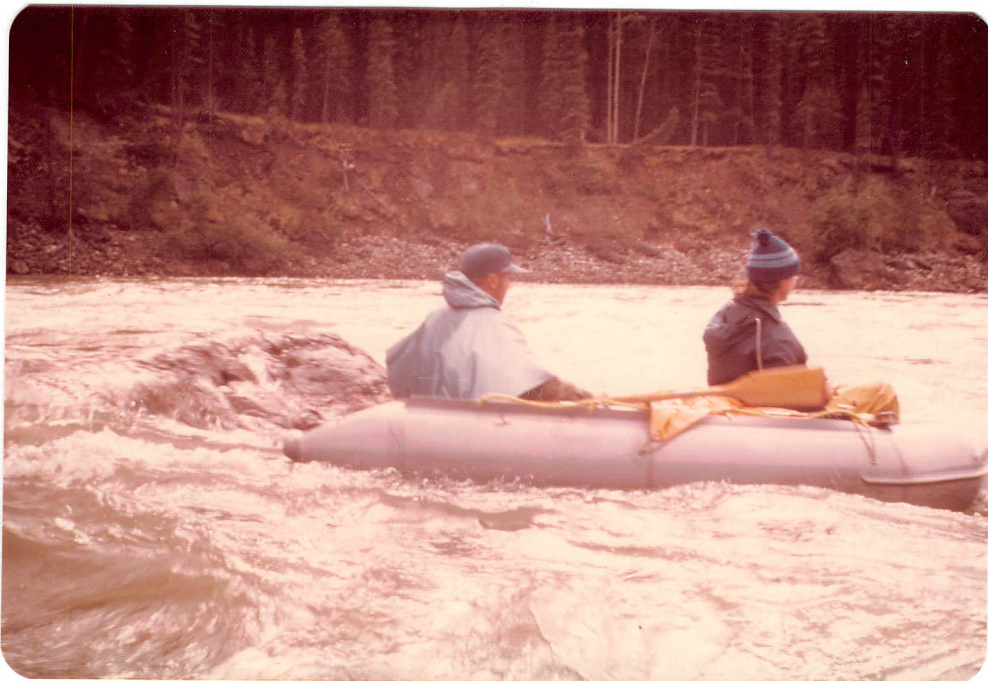
Many are almost submerged and require constant attention from the river navigator.

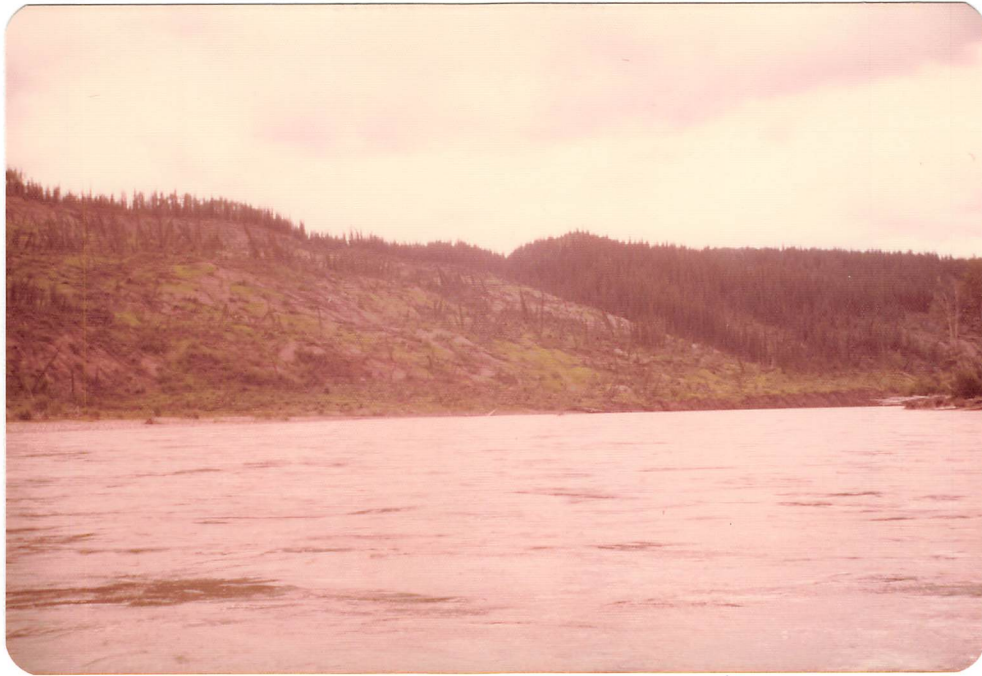
Unstable till soils of the Stikine valley promote largescale slumping along the course of the river. Any logging or road-building in this area would only accelerate this process.

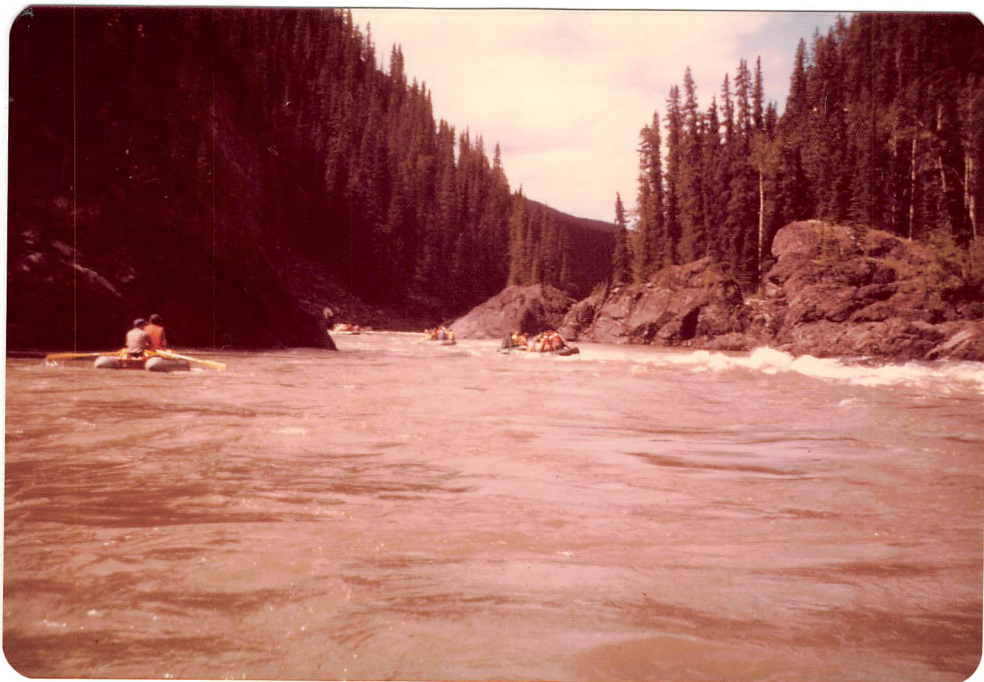
Beggerlay canyon on the Stikine river is one of the dangerous parts of the float trip. Portaging is almost impossible and extreme caution should be exercised.

Recreation. Only the most competent canoeists should attempt to run the canyon. The dangers are from swamping by high standing waves and from loss of control in the surges and boils. In the water conditions of our trip the best route was close to the left bank while taking care to stay clear of the ledge jutting out opposite Beggerlay creek. This route avoids the worst standing waves but remains in the main stream and thus avoids the boils. An approach on the right bank would result in being swept by the flow from Beggerlay creek into the most turbulent water.

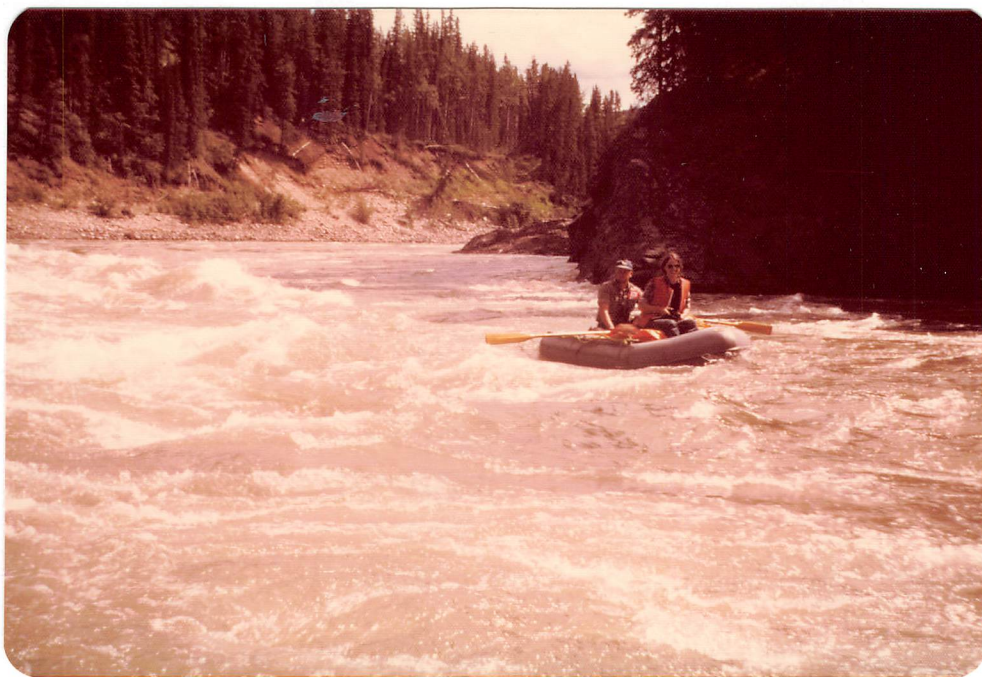
Keeping to the extreme left in Beggerlay canyon avoids the wash from Beggerlay creek meeting the Stikine's waters.

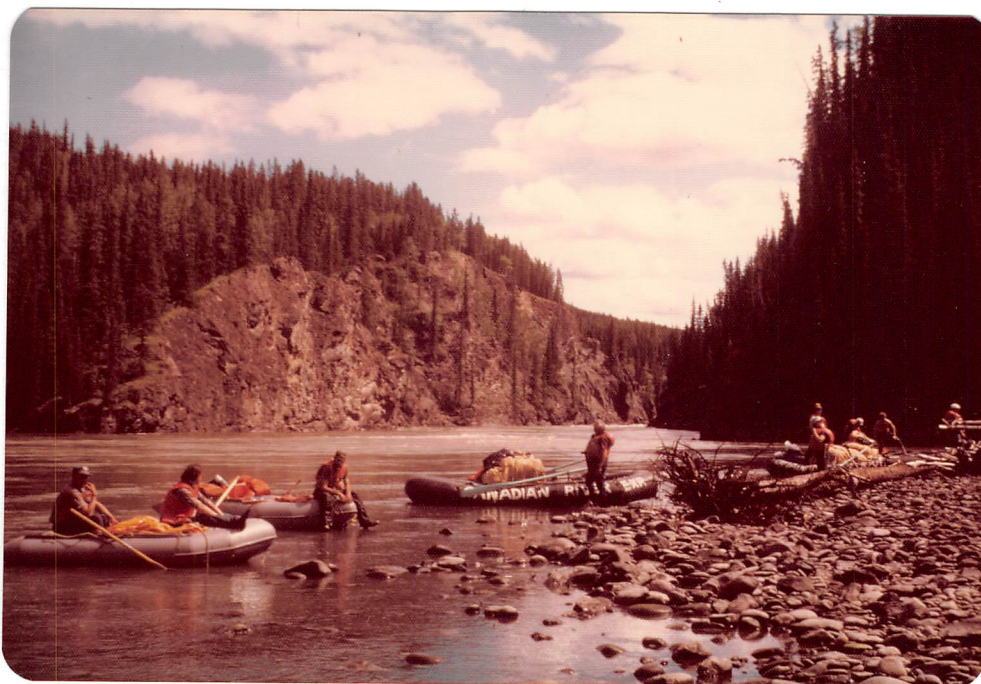
The bottom of the canyon fans out into a large pool where the boater's tingling excitement can subside before proceeding the final kilometer to the railway bridge.
