**1997 TULAMEEN RIVER WATERSHED
STREAM RESTORATION**

FINAL REPORT

**MINISTRY OF ENVIRONMENT, LANDS
AND PARKS, PENTICTON, B.C.**

February 1998

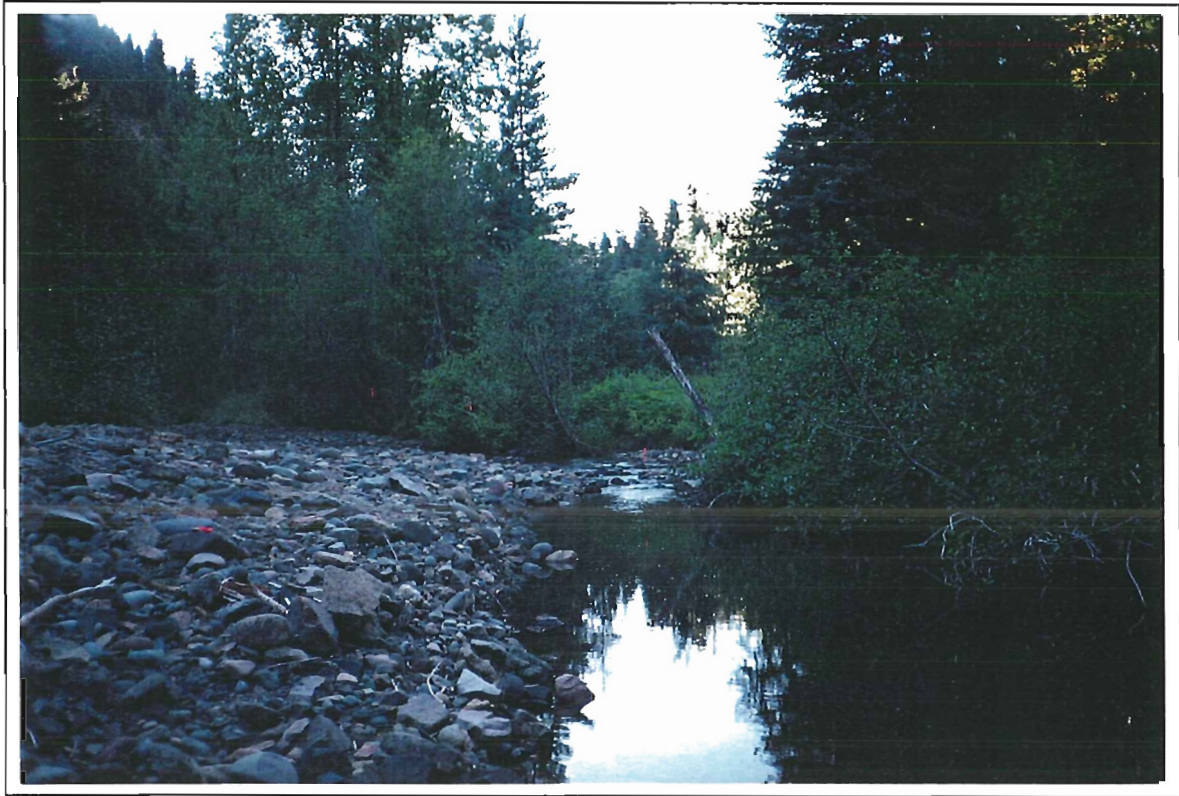
Photo 1: Spearing Creek. View of Site 2 facing upstream from 10 m.
Note: Overhanging vegetation and pooling. (9 August 1997).

In conjunction with the fish inventory, a habitat assessment was conducted on 9 August 1997 at Site 2 and Site 3. The habitat assessment was comparable to that conducted by IRC in the 1996 Tulameen River watershed stream survey. The data collected during the habitat survey is also included in Appendix B. Fish habitat at Site 2 was primarily characterized by riffle-glide habitat with pooling associated with the cutbanks. The substrate was dominated by cobble and gravel with some sand. Cover was provided to the creek by LWD instream and riparian vegetation including Red alder, Red-osier dogwood and Thimbleberry. The surrounding riparian vegetation provided fair cover during low flows (Photographs 1 and 2). Fish habitat at Site 3 was characterized by riffle-pool habitat. The substrate was dominated by cobble with some fines and few boulders. Riparian vegetation, primarily Red-osier dogwood, provided ample cover to the creek however LWD was sparse (Photographs 3 and 4).

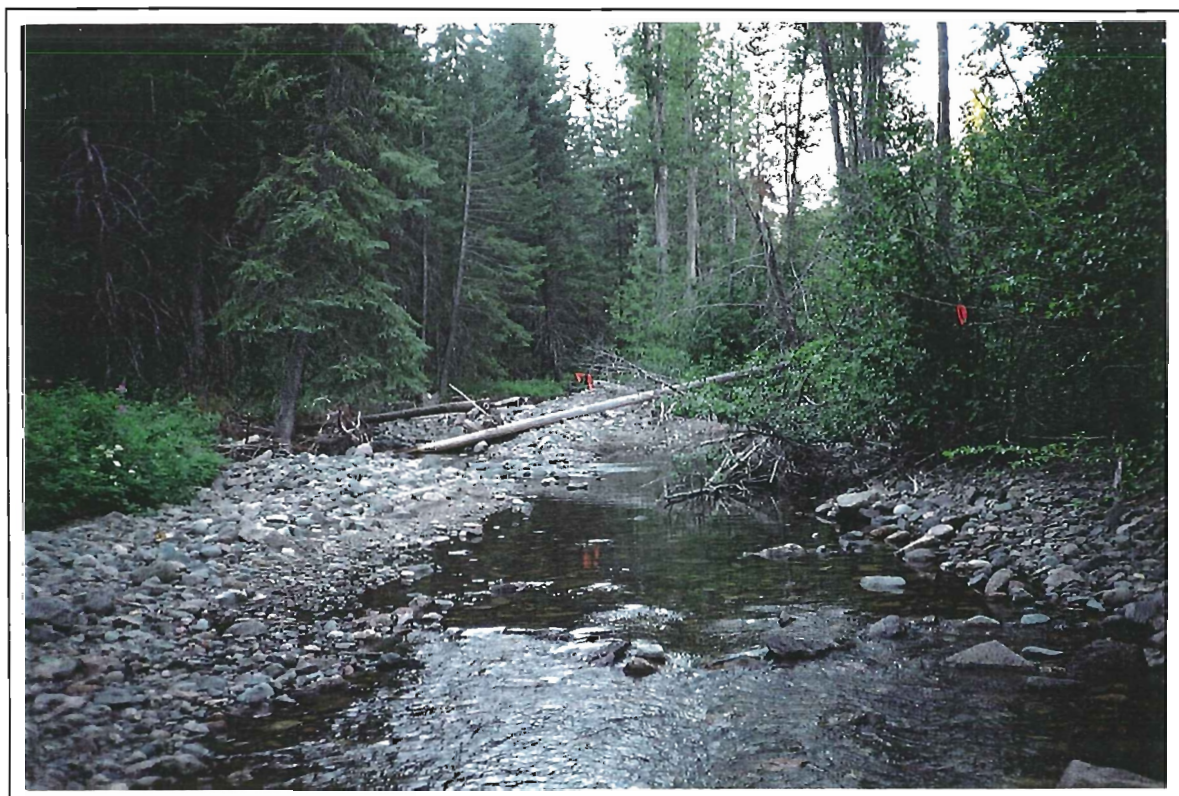
Photo 2: Spearing Creek. View of Site 3 facing upstream from 80 m.
(9 August 1997).

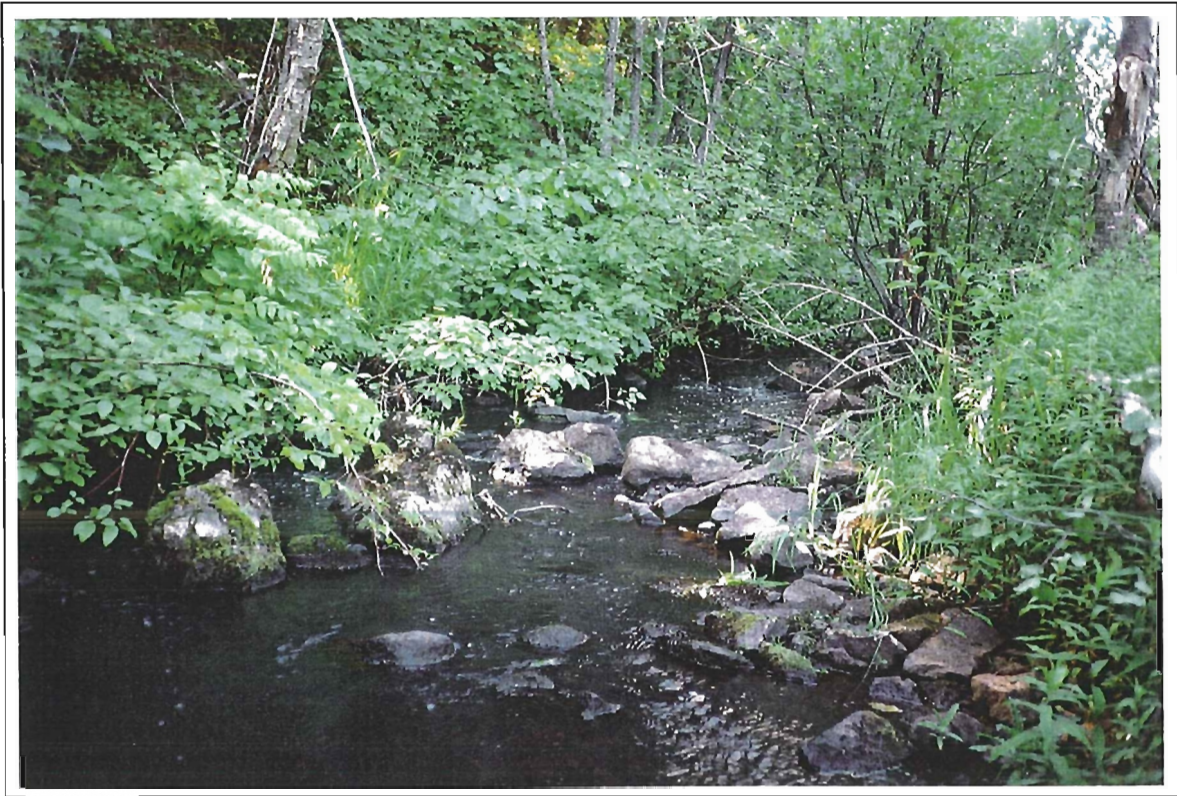
Photo 3: Spearing Creek. View of Site 3 facing upstream from 60 m.
Note: Riparian vegetation. (9 August 1997).

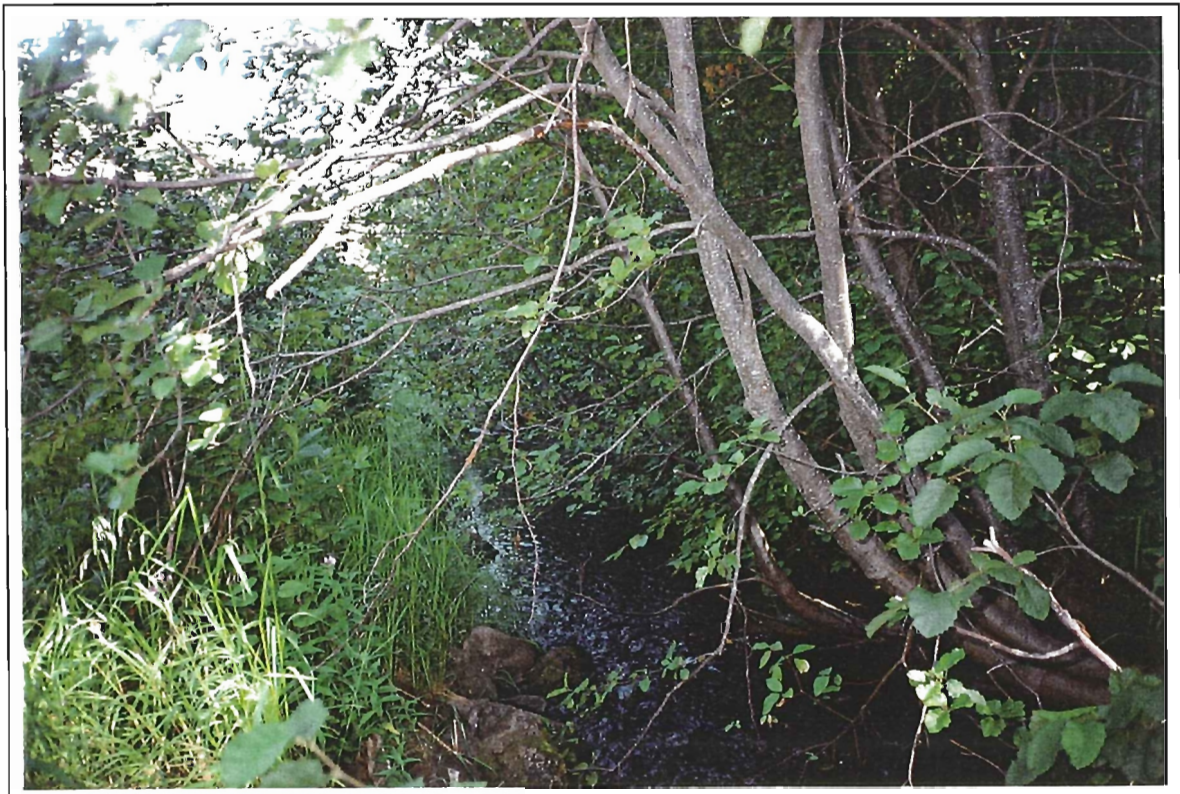
Photo 4: Spearing Creek. View of Site 3 facing downstream from 100 m.
Note: Riparian vegetation. (9 August 1997).

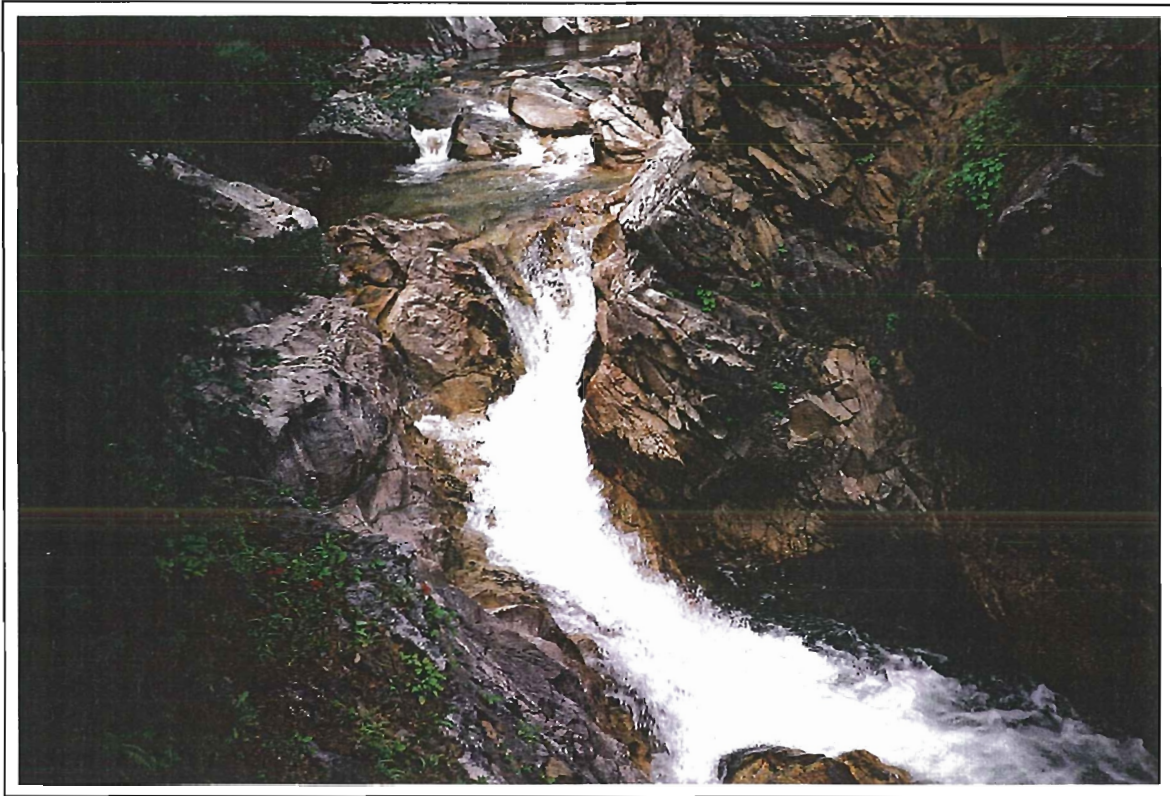
Photo 5: Jim Kelly Creek. View of falls presenting an upstream migration barrier to all fish. (7August 1997).

A 6.5 m falls was located 750 m upstream from the mouth of Jim Kelly (Figure 1). The falls represented a complete barrier to upstream migration of all fish (Photograph 5). A second set of falls located 1030 m upstream from the mouth of the creek also represented a barrier to upstream migration to all fish. This set of falls had a height of 15 m. Although the 280 m length of creek between the two falls was not fished due to limited access and unsafe terrain, 'no fish' were expected to exist between the two falls due to the migration barriers. A total of 720 m upstream of the second set of falls were electroshocked and yielded 'no fish' confirming fish absence above the 15 m falls. Rainbow trout were present in Jim Kelly Creek from the mouth upstream to the 6.5 m falls, a distance of 750 m (IRC, 1996).

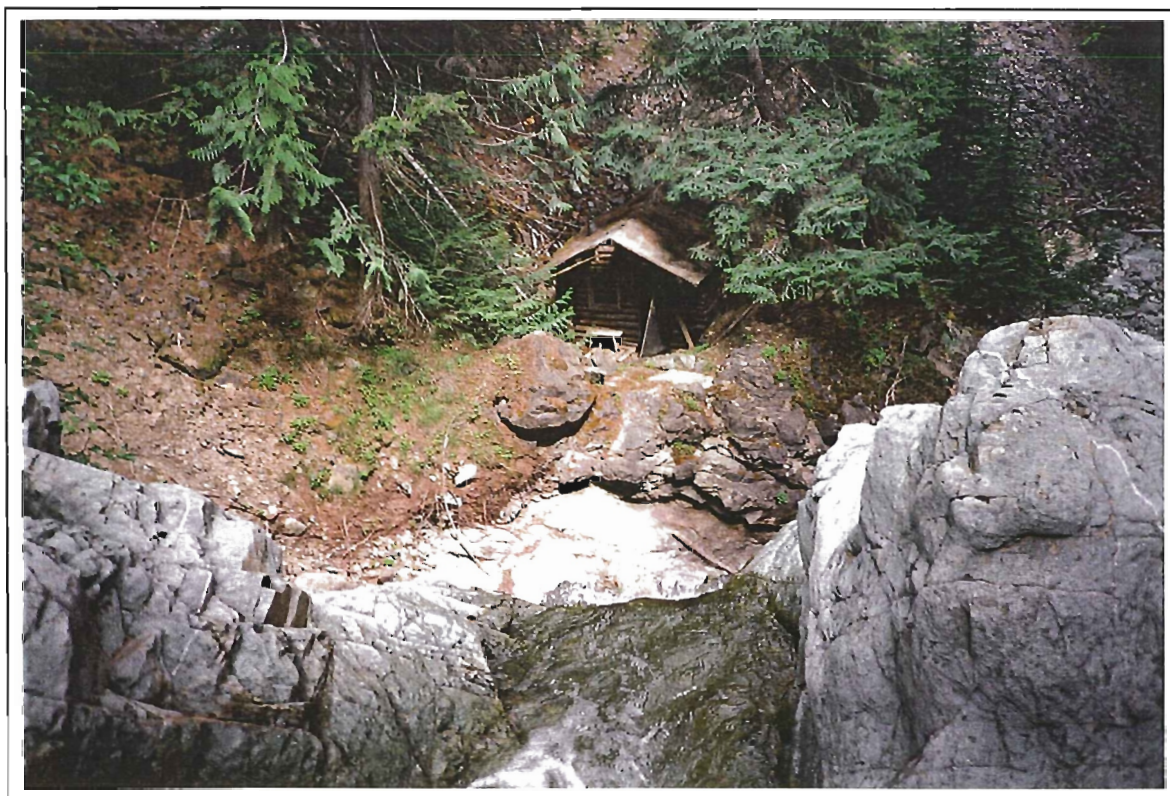
Photo 6: Olivine Creek. View facing downstream of falls presenting an upstream migration barrier to all fish. Note: Abandoned miner's shack. (8 August 1997).

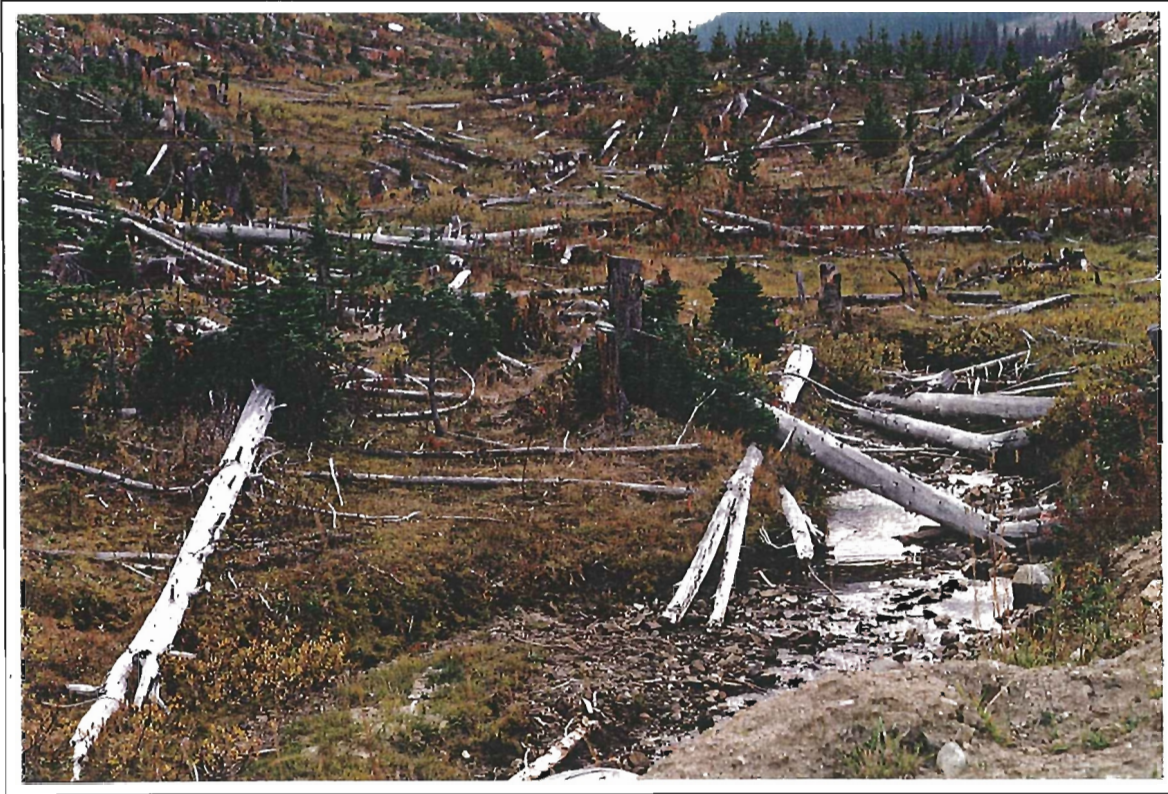
Photo 7: Granite Creek headwaters. View of Site 1 from road. Post planting.
Note: Clearcut to stream banks. (25 September 1997).

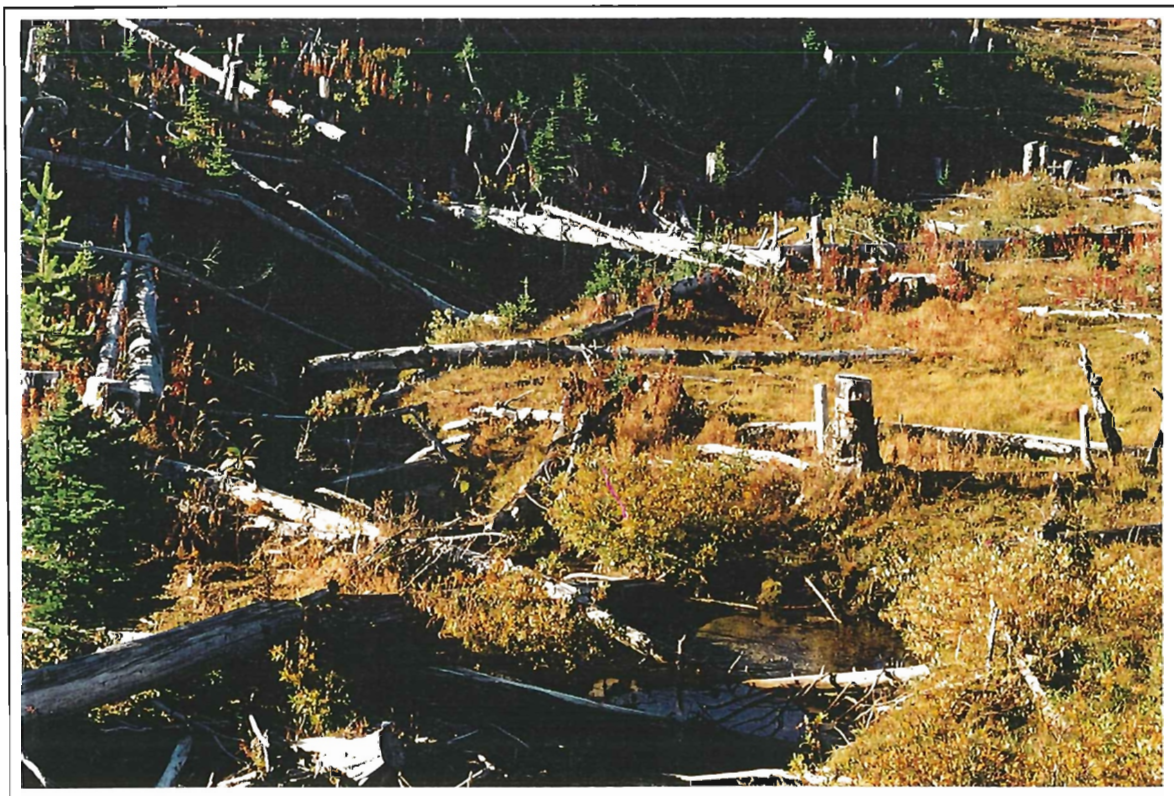
Photo 8: Granite Creek headwaters. View of Site 1. Post planting.
(26 September 1997).

Native tree and shrub species were planted along Granite Creek within the riparian zone of the clearcut area to restore and enhance fish habitat (Figure 3). Rainbow trout were captured in Granite Creek within this clearcut during the field survey portion of the 1996 Tulameen River watershed stream assessment.

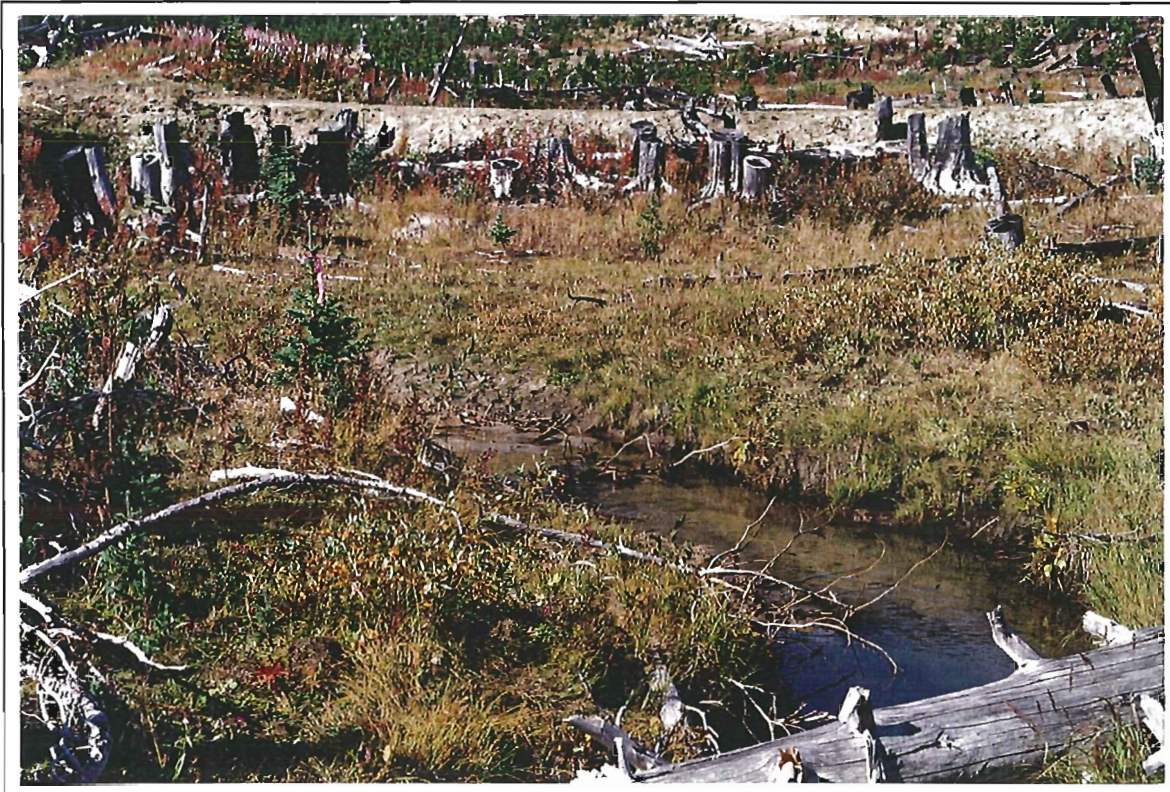
Photo 9: Granite Creek headwaters. View of Site 6. Post planting.
Note: Burned stumps in background. (25 September 1997).

An total of 670 specimens representing 13 tree and shrub species were planted. Five of the 13 tree and shrub species planted were berry producing. Approximately 370 of the total 670 specimens were planted as relatively larger bare-root "bands" or one gallon pots. The remaining 300 specimens which were relatively smaller plugs were planted within the 26 planting sites as well as randomly between sites where it appeared they may be beneficial but not necessarily crucial. The approximate number of tree and shrub species planted at each site as well as between sites is listed in Appendix D. Larger specimens were planted within sites where vegetation was most lacking. Photographs 9 to 12 demonstrate post planting conditions in the headwaters of Granite Creek.

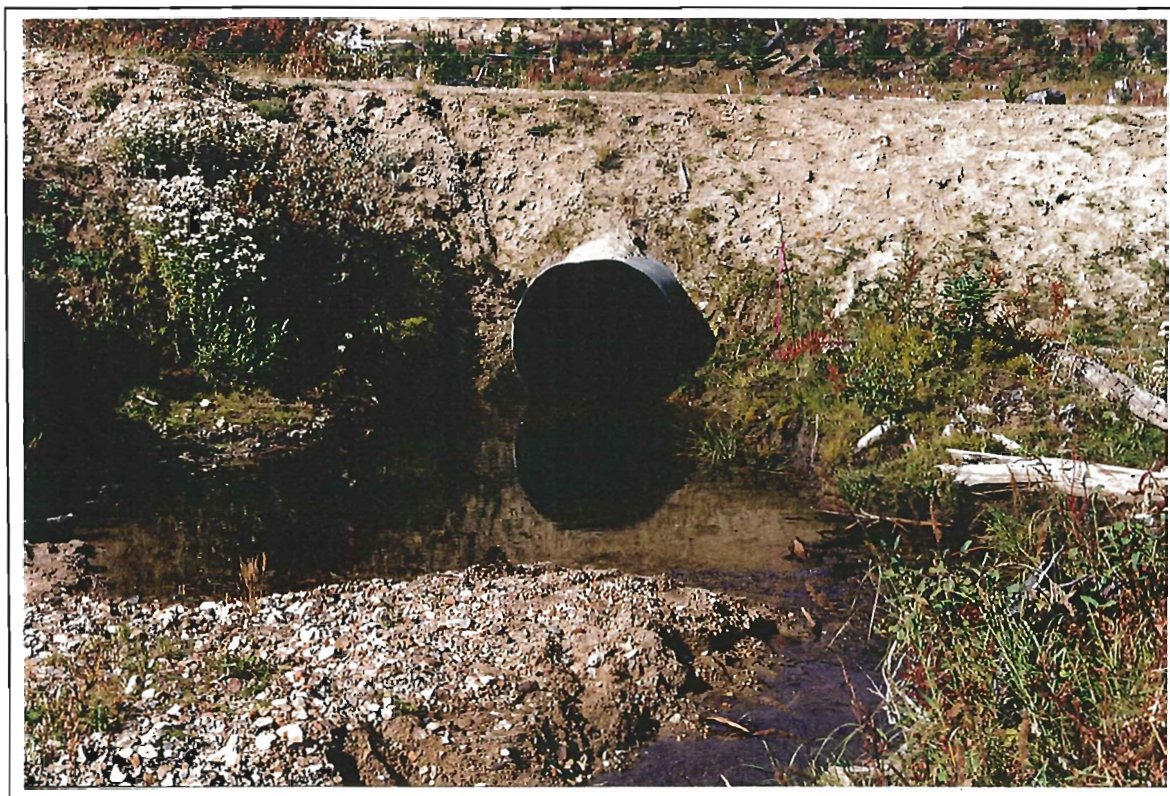
Photo 10: Granite Creek headwaters. View of Site 7. Pre-planting.
Note: Rainbow trout present in pool. (25 September 1997).

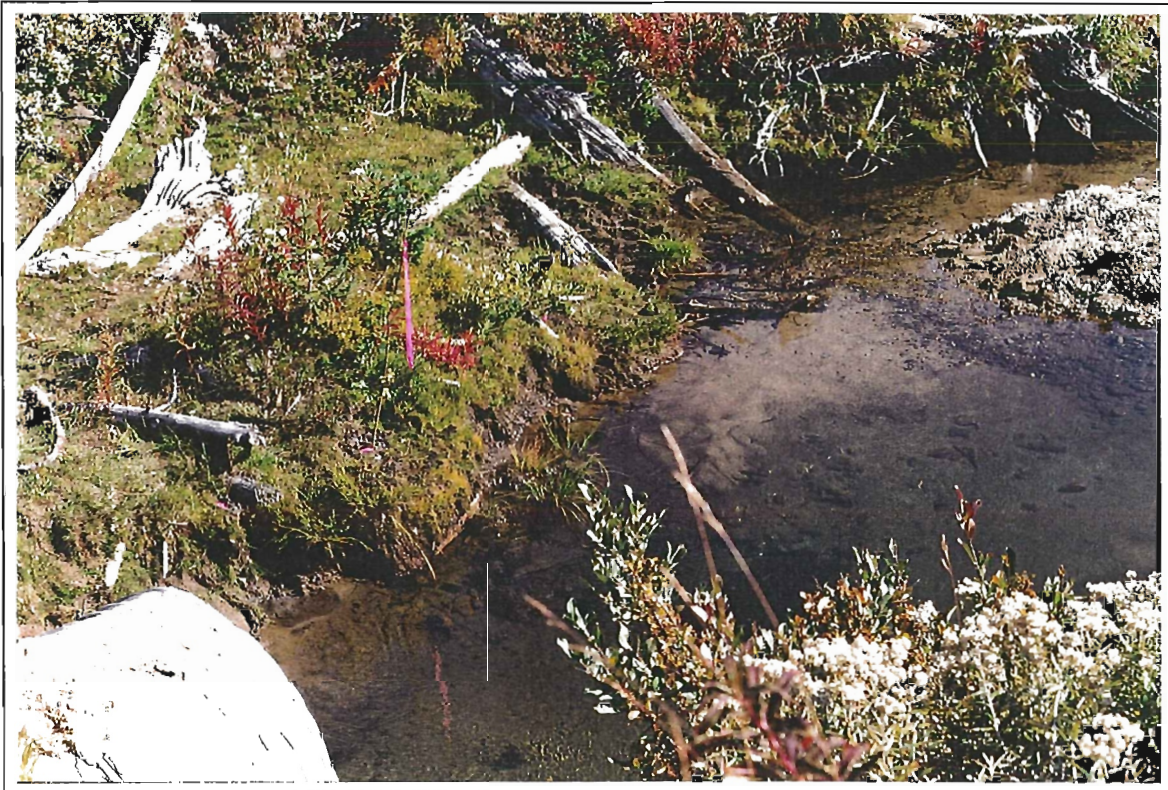
Photo 11: Granite Creek headwaters. View of Site 7. Post planting.
(25 September 1997).

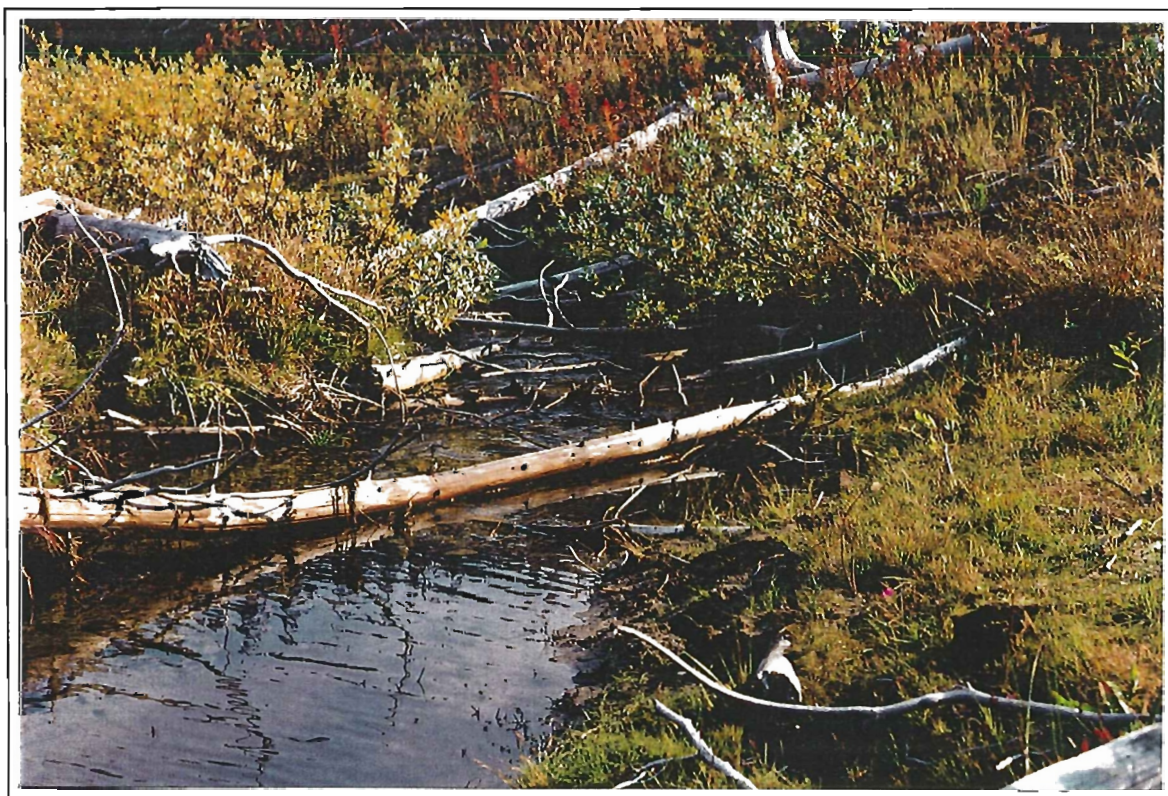
Photo 12: Granite Creek headwaters. View of Site 15. Post planting.
(25 September 1997).

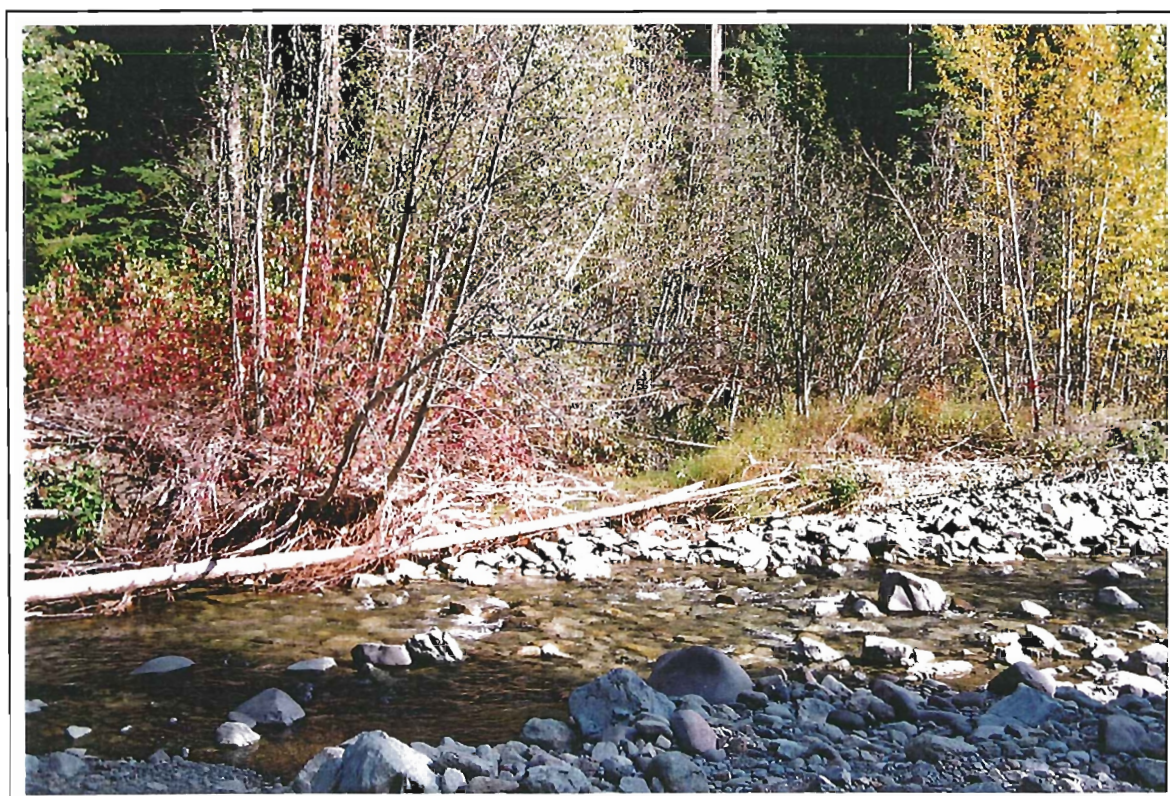
Photo 14: Granite Creek. View of Section 1 facing east bank. Pre-construction.
Note: Dry side channel. (25 September 1997).

Section 1 included 40 m of an eroding bank which was stabilized with dry logs anchored to rooted trees on top of the east bank with $\frac{3}{4}$ inch galvanized steel cable. The success of bank stabilization at Section 1 cannot be fully determined until peak flows have been experienced. The deflector logs placed at the east bank provided some additional fish cover for shade and protection as well as a source of food organisms, and are expected to continue to do so at higher flows. Photographs 13 to 16 demonstrate pre-construction and post construction conditions at Section 1.

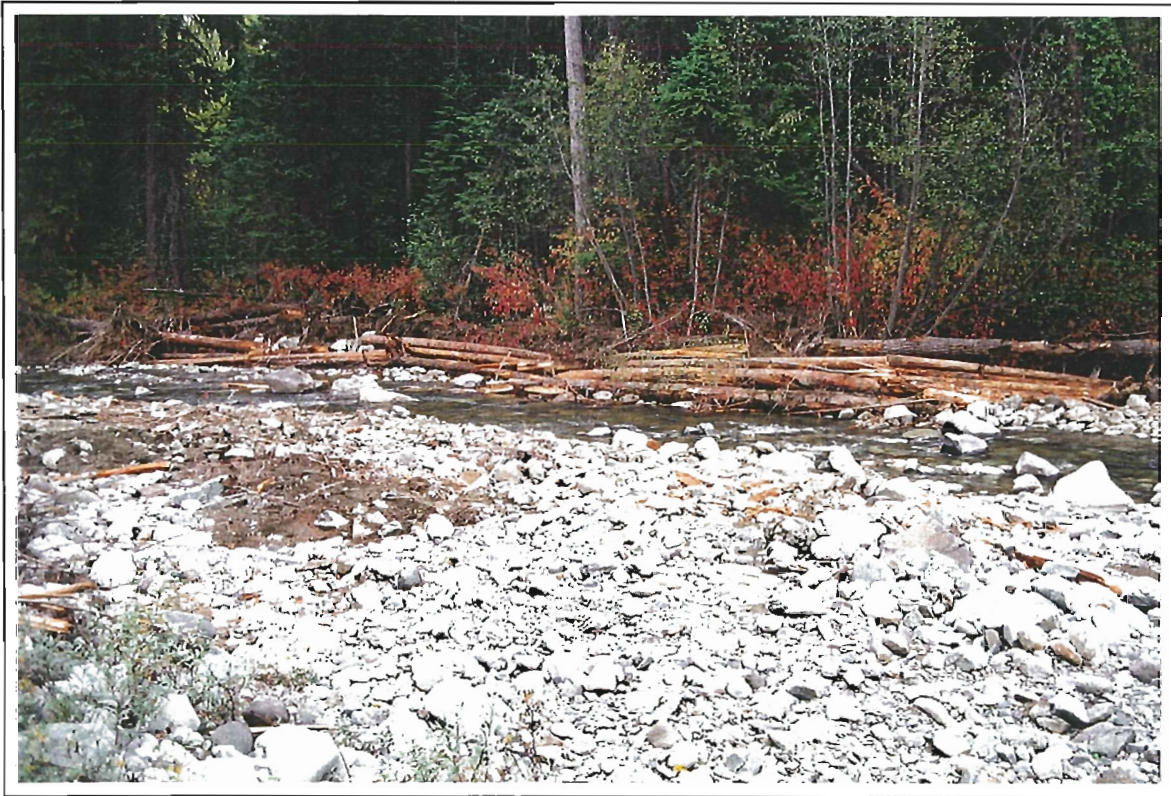
Photo 15: Granite Creek. View of Section 1 facing east bank. Post construction.
(26 September 1997).

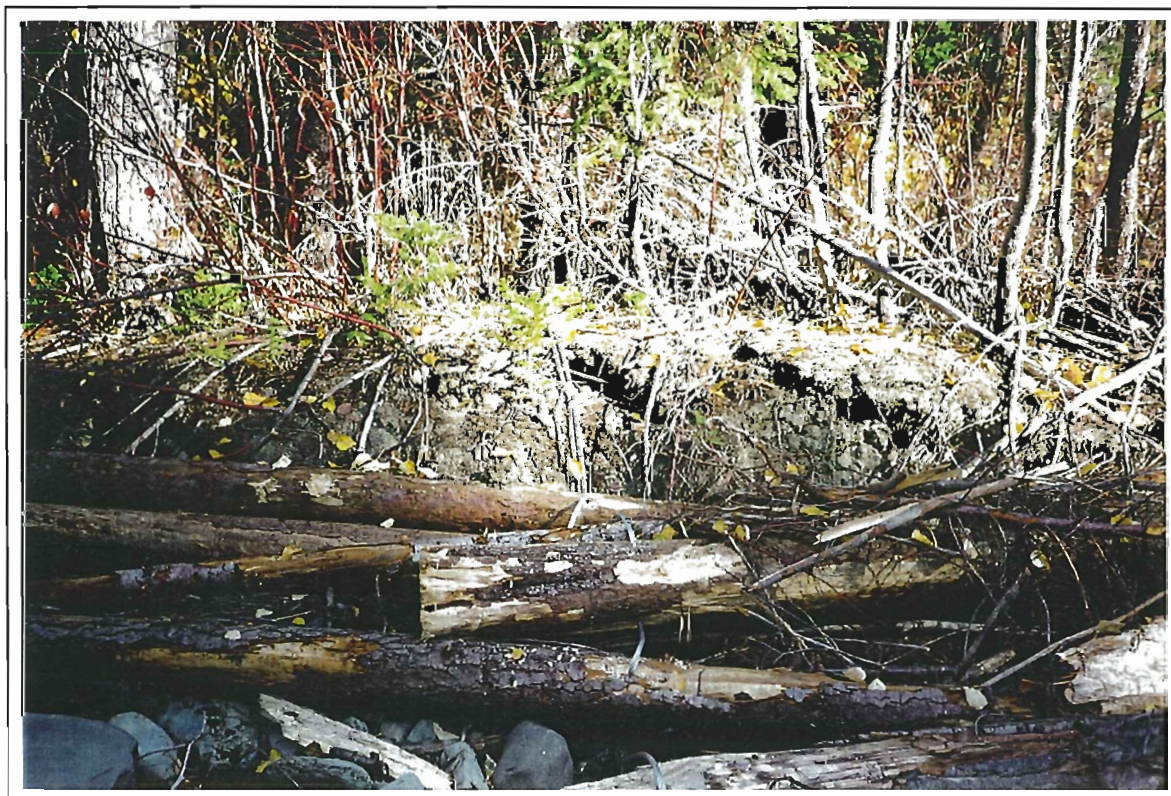
Photo 16: Granite Creek. View of Section 1 facing east bank. Post-construction.
Note: Galvanized steel cable. (20 October 1997).

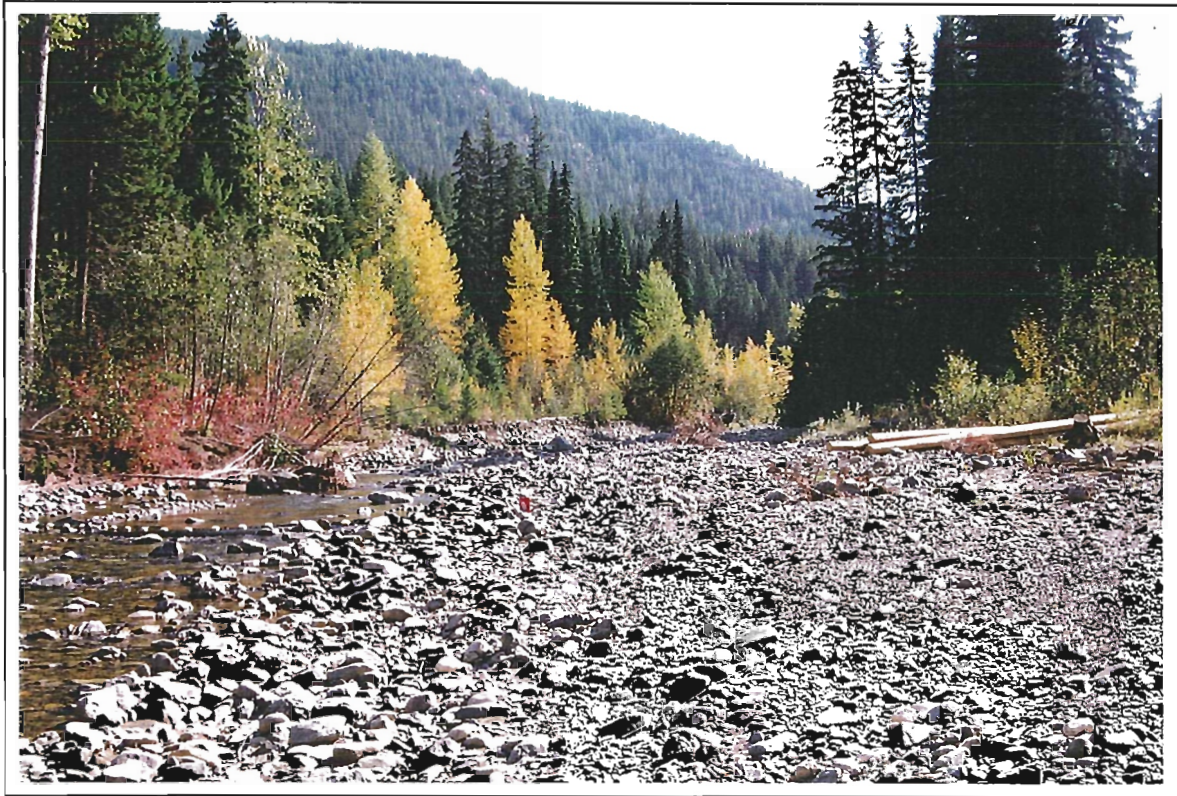
Photo 17: Granite Creek. View of Section 2. Pre-construction.
Note: Gravel/ cobble bar. (25 September 1997).

Section 2 consisted of a cobble/ gravel bar located at the access road to the river bed from kilometer 6.5 of the Arrastra Creek logging road. Three rootwads were placed on the cobble/ gravel bar with the rootwad end facing upstream so as to trap woody debris, promote sediment deposition, and cause accretion of the west bank with the ultimate goal of stabilizing the creek channel and enhancing fish habitat. The partial trunk of the rootwad was embedded into the bar at an angle of approximately 45°. To assure stability, the rootwads were anchored to 'deadmen' also embedded into the bank

Photographs 17 to 19 demonstrate pre-rootwad installation and post rootwad installation conditions of the gravel/ cobble bar at Section 2.

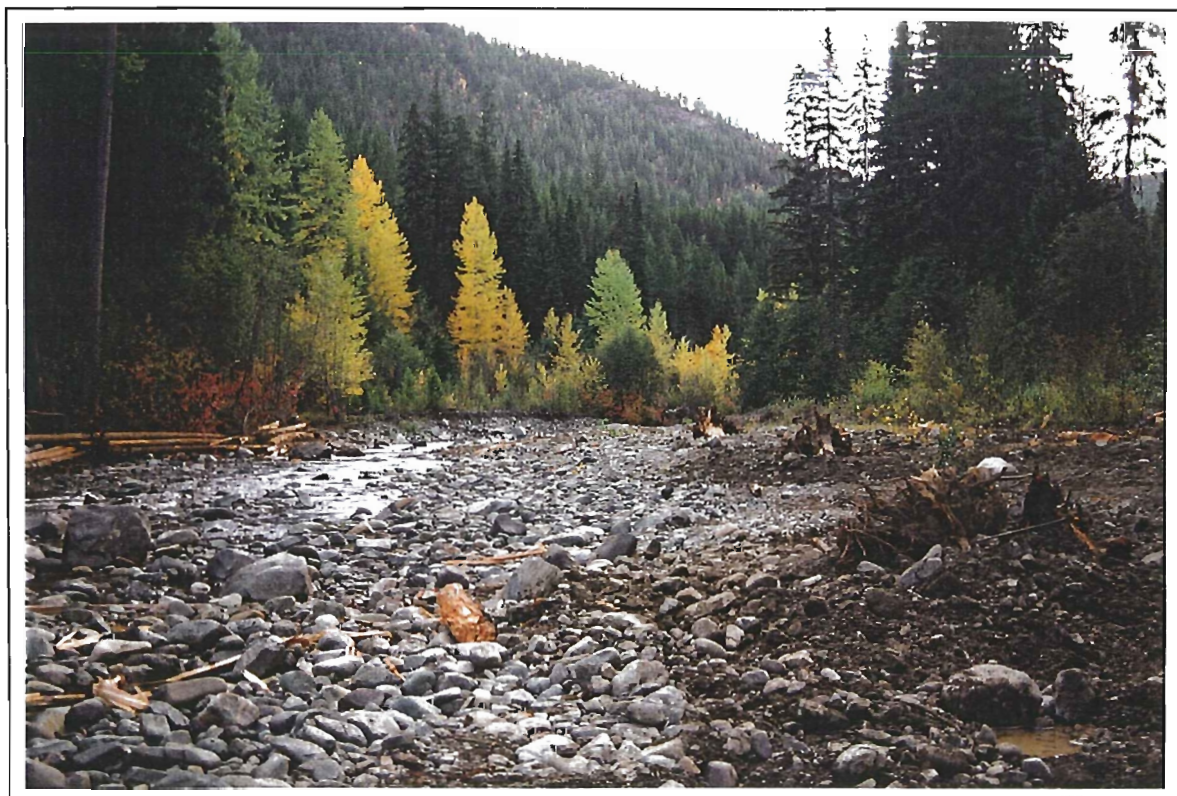
Photo 18: Granite Creek. View of Section 2 facing upstream. Post construction.
Note: Rootwads and planted nursetrees. (26 September 1997).

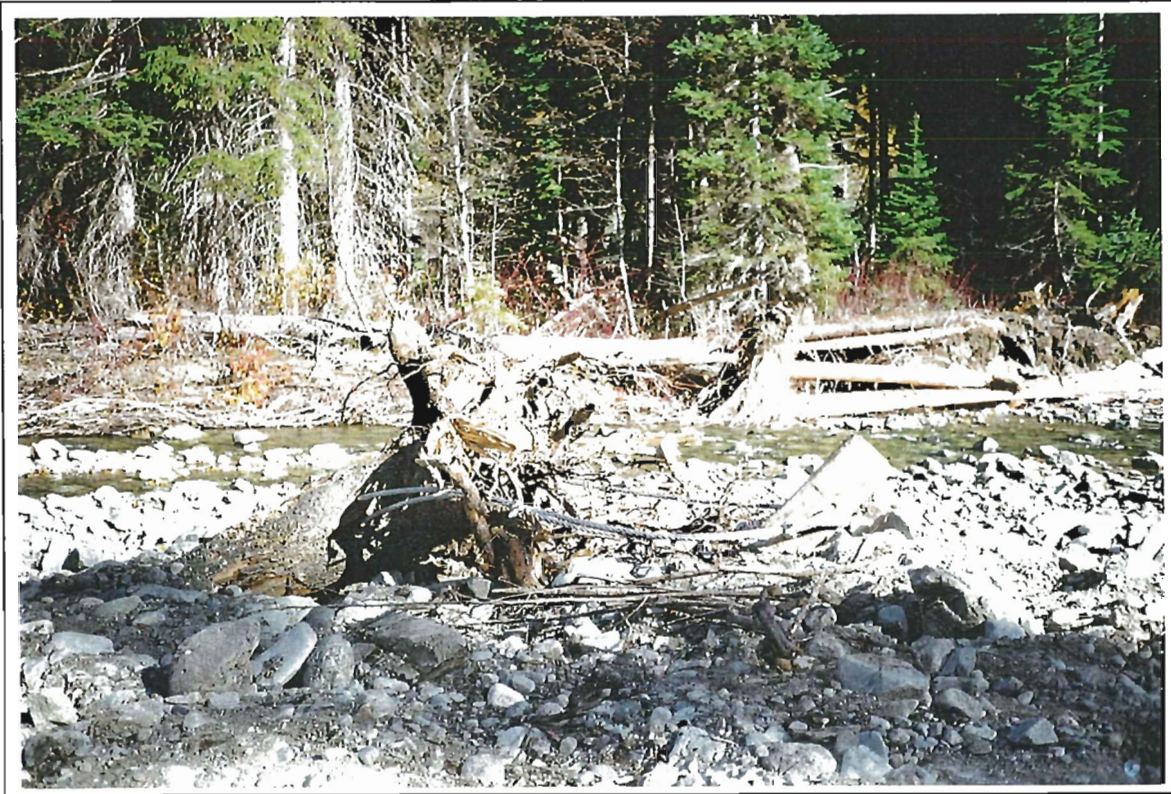
Photo 19: Granite Creek. View of Section 2. Post construction.
Note: Rootwad cabled to deadman. (20 October 1997).

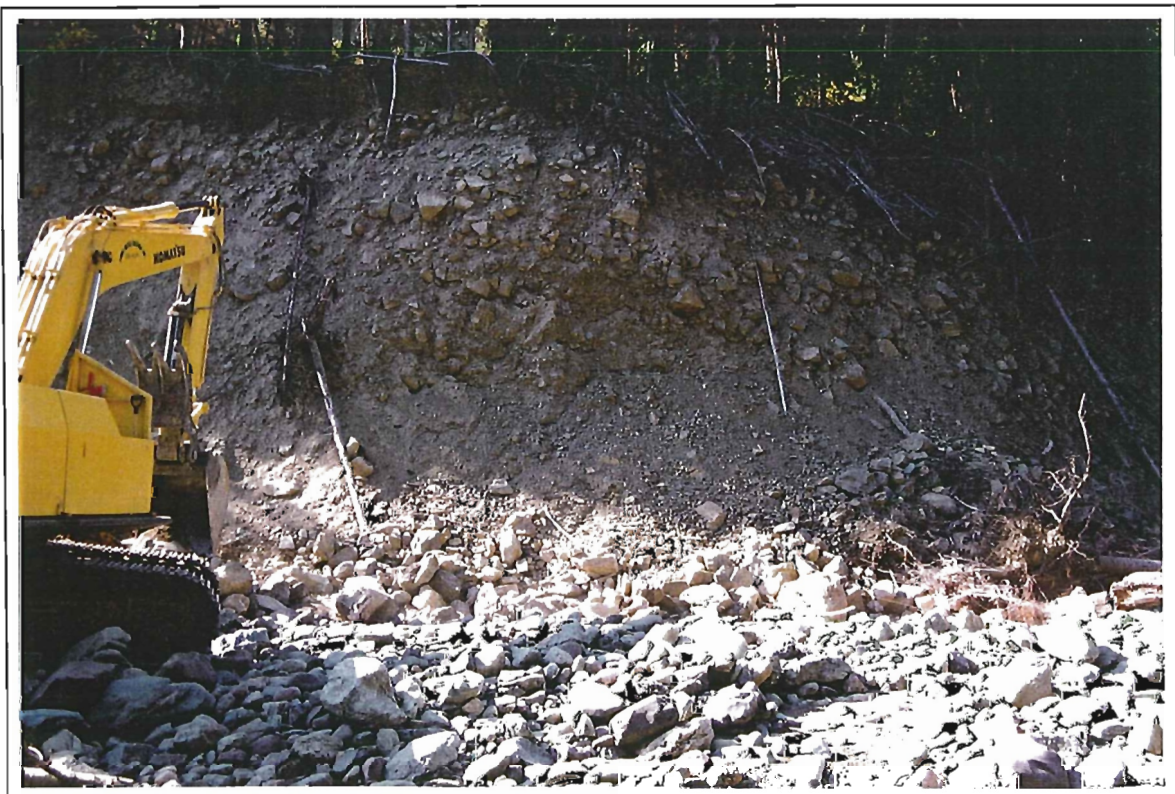
Photo 20: Granite Creek. View of Section 3. Pre-construction.
Note: Eroding west bank and excavator. (25 September 1997).

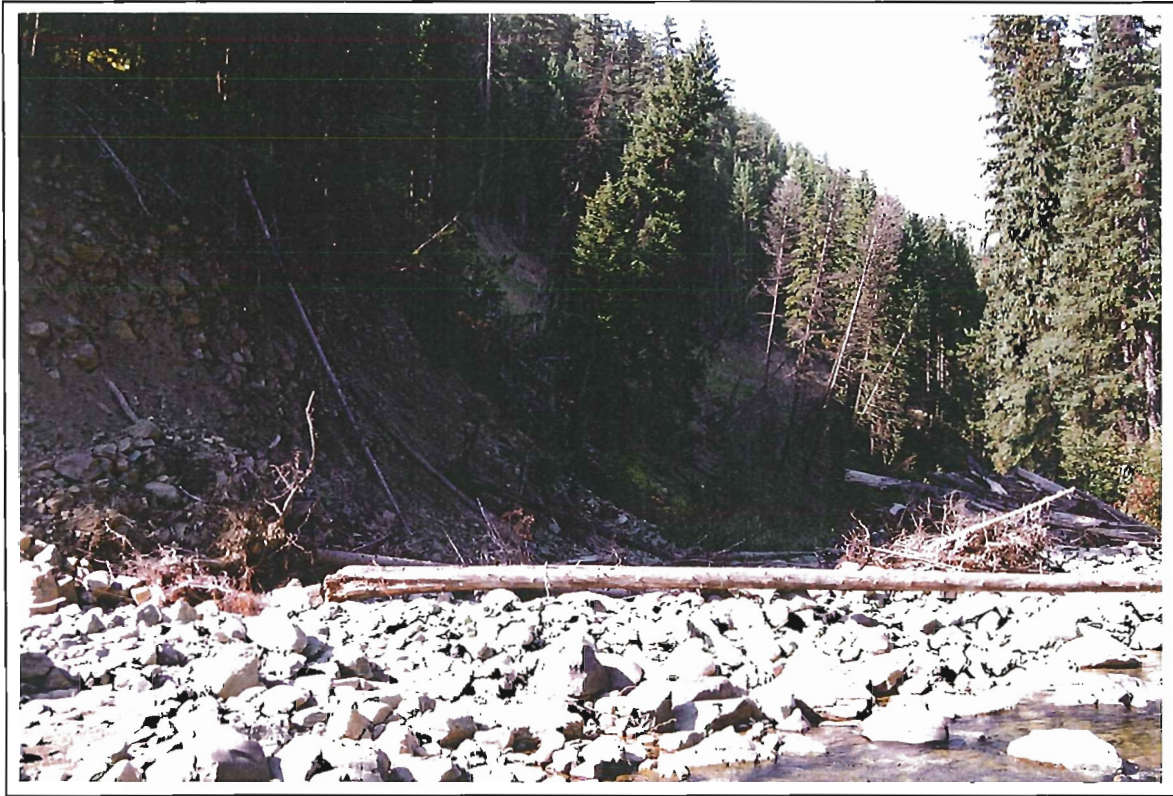
Photo 21: Granite Creek. View of Section 3. Pre-construction.

Note: Dry side channel downstream of eroding west bank. (25 September 1997).

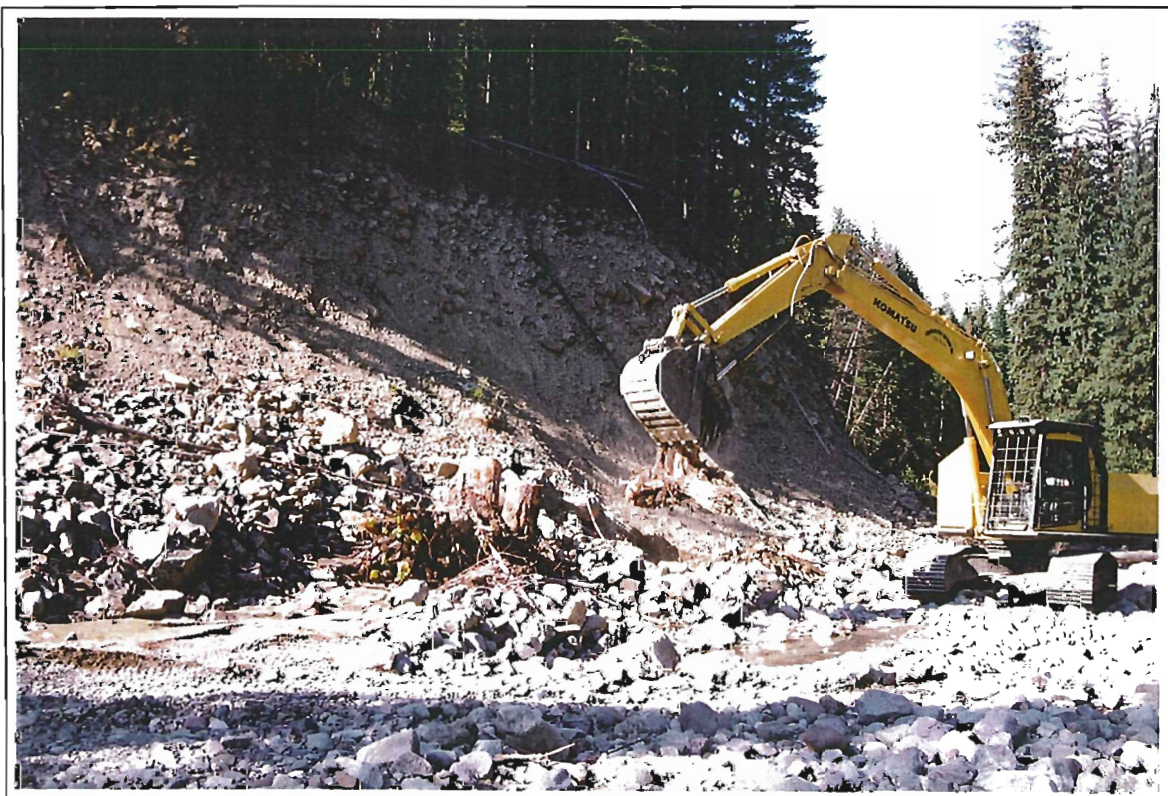
Photo 22: Granite Creek. View of Section 3. Mid construction.

Note: Excavator placing rootwads at toe of eroding west bank. (25 September 1997).

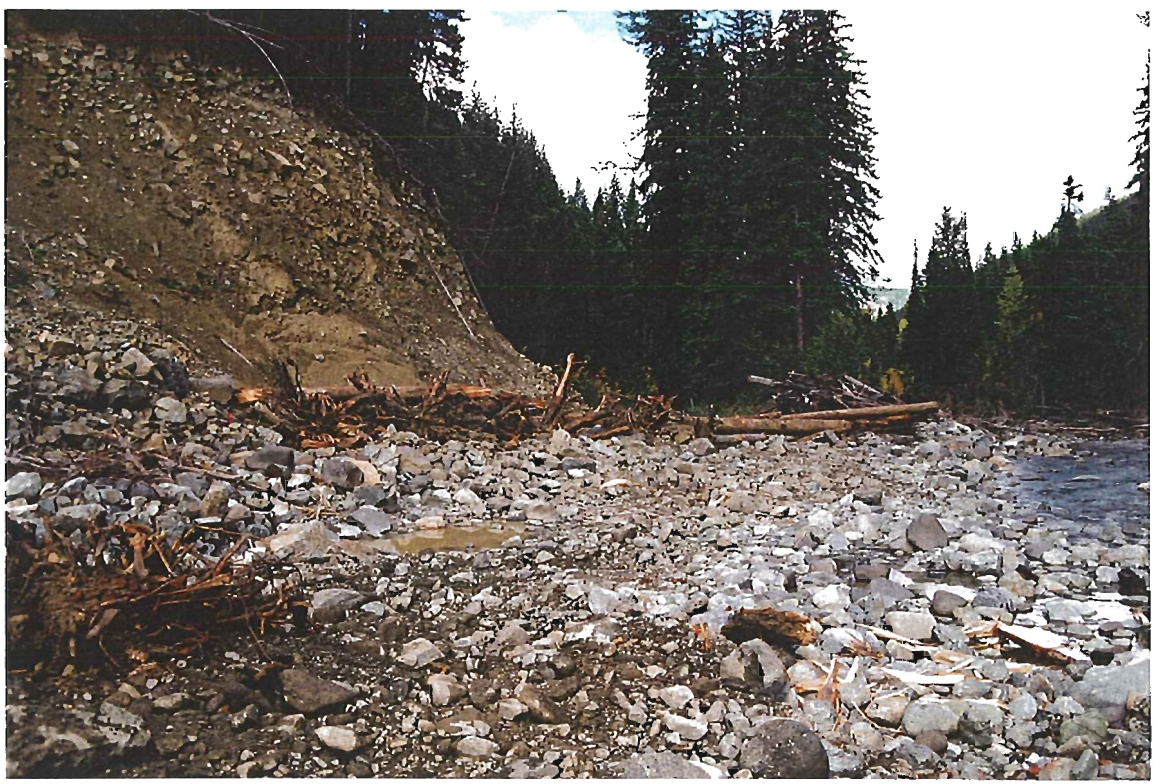
Photo 23: Granite Creek. View Section 3 facing downstream. Post construction.
Note: Placed logs extend across dry side channel entrance. (25 September 1997).
