**1997 TULAMEEN RIVER WATERSHED
STREAM RESTORATION**

FINAL REPORT

**MINISTRY OF ENVIRONMENT, LANDS
AND PARKS, PENTICTON, B.C.**

February 1998

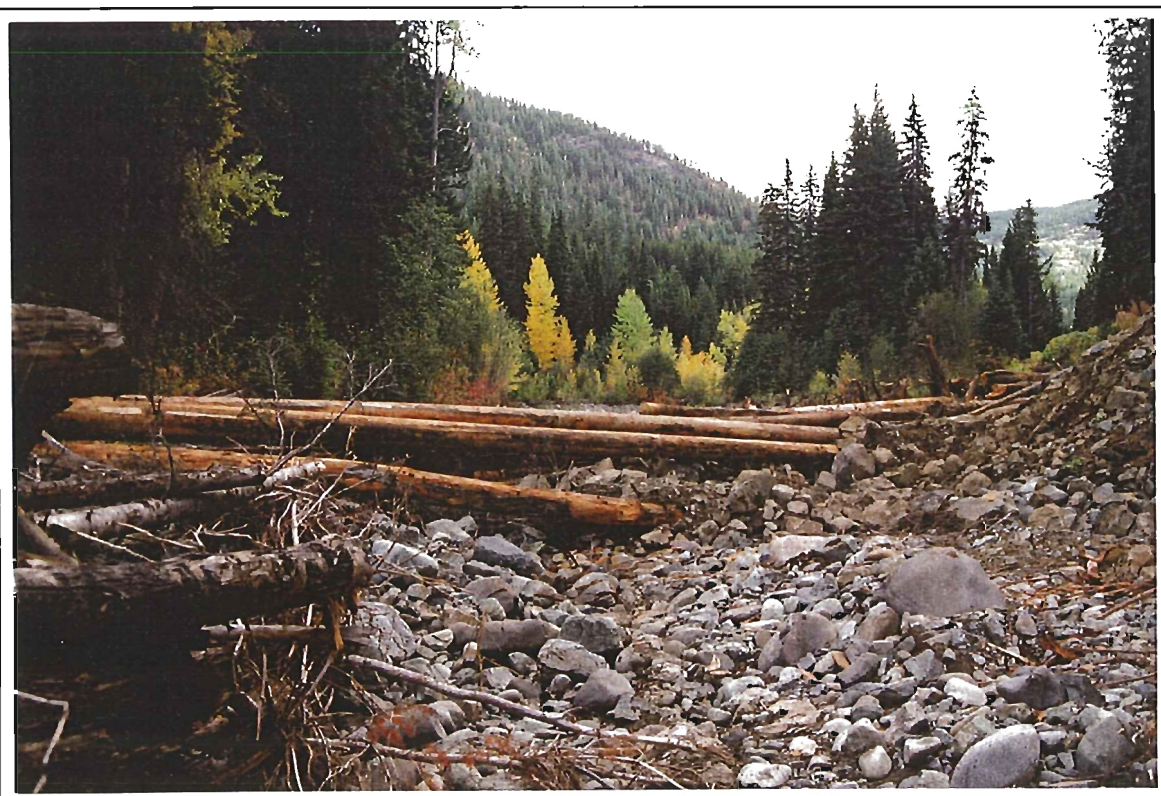
Photo 24: Granite Creek. View of Section 3 facing upstream at entrance to dry side
channel. Post construction. (25 September 1997).

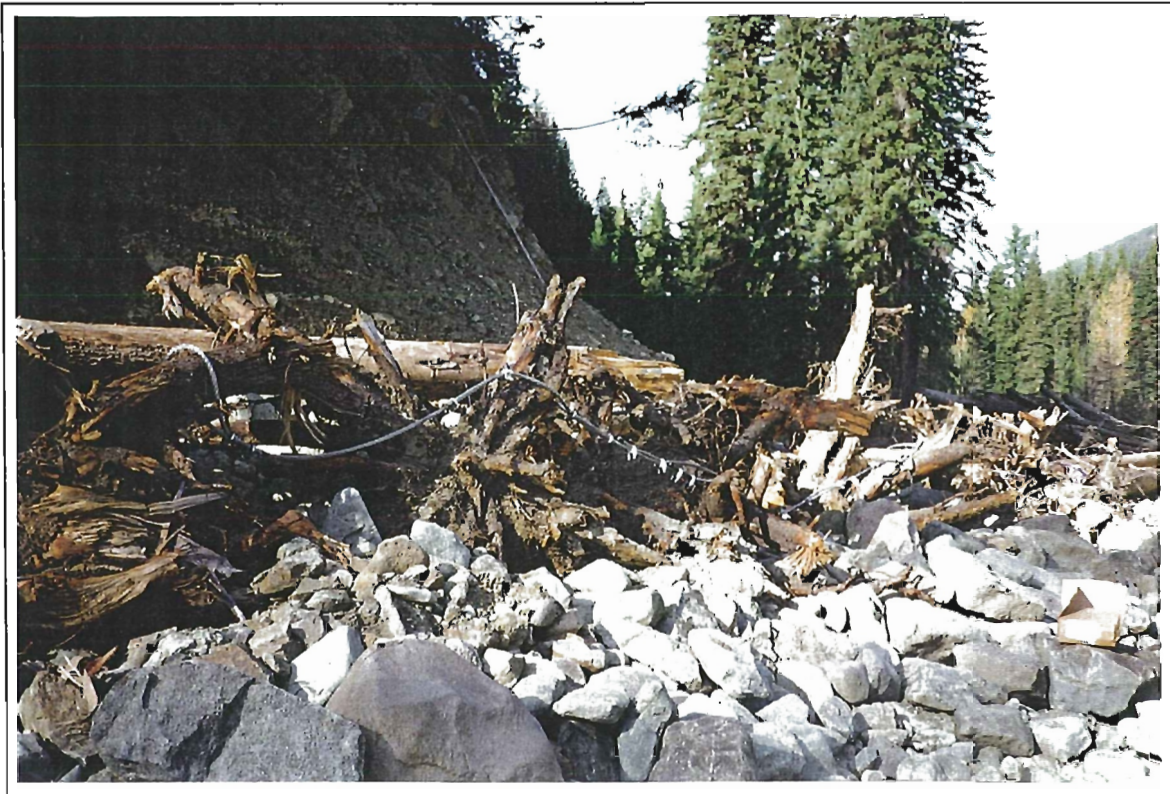
Photo 25: Granite Creek. View of Section 3 facing stabilized west bank.
Note: Galvanized steel cable. (20 October 1997).

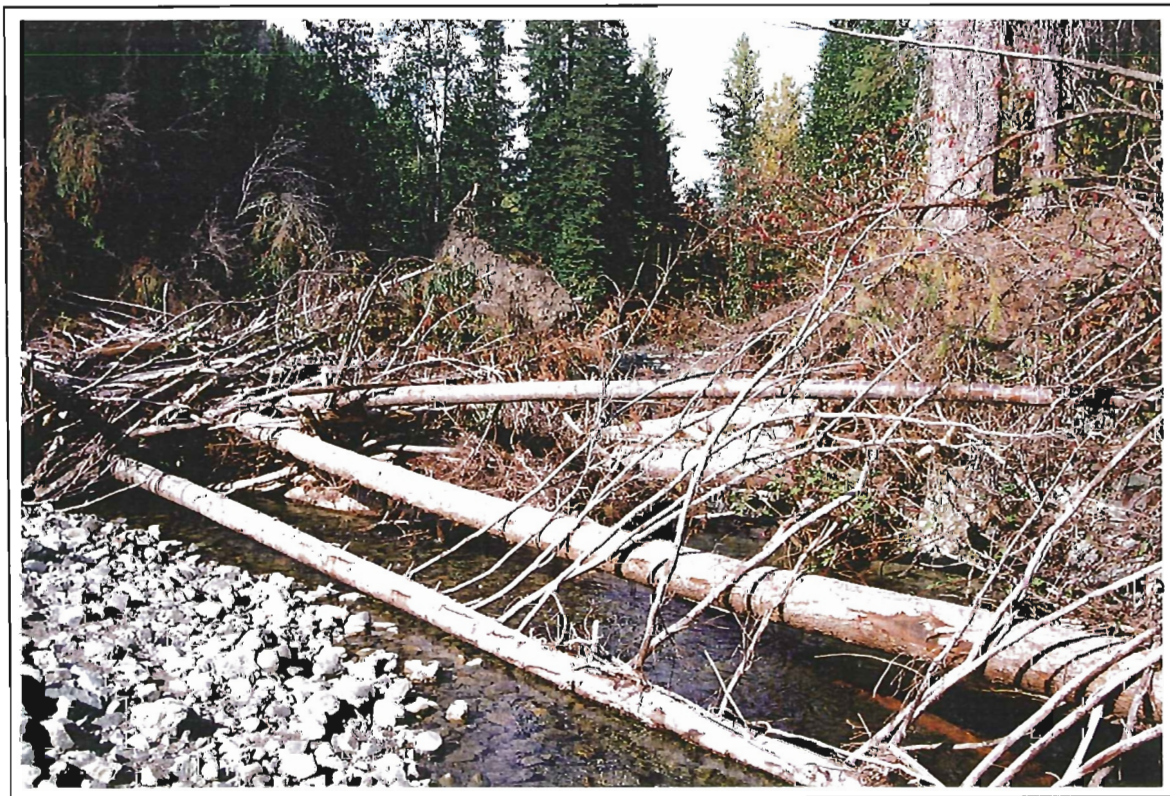
Photo 26: Granite Creek. View of Section 4 facing downstream. Pre-construction.
Note: Logjam. (25 September 1997).

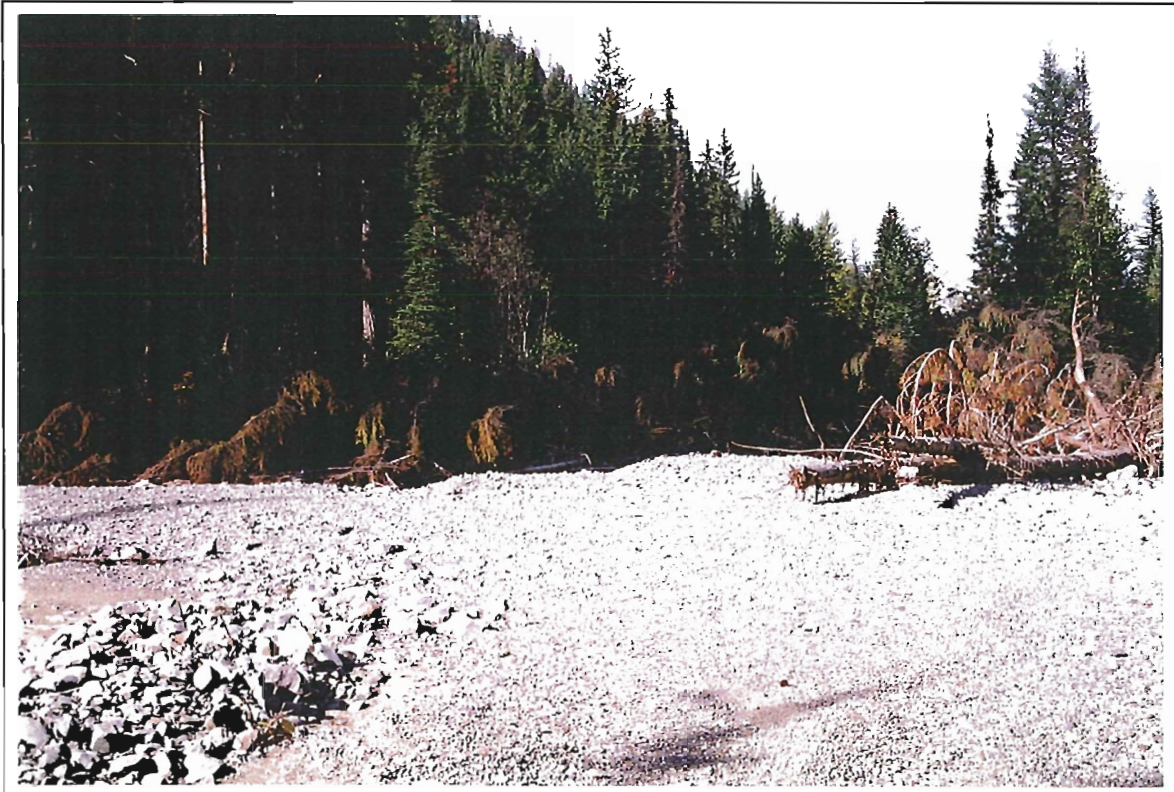
Section 4 included a logjam which split Granite Creek into two channels (Photograph 26), an eroding east bank immediately upstream of the logjam, and an unvegetated gravel/ sand bar (Photograph 27). Previously, one channel flowed in a northerly direction bypassing the logjam (Photograph 28) and the other channel flowed under the logjam in a northwesterly direction at a slightly lower elevation (Photograph 29). Downstream of the logjam, the northerly channel flowed at an elevation of approximately 1 m above the other causing some of the water to wash over the gravel/ cobble substrate and enter the northwesterly channel.

Photo 27: Granite Creek. View of Section 4. Pre-construction.
Note: Gravel/ sand bar. (25 September 1997).

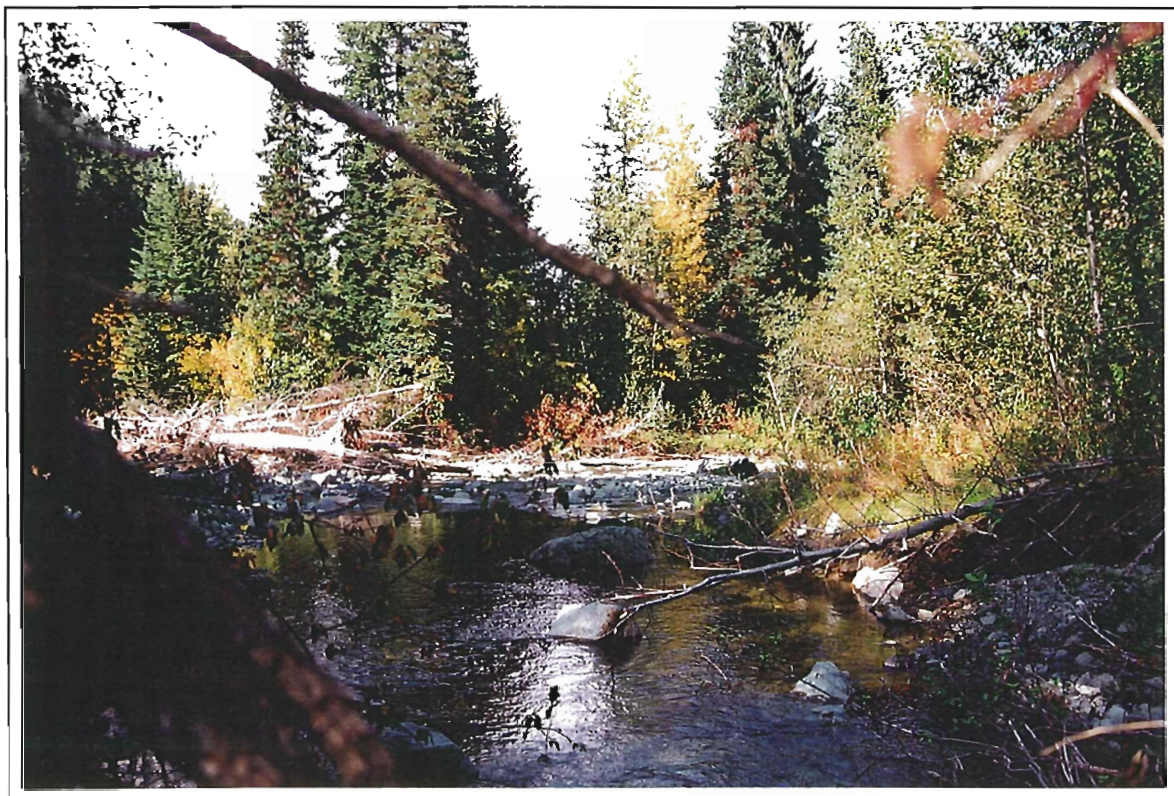
Photo 28: Granite Creek. View of Section 4 downstream from logjam. Pre-construction.
Note: Channel flows in a northerly direction bypassing logjam. (25 September 1997).

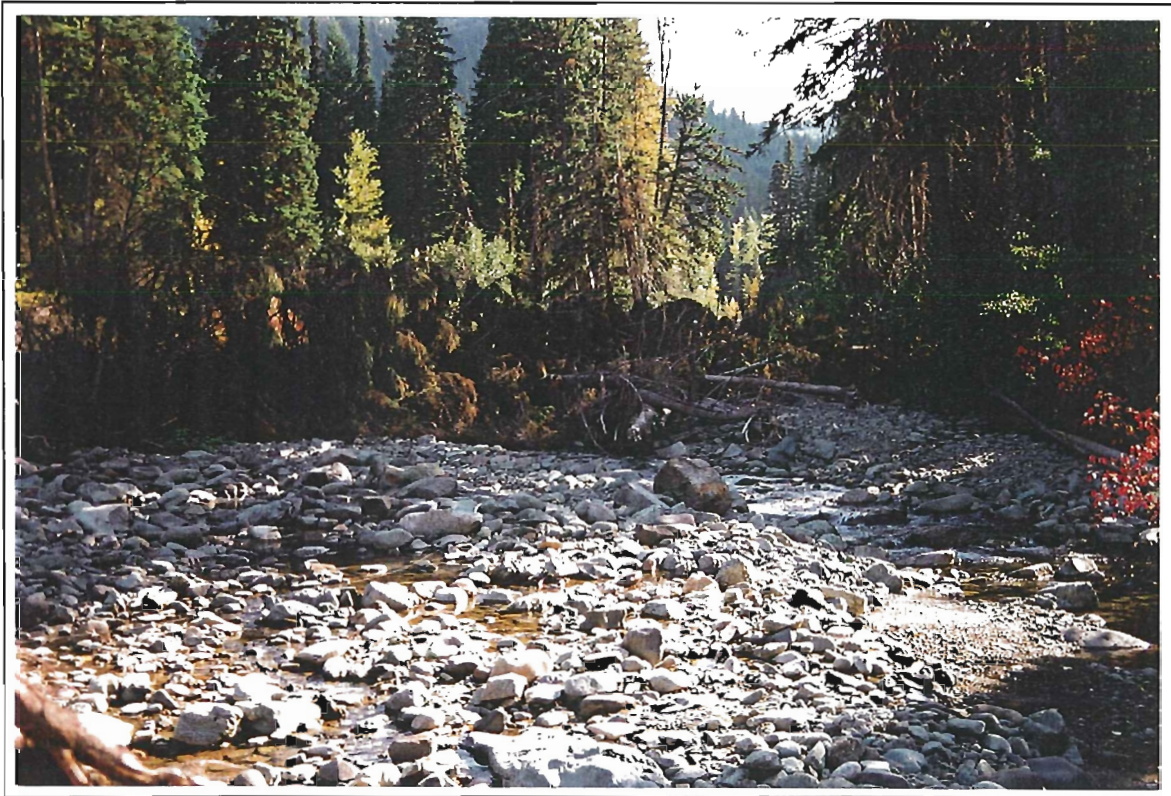
Photo 29: Granite Creek. View of Section 4 facing upstream. Pre-construction.
Note: Channel flowing in a northwesterly direction under logjam. (25 September 1997).

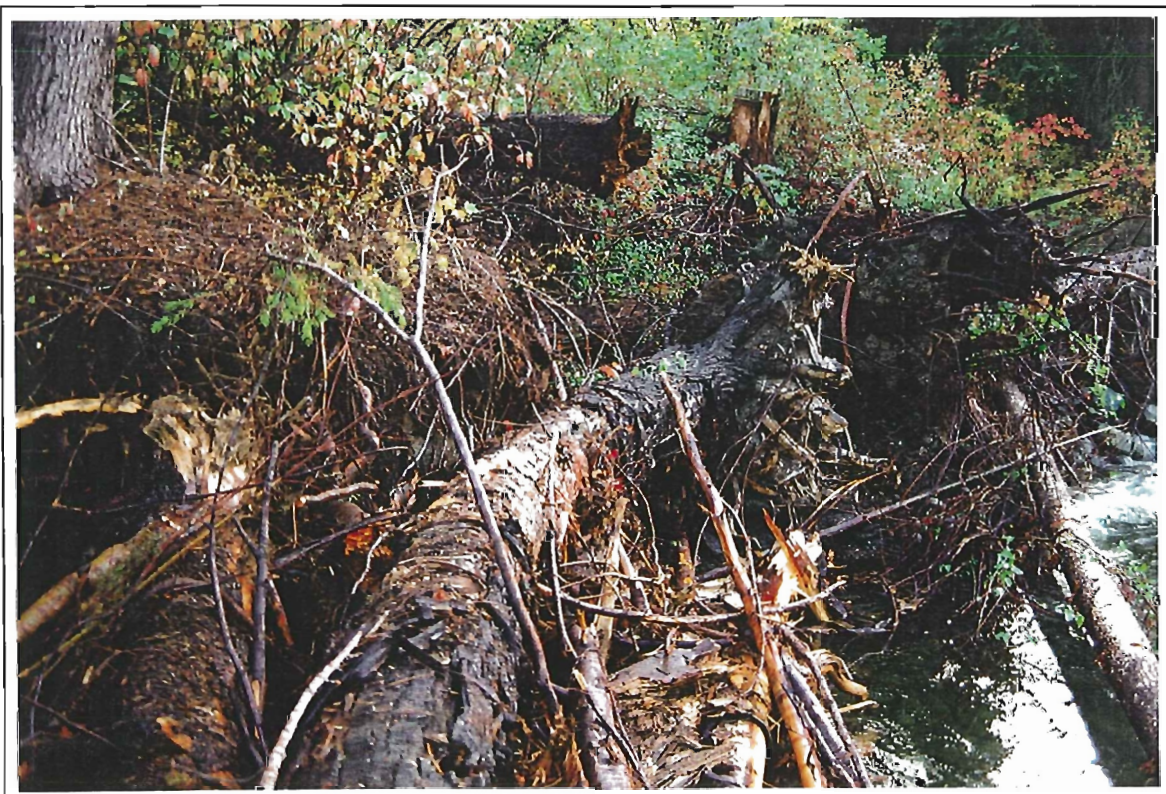
Photo 30: Granite Creek. View of Section 4. Post construction.
Note: Logjam has been fortified with logs. (25 September 1997).

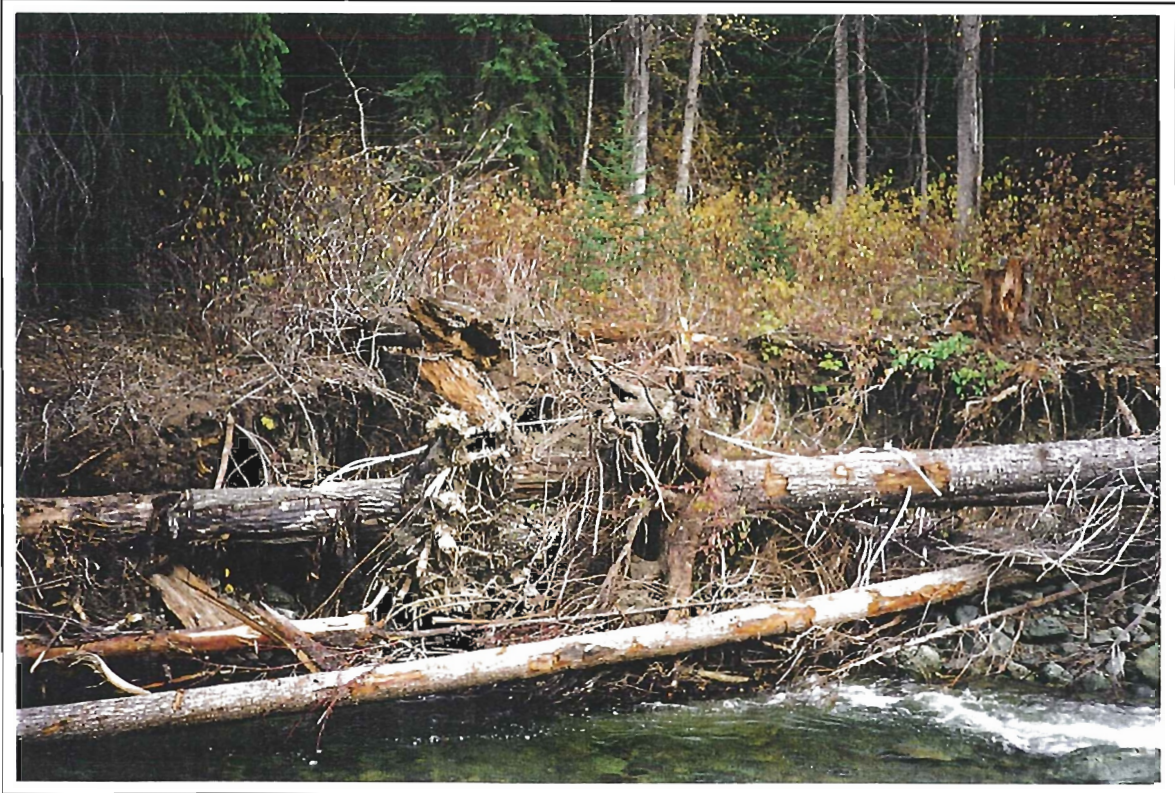
Photo 31: Granite Creek. View of Section 4 facing east bank immediately upstream of logjam. Post construction. Note: Galvanized steel cable. (20 October 1997).

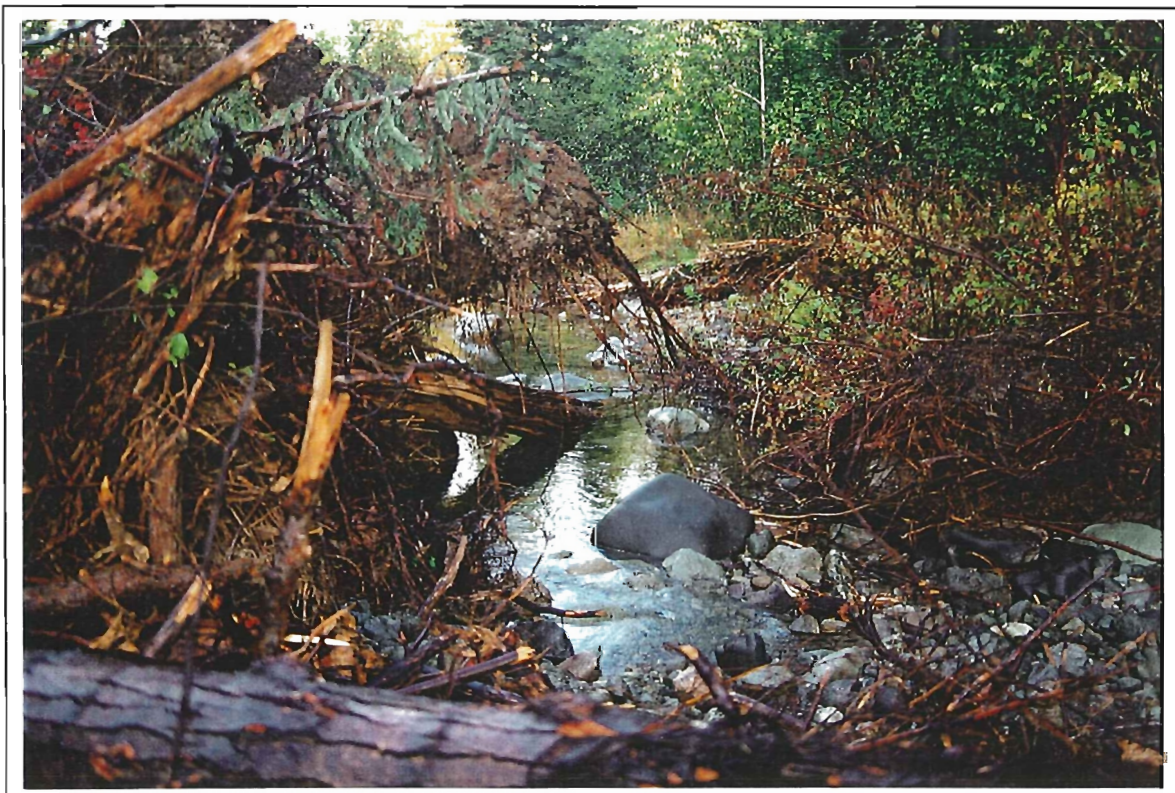
Photo 32: Granite Creek. View of Section 4. Channel flowing north. Post construction. Note: Flow decrease compared to pre-construction. (25 September 1997).

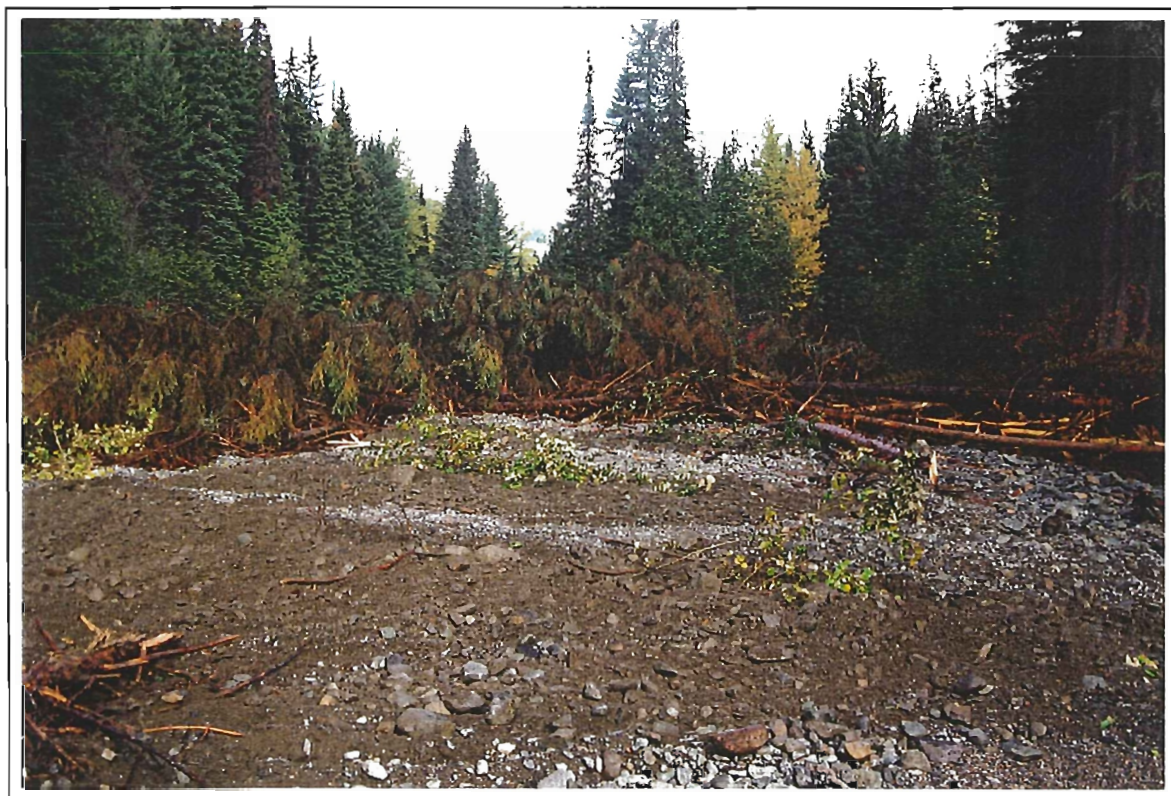
Photo 34: Granite Creek. View of Section 4. Post construction.
Note: Nursetrees planted in gravel/ sand bar. (26 September 1997).

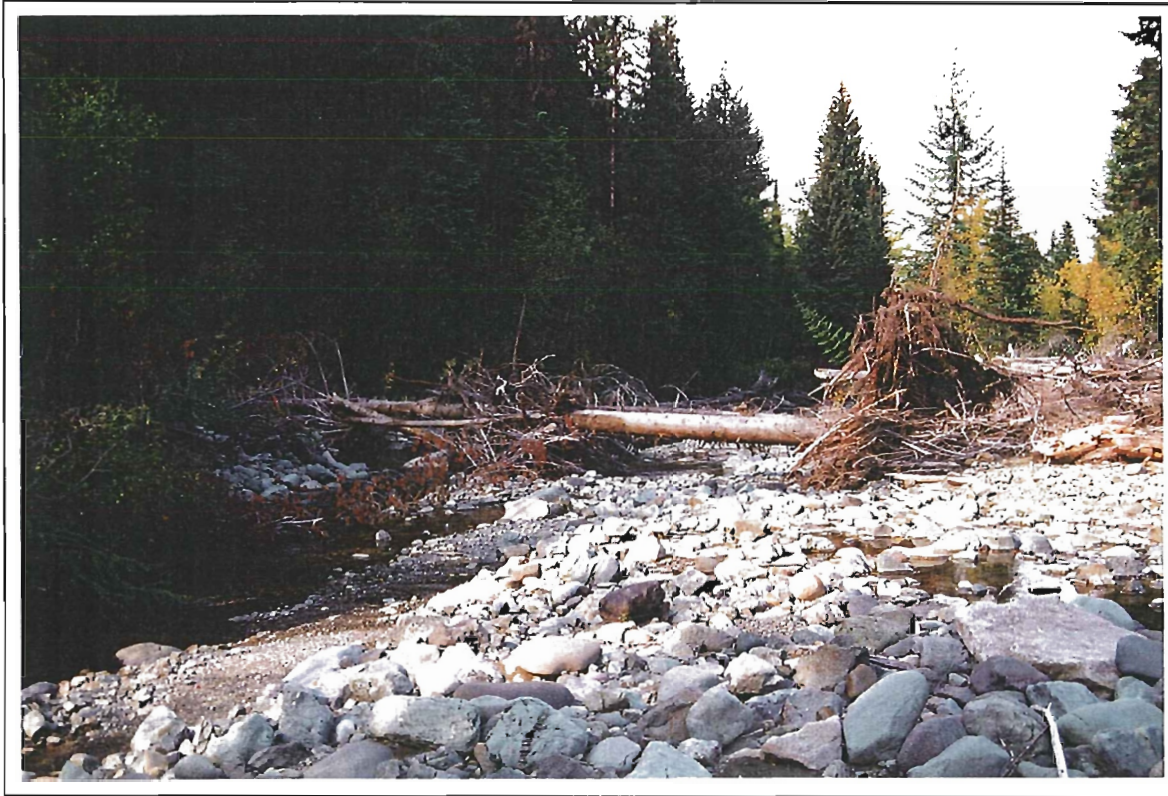
Photo 35: Granite Creek. View of Section 5 facing downstream. Pre-construction. Note: Rootwad instream and large rootwad with log across channel. (25 September 1997).

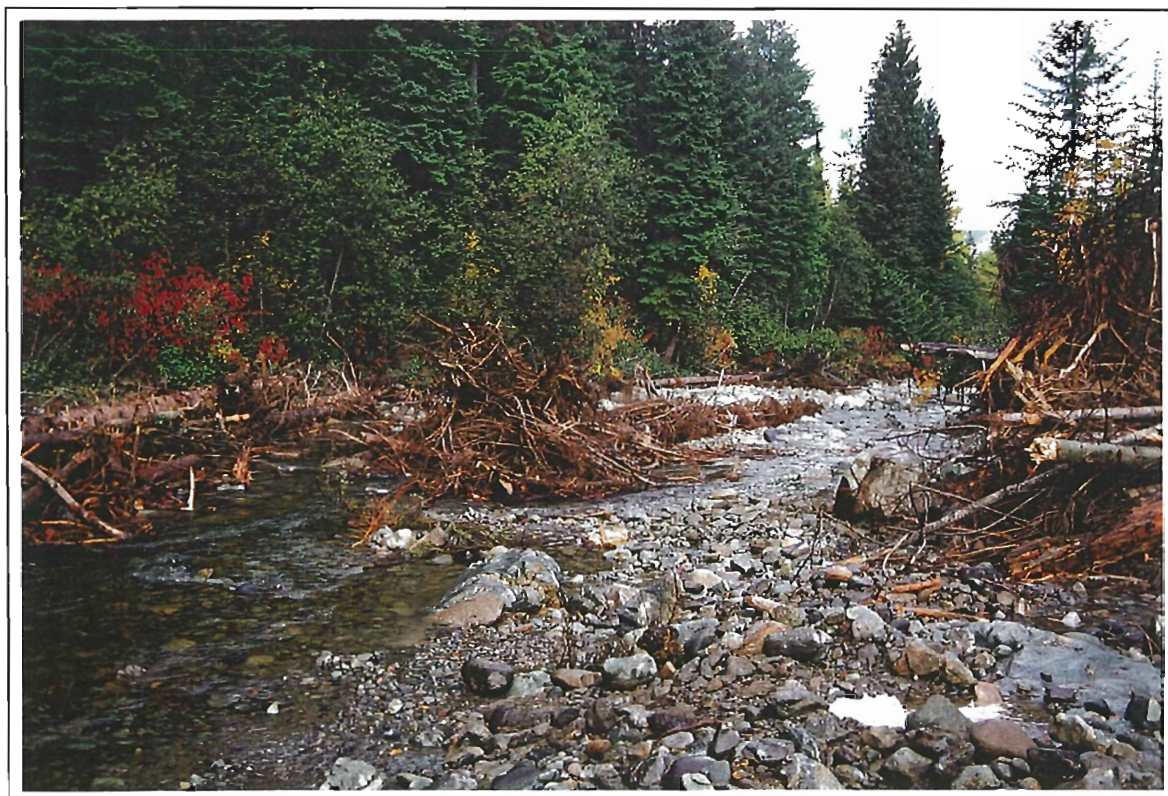
Photo 36: Granite Creek. View of Section 5 facing downstream. Post construction. Note: Rootwad instream, logs at west bank, debris at east bank. (26 September 1997).

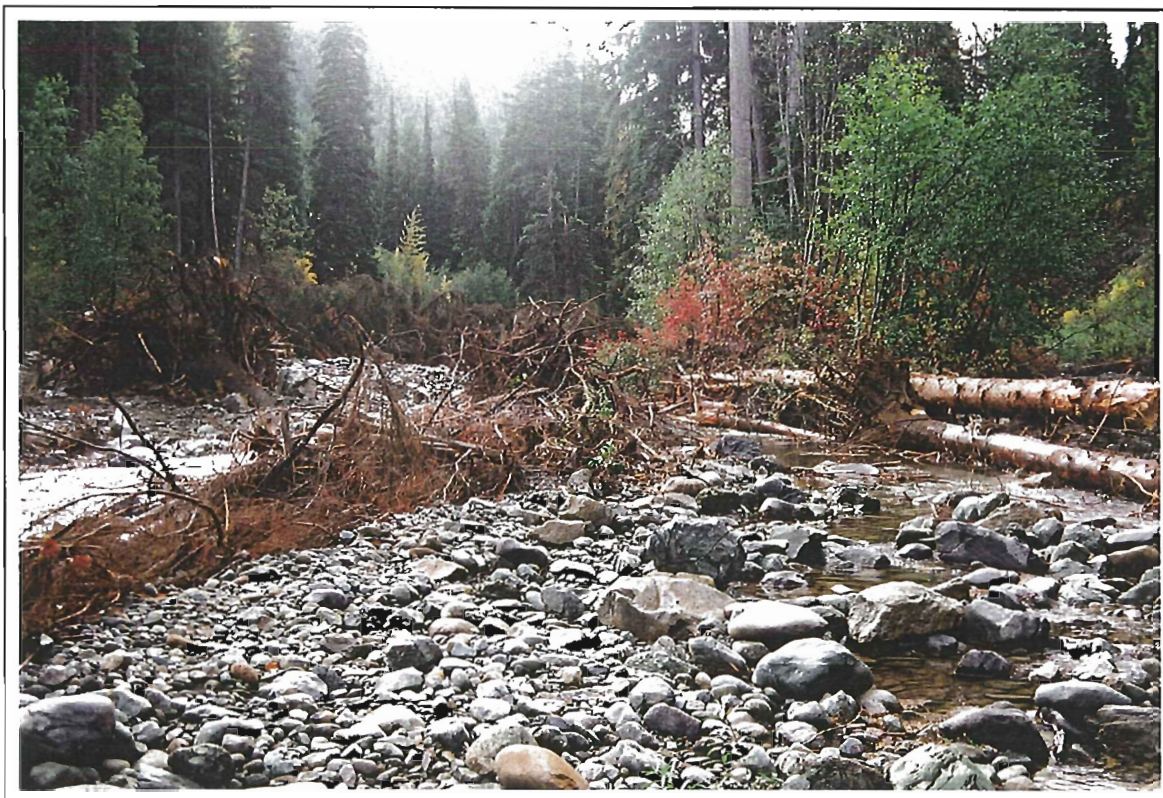
Photo 37: Granite Creek. View of Section 5 facing upstream. Post construction. Note: Large rootwad east bank, rootwad instream, stabilized west bank. (26 September 1997).

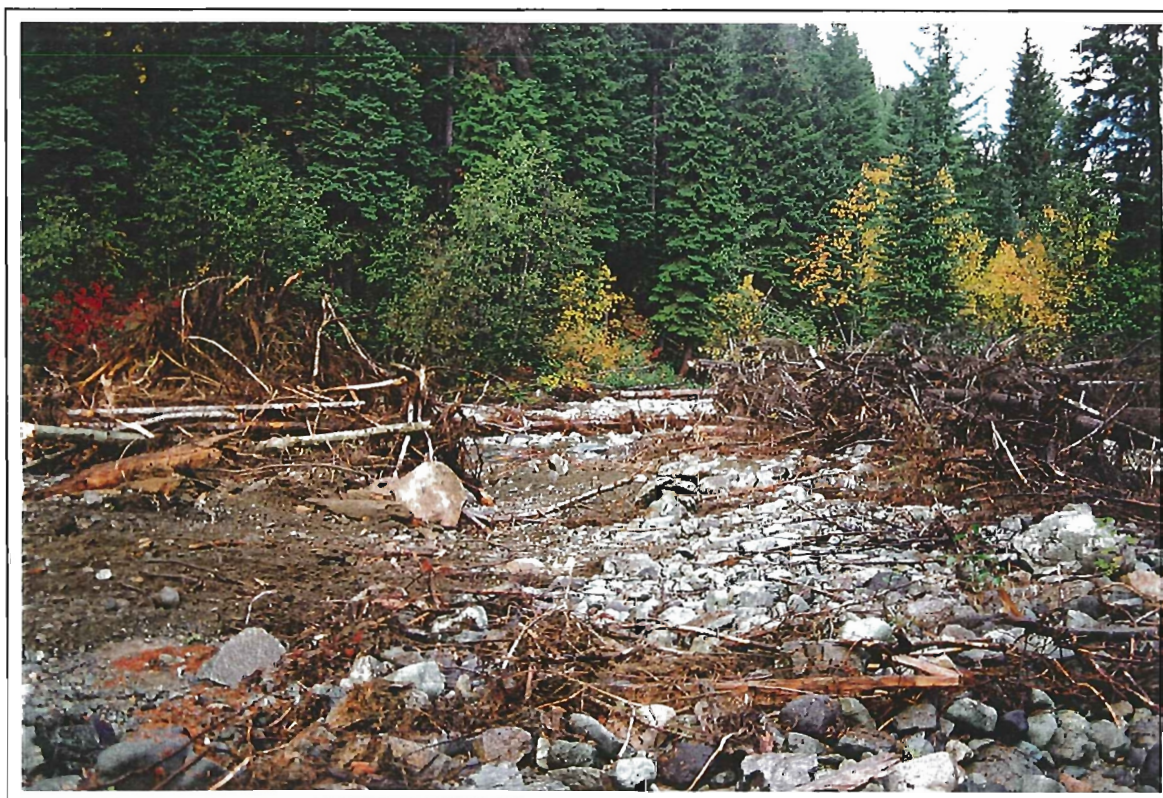
Photo 38: Granite Creek. View of Section 6 facing downstream. Post construction. Note: East bank stabilized with logs and debris. (26 September 1997).

The fallen coniferous tree located within the wetted width adjacent to the west bank approximately 20 m downstream of Section 6 was secured to a rooted tree upon the bank with $\frac{3}{4}$ inch galvanized steel cable. This LWD is expected to provide fish cover during all flow conditions.
