Re: The Trout Creek Slide

THE TROUT CREEK SLIDE

Comments by C.P. Lewis, Physical Processes Unit,
Recreational Fisheries Branch, Victoria
July 1988

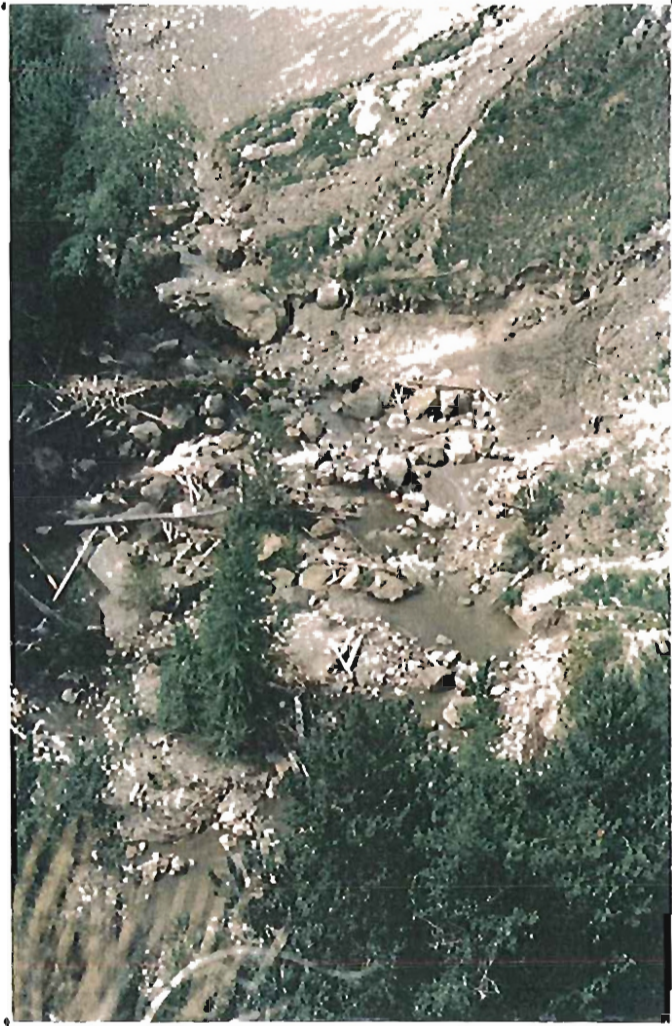
PHOTO 7: Boulders and wood debris
in Trout Creek near the down-
stream end of the slide zone.

- most of the slide material is probably stored temporarily in canyon wall and bottom debris lobes and enters the stream system when those lobes are eroded by high flows in May and June.
- Photos 5-7 show scarps cut in the toes of debris lobes and coarse debris in the Creek.
- sediment from the lobes will include appreciable amounts of sand and gravel and could significantly affect both the nature and amount of fish habitat in the Creek.
- no data are available to permit assessment of the competence and capacity of Trout Creek to move this bed-material through its lower reaches.

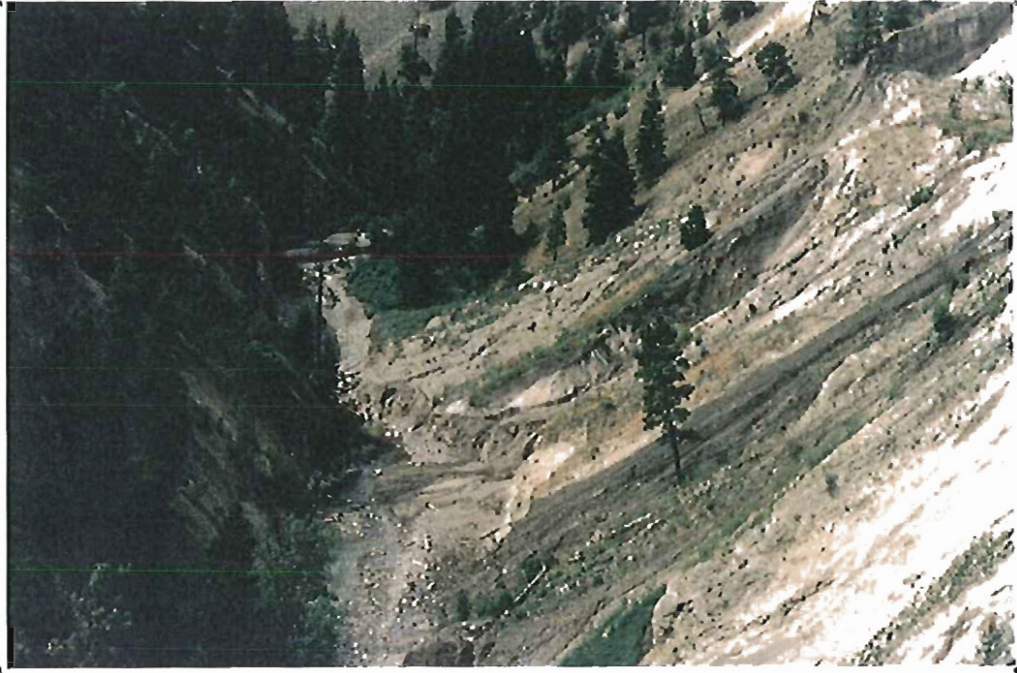
PHOTO 5: View up Trout Creek canyon past slide. Lone tree in foreground was also present in Fig. 1-4k of Riglin (1977). Note eroded toes of debris lobes.

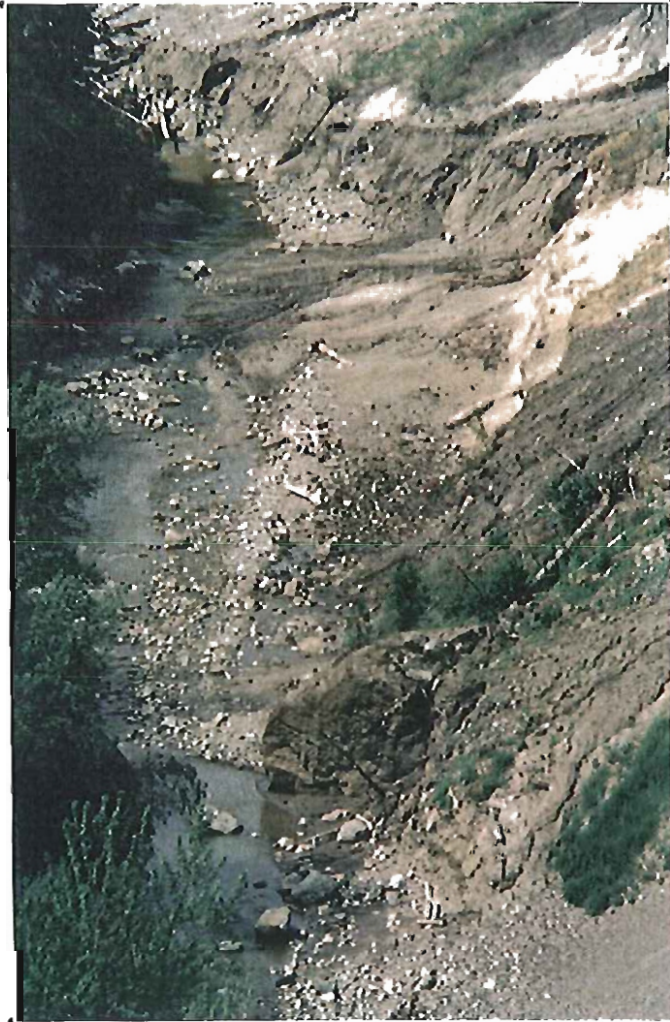
PHOTO 6: Trout Creek at the slide. Note eroded debris lobes and gully-mouth fan.

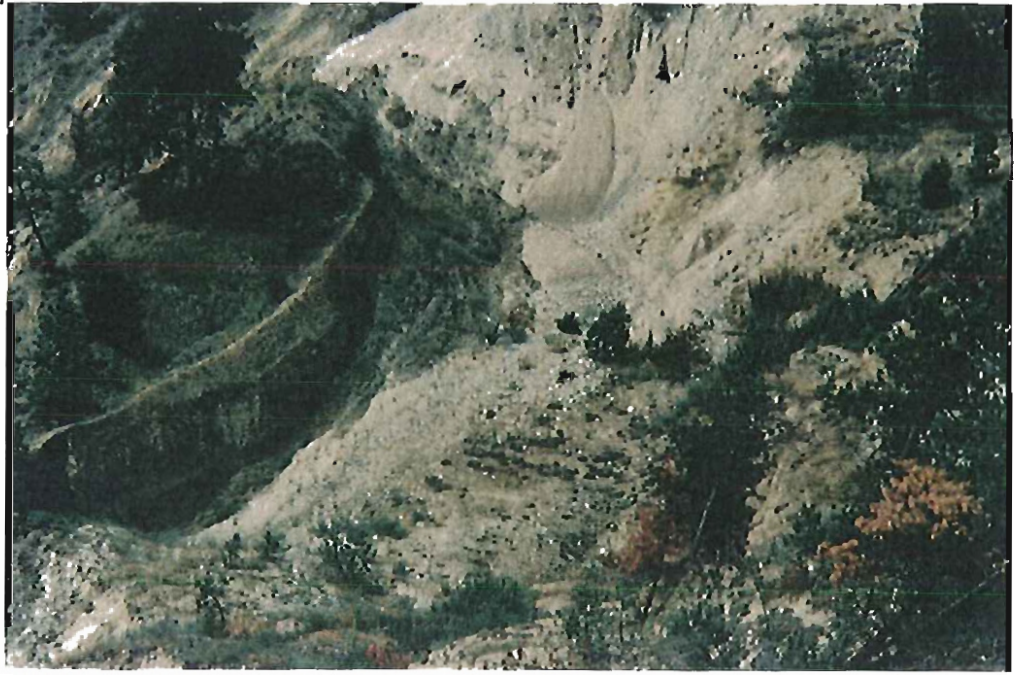
PHOTO 3: Small slump block at the southwest corner of the Trout Creek slide. Note backward rotated trees in the foreground.

- the failure is a large slump/earthflow that moves gravel, sand and mud over the bedrock lip of Trout Creek canyon and down into the stream below (Photos 1-4).
- it has been studied on numerous occasions -- on the surface (e.g. Riglin, 1977; Wei, 1988) -- but no holes have been

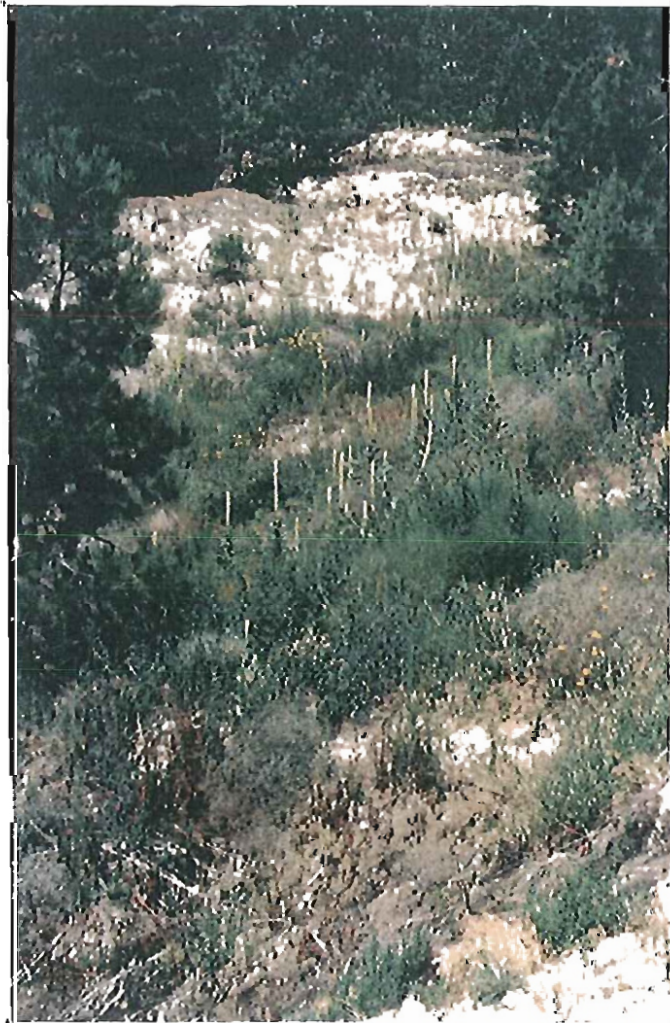
PHOTO 4: Ground surface on the upper block of the slide.

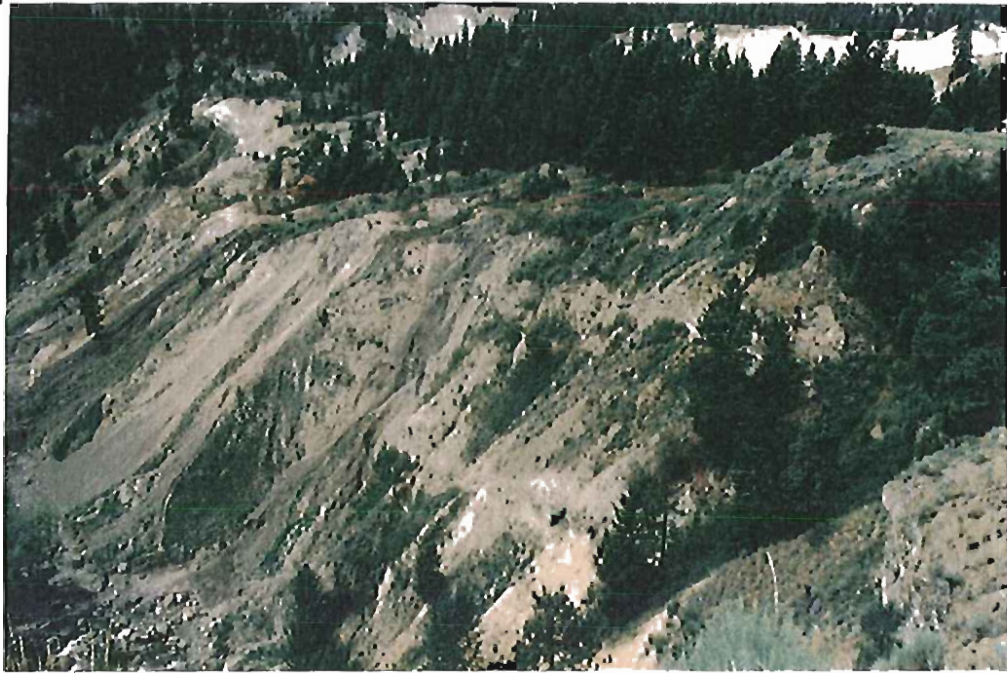
PHOTO 1: View southwest along the canyon wall toward the Trout Creek slide. Note the bedrock outcrops in the centre and the debris lobes to the left.

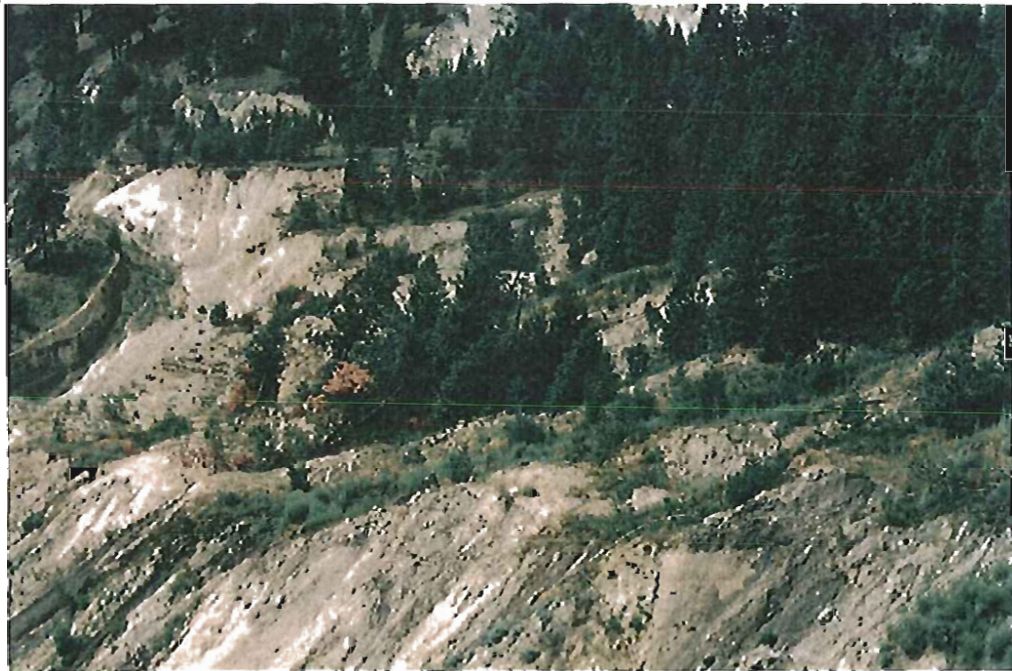
PHOTO 2: The lower block of the Trout Creek slide and its contact with the upper canyon wall.
