**A RECONNAISSANCE SURVEY OF
BOWSER LAKE**

WATERSHED: Nass River
DATE OF SURVEY: October 2, 1988
FIELD CREW LEADER: D.M.V. Coombes
FIELD ASSISTANT: Sigurd P. Hatlevik

**FISHERIES BRANCH
B.C. ENVIRONMENT**

LAKE: Bowser

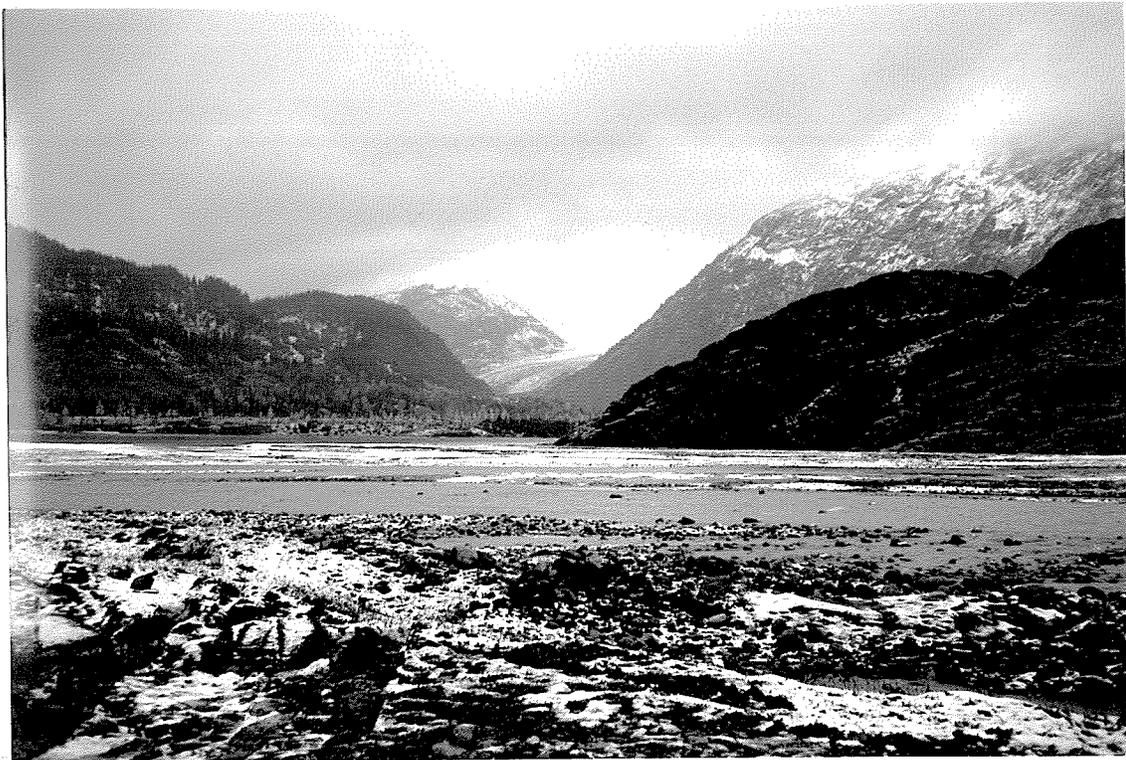
A minor tributary flows into Knipple Lake through a culvert road crossing. The water temperature was 2°C with an air temperature of -7°C. Some possible rearing habitat for salmonids was considered to exist. See Plate 2 of area. Four minnow traps here caught nothing in 20 hours.

Plate 2: View west across Knipple Lake.

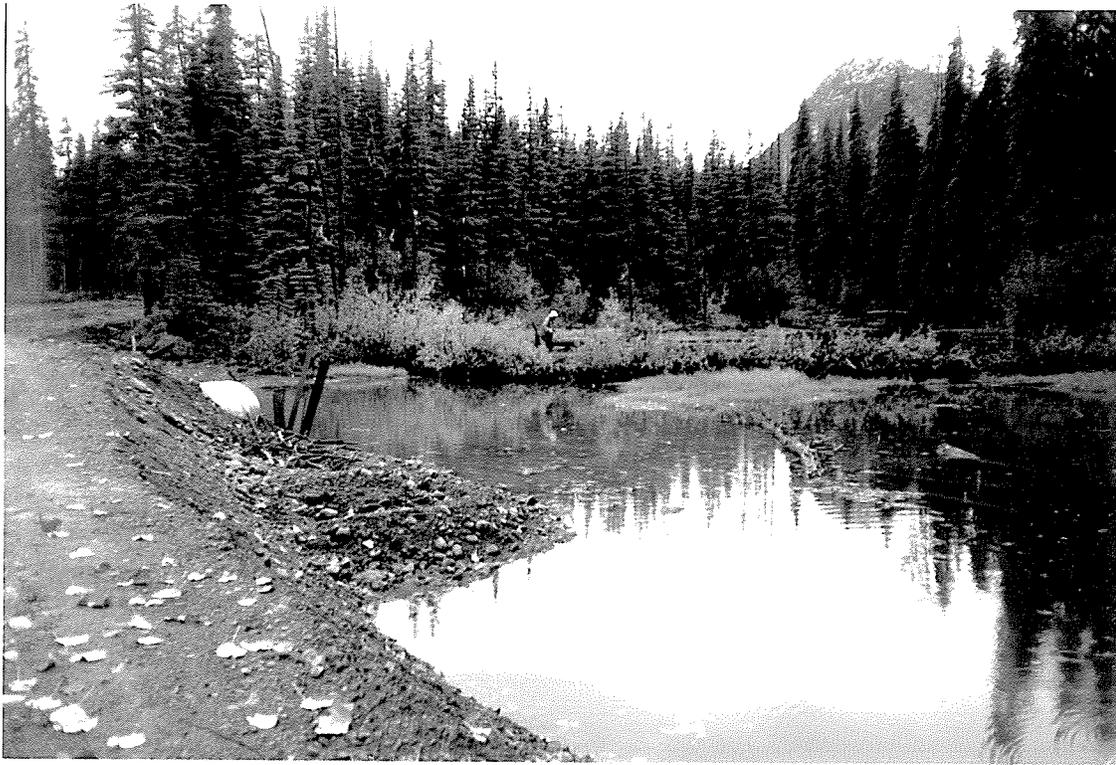
Plate 3: Side channel of Bowser River, looking upstream from 9.4428.62507 (U.T.M.),

Downstream of the above, with a confluence at UTM 9.4428.62507, there was a small stream with a water temperature of 4.5°C, turbidity of 30+ cm, est. max. depth of 50 cm, est. stream velocity of 0.1 m/sec., wetted width 17 m. The substrate was 10% fines, 70% gravels, and 20% cobbles, with low compaction. This is partly a side channel of the Bowser River. Two traps caught one Dolly Varden (19.5 cm) in twenty hours. See Plate 3.

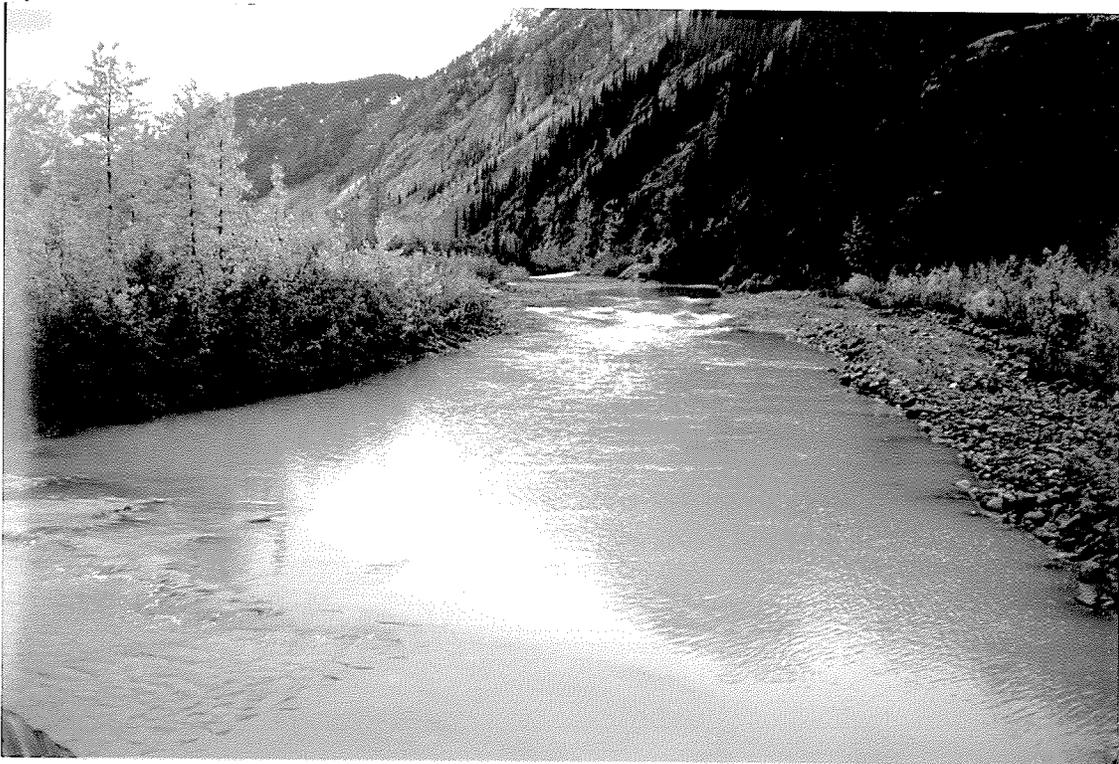
This creek was in a series of beaver ponds with a silt substrate and clear water at the time of survey, with a water temperature of 6°C and no discernable water movement. There might be no access to fish, due to the beaver dams. See Plate 4. Three traps here caught nothing in twenty hours, and a trap put in at the confluence with the Bowser River, U.T.M. 9.4455.62505 at road crossing, caught nothing in the same time period.

Plate 4: Small tributary looking upstream from road crossing at 9.4455.62505 (U.T.M.),

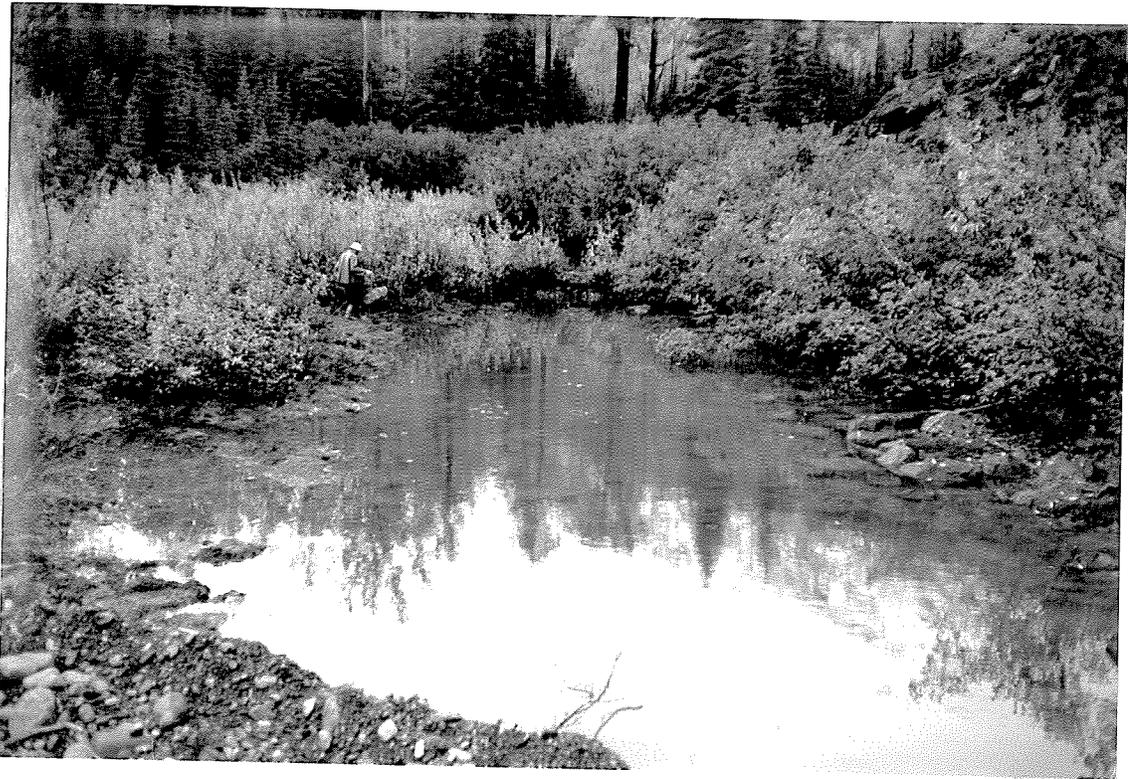
This creek was similar to the above, and in a series of beaver ponds with a silt substrate and clear water at the time of survey, with a water temperature of 6°C and no discernable water movement. There might be no access to fish, due to the beaver dams. See Plate 5, from U.T.M. 9.4465.62494. Three traps here caught nothing in twenty hours, and a trap put in at the confluence with the Bowser River caught nothing in the same time period.

Plate 5: Small tributary looking upstream from road crossing at 9.4465.62494 (U.T.M.).

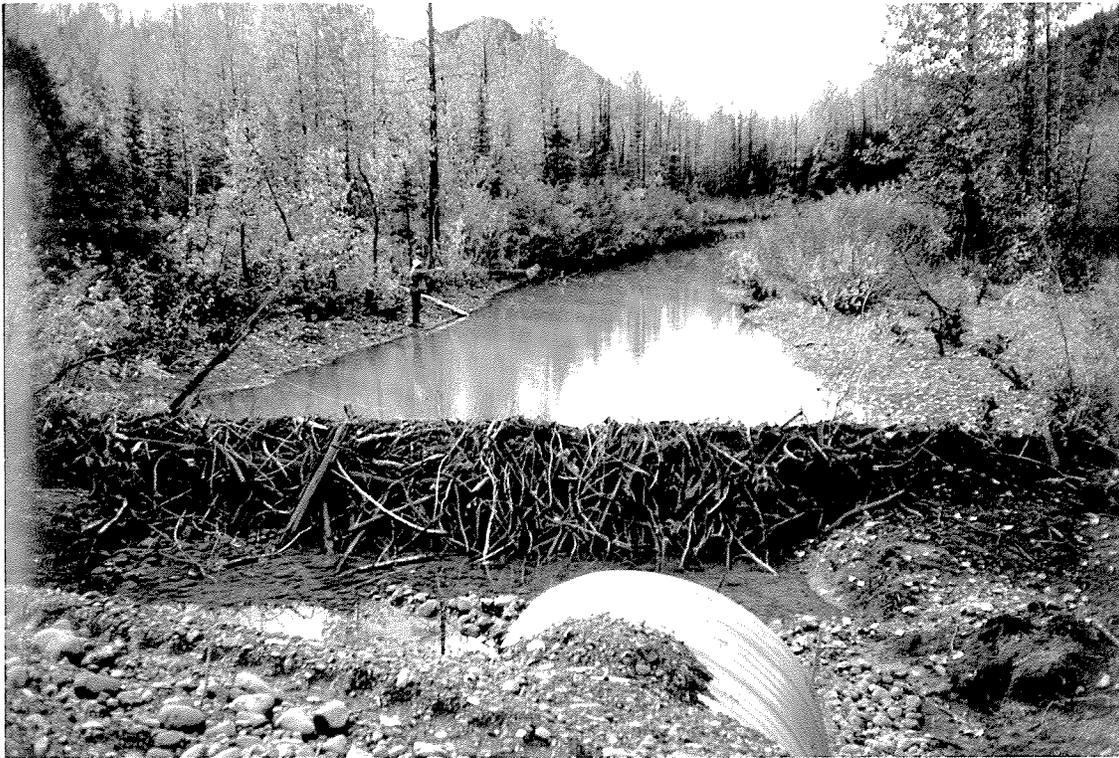
This creek was a side channel of the Bowser River which was not occupied by the river at the time of the investigation, and was fed by underground drainage. Beaver dams may prevent fish access. The water temperature was 6°C, turbidity approximately 30 cm, and the substrate was silt. At the confluence with the mainstem Bowser, the substrate was cobbles, turbidity 1 cm, and the water temperature 2°C. See Plate 7, from U.T.M. 9.4503.62511. Three traps here caught nothing in twenty hours.

Plate 7: Side channel of Bowser River, looking upstream from road crossing at 9.4503.62511(U.T.M.),

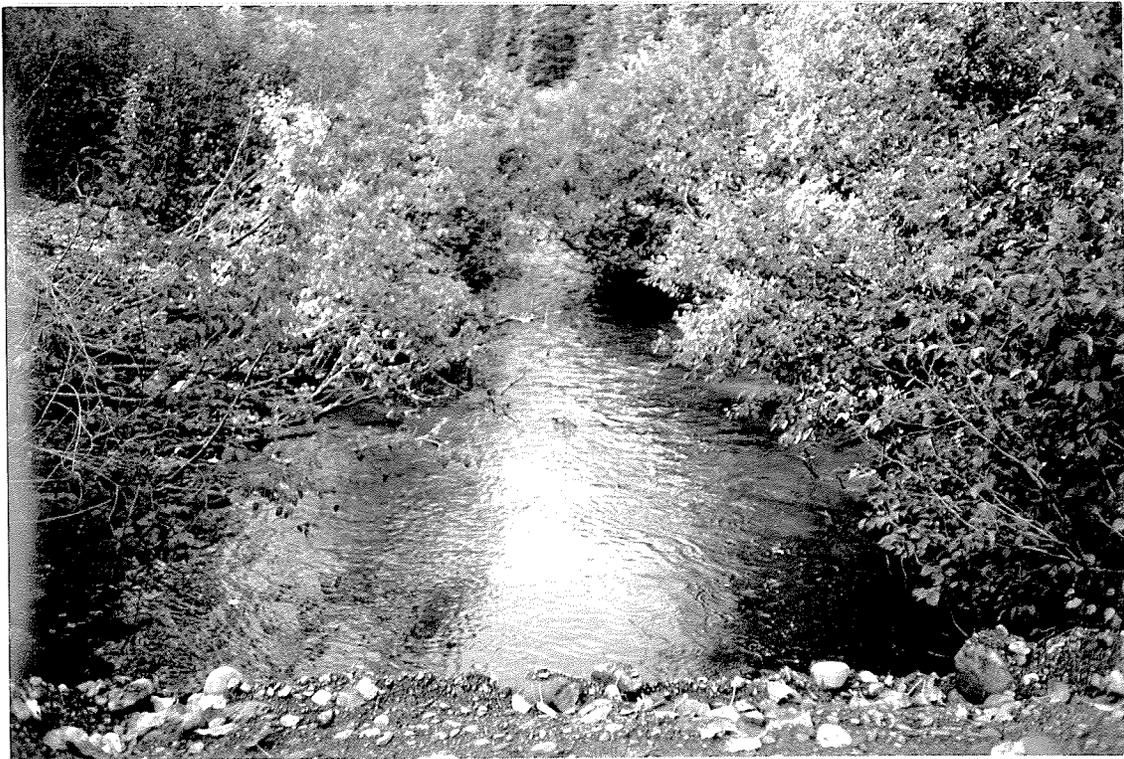
Plate 8: Looking upstream on a small tributary of the Bowser from the road crossing at U.T.M. 9.4506.62515.

This unnamed creek was a medium-sized creek, with many areas of potential spawning and rearing habitat. Above the road crossing, the channel width was 9 m, wetted width was 7 m, and the velocity was 0.6 m/sec., with a depth of 40 cm. The substrate was a mixture of cobbles and small gravels, and the water temperature was 6°C. Three traps caught one Dolly Varden (6.5 cm) in twenty hours. See Plate 8, taken from U.T.M. 9.4506.62515.

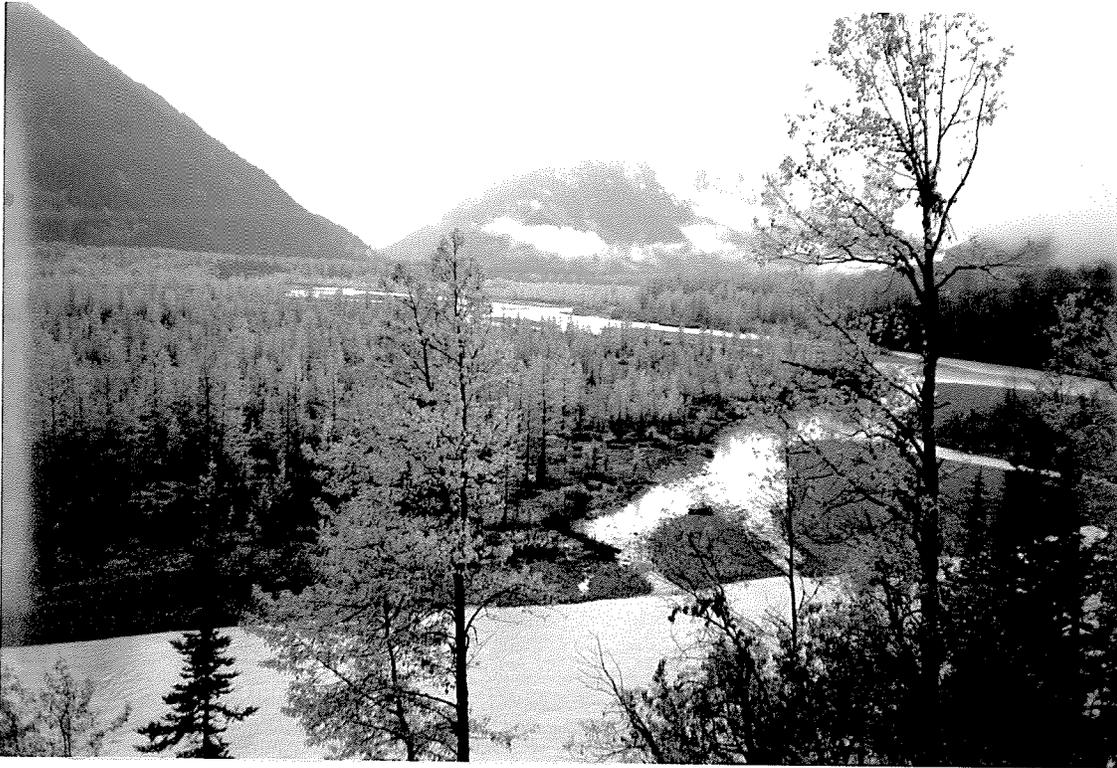
Plate 9: View southwest of Bowser River from east of Scott Creek.

Bowser River is a large, swift, turbid river with a low slope, armoured bed (the cobbles and boulder substrate are highly compacted in the main channel) and many side channels (much of the river from the source to Bowser Lake is braided). There were many distributaries into Bowser Lake (see the aerial photograph). Many of the side channels are fed by groundwater filtered through the valley bottom sediments, and would be suitable habitat for rearing salmonids, and, in some cases, spawning. See plates 9 and 10.

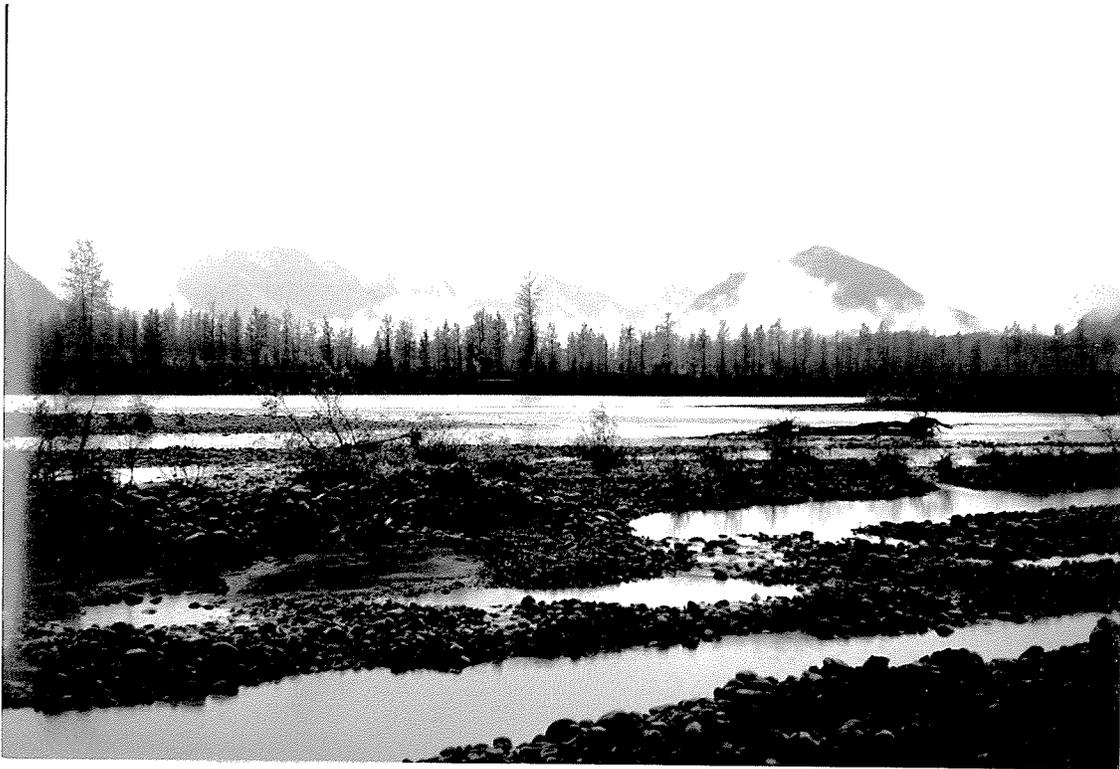
Plate 10: A view south across Bowser River from near Scott Creek on the mine access road.

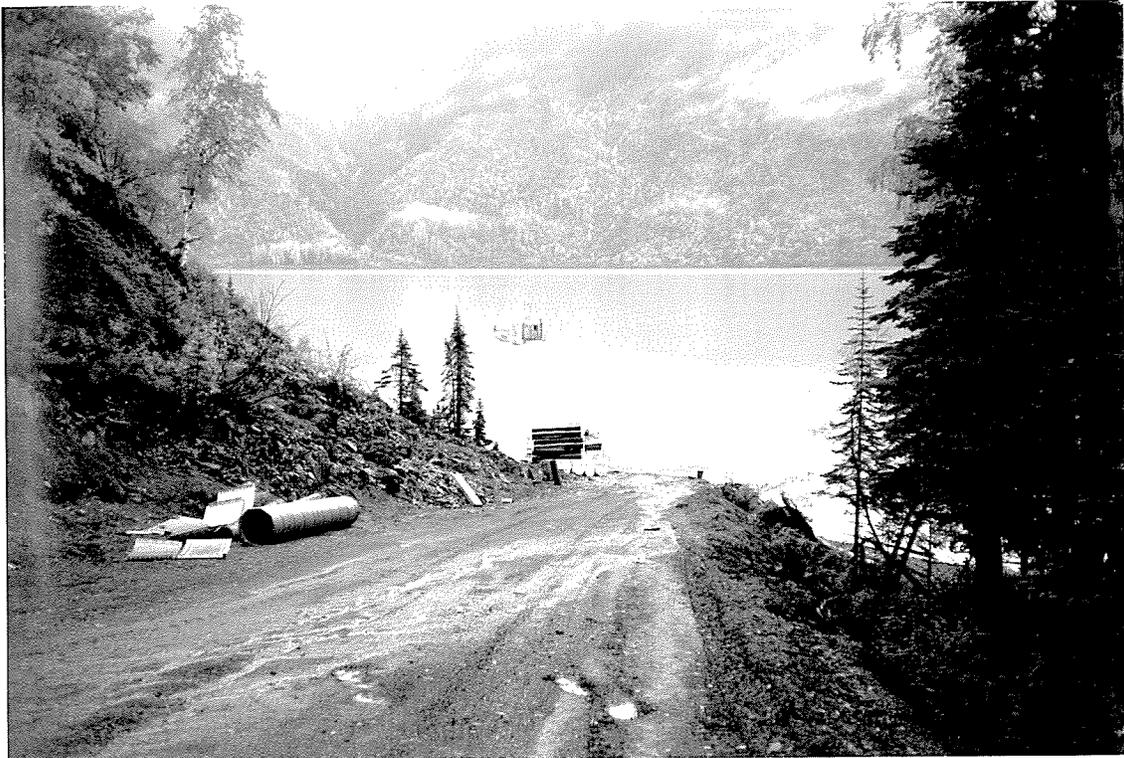
Plate 13: Looking down to the barge dock at the west end of Bowser Lake. Note oil and diesel fuel running down the road.

At the time of survey, some oil and fuel was observed flowing into the lake from the vicinity of the ferry dock near the inlet end. Also, there was some silt from road building or exploration work that would find its way into the lake.

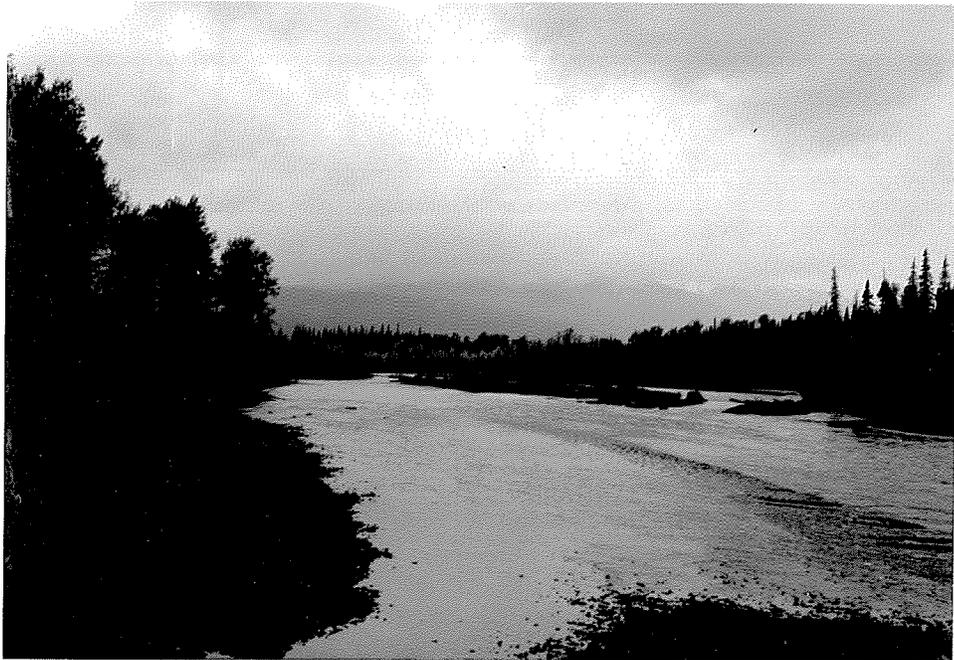
Plate 27: View upstream from road crossing on Bowser River.

Bowser River is a large swift river with a moderate slope and high turbidity. See photo plates 27 and 28. Four traps set for approximately 10 hours captured one 245 mm Dolly Varden. There were four large set lines below the bridge in the large pool there. The water temperature was 5.5°C, and the turbidity was 0.15 m, with a substrate of 20% small gravels, 40% large gravels, and 40% cobbles. The wetted width was from 35 to 55 m, and the channel width was 75 to 95 m, with some wide sections of approximately 150 m. There were multiple channels. Time constraints prevented the collection of any other data (Oct. 1, 1988, pers. comm. D. Deleeuw).

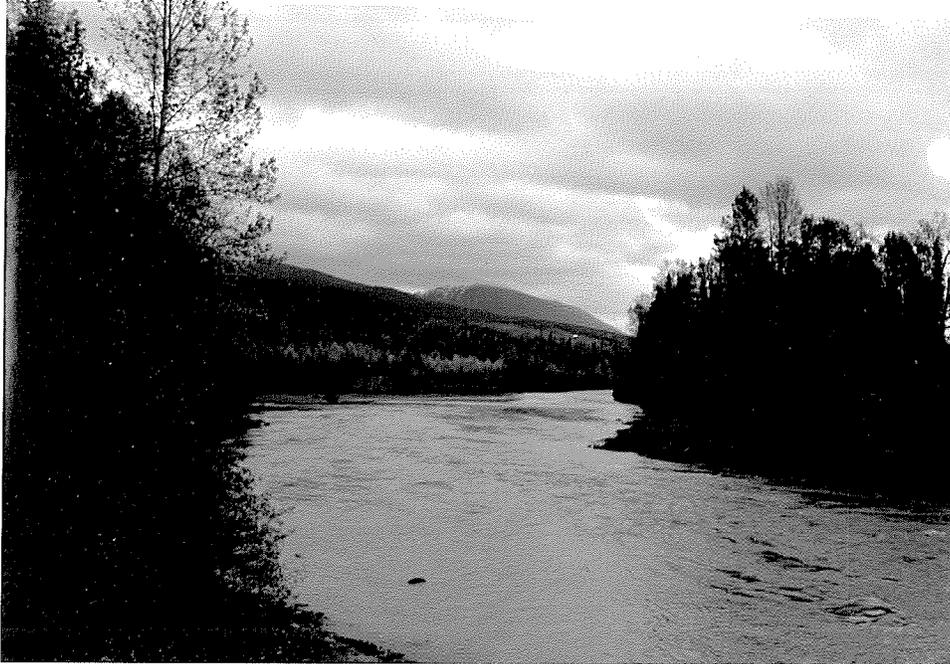
Plate 28: View downstream from road crossing on Bowser River.
