Lizard Creek Riparian Restoration Pilot Project

Project Reference Number F-15-26

Project Name: Lizard Creek Riparian Restoration Pilot Project

Project Lead: Allison Dickhout, Elk River Watershed Alliance www.elkriveralliance.ca

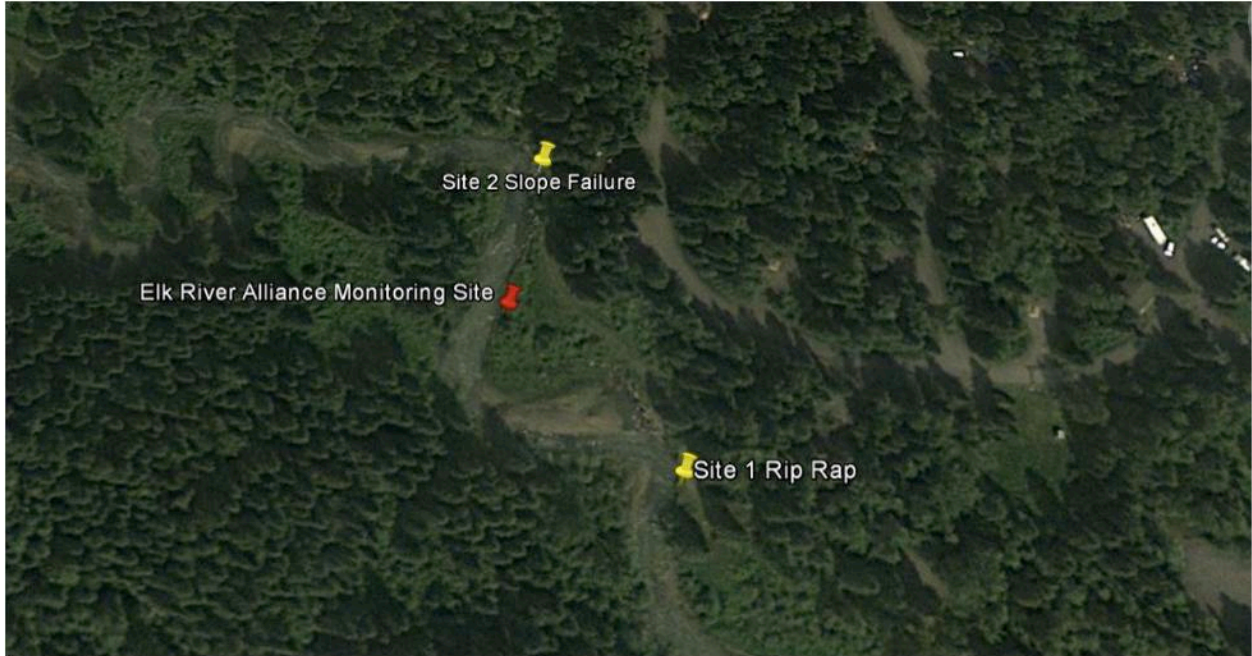
Figure 1 - Restoration site locations on Lizard Creek

Figure 1 outlines the location of the two restoration sites relative to the ERA monitoring site on Lizard Creek adjacent to Mount Fernie Provincial Park Campground. Site 1 Rip Rap is adjacent to the trail and has been previously re-enforced with large rip-rap. Site 2 Slope Failure is a slide with bare soil exposed caused by two large trees falling into the creek. Both restoration sites are on the left bank or river left when facing downstream. ERA's water monitoring site is downstream of Site 2 and upstream of Site 1.

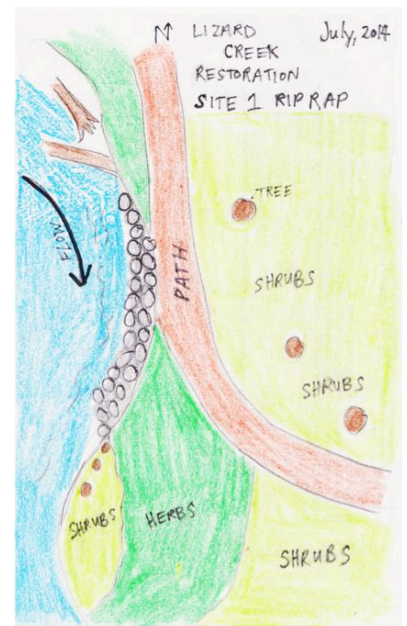
Figure 2 - Drawing of Site 1 Rip Rap

Site 1 is a section of the bank that has been enforced with rip rap forming a steep and hard bank. A heavily used trail is directly adjacent to the rip rap slope. The rip rap was placed several years ago in order to prevent further erosion of the bank and protect the adjacent trail. The initial erosion was likely caused due to clearing of vegetation to build the trail along with the direct hydrologic force at a 45 degree angle as the stream channel has a sharp meander at this bend. The energy of the stream flow is being deflected off the hard surface of the rocks towards the opposite bank downstream. Fortunately, erosion is limited downstream as the point bar bank is heavily rooted with red-osier dogwood and willow.

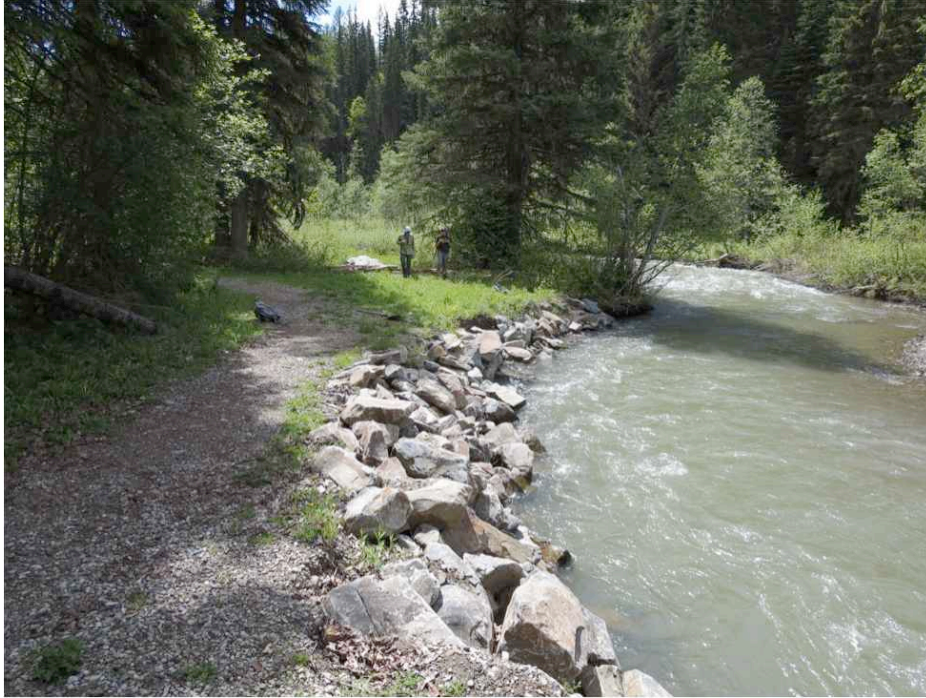
Figure 3 – Photo of Site 1 Rip Rap restoration site, July 2014

Table 1 illustrates the current characteristics of Site 1 Rip Rap. Figure 3 shows a photograph of Site 1 during site assessment. The surface above the bank is flat with a variety of herbs and shrubs in the surrounding area. A list of plant species observed at site 1 is listed below. While the shrubs are beginning to propagate naturally, there is still a large area of exposed sunny area. A few black cottonwood trees were beginning to grow in between the large boulders as shown in Figure 4. The soils are silty clay loam about 4-6 inches deep with very rocky soil below.

In order to increase shade and overhanging riparian vegetation at Site 1, native plant species were planted behind the existing rip rap and in large holes between the rip rap. The plants were sourced from Tipi Mountain Native Plants near Kimberley, BC and included: willow, red-osier dogwood, prickly rose and black hawthorn. The plants were in 1 gallon pales and were planted with extra soil around them to provide nutrients.

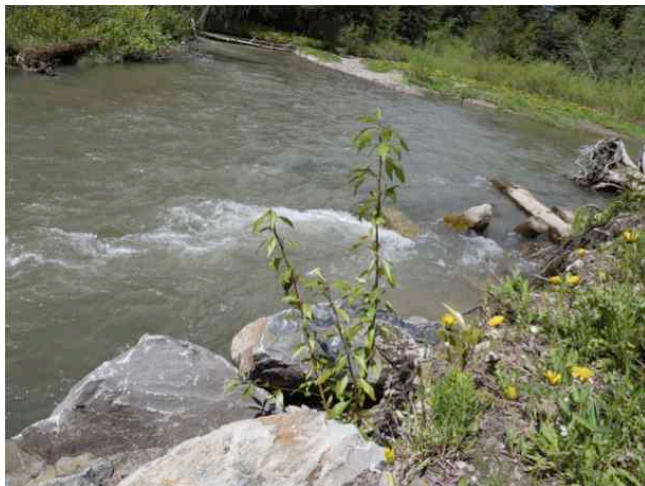
Figure 4 - Black cottonwood growing out of the rip rap

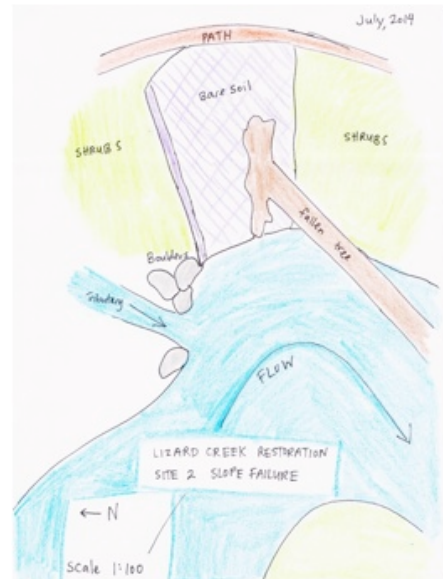
Figure 5- Site 2 Slope Failure Drawing

Site 2 is a failed slope adjacent to the decommissioned trail. Two large trees fell into the creek as a result of ongoing erosion, exposing a slope of bare soil about 9m tall and 7m wide. The slope is an average about 22 degrees or a percent slope of 40%. The bare slope is continuing to erode and cause increased sedimentation. A variety of trees, shrubs and herbs exist in the surrounding area, as shown in Table 2. Common horsetail has begun to pioneer the exposed slope. Figure 5 shows a to-scale drawing of site 2. Figure 6 shows a photograph of the site.

On October 8, 2014, in order to restore Site 2 on the slope failure we implemented a bioengineering technique called brush layering (as shown in Figure 12). One-hundred and fifty cuttings of red-osier dogwood, willow and cottonwood were taken from sources within 500m of the site by two ERA staff and three volunteers. The cuttings were harvested from an area close by the site with permission from BC Parks and soaked in the stream for 24hours. These cuttings were buried horizontally across the slope in layers. Each cutting was placed about 10cm apart. The layers were installed in approximately 1m increments in elevation, a little closer at the bottom, with coir erosion control cloth wrapped between the layers, in a similar fashion as shown in Figure 12. An additional mix of topsoil, peat moss and mycorrhizal fungi was placed between the brush layers and wrapped with coir fabric in order to increase success of the cuttings.

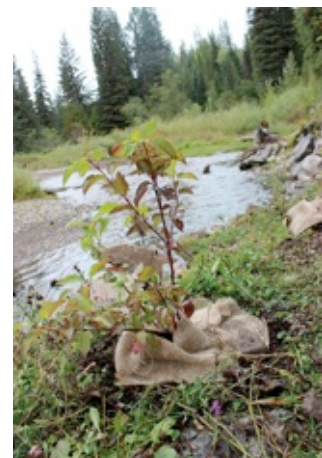
Figure 7- Red Osier Dogwood Planted at Site 1

Twenty-five seedlings were planted approximately 1 m apart to allow adequate space and sun. The bases of the seedlings were wrapped with burlap material to help hold moisture and prevent damage from frost.

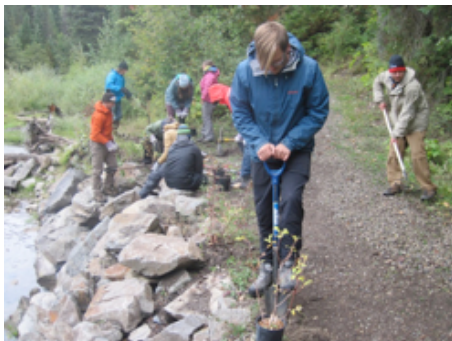
Figure 10- Planting in action at Site 1

Planting of the seedling was completed by ERA staff who engaged fifteen youth volunteers that were part of the College of the Rockies Mountain Adventure Skills Training Program (MAST) on September 10th, 2014. Shovels, wheel barrows and clippers were borrowed from the Eco-garden and the Fernie Trails Alliance. Below are some photos from the planting.

The trail was moved by about 1.5m away from the stream to allow enough room for growth of the plants. Some undergrowth was removed with clippers, but no trees were removed. As the small seedlings grow next to the stream, there will be a net increase in riparian vegetation.

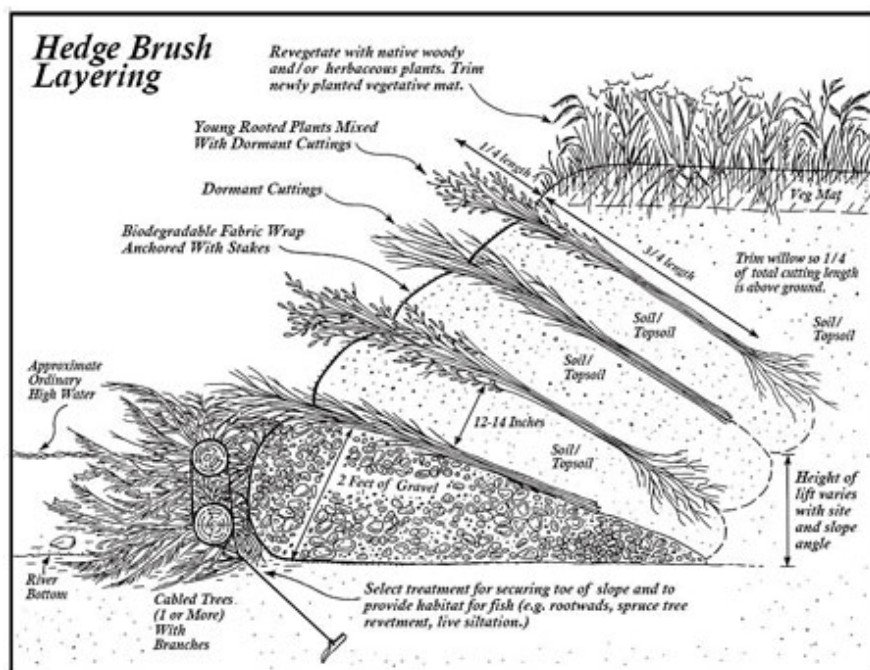
Figure 12- Brush layering diagram (Walter & Hughes, Alaska Department of Fish and Game, 2005)

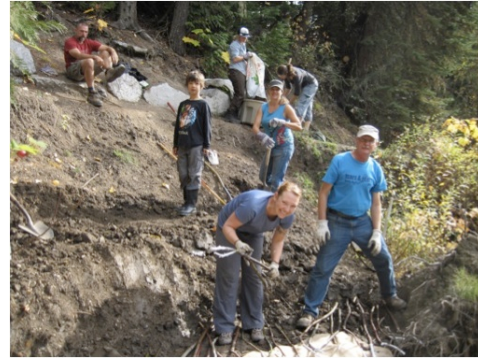
Figure 15- Field crew installing live cuttings

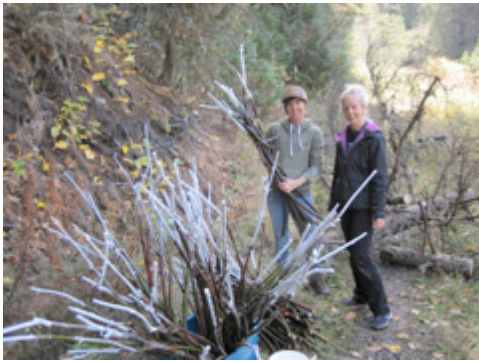
Figure 14- Cuttings with latex paint on ends to prevent drying

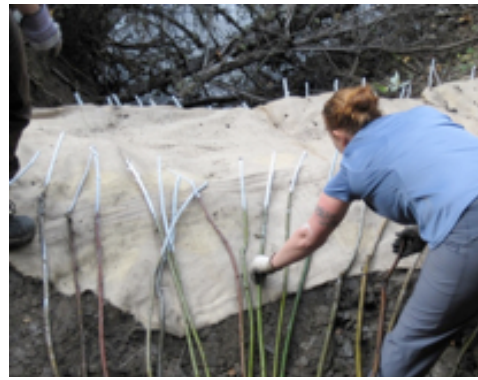
Figure 16- Live cuttings were planted between layers of coir erosion control cloth

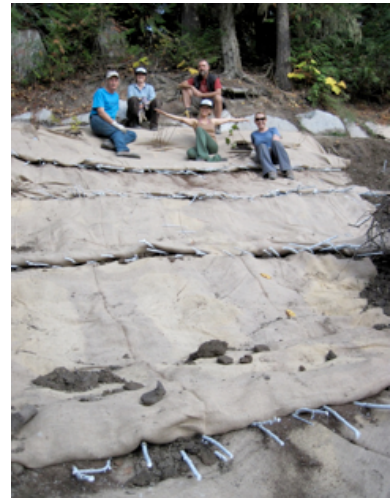
Figure 17- Completed project at Site 2

The Lizard Creek Riparian Restoration Pilot Project was completed in the fall of 2014. The true success of the project will be determined in the following years as the cuttings and seedlings begin to grow. If the cuttings and seedlings grow with rigor they will enhance fish habitat by providing shade as well stabilizing the bank to reduce siltation into Lizard Creek. The sites will be monitored regularly throughout the first summer by ERA staff and community based water monitoring volunteers. Photos of the sites will be taken to monitor the growth of the plants.
