Sát`atqwa7 - The River
**Powerhouse Foreshore Restoration Project
2014 Final Report**

14.W.SON.03

Fish and Wildlife Compensation Program

May 1, 2015

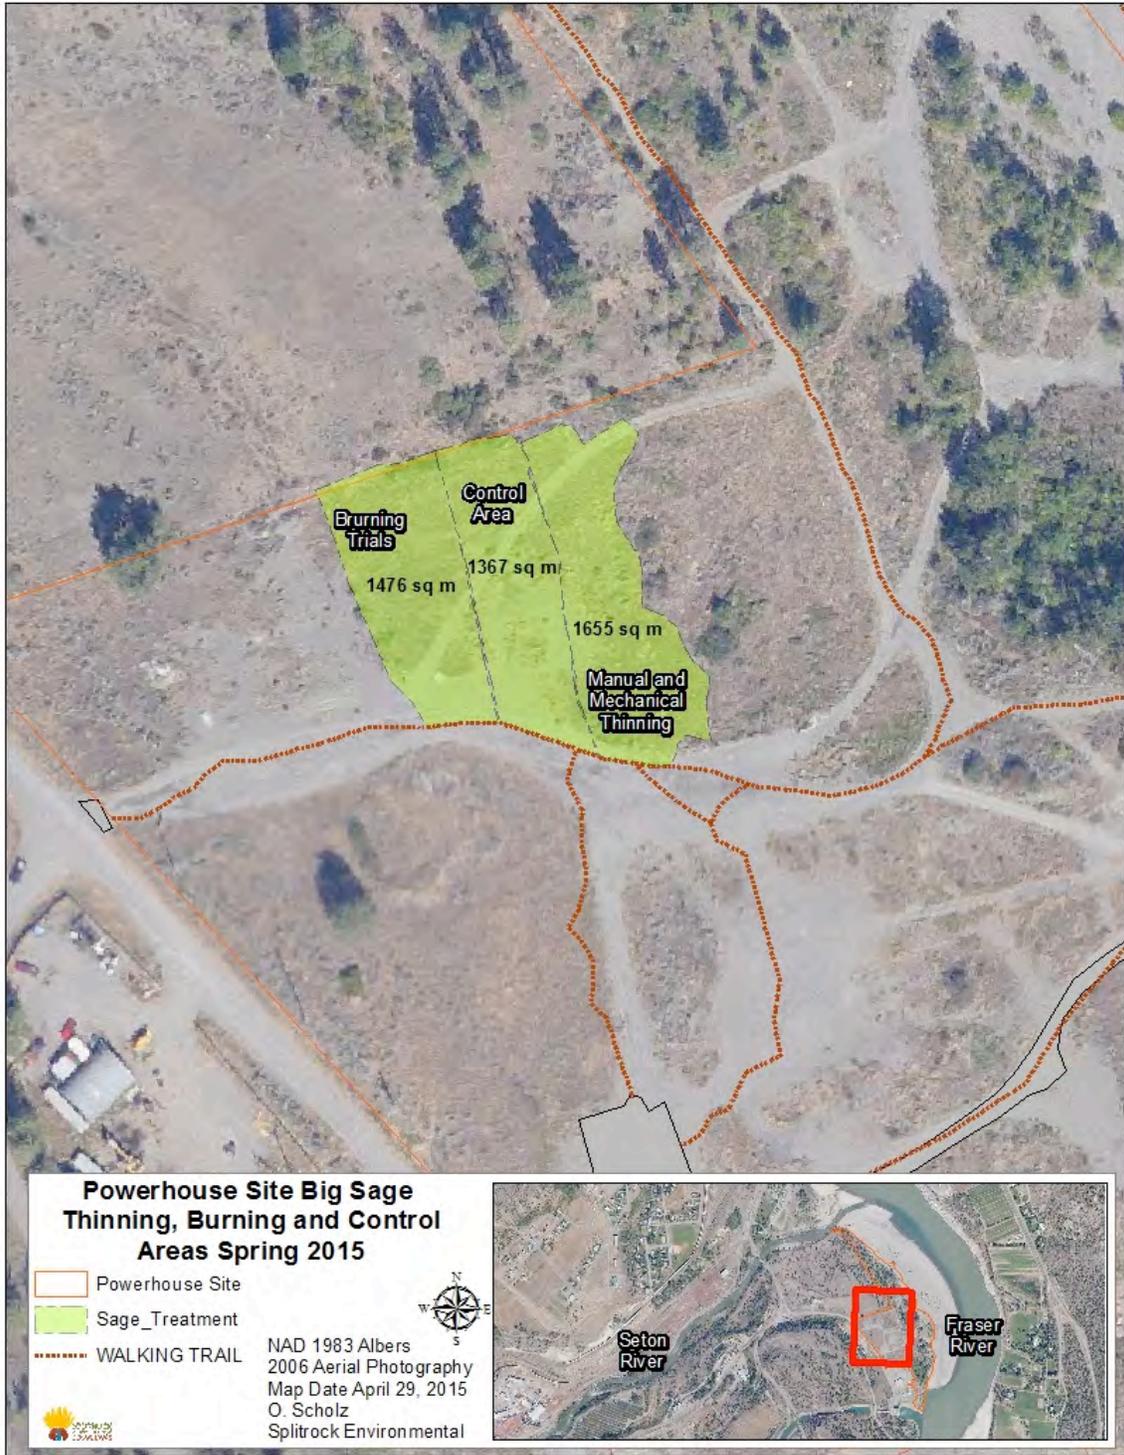
Map 4: Prescribed burn grid layout

Three trial grids were established on the upper bench. Grids were 25m wide and approximately 50m long (See Map 4). Treatments for the grids are described in Table 2.

Grid No.	Treatment
1	Hand-pulling sage followed by seeding.
2	Control site; no treatments applied.
3	Prescribed burn followed by seeding.

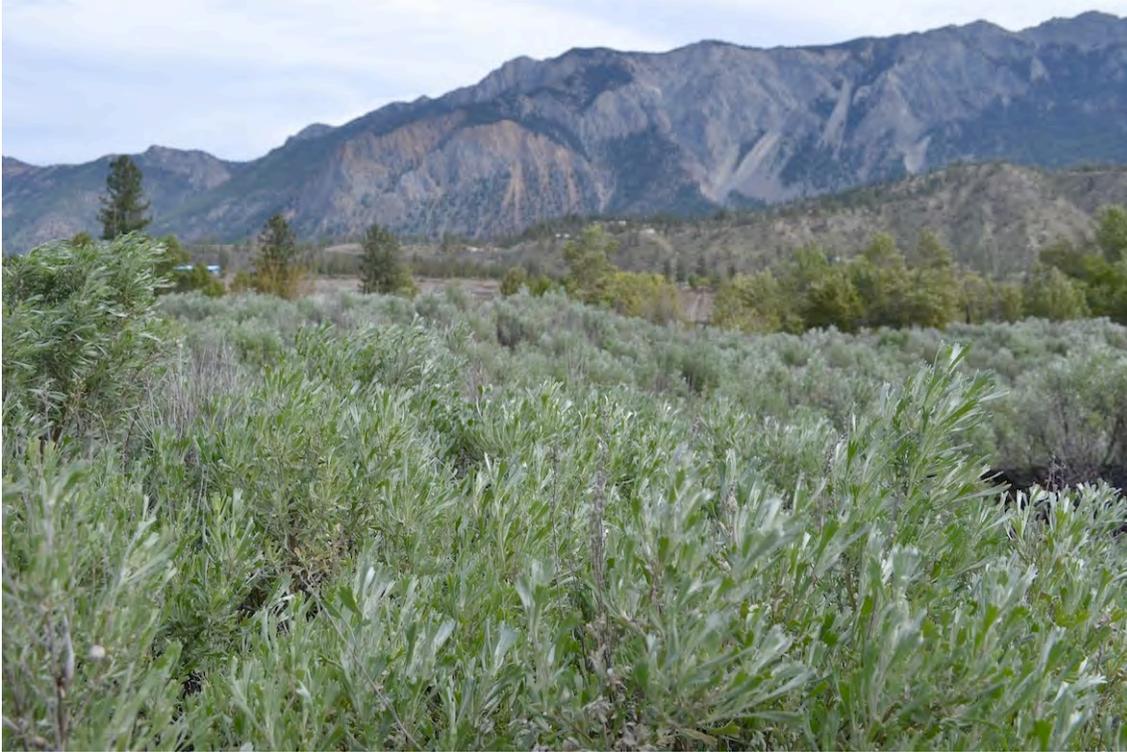
Figure 14: Sagebrush is taking over the restoration site. 27 April 2015

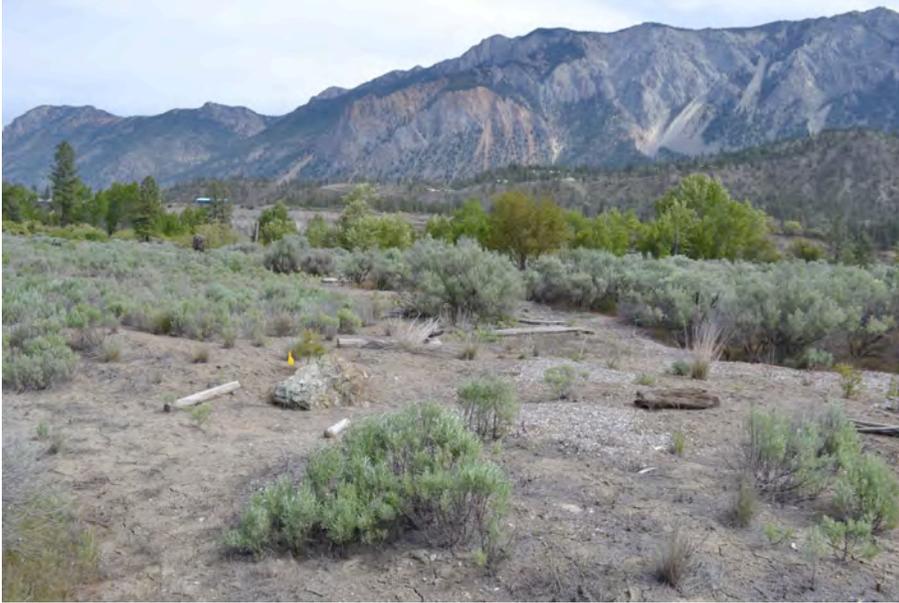
Figure 15: The area where sage was hand-pulled. Around this area, the sagebrush has grown in to almost 100% cover. 23 June 2014

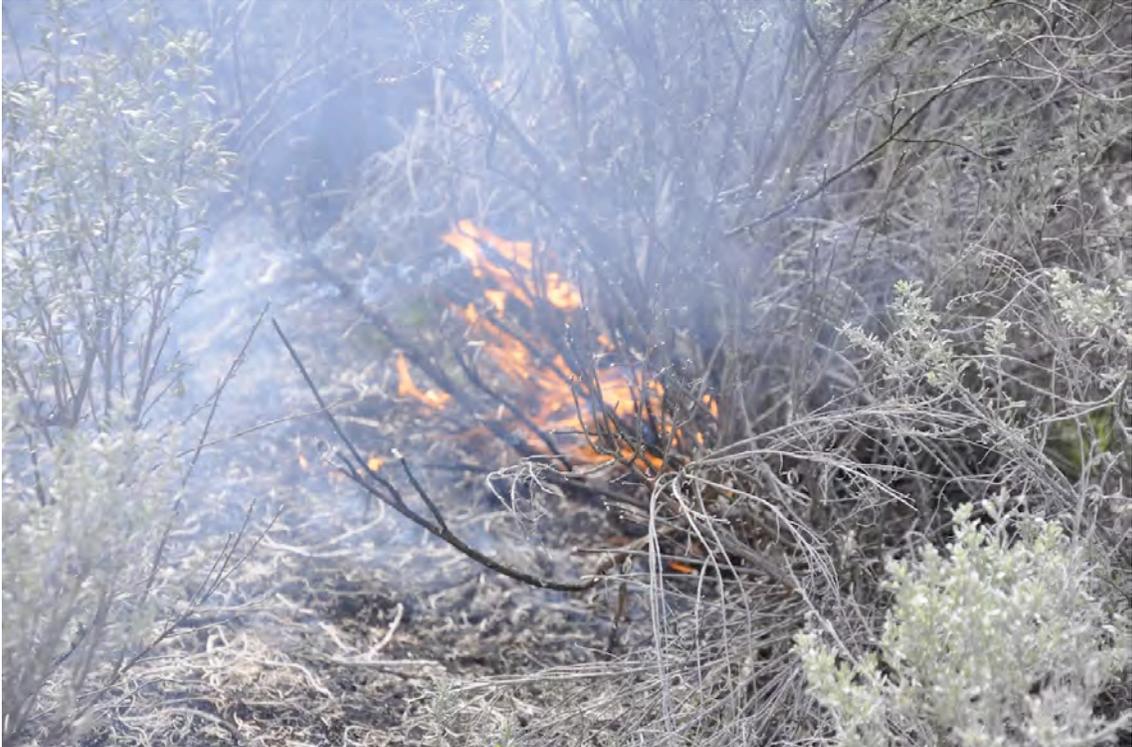
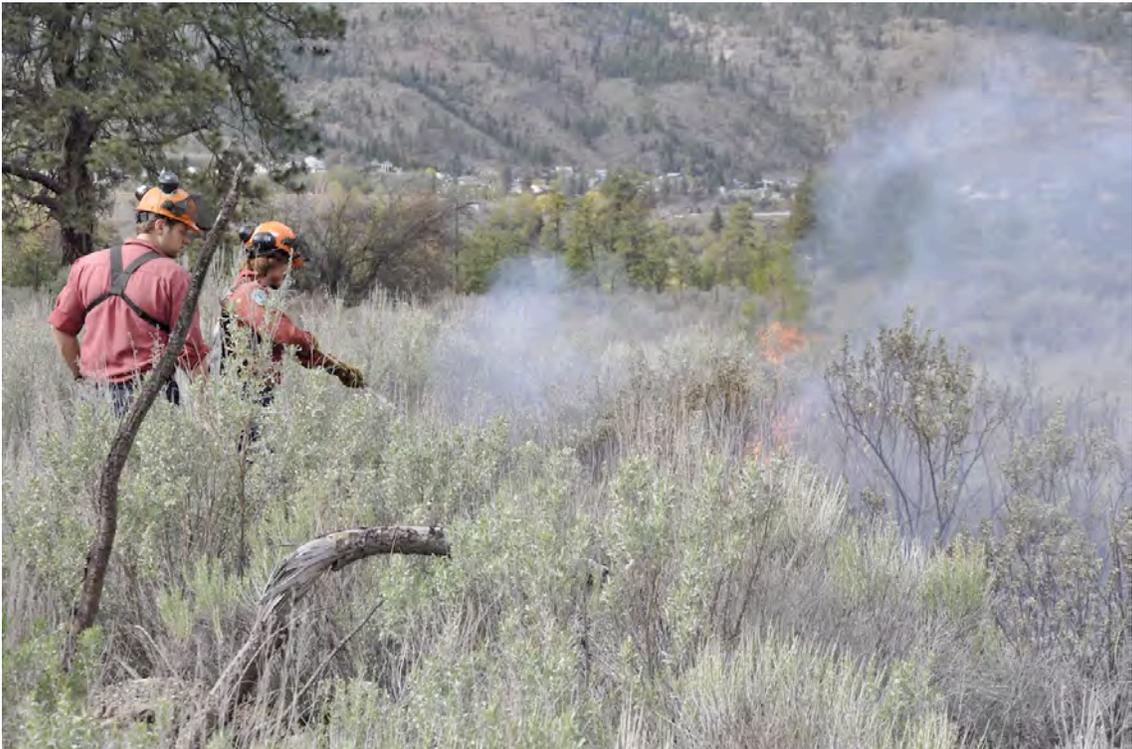
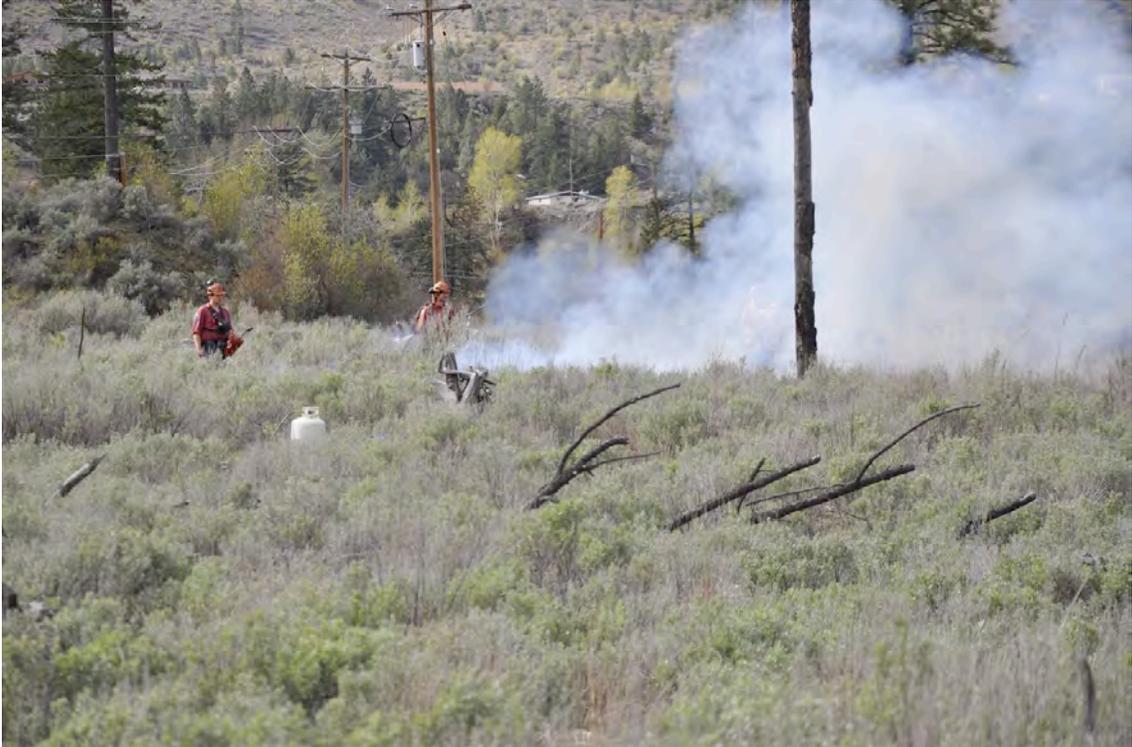
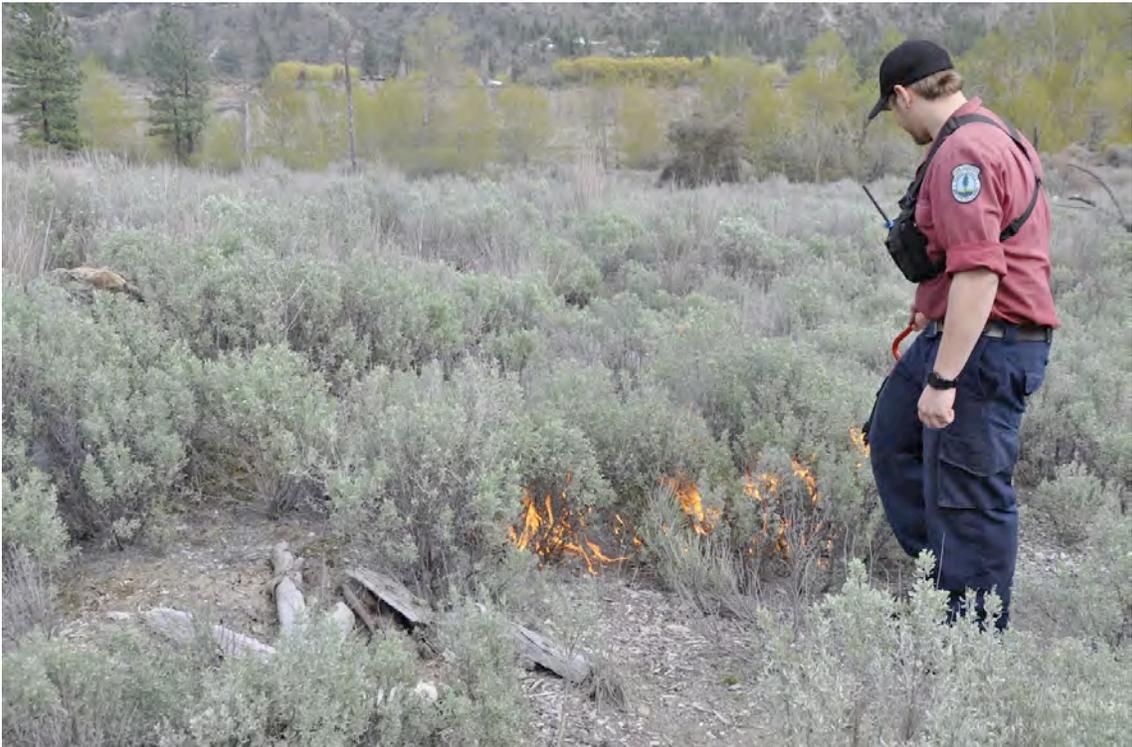
The prescribed burn was conducted on 30 March 2015, after two false starts the previous week due to windy conditions. Weather conditions and the early green-up of the restoration site made for challenging burning conditions. The fire crews used drip torches to light the sage on fire, but found that the new growth on the plants prohibited the fuel from carrying the fire through the grid. Crews tried using a propane torch to light the fire, but very little was burned.

A small area outside of the grids was burned successfully. However, the control grid is not similar to this area, so it cannot be used to monitor the burned area. We plan to monitor this area in 2016 to determine the fire effects.

Figure 17: The prescribed burn. 30 March 2015

The grids were not seeded in because the fire was not effective at removing the sage. The seeding is scheduled for directly after the burn during the 2015-16 restoration season. The seed mix to be used is outlined in Table 1.

The prescribed burn was somewhat disappointing, given the challenges lighting it due to weather and early green-up. The trial grids remain in place for a burn in the autumn of 2015 or spring of 2016. The exact timing of the burn will be dependent on the advice from the Lillooet Fire Zone. Seeding of native grassland species will be done following the burn.

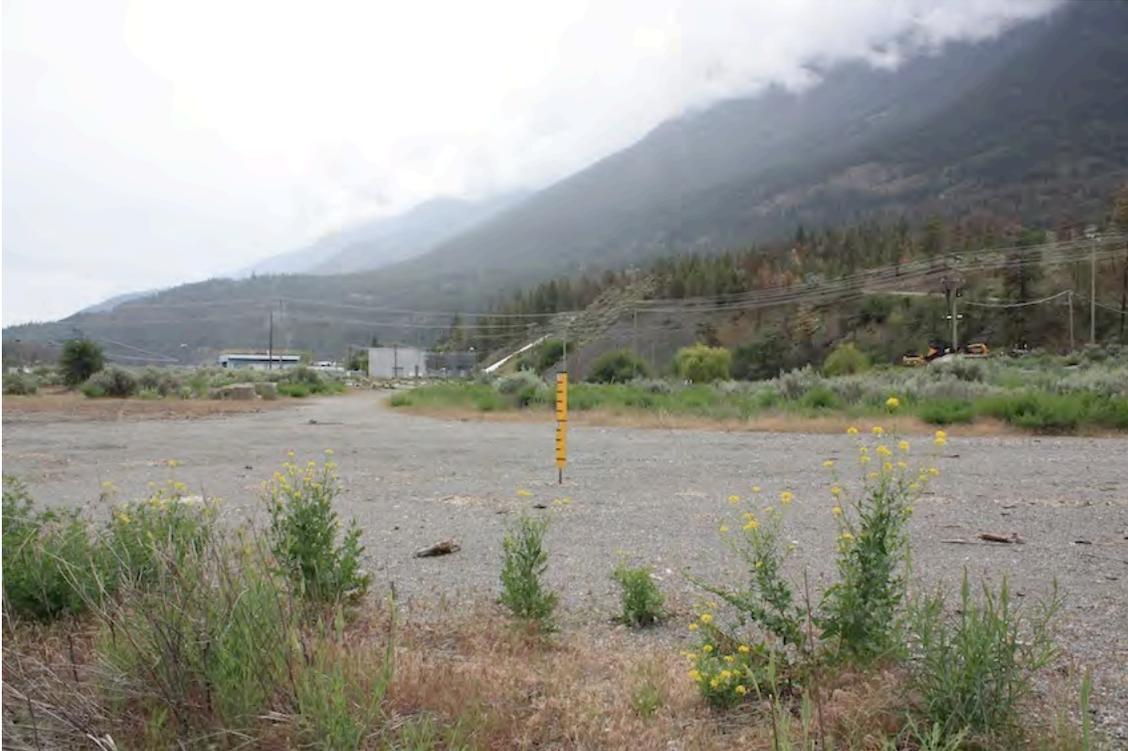
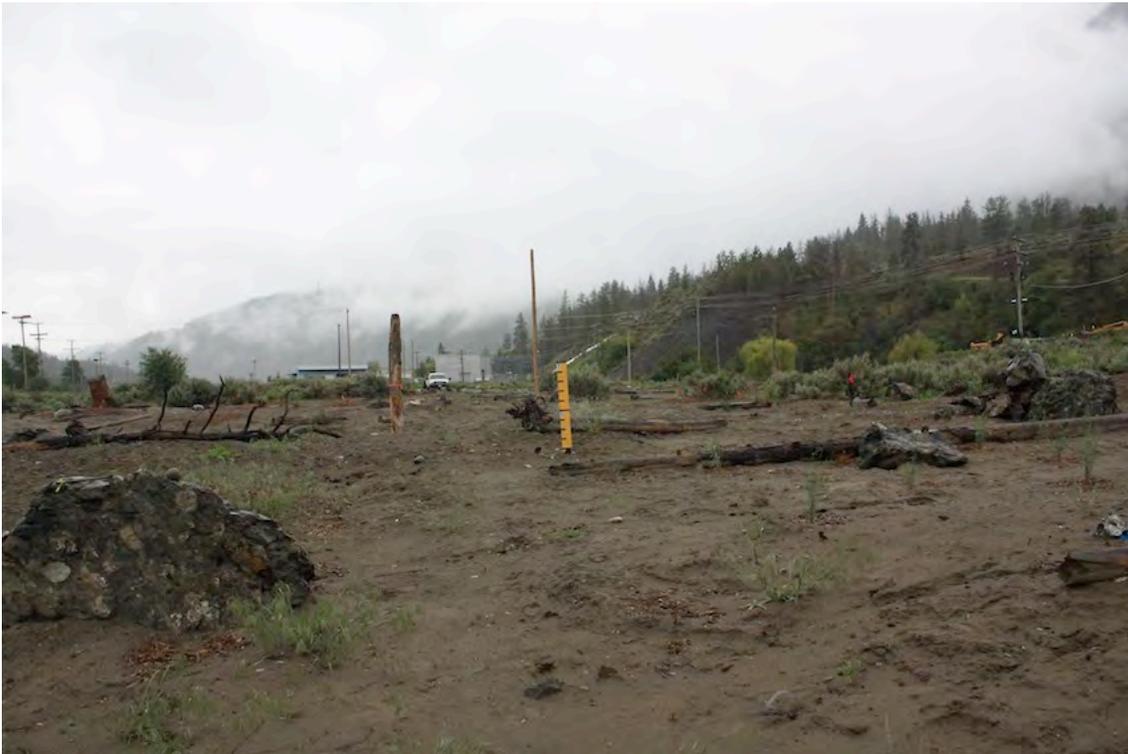
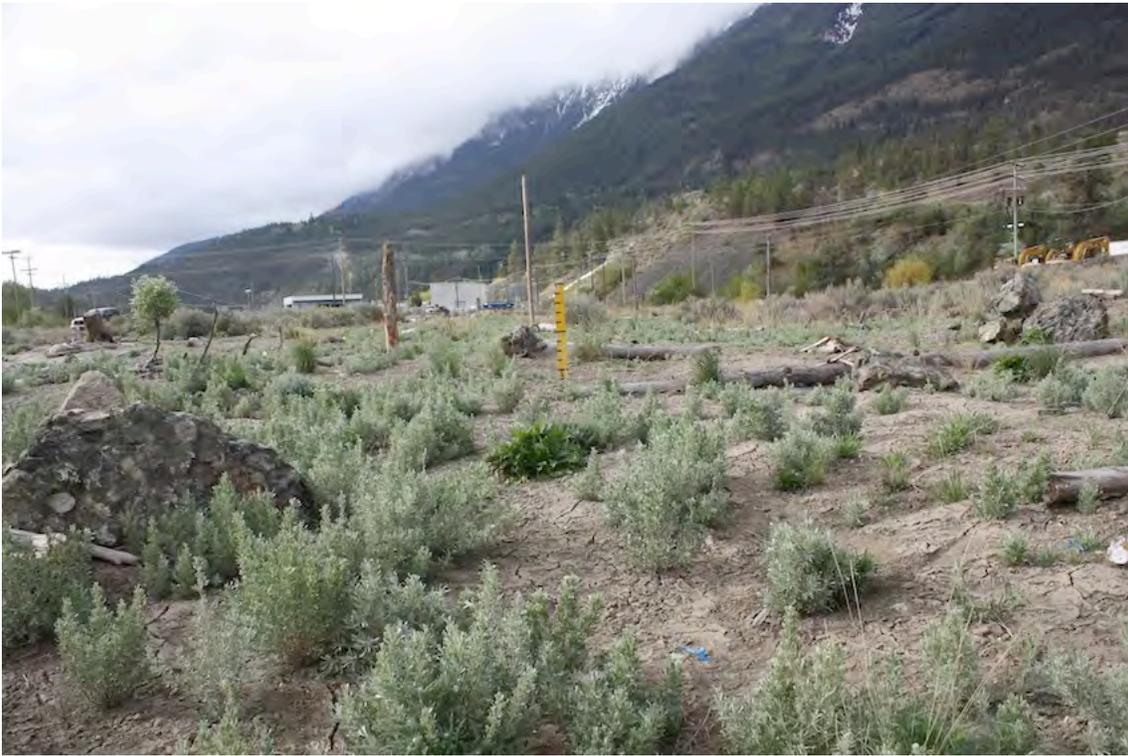
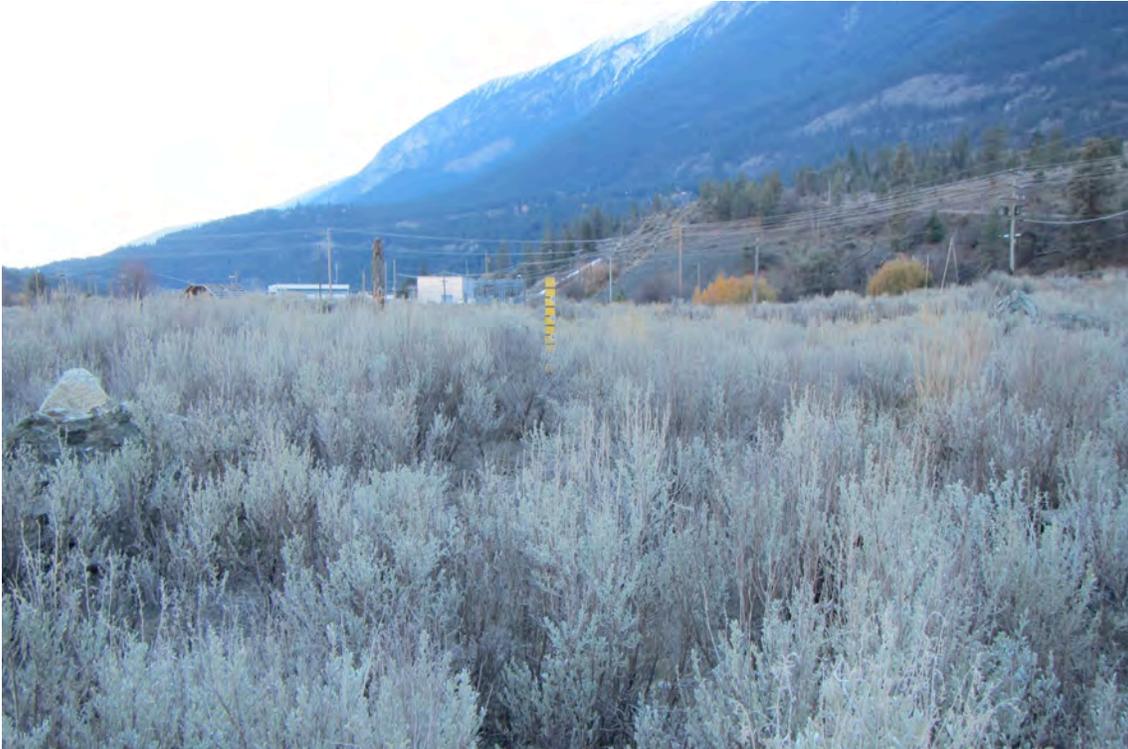
The most significant results that we see from the photo point monitoring is the increase in sage species in the upper bench (Photo Point 02) (see Figure 21, Figure 22, Figure 23, and Figure 24). Species that are growing in include big sage (*Artemisia tridentata*), rabbitbrush (*Crysothamnus nauseosus*), and pasture sage (*Artemisia frigida*). The sage has all self-seeded (we didn't plant any), and it has spread surprisingly quickly, to the point where it is out-competing native vegetation.

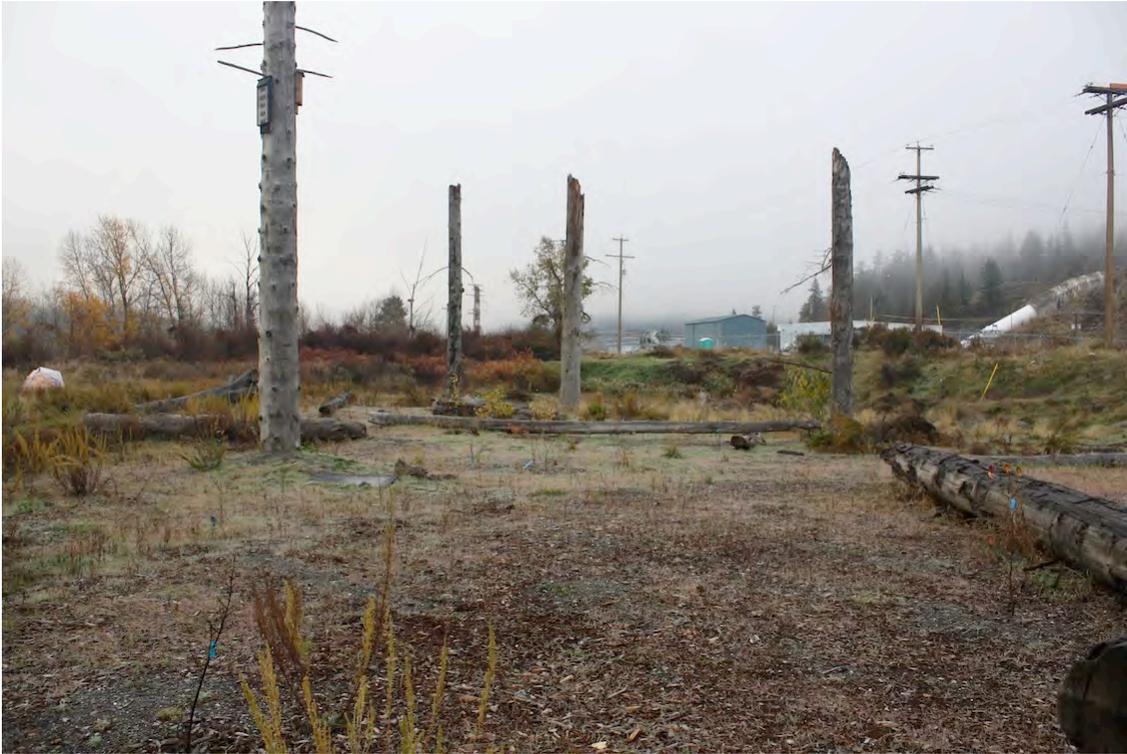
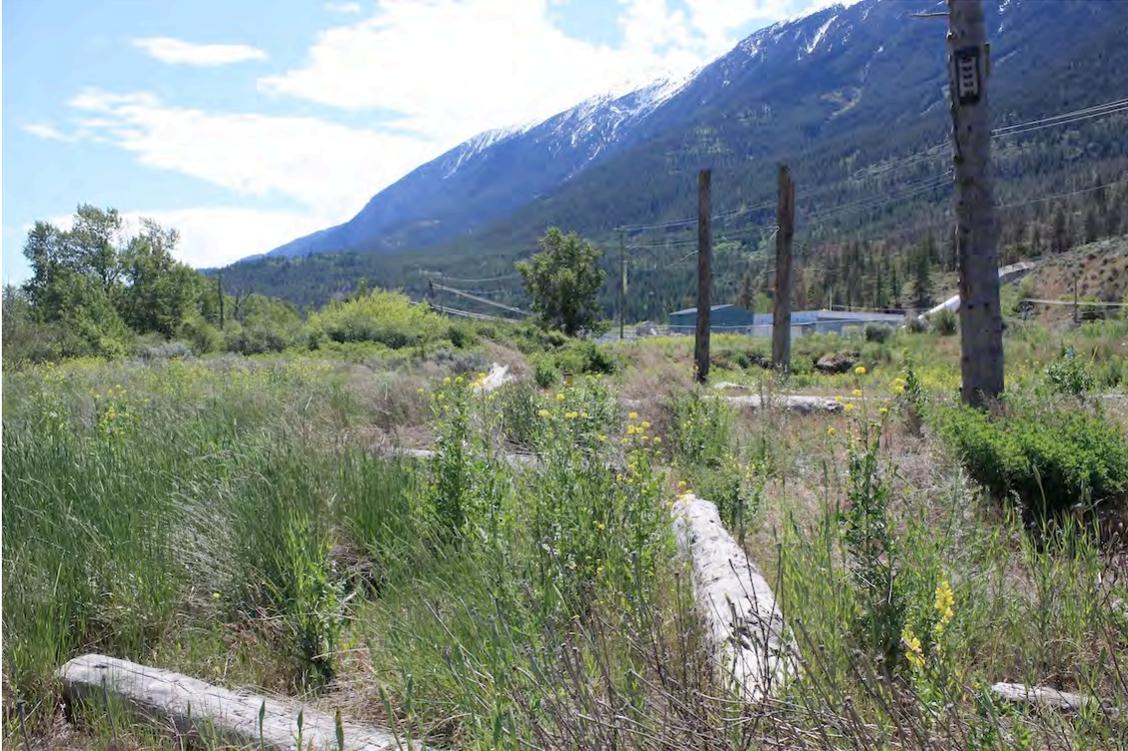
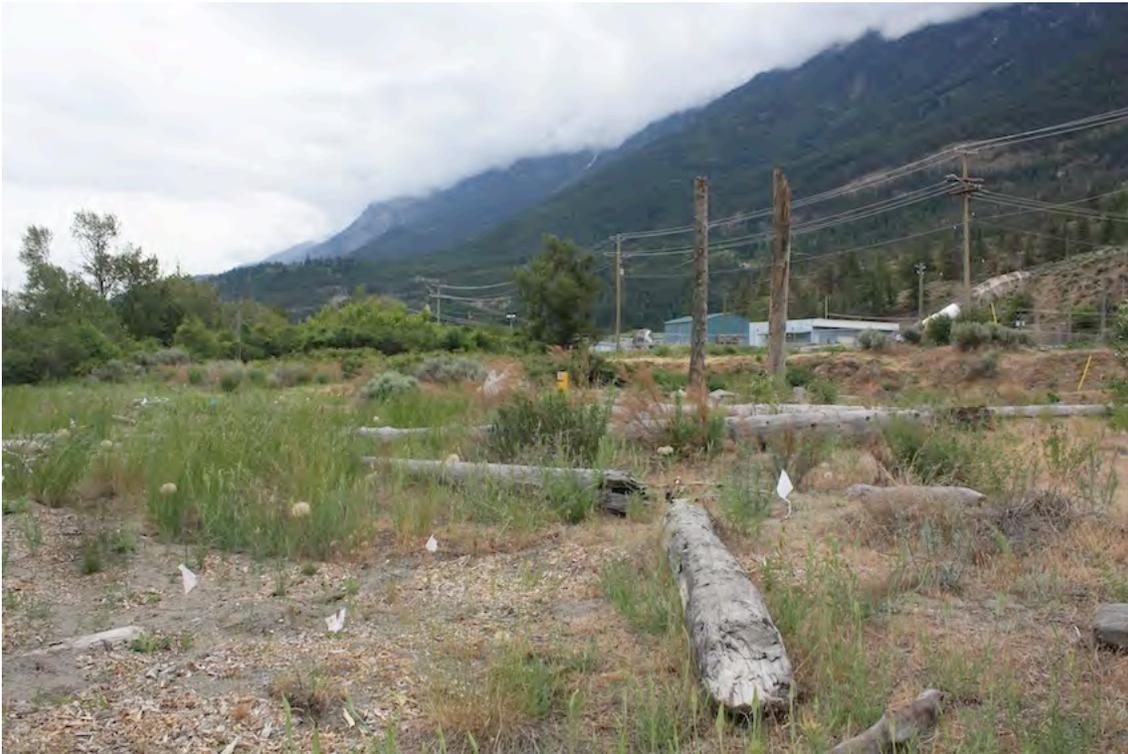
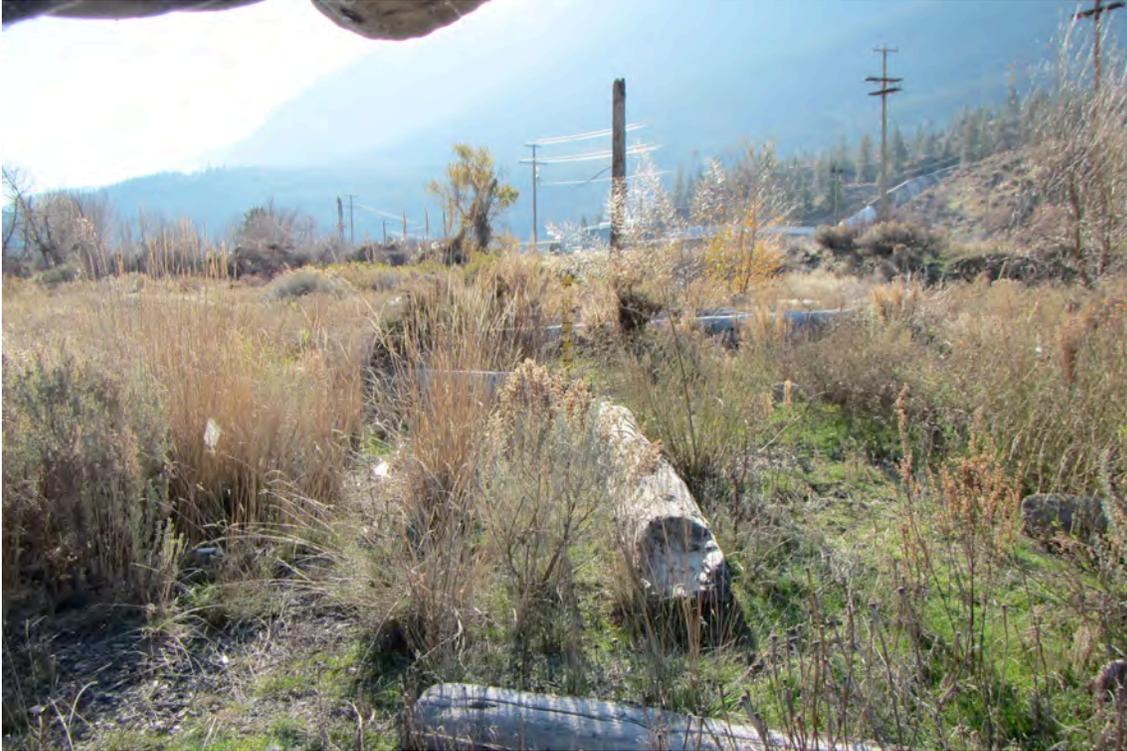
Photopoint 03 is located in an area that we focused on planting native grasses and shrubs. 2014 is the first year that we are able to see well-established shrubs, herbs, and grasses, including giant wildrye (*Elymus cinereus*) and tarragon (*Artemisia dracunculus*). Sage in-growth is not as big of a problem here, possibly because we have been mowing the alfalfa in this area, which would result in the mowing of sage seedlings that are coming up through the alfalfa.

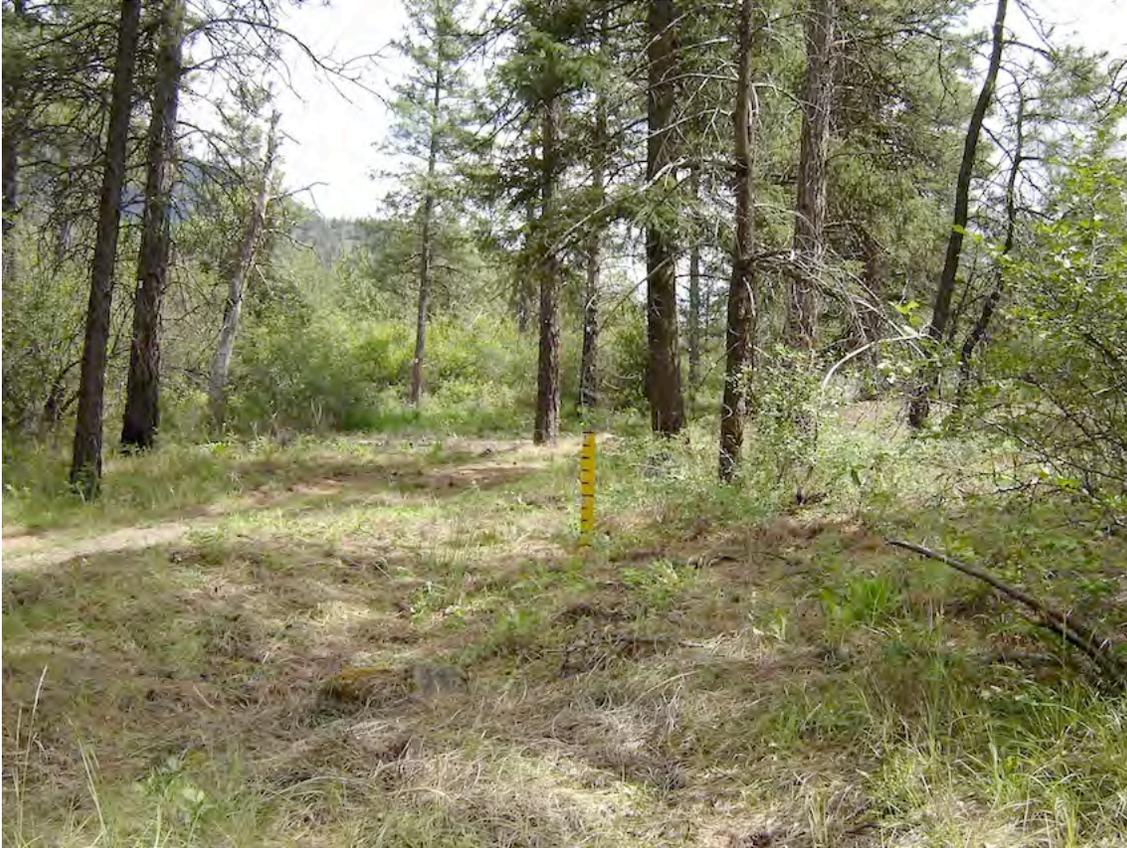
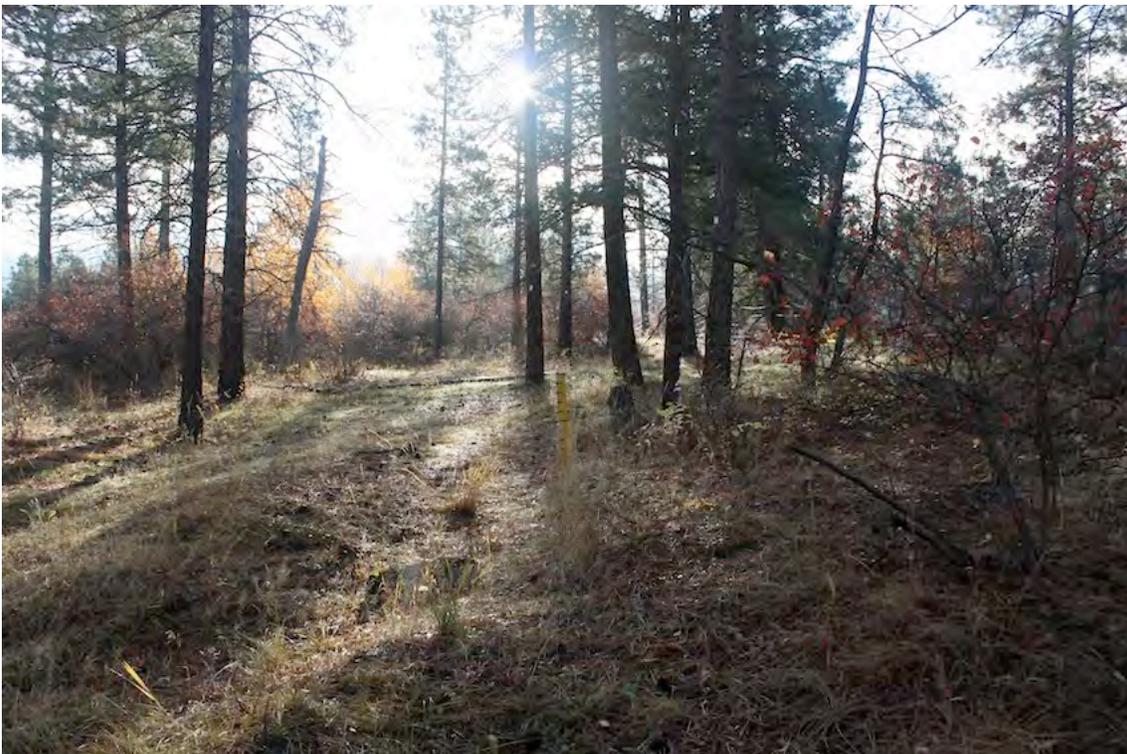
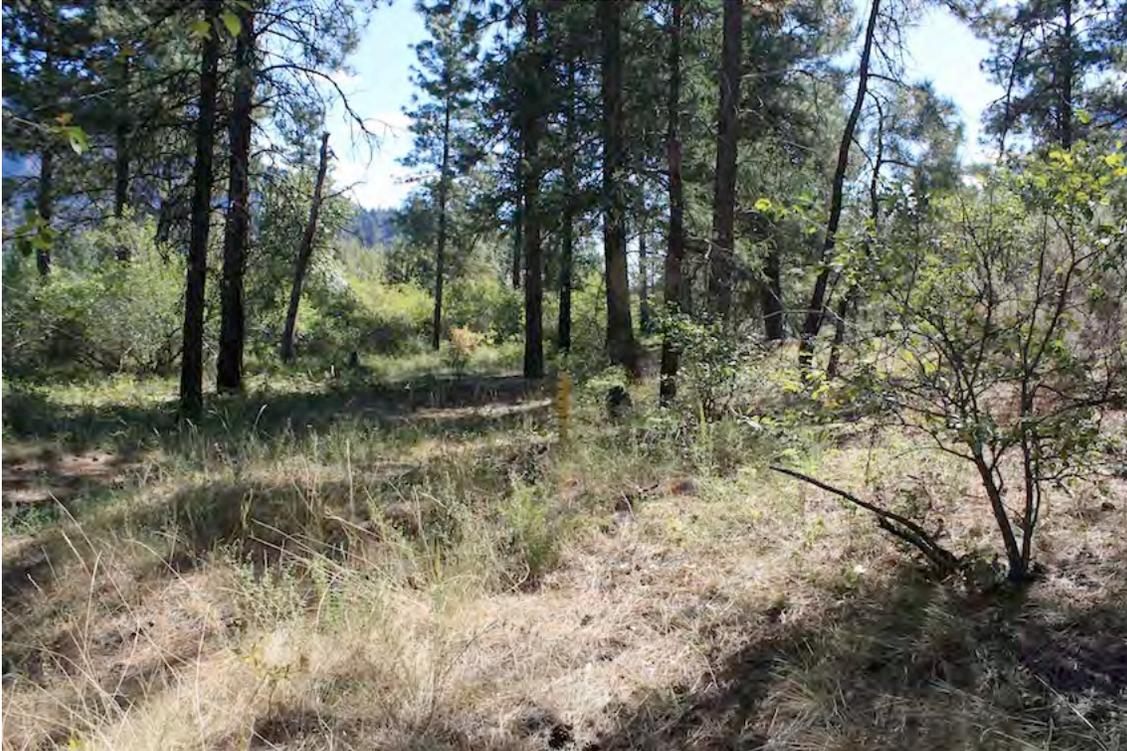
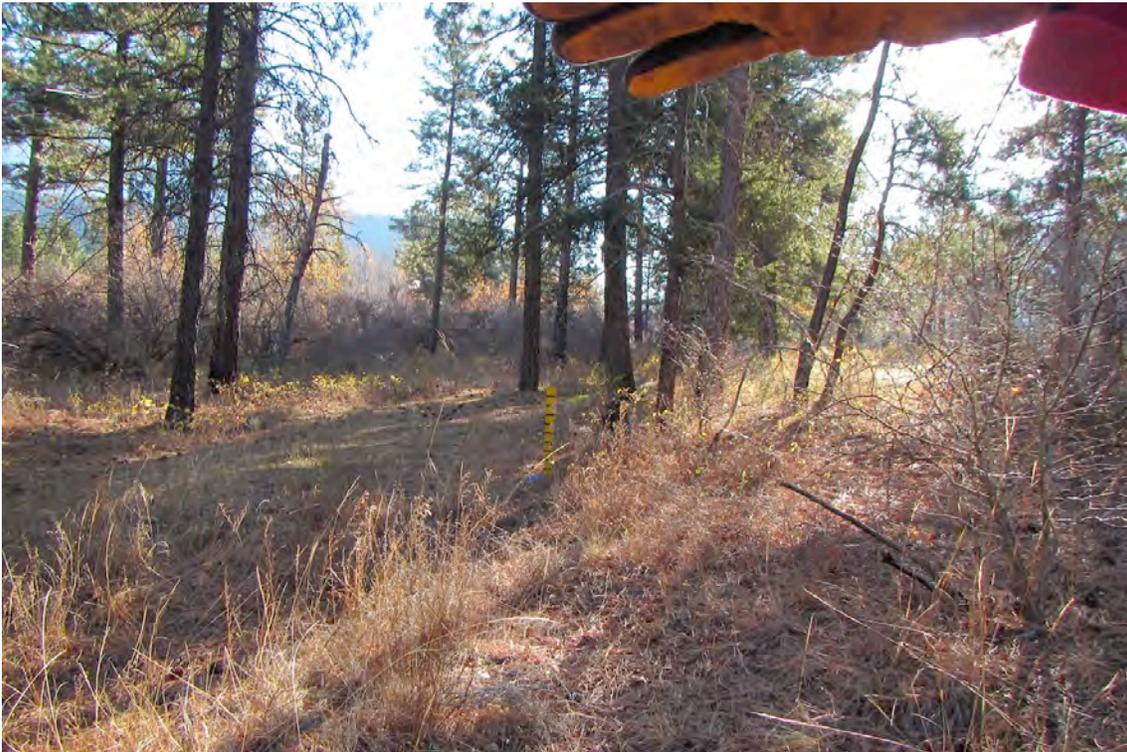
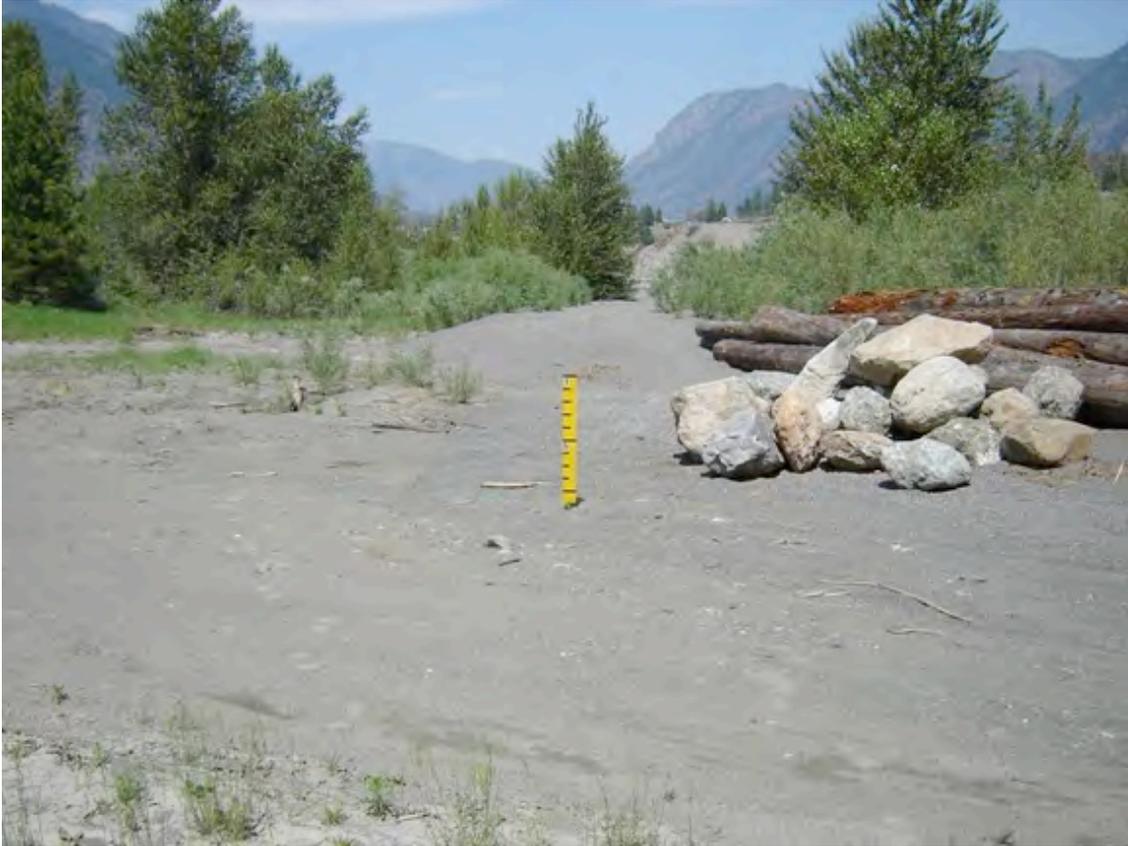
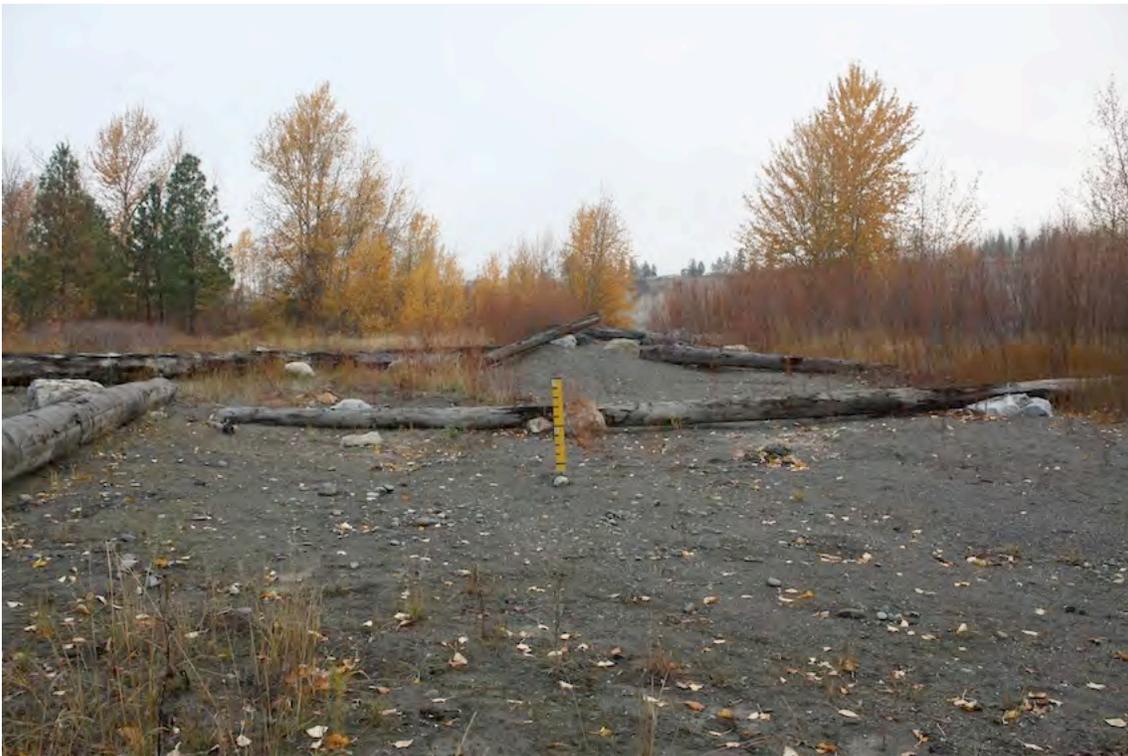
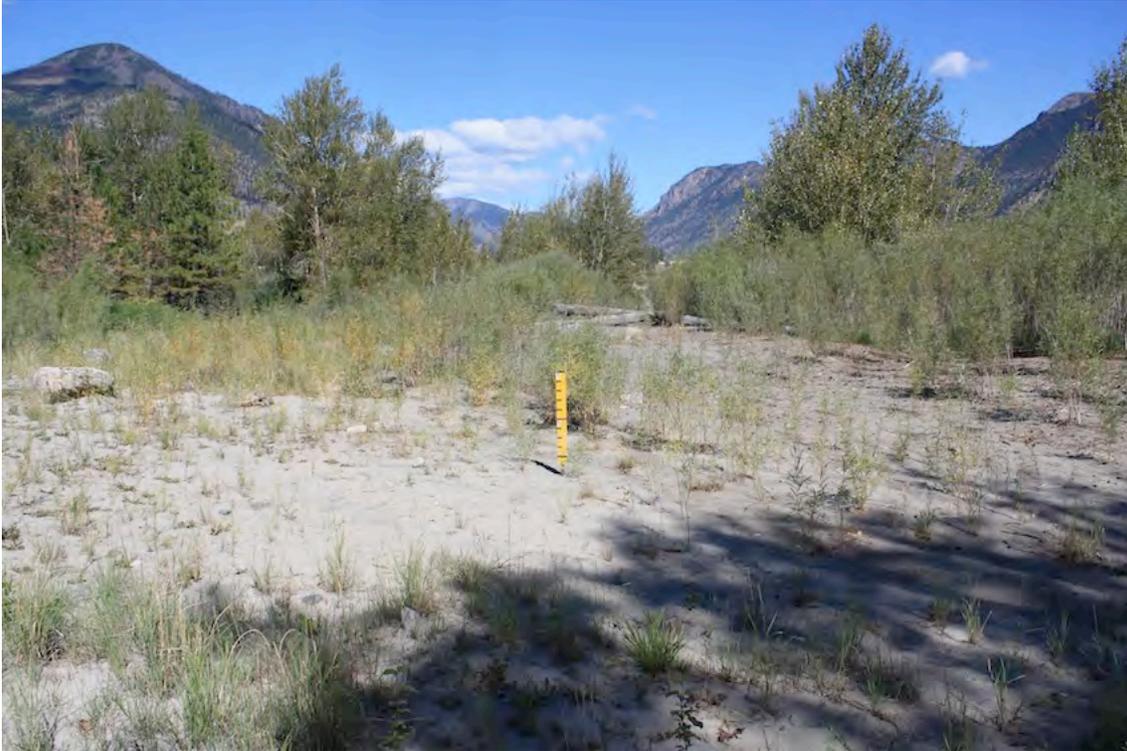
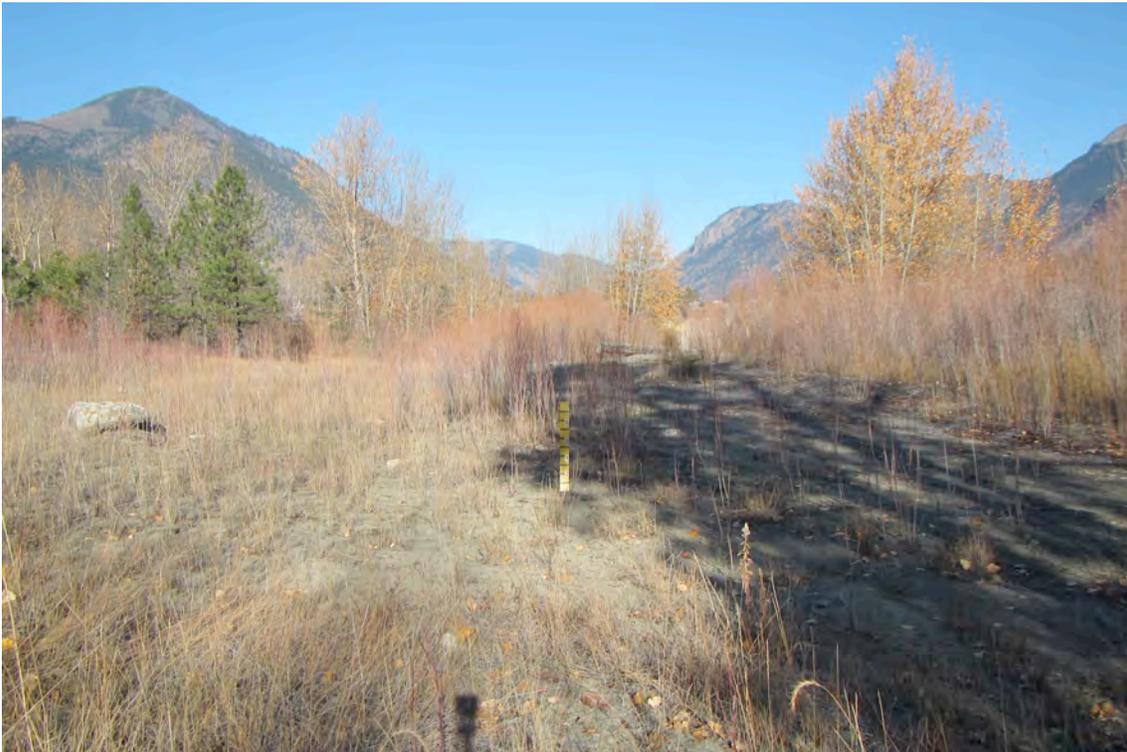
There is little change noted in the Photo Points 01 and 04. Ponderosa pine (*Pinus ponderosa*) in PP01 has been protected from the pine beetle by the ongoing use of pheromone bags, and we did not see tree mortality in 2014. Mowing treatments for alfalfa has remained successful in this area.

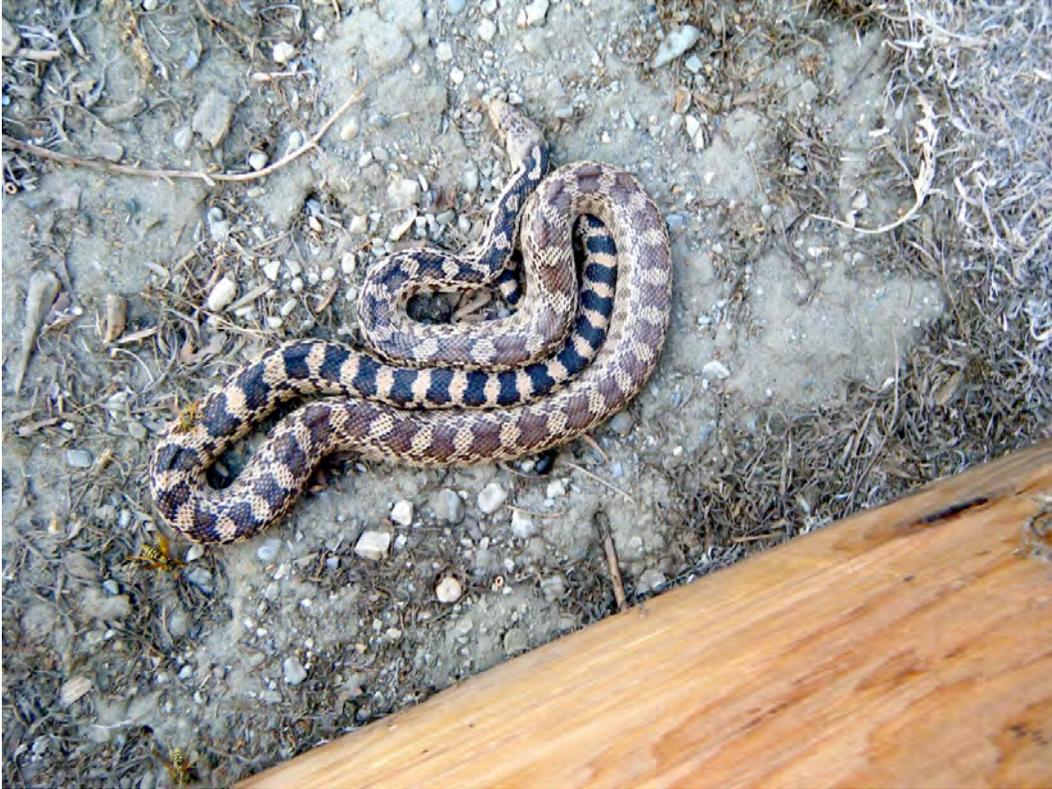
The gophersnake was discovered in early September, when the snakes are migrating to their den sites. The cover board (3-6) is located in an area that has been challenging to restore to a native plant community, and is rife with cheatgrass (*Bromus tectorum*) and alfalfa (*Medicago sativa*). Interestingly, a study conducted in Utah in 2009 found a negative correlation between cheatgrass cover (%) and the relative abundance of Great Basin gophersnake

Figure 37: Great Basin Gopher Snake found under board 3-6. 7 September 2014

(Hall, Mull & Cavitt, 2009). This suggestion, that invasions of cheatgrass reduce the relative abundance of gopher snake, points to a need to continue efforts in reducing invasive species in the restoration site, in order to improve habitat conditions for this threatened species.
