Squamish Central Estuary Brownfield Restoration Project Final Report 16.CMS.02

November 10, 2015

Executive Summary

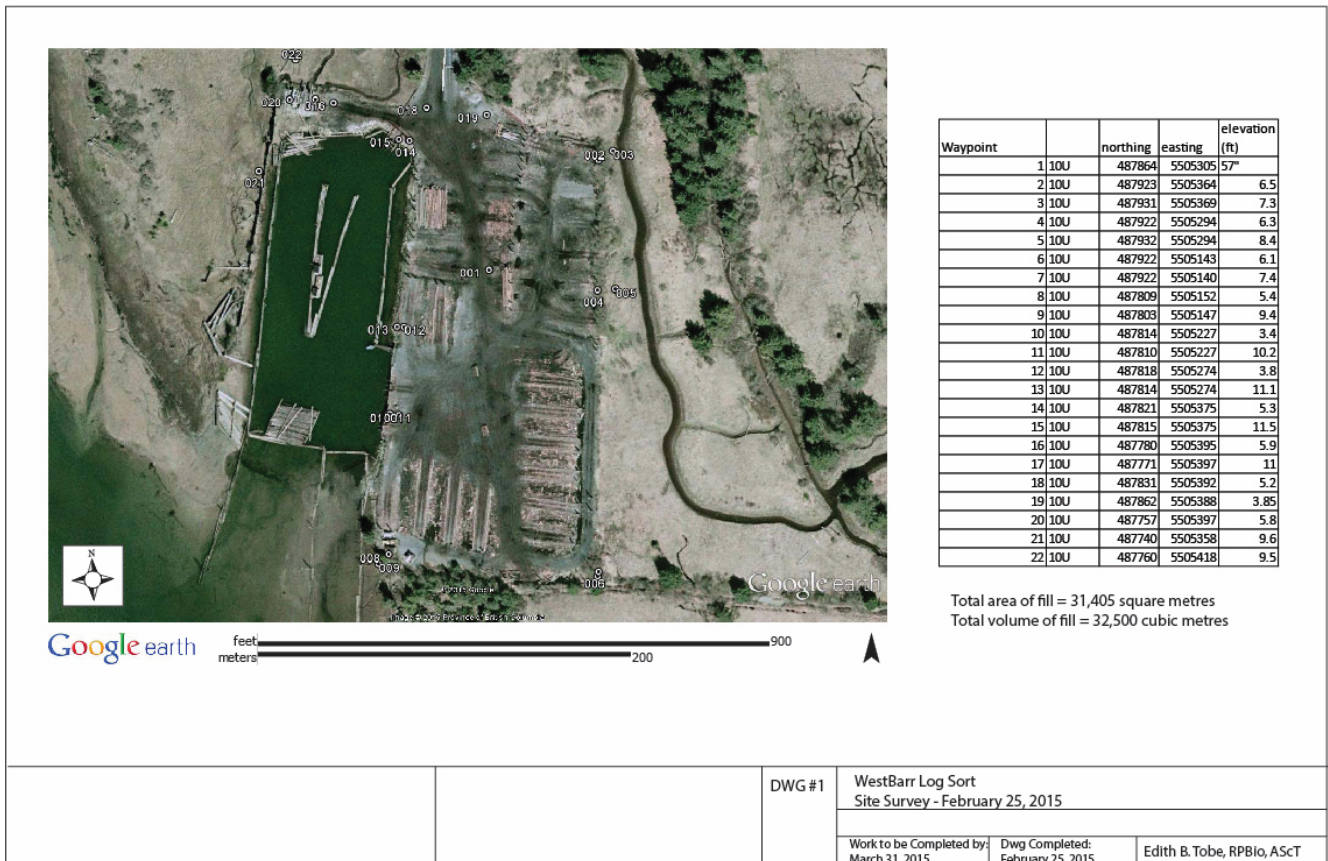
Figure 2. Site survey

The Squamish River Watershed Society initially surveyed the site (Figure 2) establishing the total terrestrial and aquatic area and the approximate total volume of material that would need to be removed at around 17,000 cubic metres. Through detailed bathymetry of the log-dump pond the total volume by which the pond could be infilled was established at around 32,000 cubic metres (Figure 3).

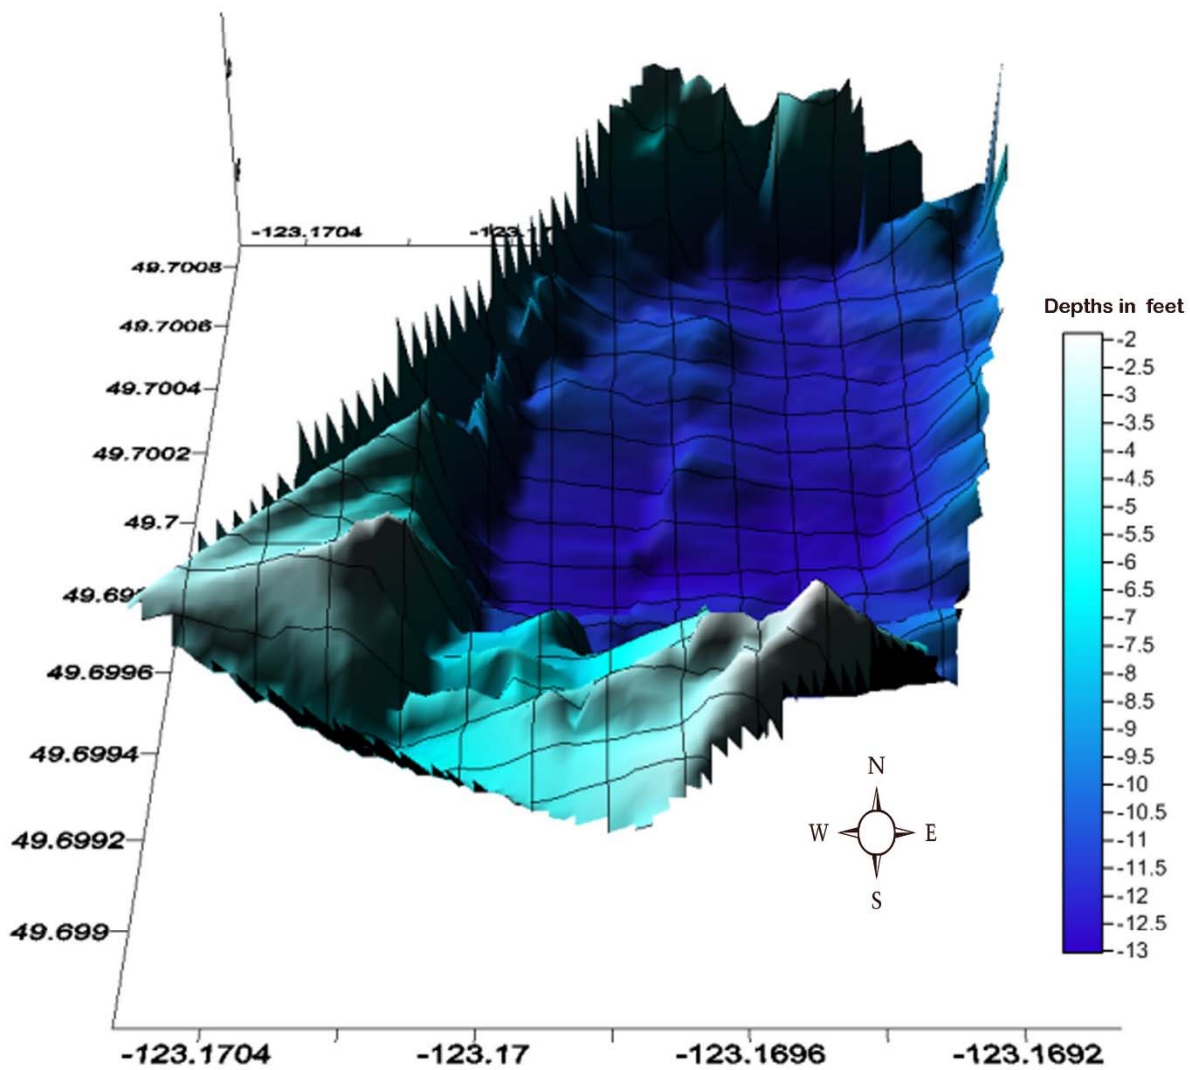
Figure 3. Bathymetry of pond illustrating total pond depth.

Westbar Bathymetric Map - Jan 26/2015
 CPS Imaging - 3D

Time of sonar recording 12:01 - 12:51
 (no tidal offset added to chart)

Chart depths from raw time
 of day recordings.

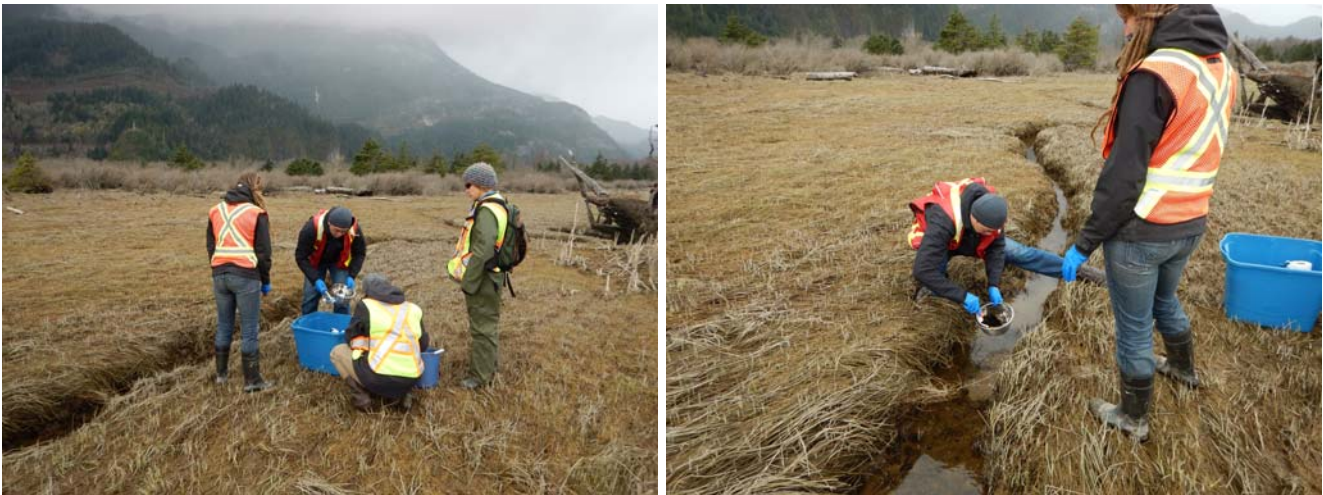
Photo 1 & 2: March 2015. Soil sampling (adjacent to brownfield on natural estuary)

In early March, in partnership with Simon Fraser University, soil and sediment sampling were undertaken to establish a baseline of the site (samples being taken on-site and off-site) and to determine if there were any deleterious substances within the subject site and identify any concerns regarding the nature of any contaminants (Photos 1 & 2). Sampling was again undertaken in June once the majority of the overburden of material had been removed. Although the sediment sampling revealed no areas of concern a small pocket of hydrocarbons were detected almost as soon as excavation of the site commenced – not surprisingly under the location of the former fuel tank. With the discovery of the contaminated soils all work in that area ceased immediately and the Provincial government was notified and immediately attended the site. The result was a detailed sampling of the contaminated areas to determine the depth and area affected. All contaminated materials were removed from the site and disposed to a suitable location (materials that exceeded Provincial hydrocarbon limits were transported – two truck-loads – to a suitable location in Burnaby; the remainder of the material, approximately 20 truck-loads, were disposed of at the Squamish land-fill site).

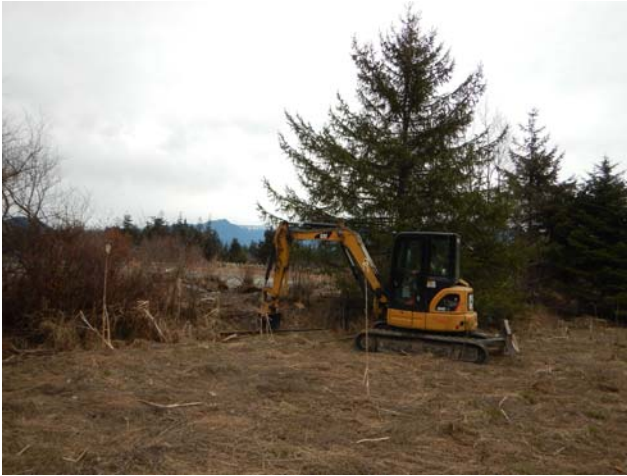
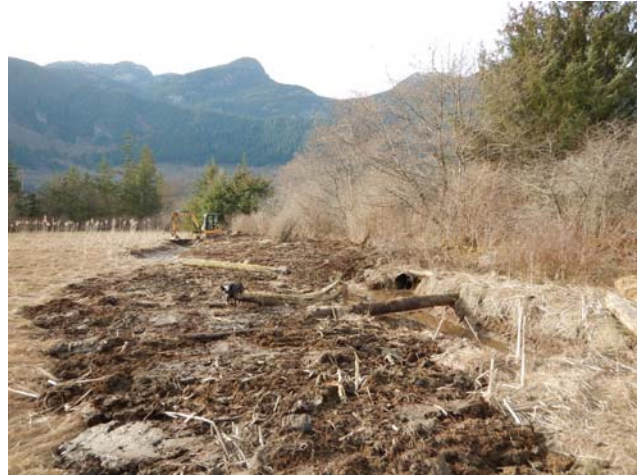
Photo 3 & 4: March 2015 with initial side tidal channel connector

Works commenced in early March with an initial side channel constructed to connect to the existing tidal channels to the south-east of the brownfield site. A small excavator was used to construct the connector tidal channel to reduce impacts to the estuary. The material removed from the channel was side cast in a thin (<0.5m) layer adjacent to the channel which was followed up with dense riparian planting (Photos 3, 4, & 5).

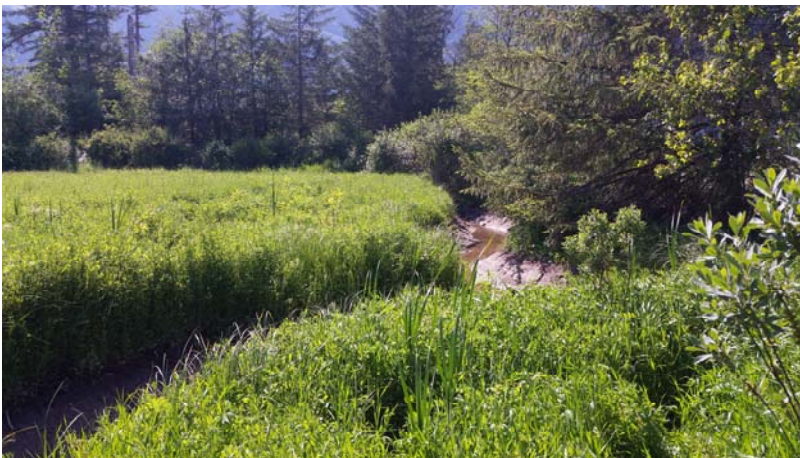
Photo 5: September 2015 showing fully regrown site

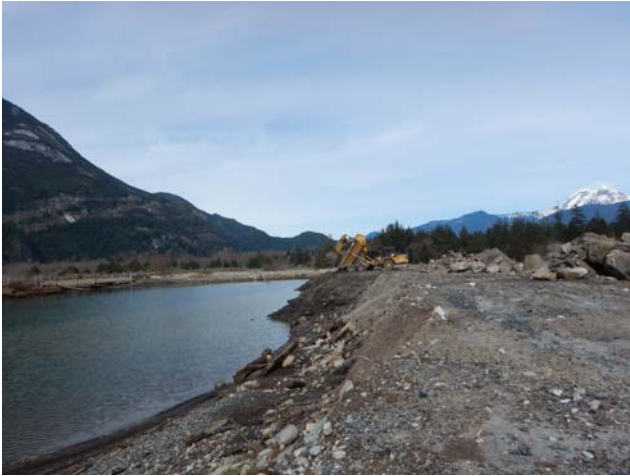
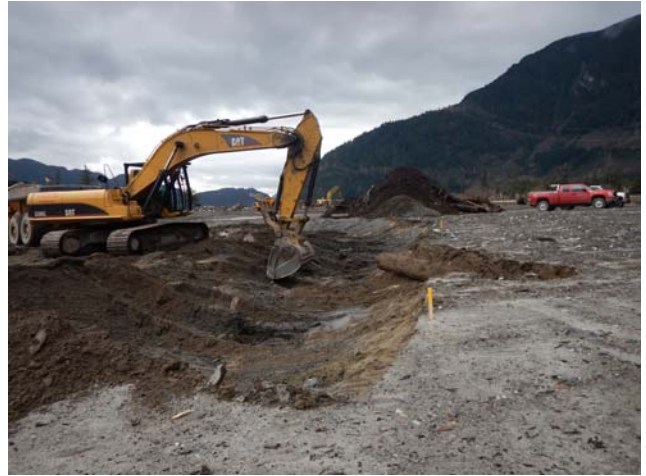
Photos 6 & 7: March 2015. Site excavation – right photo including central tidal channel construction

Two large excavators (200 and 300 series) were used to clear the vast amount of soil in the main site and two rock trucks were also used to transport the material to initially stockpile at the edge of the log-dump pond and later the excavators were used to push the soil into the pond (Photos 6 & 7).

The soil was removed to the same elevation as the adjacent natural estuary gradients with some features including ridges, knolls, and small hills to provide variations in the topography to attract different vegetation types and different species of wildlife.

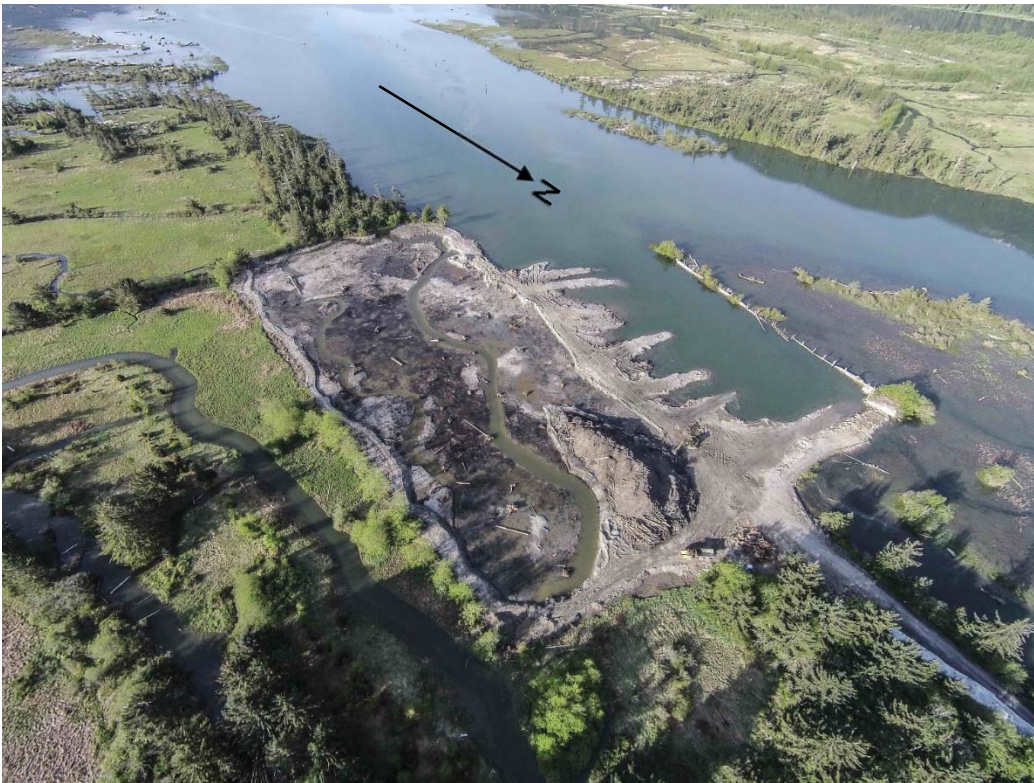
One large tidal channel was excavated diagonally from the north-east corner (connecting to the Central Estuary tidal channel constructed in 2005) in a meander towards the south-west corner of the site discharging into the lower section of the former log-dump pond. A second ephemeral tidal channel was constructed adjacent to the eastern edge of the site and then following a south-western direction towards the lower section of the former log-dump pond and the smaller side tidal channel for a total of three main new tidal channel connections (refer to photo below and Figure 4).

Photo 8: (courtesy of Colin Bates) taken in June 2015

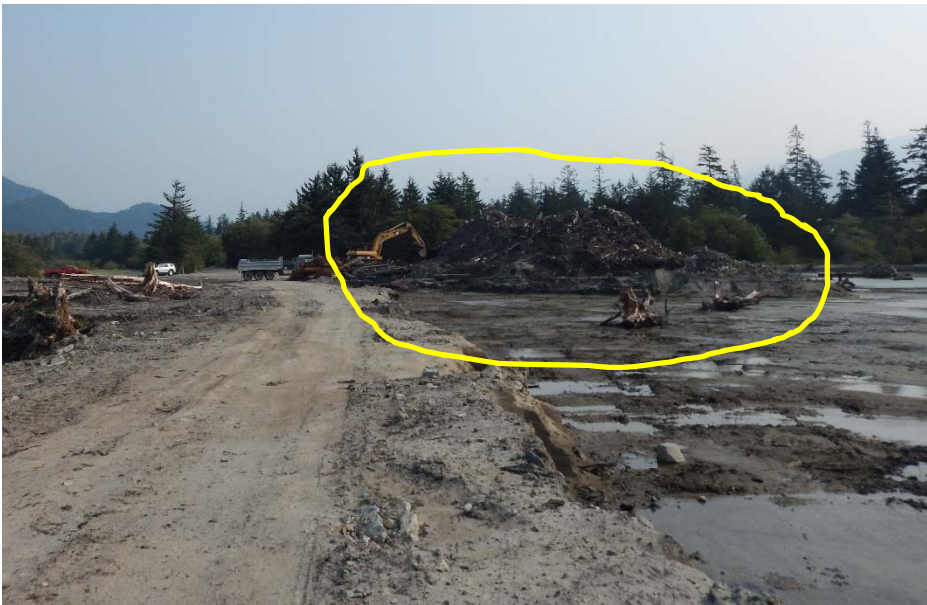
As the soil was being stripped a layer of wood waste was discovered across the entire site approximately 1.0 m below the surface. This material was stripped away and stockpiled (as can be seen in the centre of Photo 11). The total volume of wood waste material was approximately 15,000 cubic metres. Several meetings with staff from the Ministry of Forests, Lands, and Natural Operations (MFLNRO), Fisheries and Oceans Canada (DFO), Squamish Nation, and the District of Squamish were held to discuss how best to manage and ultimately remove the wood waste material from the site. The SRWS worked closely with the District of Squamish (DOS) to determine a suitable location where the wood waste could be removed and the DOS ultimately agreed to allow the wood waste in DL69, which is zoned wood waste disposal (located by the Squamish Airport in Brackendale). The SRWS was able to secure additional outside funding to removal all the wood waste as this cost had not been budgeted for in the existing funding.

Photo 11. July 2015. Wood waste being stockpiled at north end of site (circled in yellow).

The second unexpected issue that immediately became apparent was a layer throughout the site of wood waste material (approximately 1.0 metre in depth and approximately 1.0 metres below the surface). This wood waste (also known as hog fuel), although no contamination was found in the tested materials, was nonetheless not deemed to be suitable for infilling the former log-dump pond and arrangements had to be made to find a suitable location off-site to remove the materials. As well as additional funding needed to be secured to cover the costs of the trucking the material away. Several meetings were held between April and June with MFLNRO, DFO, Squamish Nation and DOS staff to discuss options for the disposal of this material. By early August all wood waste (over 15,000 cubic metres) was removed to a location on District of Squamish Lands (Lot DL69) located adjacent to the Squamish Airport and zoned for the storage of wood waste.

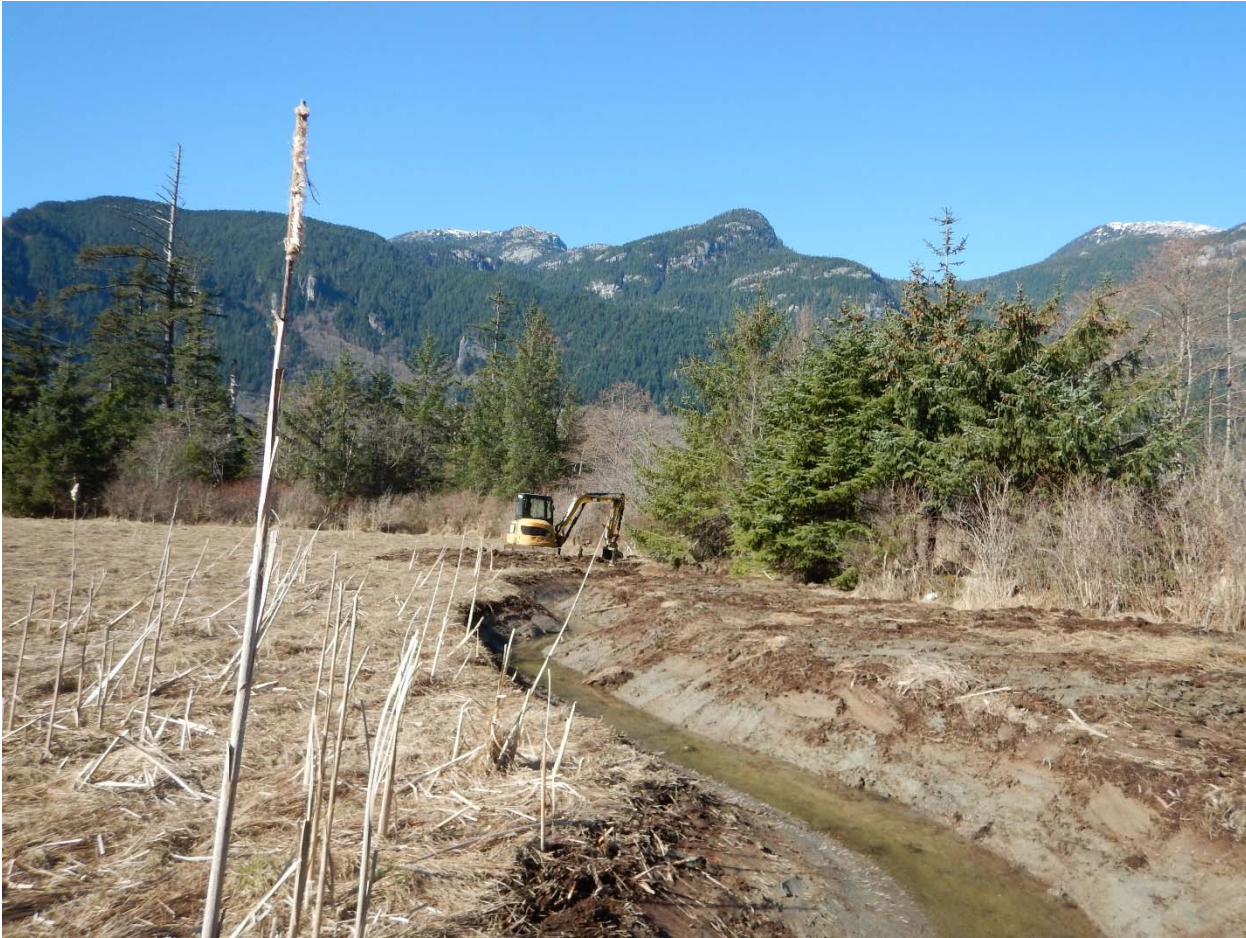
Photo 14. March 7, 2015 – Constructing new tidal channel – facing west

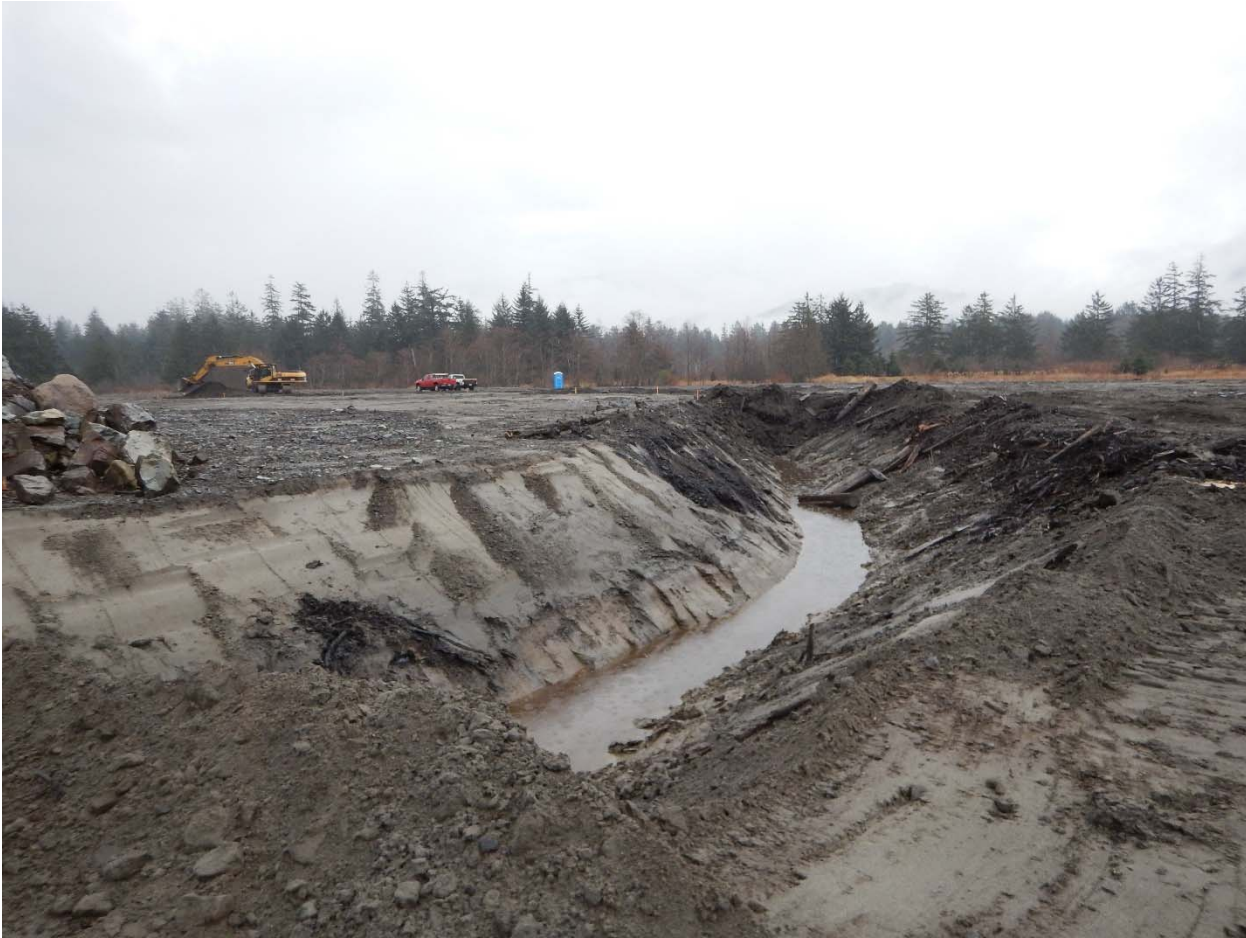
Photo 15. April 11, 2015 – Facing east. Constructing large tidal channel at south end

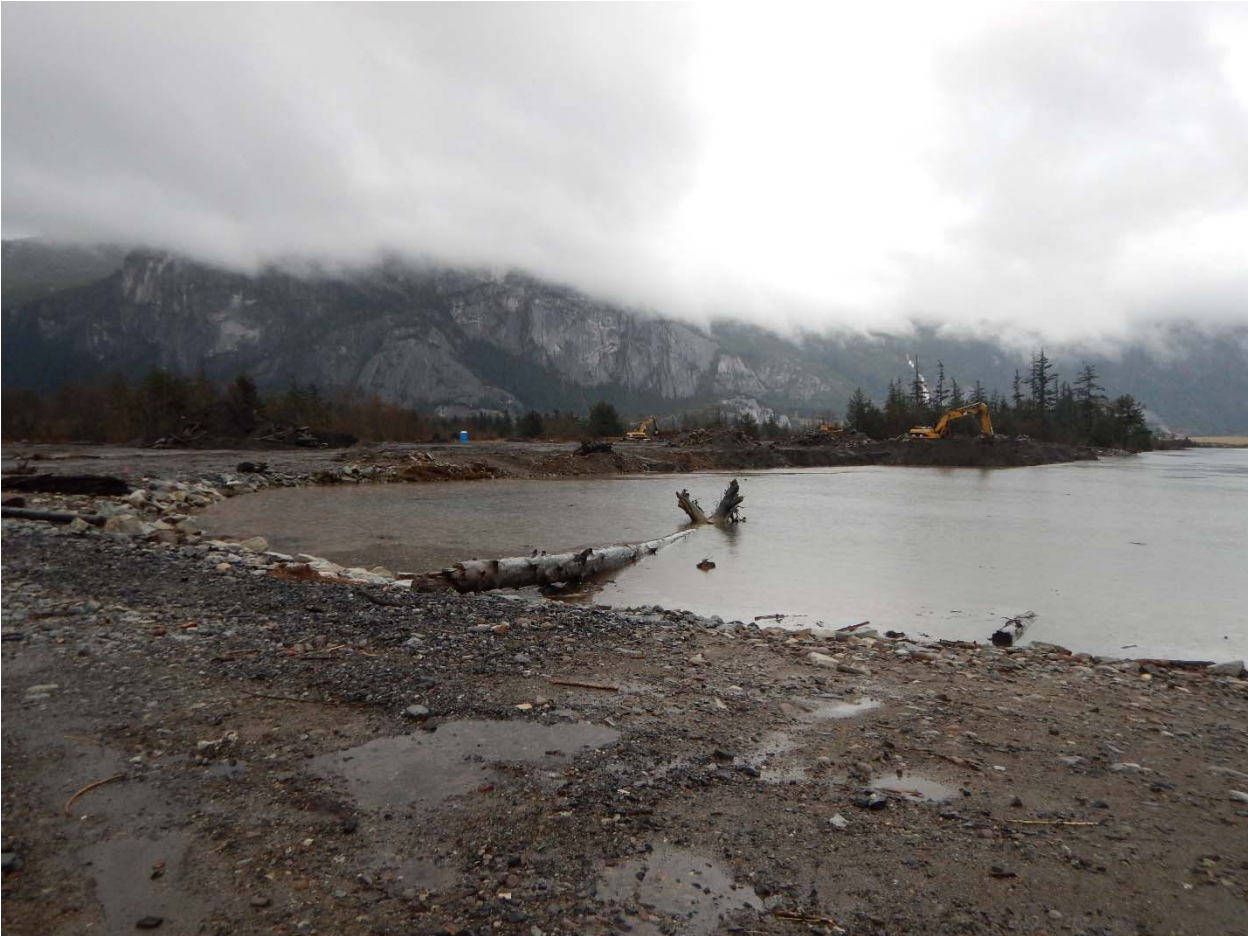
Photo 16. April 14, 2015 – facing east towards construction (note in-filling of log-dump pond)

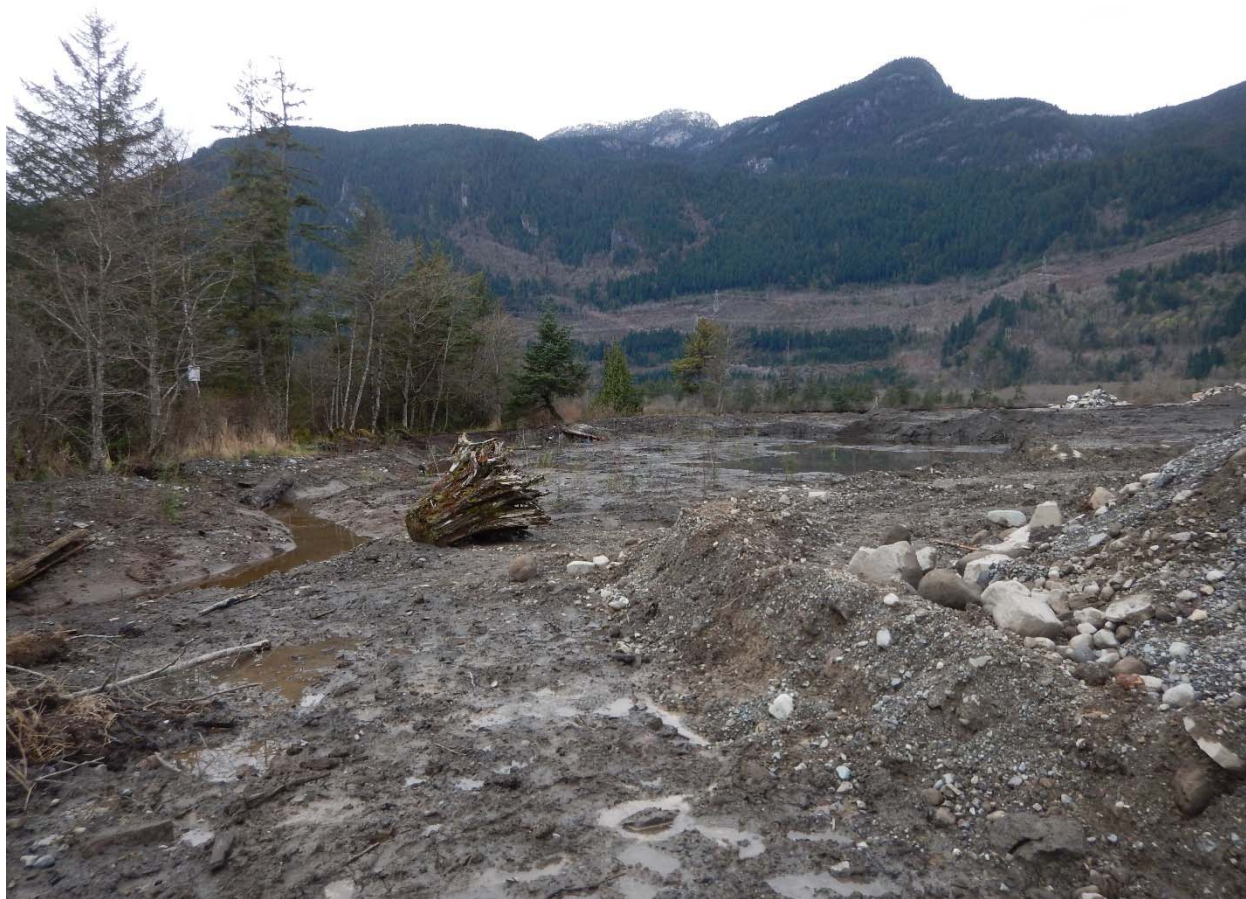
Photo 18. April 22, 2015 – Completed tidal channel at south end of site (lower section)

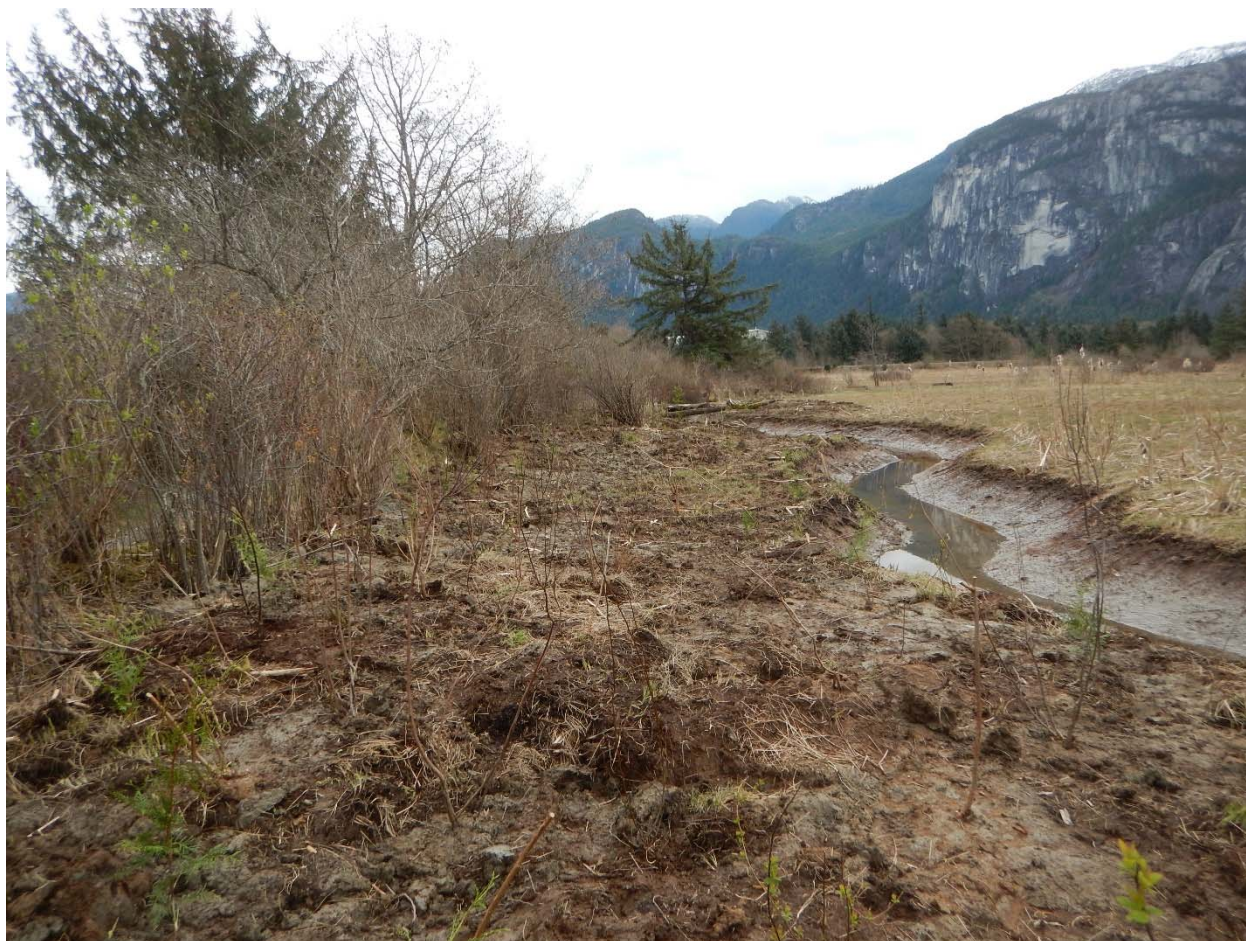
Photo 19. May 22, 2015 – top end of completed southern tidal channel – note riparian vegetation planted by volunteer support
