# FINAL REPORT 2015 – 16

## Seton River Corridor Conservation and Restoration Project

Project No.: FWCP 16.W.SON.01, 2015AFSAR2498, PSF CSP15S030

Prepared by: Splitrock Environmental Sekw'el'was LP  
Box 798  
Lillooet BC V0K 1V0

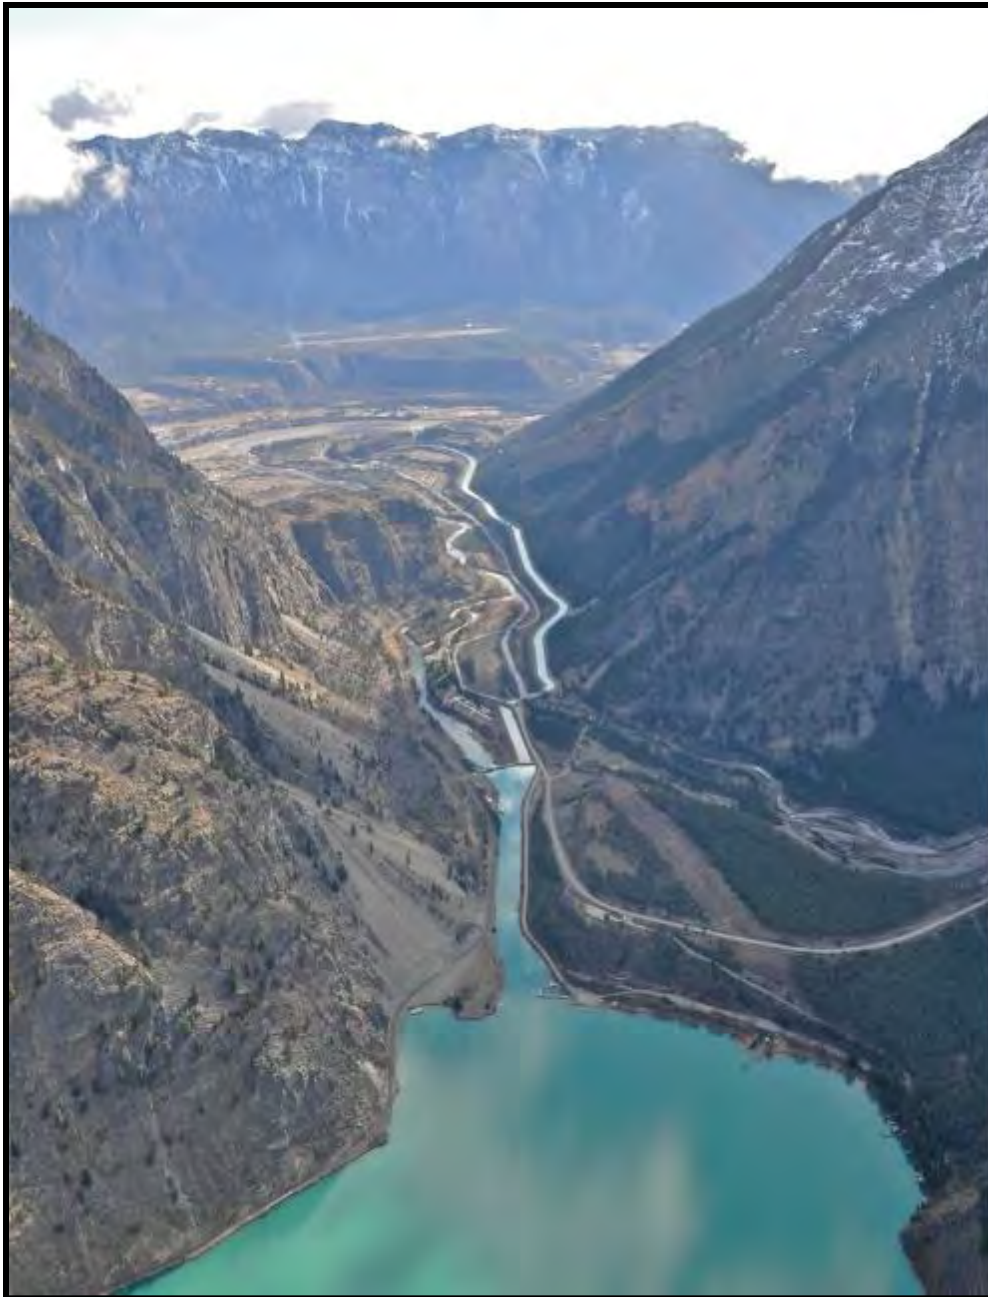
*Figure 2 Aerial photograph showing the narrow valley and some of the impacts 29 Mar 2011*

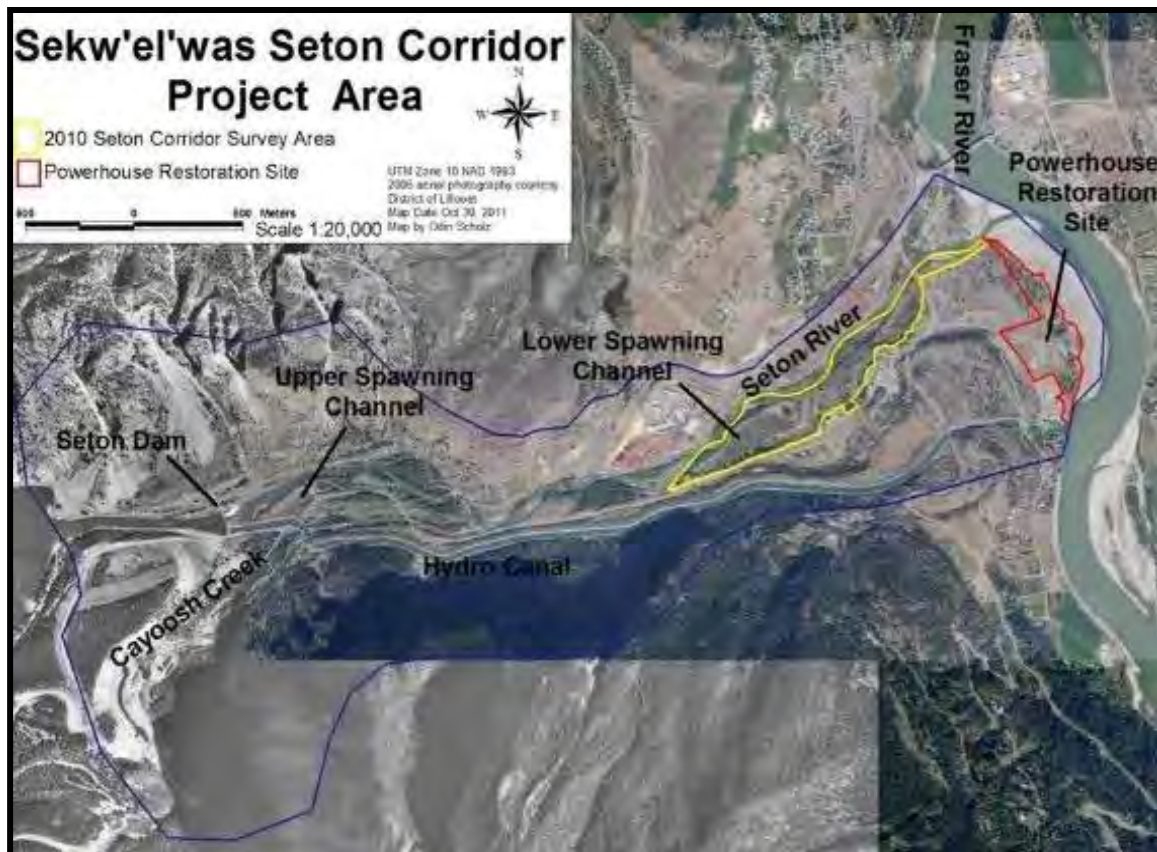
Map 2 Sekw'el'was Seton Corridor Project Area (Seton Lake to Fraser River)

The boundaries created for the corridor plan includes the entire stretch of the Seton River corridor from Seton Lake to the Fraser River, and incorporates the Seton and Cayoose Rivers, three spawning channels, the Seton Canal, Powerhouse site, the upland habitats and cliffs on both sides of the rivers (Map 2 - blue boundary). This map also shows the Powerhouse and Mariposa Flat sites (*red boundary*), and the Lower Seton Corridor (*yellow boundary*).

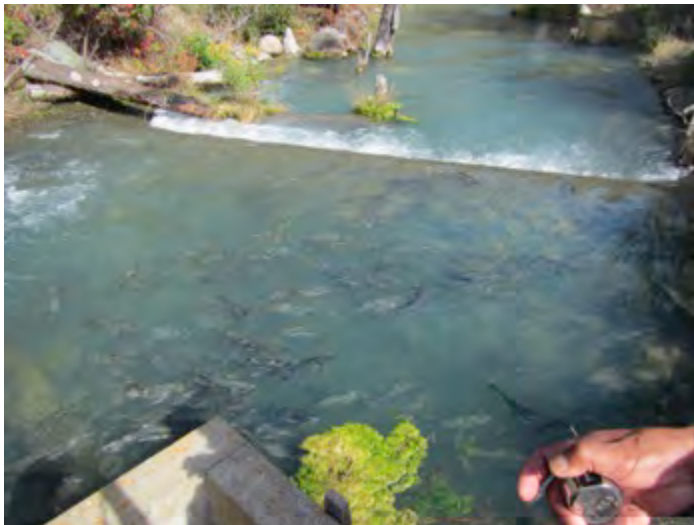
Figure 4 Spawner Counts Upper Spawning Channel 15 Sept 2015

Visual stream bank counts were undertaken for spawning Steelhead, Rainbow, Chinook and Coho salmon weekly throughout the whole extent of the Seton River (Figure 4). The Spawning Channels were also surveyed in attempts to identify their use by adult Salmonids. Methods replicated those utilized in BRGMON3 surveys (Burnett et al. 2016) and data collected is an index of abundance rather than total counts. Briefly, two observers walked in a downstream direction on the riverbank looking for visible signs of fish. Fish were classified by species and location and recorded in field notebooks. Viewing conditions, cloud cover and lateral water visibility were also recorded. Surveys commenced on 04 March for the enumeration of Steelhead and were completed on 15 June, when the Steelhead migration and spawning had completed. Chinook and Pink migration overlapped and surveys for both species commenced on 04 August and were completed on 30 September. Coho surveys began on 06 October and were completed on 15 December.

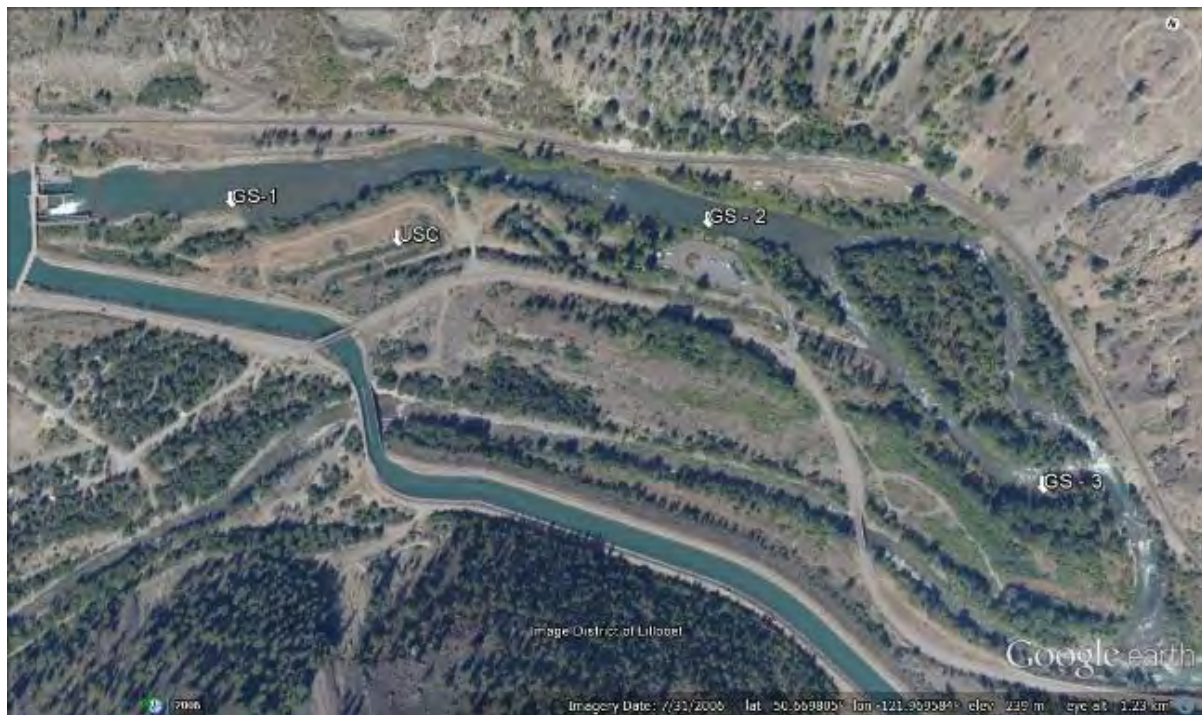
*Map 3 Location of Juvenile Growth Sampling Sites - upper Seton River*

In total 13 sites were surveyed: 3 in upper corridor (Map 3), 6 in middle corridor (Map 4) and 4 in lower corridor (Map 5). These sites were selected according to their appearance to hold fish as the main purpose of these surveys was to sample as many fish as possible. The spawning channels were sampled throughout their entire lengths.

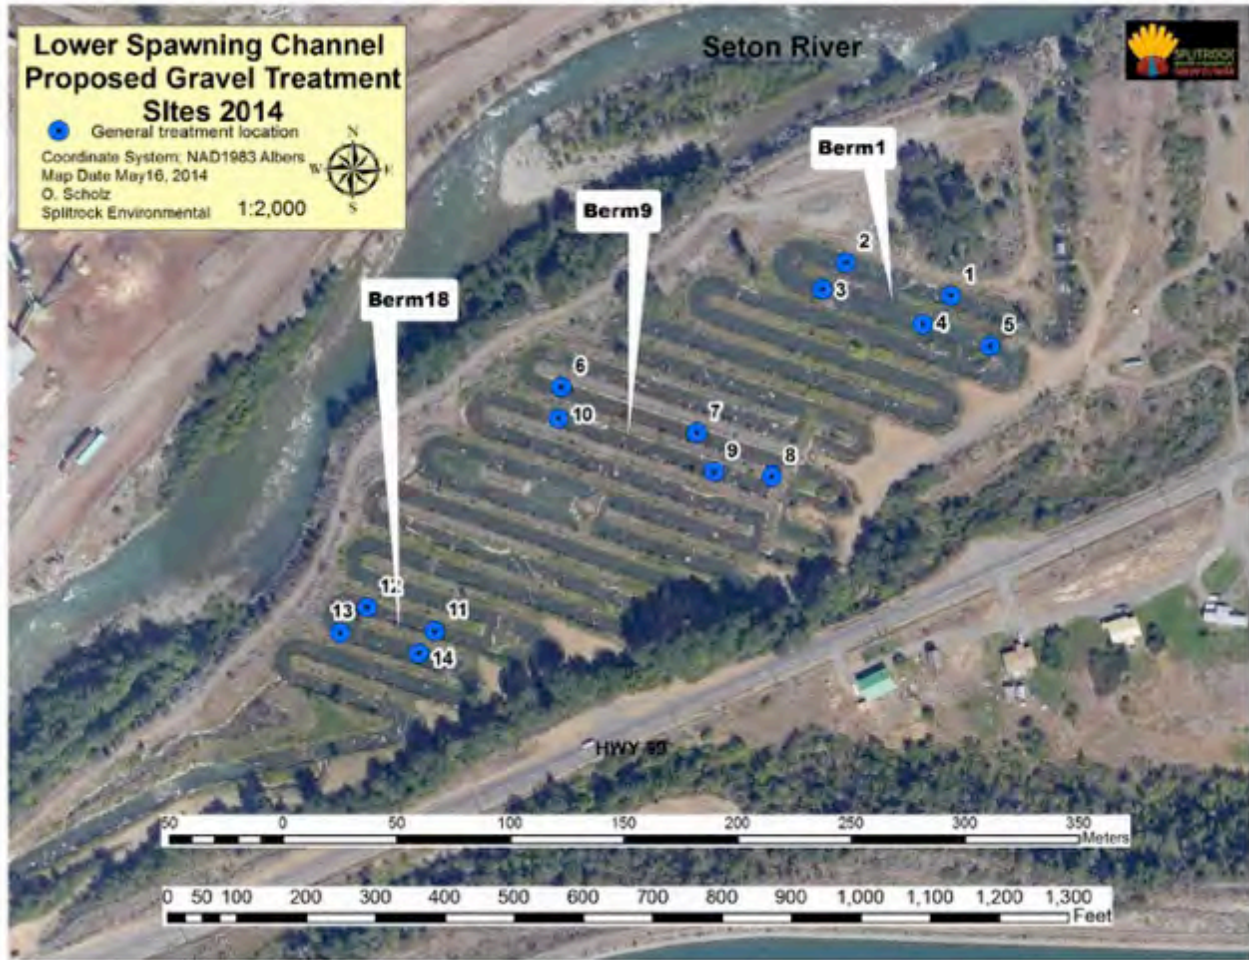
Map 6 Proposed Gravel Treatment Sites Lower Spawning Channel

Control areas were also flagged in the field to represent similar sites to the treated areas. Control sites will be monitored with the same intensity as treated sites through time for comparative effects.

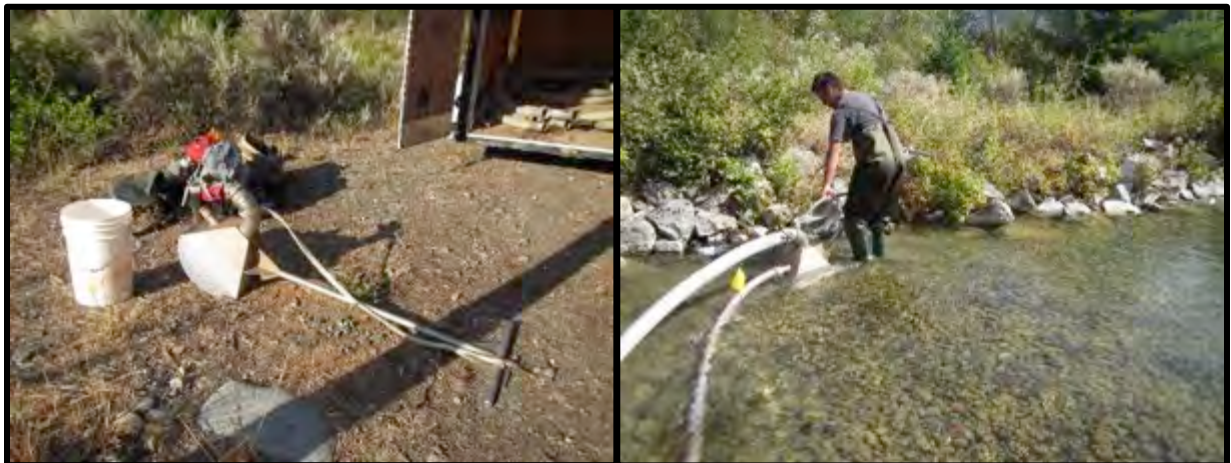
*Figure 6 SandWand head (left) and equipment in operation Aug 2015*

The 'Sand Wand' uses a combination of water jet and suction to mobilise and transport fine sediments beneath an enclosed hood (Figure 5). Crew manually moved the equipment across the streambed using a rocking motion moving parallel to flow (Figure 6). The arrangement of 3-inch pumps relative to the hood depends on the topography of the stream. Slurry was discharged to land in areas where restoration works were planned.

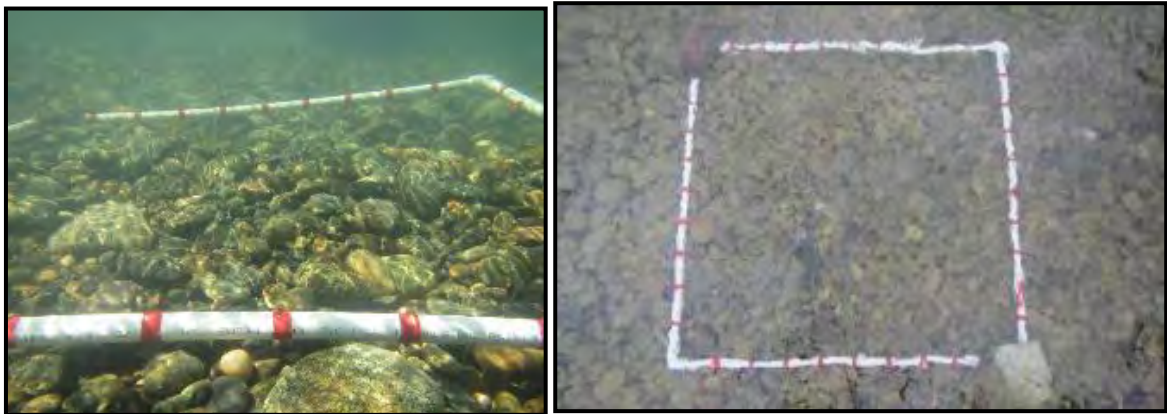
Figure 7 Photo monitoring grids Aug 2015

Photo monitoring was set up using 1X1m plot frames to photograph surface gravels in treated vs control plots (Figure 7).

3. Take photo of plot frame from above water surface to include entire frame in picture (Figure 7).
4. Use blue canon cameras and wait for the GPS satellite picture to stop flashing indicating satellite reception.

7. Mark Plot location:
  - i) Using permanent paint, make marks on either bank to indicate the downstream locations of the plot frames in the channel
  - ii) Run a measuring tape between marks and centre the plot frames in the middle of the wetted width on the upstream side of the tape.

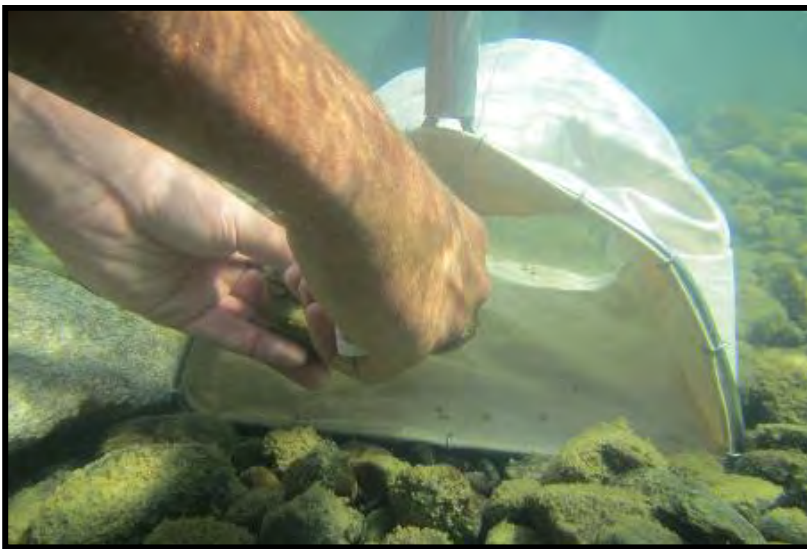
*Figure 8 Collecting invertebrates in D net (underwater view) Aug 2015*

1. Approach the first sampling area from downstream. Do not disturb the sampling area by walking in it or upstream of it.
2. Place the D-net on the downstream edge of the sample area, so the opening faces into the flow. Push the frame a little way into the stream substrate (Figure 8).

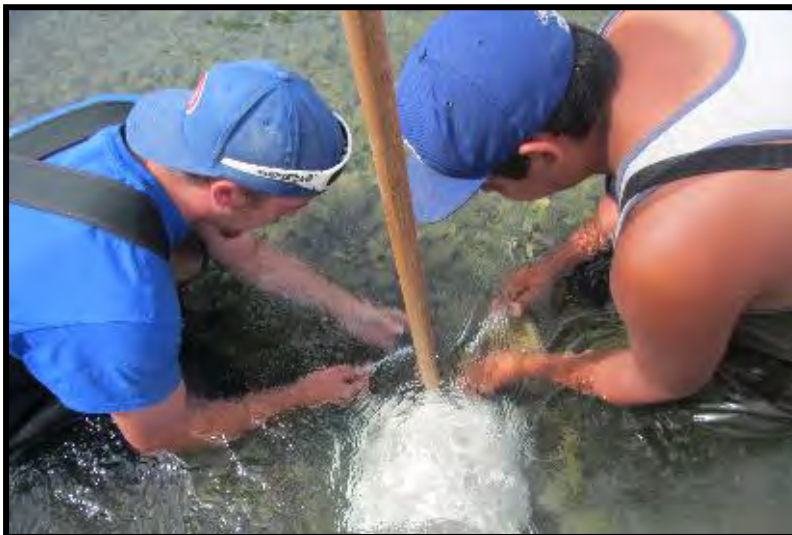
*Figure 9 Collecting invertebrates Aug 2015*

5. Using your hands and starting at the upstream end, gently agitate the streambed to a depth of 2 to 5 cm to loosen any remaining invertebrates (Figure 9).

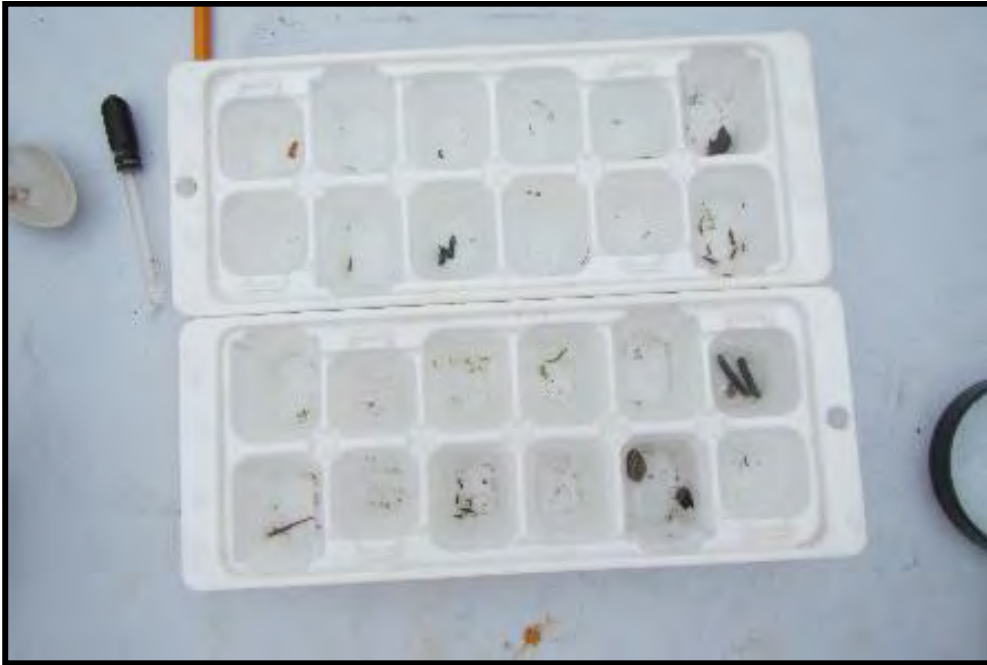
*Figure 10 Counting and sorting invertebrates for indicator tests Aug 2015*

Field Data Sheet (Figure 10). Record the total number and calculate the density (number per  $m^2$ ) in Part A of the Interpretation Sheet. Record the most abundant or predominant taxon in Part B. Return the organisms to the area of the stream you sampled.

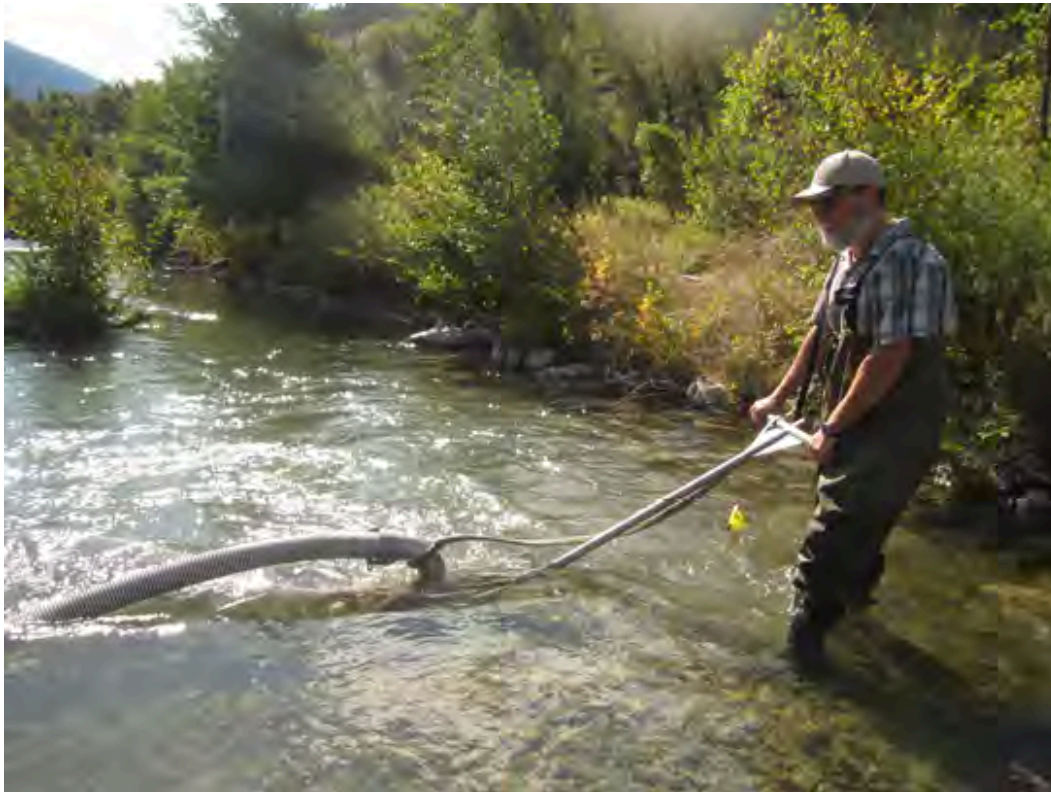
Figure 13 Cleaning gravels using SandWand technology Aug 2015

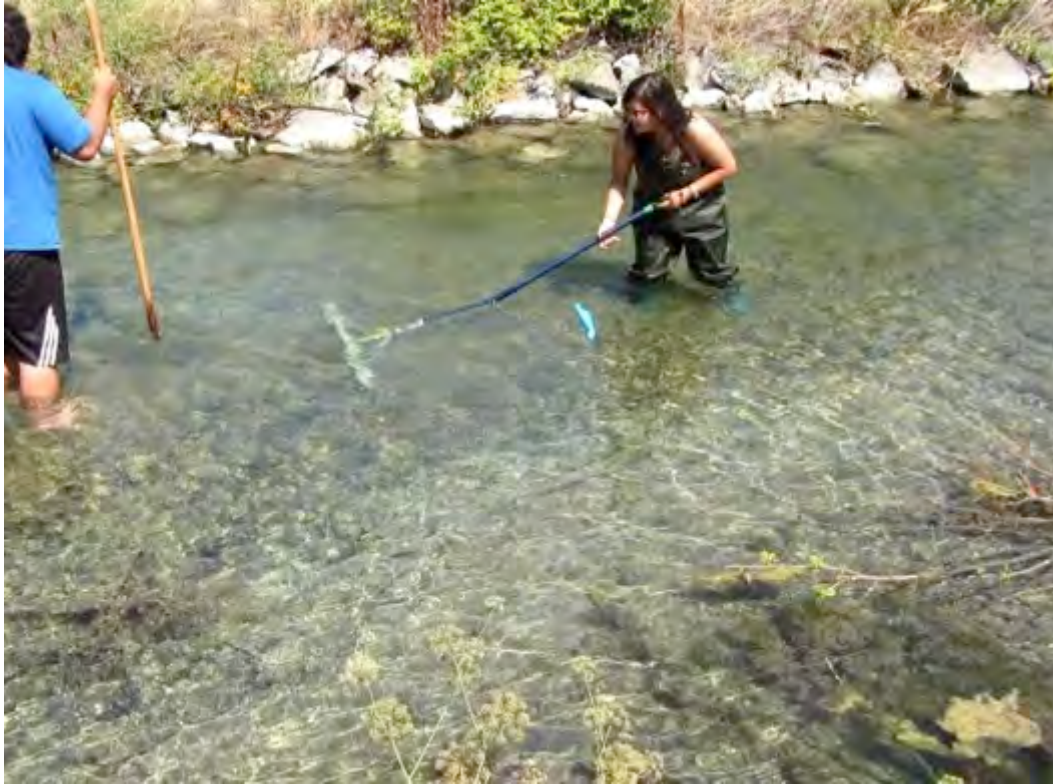
*Figure 14 Cleaning gravels using rakes Aug 2015*

Crew technicians, using garden rakes (Figure 14), cleaned an additional area of 69m<sup>2</sup> based on recommendations from Sean Bennett, DFO (Map 7). The aim behind this idea is to compare a simple raking method to cleaning gravels compared to ‘Sand Wand’ treated areas.

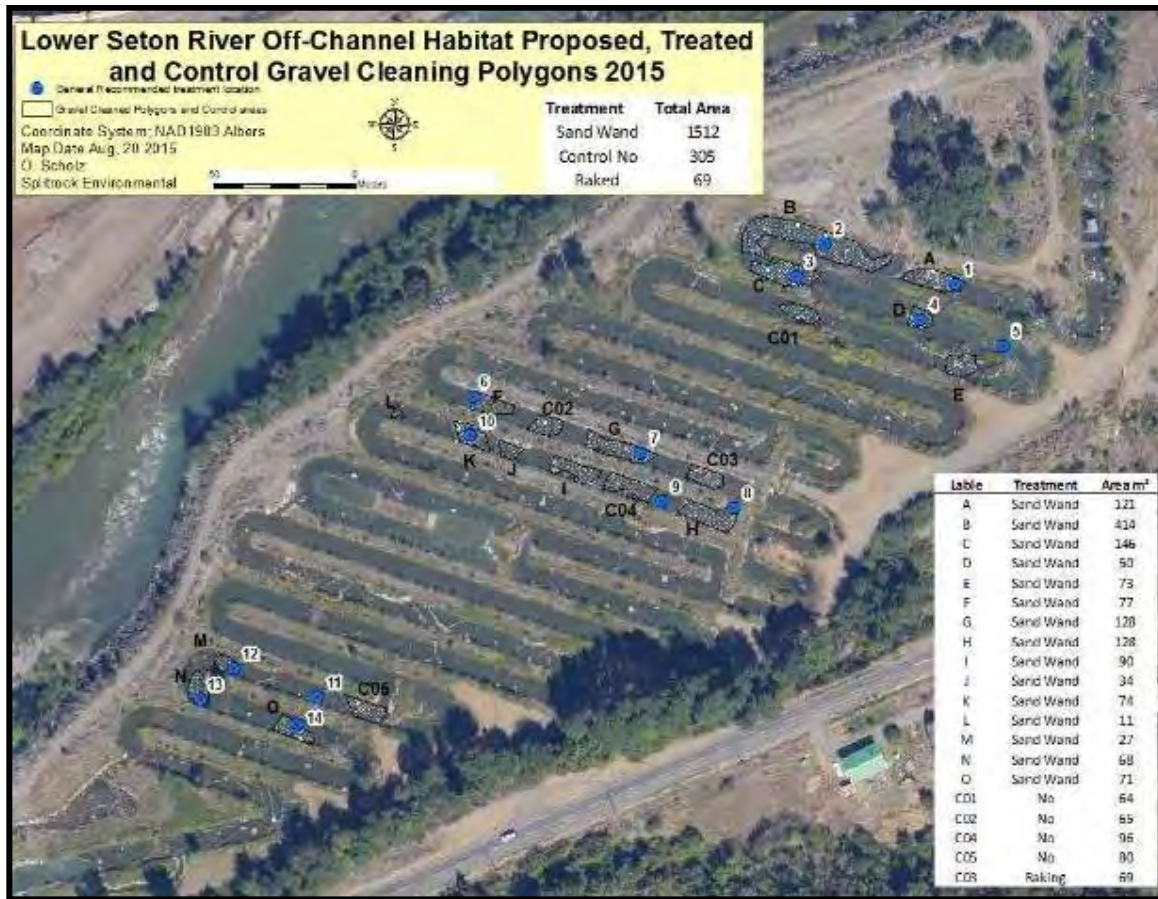
Map 7 Gravel and Control Site Locations Lower Spawning Channel 2015

Cleaning took place in August 2015 using ‘Sand Wand’ technology (Figure 13). Since the gravel cleaning process was faster than expected, 1512m<sup>2</sup> was cleaned as compared to the proposed amount of 840m<sup>2</sup>. This represents an increase in cleaned areas of 672m<sup>2</sup> (Map 7). Silts removed from the system were deposited in areas where restoration works were planned.

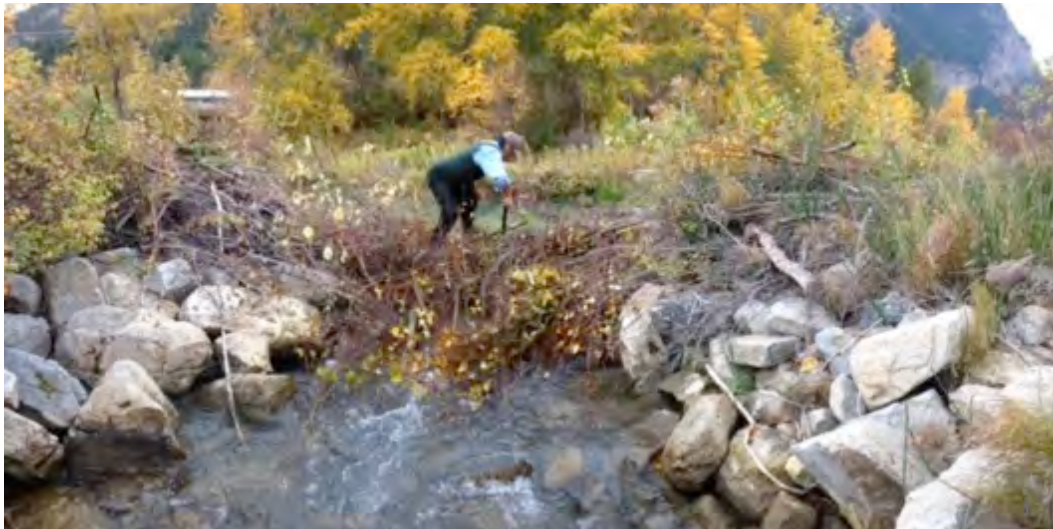
*Figure 21 Beaver dam being removed 19 Oct 2015*

Spawning Channel Committee members continue to recommend beaver control as the only option in the man-made system, to ensure bank structure is not comprised and vegetation is protected.

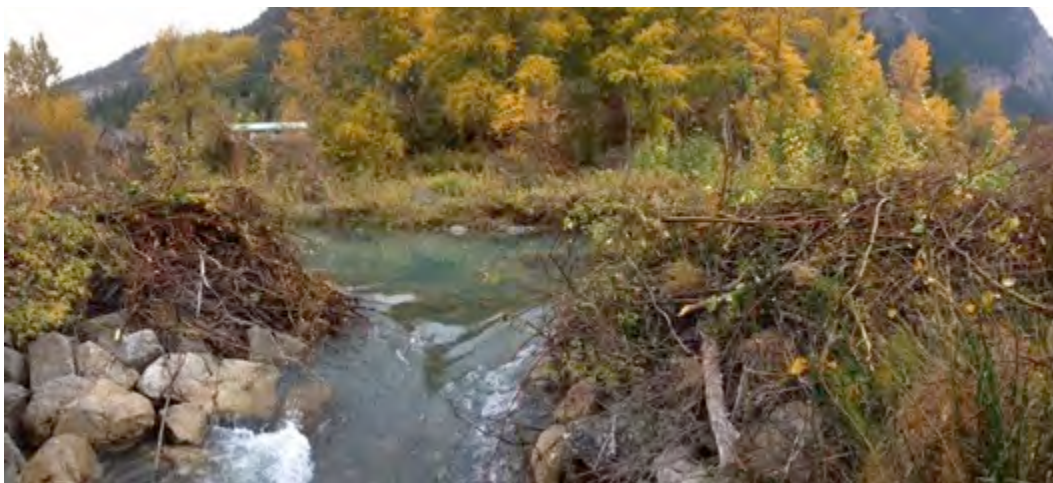
*Figure 22 Beaver dam removed 19 Oct 2015*

No new beaver lodges were constructed, but increased presence of beaver activity cutting existing vegetation was observed in November and December 2015. One beaver was removed in December and no further damage was observed until March 2016 (Figure 21, 22).

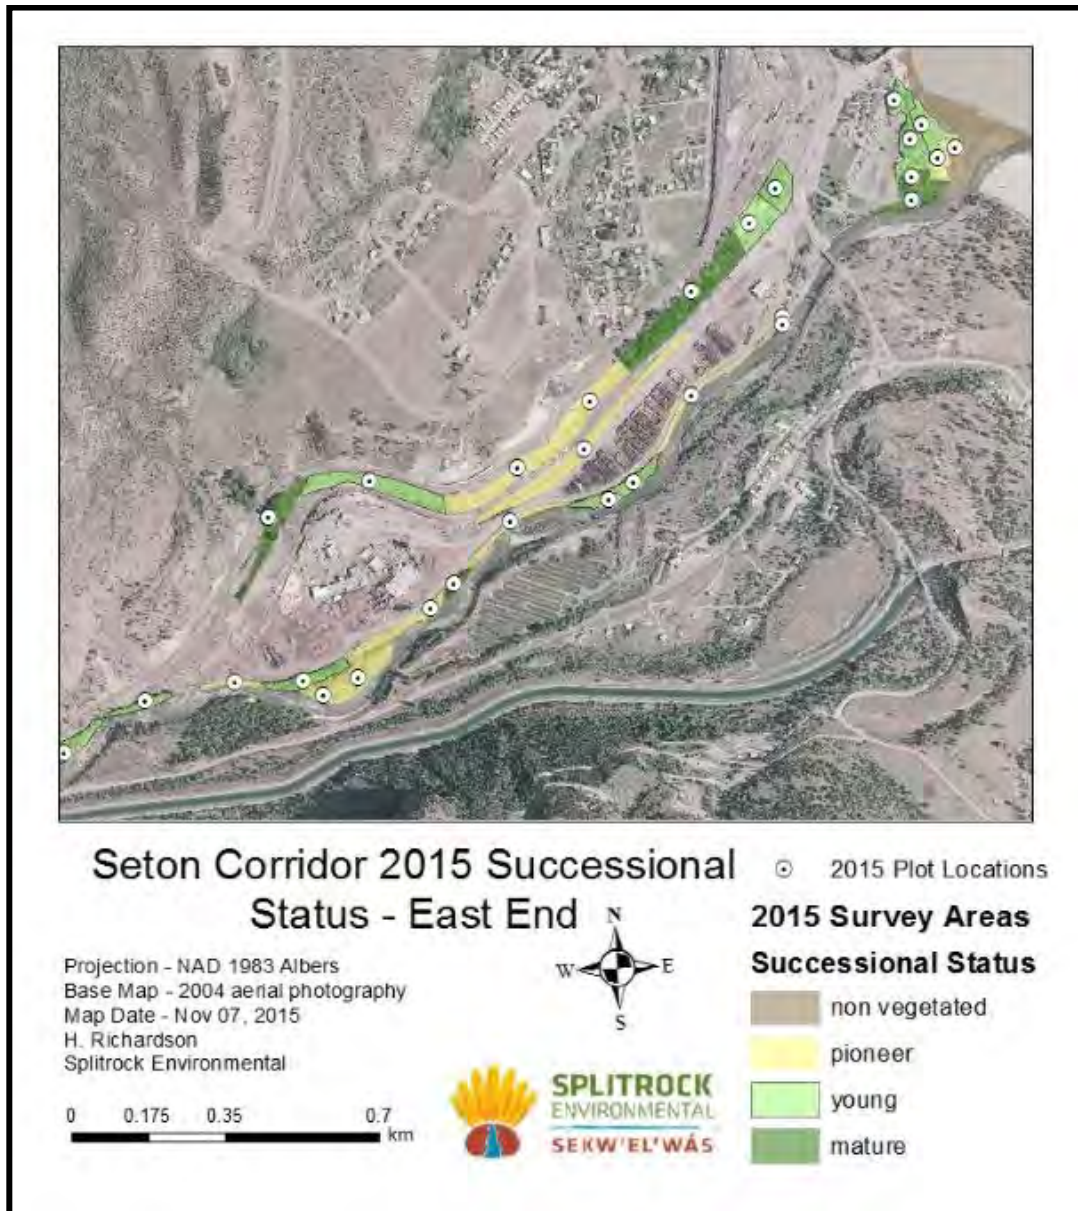
Map 19 Seton Corridor 2015 Successional Status - east

By recording the species present and aging trees, we categorized each plot as non-vegetated, pioneer, young, or mature (Map 19, 20). Non-vegetated status areas may represent disturbed areas that require restoration or areas that remain bare as a function of the unstable steep slopes and dry terrain on which they reside. Pioneer status areas have begun the process of succession and may require monitoring or assistive restoration measures to remove competing invasive species and or to speed up natural successional processes. We defined areas of young successional status as newly established ecosystems with pioneer species while areas of mature successional status represent older (>60years) forest stands.

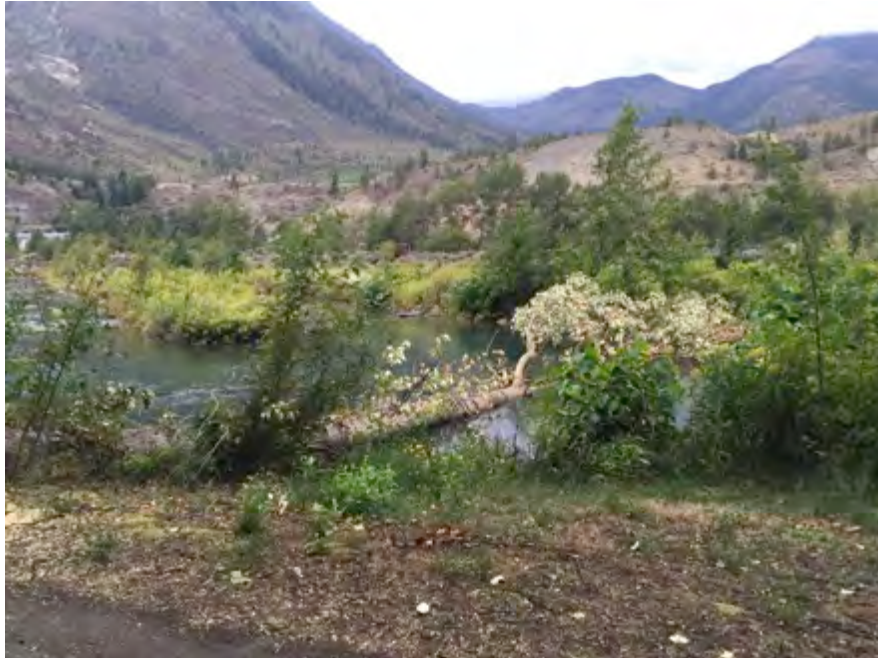
*Figure 51 Large tree placed in Lower Spawning Channel 29 Aug 2015*

During a windstorm in August 2015 a large cottonwood tree fell over the access road through the Lower Spawning Channel. The tree was cut and pushed part-way into the water to create both in-stream and riparian habitat (Figure 51).

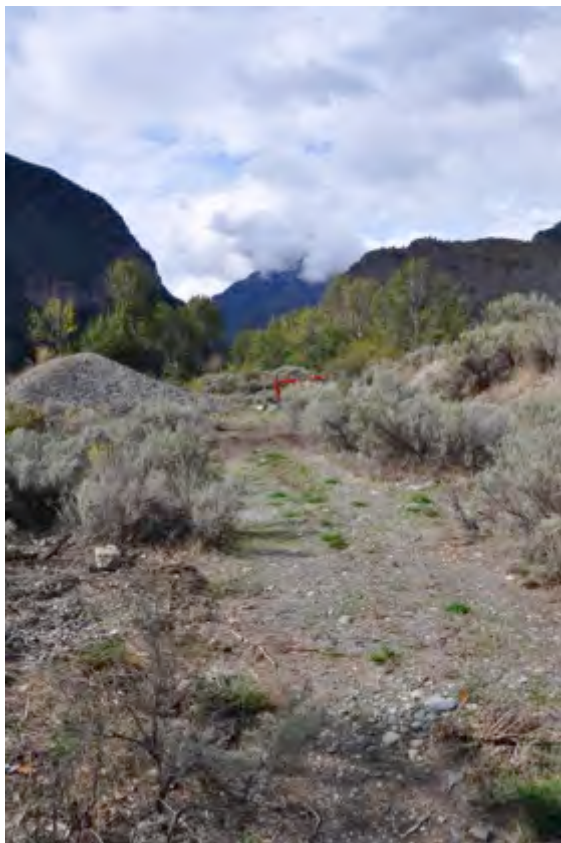
*Figure 52 Excavator preparing old road and gravel berm site Lower Spawning Channel*

An excavator was employed on 27 May 2015 to decompact an old road and dig large holes in the gravel berm and slope (Figure 52). During that time a lot of small boulders, rocks and cobbles were unearthed while soil was being manipulated to create a rough-and-loose texture for future planting. The machine operator created small piles of rocks and cobbles throughout the restoration site and kept some of the material aside for the hibernacula construction. The excavator returned to the site on 14-15 September and 05 October to fill the large holes made in the gravel berm with purchased top soils and to fill the hibernacula with boulders and rocks.

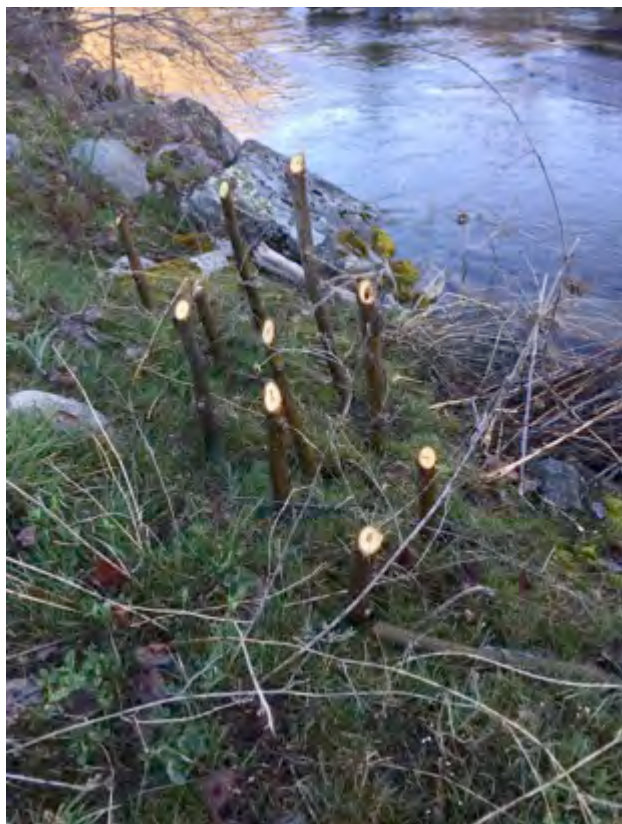
*Figure 53 Cuttings along Lower Spawning Channel berms 30 March 2016*

In mid-March 2016, black cottonwood cuttings were collected in the Seton Corridor, in an area under BC Hydro transmission lines. Splitrock has an agreement in place with BC Hydro to harvest in this area, benefitting both our revegetation efforts and BC Hydro's vegetation management program. Between 22-24 and 28-29 March 2016, seven crew technicians successfully planted 2,255 cuttings long every second berm at the Lower Spawning Channel (Map 35, Table 25, Figure 53), with the goal of increasing shade to reduce deil water temperatures and temperature fluctuations that put fish at risk. An additional 692 potted plants were planted on the berms above the water level to supplement the cuttings and along the hillside near the bird blind (Map 35, Table 25, Figure 54). The estimated area planted along every second berm and around the spawning channel is 8,100sqm.

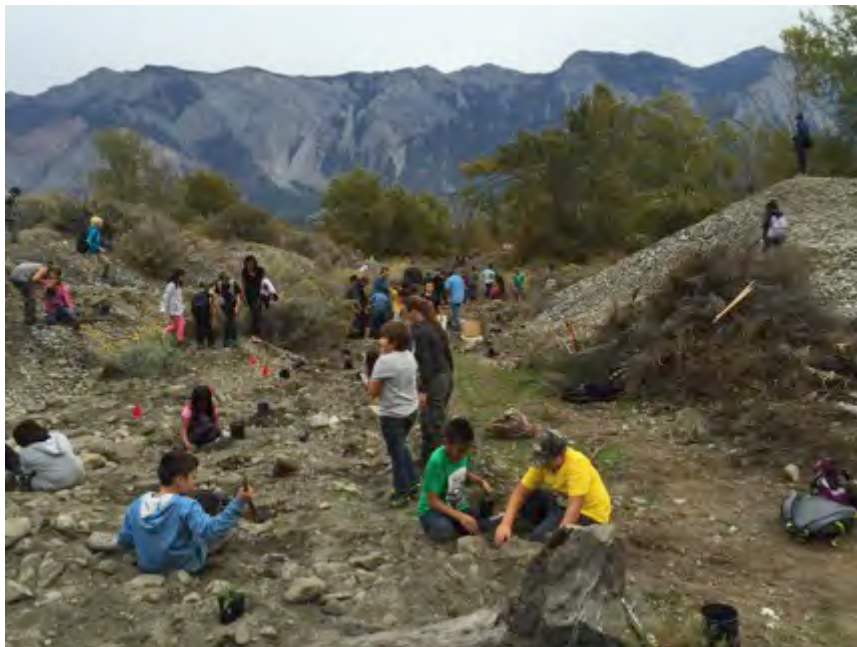
*Figure 55 Planting Old Road/Gravel Berm Area Lower Spawning Channel 07 Oct 2015*

During April, May and October 2015, potted native species were planted at the Lower Spawning Channel. This work was possible due to leveraging of additional funds from AFSRA for the benefit of the listed gopher snake and western screech-owl. Planting took place after an old road at the Lower Spawning Channel was deactivated and planting pockets dug into an old gravel berm left over from the recomplexing of the channels. Crew and volunteers attending the Walking with the Smolts and Fall Stewardship events planted a total of 547 riparian species and 1,726 grassland species over a 2,010sqm area (Map 35, Table 25, Figure 55).

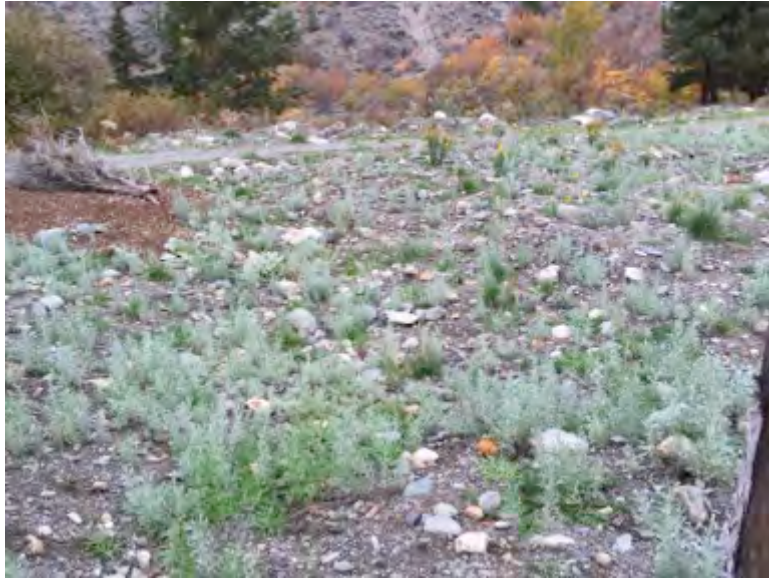
Figure 56 Increase in density/remove sage Upper Spawning Channel 07 Oct 2015

Sage seedlings were also thinned out while still small so that they do not overcrowd the native species in the future, in an attempt to decrease sage levels as has been observed at the Powerhouse site.

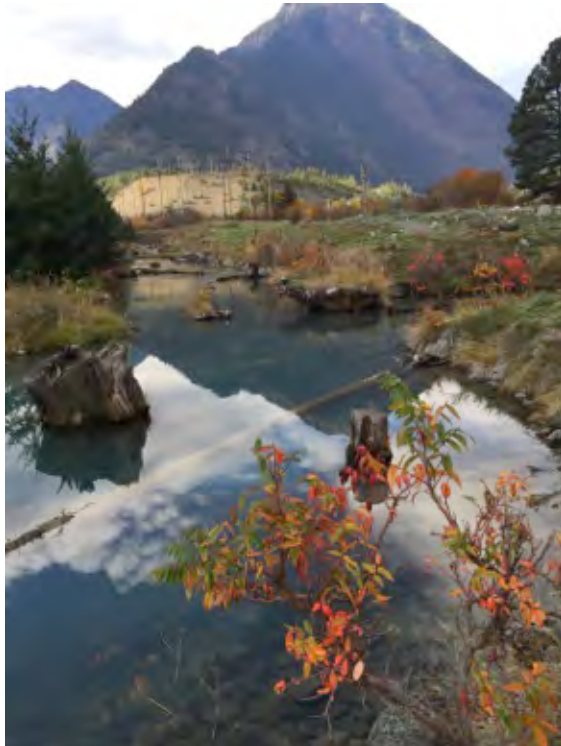
Figure 57 Restoration site showing lack of trees/shrubs 22 Oct 2016

At the upper spawning channel planting occurred on 23 and 27 October 2015 by crew technicians and volunteers from the local schools and community during the annual fall stewardship days. A total of 729 plants were stocked into 2,277sqm area to increase density and to replace several dead fir trees (Map 36, Table 26, Figure 56, 57).

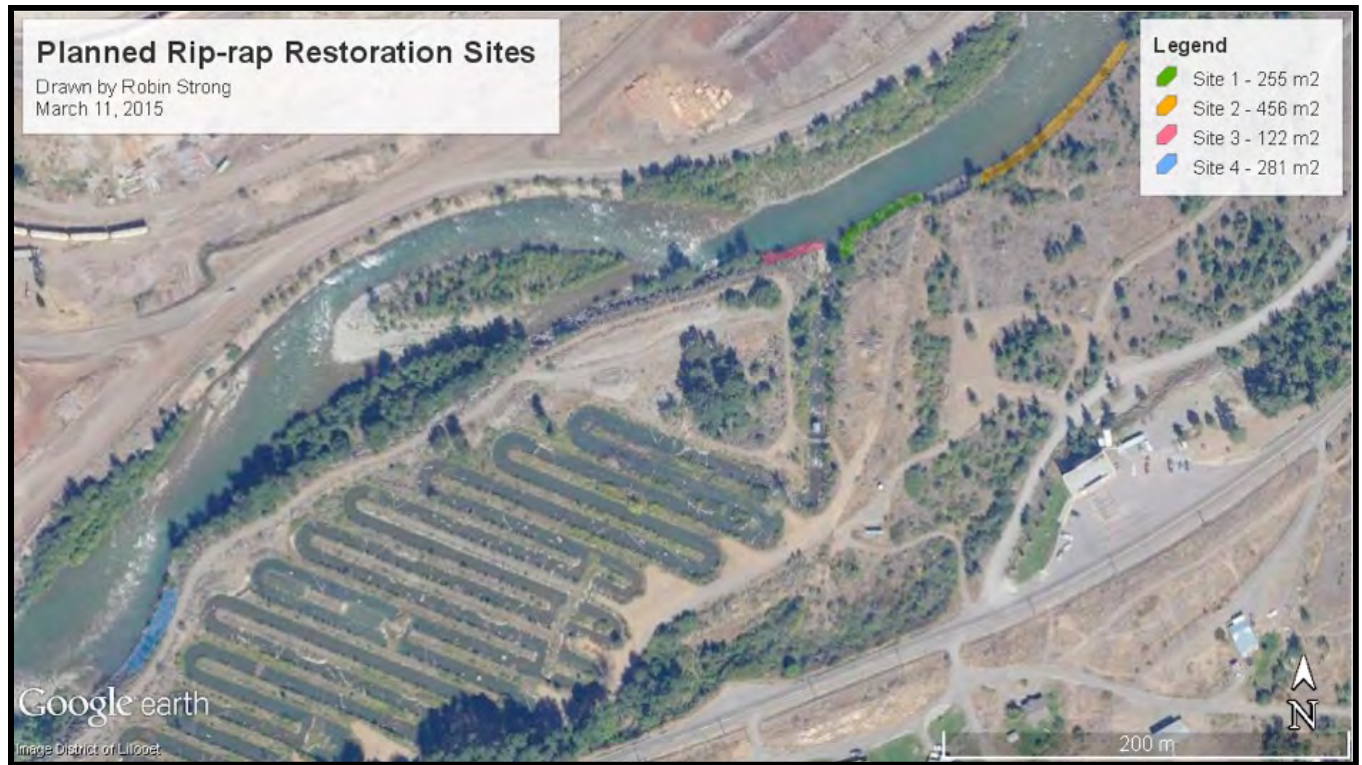
Map 37 Seton River Riprap Restoration Locations 2015

More information about the restoration methods can be found in the 2014-2015 FWCP Final Report (North & Scholz, 2015), and in “Natural Processes: Restoration of Drastically Disturbed Sites” by David Polster (2011).

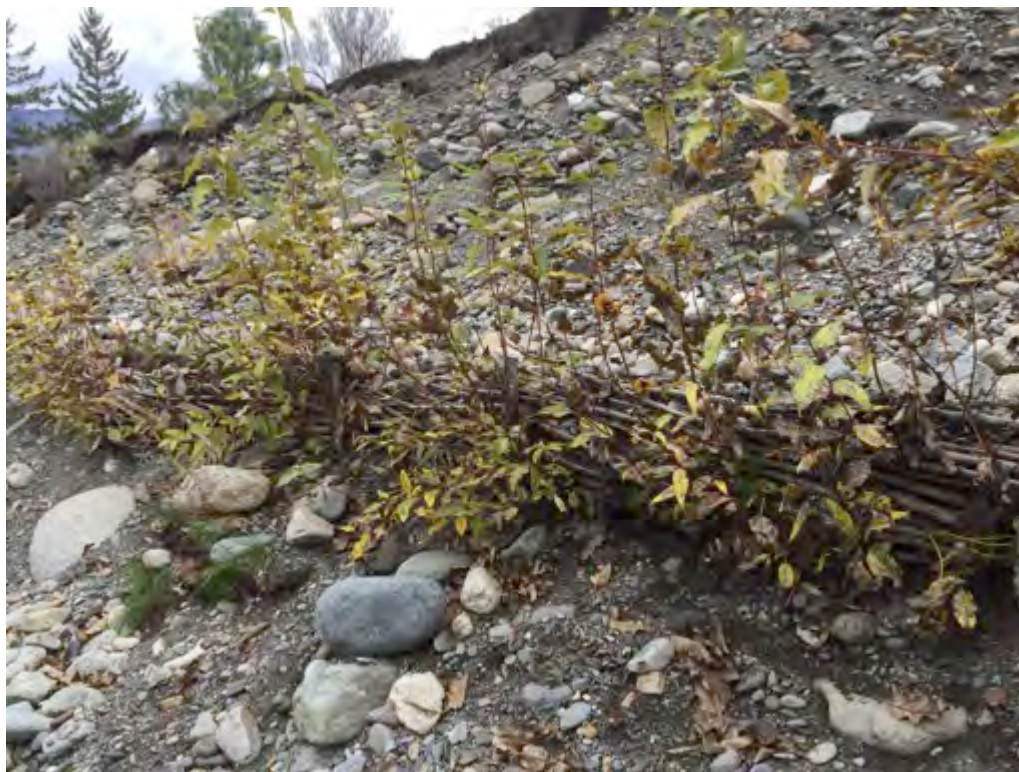
Figure 58 Wattle fence 1 06 Seton River 06 Oct 2015

Five of six wattle fences sprouted and grew (Table 34, Figure 58), and we expect these fences to gain structural strength as the cuttings grow. One wattle fence sprouted and then died. The most vigorous wattle fence, Fence #2, was located on the lower slope near the high water mark. Wattle fences above the high water mark sprouted in spring but partly died back in the hot summer months when soil moisture was scarce. Wattle fences below the high water mark sprouted in spring, were submerged for a period of time, and survived the dry summer months. The dead wattle fence is providing erosion control, but will lose structural integrity as the cuttings rot or are washed away. It will be interesting to resurvey in spring 2016 to see if this fence will re-sprout. See Table 34 below for summary of results.
