# FINAL REPORT 2015 – 16

## Seton River Corridor Conservation and Restoration Project

Project No.: FWCP 16.W.SON.01, 2015AFSAR2498, PSF CSP15S030

Prepared by: Splitrock Environmental Sekw'el'was LP  
Box 798  
Lillooet BC V0K 1V0

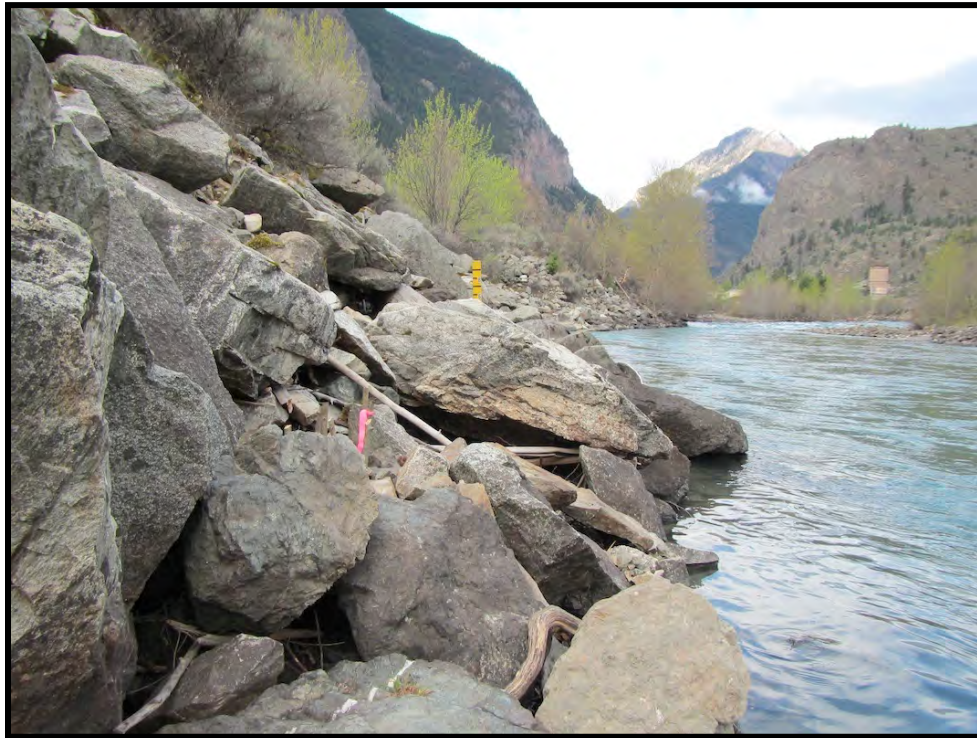
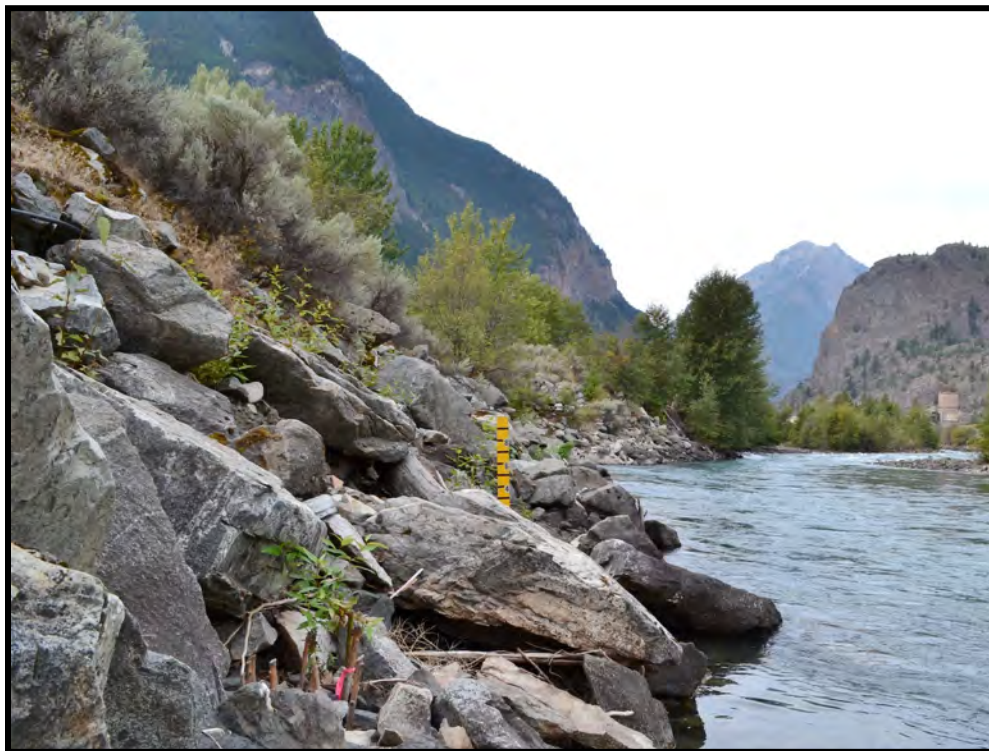
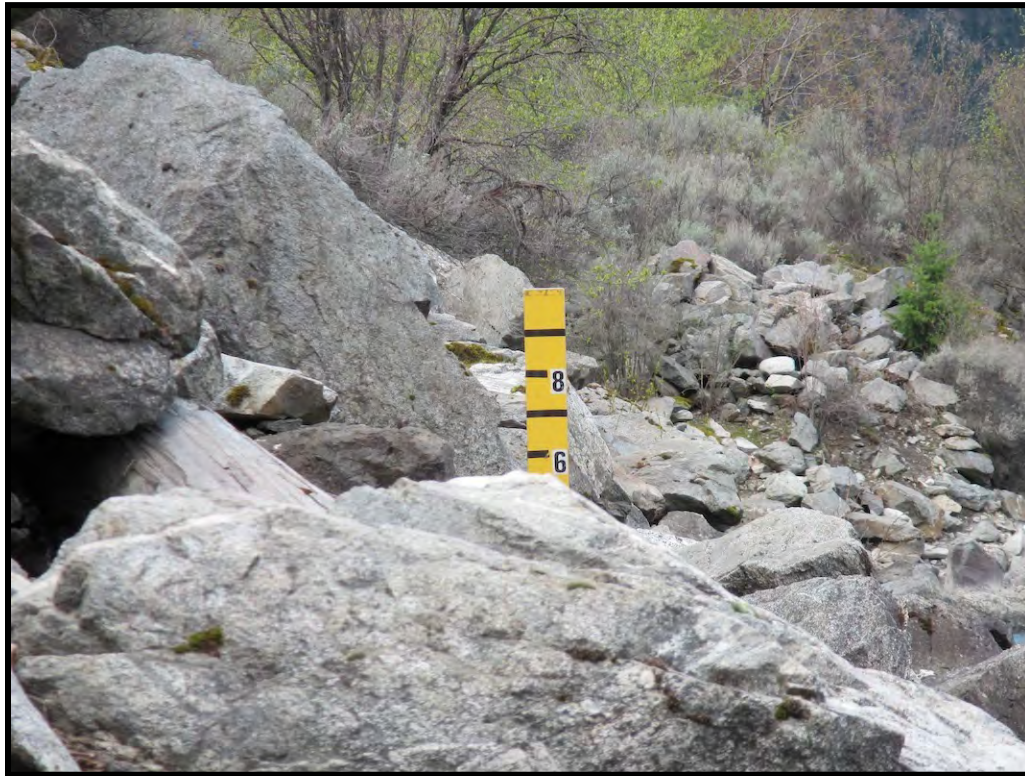
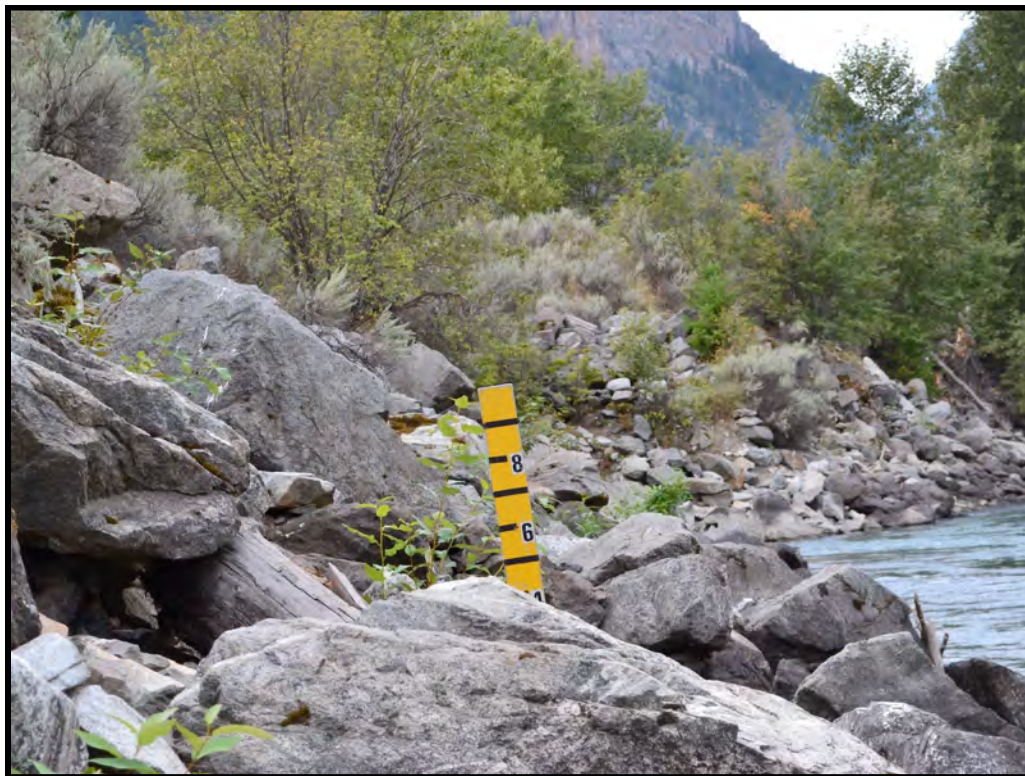
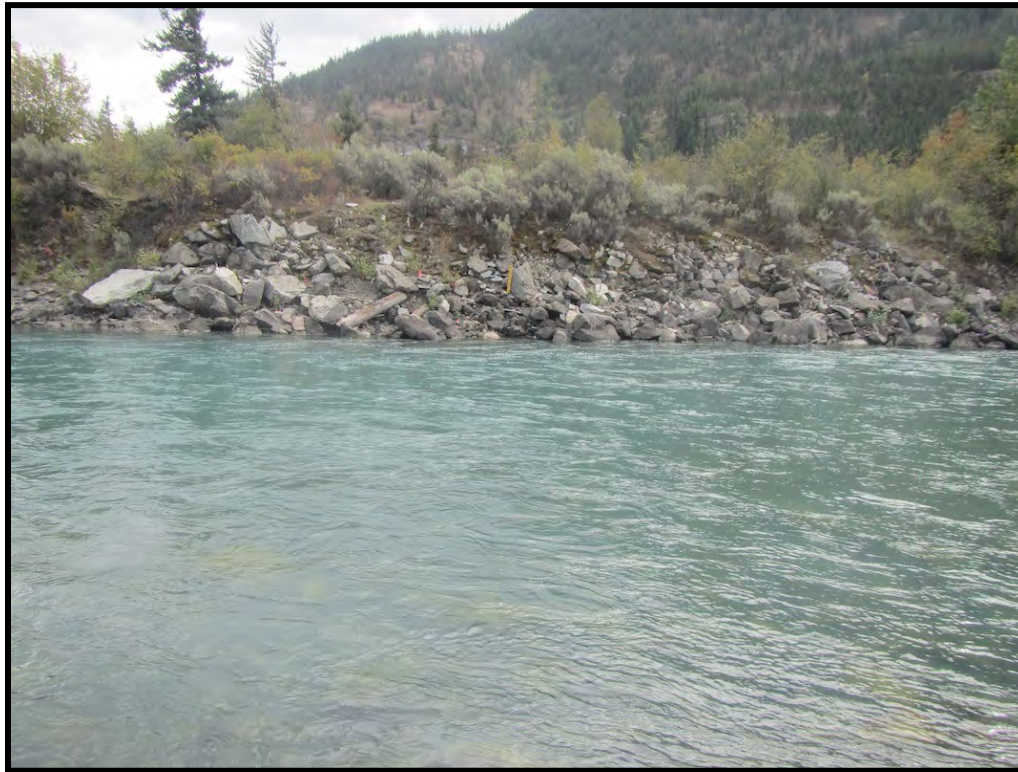
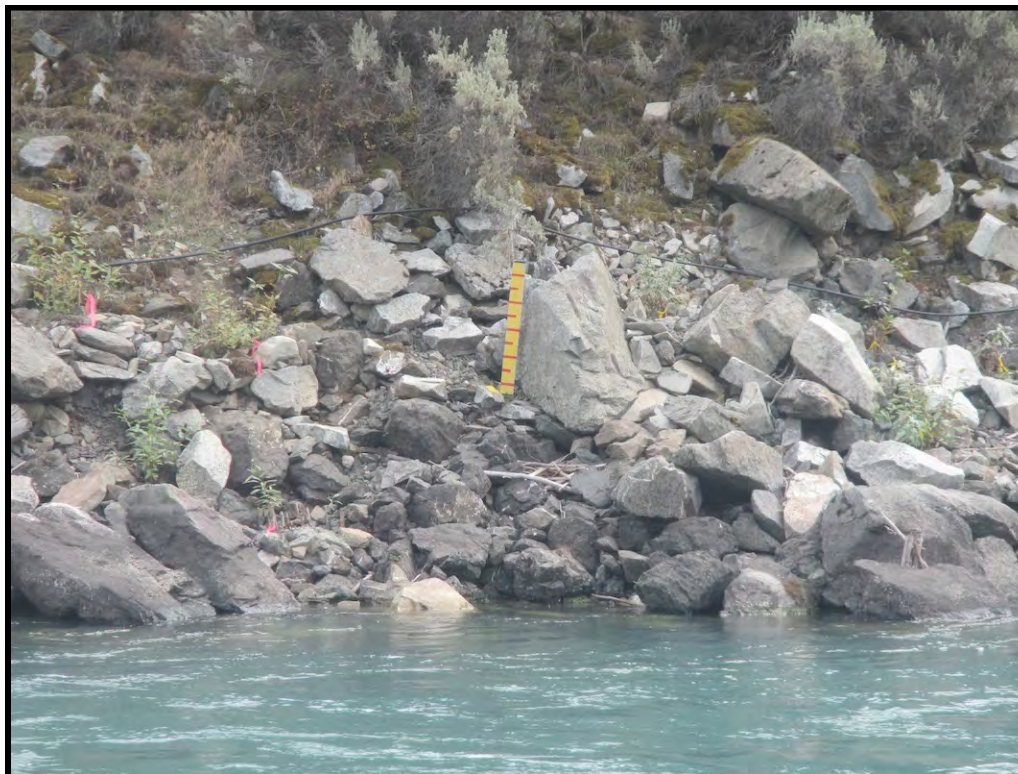
Eight photo points were established to track changes in the vegetation. Four photo points were set up in March 2015, and four more were set up in September 2015. Figures 59 to 83 show the results of the photo point monitoring.

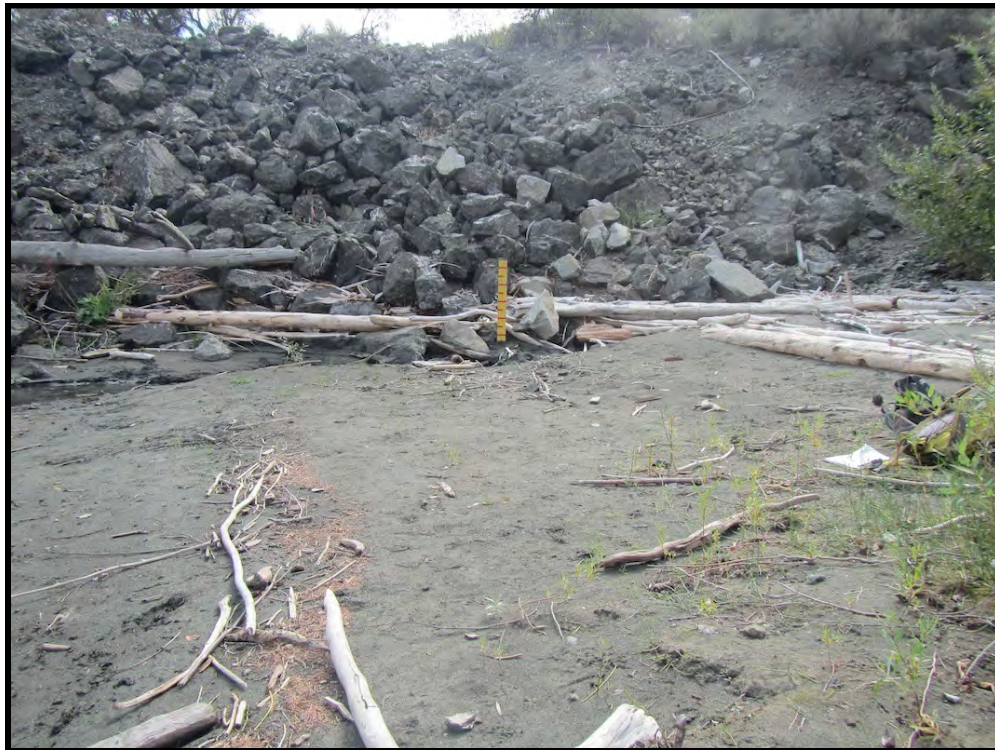
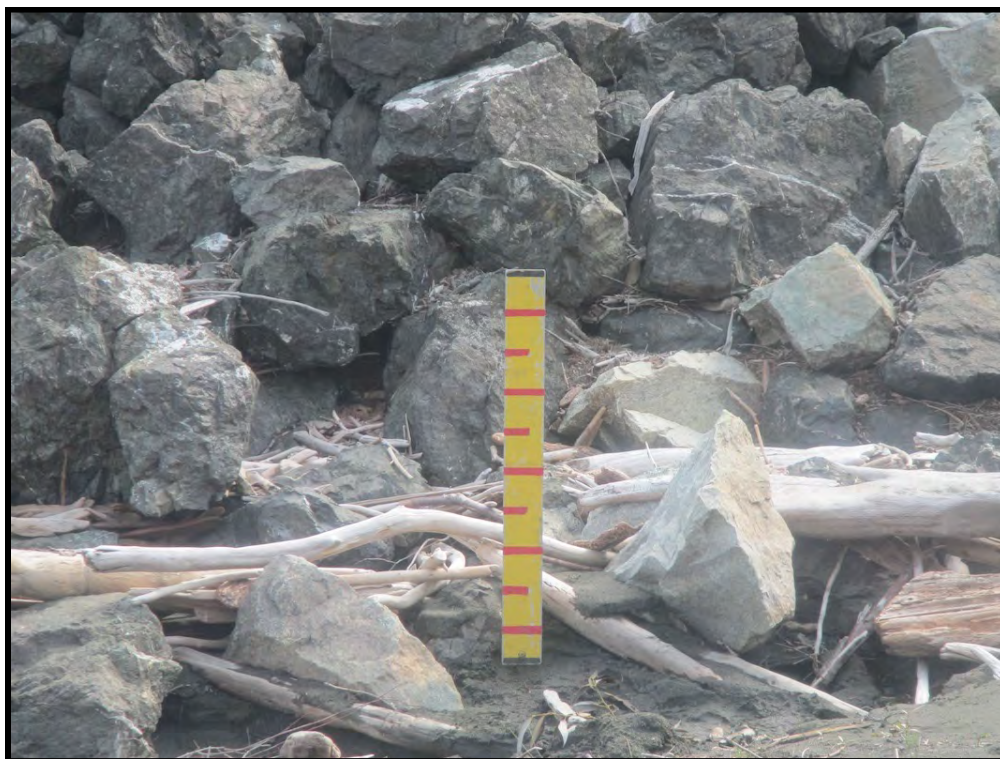
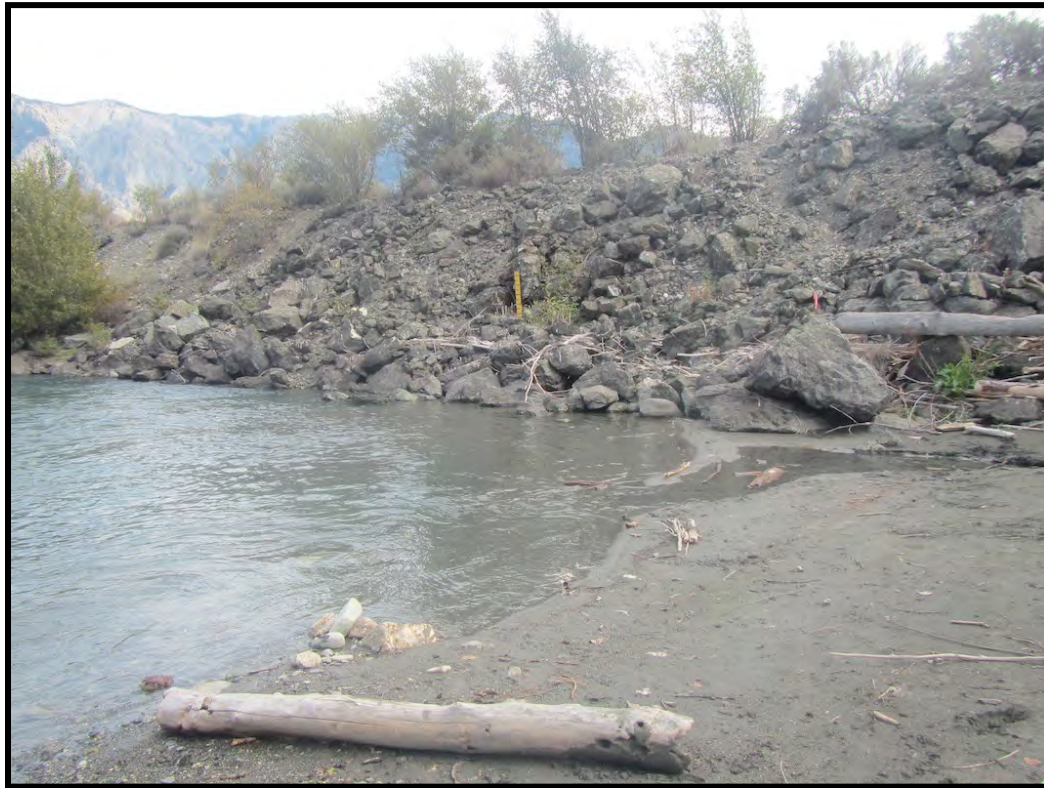
The following photos were taken in September of 2015 in the new location.

*Note: The location of this photo point has been changed, since the existing vegetation blocked the view of the stream bank when the leaves emerged in spring. The following photos were taken in September of 2015 in the new location.*

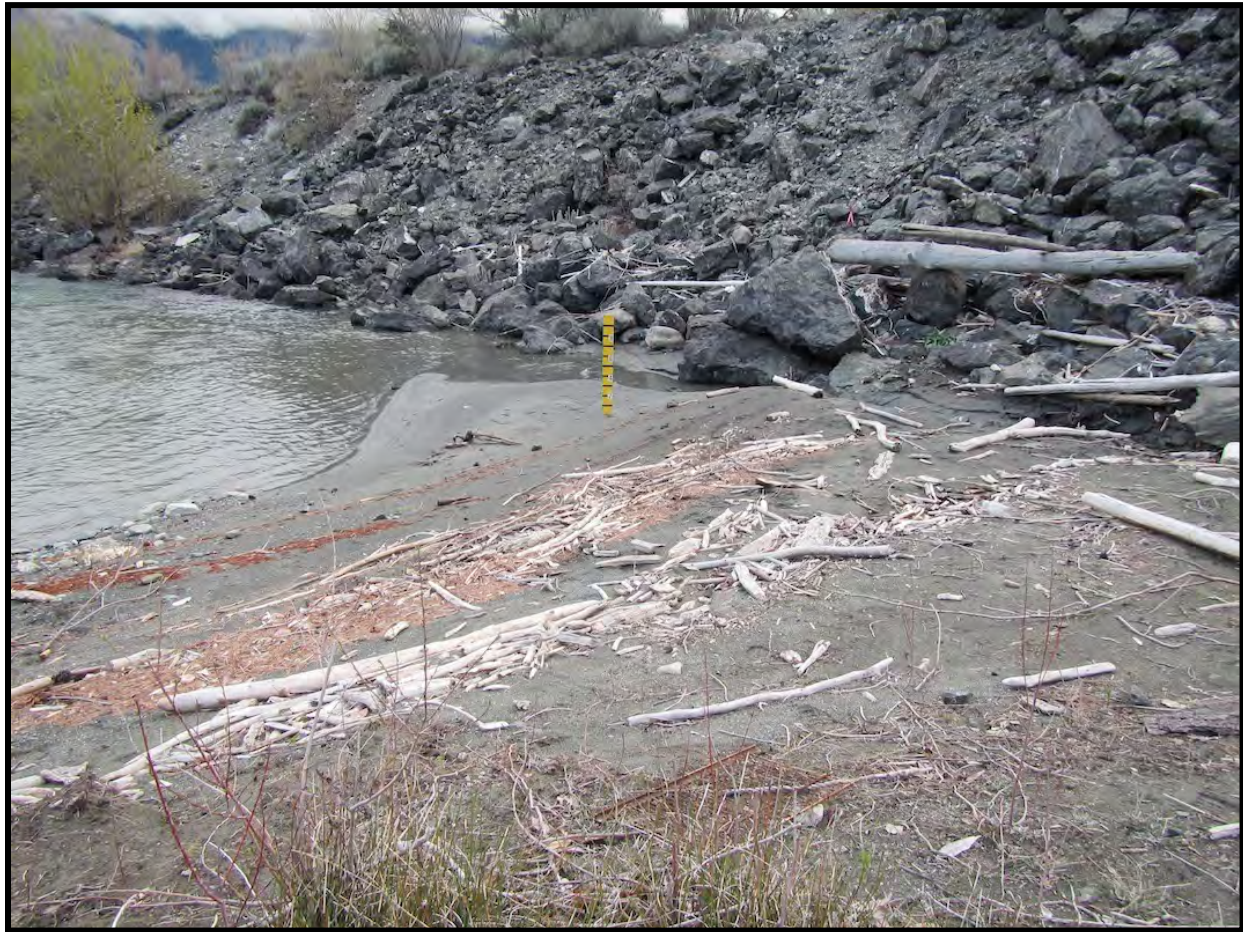
*Figure 79 Photo Point Monitoring - Site 4 PP 2; 30 March 2015*

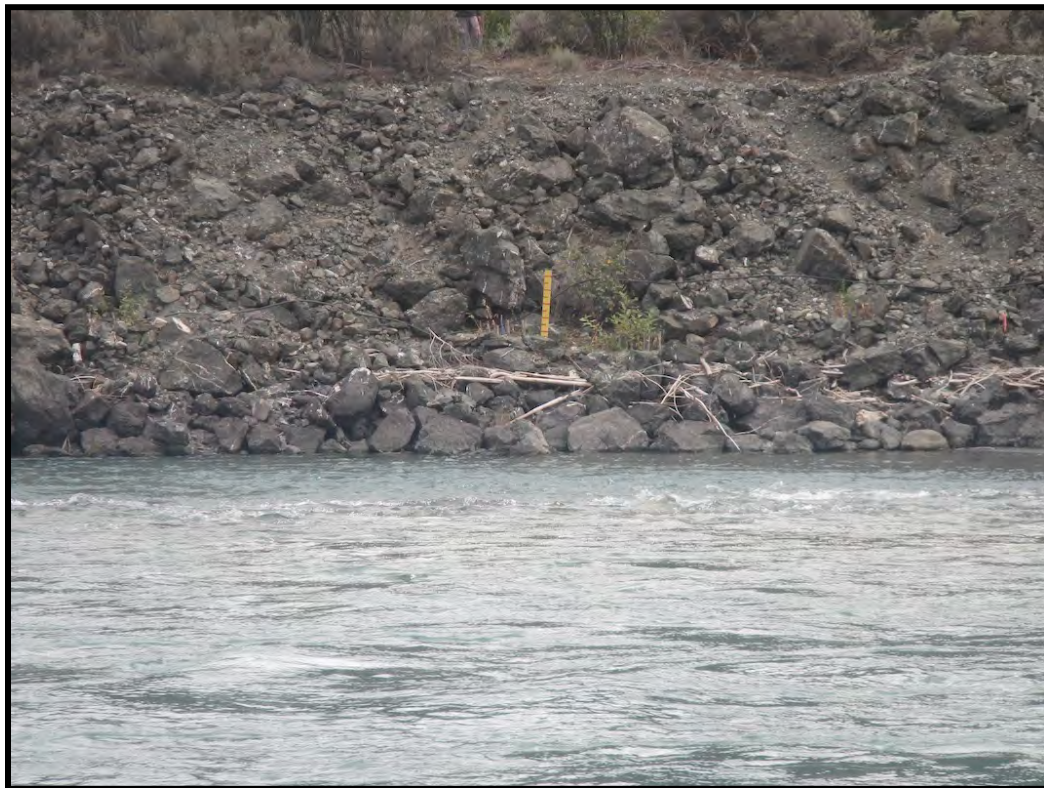
*Figure 83 Photo Point Monitoring - Site 4 PP 5, zoomed, 16 September 2015*

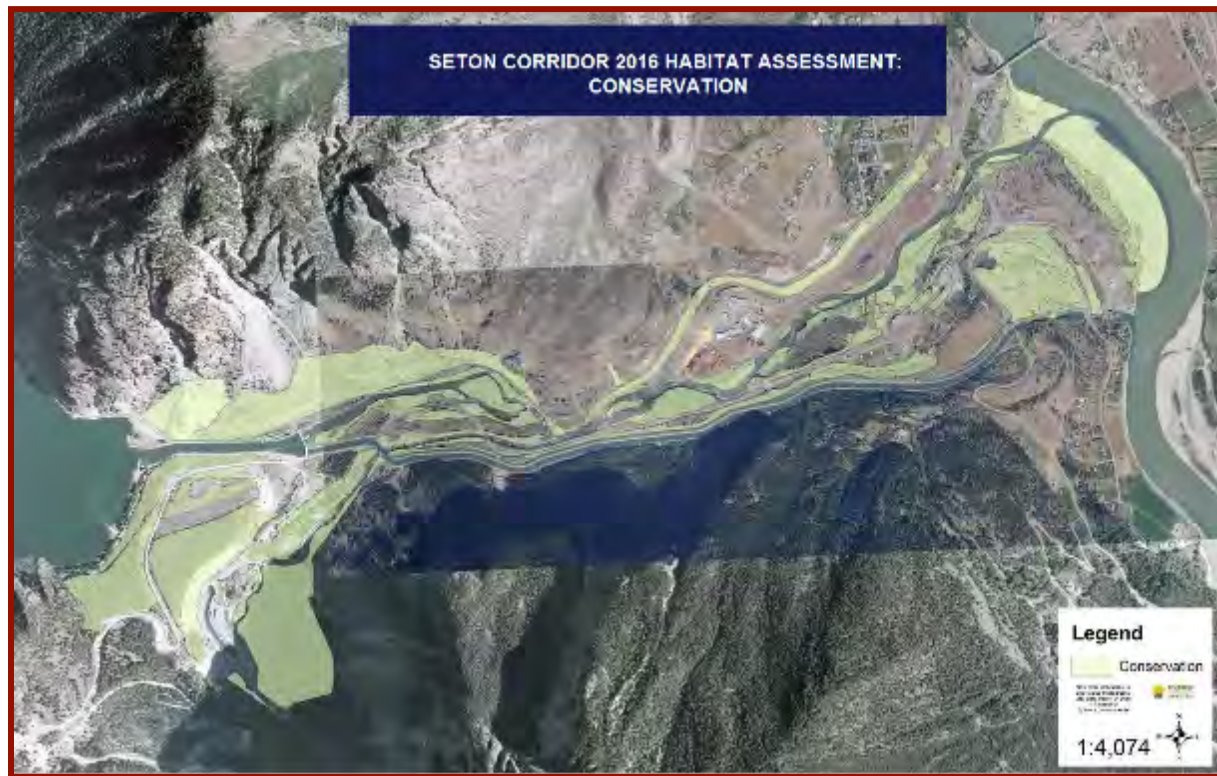
Map 39 Seton Corridor Habitat Assessment 2016 - Conservation

Habitat Assessments highlighted seven main areas as priority conservation zones due to their high ecological value. The intact riparian areas and side-channels were also highlighted for conservation and occur along the length of the Seton River, as well as areas along the bank above Aspen Planer. The areas that have some of the larger intact areas left in the corridor occur in all three locations (Map 39, Table 39).

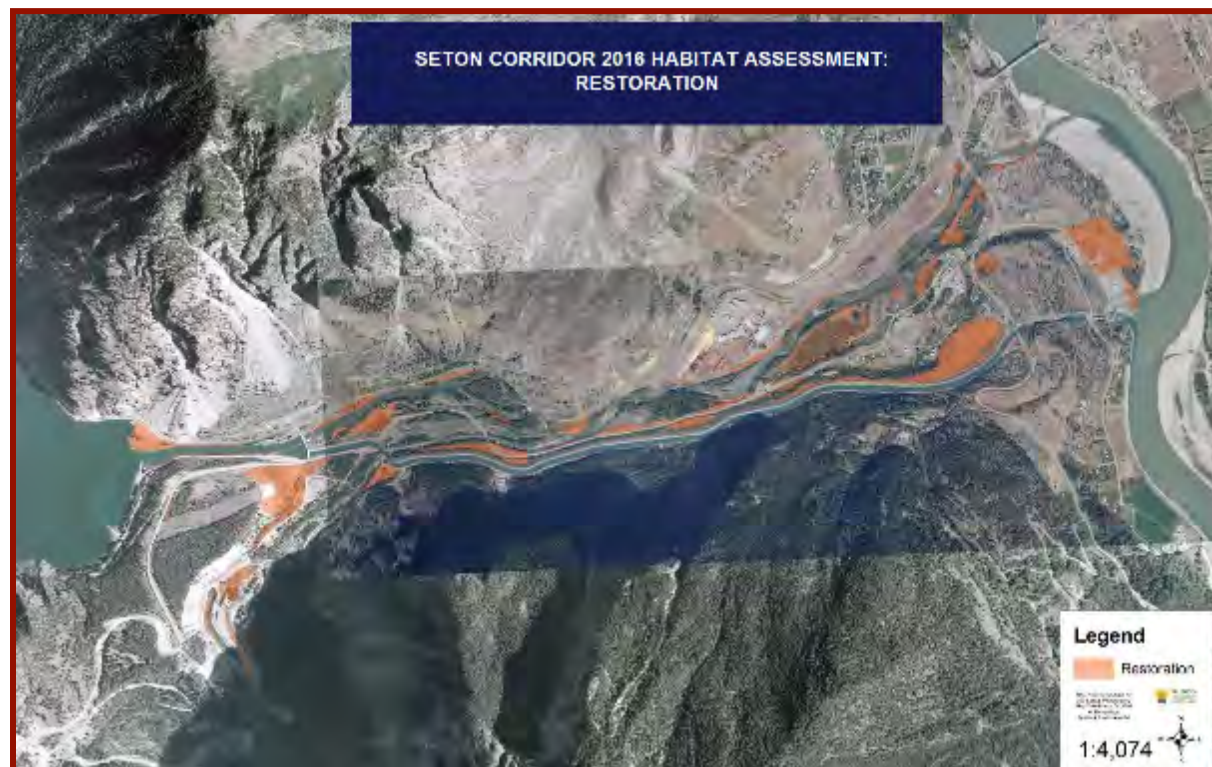
Map 40 Seton Corridor Habitat Assessment 2016 - Restoration

Habitat assessments identified the sparsely vegetated disturbed flats on the north side of Seton River as regions suitable for restoration. Areas include an old mill/lodge site on the edge of Seton Lake and areas alongside the tracks. CN Rail was not present at the stakeholder meeting and the communities again reiterated the importance of CN being involved in the process.

After consulting with the partners, it was noted that land use planning is also underway in the areas around Seton Lake Campground and Cayoose Flat (shaded red Table 39). A field tour will be scheduled for land planners. Restoration will not be planned for an area unless the area can be conserved afterwards. For the complete management planning process working document, see Attachment 4.

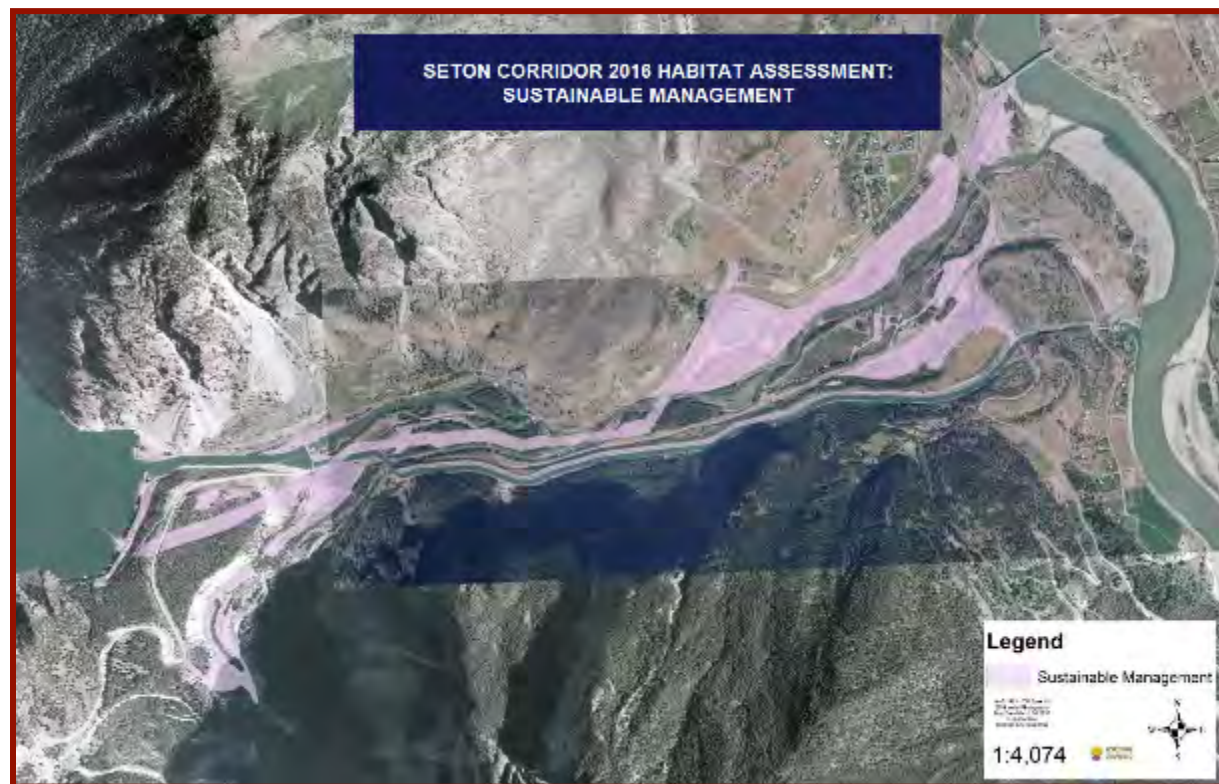
Map 41 Seton Corridor Habitat Assessment 2016 - Sustainable Management

Because of the steep topography of the Seton Corridor and the industrial and recreational activity, there is little available space for wildlife to move through the corridor. Therefore, it is important to develop relationships with the industrial stakeholders in order to develop best practice strategies. Key partners identified to pursue sustainable management strategies include Innergex, BC Hydro Transmission, Operations and Parks, Ministry of Transport and Interior Roads, CN Rail, Aspen Planers, Lightfoot Gas, Splitrock Nursery, District of Lillooet. Representatives of all the identified groups have agreed to work towards developing sustainable management strategies, excluding CN Rail who has only been represented at one meeting (Map 41, Table 41).

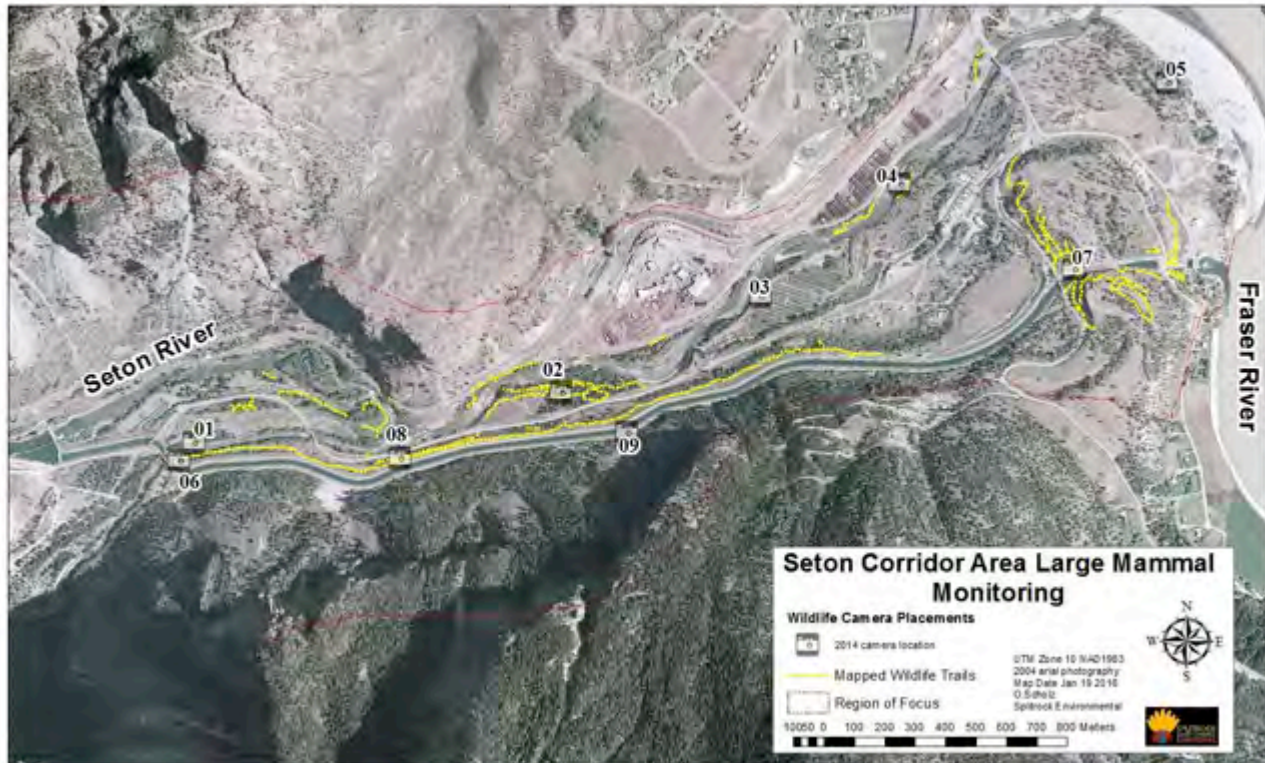
Map 42 Seton Corridor Identified Wildlife Trails 2010-2015

A number of wildlife travel routes have been identified within the corridor (Map 42) and will be assessed during 2016-17 to see how they connect with areas of high ecological value. This map does not show the wildlife trails observed at the Powerhouse site, but wildlife are moving from the canal area (Camera 07) over Mariposa Flat and down to the riparian areas along the Fraser River.

Wildlife may be crossing the Seton River at one of the narrowest points in the corridor (near Camera 02), and are definitely crossing through the landscape at both ends of the canal (near Camera 01, 06 and 07). Wildlife trails observed running east-west above the highway and below the canal may be shown to be important for the movement of wildlife away from the highway. Deer bedding/fawning areas and bear resting places have been identified and trails come and go from these areas.
