**STAVE RIVER WATERSHED – RESTORING SALMON SPAWNING,
REARING AND OVERWINTERING HABITAT**

FWCP No: 16.SFN.01
Prepared for Fish & Wildlife Compensation Program

Prepared by
Natashia Cox, BA.,EP.,RB.Tech
Project Manager
Fraser Valley Watersheds Coalition (FVWC)

STAVE RIVER WATERSHED -RESTORING SALMON SPAWNING, REARING AND OVERWINTERING HABITAT

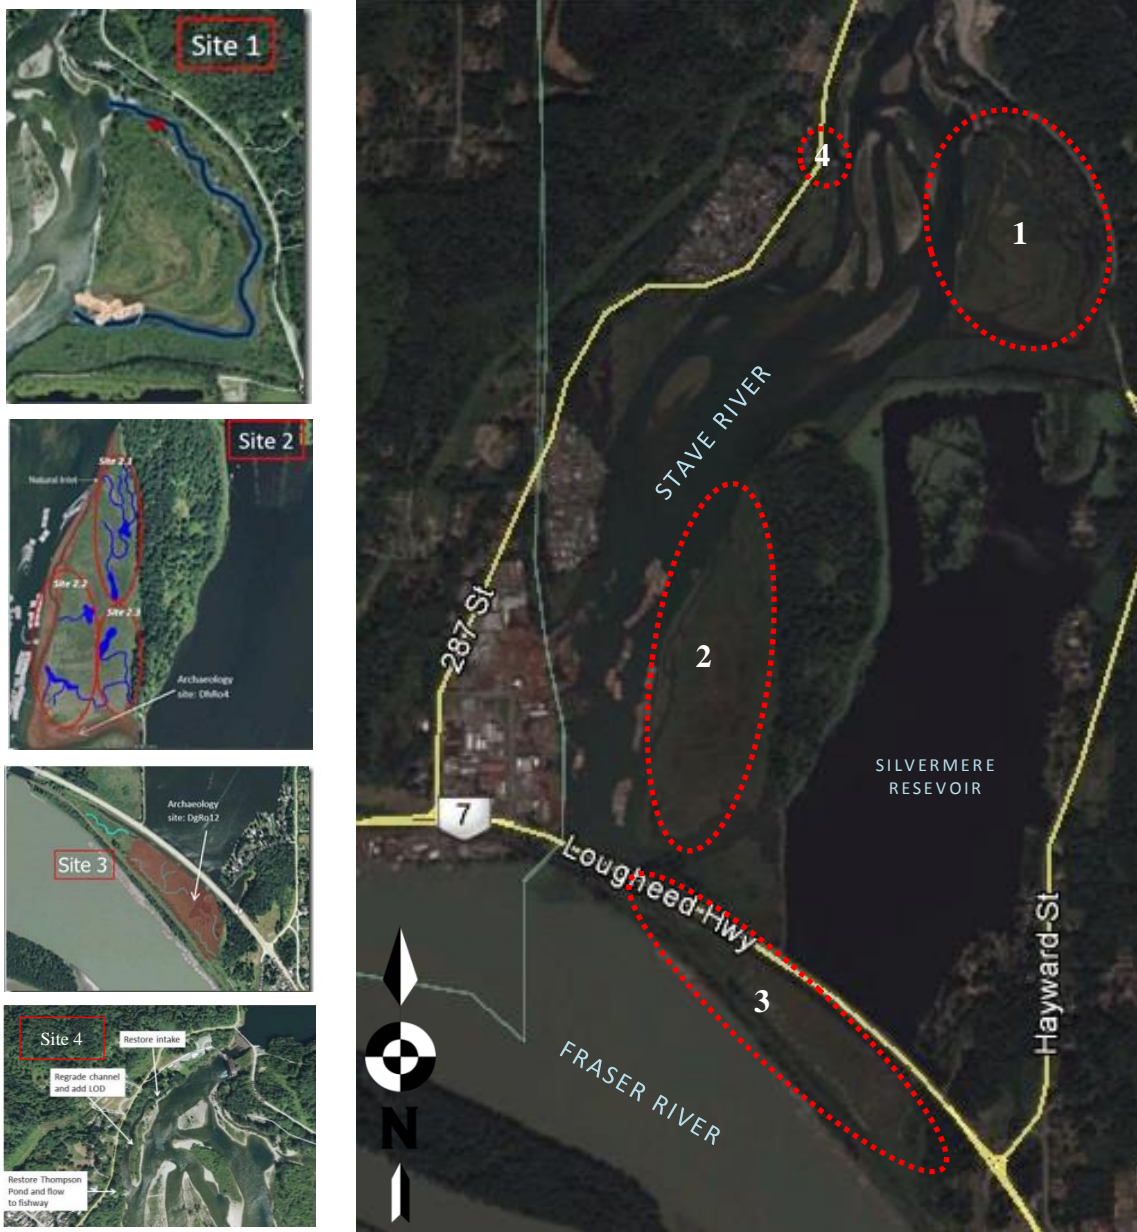
Figure 1. Locations of Restoration Project Sites within the Lower Stave Rivers Images © Google Earth.

The associated projects are located in the Stave River Watershed within the municipal boundaries of the District of Mission, Silverdale community, and Fraser Valley Regional District (Figure 1). The Stave River flows south-southwest from the Hayward Lake reservoir and joins the Fraser River. Four main restoration project sites were identified for restoration activities over the next several years (2014-forward). Restoration and associated assessment works completed under the 16.SFN.01 project occurred at all Project Sites: 1, 2, 3 and 4.

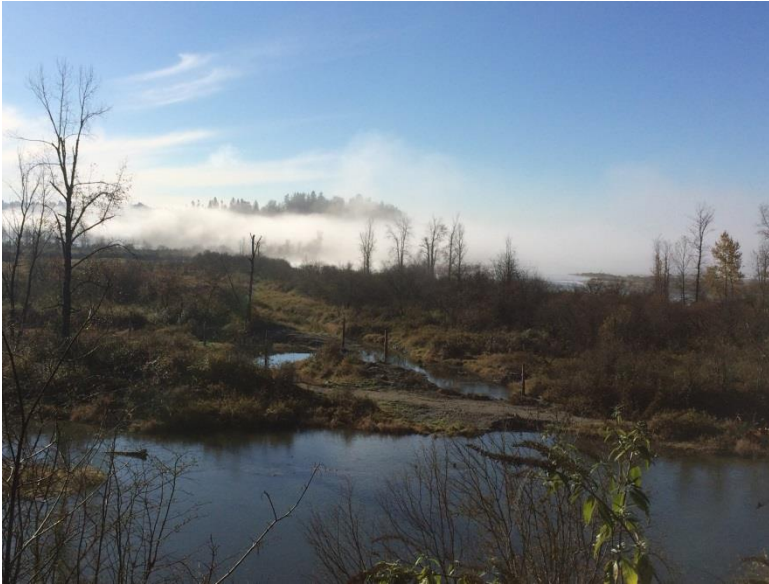
6.1 SITE # 1- RUSKIN ISLAND

The challenge associated with Site # 1 (see Figure 1) was the need to improve sustained flows into the recently constructed off-channel habitat in Ruskin Island. Recent beaver activity and fluctuating Stave River flows had limited the volume of water passing through the existing culvert into the channel and limited the viability of the habitat, and its connectivity back to the Stave River downstream.

In addition, the previous placement of the intake created a blind-back-channel pond. The replacement of the intake enabled direct flows, eliminating this pond, and increasing the overall water quality for that habitat. The priority was to replace the upstream intake with a larger intake to provide greater flow volumes and improve the off-channel habitat conditions. The work was completed in the 2015 In-stream Fisheries Works Window under the direct supervision of DFO.

Using an excavator the old intake was removed and replaced with a 914 mm diameter Boss 2000 corrugated, high-density polyethylene pipe. The pipe connected the flows from the back-channel along the Site 1 Ruskin Island to those within the islands off-channel habitat. (See Appendix 1. Project Photo-Documentation)

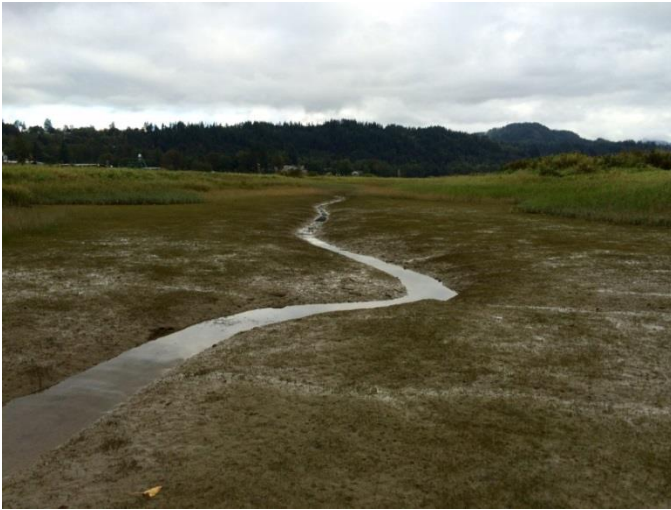
6.2 SITE # 2 – KWANTLEN FIRST NATION IR3 ISLAND

The need for salmon habitat restoration at this site reflects the profound encroachment from invasive reed canary grass (*Phalaris arundinacea*) creating a monoculture, engulfing the natural sedges and aquatic vegetation. The grass has formed dense mats that alter the physical and chemical composition of the existing channels. Through its decomposition, it reduces the availability of oxygen for salmonid species and has filled-in historical

channels at this site. In addition, some encroachment from Himalayan Blackberry (*Rubus armeniacus*) along the riparian areas and toe of western-edge hillslope was also observed.

Site # 2 (see Figure 1) was the original habitat targeted for restoration activities. It is owned by Kwantlen First Nation and is situated within a known archaeological hot-spot, requiring the completion of archaeological and species-at-risk assessments. However, Kwantlen First Nation had not finalized their land management plans before the 2015 Instream Fisheries works window and thus, only the archaeological assessment, species-at-risk inventory, and Vegetation assessment memo, work was completed. The archaeological assessment identified significant cultural features that will need to be protected during future restoration activities at this site. It also identified numerous opportunities for restoration in low-lying areas and within historic and existing channels that would be consistent with the conceptual restoration plan. Considerations for existing nesting western painted turtles will be required, especially at access routes for mobilizing heavy machinery and equipment. In addition, a blue-listed taxon in BC, false-pimpernel *Lindernia dubia* var. *anagallidea*, was found on the tidal mudflats along the west shore of Site #2.

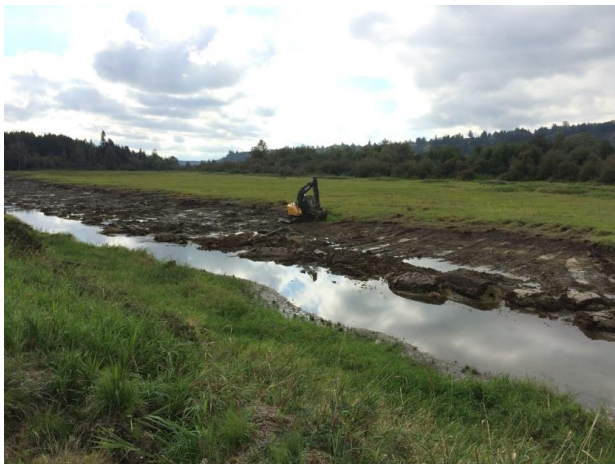
6.3 SITE # 3 – LOWER STAVE TIDAL ESTUARY

The most pressing challenge at Site # 3 is the significant encroachment from invasive reed canary grass (*Phalaris arundinacea*), coupled with restricted salmon overwintering habitat that required regrading and an overall lack of habitat diversity.

Majority of the restoration activities were completed at Site # 3 (see Figure 1). During the 2015 Instream Fisheries Works window, under the direct supervision of DFO, up to two large

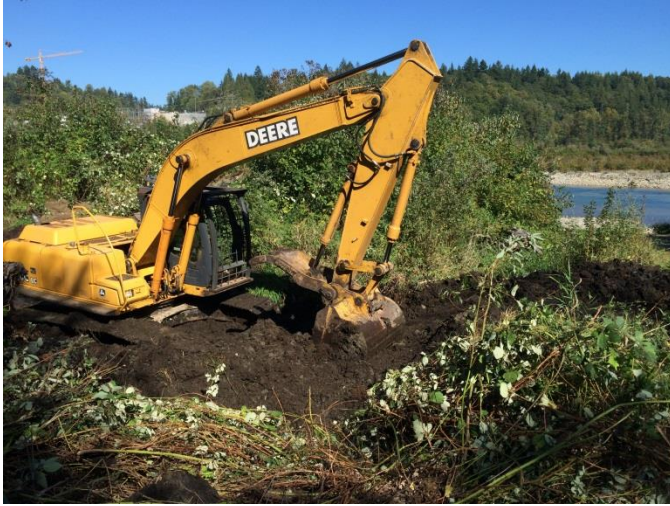
6.4 SITE # 4- THOMPSON CREEK AND OFF-CHANNEL HABITAT

Site # 4 is situated on the west bank of the Stave River. It was added to the project scope in May 2015. The challenges at this project site included the de-watering of the refuge pond and fishway, adjoining Thompson Creek due to a beaver tunnelling through the bank into the Stave River. The intake and upper slough immediately upstream of Thompson Creek was buried during a spill event during the 2014 winter, and there have been significant angler and

recreational impacts to Thompson Creek, resulting in the lack of riparian and sloughing of the existing channel.

The works occurred in the 2015 Instream Fisheries works window under the direct supervision of DFO. As this project site is situated within known archaeological hot-spots, an archaeologist from Cordillera Archeology and a Kwantlen First Nation field technician monitored the works. An excavator was used to repair the intake at the northern – upper end of the slough-fishway, repair the tunnelling and de-watering from the beaver by using spoil to re-inforce the bank. The sediment that had filled the fishway was removed and the material was side-casted to create a protective berm along Thompson Creek as it joins the Stave River. This berm was then planted by FVWC field crew with native plant species, Table 2. Plant species were chosen for their ability to withstand season high-water and inundation, season droughts and act as a barrier discouraging damage and trampling from recreationalists.

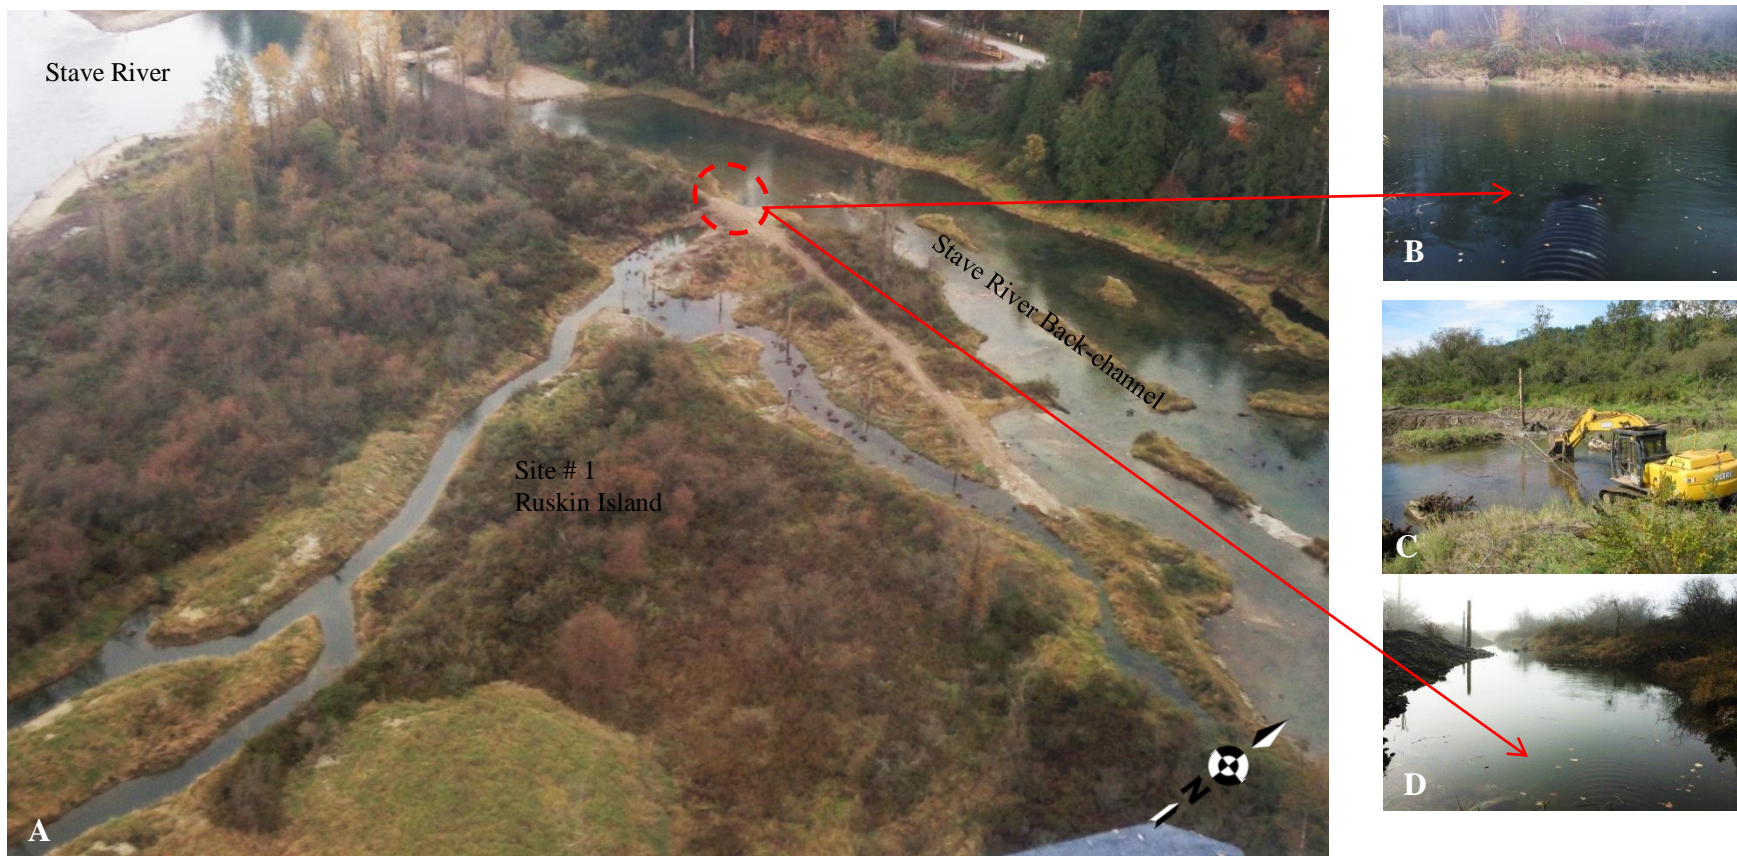
APPENDIX 1. PROJECT PHOTO DOCUMENTATION
SITE # 1 RUSKIN ISLAND

A. Air-photo of Ruskin Island showing location of intake replacement. **B.** New Boss 2000 intake installed north-view in the back-channel. **C.** Machine installing new intake and avoiding archaeological feature. **D.** New Boss 2000 intake installed south-view to newly constructed off-channel salmon habitat. C.

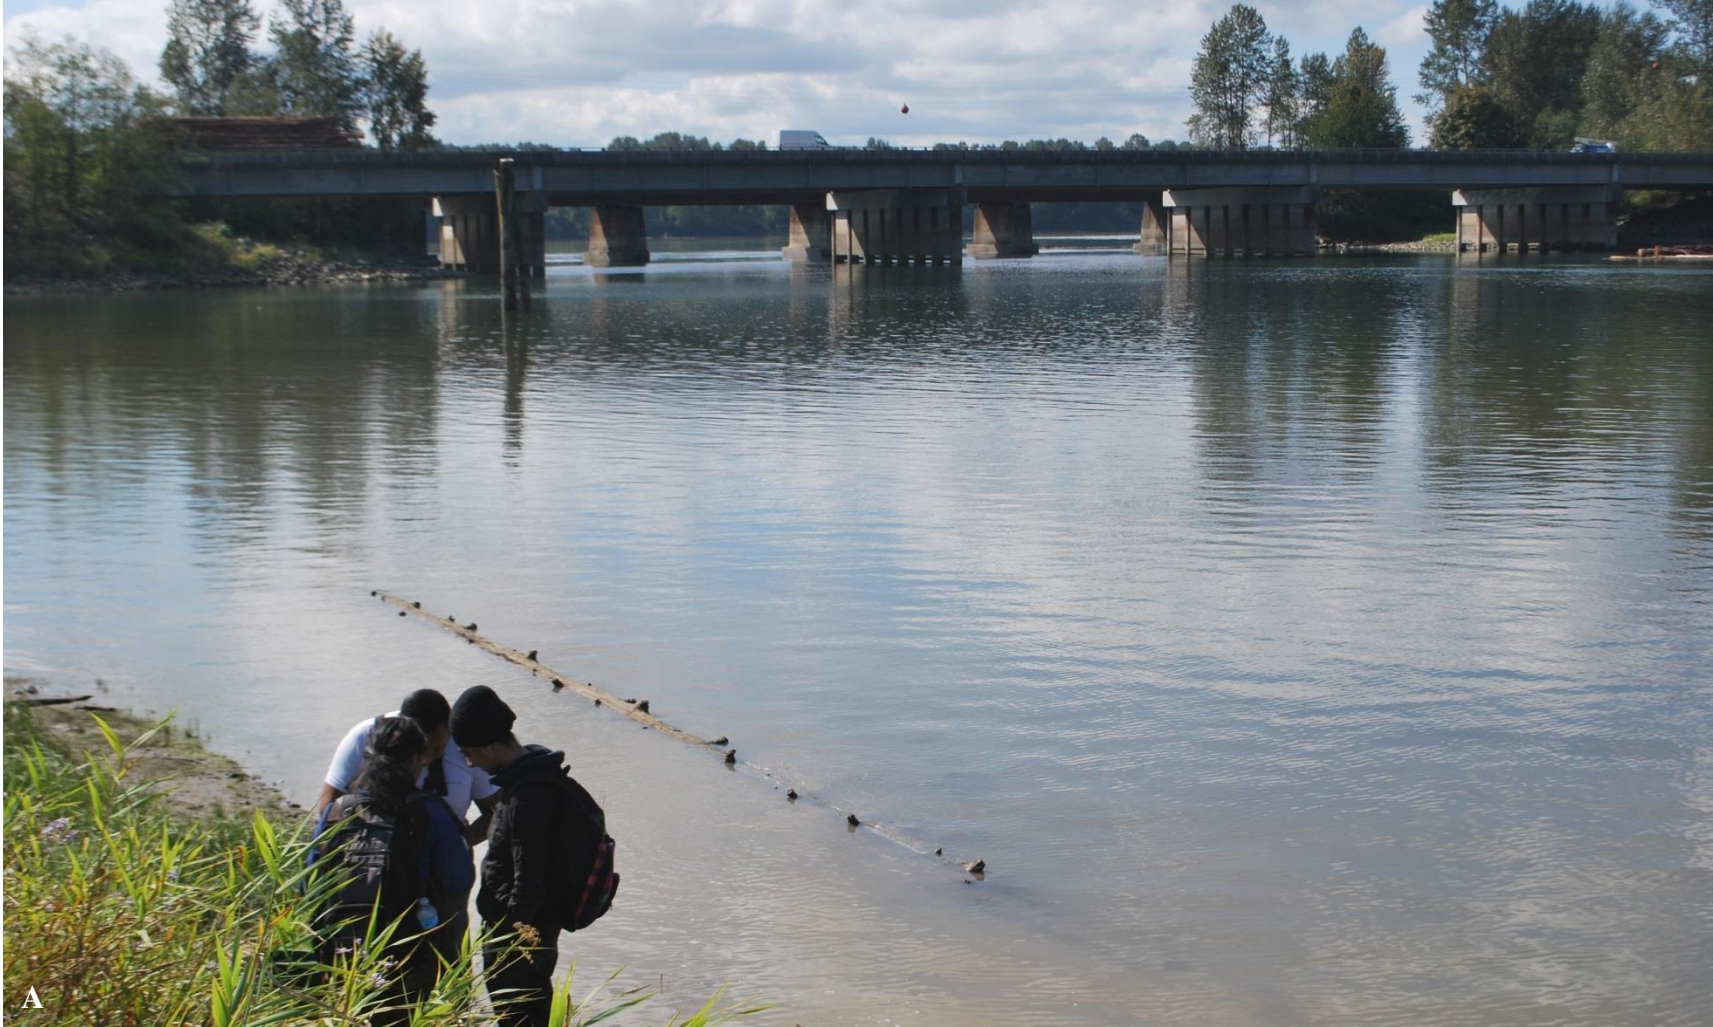
APPENDIX 1. PROJECT PHOTO DOCUMENTATION
SITE # 2 KWANTLEN FIRST NATION IR3 ISLAND

A UFV students participate in the archaeological assessment. They have found cultural features and the Kwantlen First Nation technician is describing how it may have been used in the past.

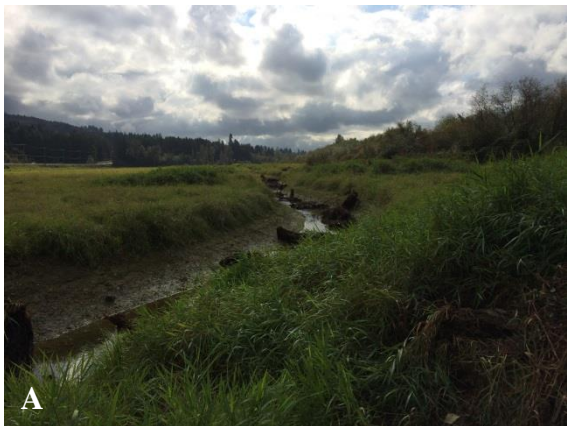
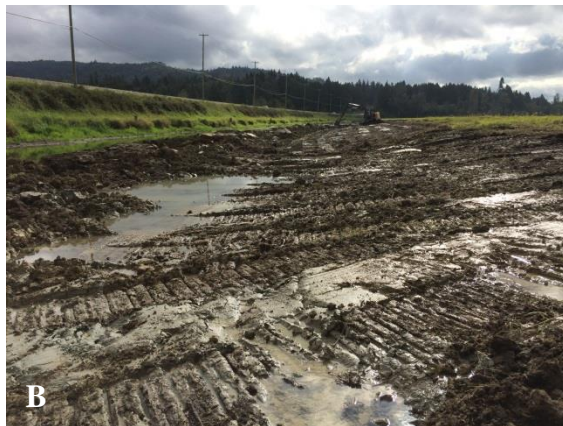
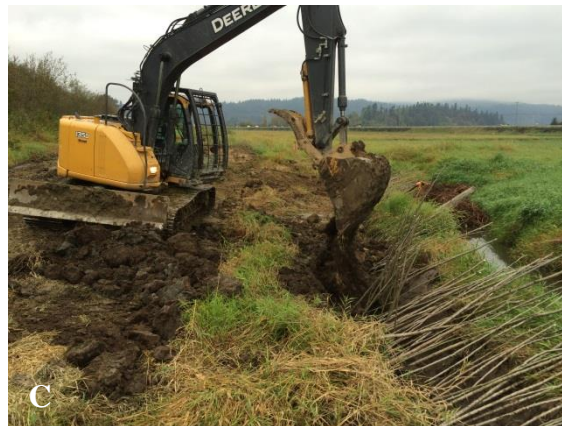
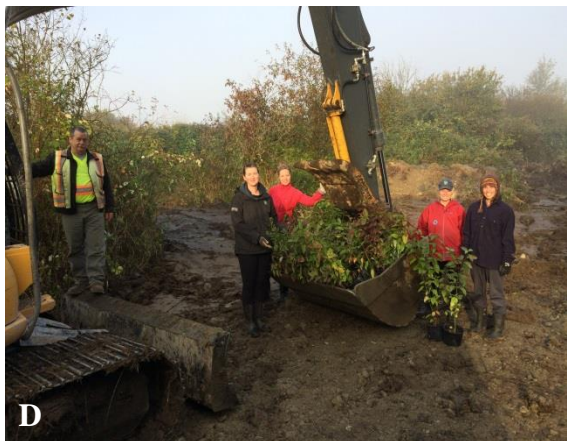
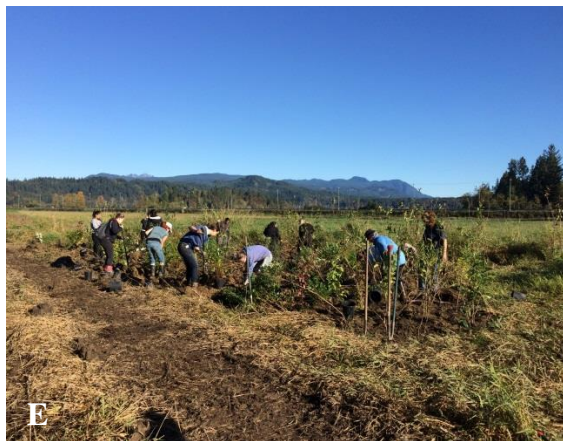
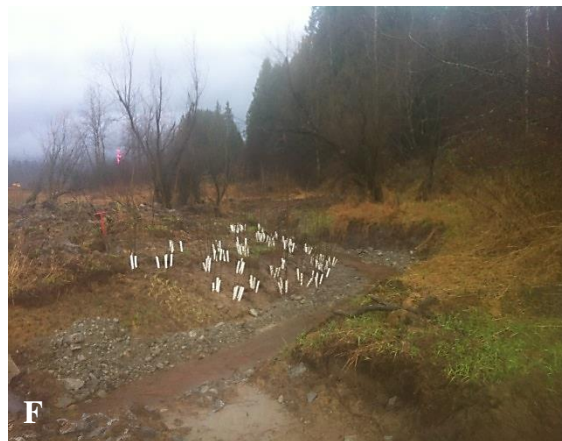
APPENDIX 1. PROJECT PHOTO DOCUMENTATION
SITE # 3 LOWER STAVE TIDAL ESTUARY

A. East-view along the groundwater channel with large wood placed throughout it. B. Long reach excavator is re-contouring the northern-most slough to support rearing salmon habitat. C. The excavator backfills a live palisade bioengineering trench. D. The excavator bucket assisted in moving the plants to where they should be planted. E. UFV students and the community help plant. F. The new spawning channel replanted and guarded to reduce damage from herbivory.

200-series excavators were used to add habitat complexity to the lower Stave River tidal estuary. Excavators were able to access the site using the Ducks Unlimited access route, located off St. Augstines Way. Works occurred on both Ducks Unlimited property and Kwantlen First Nation property. It involved re-grading the existing north slough to encourage natural flows following the Fraser freshet regime, including the contouring of the channel to allow natural draw-downs of the deeper water in the eastern edge of the property which had brown bullhead and other invasive fish and aquatic species present; side-casting spoil piles to create micro-habitat complexity; excavation and extension of the southern groundwater channel with the addition of spawning gravels to support spawning salmon; and the placement of large wood throughout the channels. (See Appendix 1. Project Photo-Documentation and Appendix 3. Project As-Builts Diagram).

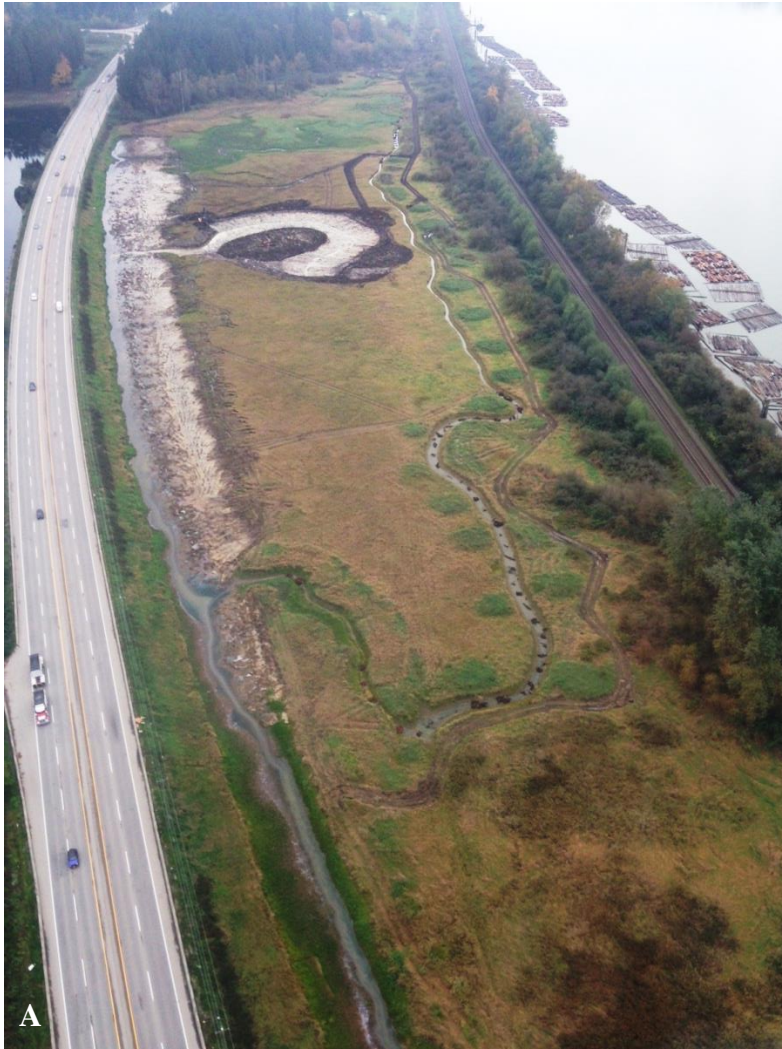
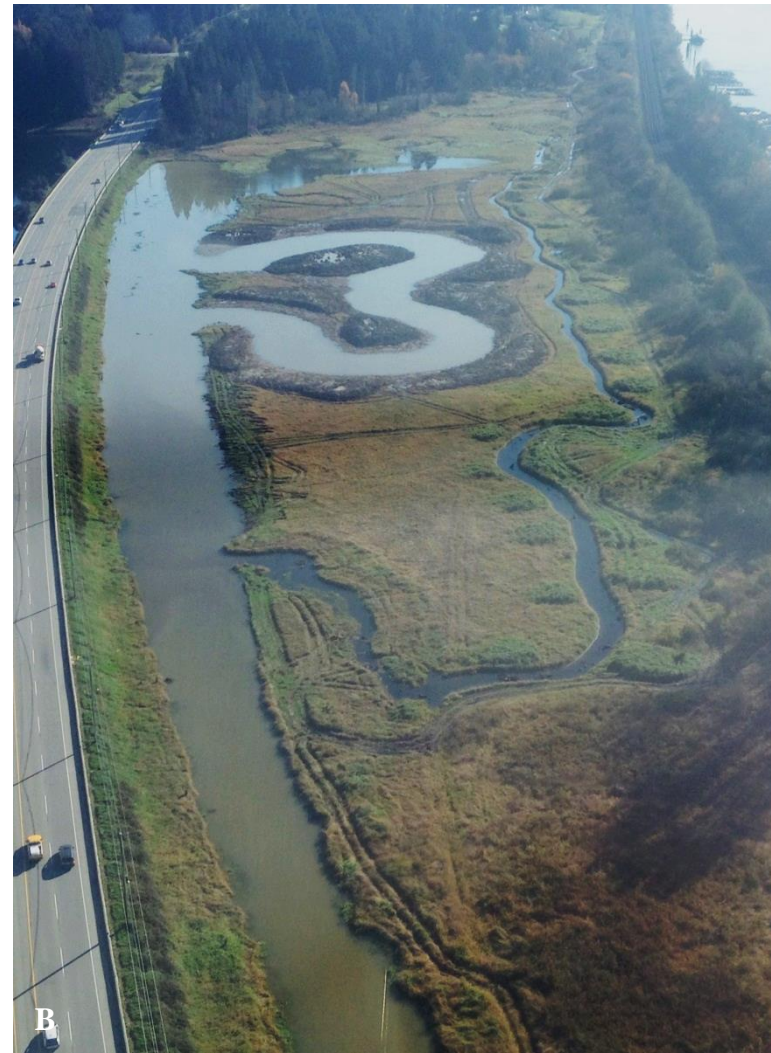
APPENDIX 1. PROJECT PHOTO DOCUMENTATION
SITE # 3 LOWER STAVE TIDAL ESTUARY

A. Air-photo of Site # 3 during in-stream restoration 2015 B. Air-photo of in-stream restoration efforts completed for 2015- prior to replanting.

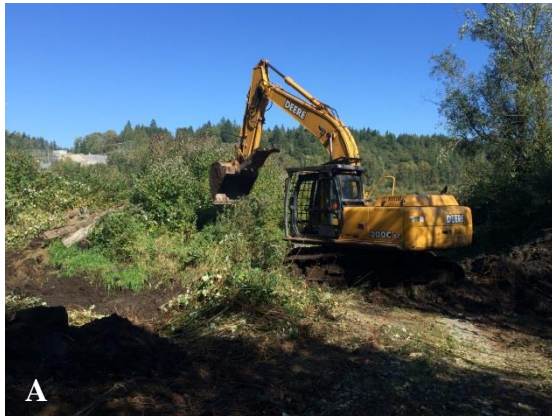
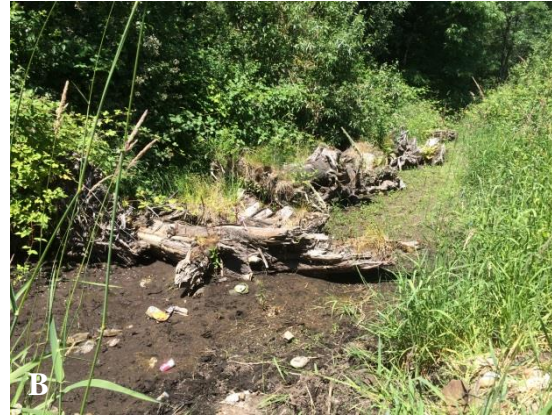
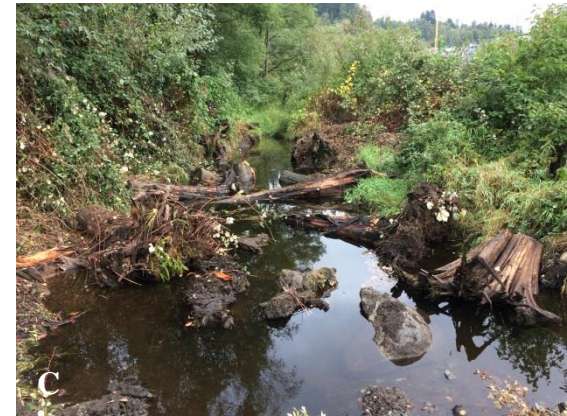
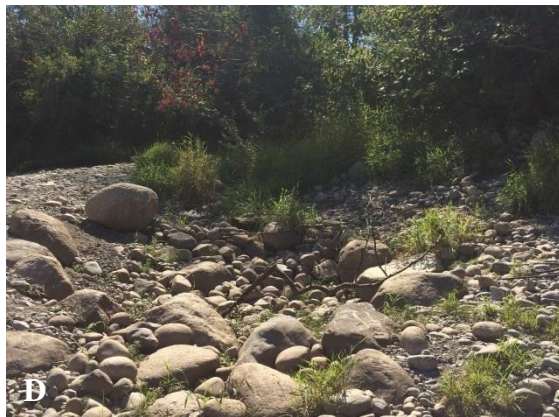
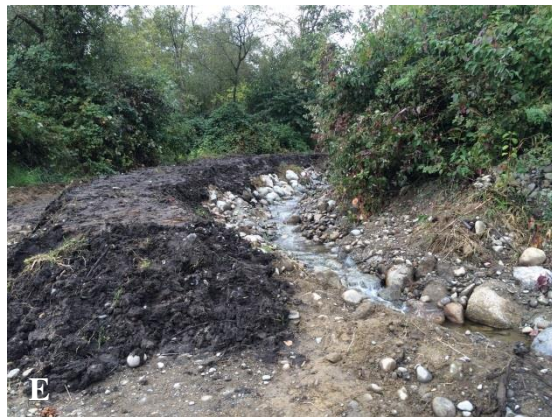
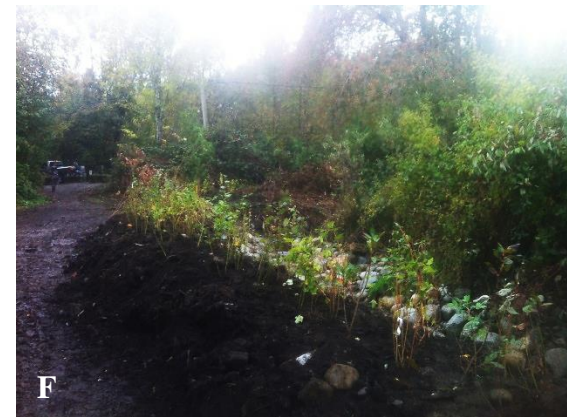
APPENDIX 1. PROJECT PHOTO DOCUMENTATION
SITE # 4 THOMPSON CREEK AND OFF-CHANNEL HABITAT

A. Excavator digs out sediment from fishway. B. Fishway before restoration-completely de-watered, C. Fishway after restoration. D. Thompson creek channel and riparian damaged and dried out. E. During works, spoil was used to create a berm and riparian habitat along Thompson Creek. F. Replanted berm with signage informing people to care for this habitat.
