# **Restoring species of conservation concern and cultural value**

**COA-F17-W-1295**

**Final Report YEAR 1**

**Fish and Wildlife Compensation Program, Coastal Program**

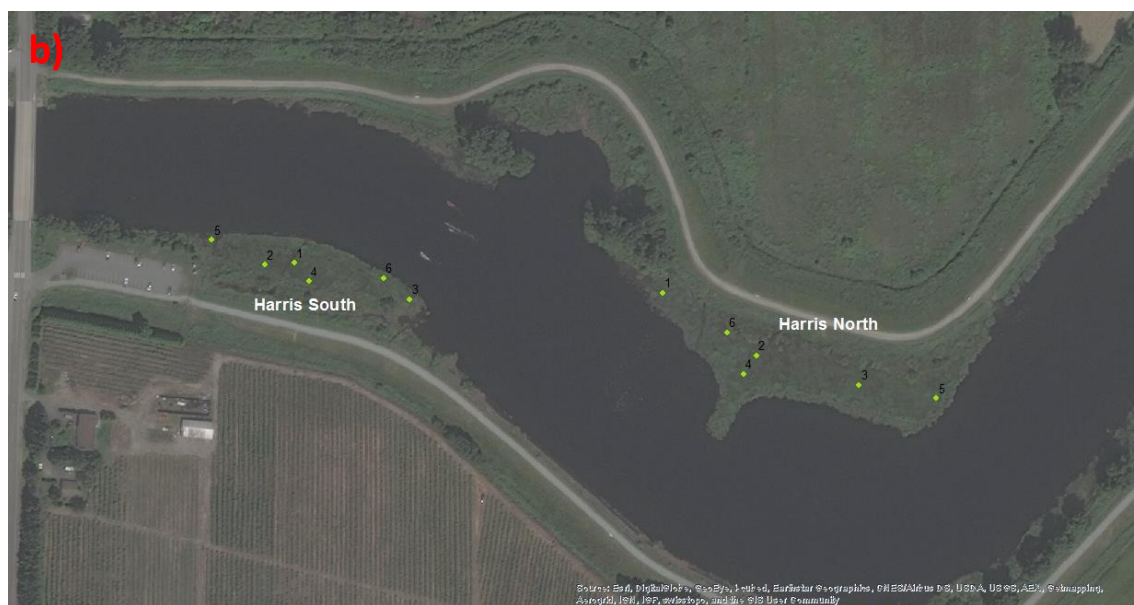
Figure 2. Location of a) transects for surveying intertidal vegetation and b) 1x1 m vegetation plots surveyed in September, 2016 at the Harris South and North restoration sites.

Vegetation in the intertidal zone was surveyed along five 75 m transects on the south and north side of the lower South Alouette River on September 12-14, 2016, between Neaves and Harris Road (Figure 2(a)). No attempt was made along transects to ensure that every species present was reported. Instead, species observed while walking transects at a normal pace were categorized as 'dominant', 'frequent', or 'rare'. Each transect contained five sampling plots spaced 15 m apart, in which relative abundance of all plant species present in the plots was estimated by visual assessment of percent cover.

Prior to restoration works, vegetation was surveyed on September 2, 2016 within six randomly positioned 1 x 1 m plots within the Harris South and Harris North restoration sites (Figure 2). Relative abundance of all plant species present in the plots was estimated by visual assessment of percent cover. Using the same methods as the intertidal transects conducted upriver along the Alouette River, the intertidal zone at each restoration site was surveyed by walking at a normal pace; species observed were categorized as 'dominant', 'frequent', or 'rare'.

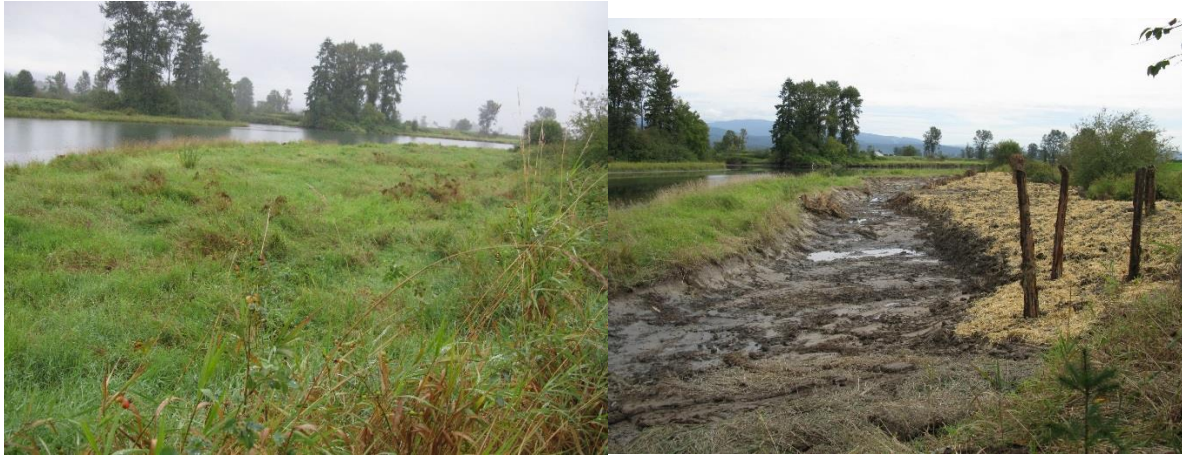
Figure 4. Harris South restoration site pre-restoration (left) showing low bench 95% covered with reed canary grass, and post-restoration (right, view west) showing excavation to create tidal marsh and anchored large wood.

The base of the exposed marshes undulates to create varied topography that will support a variety of native tidal marsh species. Our primary target elevation was based on a narrow band of wapato in the adjacent river, and additional ledges and ‘shelves’ at elevations targeting sedge and bulrush. Low ‘lips’ in the marsh bottom promote shallow ponding (< 20 cm) within the constructed marshes to encourage

wapato and other forb and herb colonization. Elevations based on nearby wapato at Harris South were from 0.50 – 0.55 m above sea level (ASL), with additional target species from 0.40 – 0.9 m ASL. Elevations at Harris North were 0.55 – 0.60 m ASL, with additional target species from 0.45 – 0.9 m ASL.

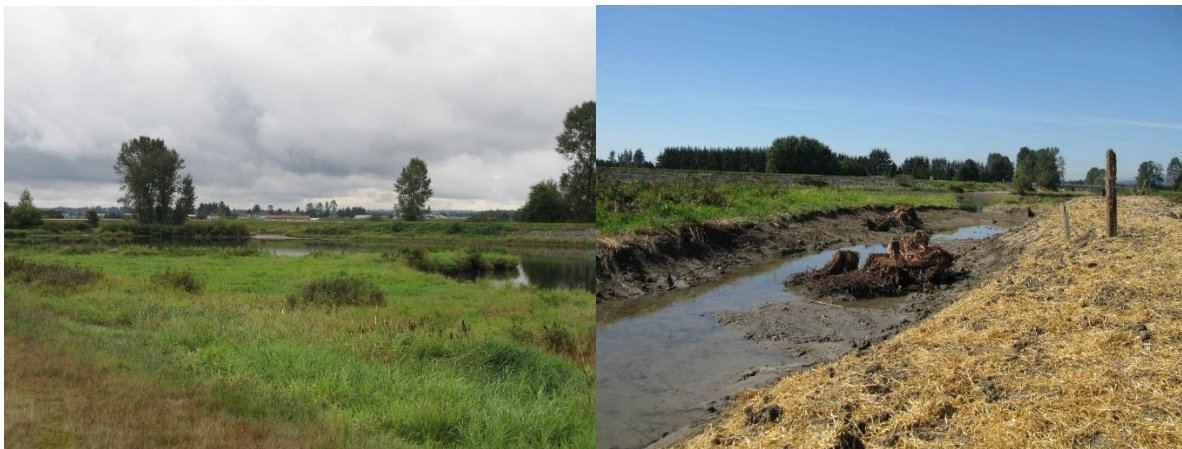
Figure 5. Harris North restoration site pre-restoration (left, view east) and post-restoration (right, view west) showing anchored large wood within excavation to create tidal marsh.

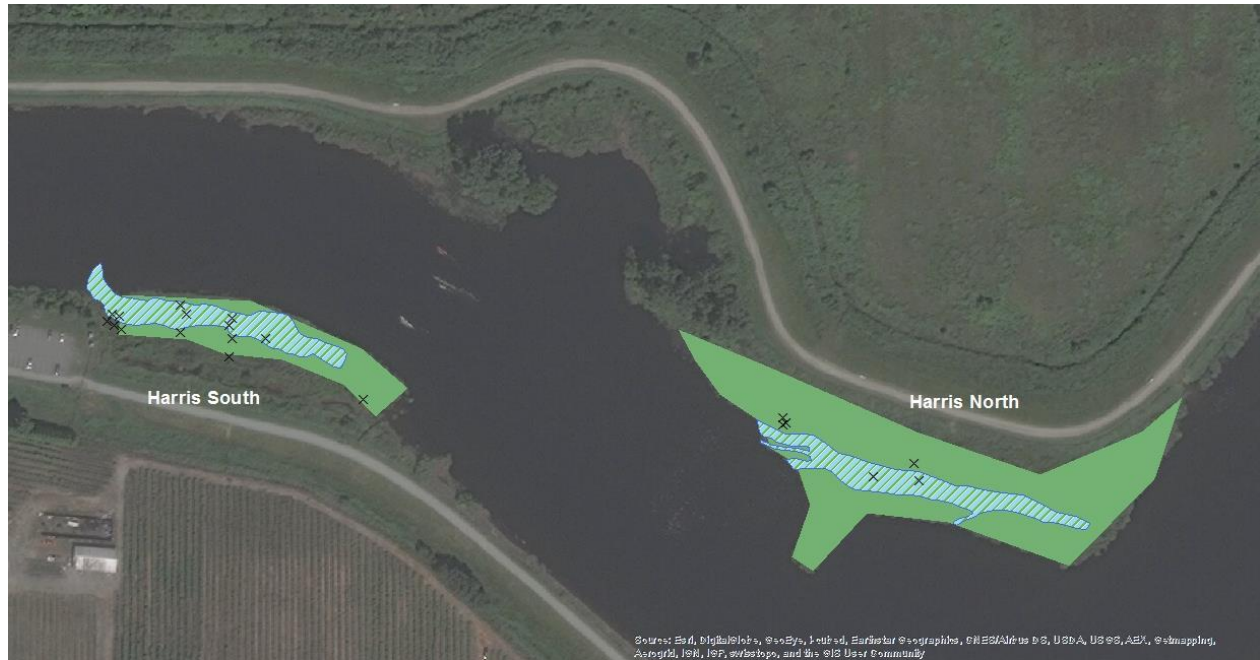
Figure 6. Final shape of excavations to create marsh habitat and locations of anchored wood at the Harris South and Harris North restoration sites.

Large red cedar stumps were anchored with stainless steel 3/8 aircraft cable to concrete roadside barriers (2.1 x 0.81 x 0.60 m) buried ~60 cm below ground surface. The wood was placed on the banks and in the center of excavated areas. Bird and bat shelter boxes have been constructed and will be erected in April 2017. Both sites were planted with native species on October 28-30, 2016 (Table 3). Planting prescriptions focused on culturally valued shrubs (e.g. beaked hazelnut) and aquatic species (wapato, tule), in addition to fruit-bearing shrubs, and species that typically grow well in wetland restoration sites.

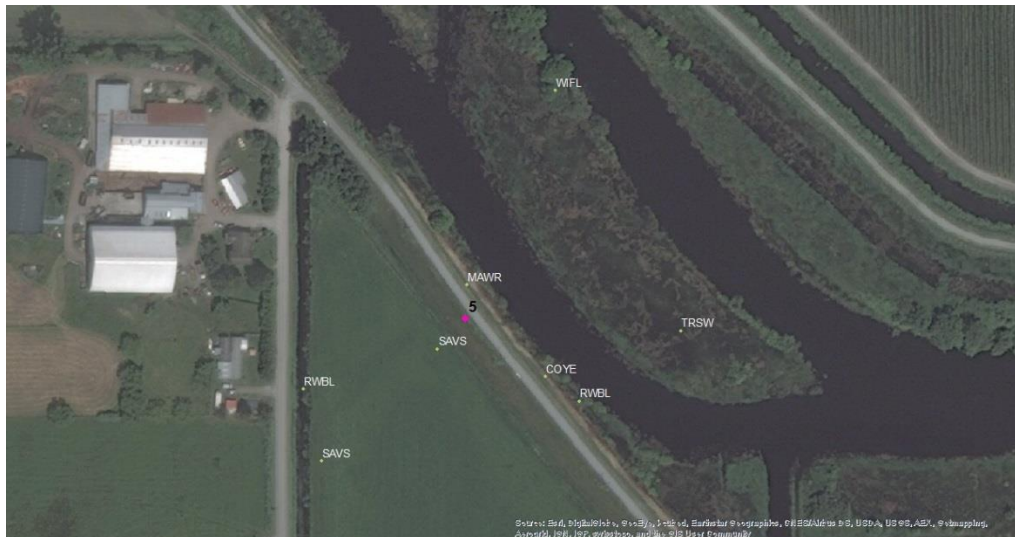
Figure 7. Geo-referenced bird detections during five minute point counts around point count #5 along the lower Alouette River, June 2016

Point count surveys resulted in a geo-referenced database of bird detections around point counts (Figure 7, Appendix 5). The database will be used in the future to relate birds to vegetation cover to support wetland restoration planning and effectiveness monitoring. Of the 520 birds seen or heard during five survey mornings in June, 60% of detections were of 10 frequently-detected species. The common yellowthroat, willow flycatcher, and marsh wren were the most frequently detected species along the low bench riparian zone within the dike (Appendix 5). Common yellowthroat males and females were frequently observed on low shrubs, and willow flycatchers were more often detected as males singing from tall shrubs. Marsh wrens were the only species observed almost exclusively within the reed canary grass. Combined these three species comprised 25% of all detections. The spotted towhee, American robin, and song sparrow were frequently observed within low and tall shrubs, and the savannah sparrow was only observed in hayfields adjacent to the dike. Bird species richness was higher in areas where reed canary grass low benches contained shrubs (Katzie First Nation, unpublished mapping). The remaining 3 of the 10 frequently-detected species were swallows – at least 20 individuals each of the barn, tree, and cliff swallow were recorded. Cliff swallows were only observed in the upriver portion of the surveyed area. Multiple and frequent observations of the barn swallow and great blue heron were made throughout the study area, and sandhill crane pairs were seen or heard on several occasions foraging in adjacent agricultural fields.

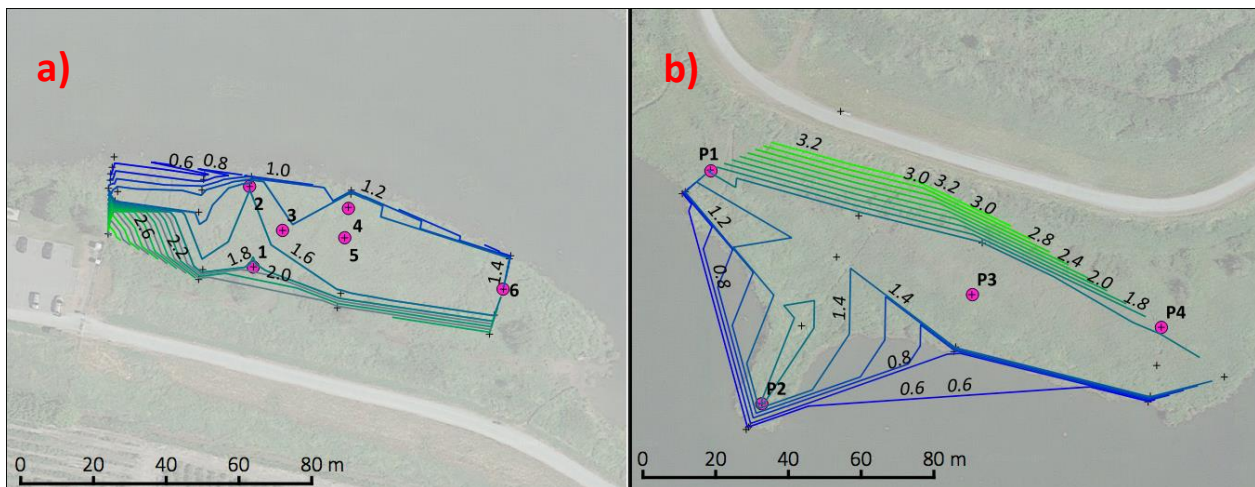
Figure A1. Map of elevations (m) at the Harris Road South (a) and North (b) sites.

The Harris Road South site is comprised of a lateral bar on the south bank of Alouette River (Figure A1 and A2 (a)). Narrow tidal mud flats are colonized by *Nuphar*, *Potamogeton*, *Sagittaria* (wapato), *Carex*, *Scirpus*, *Juncus* and *Equisetum*. Main body of the bar is colonized by *Phalaris arundinacea*, and *Rosa* dominate a longitudinal berm that parallels the Municipal dike to the south. Daily tides fluctuate approximately 0.4 - 1.1 m ASL, with annual freshets reaching 2.2 m with occasional higher elevation floods.

The Harris Road North site is comprised of a lateral bar on north bank of the Alouette River (Figure A1 and A2 (b)). Very narrow tidal flats with occasional *Sagittaria* below steep banks. Main body of the bar is colonized by *Phalaris arundinacea*, and *Spirea* dominate at the bank towards the Municipal dike to the north. Daily tides fluctuate approximately 0.4 - 1.1 m ASL, with annual freshets reaching 2.2 m with occasional higher elevation floods.

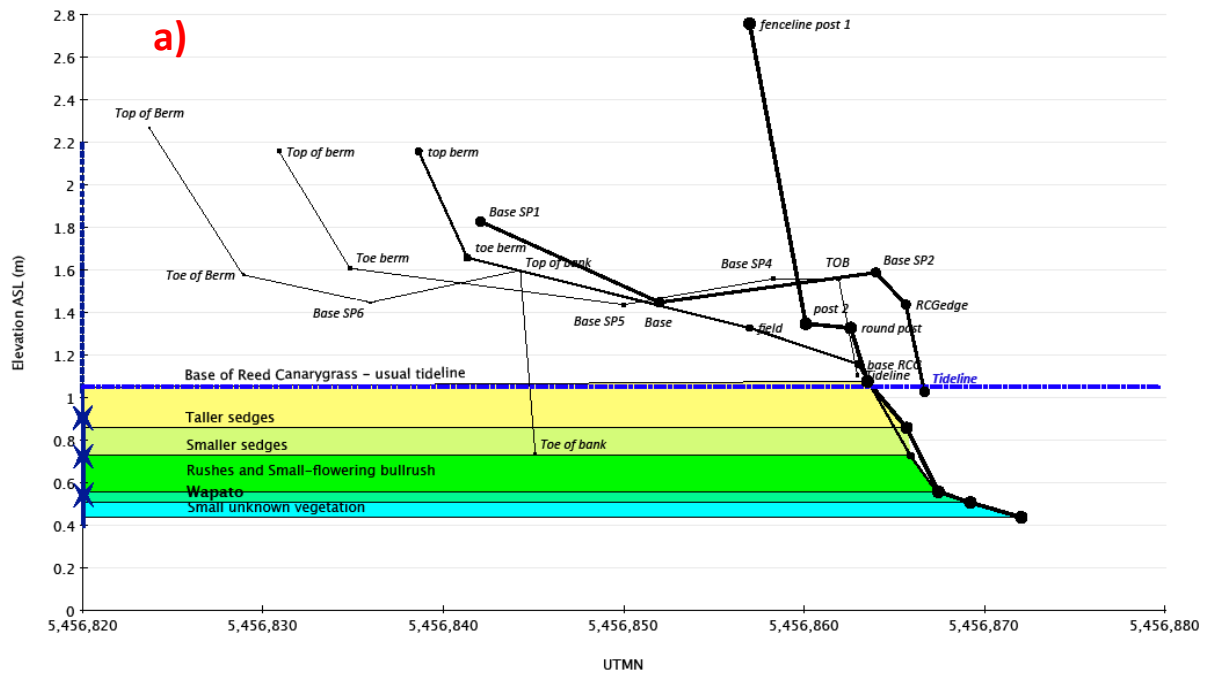
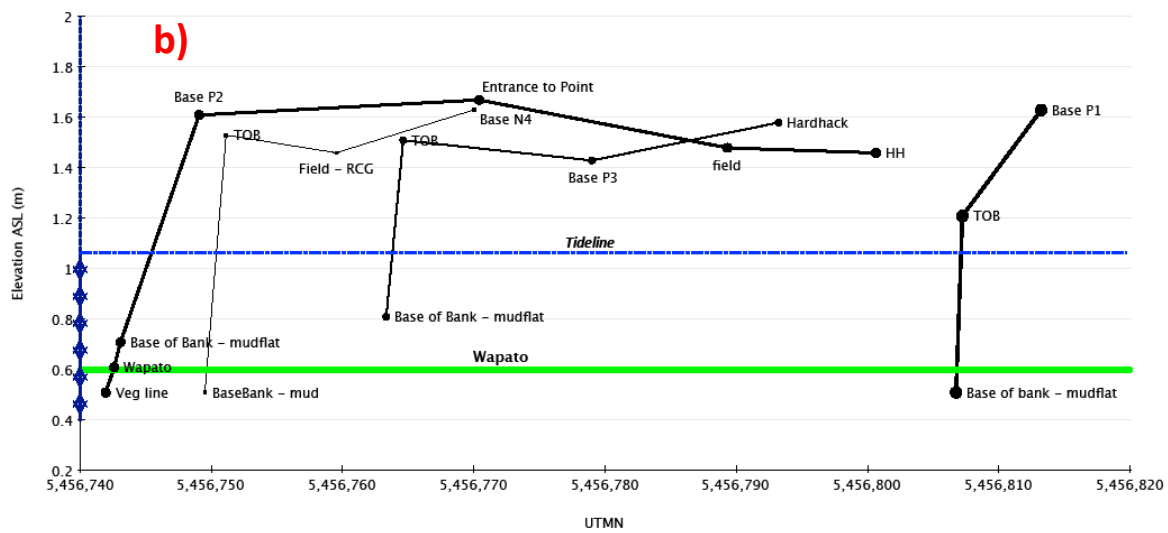
Figure A2. Cross-sectional elevation profiles of the Harris Road South (a) and North (b) restoration sites.
