NCC Land Stewardship Activities F17

FWCP Project No. W-F17-05

Executive Summary

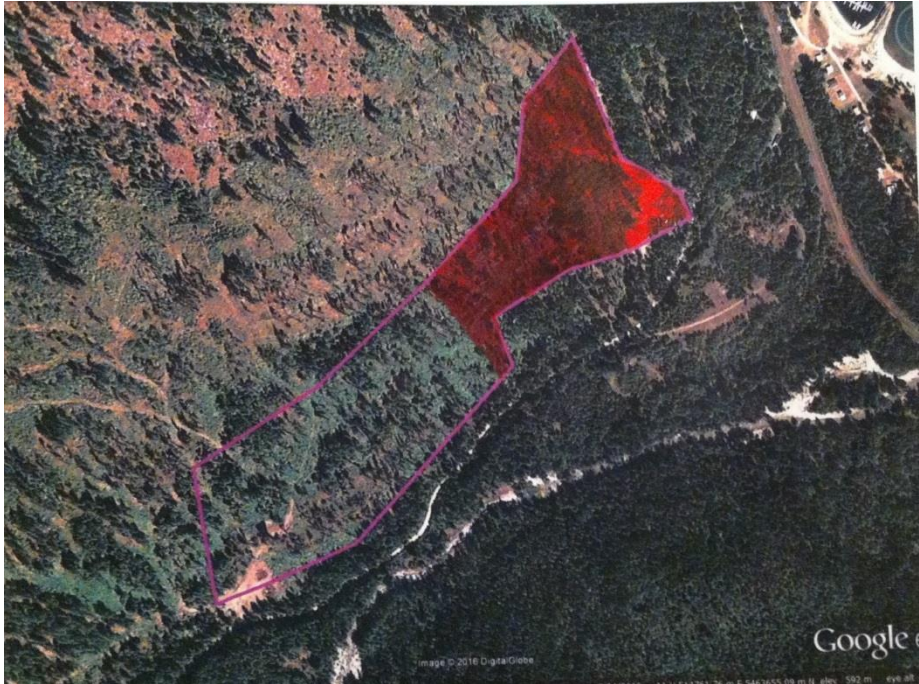
Figure 1. Treatment area outlined in purple; the area shaded red was completed in 2016.

In the fall of 2016, NCC carried out a trial restoration project in a stand that was logged and planted in 2003 in the ICHdw to assess the costs and challenges of these treatments. The trial took place on a south facing slope above Cultus Creek adjacent to areas known to support high numbers of ungulates during the winter months. Slashing contractors completed approximately 5 hectares of the treatment in October, 2016 (Figure 1).

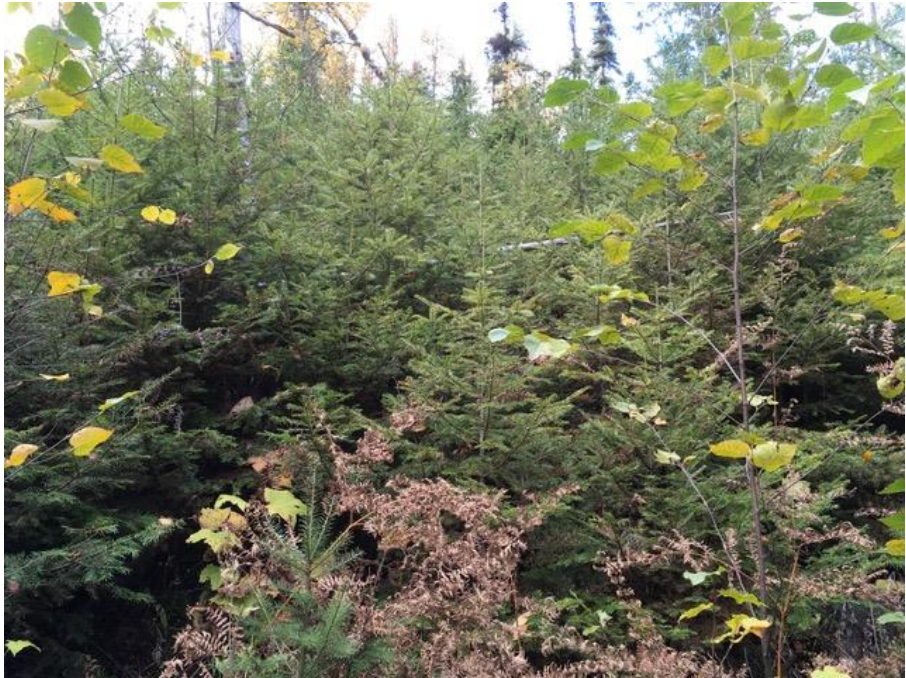
Figure 2. Densely stocked conifer plantation prior to treatment.

Prior to treatment, the stand was stocked with over 4,000 stems per hectare of Grand Fir, Larch, Douglas Fir, Western White Pine and Ponderosa pine that had become impenetrable for large ungulates and would have developed into a stand vulnerable to high severity fire (Figure 2).

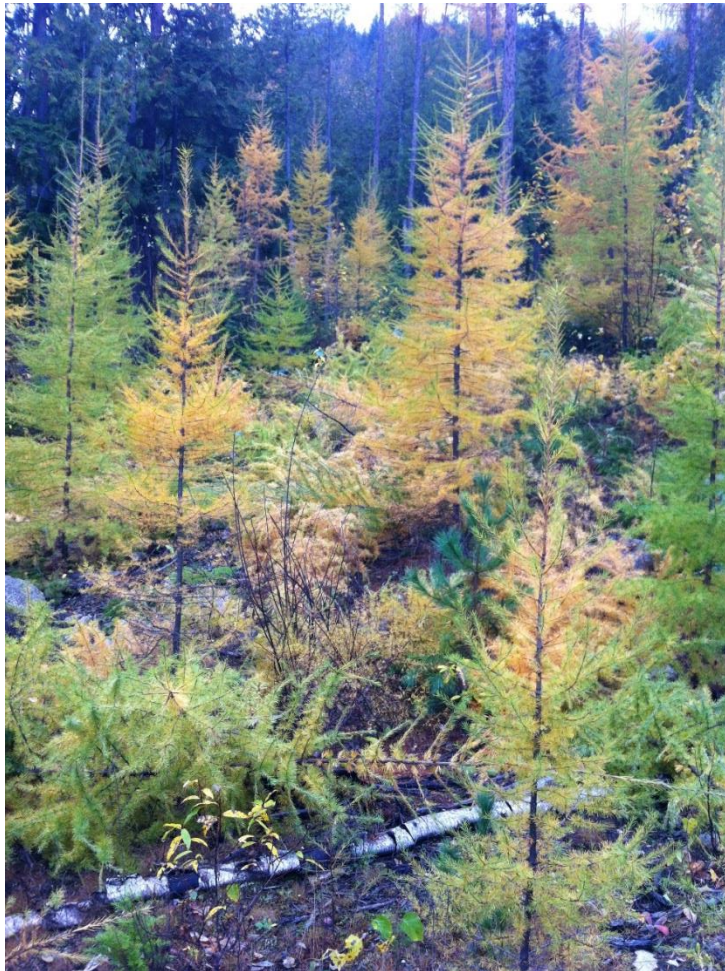
Figure 3. Post treatment spacing in treatment unit.

However, stocking was clearly reduced (Figure 3) and the crew leader reported elk sign in the treatment area immediately following completion. A full assessment of the trial will be completed in the summer of 2017.

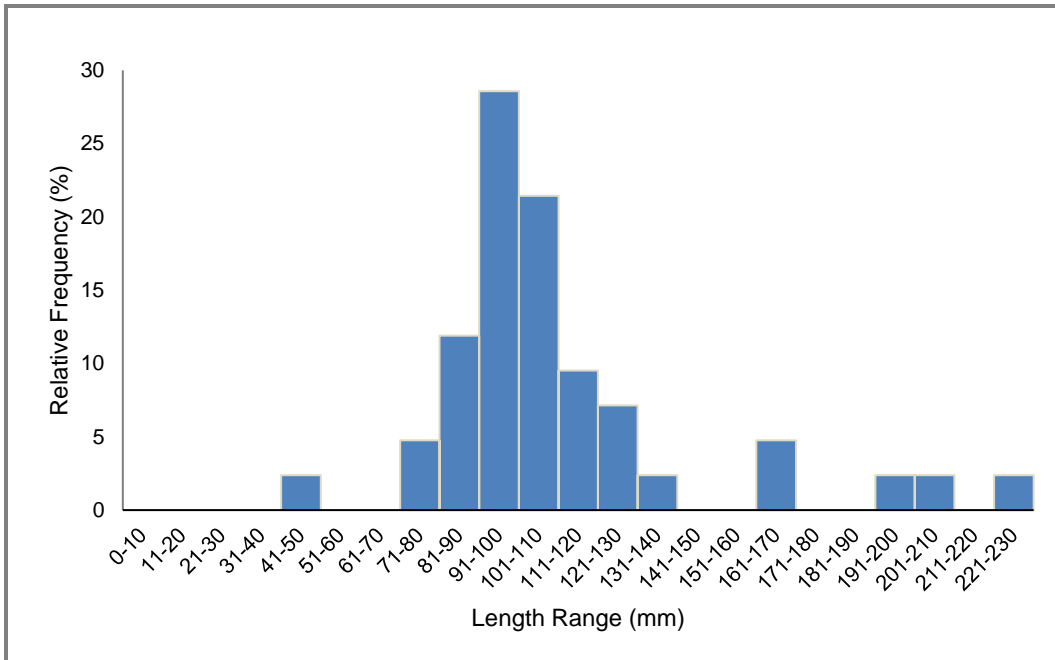
Figure 3.2-2: Relative Length Frequency Histogram of Brook Trout Captured within the Treatment Site (Laib_Creek_2), August 2016

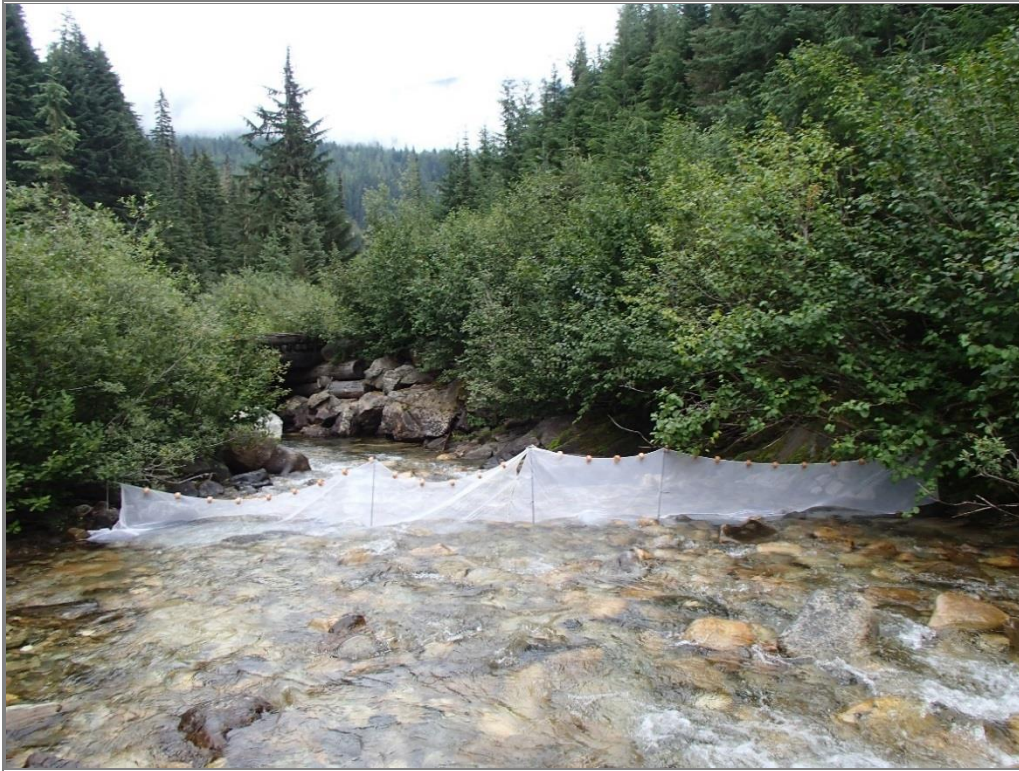
Plate 1: Laib Creek treatment site downstream blocknet, 9 August 2016. Photo taken facing downstream.

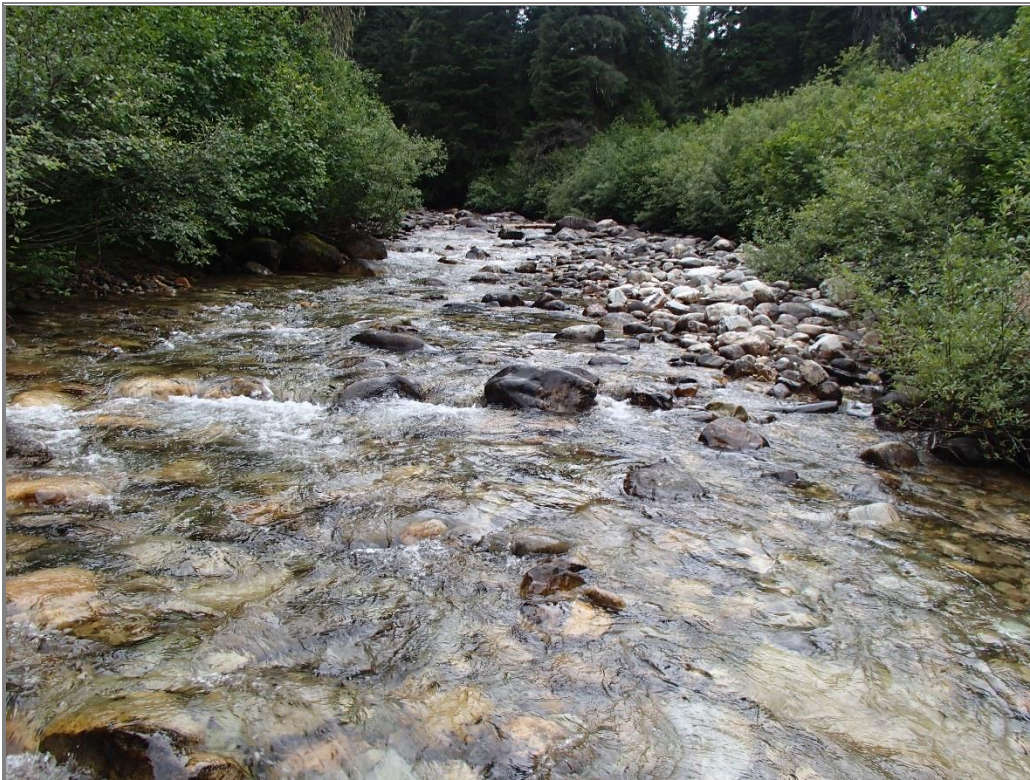
Plate 2: Laib Creek treatment site, 9 August 2016. Photo taken facing upstream.

Laib_Creek_2 is located approximately 4 km upstream of the confluence with Cultus Creek, upstream of the Laib Road Bridge. The site length in 2016 was 75 m, stream width was approximately 12 m and the habitat was riffle-pool with cobble/boulder substrates (**Appendix A, Plate 1 to Plate 3**). Abundance sampling occurred only in Laib_Creek_2 in 2016 and is herein referred to as the treatment reach.

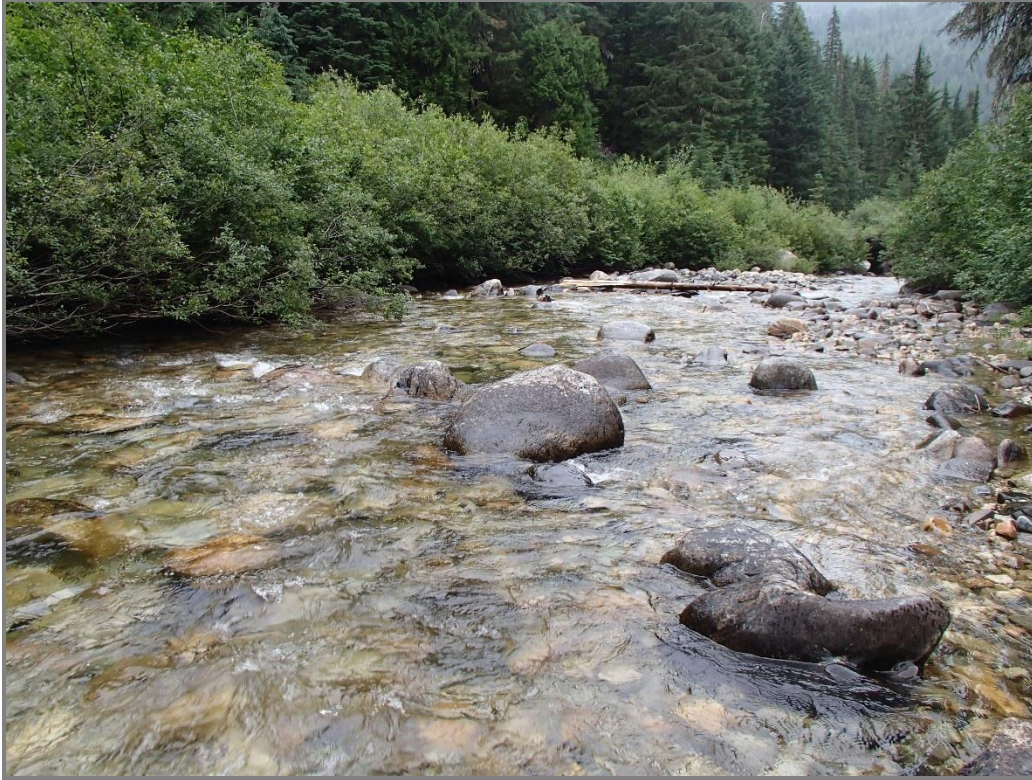
Plate 3: Laib Creek treatment site, 9 August 2016. Photo taken facing downstream.

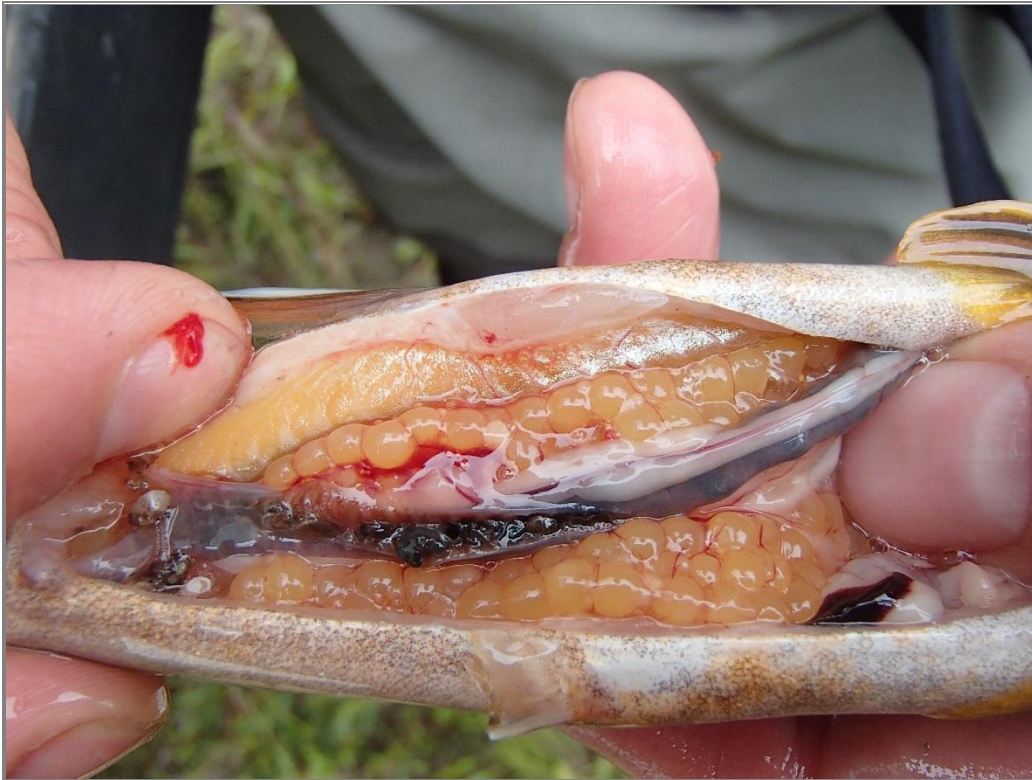
Plate 4: Mature female Brook Trout sampled from the Laib Creek treatment site, 9 August 2016.

other sizes observed, it is likely that this is the age-1 cohort and the one smaller fish is representative of the age-0 cohort while those >161 are the age-2 and older fish (**Figure 3.2-2**). Otoliths were removed from 3 fish >168 mm fork length, but have not be aged at this time to confirm age class estimations. One male (200 mm fork length) and two females (168 mm and 201 mm fork length) were identified by the presence of mature gonads. The fecundity of one female Brook Trout (201 mm fork length) was 245 eggs with an average diameter of 2.5 mm (**Appendix B, Plate 4**).

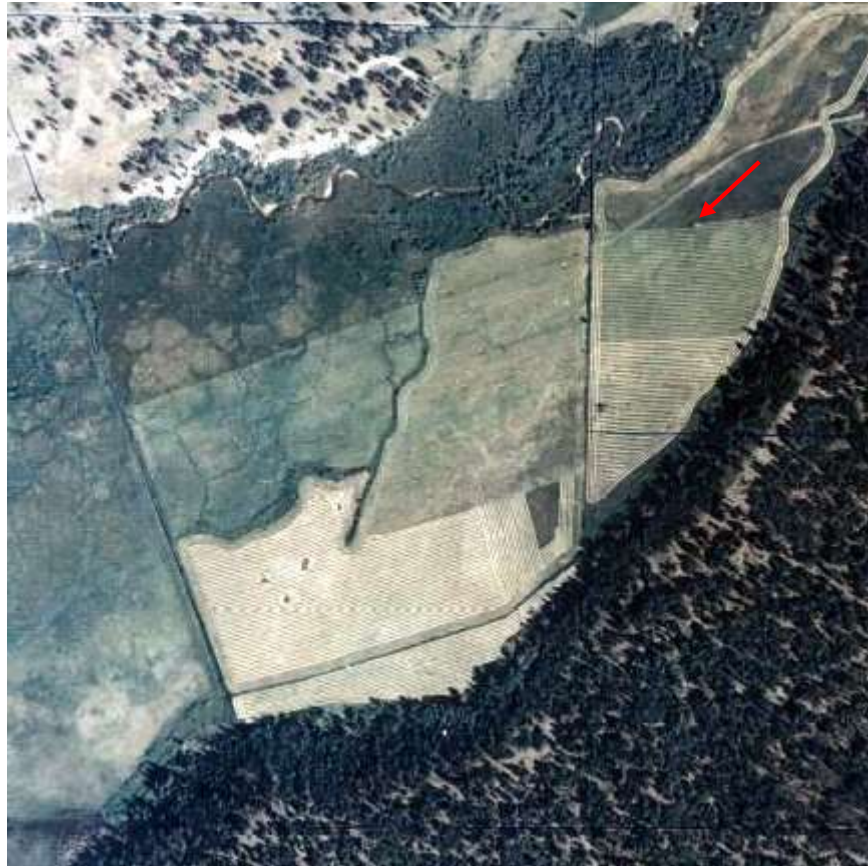
This aerial photograph shows Cherry Meadows when it was intensively farmed. The red arrow points to a tractor cutting hay. The photograph was provided by Carol and Walter Latter, who once owned the property. The date the aerial photograph was taken is unknown.

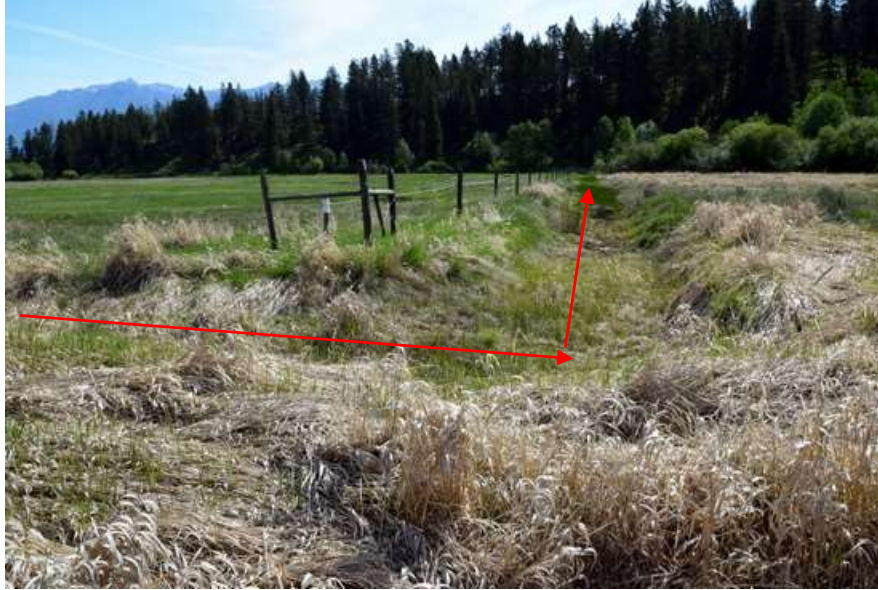
Deep ditches, like the one shown, were dug to divert runoff from Cherry Meadows.

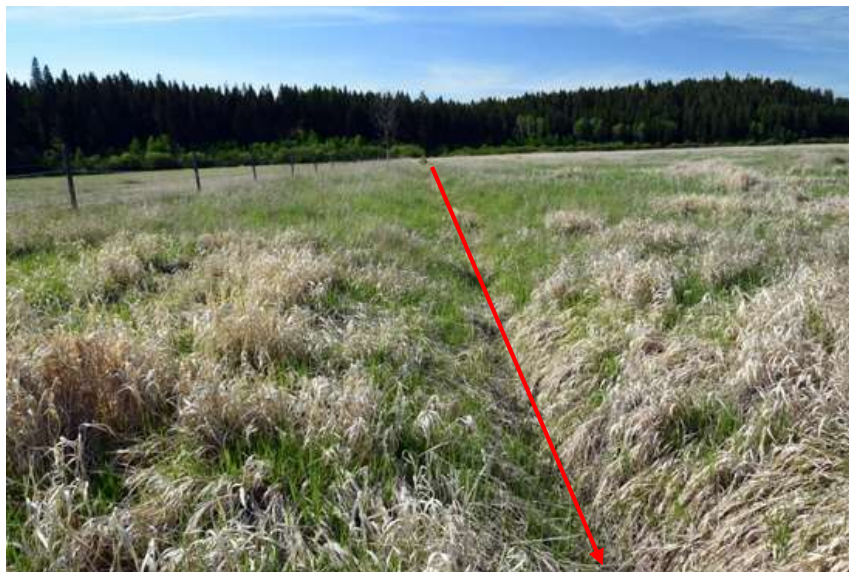
The red line on this photo shows one of many ditches dug at Cherry Meadows to drain wetlands so they could be farmed. The ditches continue to remove standing water, and lower the elevation of groundwater.

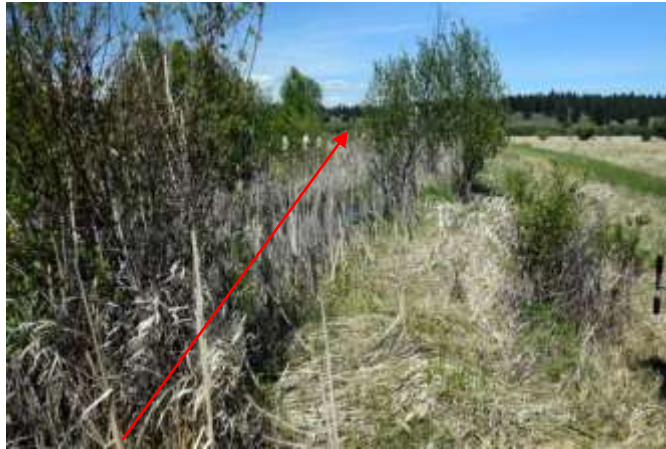
The red line on this photo shows one of the main ditches dug to dry wetlands at Cherry Meadows. The ditches continue to function though dug years ago.

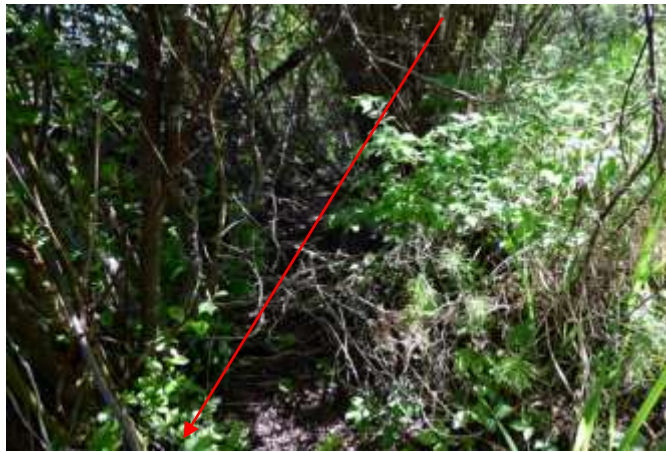
The red line shows the center of a diversion ditch, dug along the base of the mountain at Cherry Meadows. The ditch is one of many dug to drain the wetlands once present on the site, and continue to divert runoff from Cherry Meadows

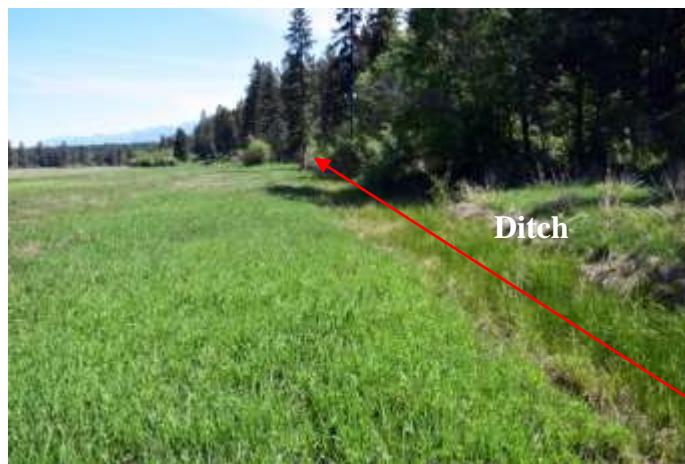
This photo shows another diversion ditch at Cherry Meadows.

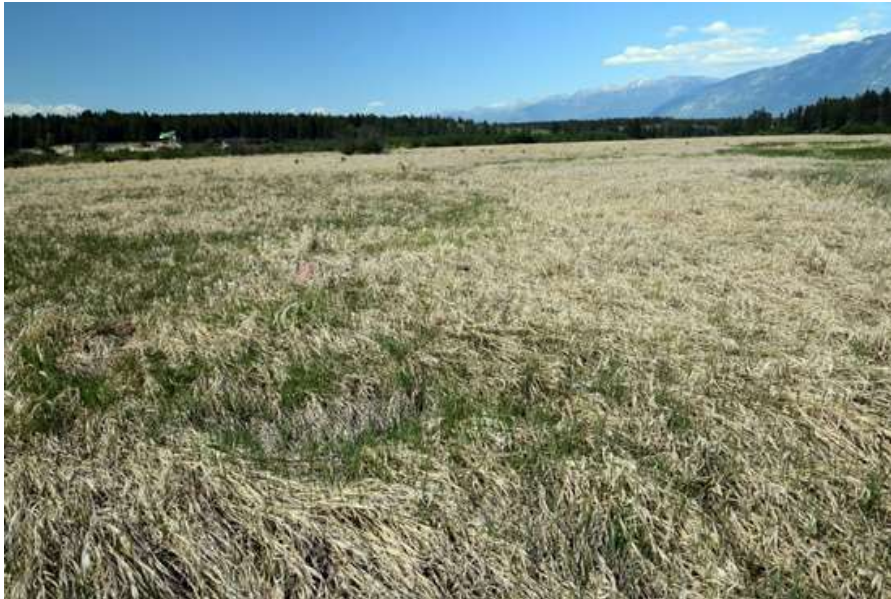
Wetlands would be restored at Cherry Meadows from large fields that were leveled and filled for farming. These old fields are dominated by reed canary grass, and support a low diversity of plants and animals.

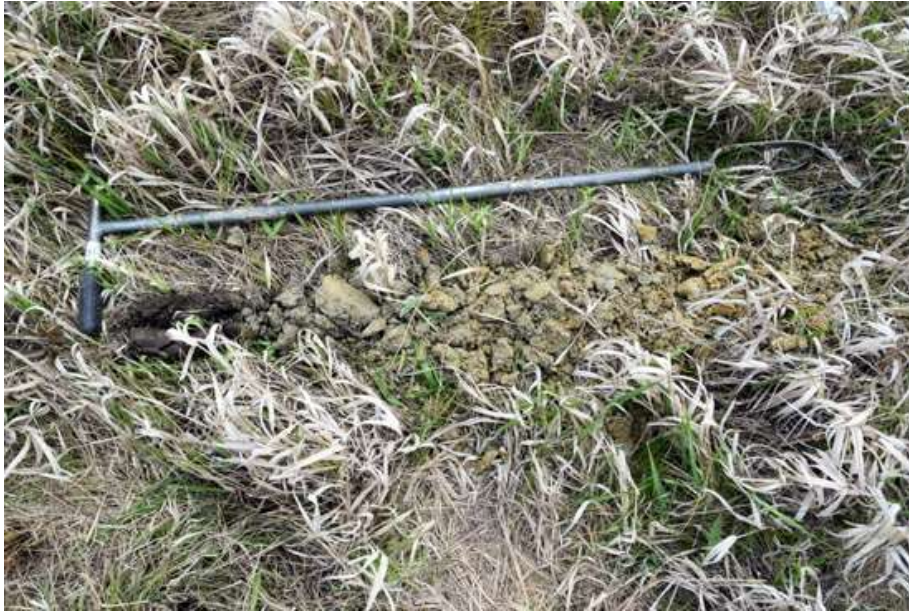
A soil auger was used to measure soil texture and to determine the elevation of groundwater at each wetland restoration site.

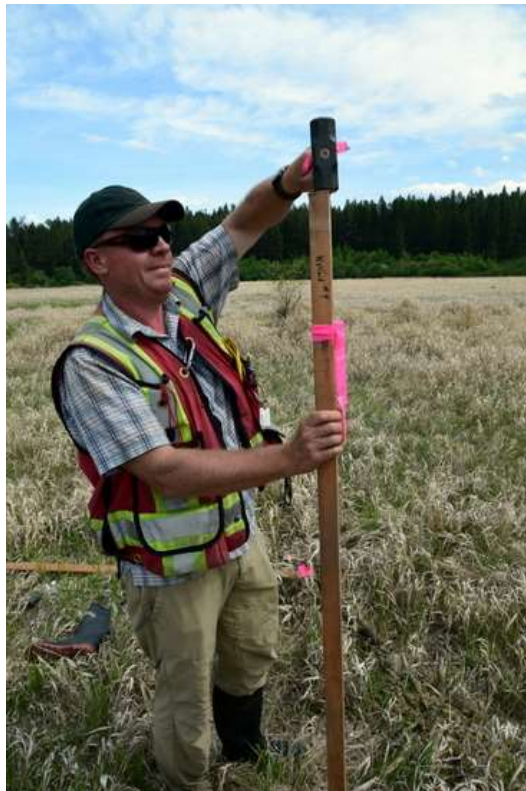
A long wooden stake was placed in the center of each wetland that was designed. A GPS was used to record the coordinates of each stake.

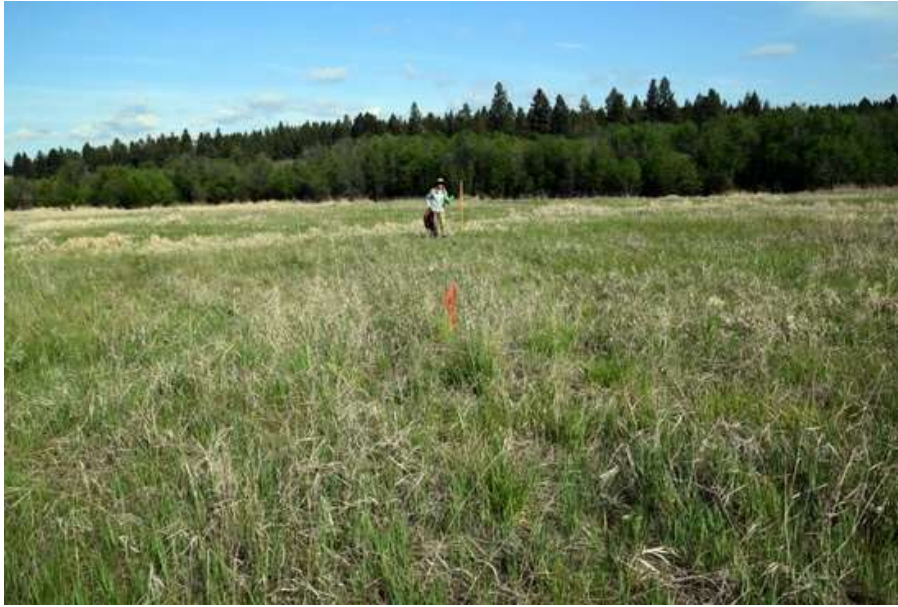
The perimeter of each designed wetland was marked using brightly colored plastic ribbon. A GPS was used to map the perimeter of each planned wetland.

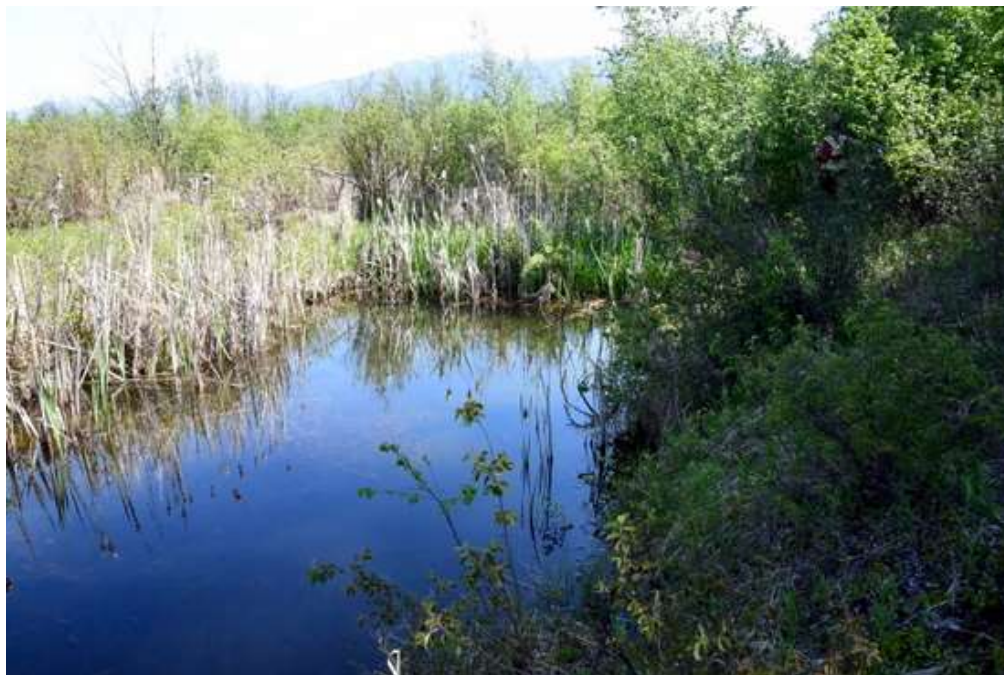
Beaver made this small wetland by blocking a drainage ditch at Cherry Meadows. The ditch remains functional as drainpipes were installed in each beaver dam. The dams are also leaking because the beaver are no longer maintaining them.

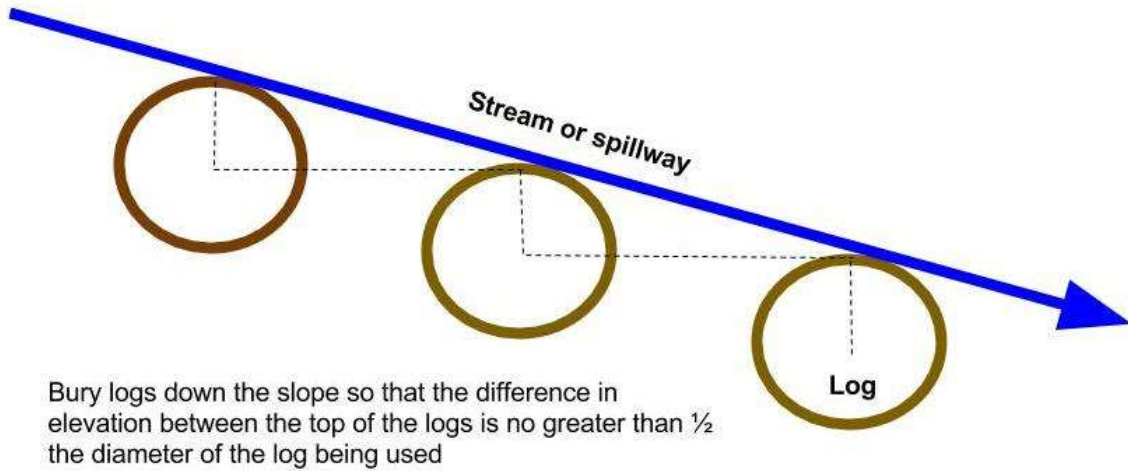
Constructed spillway using large diameter logs for vertical grade control to transition water from a restored wetland or stream into a ditch (typical side profile view)

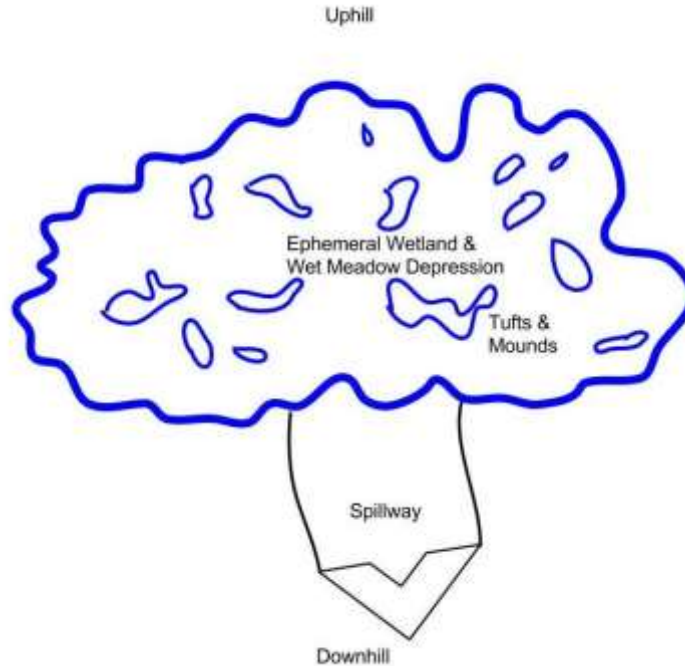
Emergent wetlands, ephemeral wetlands, and wet-meadow wetlands would be made by removing and shaping shallow depressions (Typical plan view)

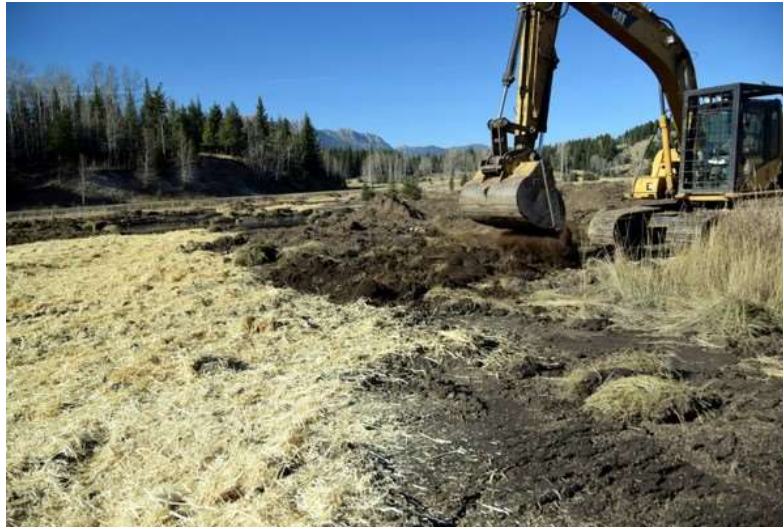
Here the excavator uses the *rough and loosen* technique to loosen compacted soils on a wetland restoration project. The loosened soils are seeded and planted to native species, and mulched using wheat straw to control erosion.

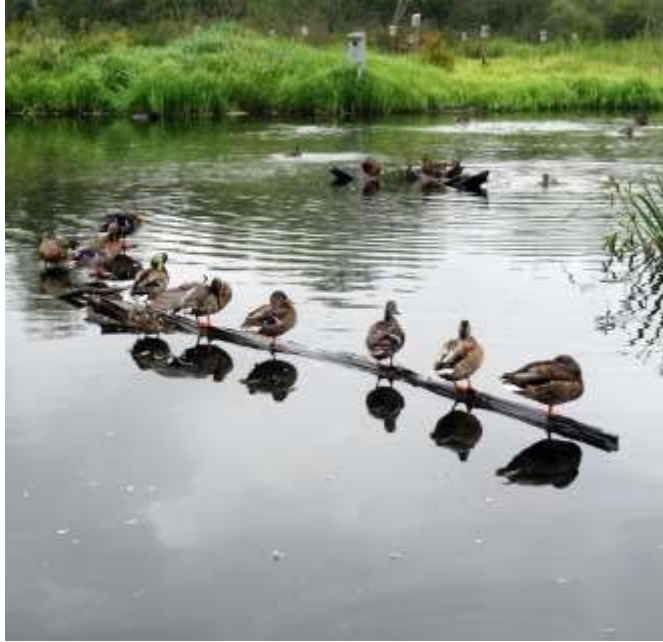
The logs placed in this emergent wetland provide loafing sites for waterfowl.

- 9) Large woody debris: Large diameter logs, branches, and root masses would be placed in the restored wetlands to improve habitat for a diversity of plant and animal species. Branches of various diameters and lengths would be placed in the wetlands to provide egg attachment sites for amphibians, and improved habitat for invertebrates, and plants. Wood would be obtained near the wetland restoration sites in advance, so it can be placed by heavy equipment during restoration.

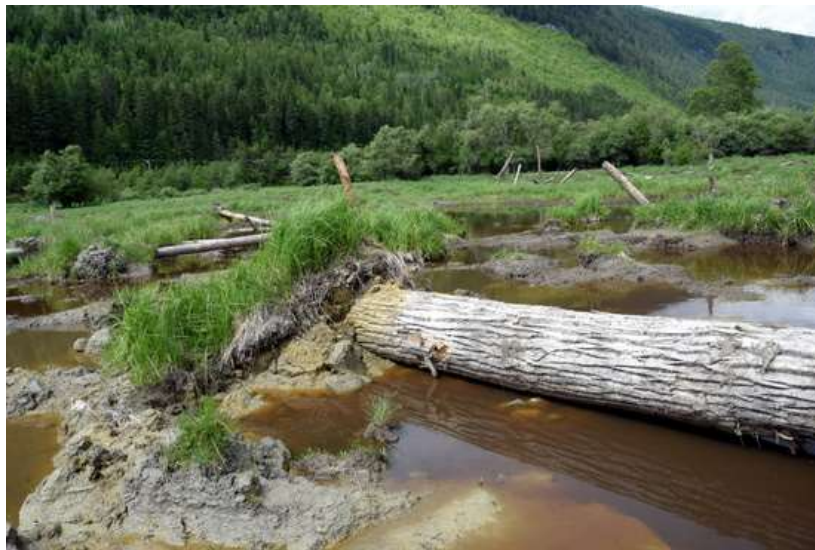
Large diameter logs would be placed in the restored wetlands to resemble trees naturally falling over. This photo shows one of many dead trees placed in wetlands restored at Meadow Creek in January 2016.

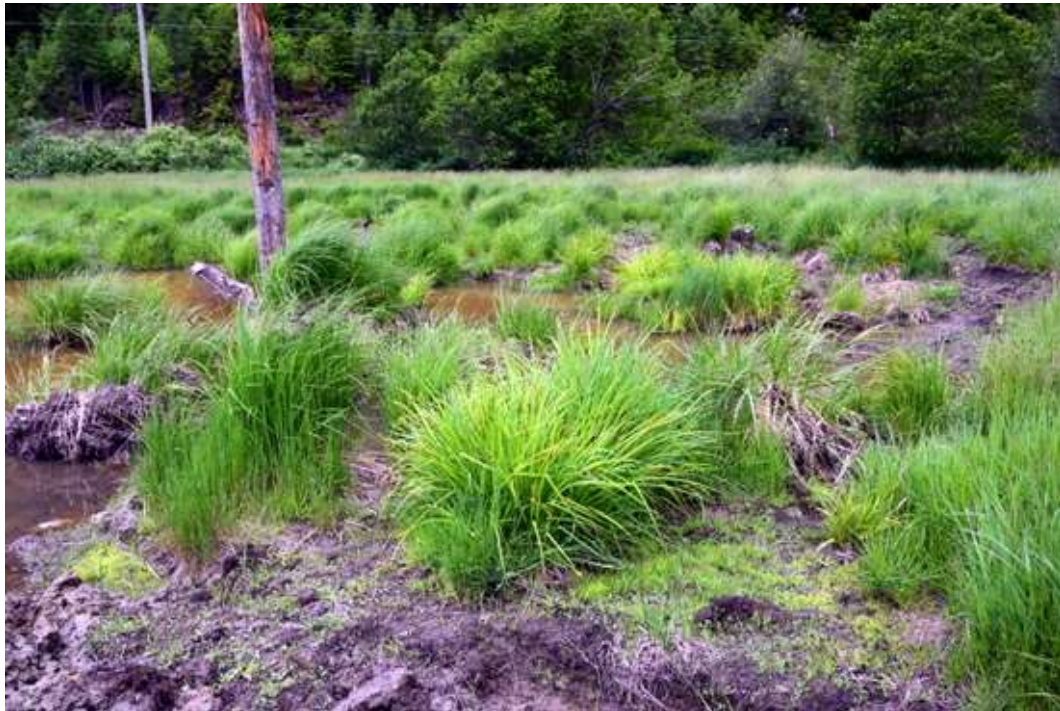
The clumps of sedges shown in this photo were saved and replanted as part of wetland restoration at Meadow Creek. The restored wetland is 4-months old in this photo.

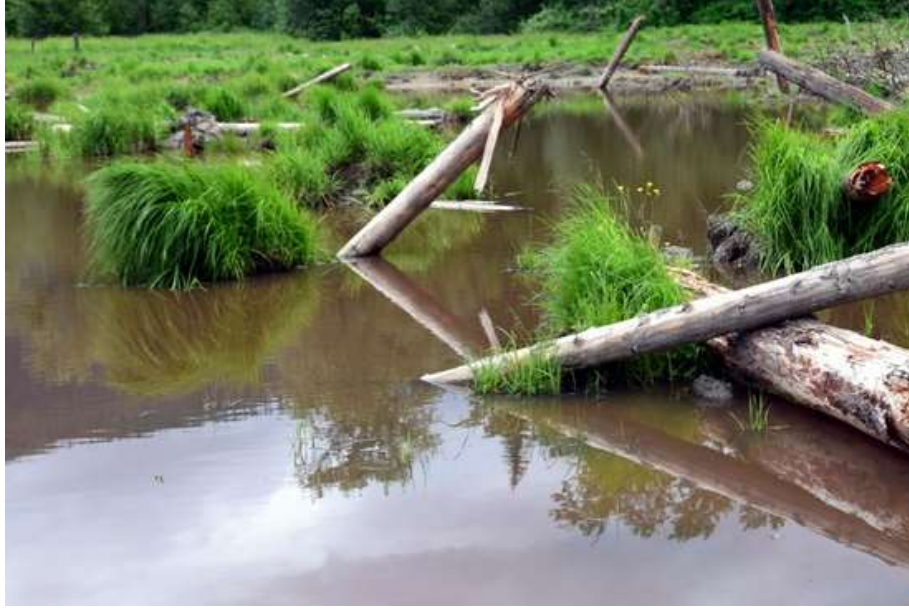
This newly restored wetland at Meadow Creek was only 4-months old when the photo was taken. The clumps of sedges were saved and replanted using the excavator during construction.

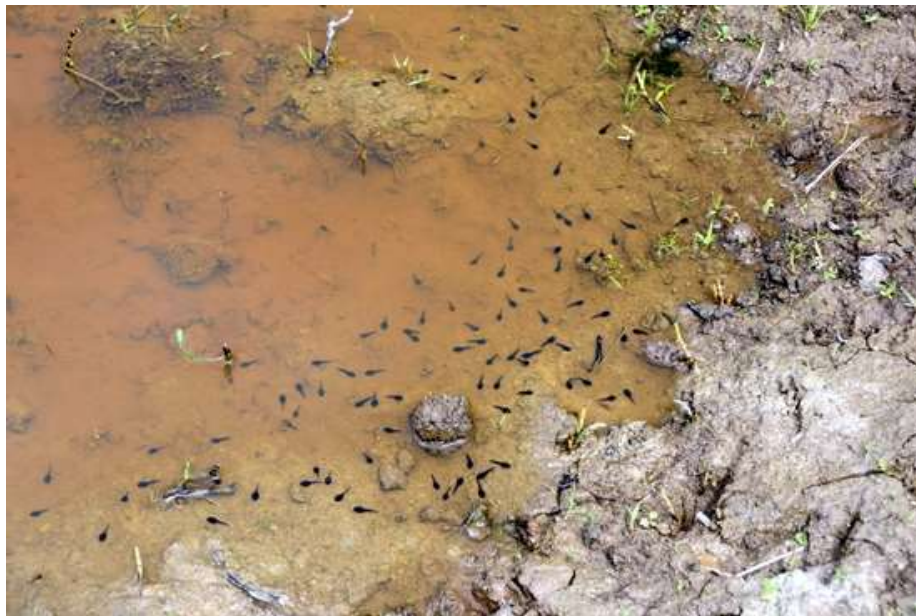
Shallow pools of water, like the one shown, would be made along the edges of wetlands to provide warm water for larval development.

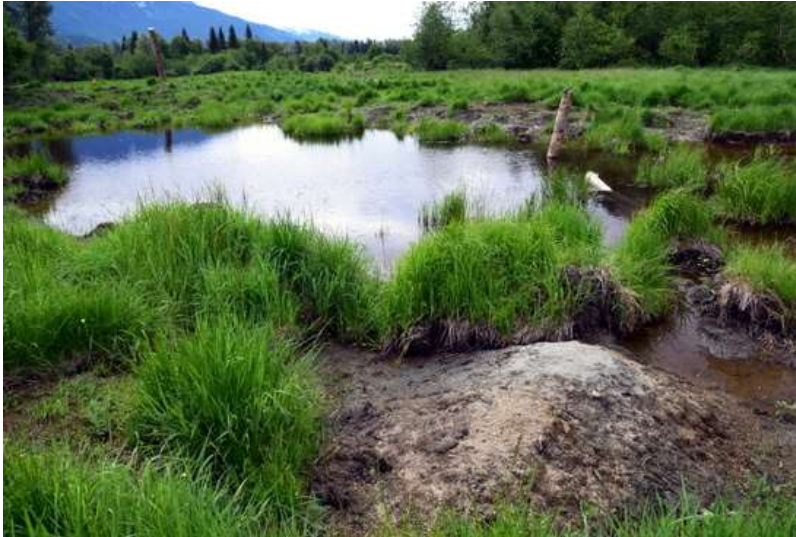
The pile of sand in the foreground is one of many uncovered and placed during wetland restoration at Meadow Creek.

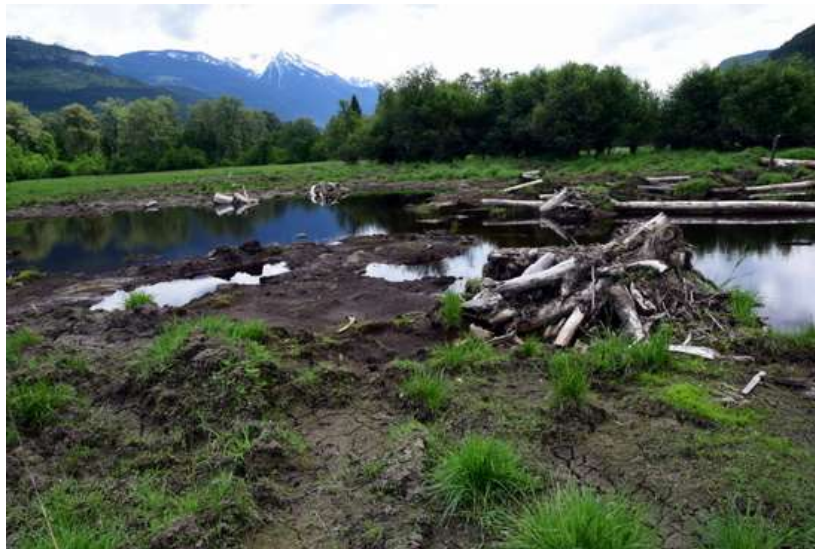
Piles of large and small woody debris, mixed with organics, would be placed in and near the wetlands to provide hiding sites for frogs, toads, and turtles. The pile shown in this photo was shaped to appear like an abandoned beaver house.

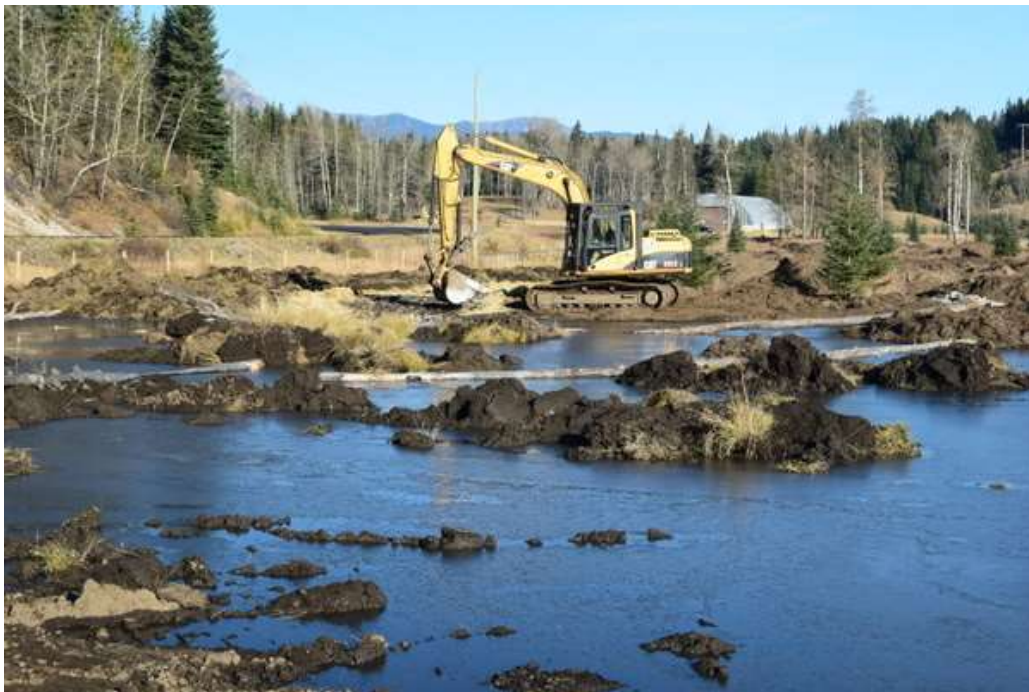
This photo shows an emergent wetland under construction near Fernie, British Columbia. Note the ridges and logs being placed in the basin.

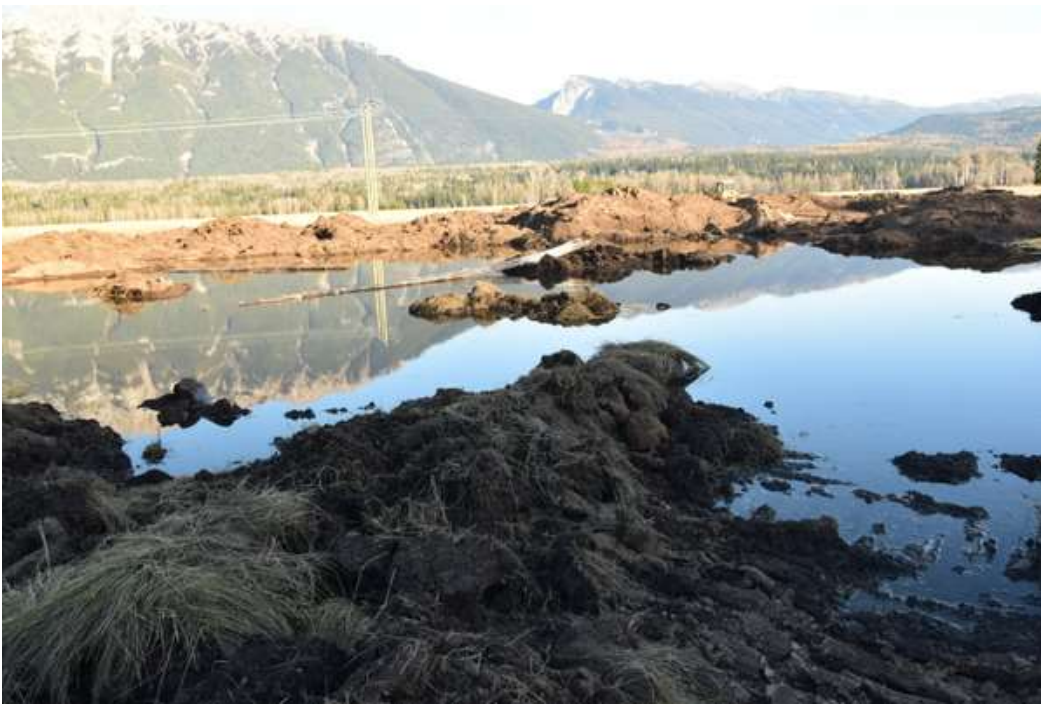
The ridges, islands, and peninsulas placed in this emergent wetland under construction near Fernie, British Columbia should support a diversity of plants and animals.

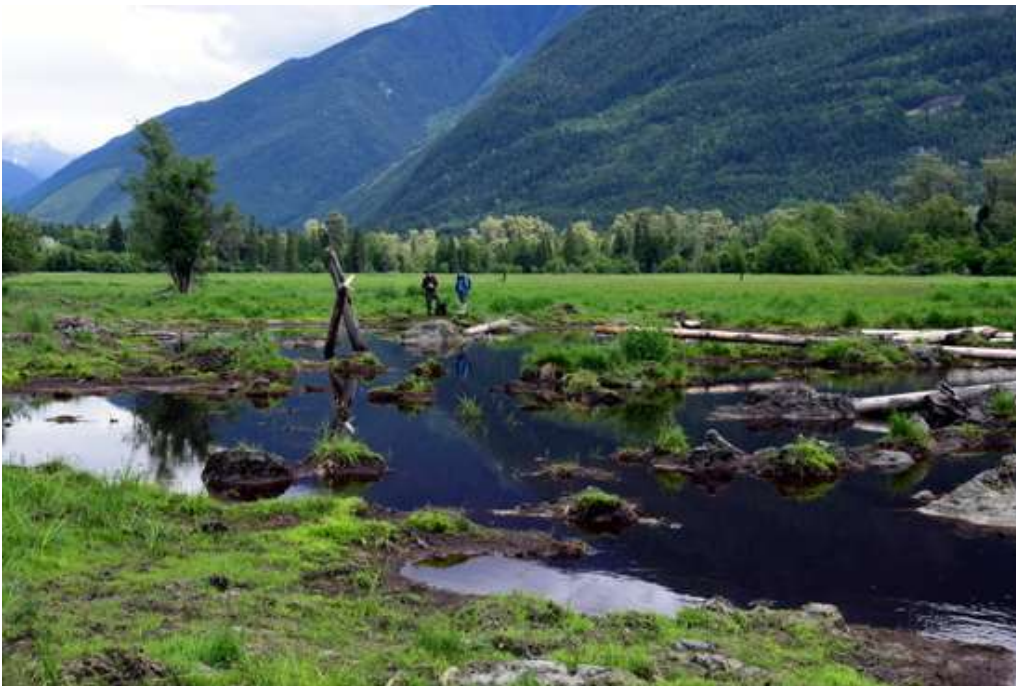
The wetlands at Cherry Meadows would be restored to have varied shapes, sizes, depths, substrates, and hydro-periods to provide habitat for common and uncommon species. This is one of many wetlands restored at Meadow Creek in January 2016. The wetland was 4-months old when this photo was taken.

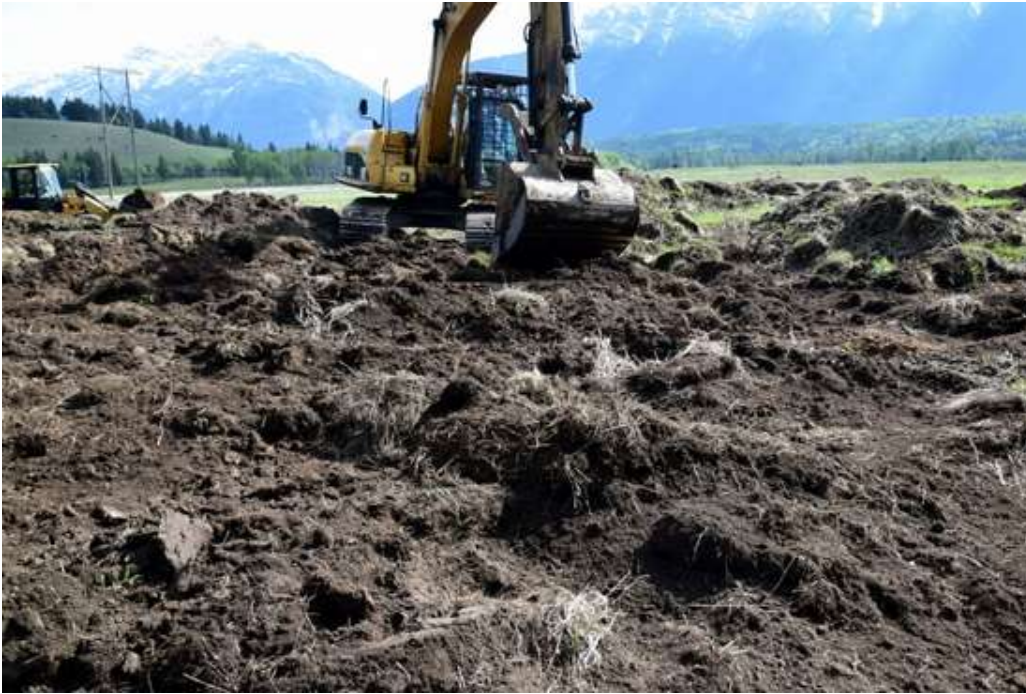
The *rough and loosen* technique, shown here, would be used to loosen compacted soils to control erosion, reduce reed canary grass, promote a diversity of plants, and improve conditions for burrowing animals.

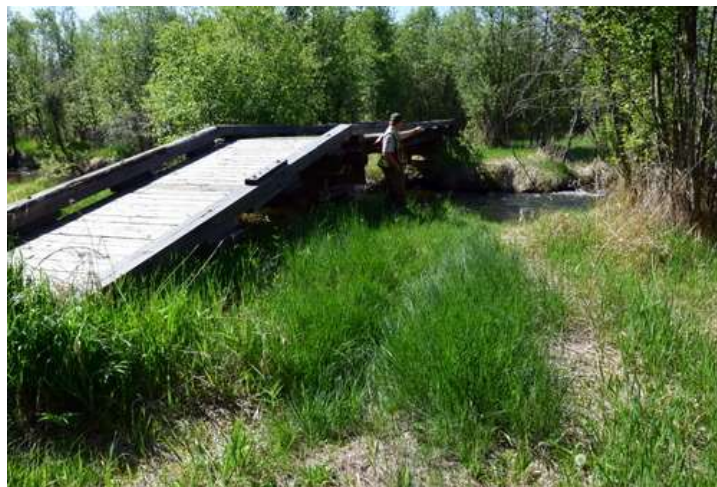
Here is the existing bridge over Cherry Creek

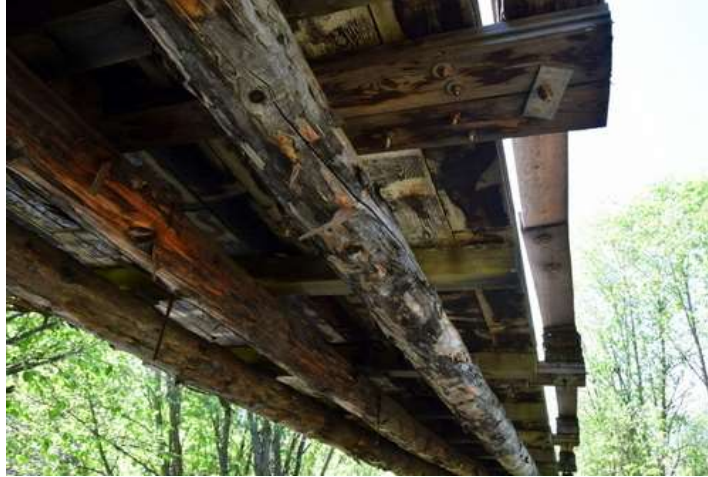
The existing bridge is supported by small diameter logs

Heavy equipment would be needed to restore wetlands at Cherry Meadows. It is not safe for heavy equipment to travel the existing bridge over Cherry Creek. The heavy equipment can weigh as much as 48,000lbs.

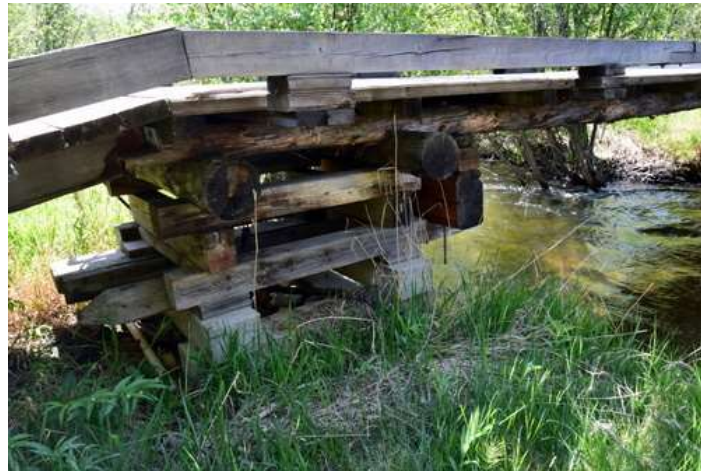
The bridge was not designed for heavy equipment to cross

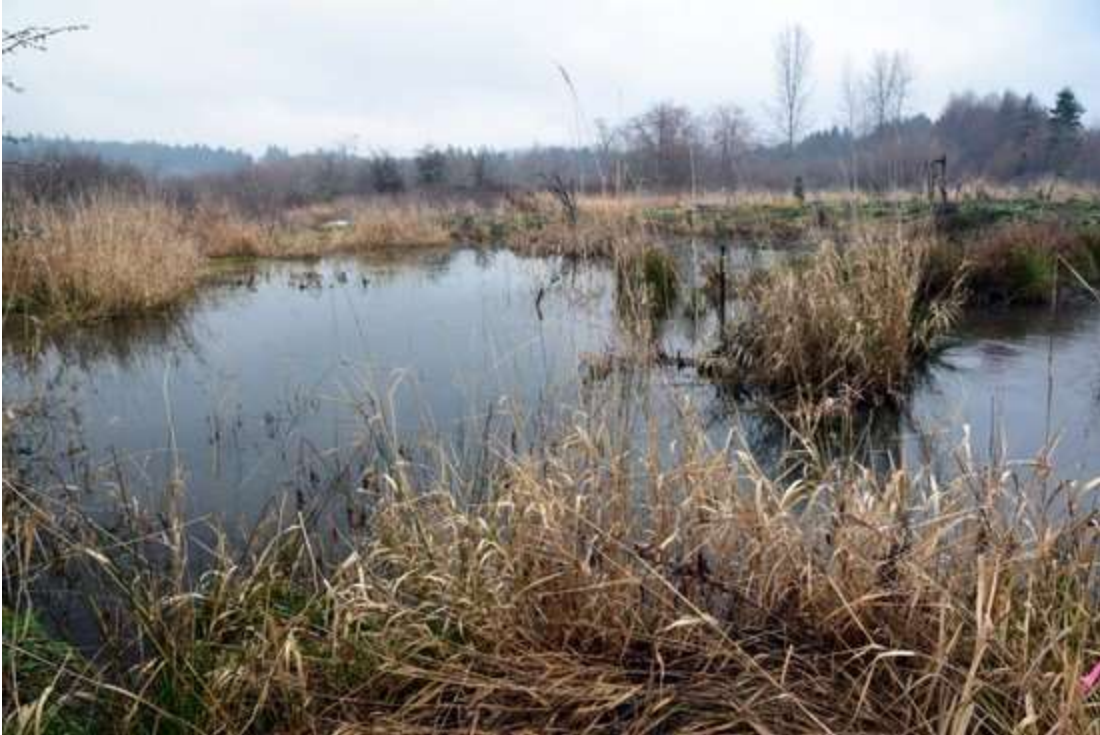
One of many emergent wetlands built to manage stormwater runoff near Duncan, British Columbia.
