NCC Land Stewardship Activities F17

FWCP Project No. W-F17-05

Executive Summary

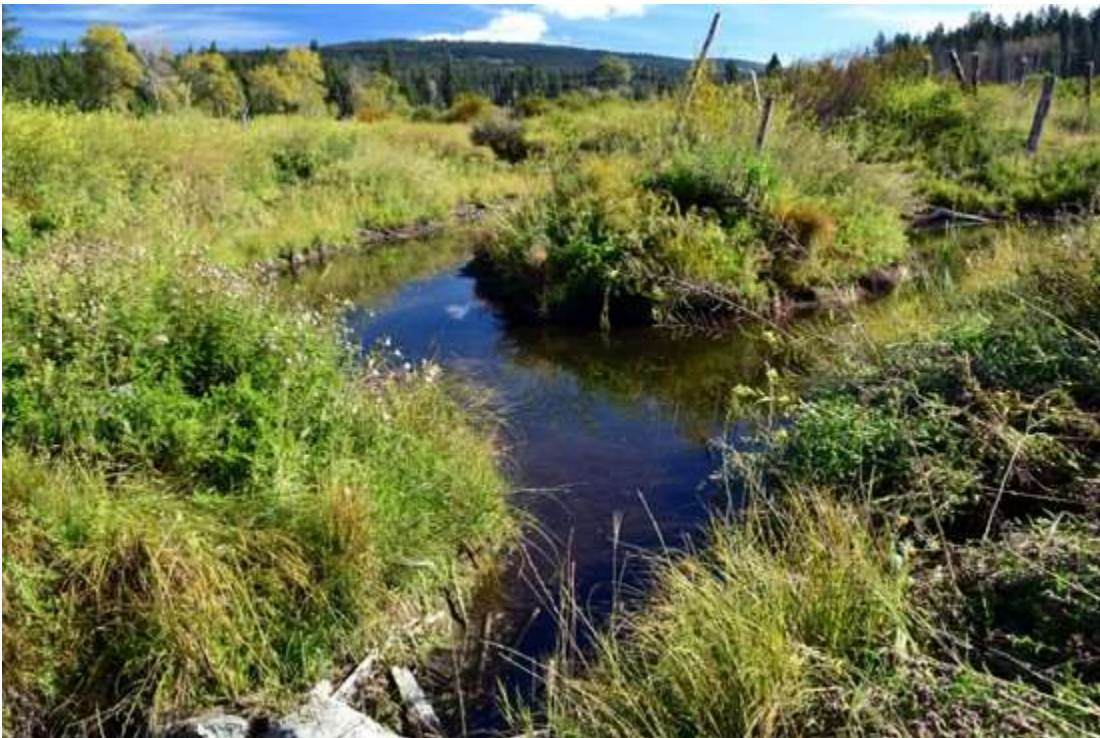
Here is one of many emergent wetlands built to manage stormwater runoff near Logan Lake, British Columbia.

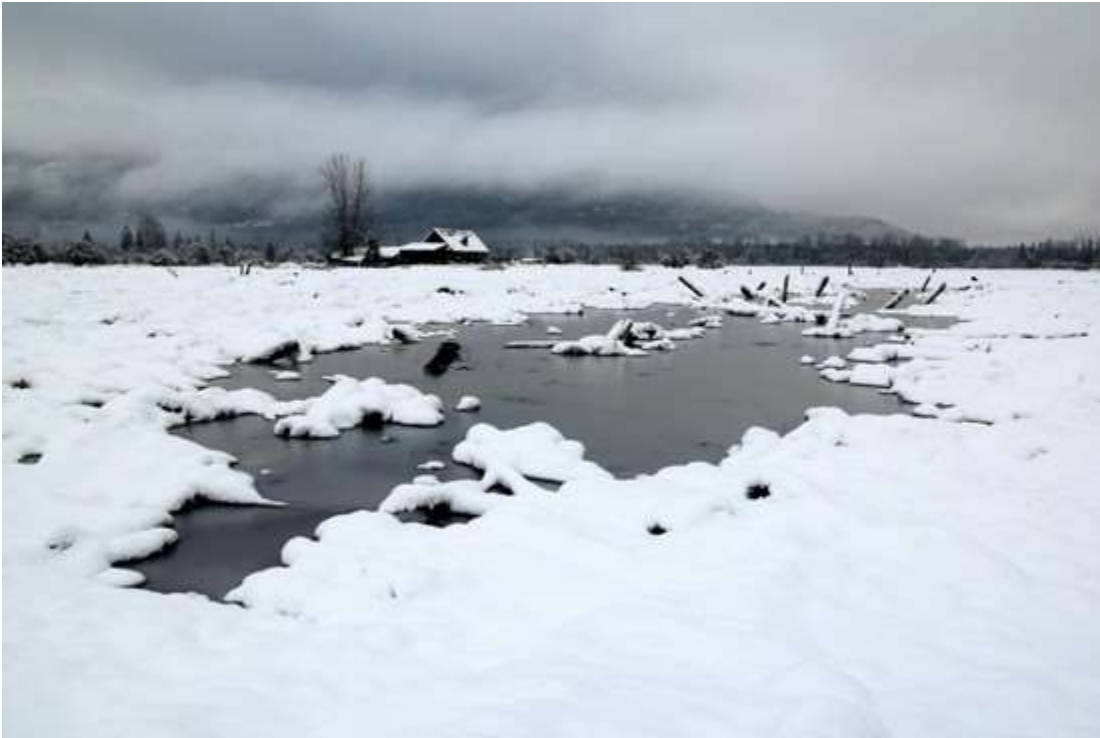
This 1-day old emergent wetland was filling with groundwater when the photo was taken at Meadow Creek, British Columbia.

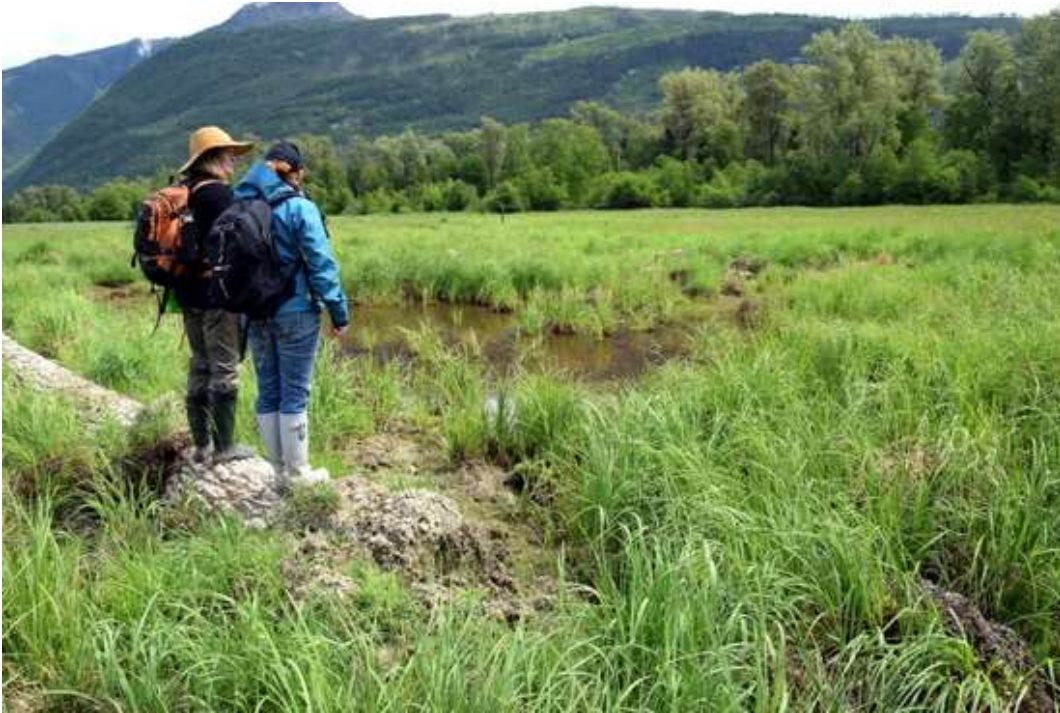
Restored wetlands are great places to watch wildlife. This restored ephemeral wetland is 4-months old, near Meadow Creek, British Columbia.

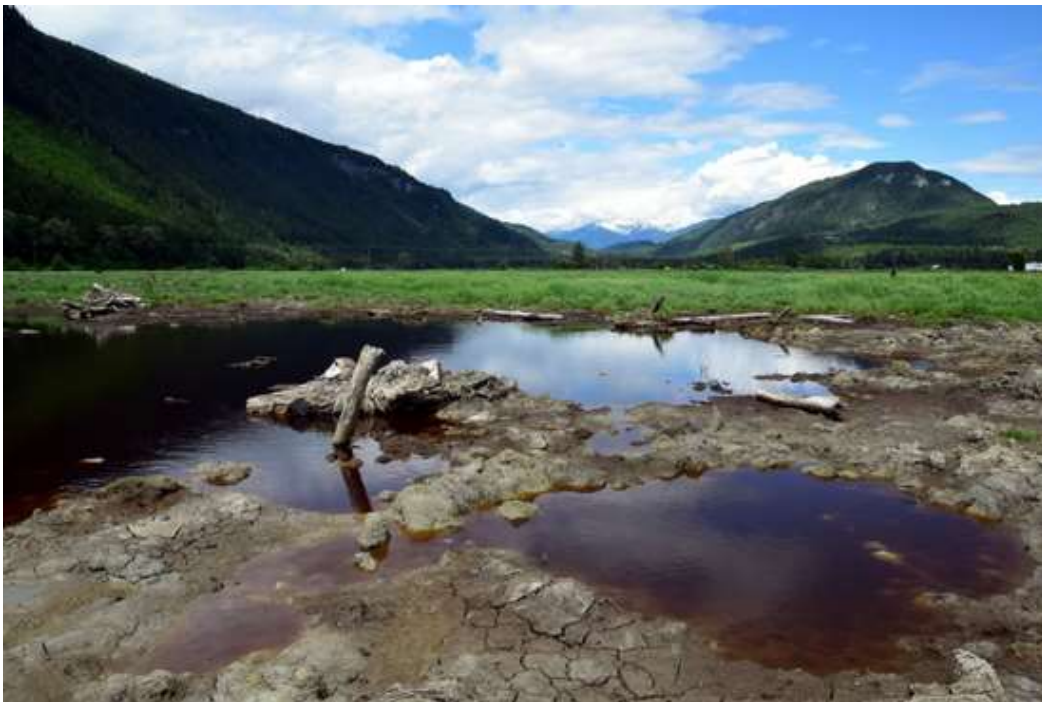
Emergent wetland (4-months old), Meadow Creek, British Columbia

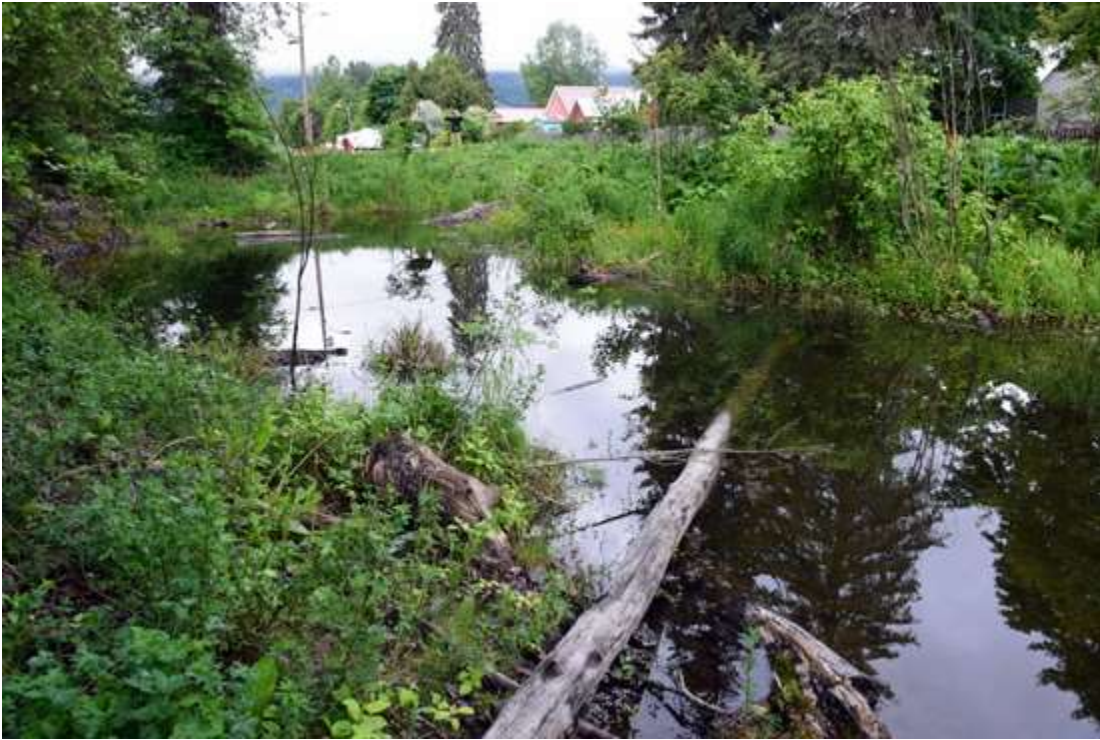
Emergent wetland built for treating stormwater at KP Park, Salmo, British Columbia

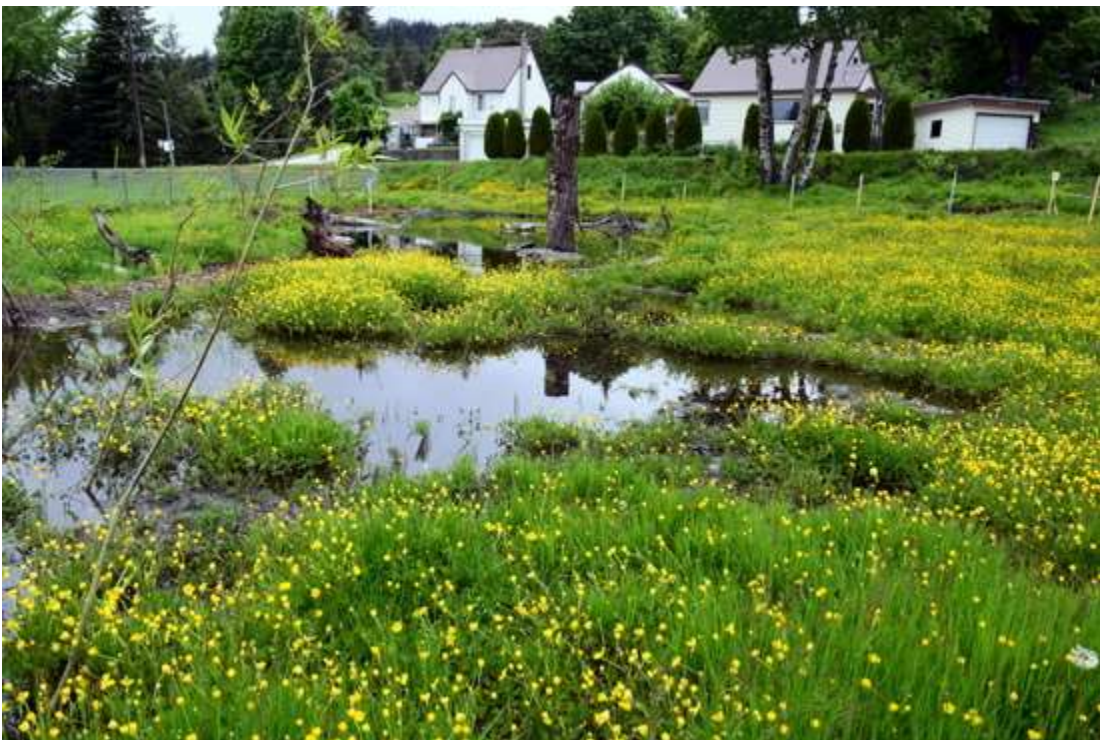
Emergent wetland (7-months old) built at North Jubilee Park, Rossland, British Columbia

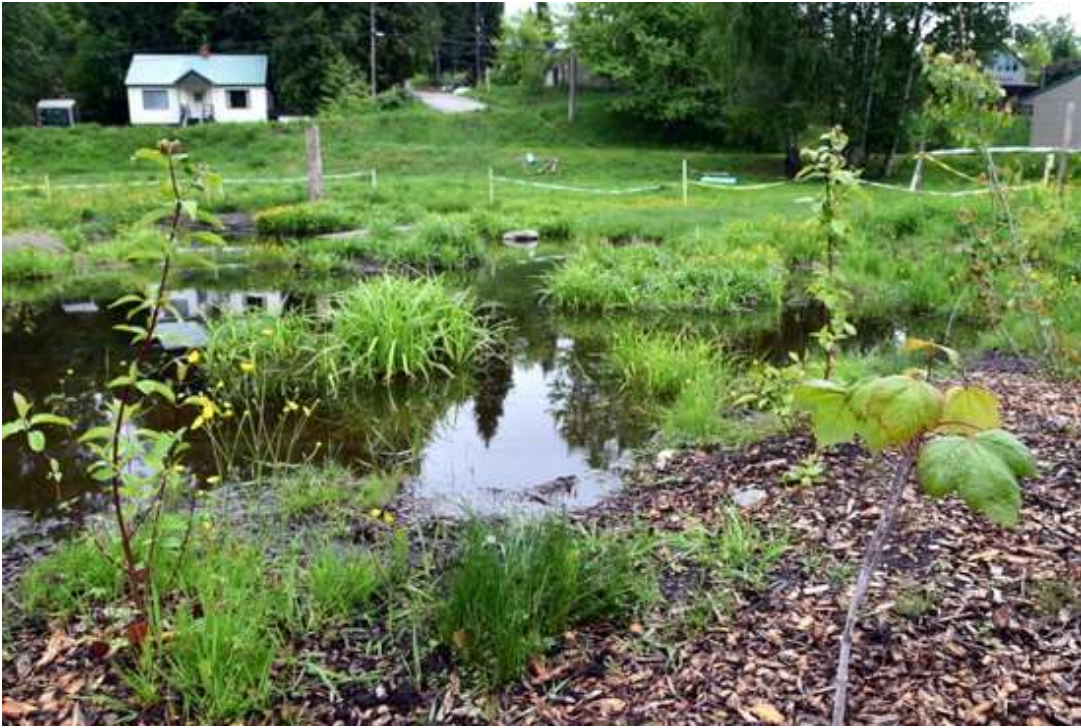
Emergent wetland (7-months old) built at North Jubilee Park, Rossland, British Columbia

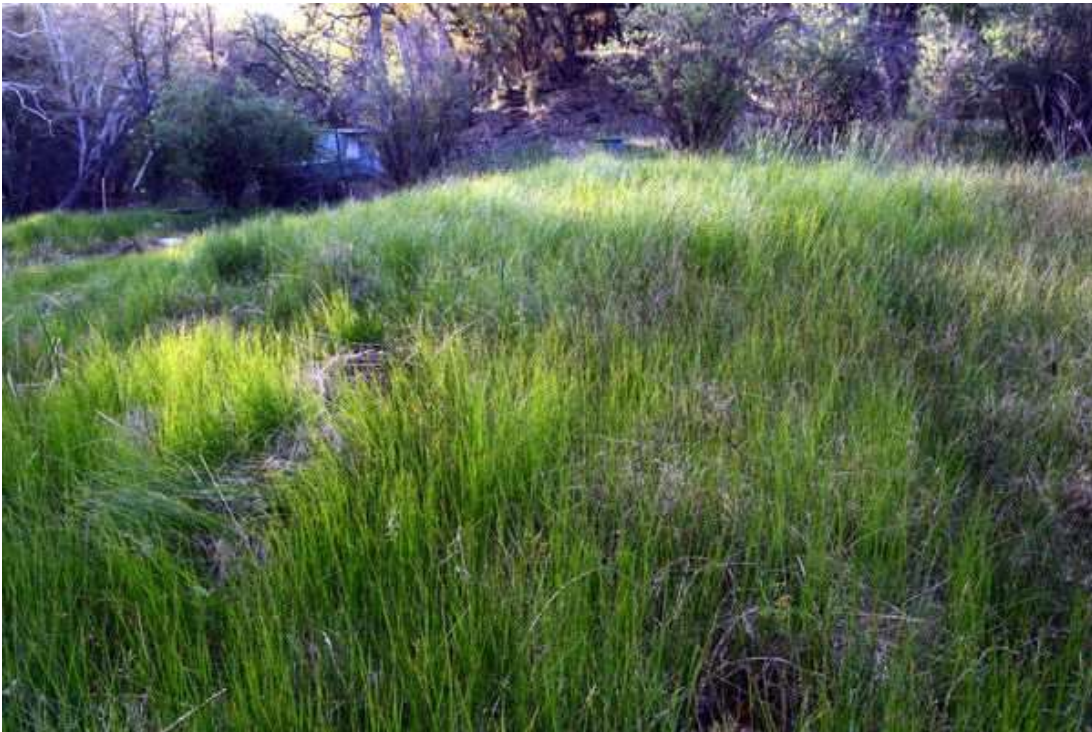
The *rough and loosen* technique was used to establish this wet-meadow wetland from a waste pile of soil at the Southwestern Research Station near Portal, Arizona.

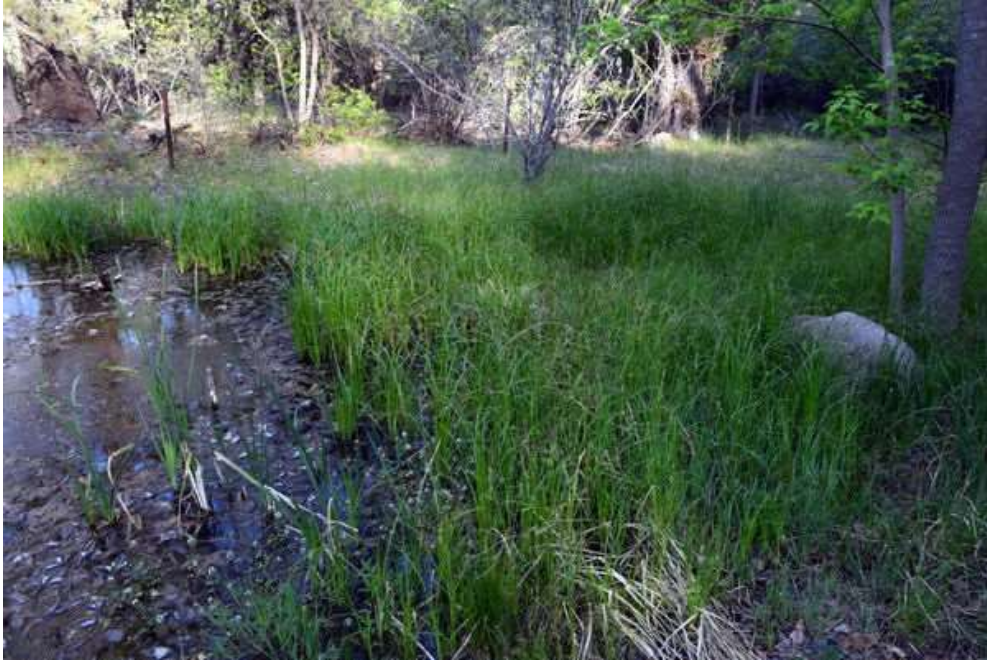
The emergent wetland (left) and wet-meadow wetland (right) were restored by disabling a ditch and a buried drain line at the Southwestern Research Station in Arizona. The wet-meadow is supplied with water from the emergent wetland. The site was a field dominated by nonnative plants before the project took place.

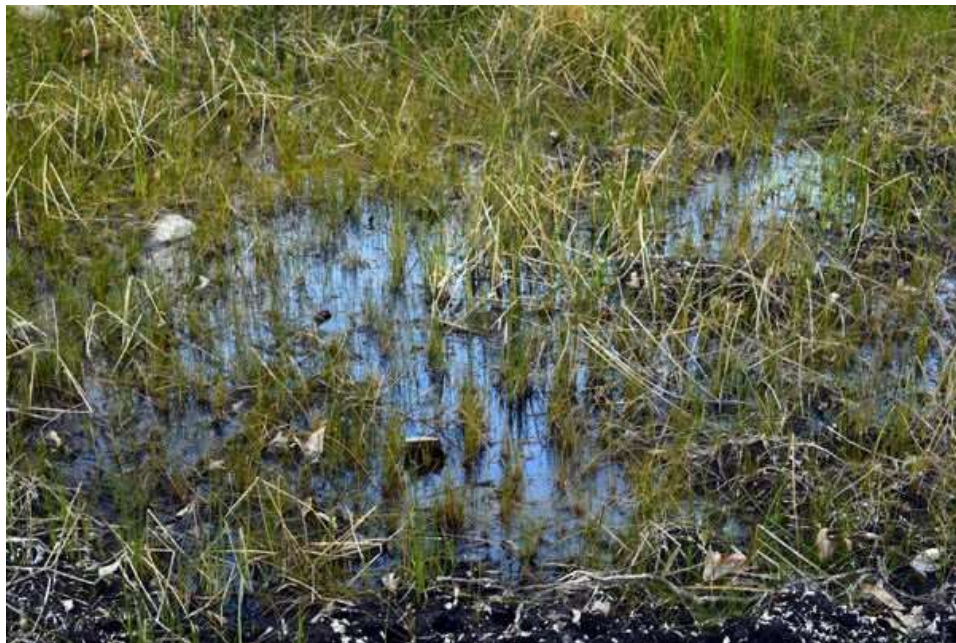
This wet-meadow wetland was restored at the Southwestern Research Station in Arizona. While the site does not contain a lush growth of plants, it does provide critical habitat for juvenile Chiricahua Leopard Frogs, a Federally Threatened species

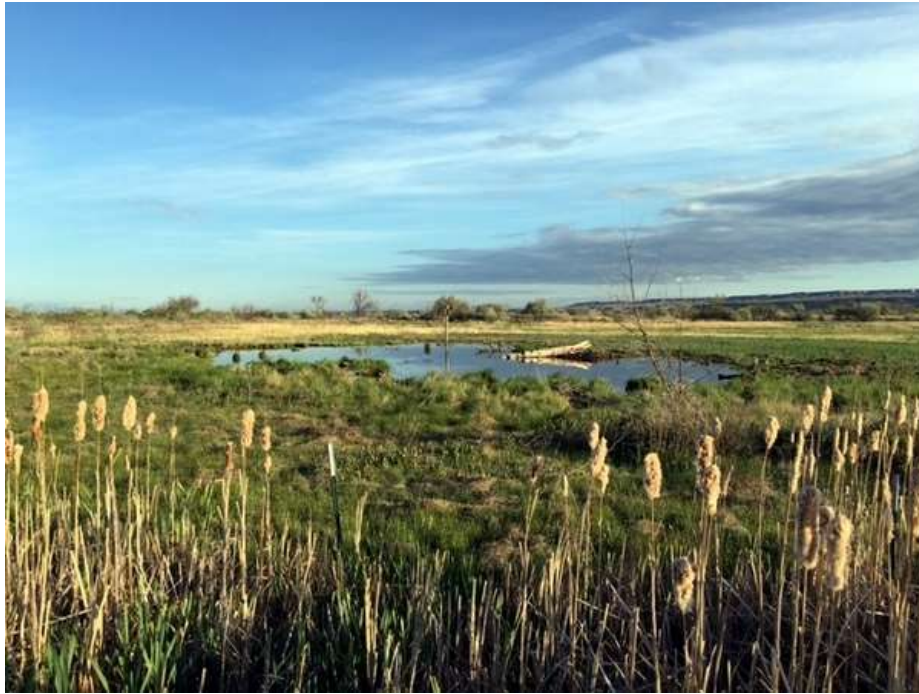
This wet-meadow and emergent wetland were restored in arid Owyhee County, Idaho. The wetlands are less than one-year old in this photo.

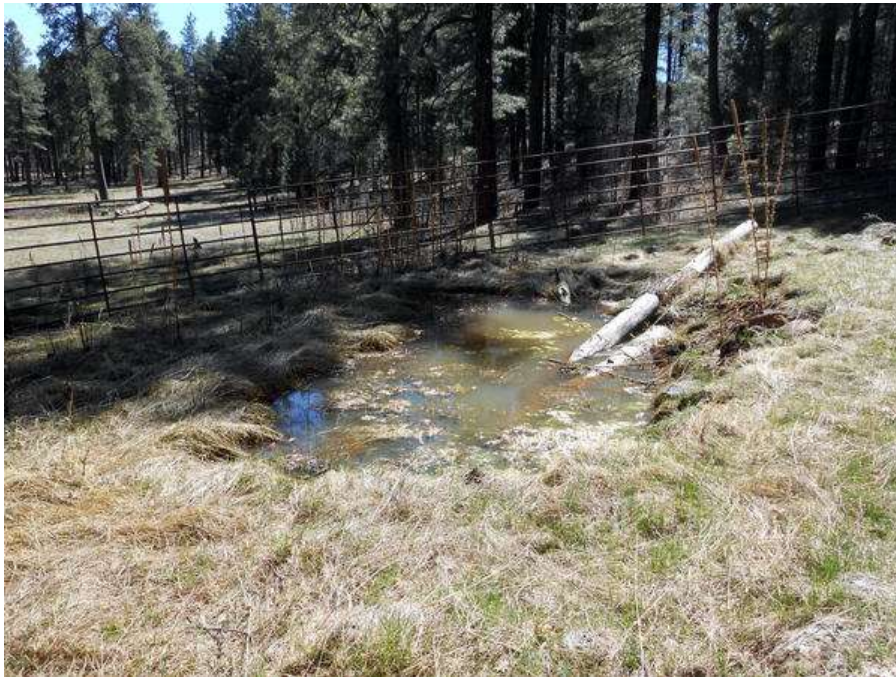
This small emergent wetland was built on a steep slope near Bill Dick Spring on the Mogollon Rim Ranger District, Coconino National Forest, in Arizona.

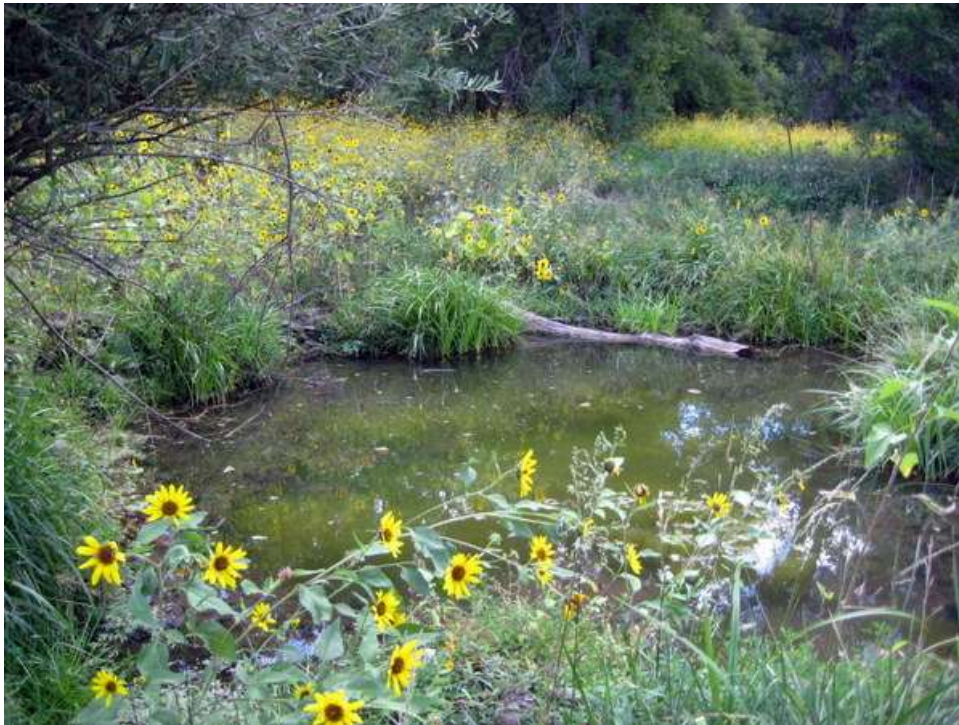
One of 14-wetlands restored at Moreno Springs along the Mimbres River in New Mexico for the Federally Threatened Chiricahua Leopard Frog and the Chihuahua Chub. The wetlands are one-year-old in these photos, and are being used by both species.

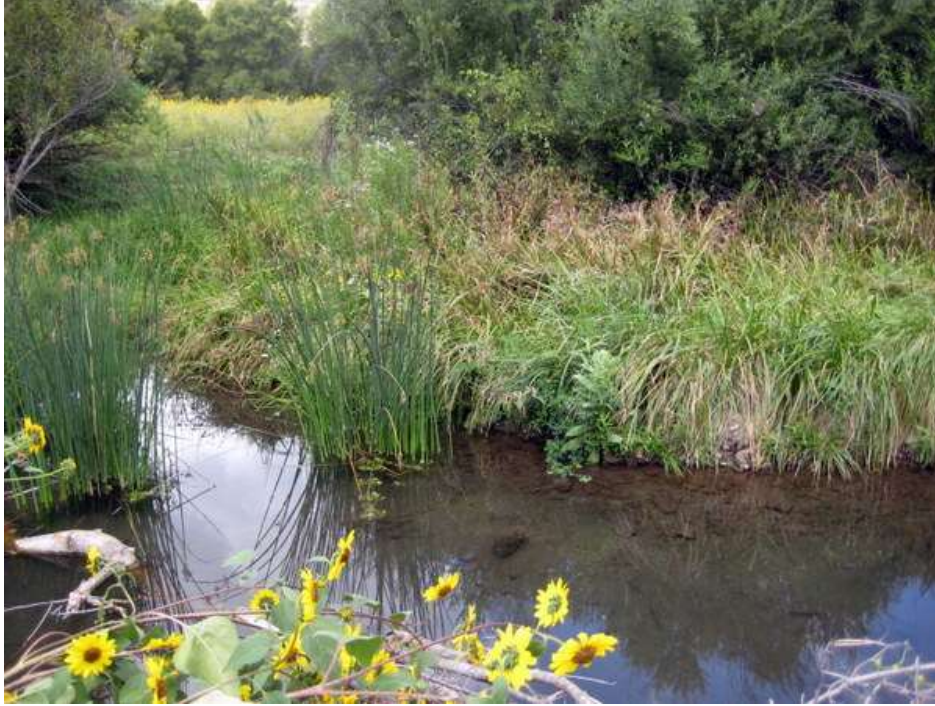
Another one of the 14-wetlands restored at Moreno Springs along the Mimbres River in New Mexico for the Chiricahua Leopard Frog and the Chihuahua Chub. This wetland is also being used by both Federally Threatened species.
