**THE IDENTIFICATION OF HABITAT IMPROVEMENT  
OPPORTUNITIES FOR ADULT AND SUB-ADULT SPORT  
FISH IN THE UPPER PINE RIVER**

**R. P. Griffith, Fisheries Biologist  
March, 1992**

**B.C. Environment  
Fort St. John**

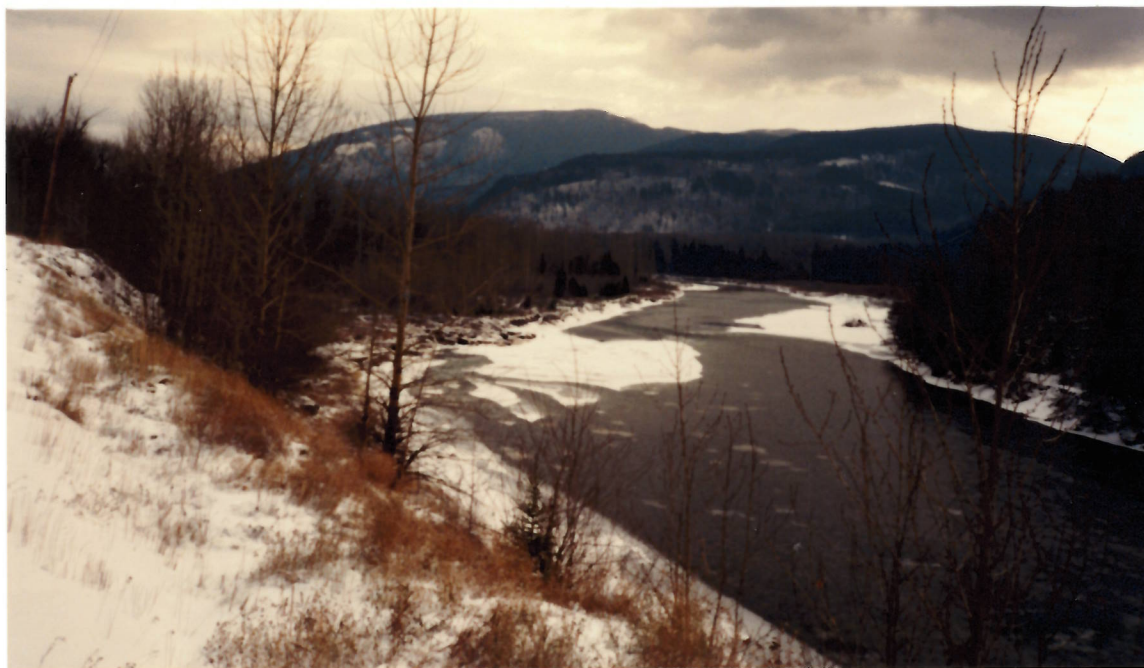
Figure 2. Example of channel instability in the Pine River mainstem between Fisher and Crassier creeks.

Accordingly, the presence/size of point bars or side bars, and associated confinement, as evidenced in the aerial video, was used as a further indication of the relative stability (and according suitability for enhancement) of the various accessible sites. Lisle and Overton (1989) stress that braided stream sections should not be considered for the installation of habitat improvement structures. Channel shifts may subsequently occur, isolating the structures, and rendering them useless. Consequently, the many areas of the Pine River study section where such instability is evidenced (Fig.2) were excluded from further consideration for such installations.

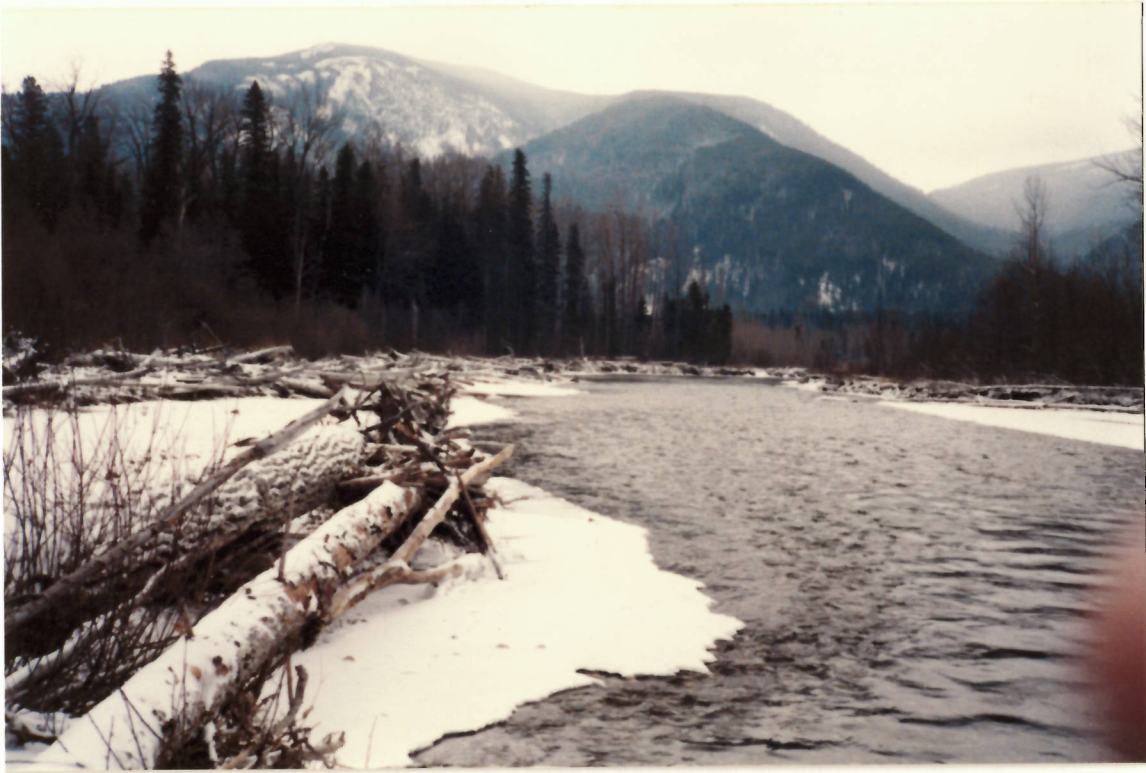
Figure 3. Example of LOD in Pine River mainstem downstream of Cleveland Creek.

Consistent with the latter, the aerial video clearly showed that LOD is, by far, the dominant form of fish cover in the project section. It is found, to varying degrees, in most section segments and components. It is frequently abundant in tight meanders and side channel areas, but is also present, to varying/lesser degrees, in many of the more stable and confined areas throughout the streamlength addressed (Figs. 3 and 4). Generally speaking, it tends to be least abundant in straight confined sections, as well as sites of highway or railway encroachments. In the latter case, rip-rap materials, displaced from associated bank armouring, appear to represent the most frequent form of cover for adult sport fish. Since streambed substrates tend to be small throughout the project section, there is relatively little in the way of natural boulder cover. One area particularly lacking in cover, in general, is the 7.5 km immediately downstream of Link Creek, near the upstream end of the project section.

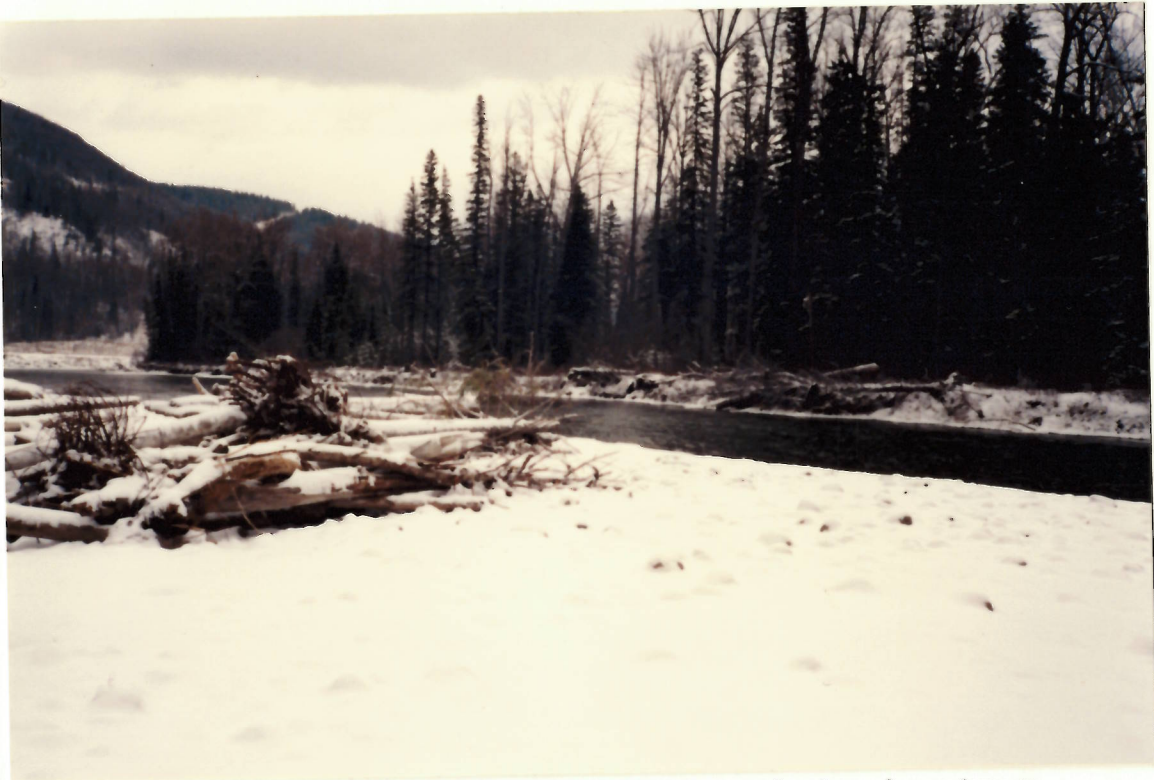
Figure 4. Example of LOD in Pine River mainstem downstream of Link Creek.

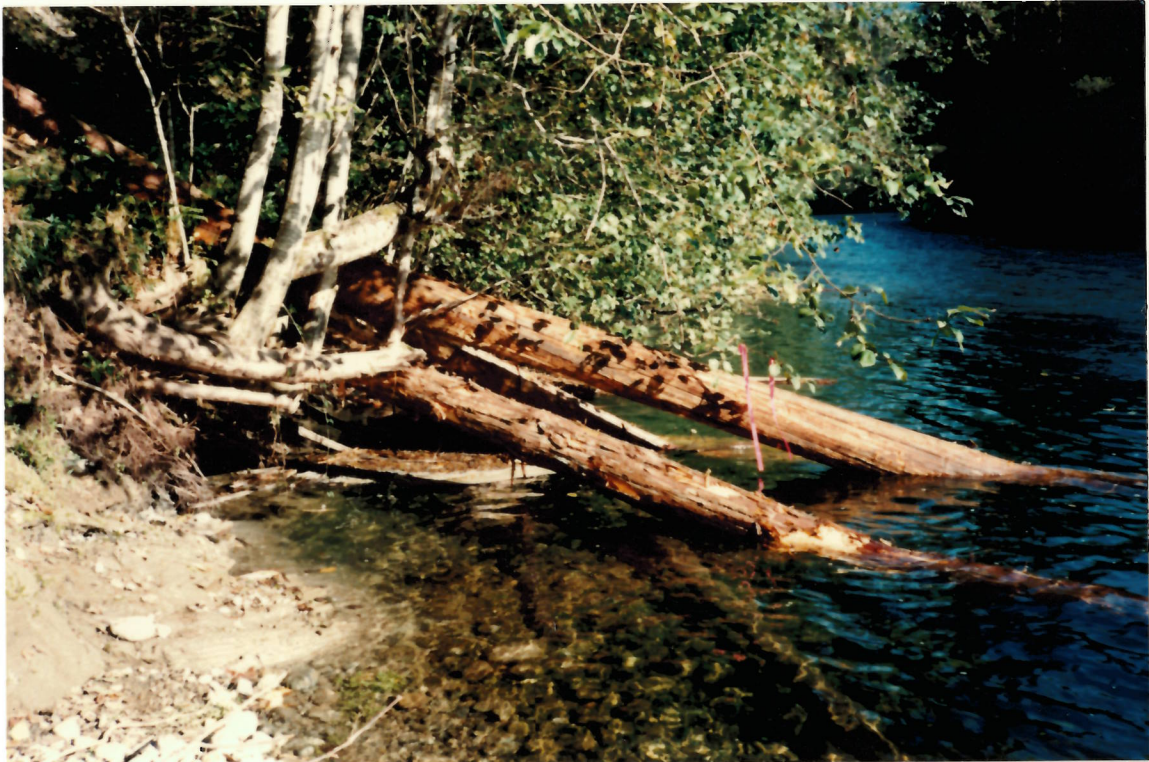
Figure 6. Example of bank LOD structures installed in the Cowichan River, 1991.

- may also require accompanying armouring of bank.
2. Bank LOD: (Fig.6)
  - LOD elements anchored at the streambank, and protruding down into the channel.

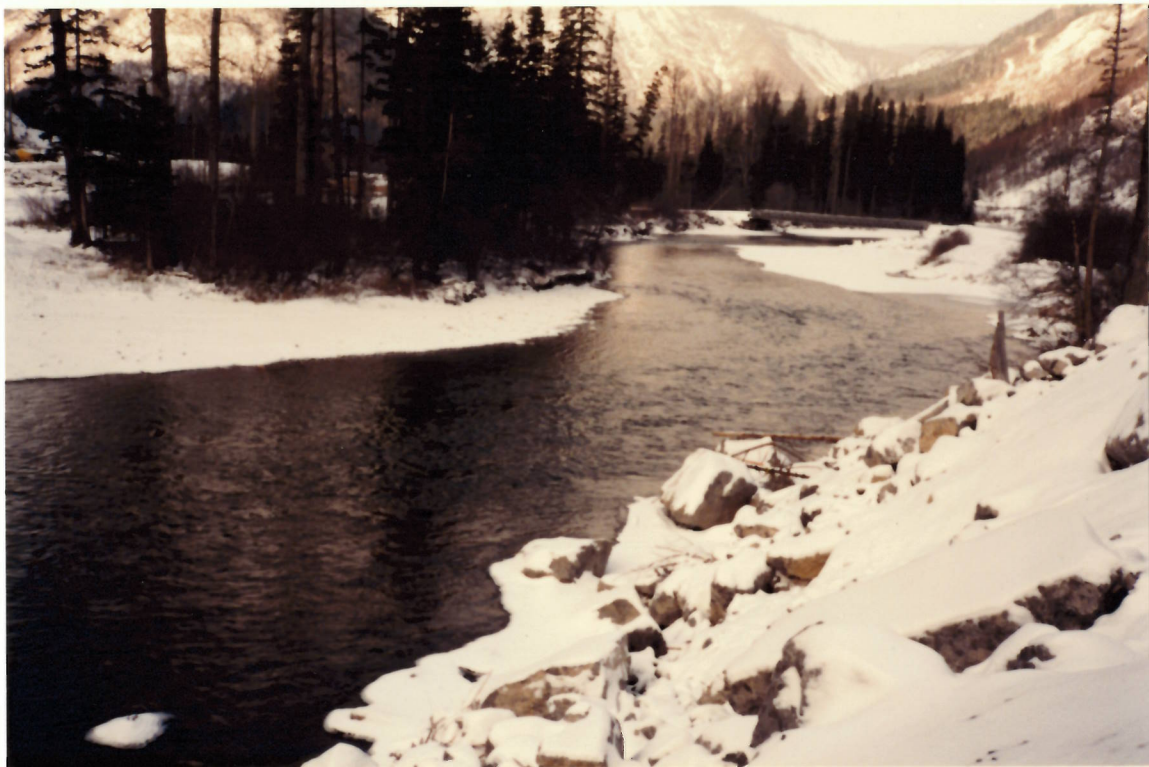
Figure 7 Example of displaced rip-rap in the upper Pine River.

3. Bank boulders: (Fig.7)
  - additions of large boulder materials along the outside bank of curved sections; placed loosely, and extending out as random groupings on the streambed (simulating existing displaced rip-rap).

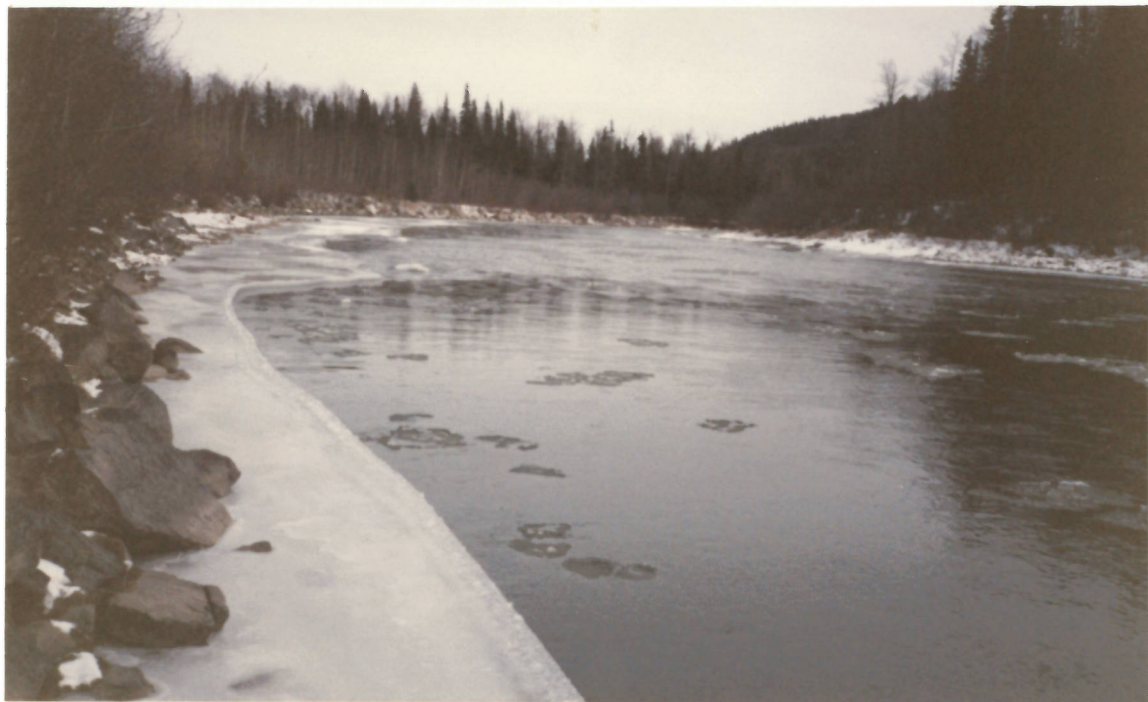
System: Pine River Section: 1 Date: Oct 29/91  
 Section location: adjacent to (and downstream of) picnic site off Hwy.97 at old oxbow; ca. 2 km downstream of Fur Thief Creek

Access (including enhancement considerations):  
 excellent, full access to left bank from picnic area off Hwy.97; however, rip-rap complicates access to channel for machinery

Enhancement options/recommendations:  
 channel characteristics and logistical considerations appear suitable for debris catchers, or additional bank boulders along left bank; however, average water velocity and depth may be inadequate (low); suggest LOW priority for any installations

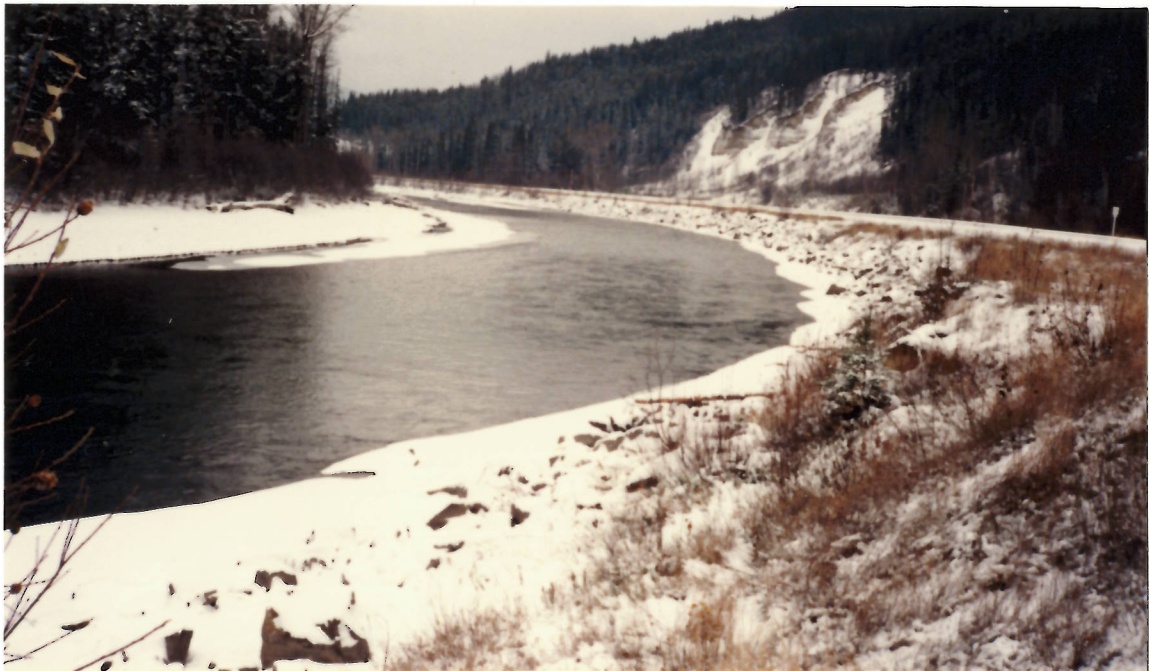
System: Pine River                      Section: 5                      Date: Oct 30/91  
Section location: ca. 2 km downstream of Fisher Creek confluence; immediately adjacent to Hwy.97, 2 km east of Fisher Creek crossing

<u>Section length (m):</u>	200+	<u>Gradient (%):</u>	0.04
<u>Sinuosity (from map):</u>	1.4	<u>Habitat type:</u>	fast glide/run
<u>Wetted width (m):</u>	40	<u>Channel width (m):</u>	60
<u>Width/depth ratio:</u>	25 est.		
<u>Mean water depth within 5m of bank (m):</u>		1.2	
<u>Mean water velocity within 5m of bank (m/s):</u>		0.8 (surface)	
<u>Streambed substrates (% composition):</u>			
fines <2mm	>5	small cobble 64-128mm	40
small gravel 2-16mm	5	large cobble 128-256mm	30
large gravel 16-64mm	15	boulders >256mm	<5
other	0	D <sub>50</sub> (mm)	15

site appears particularly well suited to further bank boulder installations (additional rip-rap), both hydraulically and logistically; water depth appears excessive for debris catchers; suggest HIGH priority for boulders

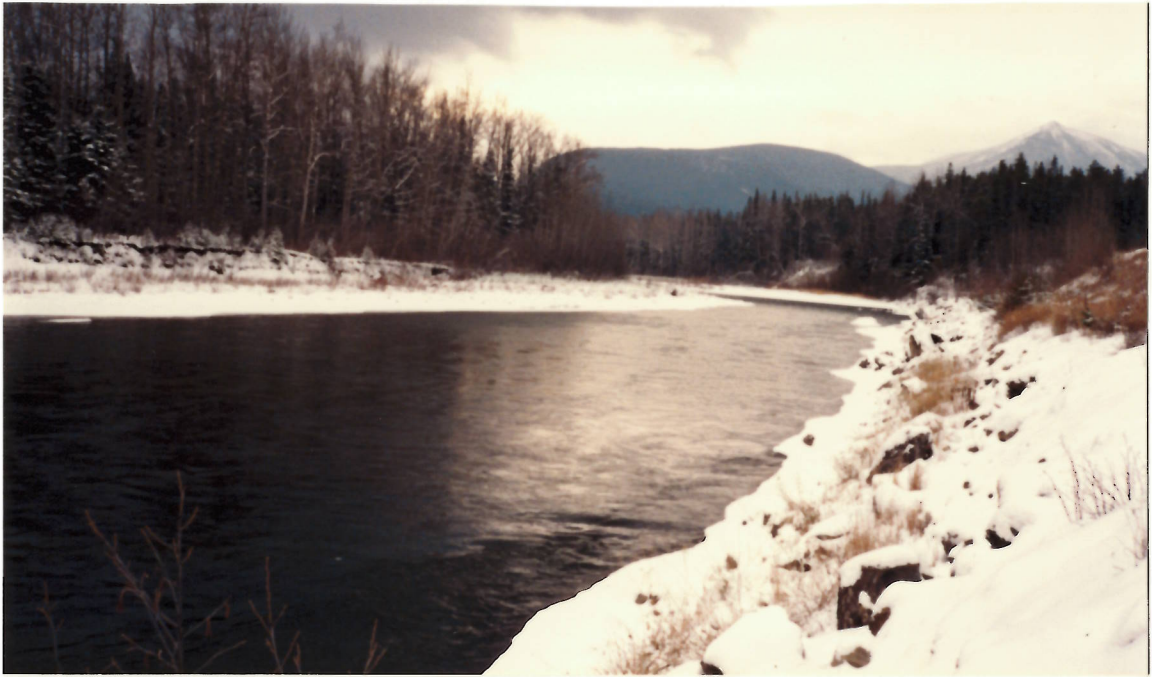
System: Pine River                      Section: 6                      Date: Oct 30/91  
Section location: ca. 1 km downstream of Fisher Creek confluence; immediately adjacent to Hwy.97 at "old diversion" (upstream of picnic site)

Section length (m): 250                      Gradient (%): 0.12  
Sinuosity (from map): 1.3                      Habitat type: riffle  
Wetted width (m): 55                      Channel width (m): 60  
Width/depth ratio: 50 est.  
Mean water depth within 5m of bank (m): 1.0  
Mean water velocity within 5m of bank (m/s): 0.9 (surface)

Access (including enhancement considerations):  
 excellent access directly from highway; only difficulty for machinery would be the stream bank itself

Enhancement options/recommendations:  
 the highly beneficial effect of existing rip-rap in the channel suggests best possibilities from augmenting such habitat; all logistical conditions are well suited to further bank boulder additions or debris catchers; recommend HIGH priority for either

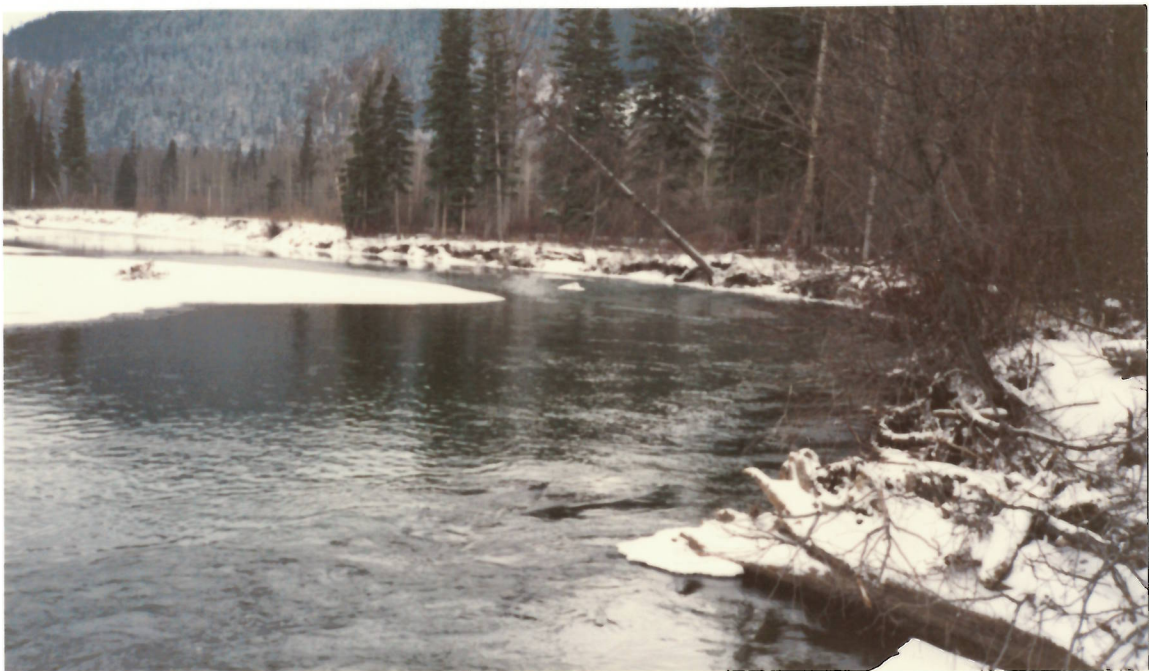
System: Pine River                      Section: 7                      Date: Oct 30/91  
Section location: ca. 3.5 km downstream of Big Boulder Creek confluence; meander  
joining Hwy.97, 2 km east of Big Boulder Creek crossing

Section length (m): 200                      Gradient (%): 0.15  
Sinuosity (from map): 1.8                      Habitat type: fast glide  
Wetted width (m): 40                      Channel width (m): 60  
Width/depth ratio: 25 est.  
Mean water depth within 5m of bank (m): 0.8  
Mean water velocity within 5m of bank (m/s): 0.9 (surface)

site characteristics and logistics appear well suited to installation of debris catchers (upper 100m) and bank LOD (lower 100m); suggest MODERATE-HIGH priority for either, or both (would be HIGH, except for abundance of existing cover adjacent to section)

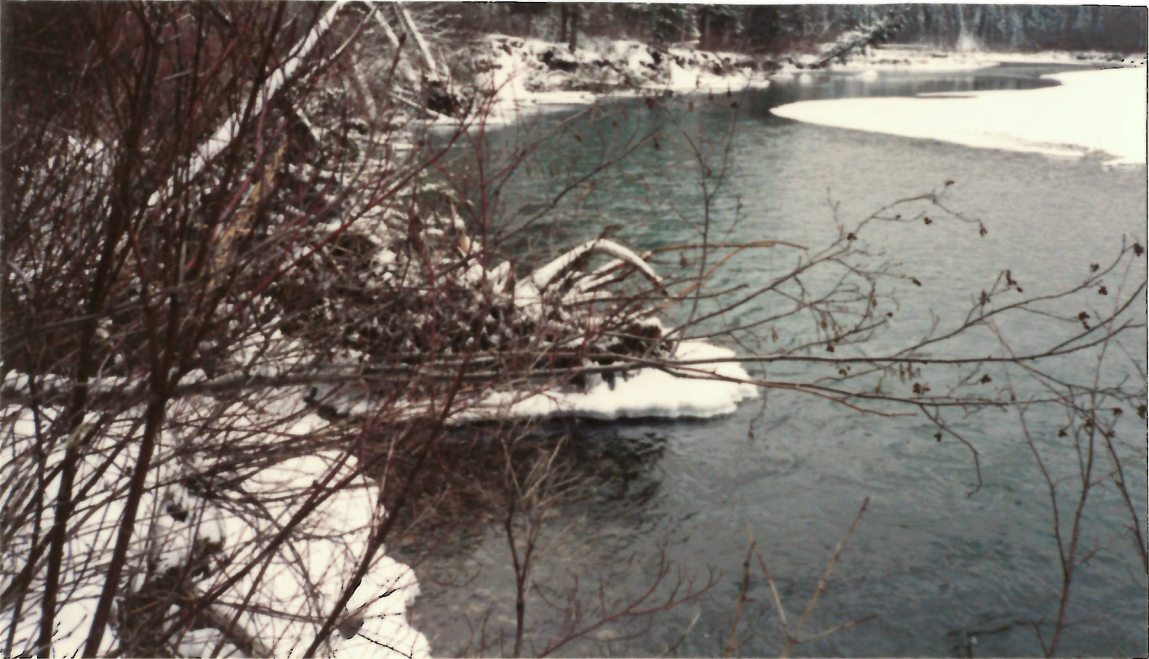
System: Pine River                      Section: 11                      Date: Oct 31/91  
Section location: ca. 700 m upstream of West Pine highway crossing (Hwy.97); immediately upstream of lowermost recent diversion (#5)

<u>Section length (m):</u>	200	<u>Gradient (%):</u>	0.49
<u>Sinuosity (from map):</u>	1.2	<u>Habitat type:</u>	riffle/glide
<u>Wetted width (m):</u>	25	<u>Channel width (m):</u>	45
<u>Width/depth ratio:</u>	40 est.	<u>Outside bank:</u>	right
<u>Mean water depth within 5m of bank (m):</u>			0.3
<u>Mean water velocity within 5m of bank (m/s):</u>			0.7 (surface)
<u>Streambed substrates (% composition):</u>			
fines <2mm	10	small cobble 64-120mm	30
small gravel 2-16mm	15	large cobble 120-256mm	15
large gravel 16-64mm	30	boulders >256mm	>1
other	0	D <sub>50</sub> (mm)	15

Access (including enhancement considerations):  
access problematic; dense tree/underbrush growth along bank; highway diversion (rip-rapped) immediately downstream; any work would require construction of access ramp to channel, and machine work within channel (using side bar on left bank as work area)

Enhancement options/recommendations:  
hydraulically, the site is good for debris catchers, except for shallow depths; due to existing erosion, bank armouring would be required; in view of this, and access constraints, suggest MODERATE-LOW priority

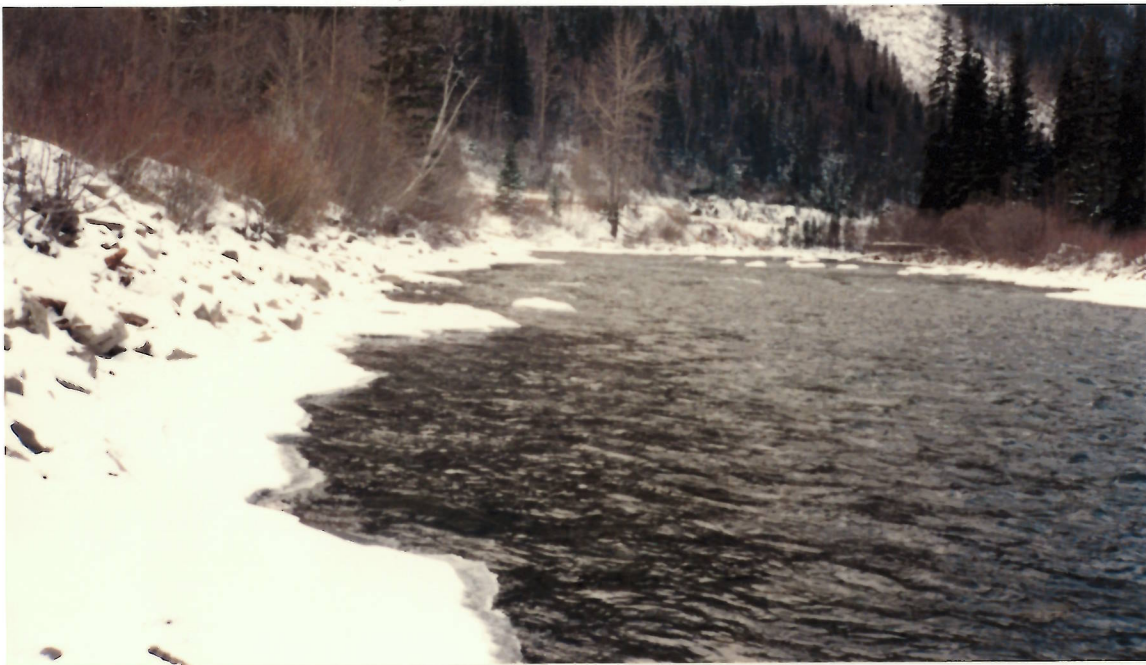
System: Pine River                      Section: 13                      Date: Oct 31/91  
Section location: between Solitude One bridge crossing (downstream) and short  
straight section along Hwy.97 (upstream)

<u>Section length (m):</u>	150	<u>Gradient (%):</u>	0.21
<u>Sinuosity (from map):</u>	1.4	<u>Habitat type:</u>	riffle
<u>Wetted width (m):</u>	35	<u>Channel width (m):</u>	45
<u>Width/depth ratio:</u>	60 est.	<u>Outside bank:</u>	right
<u>Mean water depth within 5m of bank (m):</u>	0.4		
<u>Mean water velocity within 5m of bank (m/s):</u>	0.8 (surface)		
<u>Streambed substrates (% composition):</u>			
fines <2mm	10	small cobble 64-128mm	30
small gravel 2-16mm	20	large cobble 128-256mm	10+
large gravel 16-64mm	25	boulders >256mm	<5
other	0	D <sub>50</sub> (mm)	18

Access (including enhancement considerations):  
access can be gained from left bank immediately upstream of Solitude One bridge, but at the flows observed, there was no side bar to use as work area or for access up the section

Enhancement options/recommendations:  
some potential for debris catchers, but due to lack of confinement, access constraints, and shallow depth, suggest LOW priority

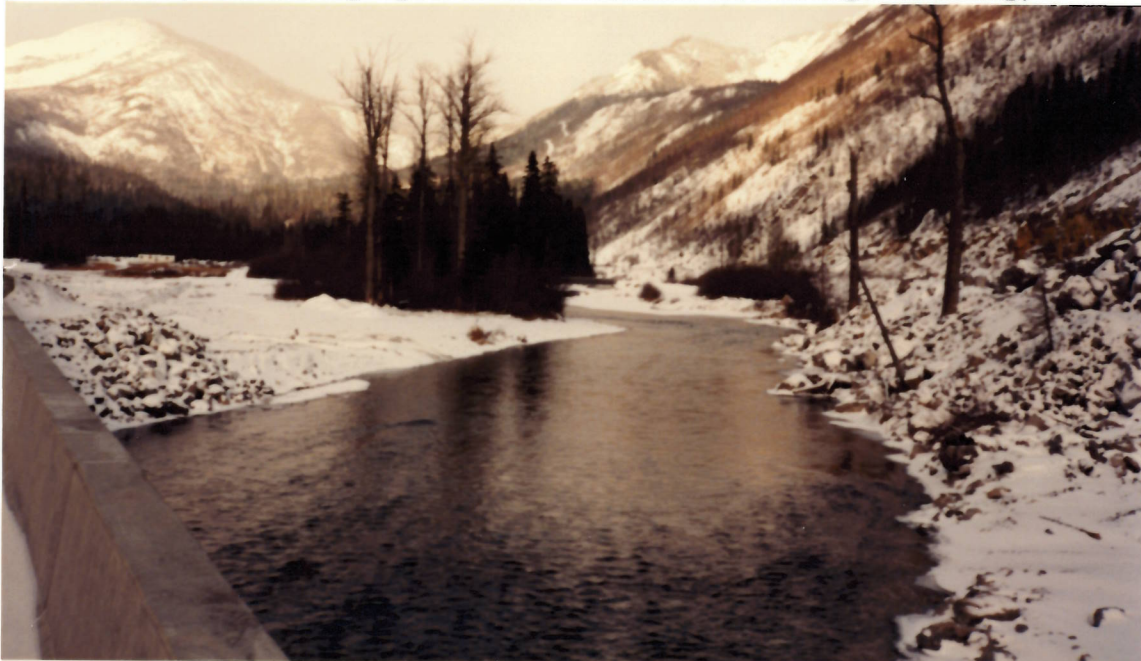
System: Pine River Section: 15 Date: Oct 31/91  
 Section location: adjacent to rock quarry, immediately upstream of Solitude Two bridge crossing

Section length (m): 100 Gradient (%): 0.30  
 Sinuosity (from map): 1.4 Habitat type: riffle/glide  
 Wetted width (m): 30 Channel width (m): 35  
 Width/depth ratio: 40 est. Outside bank: left  
 Mean water depth within 5m of bank (m): 0.6  
 Mean water velocity within 5m of bank (m/s): 0.7 (surface)  
 Streambed substrates (% composition):

Access (including enhancement considerations):  
 full access along banks on both sides of channel as a result of highway construction; machine access via right bank (shallow and cleared)

Enhancement options/recommendations:  
 based on the effectiveness of existing rip-rap in the channel, additional bank boulders are recommended; suggest HIGH priority, given the proximity of large rock materials (the quarry), the on-going construction at the site, and the likely need of further rip-rapping to fully stabilize this section (immediately upstream of Solitude Two bridge crossing)

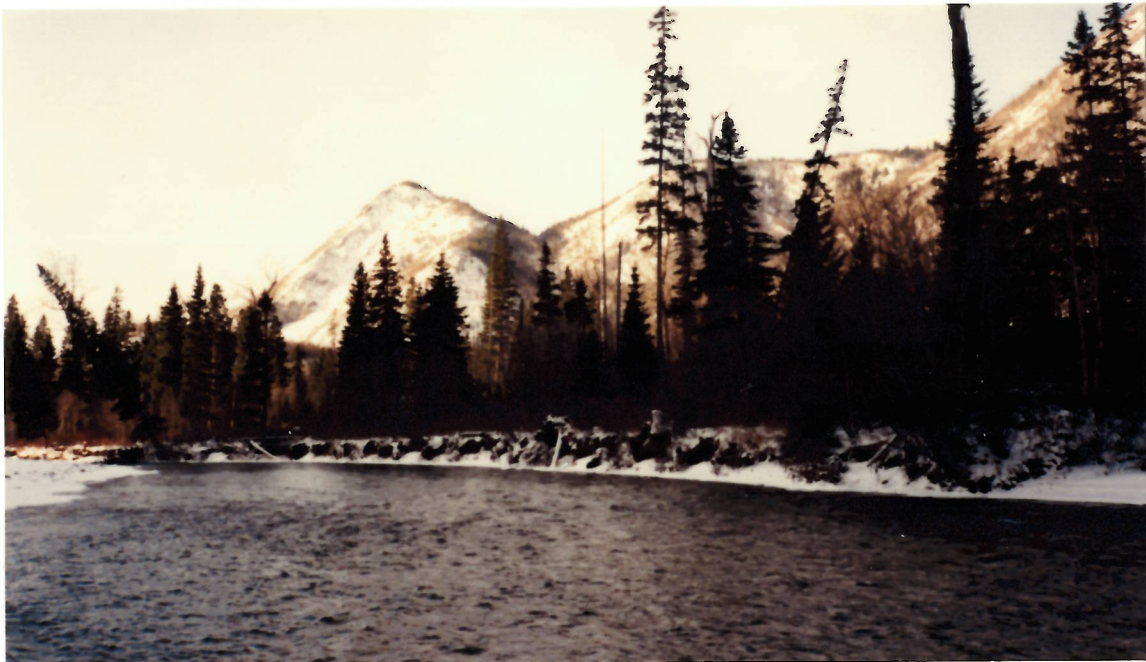
System: Pine River                      Section: 17                      Date: Oct 31/91  
Section location: section between recent diversions #1 and #2; commences immediately upstream of diversion #2

Section length (m): 300                      Gradient (%): 0.28  
Sinuosity (from map): 1.2                      Habitat type: fast glide/riffle  
Wetted width (m): 25                      Channel width (m): 45  
Width/depth ratio: 35 est.                      Outside bank: left  
Mean water depth within 5m of bank (m): 0.7  
Mean water velocity within 5m of bank (m/s): 0.8 (surface)  
Streambed substrates (% composition):

Access (including enhancement considerations):  
 access for machinery via construction area at upstream end of diversion #2;  
 wide bar on right bank to serve as work area

Enhancement options/recommendations:  
 site appears excellently suited to debris catchers; due to erosion on left bank, installations should include armouring; access is not ideal, but adequate, with a wide bar to work from; suggest HIGH priority due to excellent site characteristics

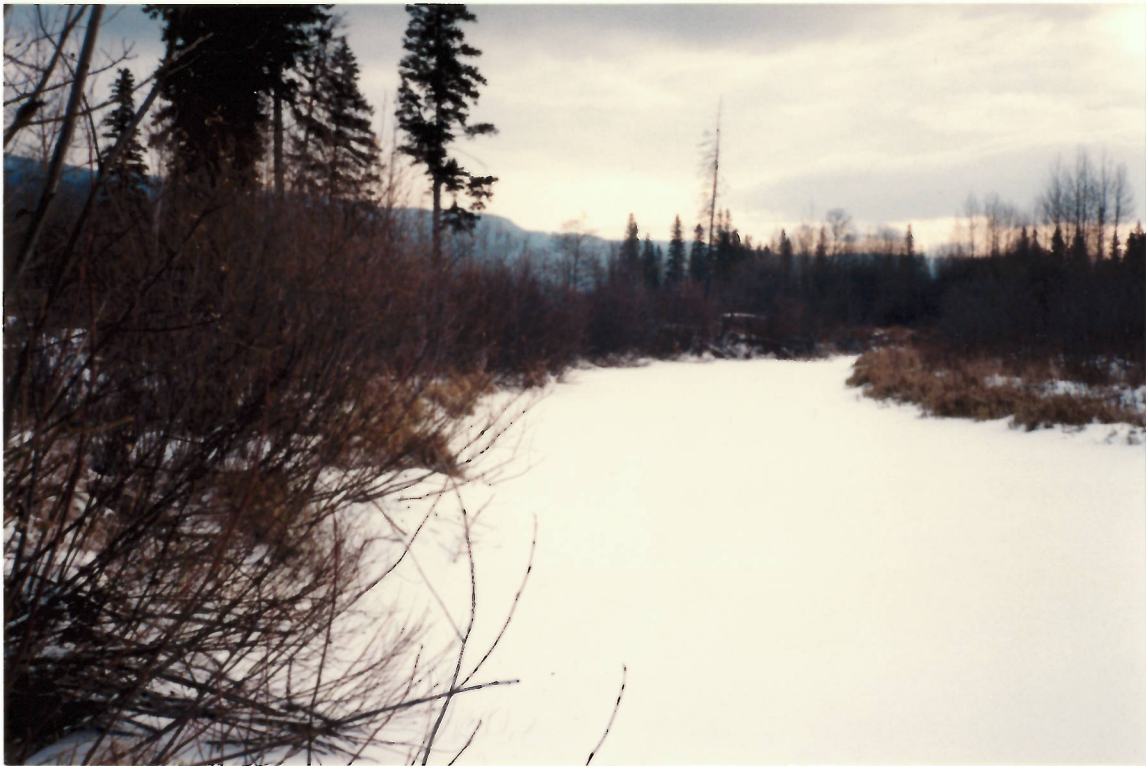
Side Channel: B

- total coverage with ice and snow
- channel width ca. 12m; well entrenched/confined
- banks ca. 0.75m high; vegetated to water
- habitat/cover unknown; however, little LOD
- at least 300m accessible for enhancement, if warranted; via bench, off Hwy. 97
- smaller secondary channels associated

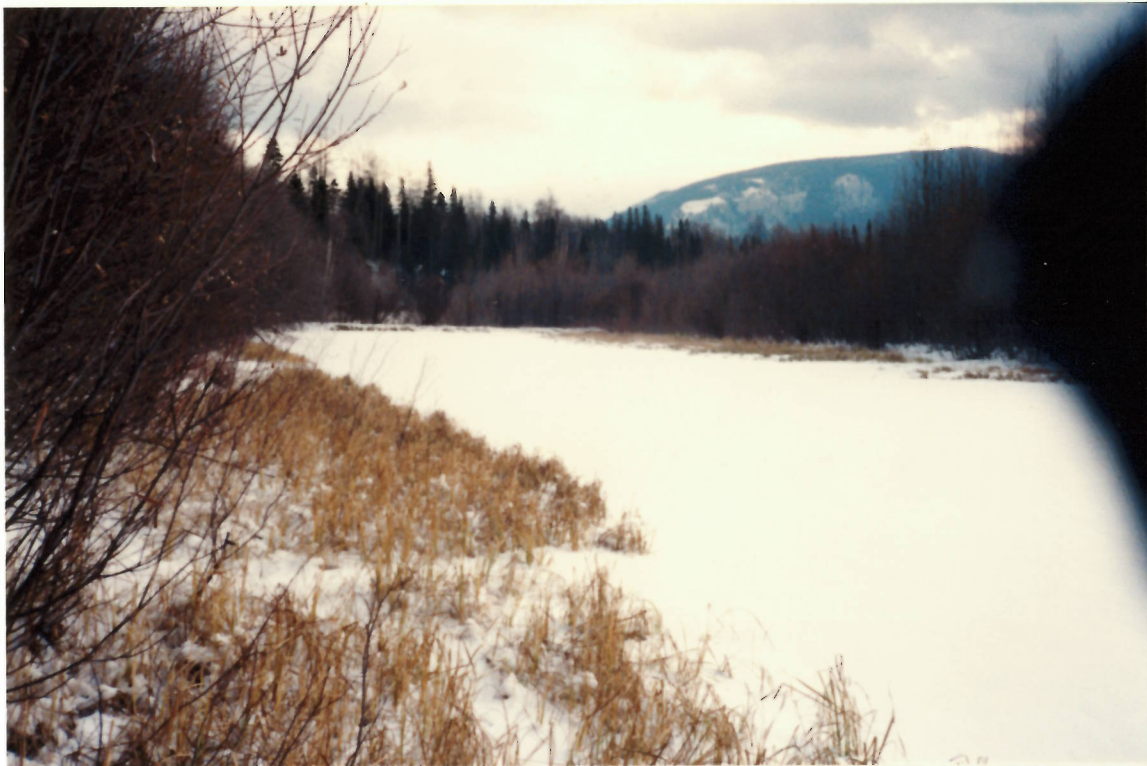
- total coverage with ice and snow
- channel width ca. 20m; entrenchment unknown
- banks 1m+ (up to 10m+ on highway side); vegetated to water
- habitat/cover unknown, but does not appear abundant; little LOD
- access would be extremely difficult due to steep high bank to highway

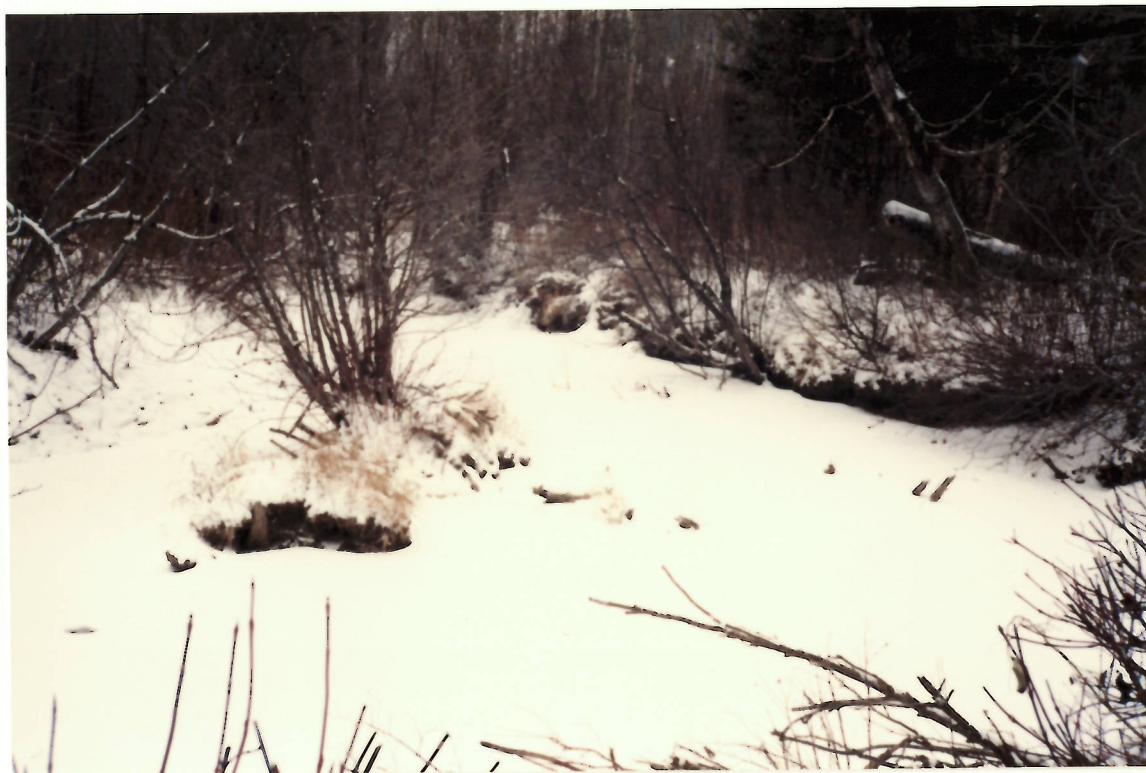
Side Channel: C

- total coverage with ice and snow
- channel width ca. 8m; well entrenched/confined
- banks 1.5-2m, and complex, with roots, cutbanks, debris, etc.
- fair amounts of apparently stable LOD as well
- no reasonable access, and enhancement would not seem warranted, in any event

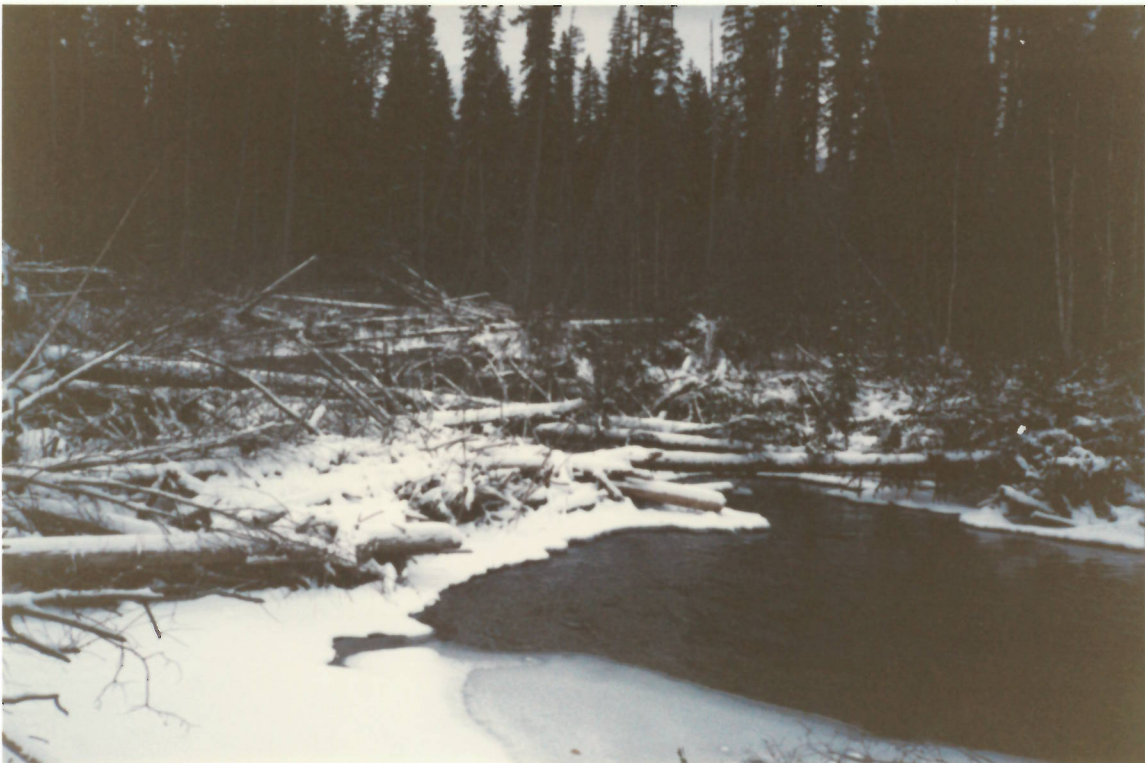
Side Channel: D

- riffle/rapid; gradient = 0.49%
- mean depth approx. 0.4m; mean surface velocity approx. 1.3 m/s
- rip-rap dyke along left bank (highway side), ca. 3m high
- streambed substrates dominated by small cobbles (30%), large cobbles (30%), and a few small boulders (5%)
- approximately 100m could conceivably be enhanced with debris catchers but not warranted in view of abundant, complex organic habitat immediately upstream

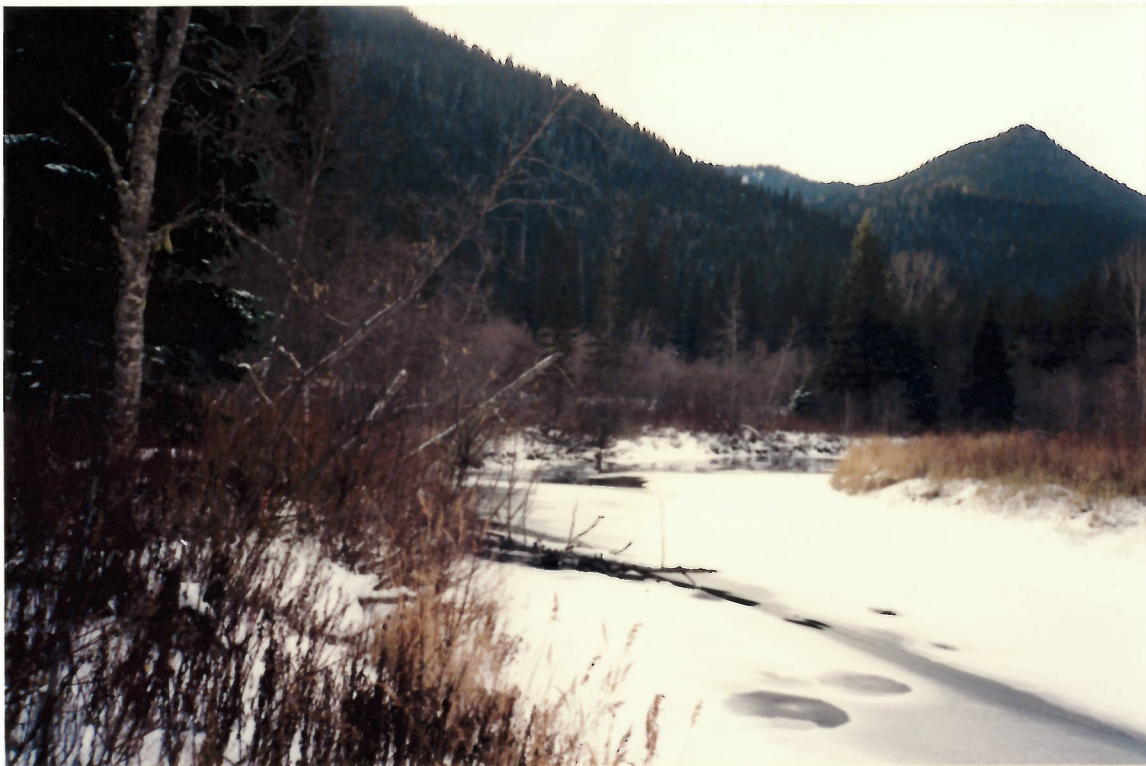
Side Channel: E

- near total coverage with ice and snow
- channel width ca. 18m; well entrenched, but some braiding
- banks 1-2m (primarily), and vegetated to water
- some roots, debris, cutbanks, etc. (debris fairly abundant, but tends to be small in size)
- difficult access, due to bush
