Coquitlam River Salmon Habitat Restoration Work  
Maintenance Project 2018: Archery Headpond Project  
Final Report

Prepared for: Fish and Wildlife Compensation Program

Prepared by: Anton Matahija  
North Fraser Salmon Assistance Project Society

Project Number: COA-F19-F-2728

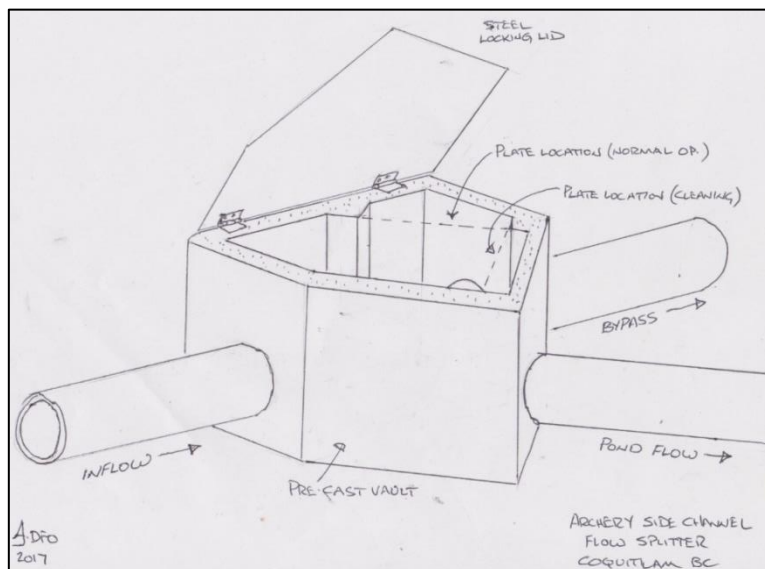
**Figure 8: Vault, Steel Panel and Intake Design Detail**

The water distribution vault was successfully installed in a new 100m<sup>2</sup> sediment detention pond. During normal operation of the vault a steel plate within the vault deflects the inflow into a short ( $\sim$  4m) section of pipe that daylights at depth within this newly created sediment pond. This sets up a clockwise circulation pattern around the pond. After a full revolution the water exits over a riffle crest formed by the short inflow pipe. The design will maximize sediment settling time and decant clear water on top.

When the pond is cleaned out of normal sediment accumulations, as designed and planned for on regular intervals, the deflection plate is lifted and reset to block flow to the pond and open the bypass pipe to continue flow into the channel. The pond can now be trapped for juveniles and remain isolated from flow for an unlimited period of time. Sediment removal will be undertaken by excavator and truck. After completion of clean-out, the plate is moved back to the original location and position and the pond will function as before.

The water distribution vault was cast on site in two pieces, in the parking area, and moved 100 m to the prepared sediment detention pond. A new shorter intake pipe was installed. The pond and berm slopes were stabilized with  $\sim .5$ -.25 m<sup>2</sup> boulders. Large woody debris was placed into the pond to provide cover, food and habitat complexity. Spawning gravel was added to the new side channel which was used during construction as the work site water by pass to provide water to the lower Archery Pond Complex.

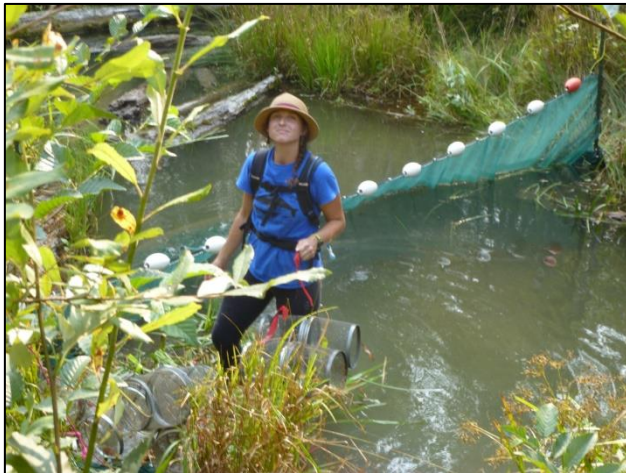
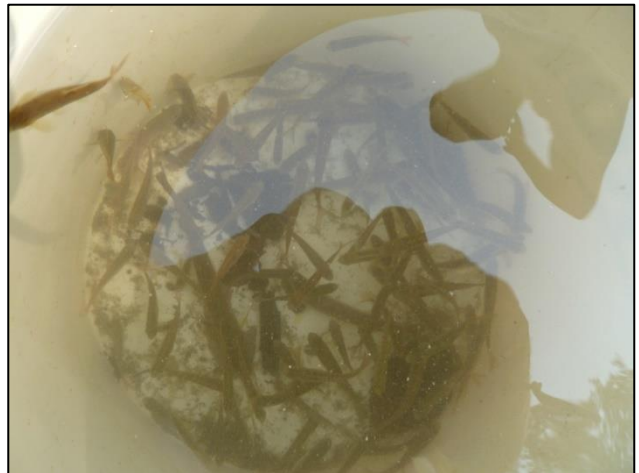
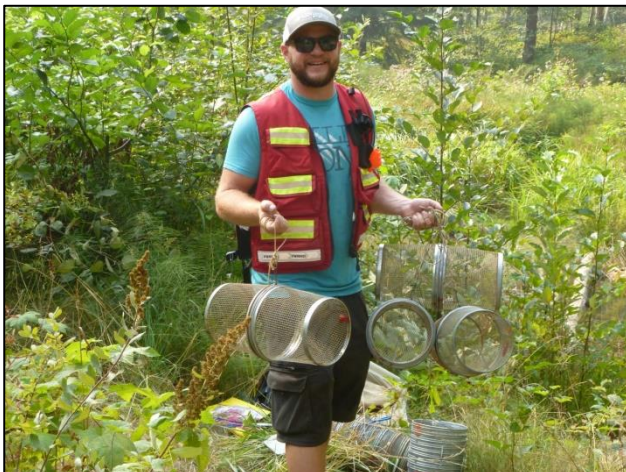
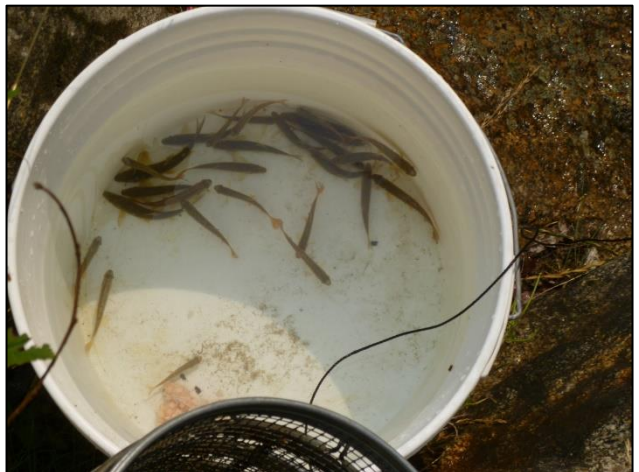
Fish removal and exclusion from the project site

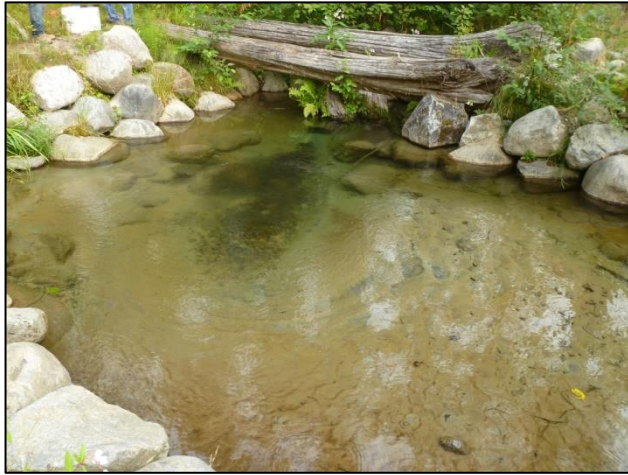
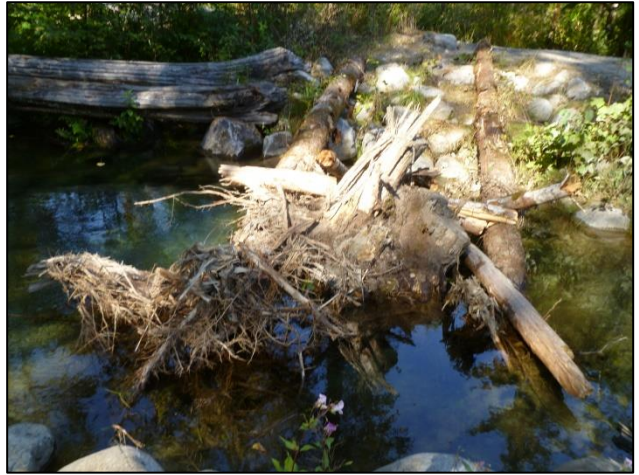
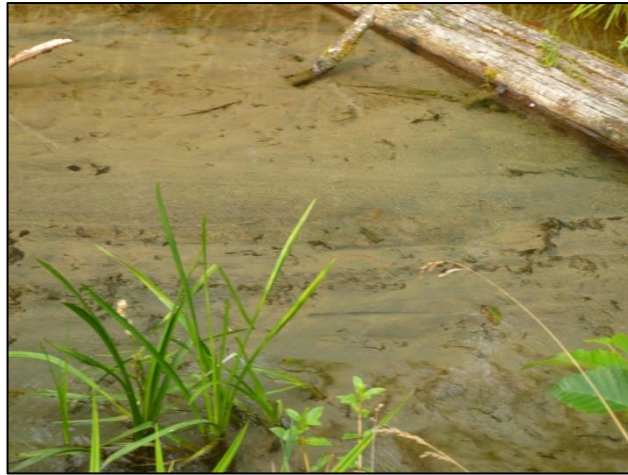
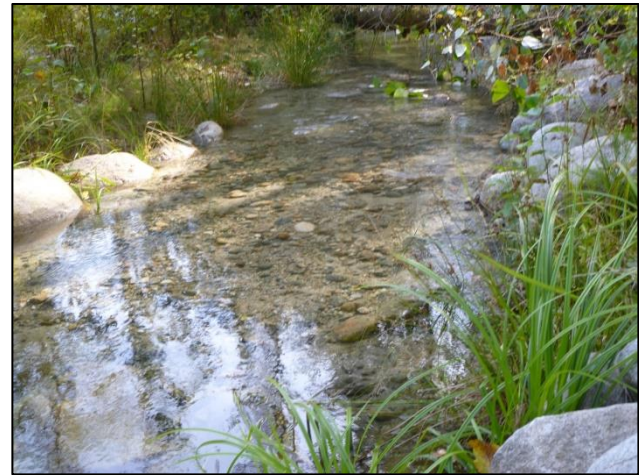
Rearing Pond (top) and Outfall Channel (Bottom) before and after excavation

Construction commenced mid-August during the fisheries window, once all fish were excluded from the work site. The existing pond and downstream channel were re-excavated. The excavated sediment was formed into a berm to separate the pond from a new parallel spawning channel constructed as part of this project.

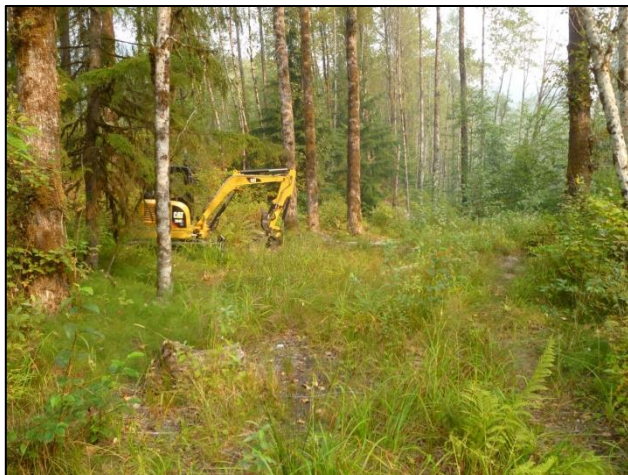
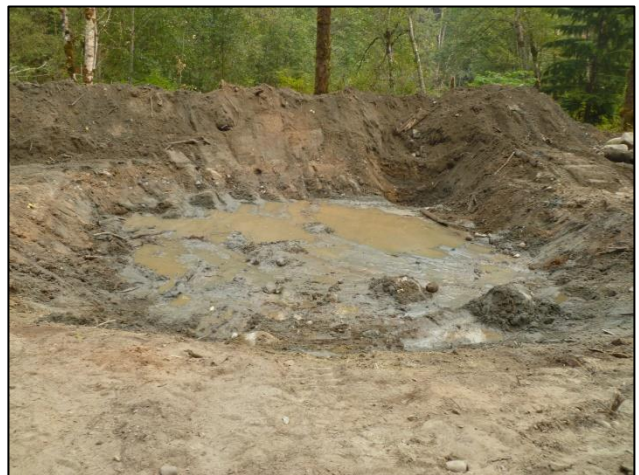
Sediment Detention Pond preparation for water distribution vault before and after

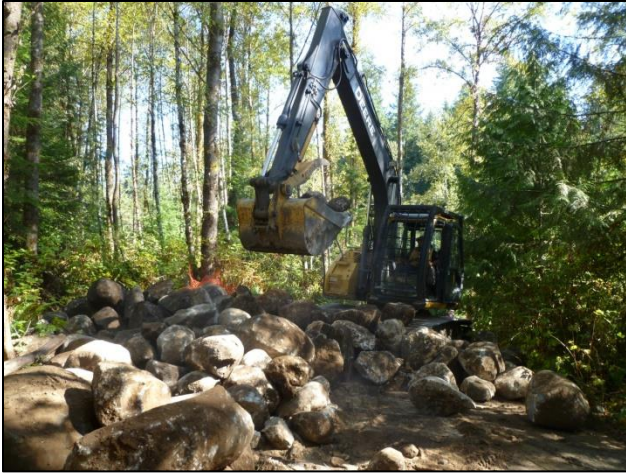
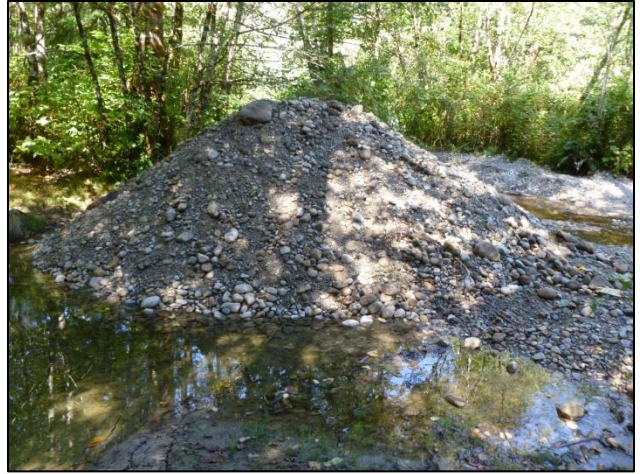
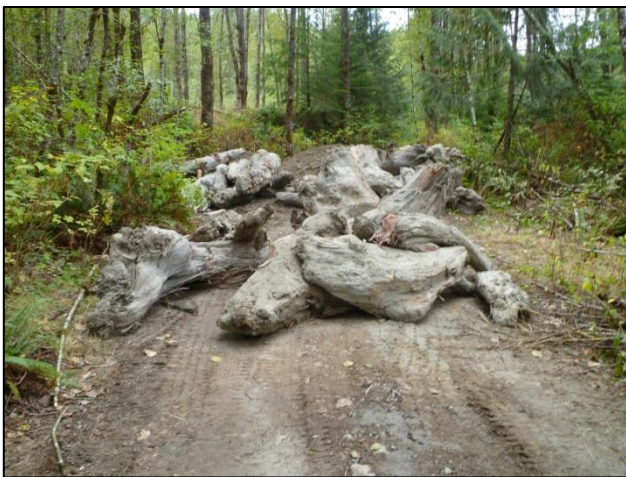
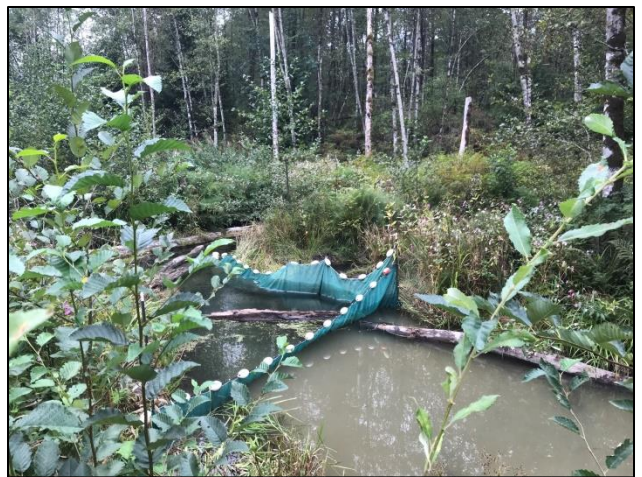
Delivery of boulders, gravel and LWD commences, erosion and sediment control installed

A new berm was created from the excavated spoils to isolate and protect the new spawning channel. The berm and restored pond slopes were protected with approximately 150 m<sup>3</sup> of large boulders.

Over 75 m<sup>3</sup> of large woody debris was installed in the restored pond.

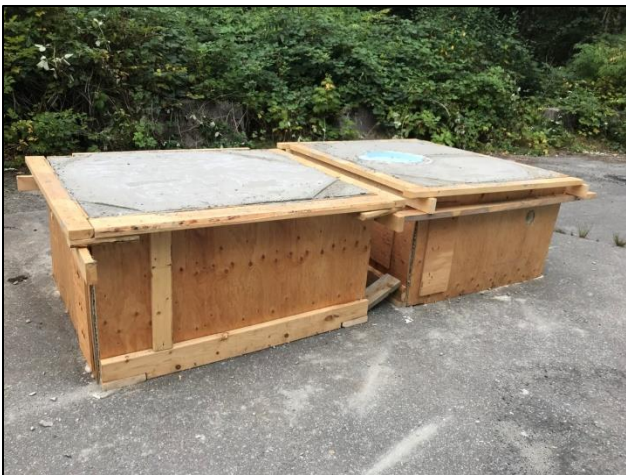
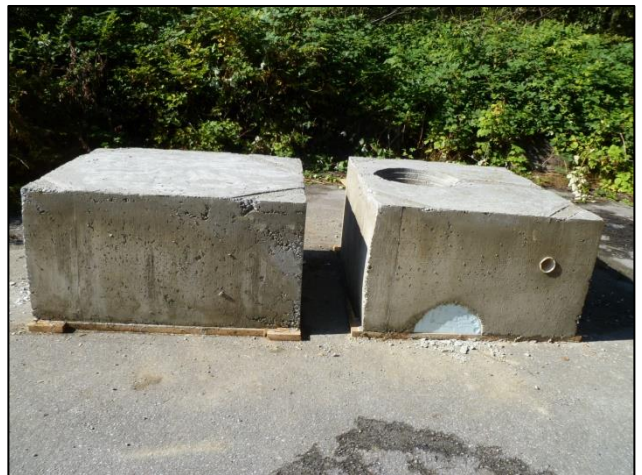
Water distribution vault forms built, cement poured, and forms removed

NFSAPS managed the project. RRU staff oversaw to construction of the water distribution vault form and the pouring and curing of the cement (Figure 6: Vault, Steel Panel).

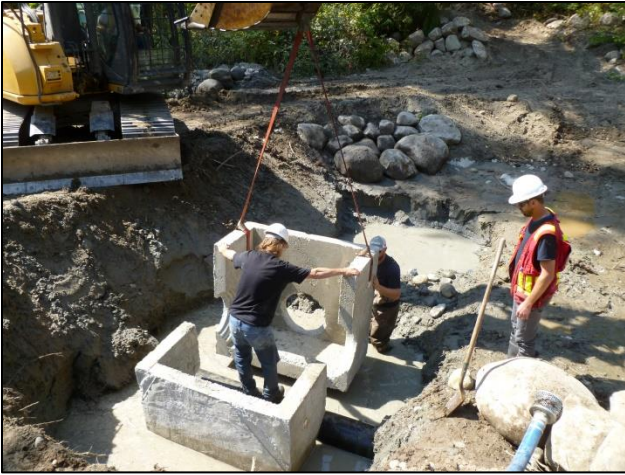
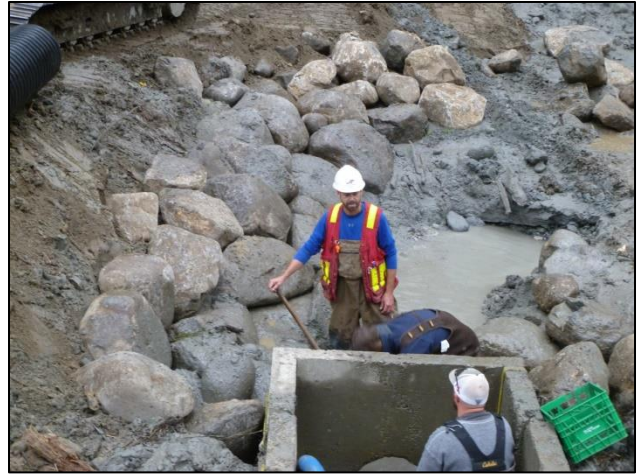
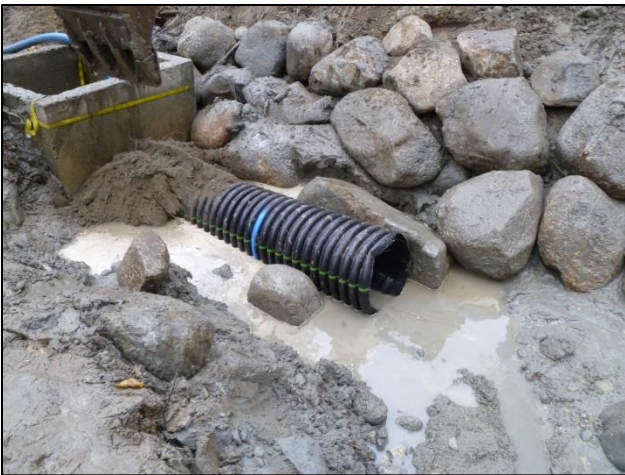
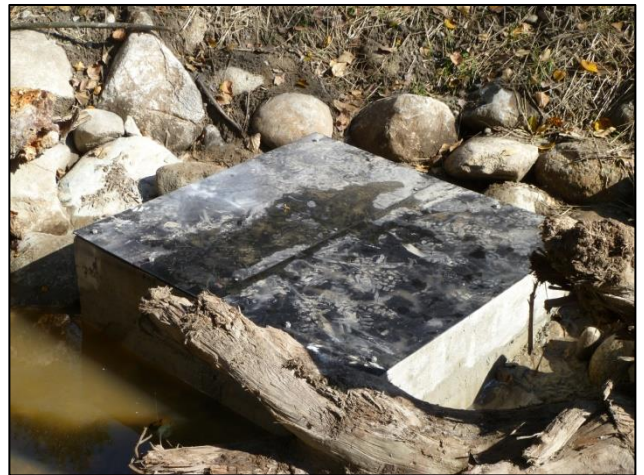
Water distribution vault assembly (top left), embedment into sediment pond (top right)  
river water connection pipe assembly (bottom left), steel lid installation (bottom right)

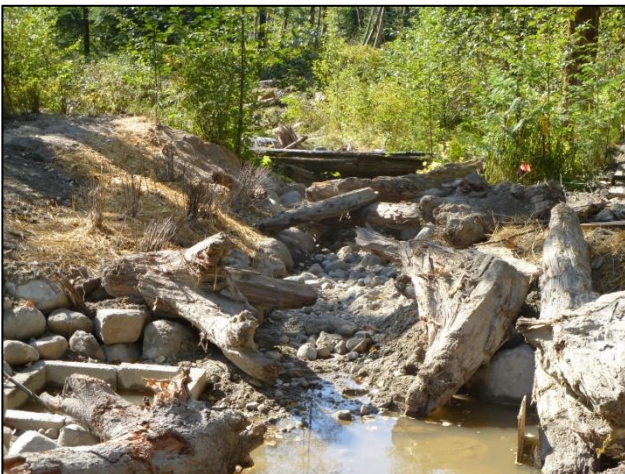
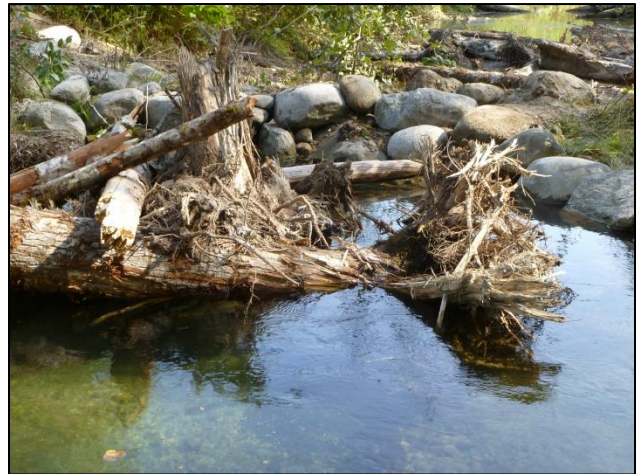
Detention Pond connection to existing pond during and after

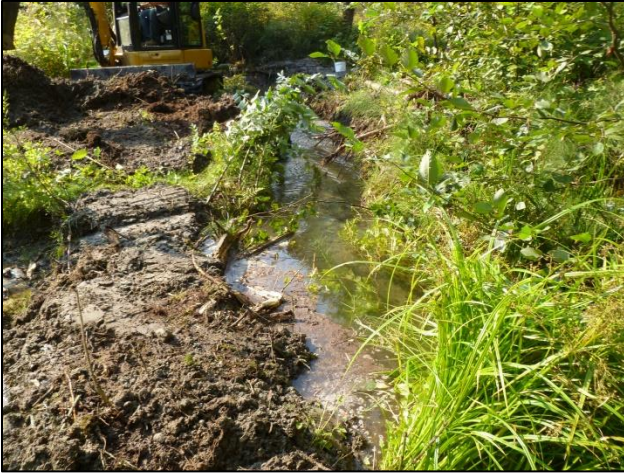
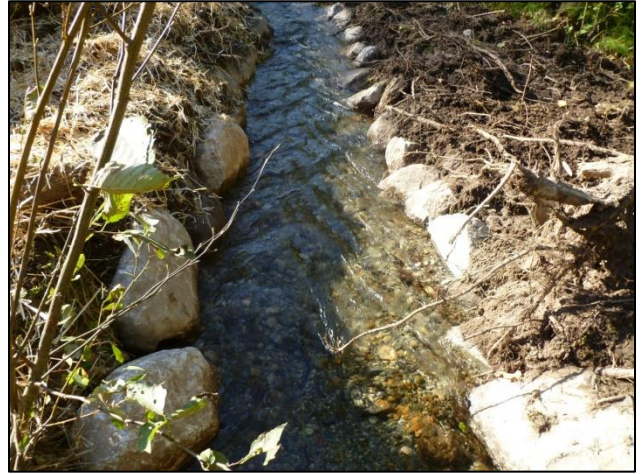
Spawning channel before and after and protective berm construction

A side channel was excavated to provide flow to the downstream habitat. Spawning gravel was placed in this at the conclusion of the project resulting in 100m<sup>2</sup> of new spawning habitat. Over 70 m<sup>3</sup> of spawning gravel was installed.

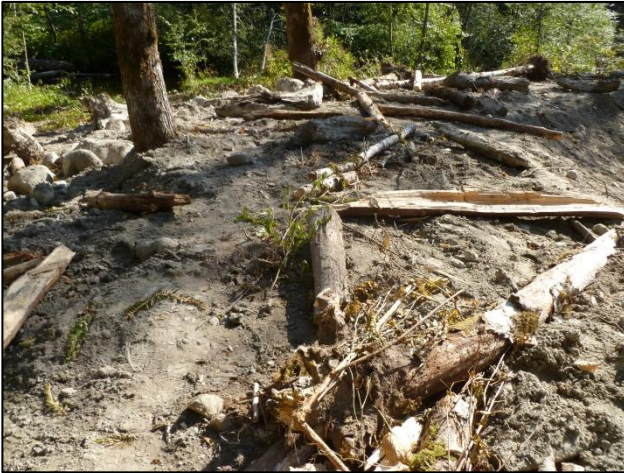
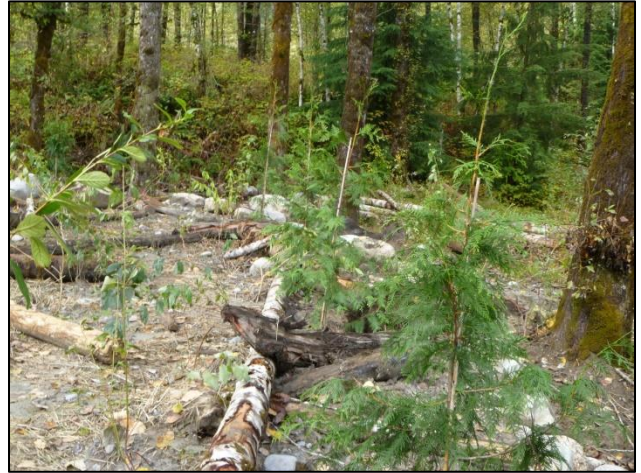
Protective berm riparian planting before and after

The berm will be live staked with native willow species spring 2019. September 2018 the berm was planted with the following:

• Nootka Rose	50
• Red Osier Dogwood	43
• Salmonberry	63
• Twinberry	43
• Pacific Ninebark	47
• Thimbleberry	2
• Indian Plum	2
• Black gooseberry	10
• Western Redcedar	16
• Sitka Spruce	13
• Cascara	3
• Black Cottonwood	10
Total	302

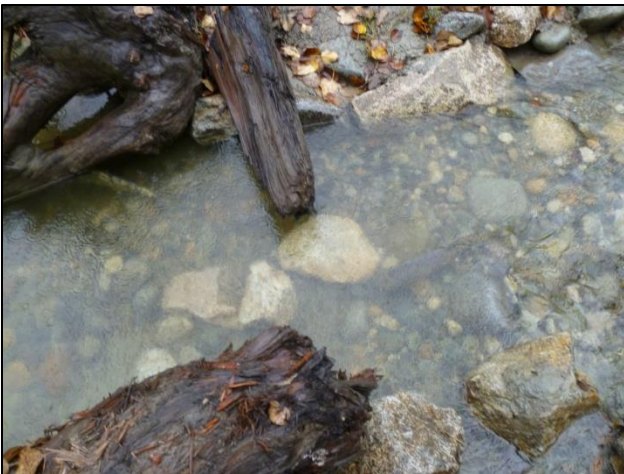
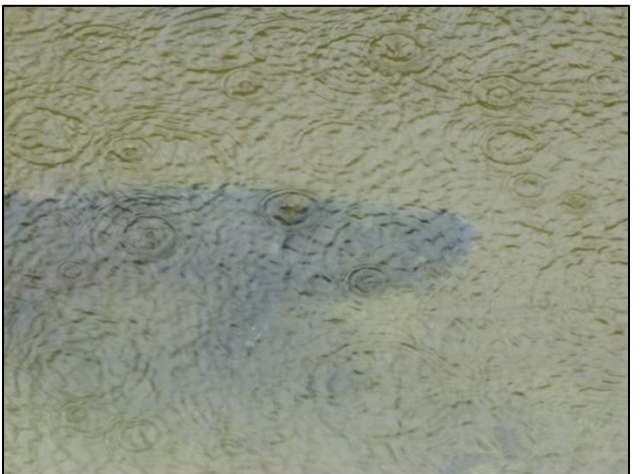
Project monitoring observed Chum utilizing spawning channel (left) and the rearing pond (right)
