# Yaqaan Nukiy Wetland Restoration Project 2018 Construction Report

Common Mallard

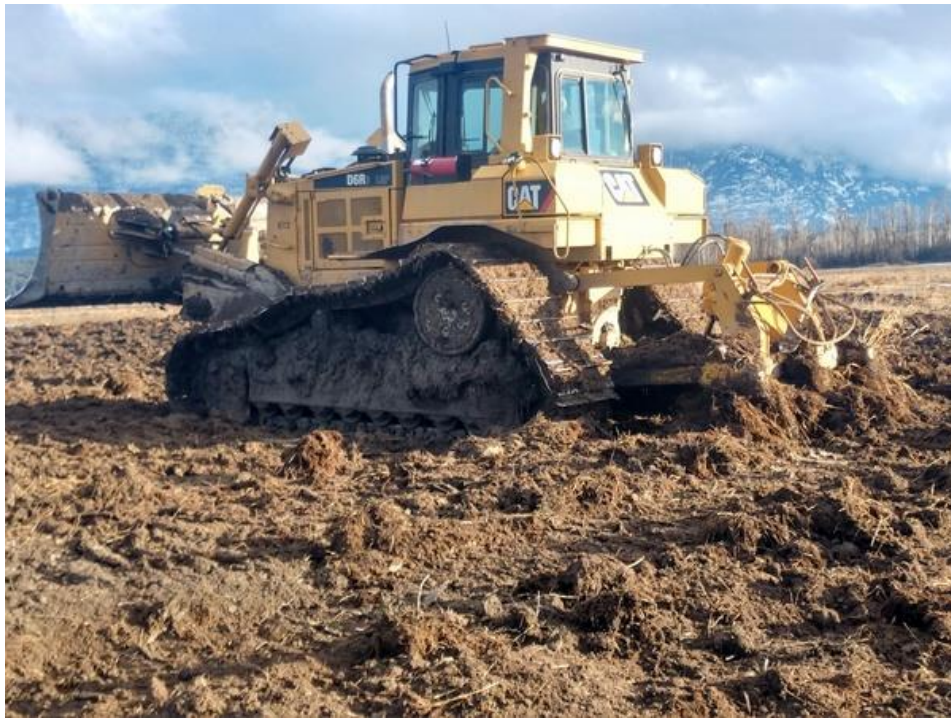
The ripper attachment on the dozer was used to loosen compacted soils over large areas.

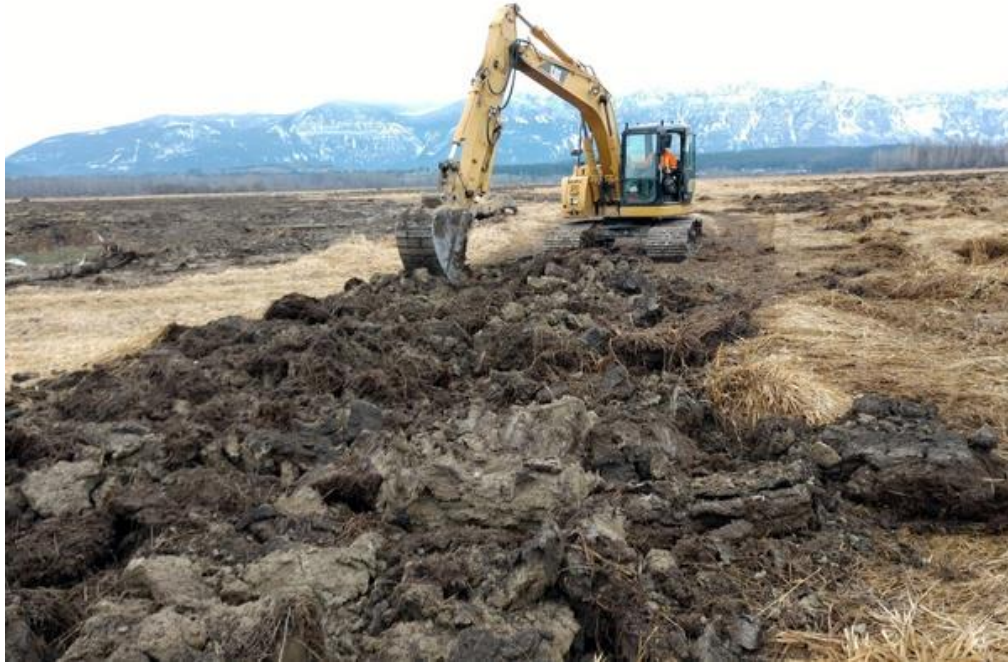
The excavator was also used to loosen soils compacted by the dump truck.

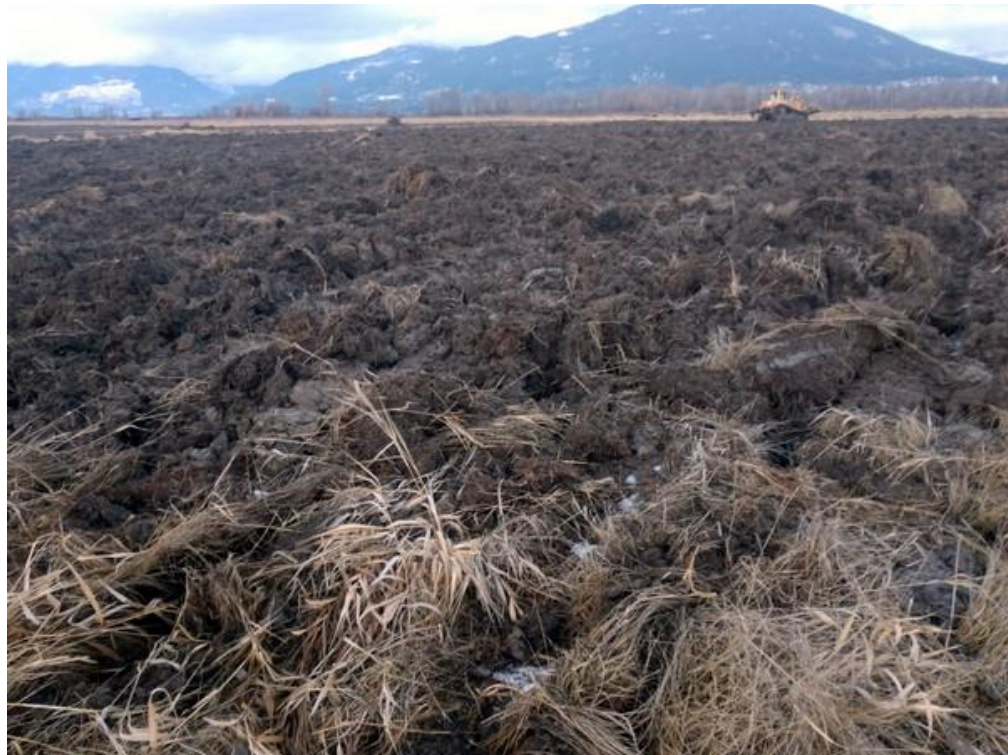
This photo shows an upland area created by covering reed canary grass with soil removed from building a wetland. The soils were loosened using the ripper on the dozer.

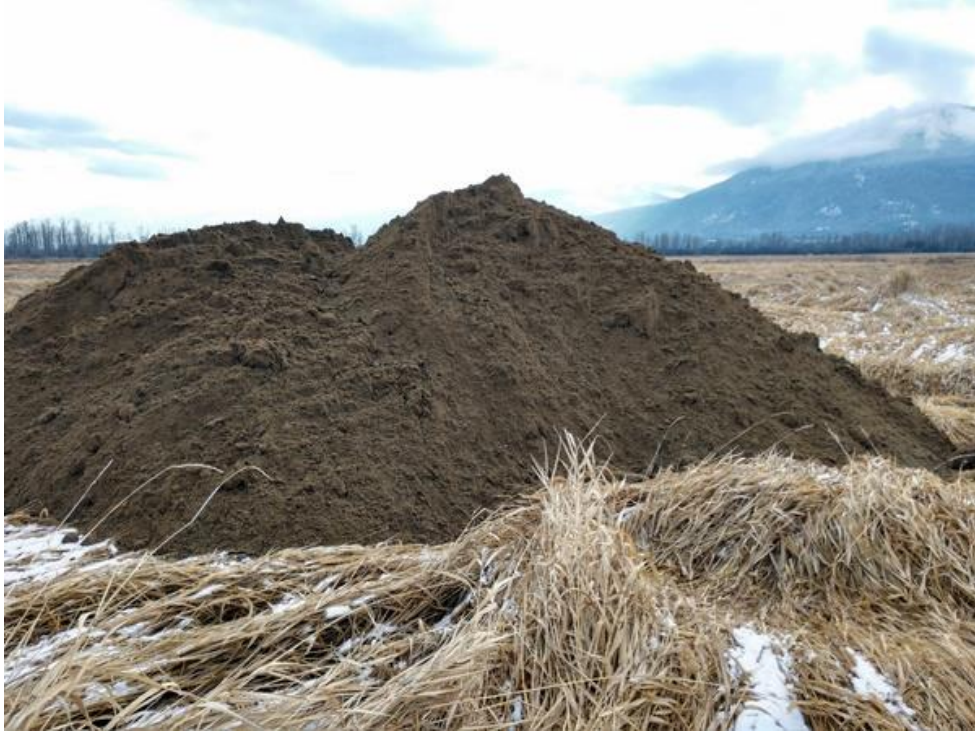
Large mounds of sandy-loam texture soil were placed near Wetland 1 and Wetland 2 to provide the Western painted turtle with nesting sites. The soils in these mounds were not compacted.

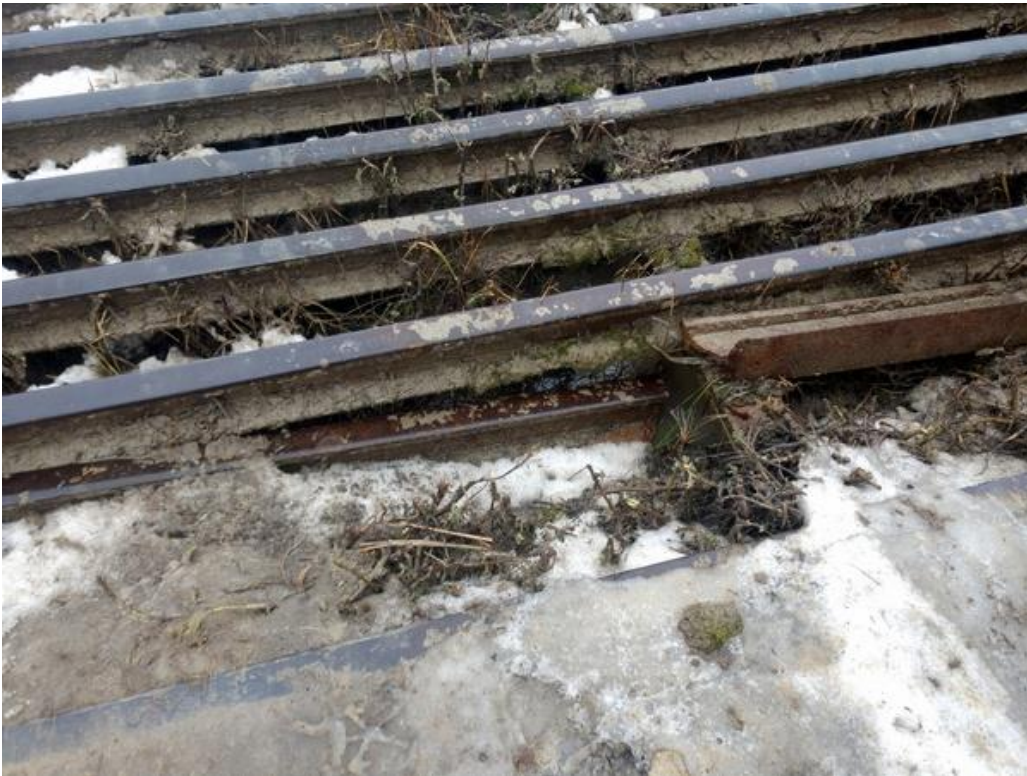
This photo shows a cattleguard damaged by the Yaqaan Nukiy Wetland Restoration Project.

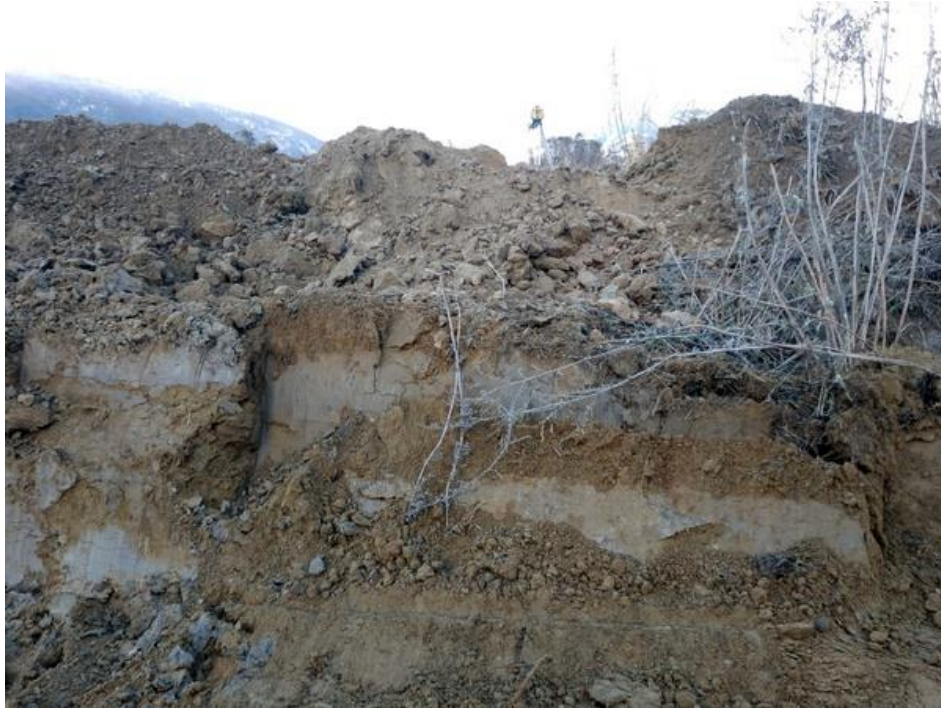
A cross-section dug in the dam surrounding the KUPI Marsh Impoundment. Photos shows where the dam has been built from sand.

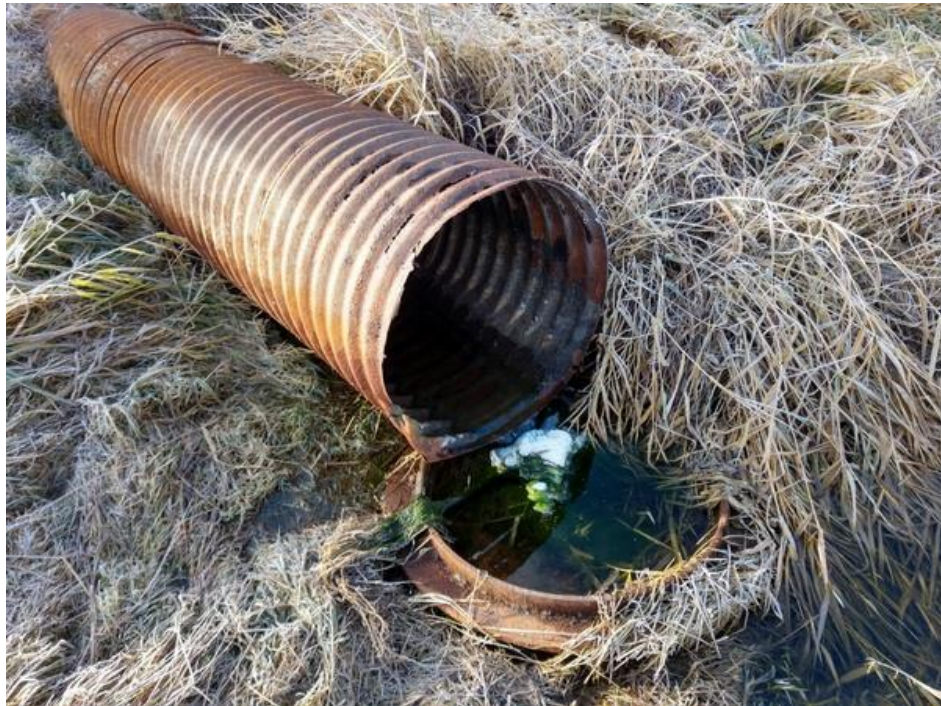
The entire KUPI Marsh Impoundment was designed to be drained by this culvert. The gate on the culvert is broken, and the culvert is rusted. The culvert is temporarily blocked with mud and a stump. The culvert may be permanently blocked in a future restoration project.
