# Murphy Creek Spawning Channel Maintenance and Monitoring 2018-19

COL-F19-F-2768

**Prepared for:**  
Fish and Wildlife Compensation Program

**April 2019**

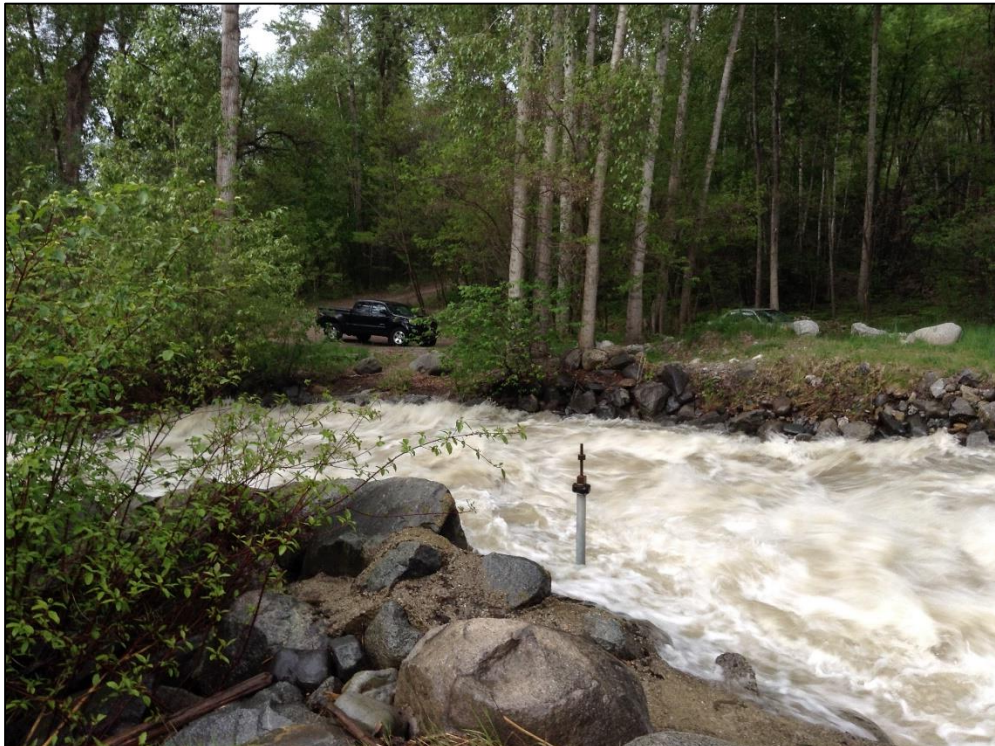
A large snowpack paired with unseasonably warm temperatures and heavy precipitation resulted in a very high freshet at Murphy Creek in May 2018 (Figure 3). The result of this freshet event was erosion of the creek bank proximate to the spawning channel and erosion of boulders from the barrier wall protecting the intake valves above the spawning channel. As well, the freshet caused significant resorting of creek bed materials and deposition of large woody debris in the plunge pool downstream of the highway culvert.

*Figure 3: View of high water in Murphy Creek looking downstream from atop the intakes, May 18, 2018.*

On May 9-10, 2018, water overtopped the barrier wall at the intakes and clogged the intakes with silt, nearly halting flows into the spawning channel. Due to unsafe conditions, the intakes were left in this state until May 21 when water levels decreased

The 2018 freshet event was highly concerning to TWA volunteers as it posed a threat to the structure and efficacy of the spawning channel and its components. Works in 2019 will include a redesign of the intakes to prevent further damage from future high water events.

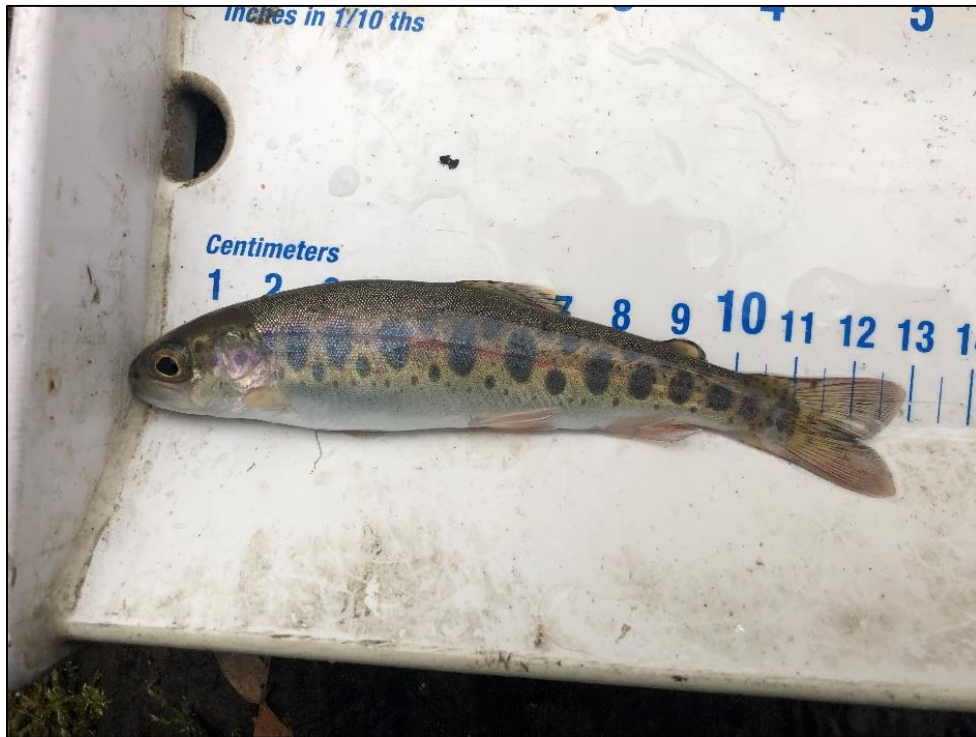
On November 29, 2018, the settling pond was isolated from the spawning channel so no fish could enter prior to dredging. The ONA and TWA conducted a fish salvage on November 29 using a beach seine. Four passes of the entire settling pond were completed and a total of 27 Rainbow Trout juveniles were removed from the settling pond (Figure 6). On November 30, prior to dredging, a final pass was completed with the

Figure 6: Rainbow Trout juvenile removed from sediment settling pond during salvage on Nov 29, 2018.

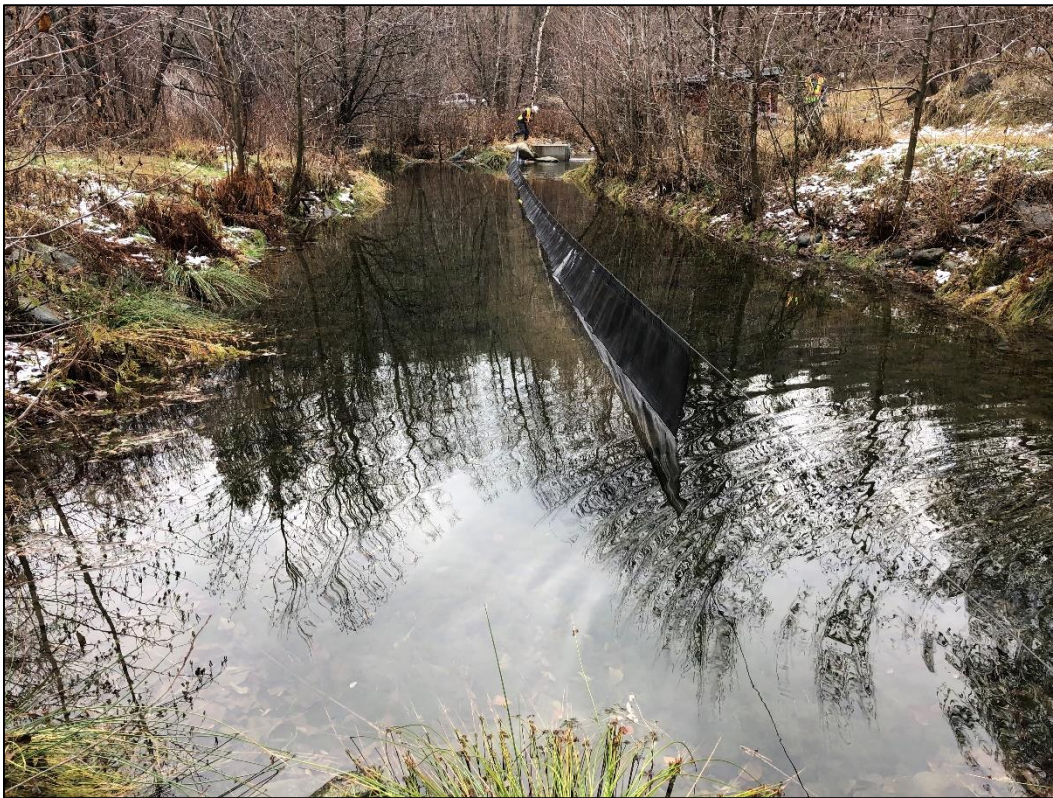
*Figure 8: North end of sediment settling pond (looking south) prior to in-water works.*

Following the fish salvage, water from the intakes was diverted from entering the settling pond through a bypass structure. An excavator was then used to dredge sediment from the settling pond. Photos were taken before (Figure 8) and after in-water works. Sediment removed was piled on the banks adjacent to the settling pond, in areas it had been placed in previous years (Figure 9). The excavator was also used to re-contour the shore between the settling pond outlet and Pool 1 of the spawning channel, to increase safety and access (Figure 10). In addition, the excavator was used to place boulders (available onsite) around the top of the barrier wall surrounding the intakes to provide additional armoring for future high-water events (Figure 11). As well the excavator dug a swale to the settling pond adjacent to the culvert to prevent highway drainage from flowing directly into the settling pond. Water clarity was observed on Dec 1 and 2, 2018, following in water works (Figure 12).

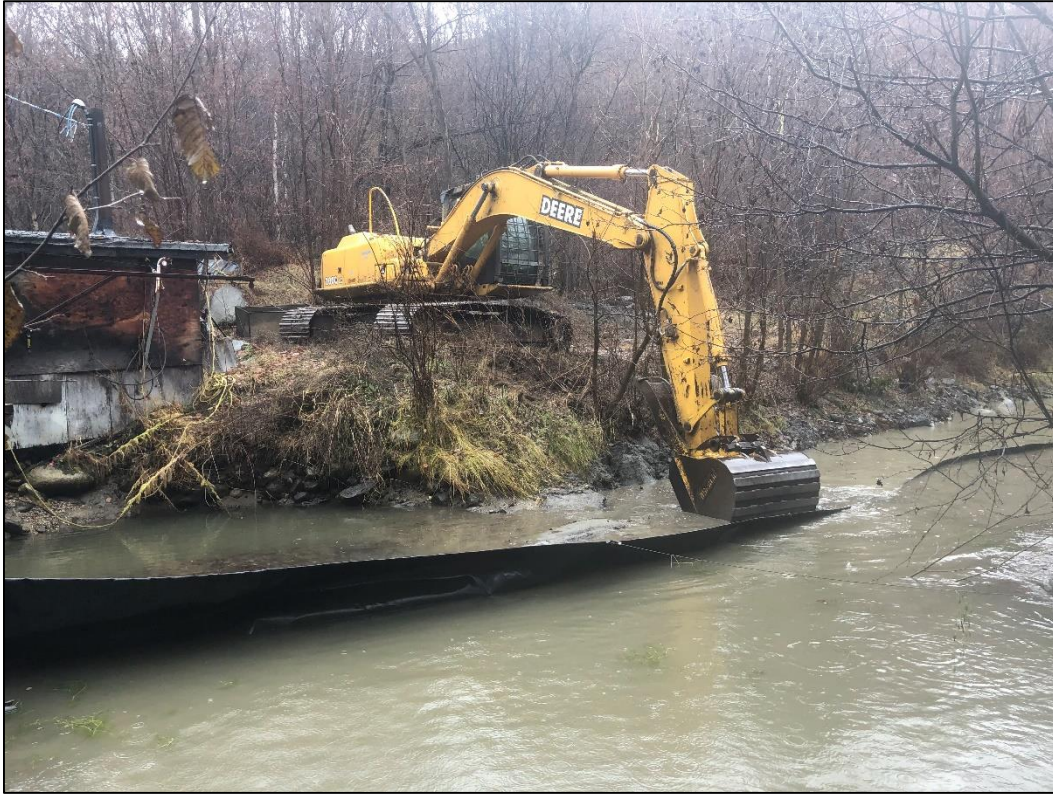
*Figure 9: Excavator dredging settling pond.*

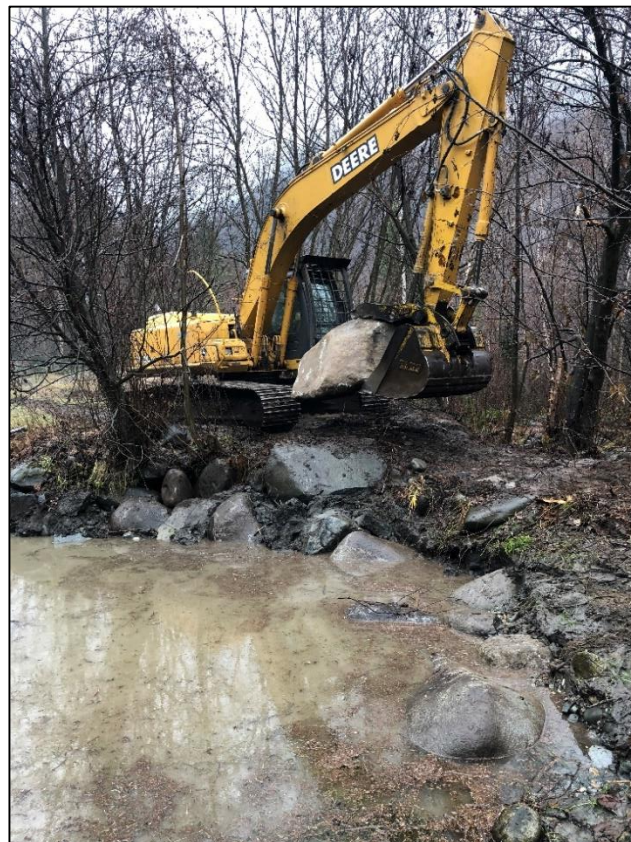
*Figure 10: Excavator re-contouring and armoring bank between settling pond and spawning channel.*

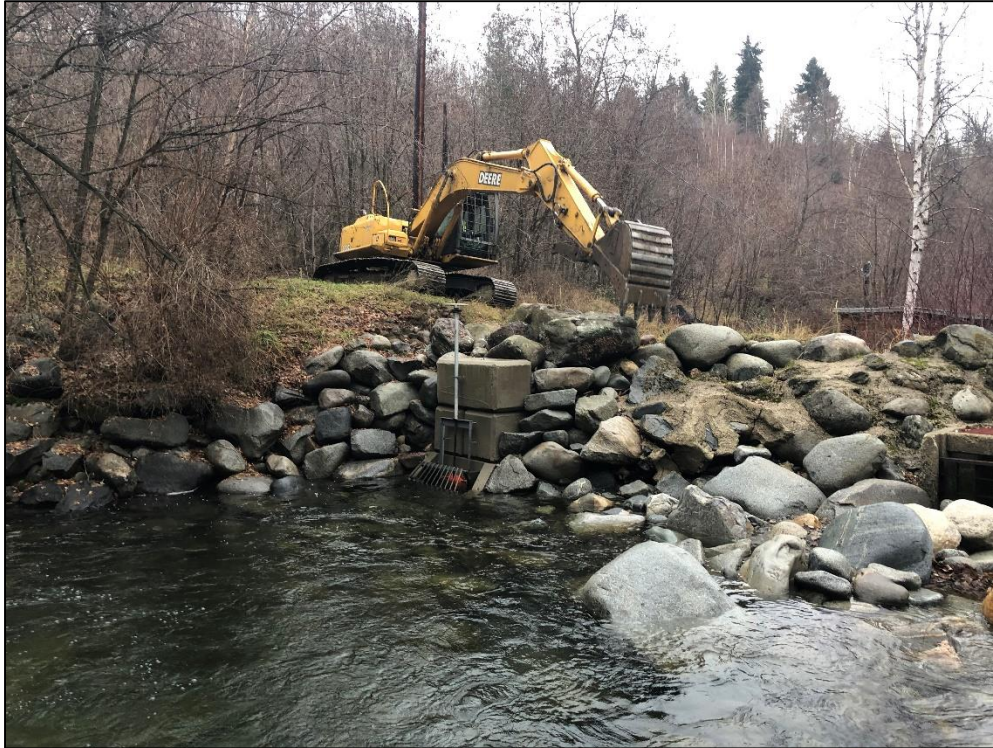
*Figure 11: Placing boulders around and on top of the intake barrier wall to increase armoring.*

Both intakes were upgraded in 2013-14 however the integrity of the barrier wall surrounding the intakes has degraded since installation due to high flood events causing erosion. An increase in spring high-water events have been apparent in since 2015 (A. Mallette, pers. comm., Nov 2018). We recommend the barrier wall be restored and

improved to withstand a 1 in 200-year freshet. A detailed construction plan will be developed by a Professional Engineer to restore the existing intakes and provide better armoring and reinforcements to protect against future high water events. In addition, a fluvial geomorphological assessment should be conducted to determine the flood frequency and intensity of flood events as a result of logging in the upstream reaches of Murphy Creek. This information will aid in the restoration of the existing intakes and barrier wall.

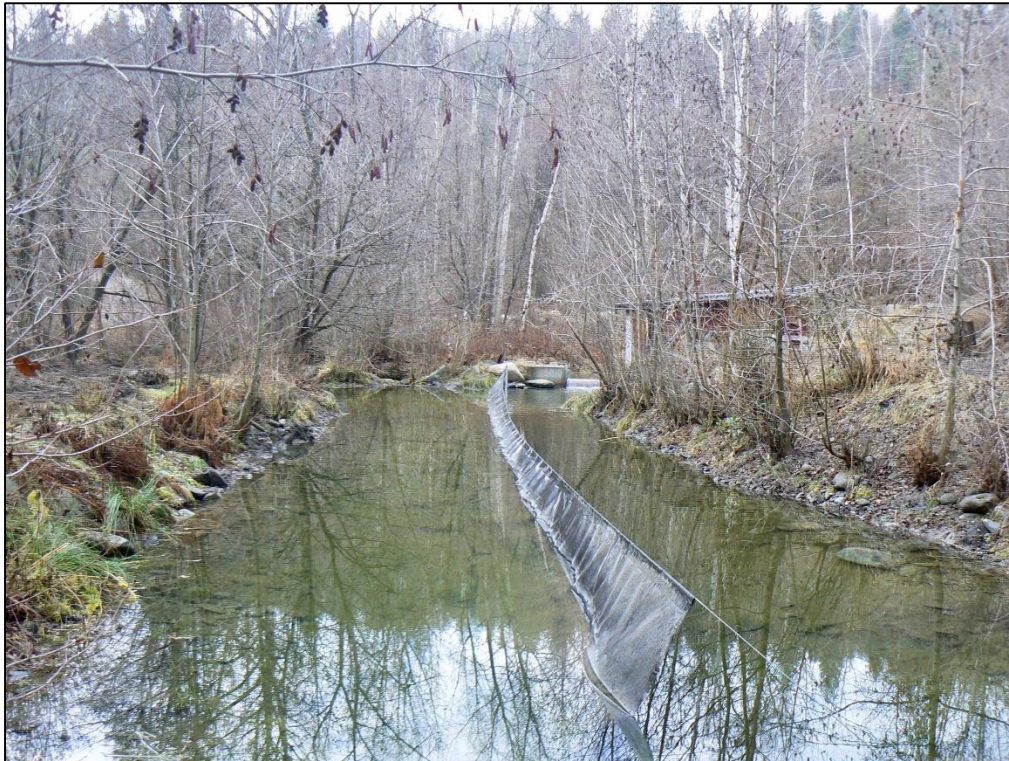
*Figure 12: North end of spawning channel (looking south) following dredging on December 2, 2018.*

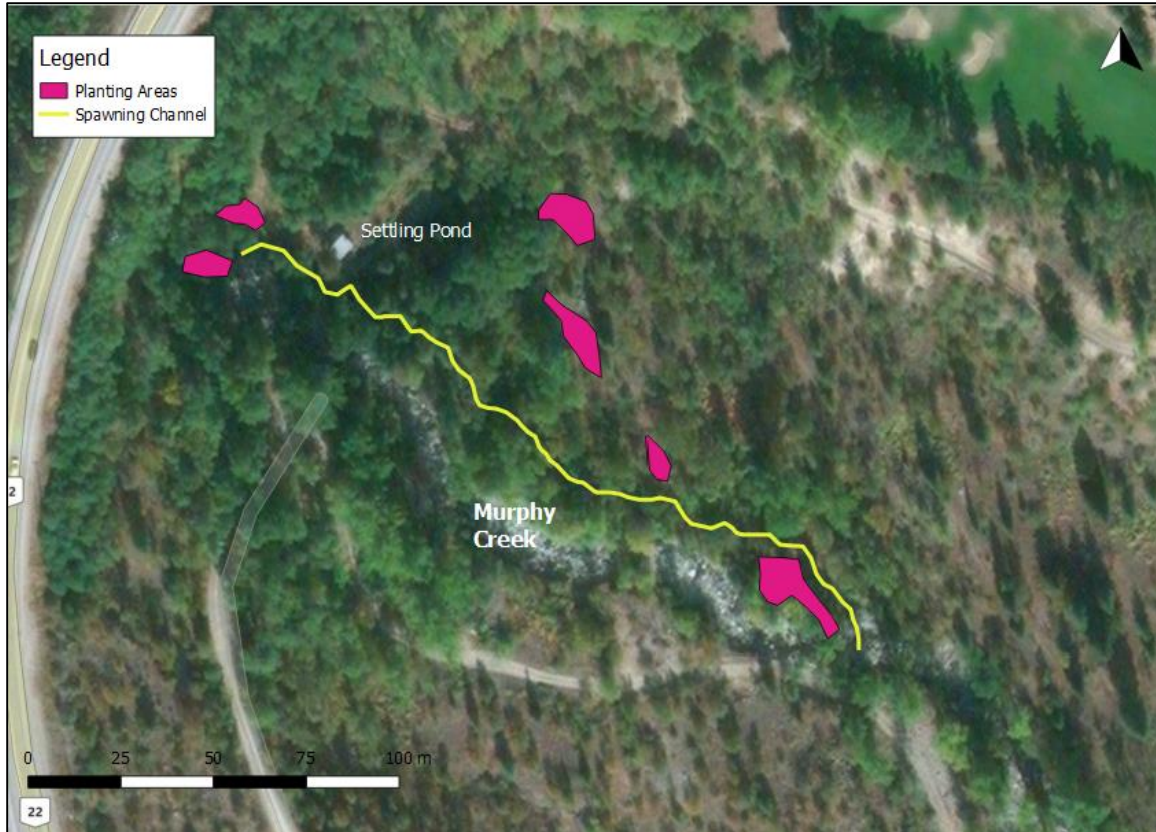
Members of the TWA, ONA and one volunteer (Karen Trebitz) completed the planting in six different locations throughout the Murphy Creek riparian area (Figures 16 and 17). Plants were monitored and watered as needed throughout the fall by Al Mallette and Rob Frew. Fortunately, fall rains assisted in watering and supplemental watering was not often required.

Figure 16: General planting locations relative to spawning channel along Murphy Creek.

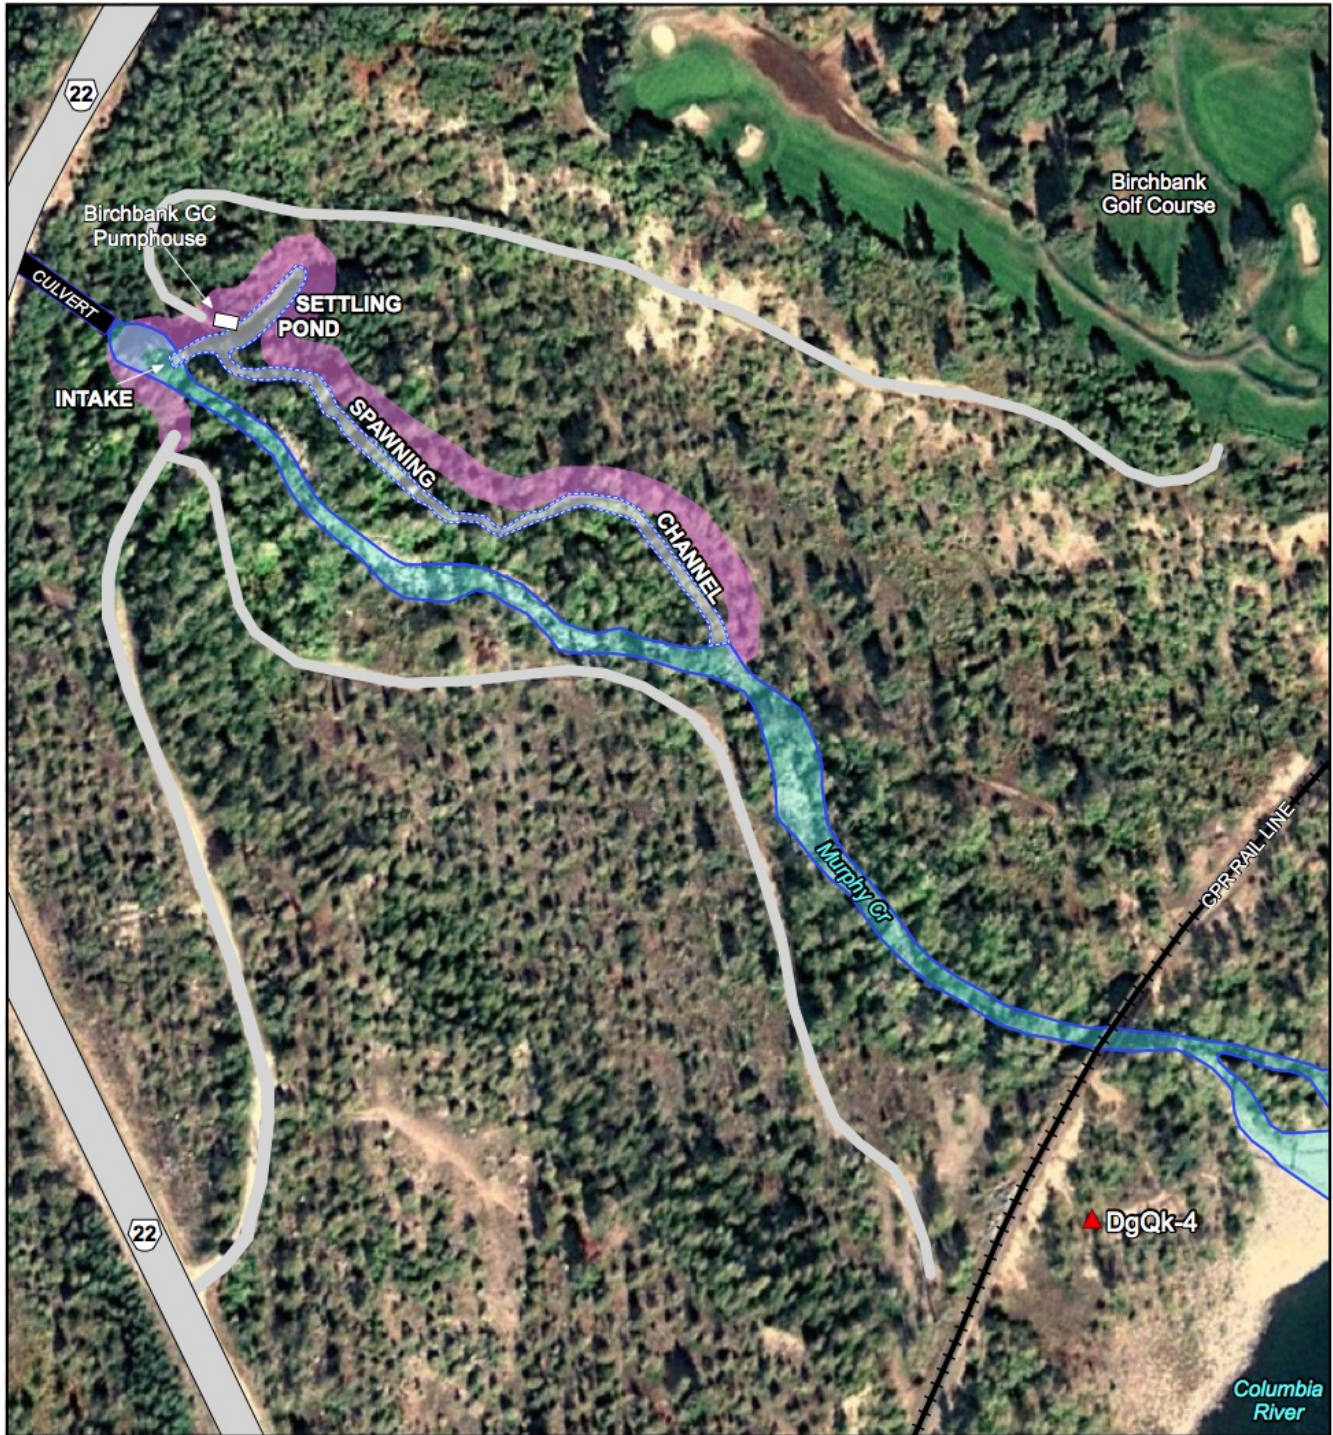
The Murphy Creek Spawning Channel consists of a diversion channel and settling pond located adjacent to the left bank of the lower reaches of Murphy Creek, immediately below Highway 22 and approximately 250 m upstream of the creek outlet into the Columbia River (Figures 1 and 2).

**Figure 2: Murphy Creek Spawning Channel Maintenance Project AOA-PFR Detailed Survey Coverage Map**

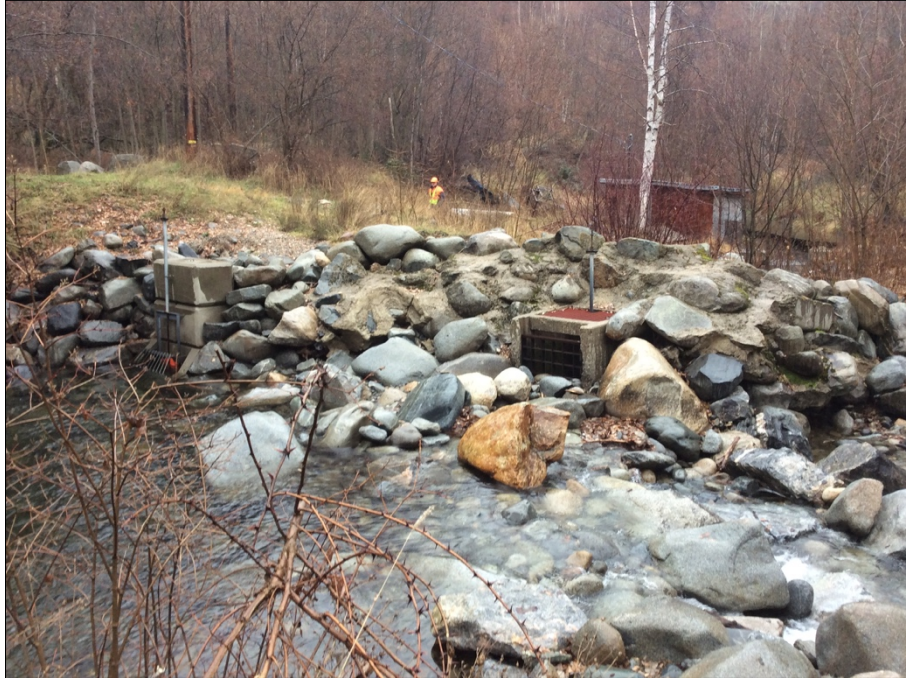
**Photo 1. View N of spawning channel intake with Birchbank Golf Course pumphouse in background. Note the boulders surrounding the intake, which have been transported in part by the seasonal flooding of the creek.**

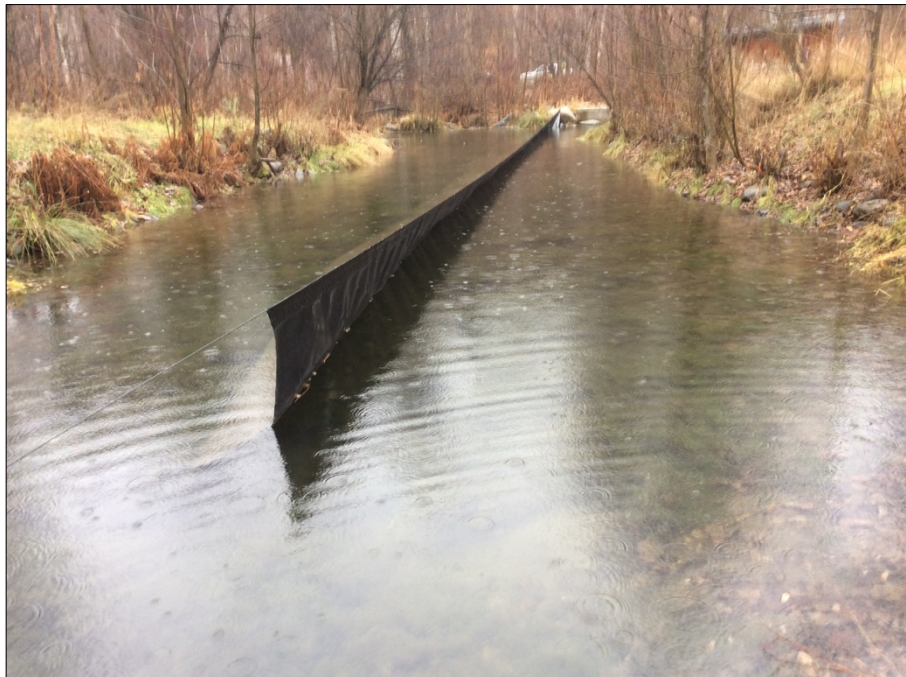
**Photo 2. View SW of the settling pond. Note the shoreline of the pond, which provides easy access for the tracked excavator used in the removal of the pond sediment.**

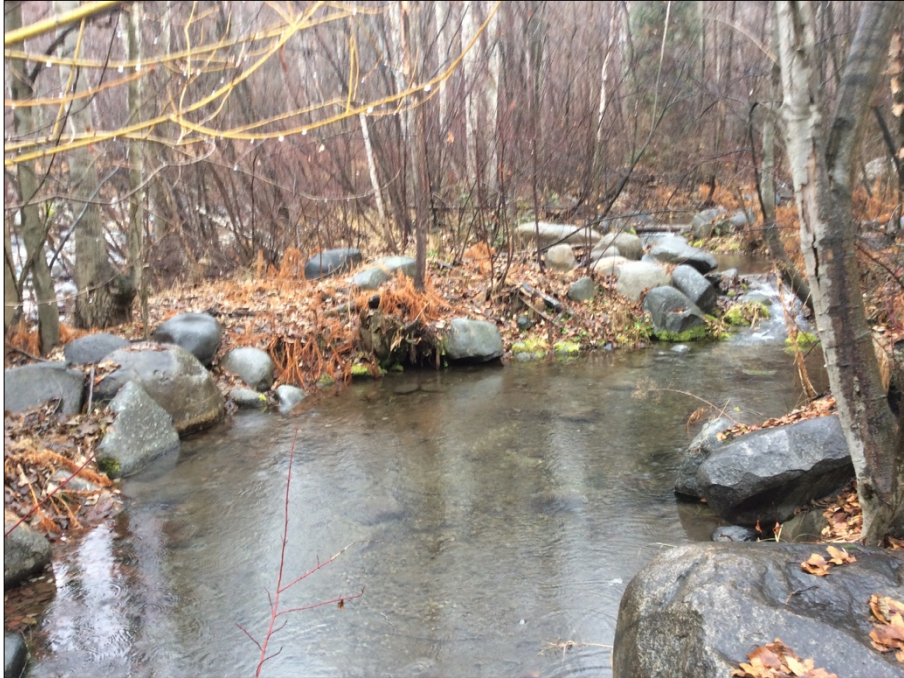
**Photo 3. View W of spawning channel with Murphy Creek in background. Note the poorly drained floodplain terrain located along the margins of the channel and creek.**

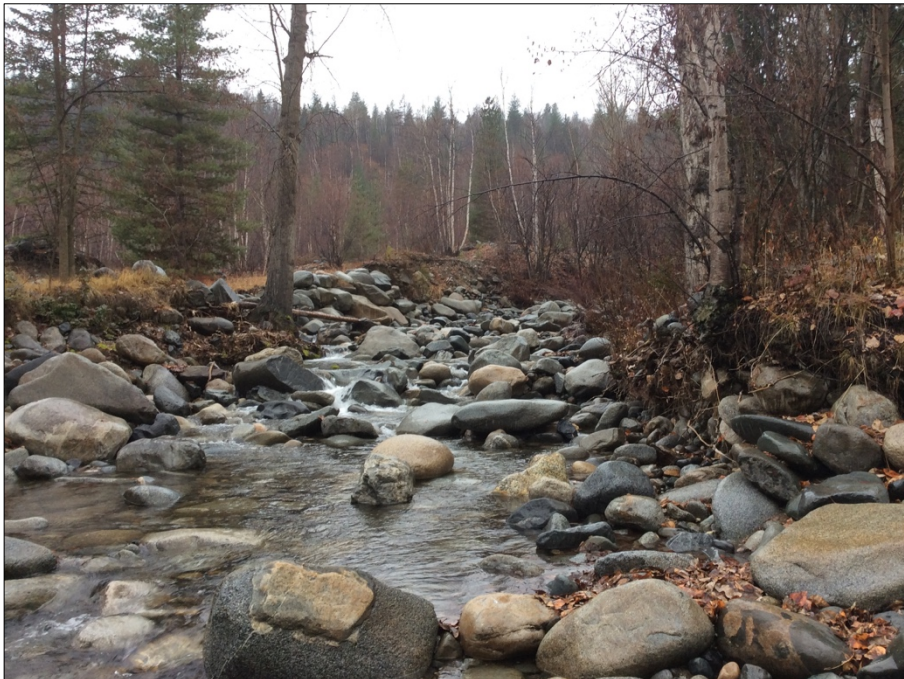
**Photo 4. View W of Murphy Creek, looking upstream. Note the alluvial deposited boulders throughout the stream that are seasonally transported by spring freshet flooding.**
