# Silvertip Ranch Wetland Restoration Project

**COL-F19-W-2797**

## Executive Summary

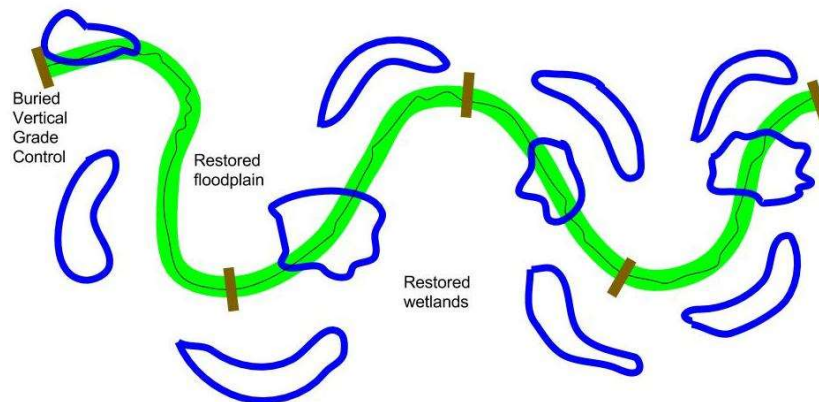
Figure 3: Typical plan view showing restored wet-meadow and ephemeral wetlands, not to scale. Green band represents the creek channel & floodplain, the brown lines are boulders used for grade control, with ephemeral wetlands adjacent.

The restoration site was located along the edge of the hayfield, in an effort to balance the ecological restoration objectives of the project, while still allowing hay to be cultivated on agricultural fields. A bulldozer and two excavators carved out a sinuous floodplain, approximately 500 metres in length by 10 metres in width, having a gentle cross section of only a few degrees. The floodplain and channel were restored with a gradual slope (Figure 2), with more than a dozen wetland basins created beyond the floodplain, in an effort to resemble historical attributes of the original watercourse (Figure 3). This was done so that water would spread out and saturate the ground, forming wet meadow and ephemeral wetland basins connected to the channel.

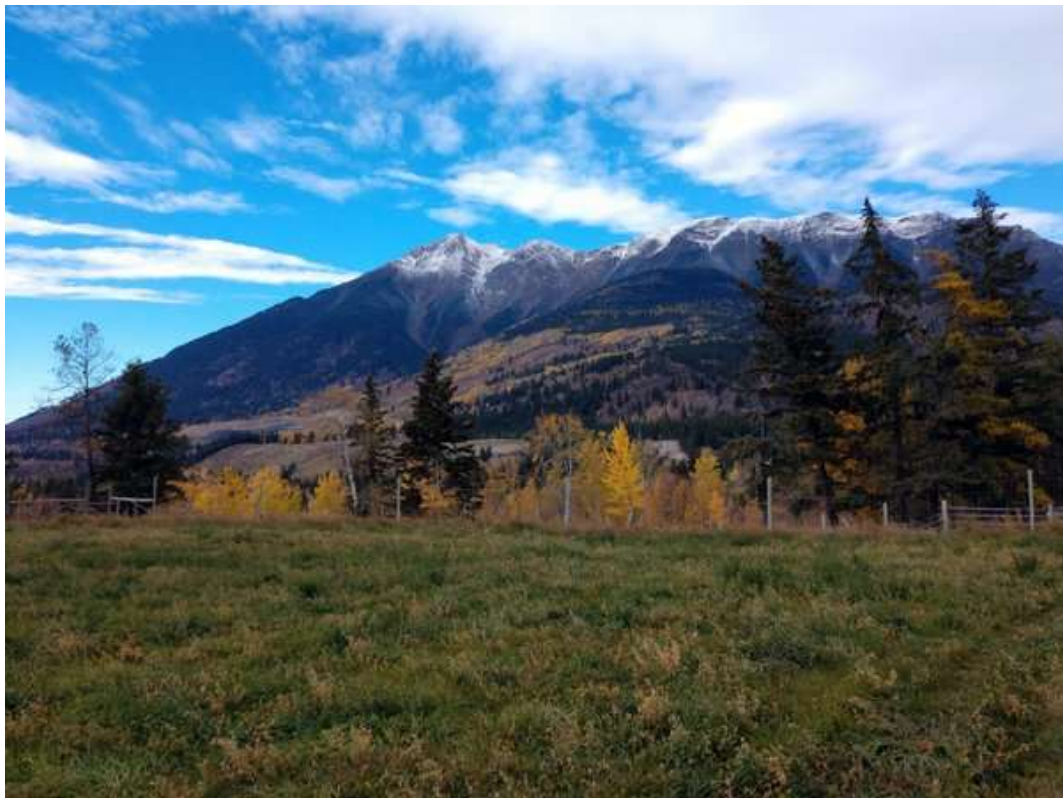
**Photo 2:** This beautiful hayfield was made by moving Douglas Creek, by filling ephemeral wetlands, levelling the ground and installing ditches on its periphery.

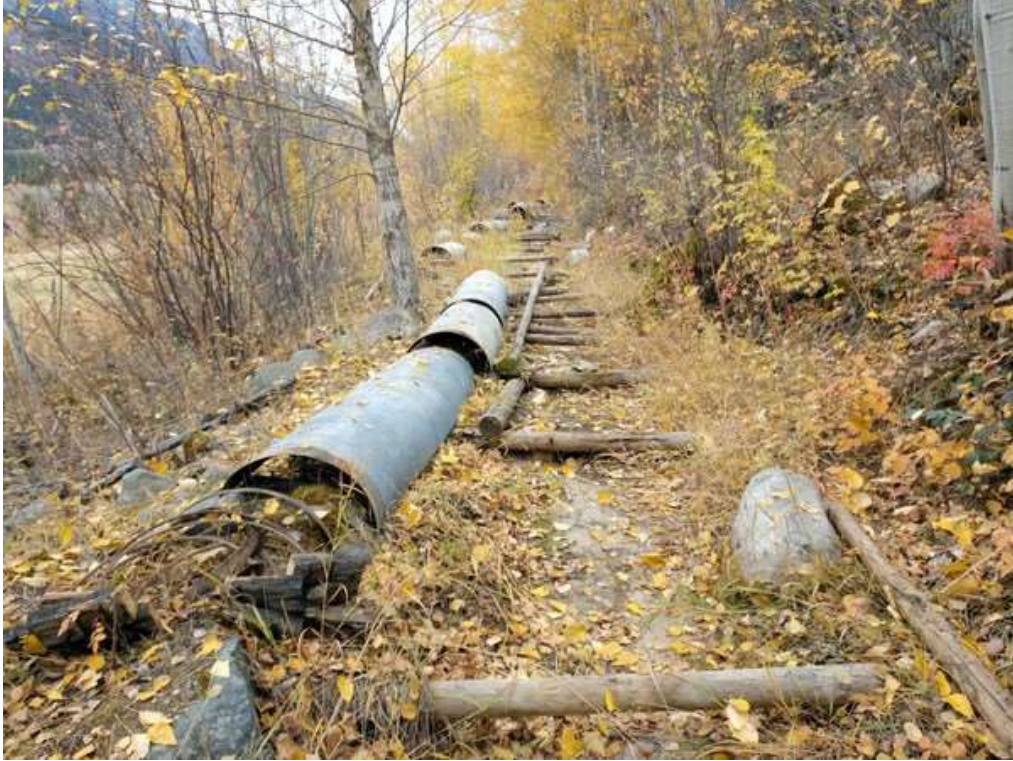
**Photo 3:** Part of the project involved removal of a metal flume used to divert Douglas Creek

The Patricia Logan and several volunteers from the ranch removed the metal flume and irrigation pipes used to divert the water from Douglas Creek, over a two-day period. The metal and non-treated wood posts were salvaged for ranch use. A section of barbed wire fence was also removed to allow machine access and was later rebuilt.

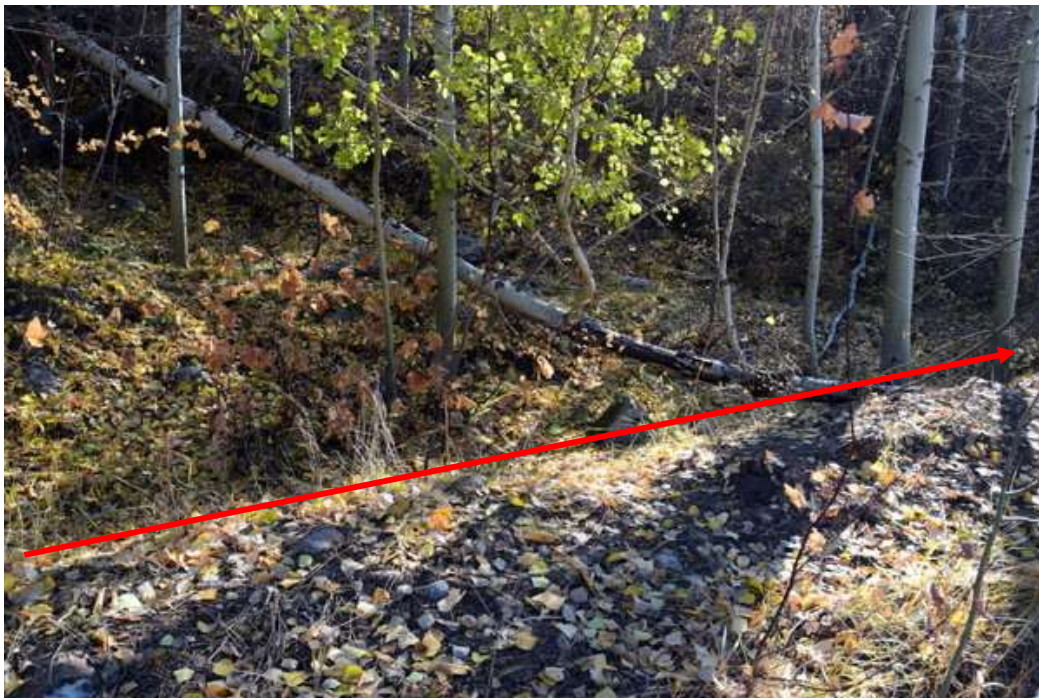
**Photo 4:** In the past, ditches (red line) had been dug to move Douglas Creek around the hayfield

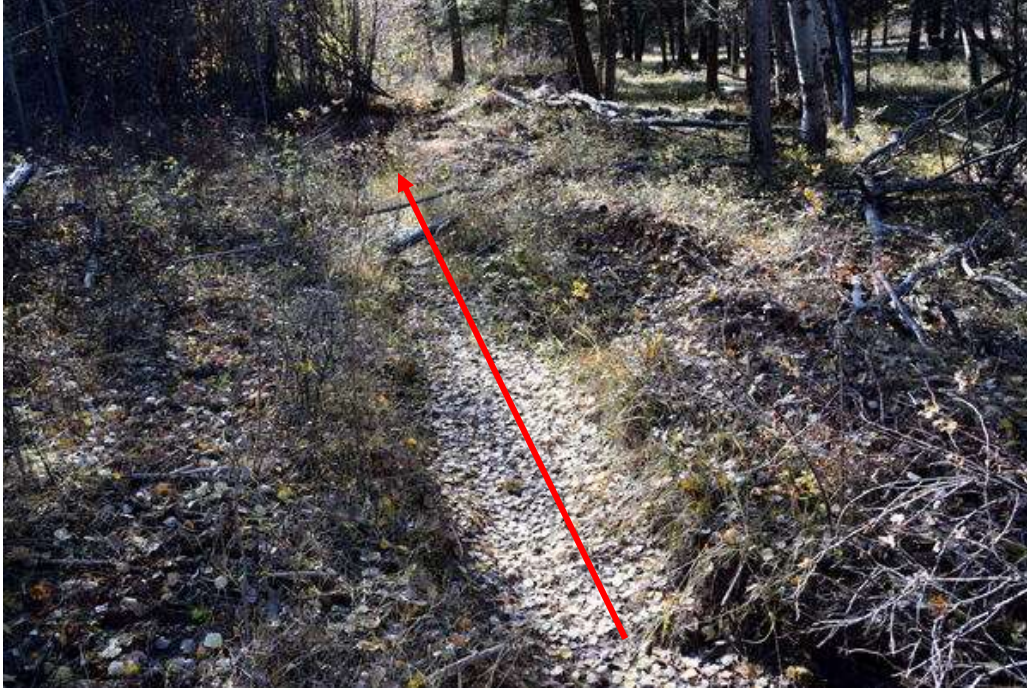
**Photo 5:** Ditches (red line) had been dug in several places, to move Douglas Creek around the hayfield, carrying surface flows far from their original watercourse

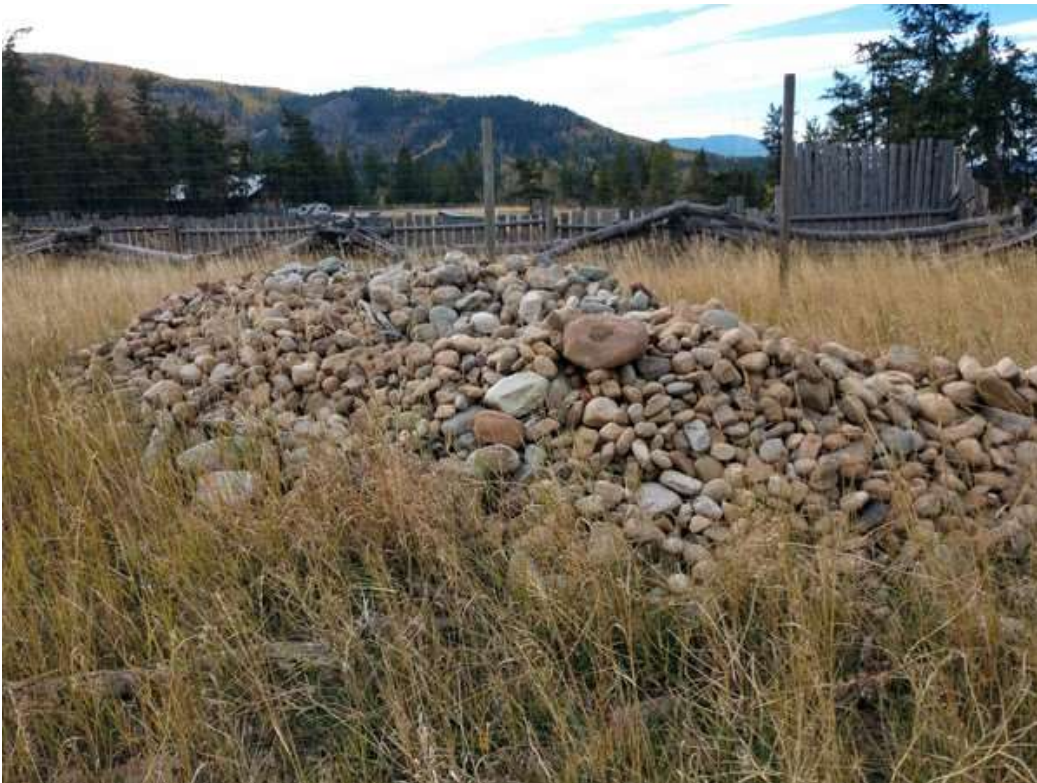
**Photo 6:** Huge piles of rock moved from hayfields were used to restore the creek bed. Having this material on-site saved money by not having to haul it in from an aggregate pit.

Rock was used to armor steeper sections of the restored streambed to control erosion and was covered with a thin layer of soil to grow vegetation and blend into the environment. Originally, rock was to be purchased and trucked to the site. However, thousands of rocks were removed from the hayfields over the years and, piled in several locations. As a result, a tandem dump truck was mobilized to transport approximately 23 loads from the upper fields to the project area.

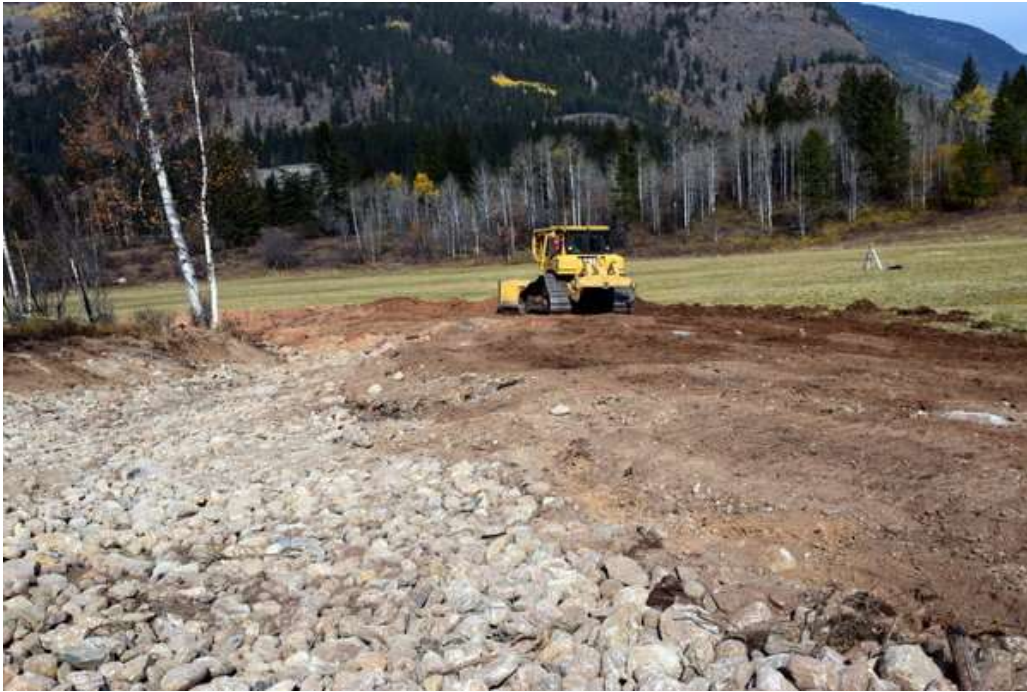
**Photo 7:** Here a dozer is used to shape a new valley and floodplain for the restored creek along the edge of the existing hayfield.

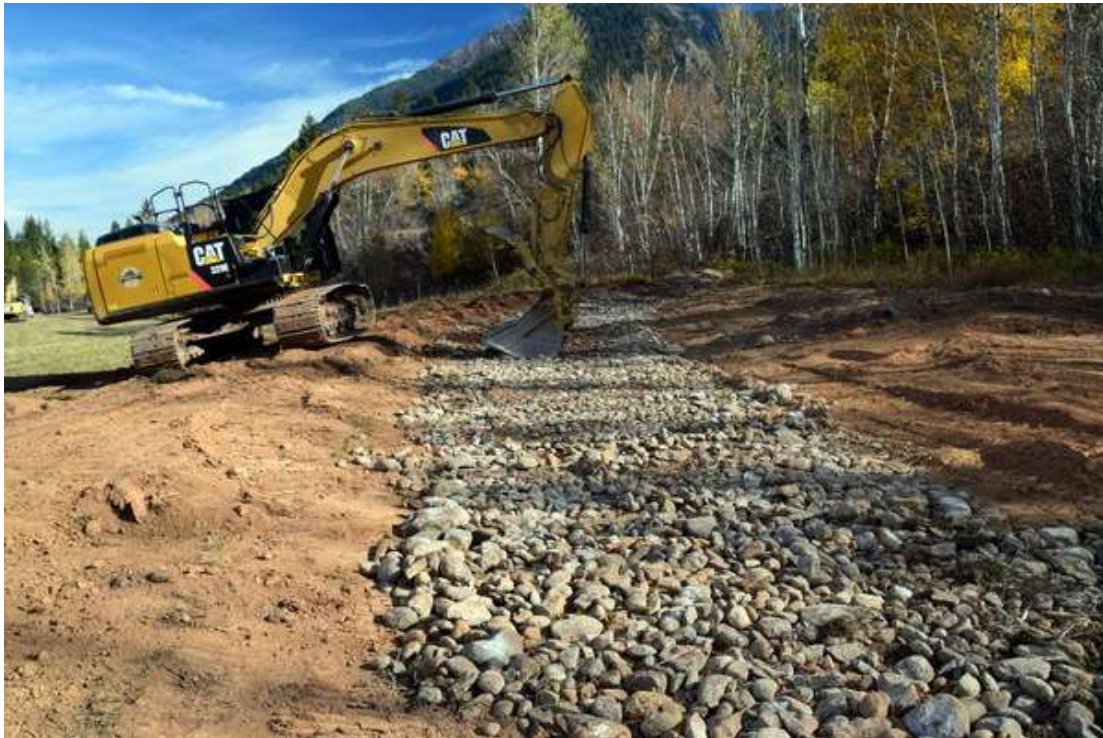
**Photo 8:** Small rock was used to armour steeper sections of the restored creek. The rock was covered with a thin layer of soil so it could be seeded

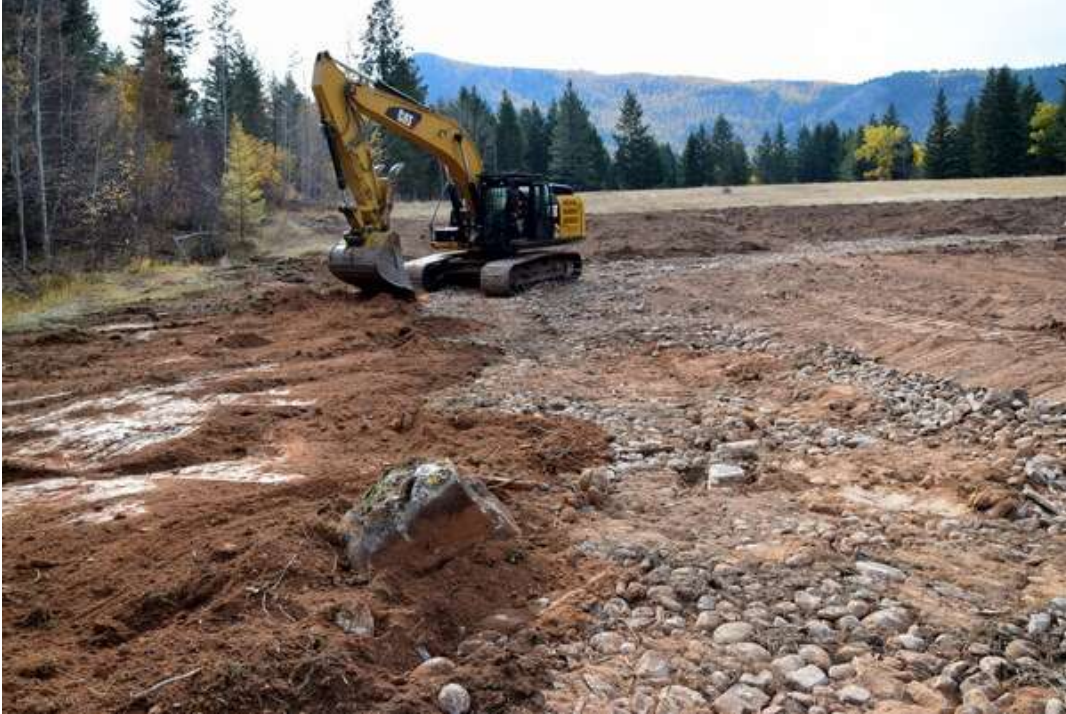
**Photo 9:** Soil is spread over the rock so the restored floodplain will support a diversity of sedges and rushes without erosion and appear more natural looking within the site context

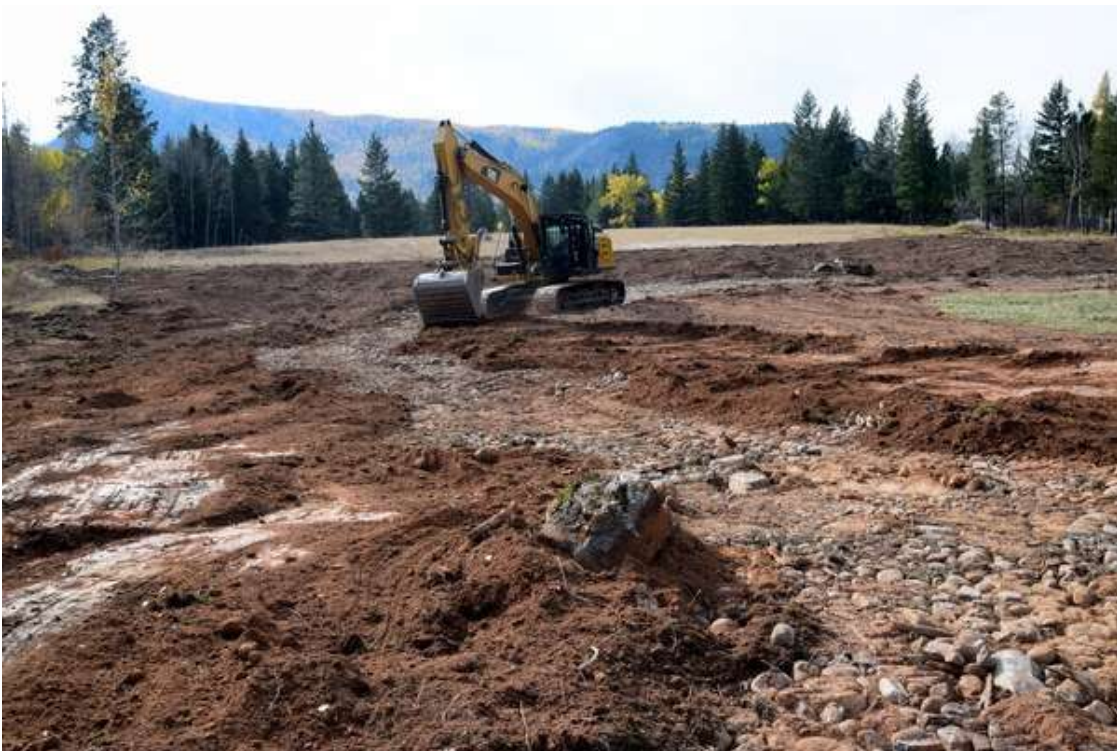
**Photo 10:** A sinuous floodplain and creek channel are shaped on a gradual slope, in which several wetland basins are designed alongside

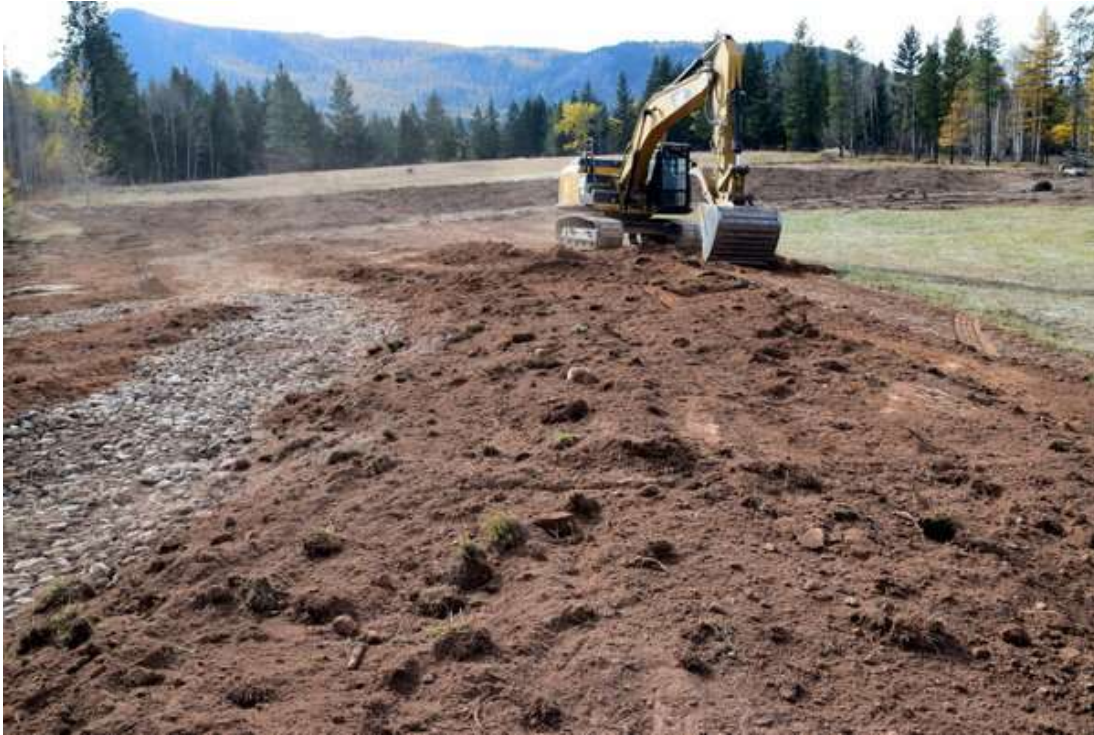
**Photo 11:** The excavator shapes low banks with gradual slopes and loosens compacted soils on the restored floodplain.

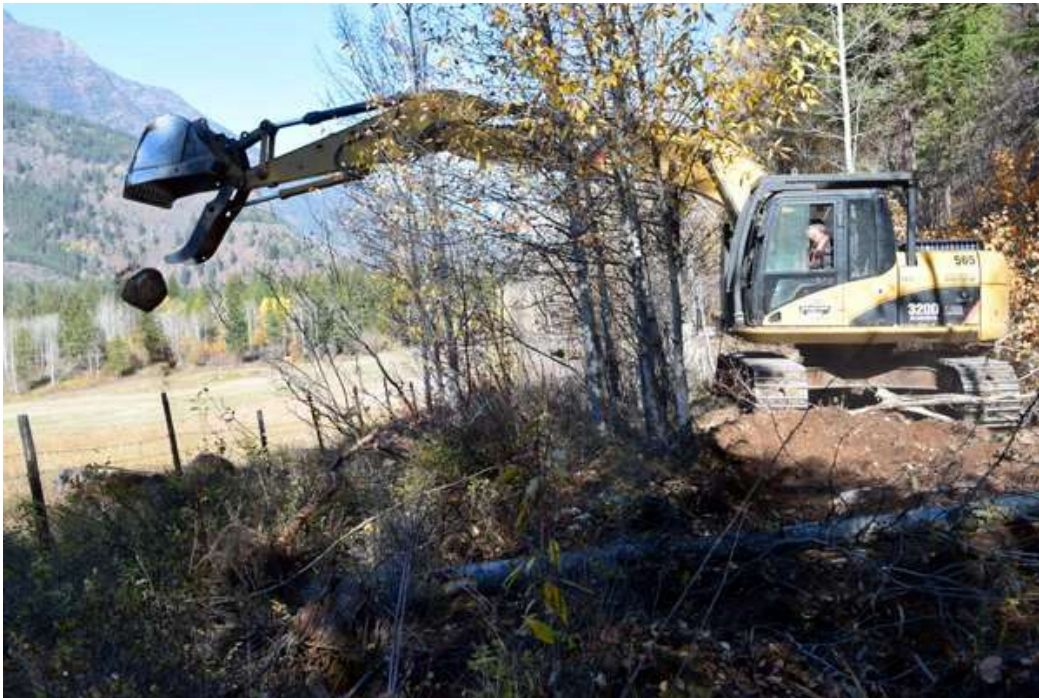
**Photo 12:** The excavator gathers boulders from the edge of the hayfield to be used to create unique habitat features along the creek and wetlands

Large boulders were also used to control erosion in the restored stream, and were placed to improve wildlife habitat diversity. Boulders were also obtained from the ranch property, having been moved when the Bull River Road was upgraded. Approximately 15-dump truckloads of boulders were re-purposed for the project.

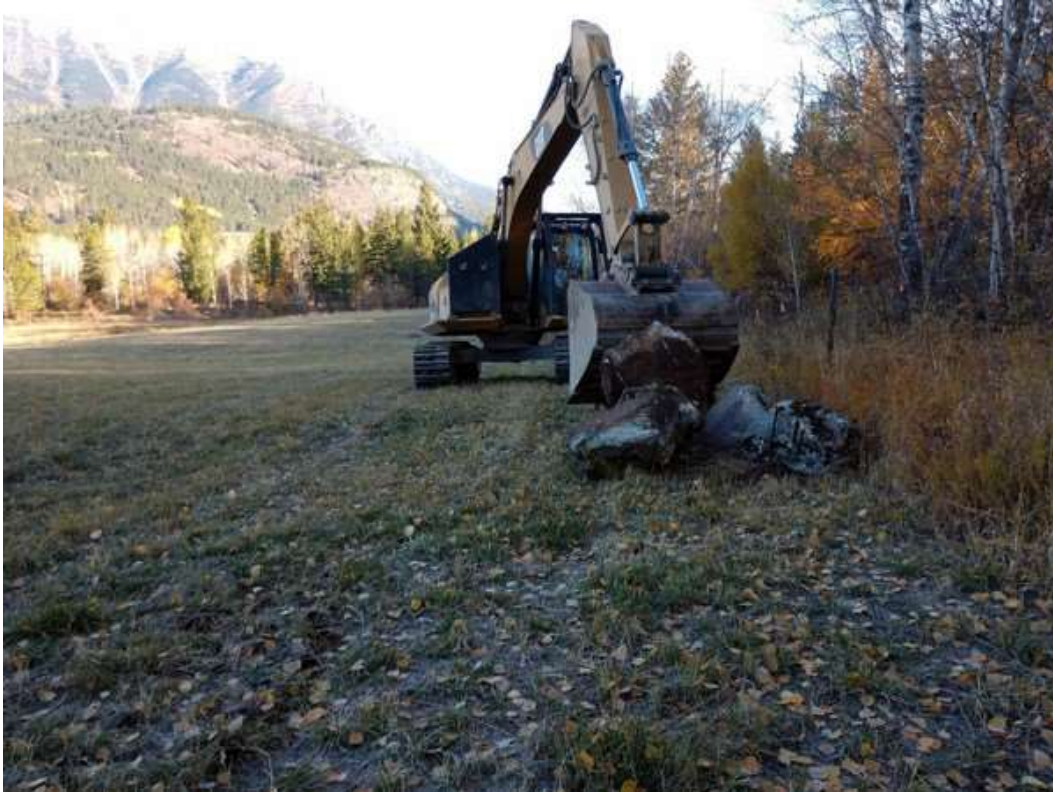
**Photo 13:** Here large boulders are being gathered for use in the restored stream

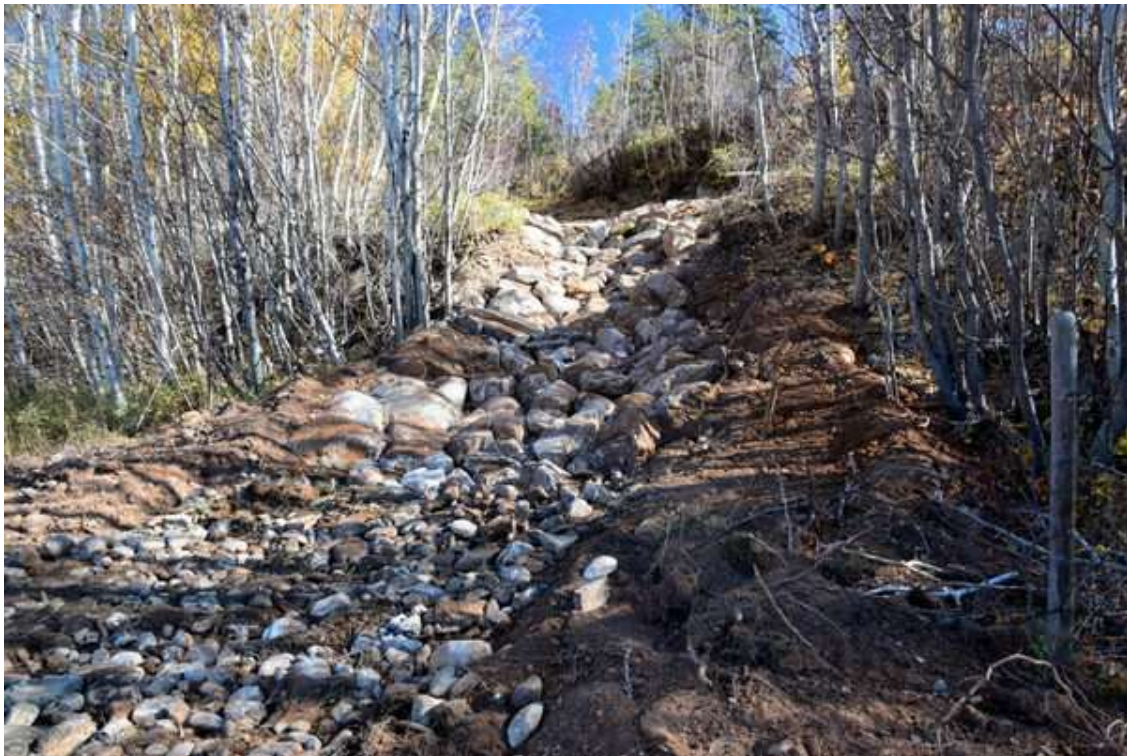
**Photo 14:** A new valley was restored to replace the flume, moving water from the culvert under the Bull River Forest Service Road into restored Douglas Creek

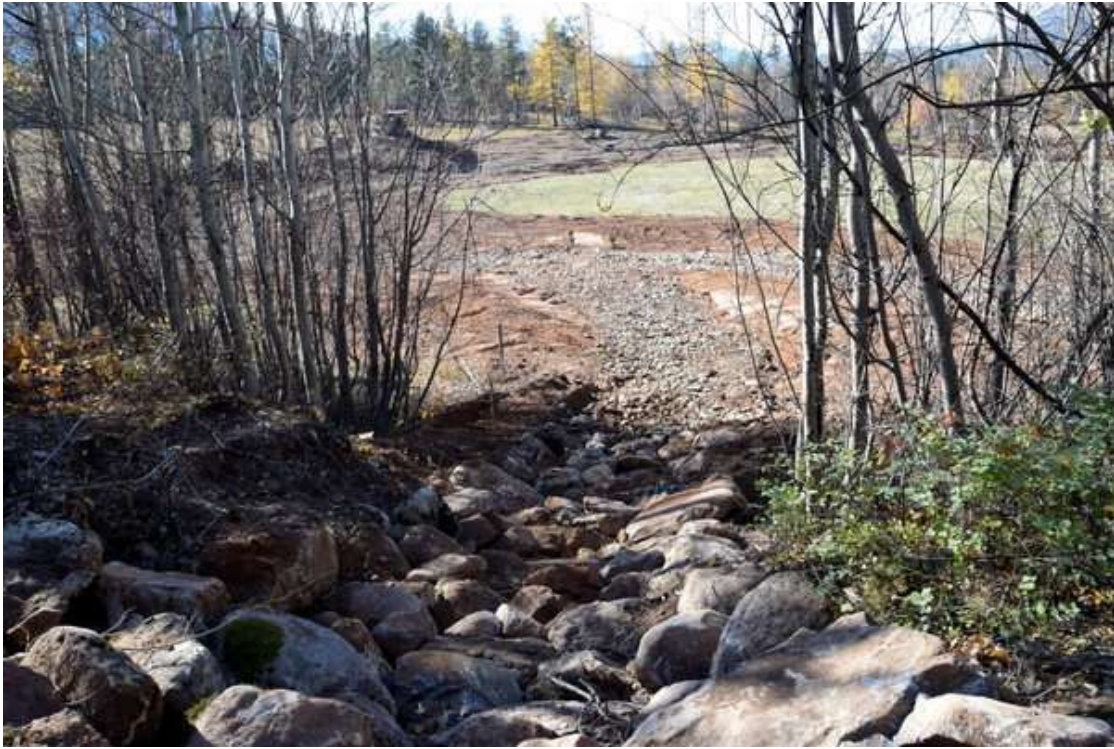
**Photo 15:** The flume was replaced with a natural rocky valley that would not erode

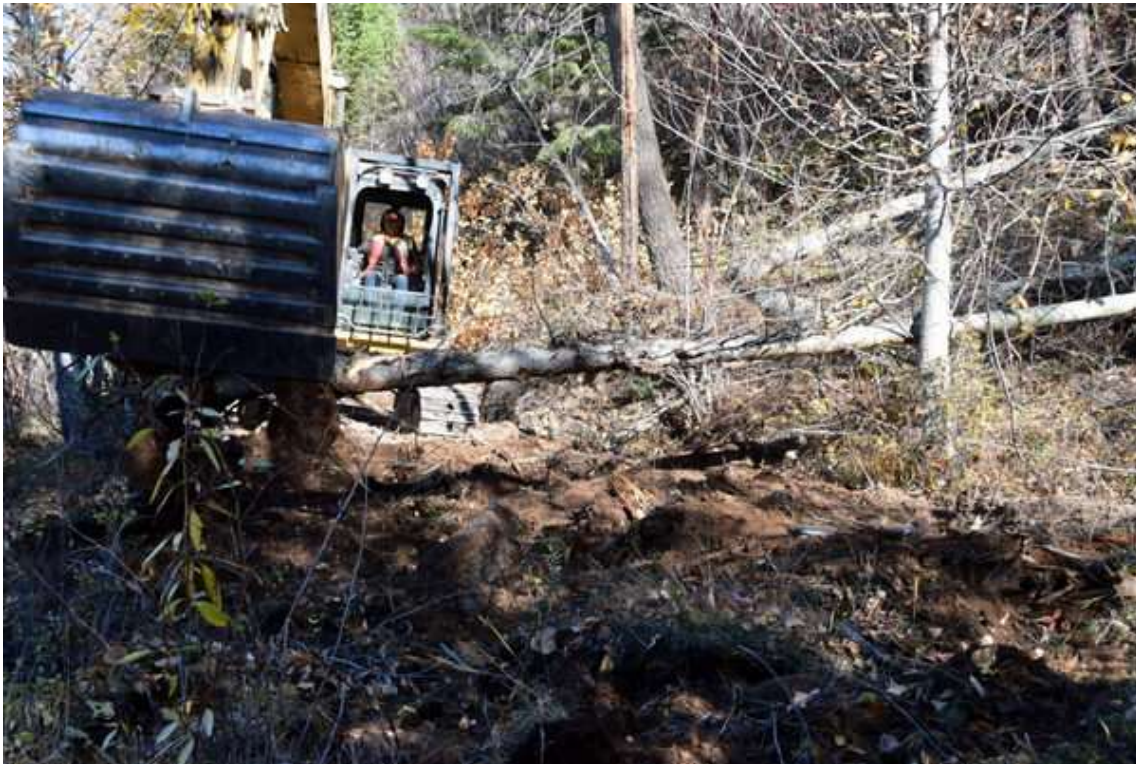
**Photo 16:** The excavator is used to fill and naturalize the ditches, as part of the overall project, thereby ensuring that flows from Douglas Creek would not be lost

The location of the flume was rehabilitated using an excavator in much the same way, as roads are decommissioned. Excavators disabled hundreds of metres of ditches used to carry water away from the property, having little habitat value. The operators filled in the ditches to grade and covered with organics to quicken recovery. A small borrow pit that was used to build ditches many years ago was also rehabilitated at the site.

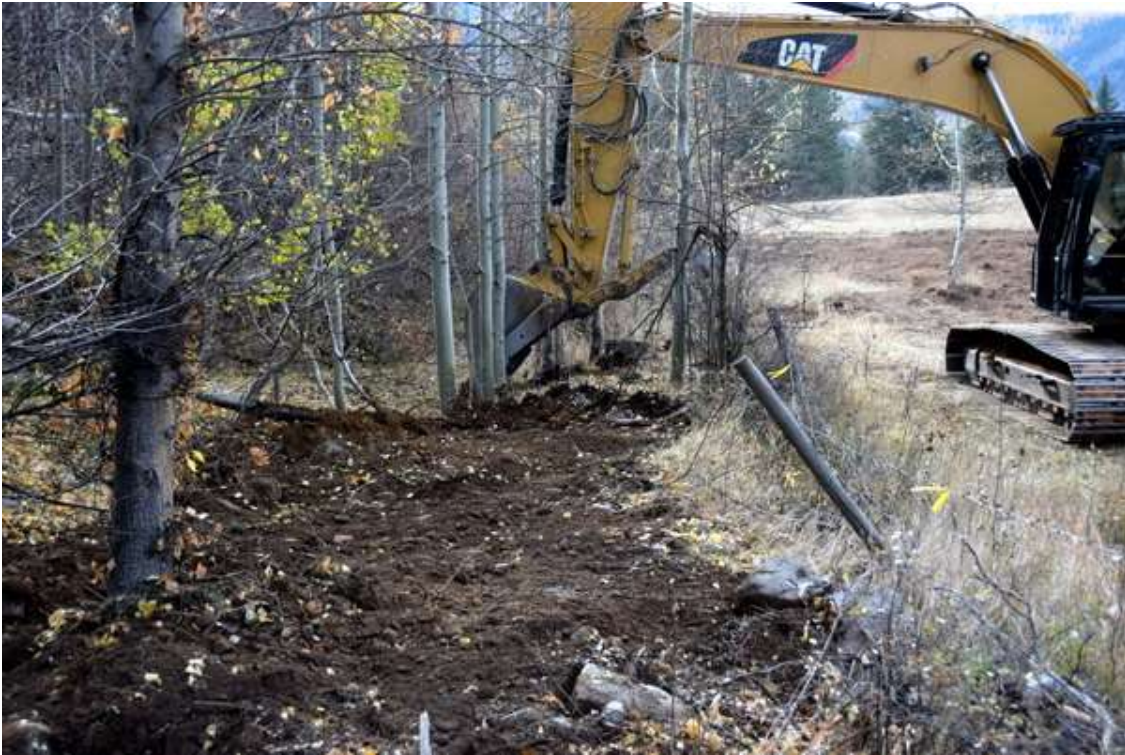
**Photo 17:** A section of a former ditch is being filled and brought to grade

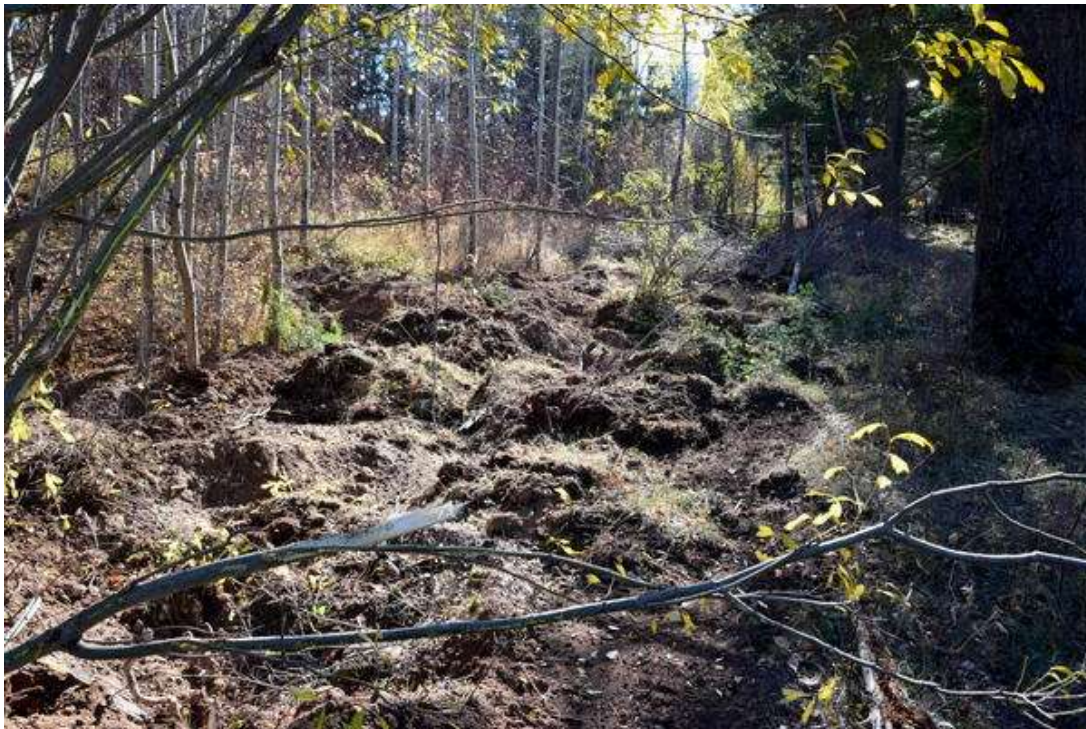
**Photo 18:** A filled and naturalized section of ditch.

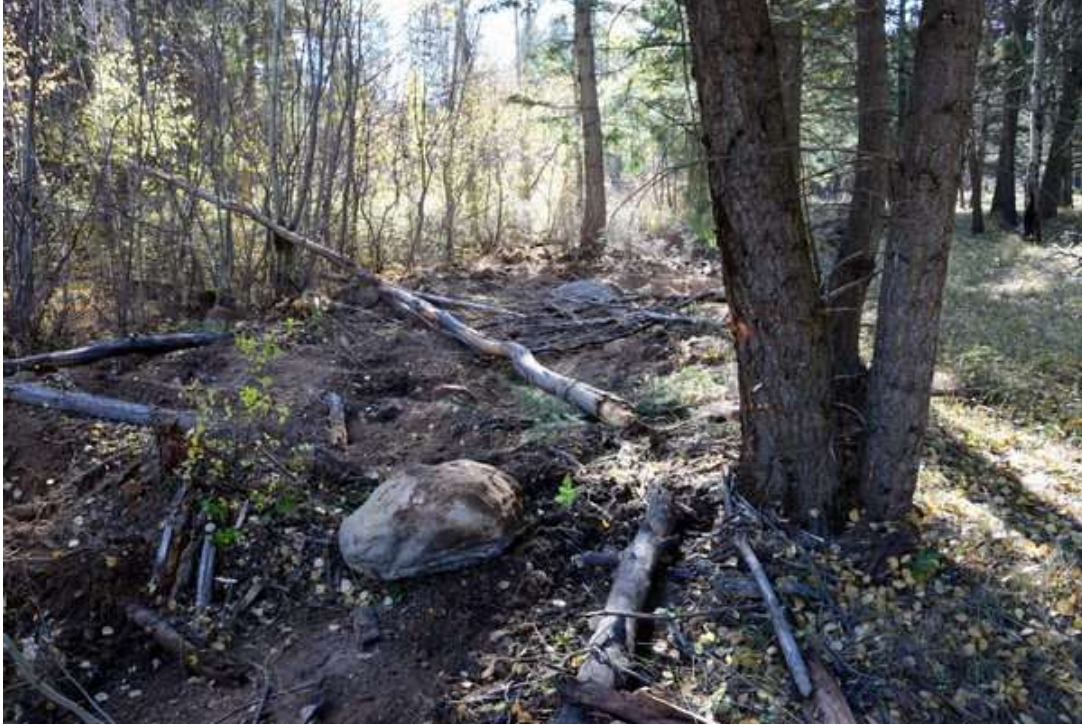
**Photo 19:** A filled and naturalized section of ditch, in time it will blend in with the surroundings

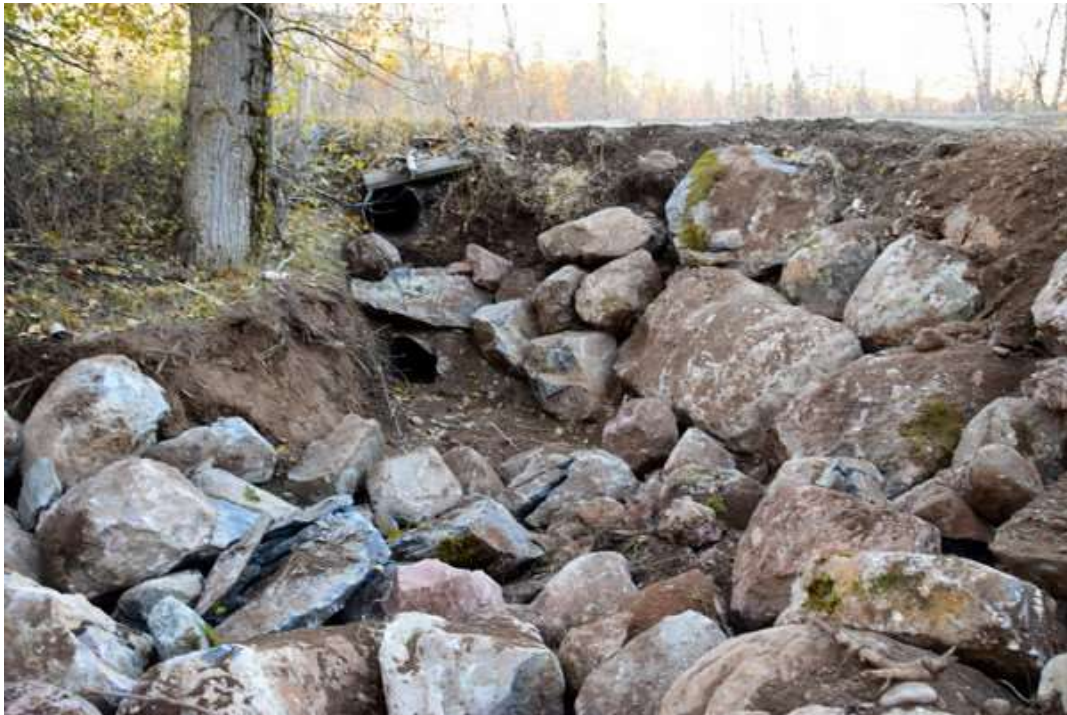
**Photo 20:** This photo shows the two culverts carrying water from Douglas Creek under the Bull River Forest Service Road. The culverts were unplugged during the project, and erosion was controlled by placing rock salvaged alongside the FSR

Culverts were designed to channel water under the Bull River Road yet, were partially clogged and necessitated a clean out. Areas around the culverts were armored with rock to prevent erosion during high flows.

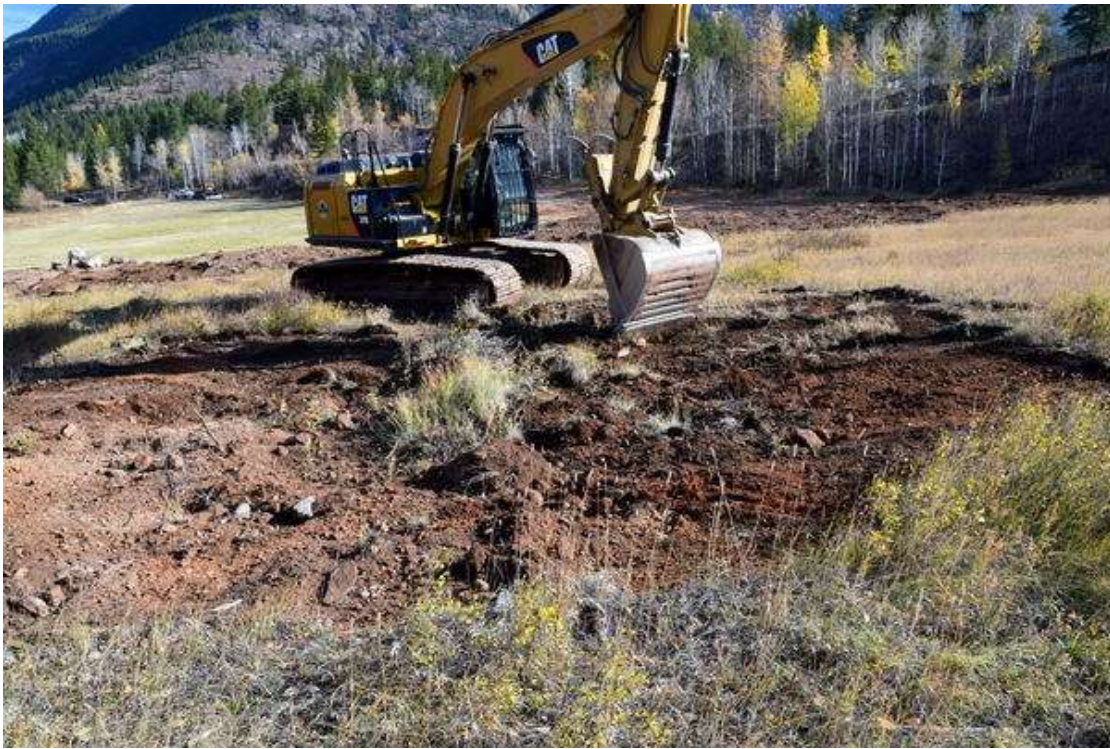
**Photo 21:** Here a small borrow pit from years ago is being restored, beside the restored creek

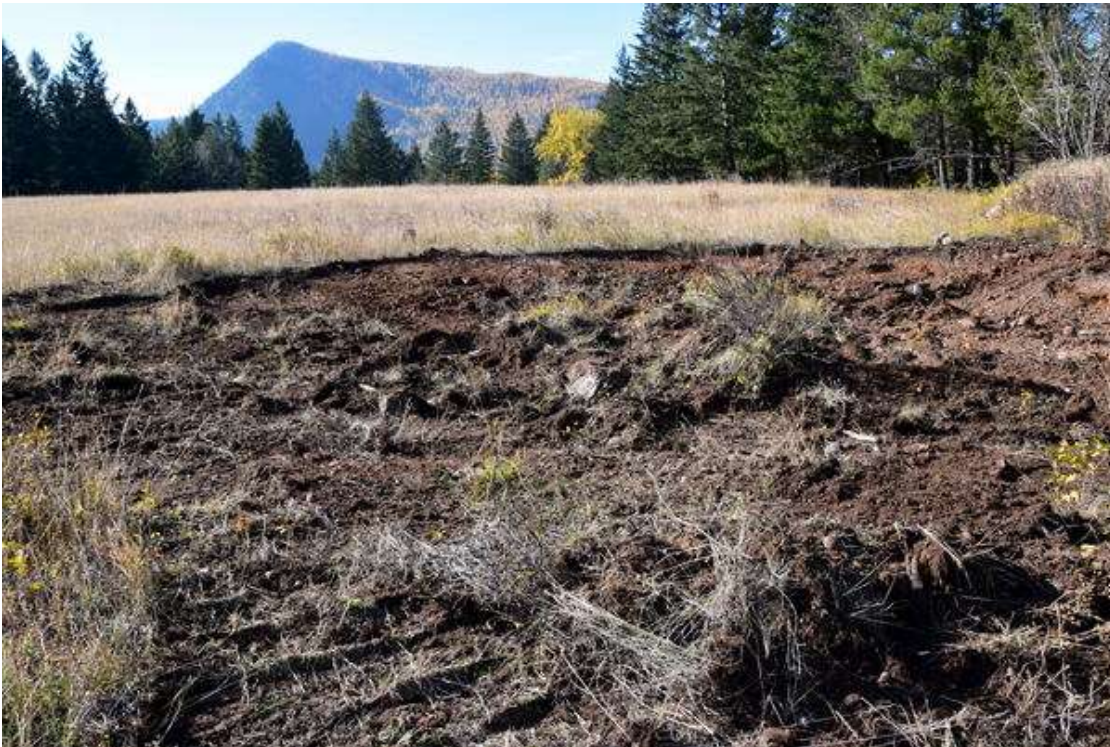
**Photo 22:** The loosened soils in the restored gravel pit and alongside the creek bank may be used by the Columbian Ground Squirrel, and by the American Badger

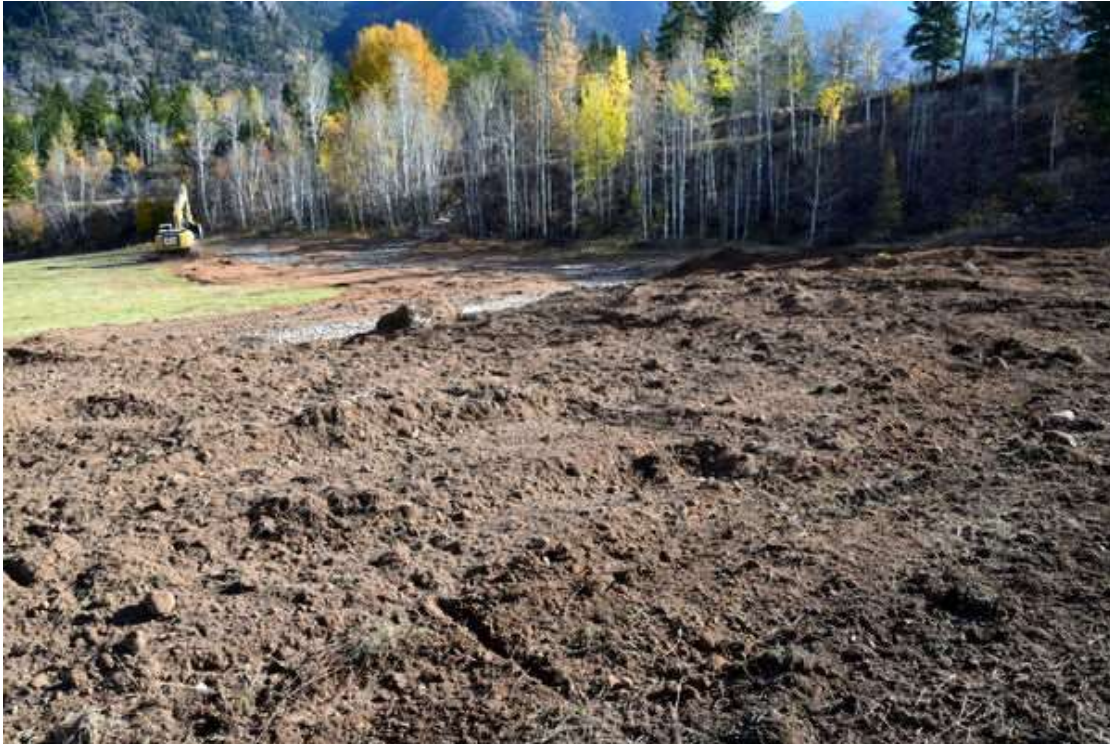
**Photo 23:** Large areas of compacted soil were loosened to provide habitat for the American badger and Columbian ground squirrel, as part of the prescription. Sightings and evidence of both ground squirrel and badger use are relatively common on the property

6. Over 2,000 square meters of habitat was created for Columbia Ground Squirrels and American Badgers. This was accomplished by loosening compacted soils and by building natural ridges, as part of soil disturbance associated with the project, located on upland areas beside the restored floodplain;

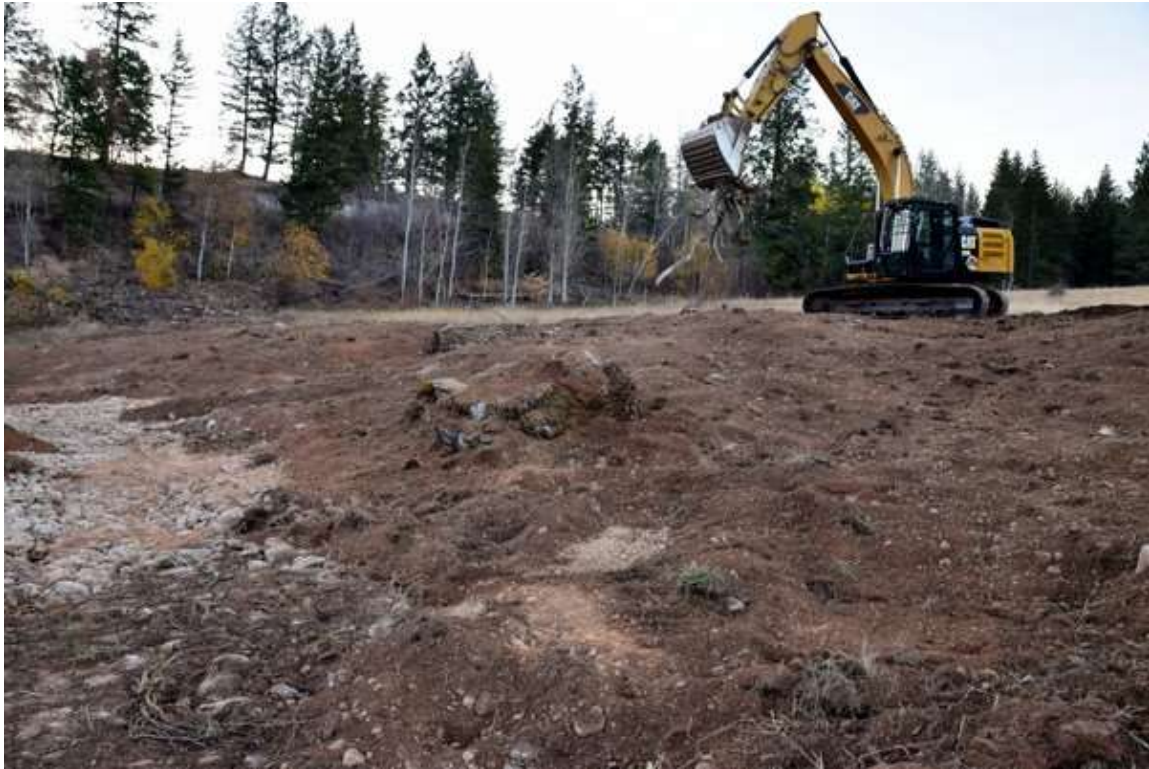
**Photo 25:** Log, branches, root wads and boulders placed on the restored floodplain to break up homogeneity on the landscape and improve wildlife habitat by providing micro features.

On the last day of the project, equipment operators put the finishing touches on the project, ensuring that the site was contoured to blend into the surrounding topography. Woody debris was added to wetland basins as microhabitat features and, the edge of the project area was graded level to limit disturbance to haying of the adjacent fields. Loosening soils in one area was done to provide encourage ground squirrel colony excavations, a key food source for badgers.

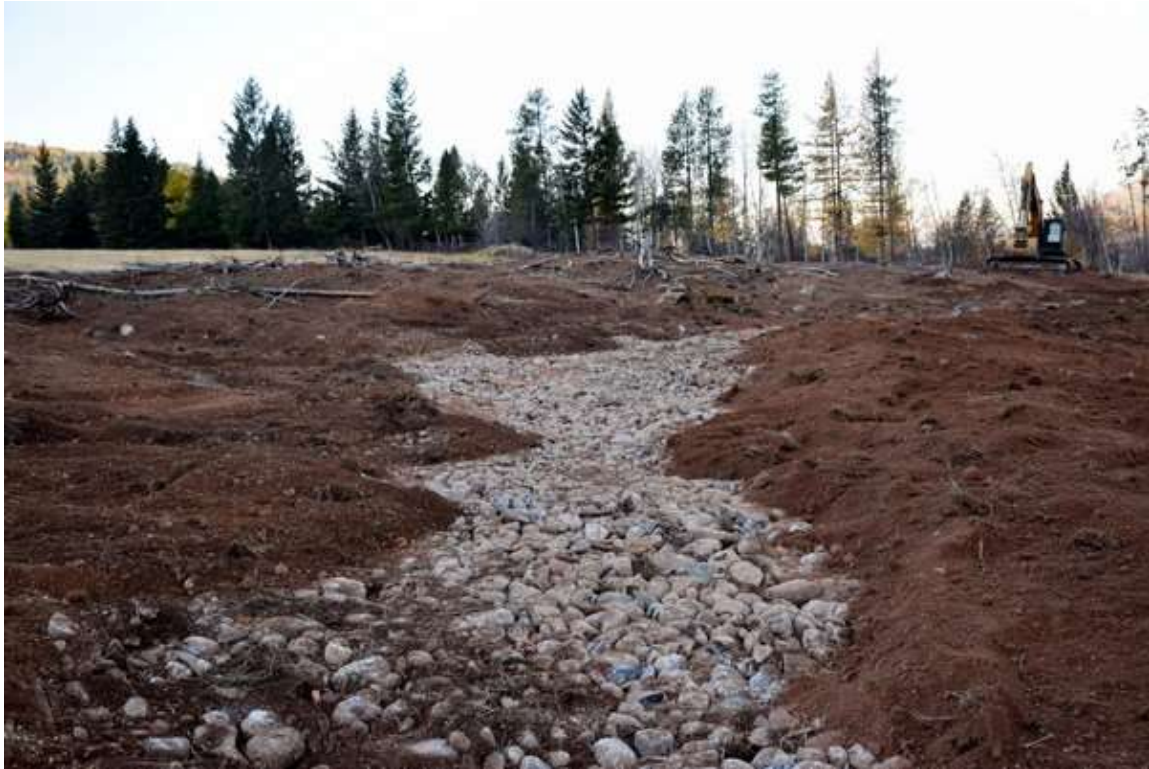
**Photo 26:** Restored creek and floodplain in progress, looking upslope

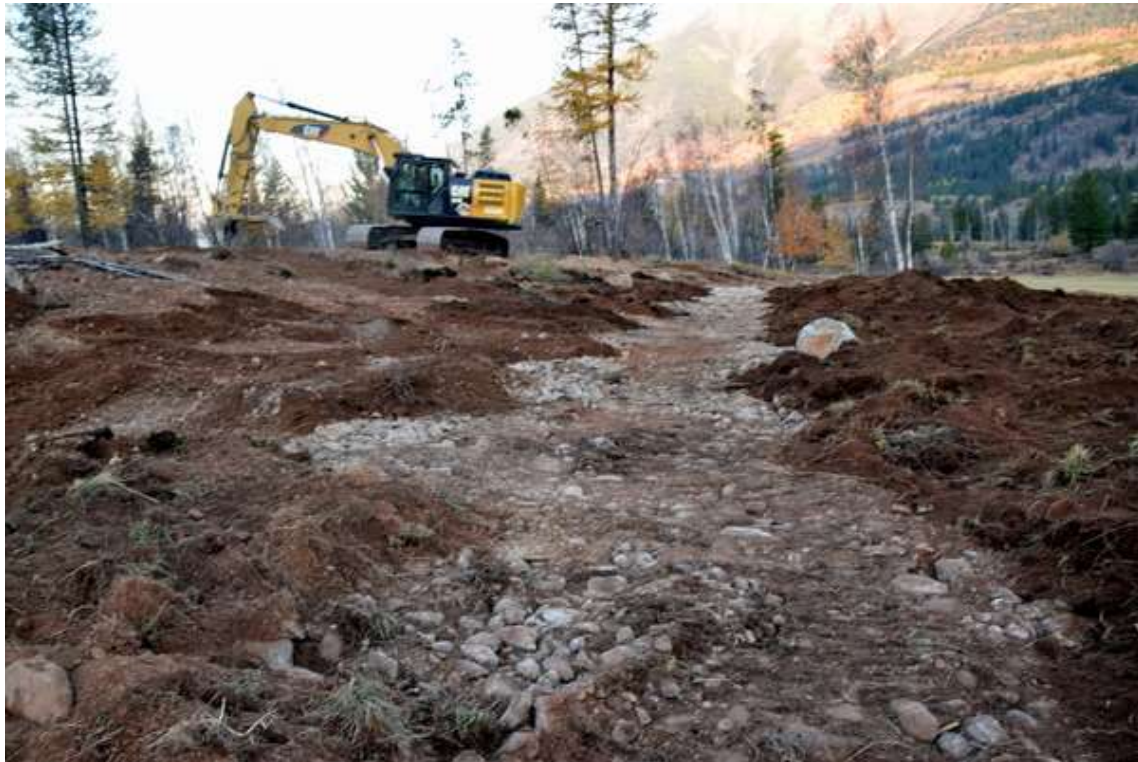
**Photo 27:** Restored creek and floodplain in progress, looking downslope
