# Silvertip Ranch Wetland Restoration Project

**COL-F19-W-2797**

## Executive Summary

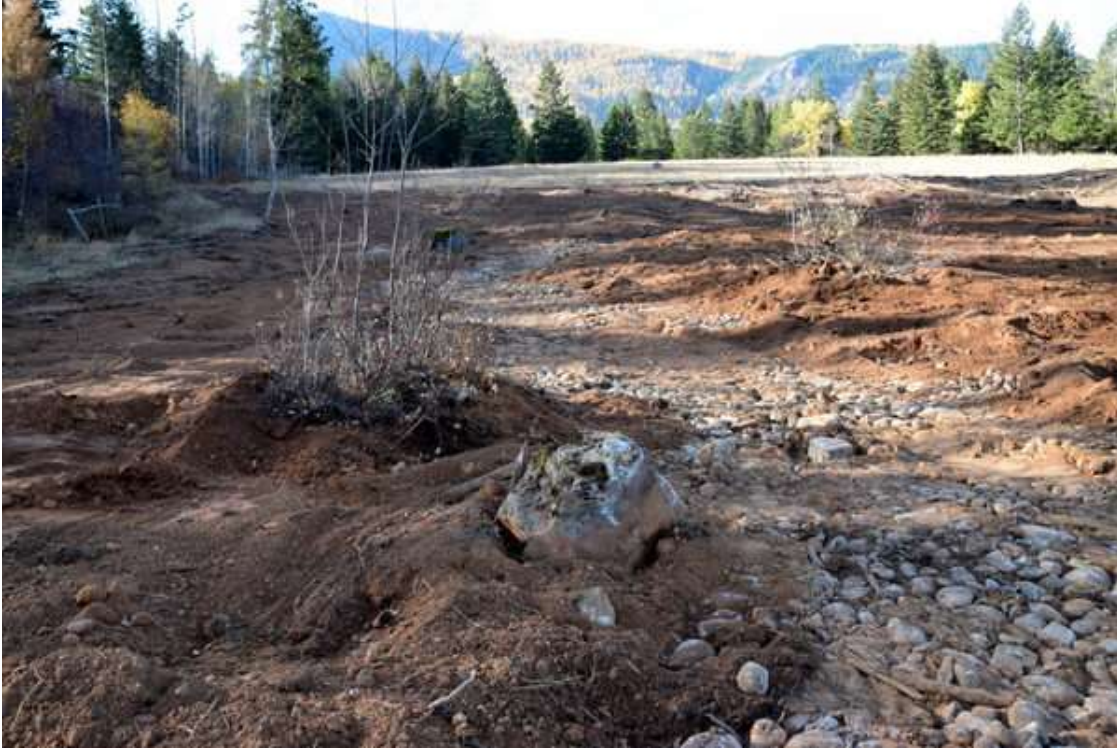
**Photo 28:** Restored creek and floodplain, looking downslope. Note the boulder placement and re-planting of shrubs in the foreground and background

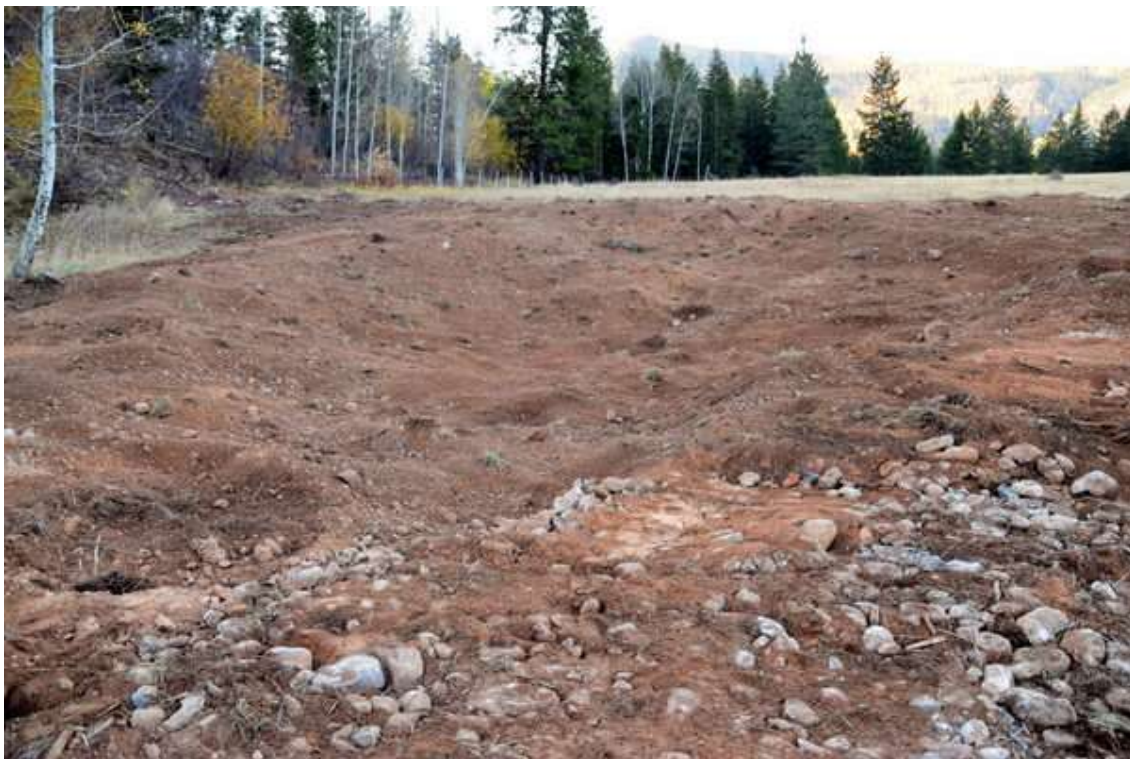
**Photo 29:** More than a dozen wetland basins feed off the creek channel as shown here

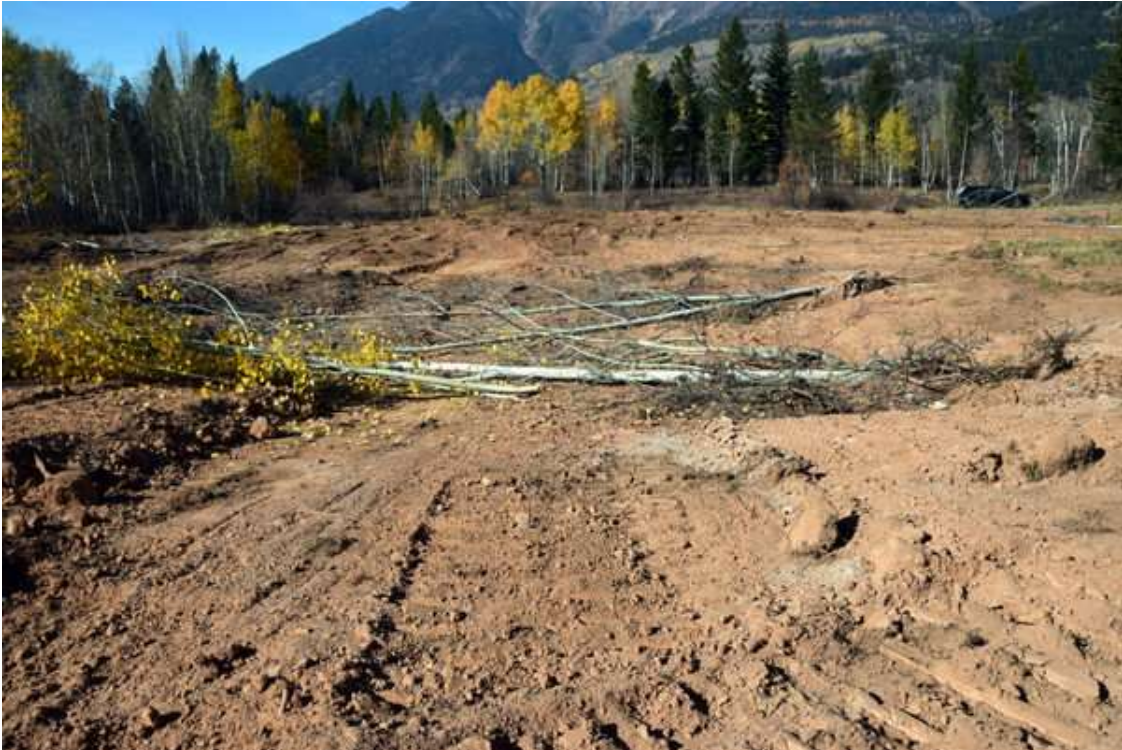
**Photo 30:** Many of the restored basins are located at the bottom of the creek channel

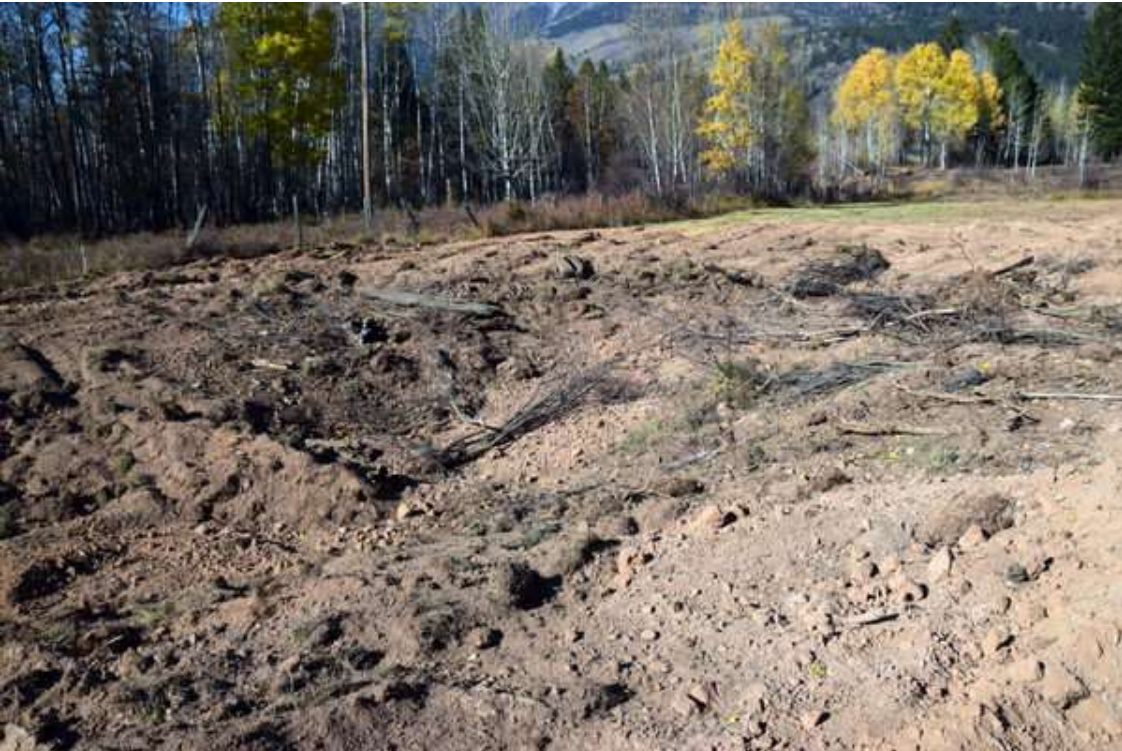
**Photo 31:** This wetland forms the terminus of the project area, property line is in the background

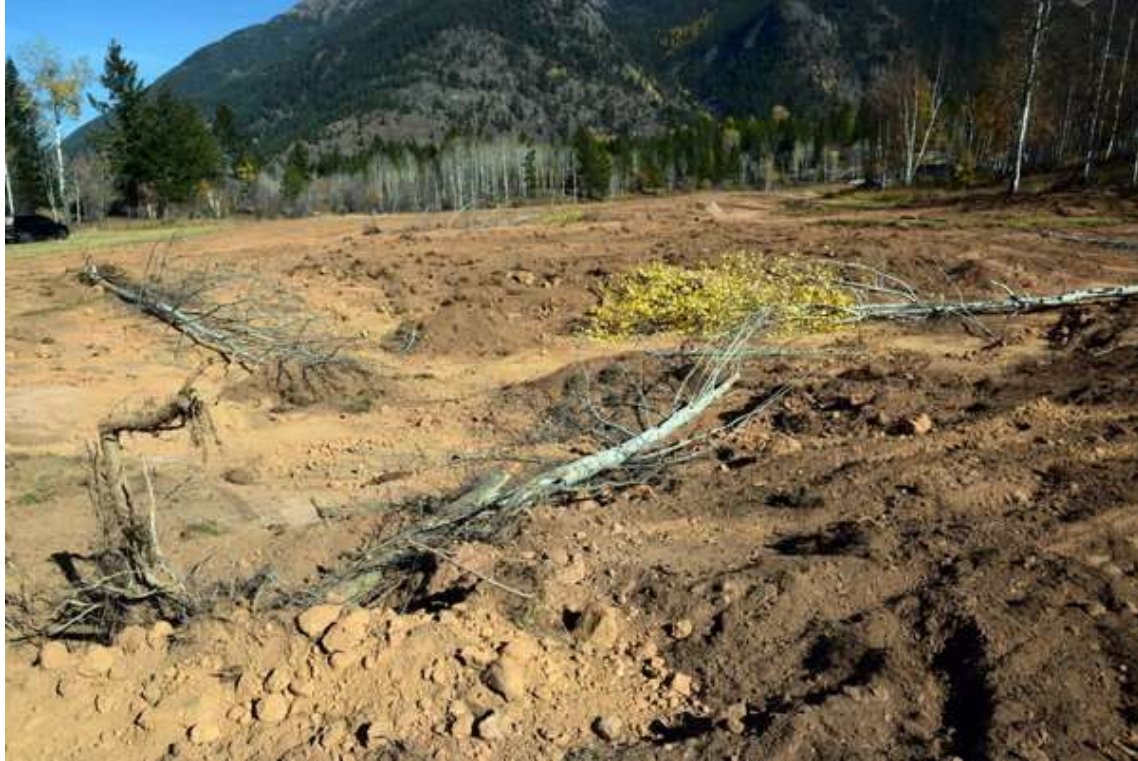
**Photo 32:** Restored wetland, looking upslope over the entire project area

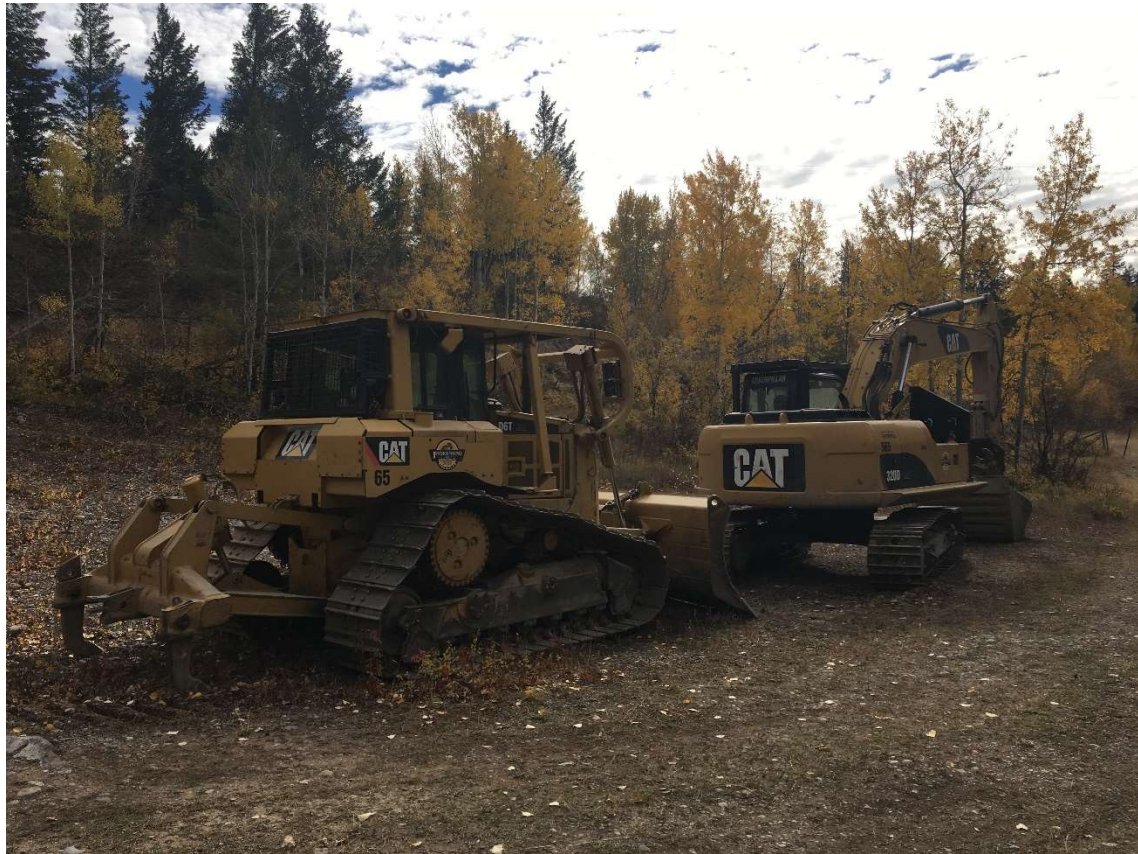
**Photo 33:** Two excavators, a dozer, a dump truck and a tractor were used on the project

1. Caterpillar D6T Dozer LGP
2. Caterpillar 329EL Excavator
3. Caterpillar 320DLRR Excavator
4. Tandem Dump Truck

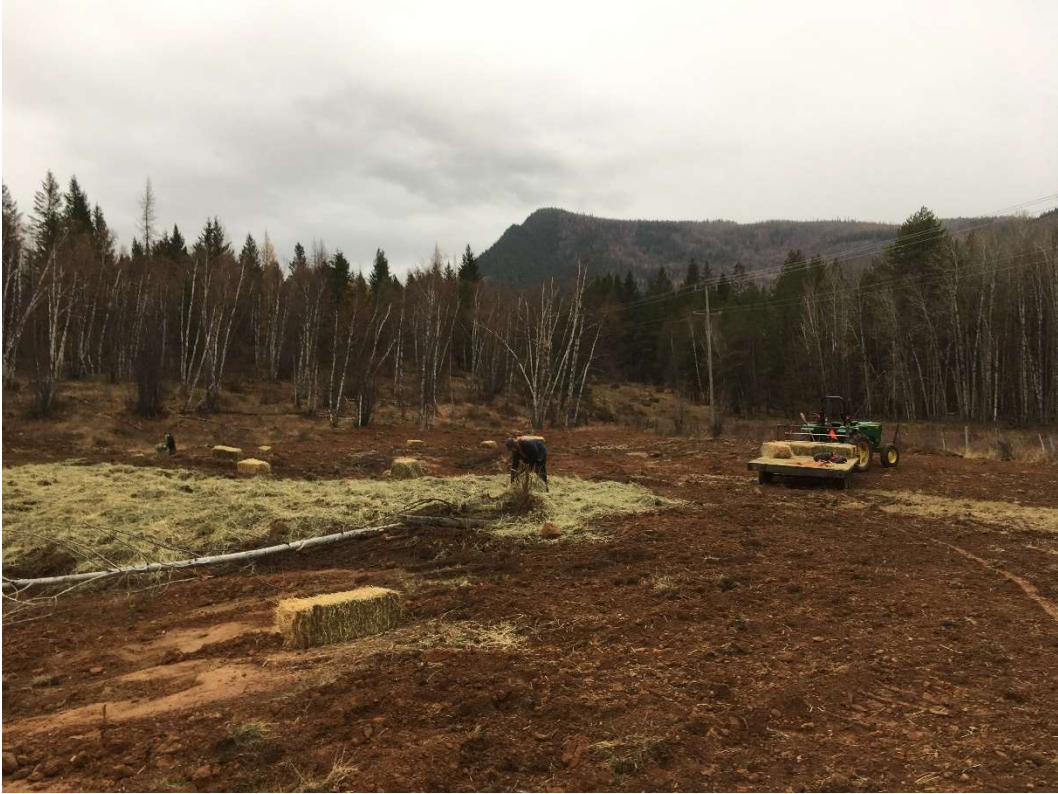
**Photo 34:** All ground disturbance was covered by hand with hay/straw mulch

9. Approximately 200 bales of organic straw and hay mulch were hand placed on disturbed areas, in an effort to guard against erosion, to protect seed, limit invasive plant establishment and to retain moisture and temperatures necessary to incubate the seed.

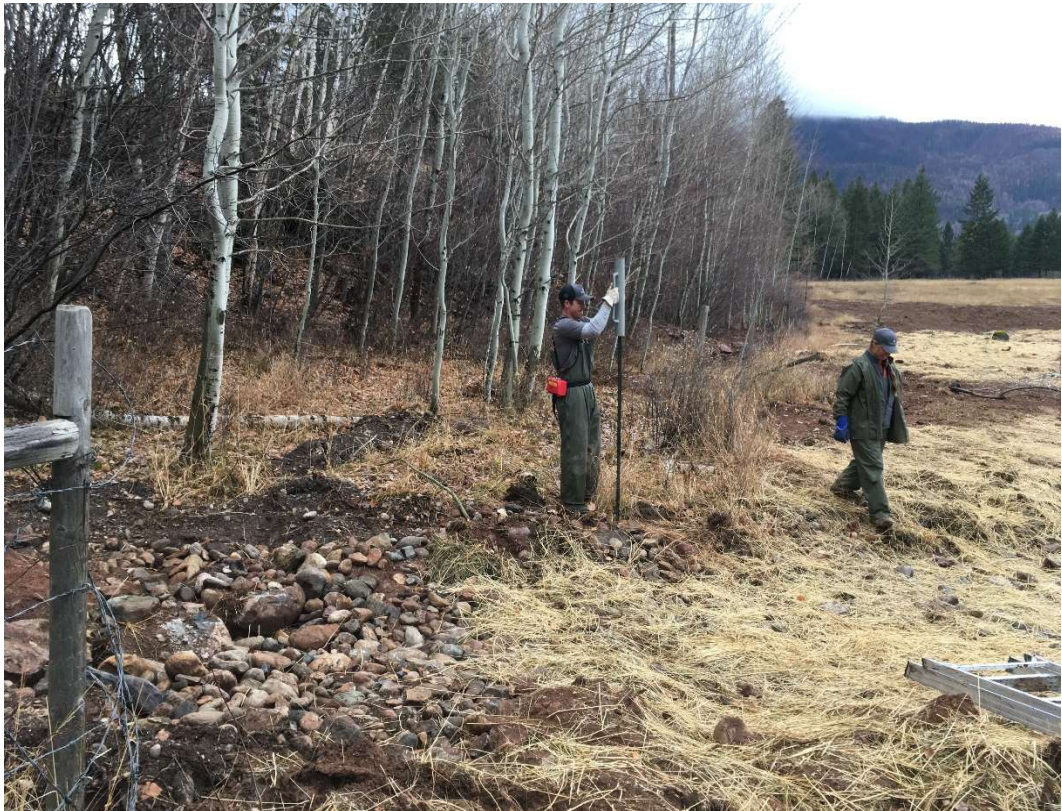
**Photo 35:** Fences were re-built following earthworks to keep livestock out of the site

10. Approximately 75 metres of livestock fencing was removed in the project area, allowing heavy equipment access. It was later replaced.

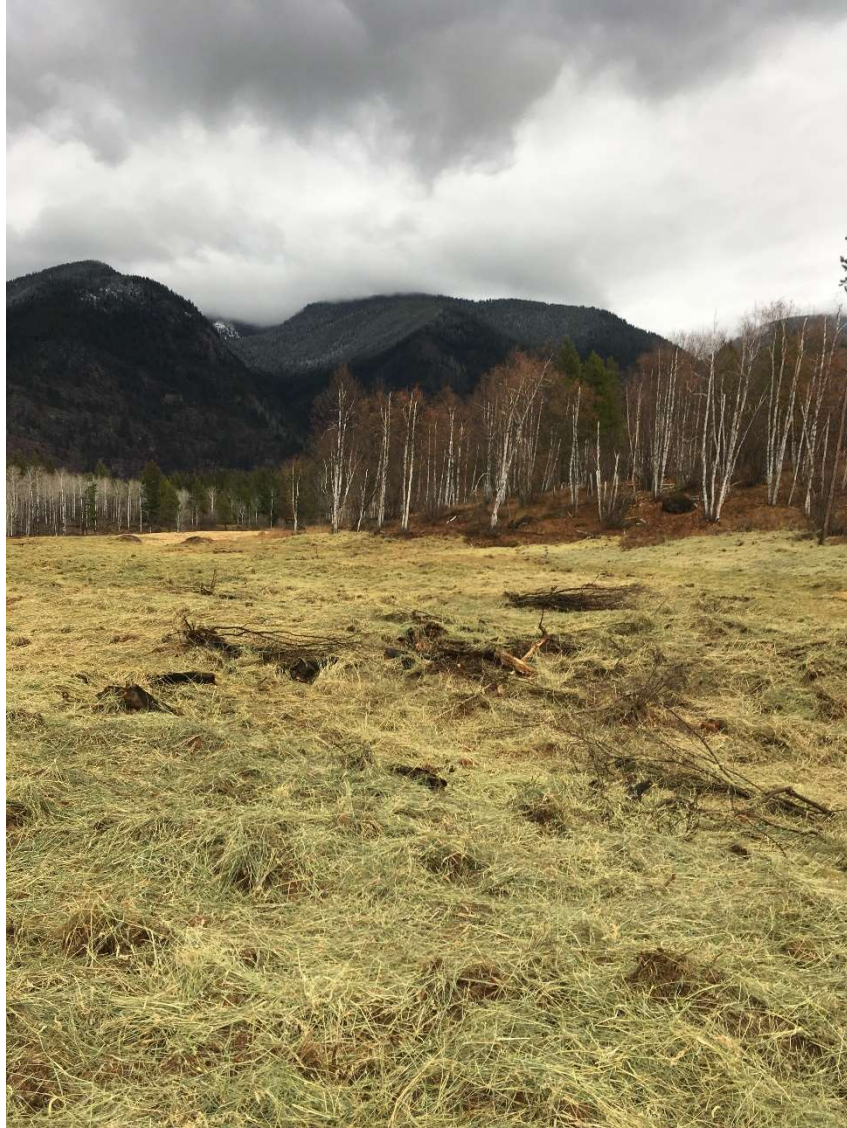
**Photo 36:** All ground disturbance associated with the project was seeded with an organic blend of grasses and forbs and covered by hand with mulch to stimulate growth and reduce the potential for erosion

Following the earthworks, NTBC staff and ranch volunteer's hand-seeded areas of soil disturbance. An organic seed mix of grasses and forbs was used. Next, all areas of soil disturbance were covered with approximately 200 bales of straw and hay mulch. Mulch was laid to reduce the chance of erosion, build a layer of organics into the soil horizon, reduce the threat of invasive plant establishment and retain moisture to assist with seed germination.
