Project Title: Lower Stave River- Restoring and Enhancing Freshwater Tidal Floodplain Habitats

FWCP Project No. COA-F19-2720

March 27, 2019

Prepared by: Natasha Cox and Rachel Drennan Fraser Valley Watersheds Coalition

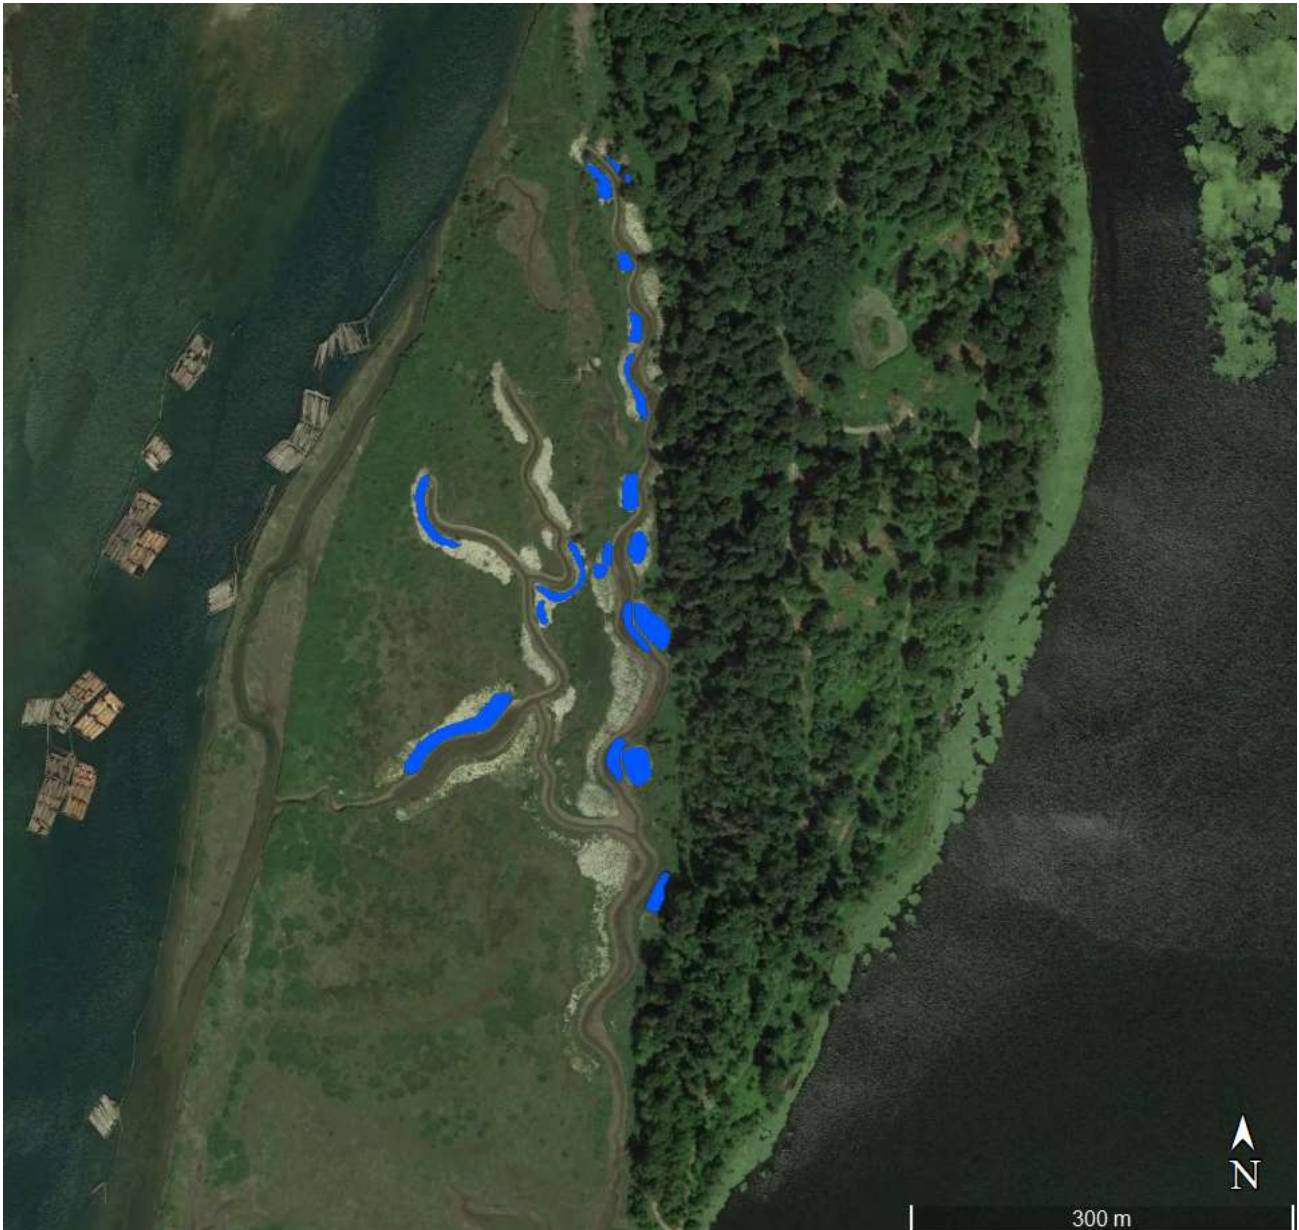
Map 2 Stave Site 2 Planted areas (totalling 4,454m²) from September 1, 2018 to March 31, 2019

Between September 4, 2018 and March 31, 2019 FVWC staff, Kwantlen First Nation field technicians and volunteers planted 11,829 individual plant species over 4,454 m² of aquatic-bench riparian areas on Stave Site 2, Table 1, Map 2. Figure 1. This years planting efforts represents 66% of the total planted areas at Stave Site 2, of which since planted efforts began, has resulted in a total planted area of 6,790 m², Map 3. Of the approximate linear 1,727 m of recently constructed off-channel habitats, of which require an estimated minimum 15m riparian area on both left and right bank (totalling an approximate 51,810 m²) is required. Efforts of replanting focussed on highest elevations areas so that planted stock can withstand the freshet and high-water tides, and were closest to the newly constructed channel.

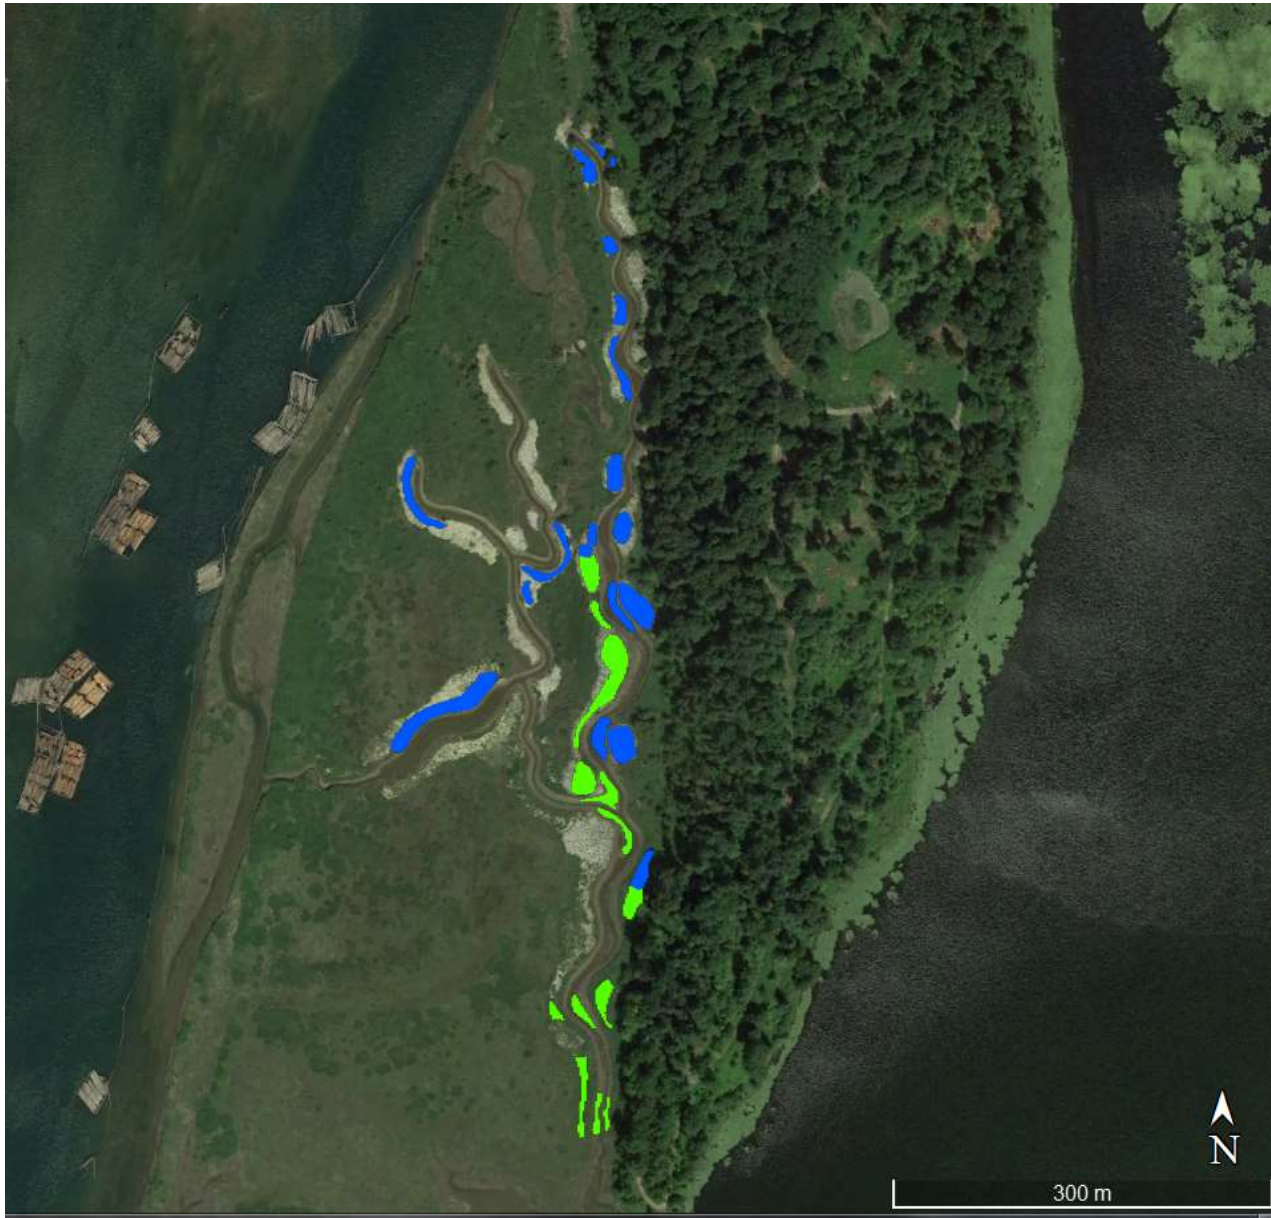
Map 3 Stave Site 2 Cumulative planting areas (totalling 6,790m² and represents 13% of total replanting needed within lower floodplain). Green polygons represent efforts up to April 1, 2018. Blue polygons represent efforts from September 1, 2018 to March 31, 2019.

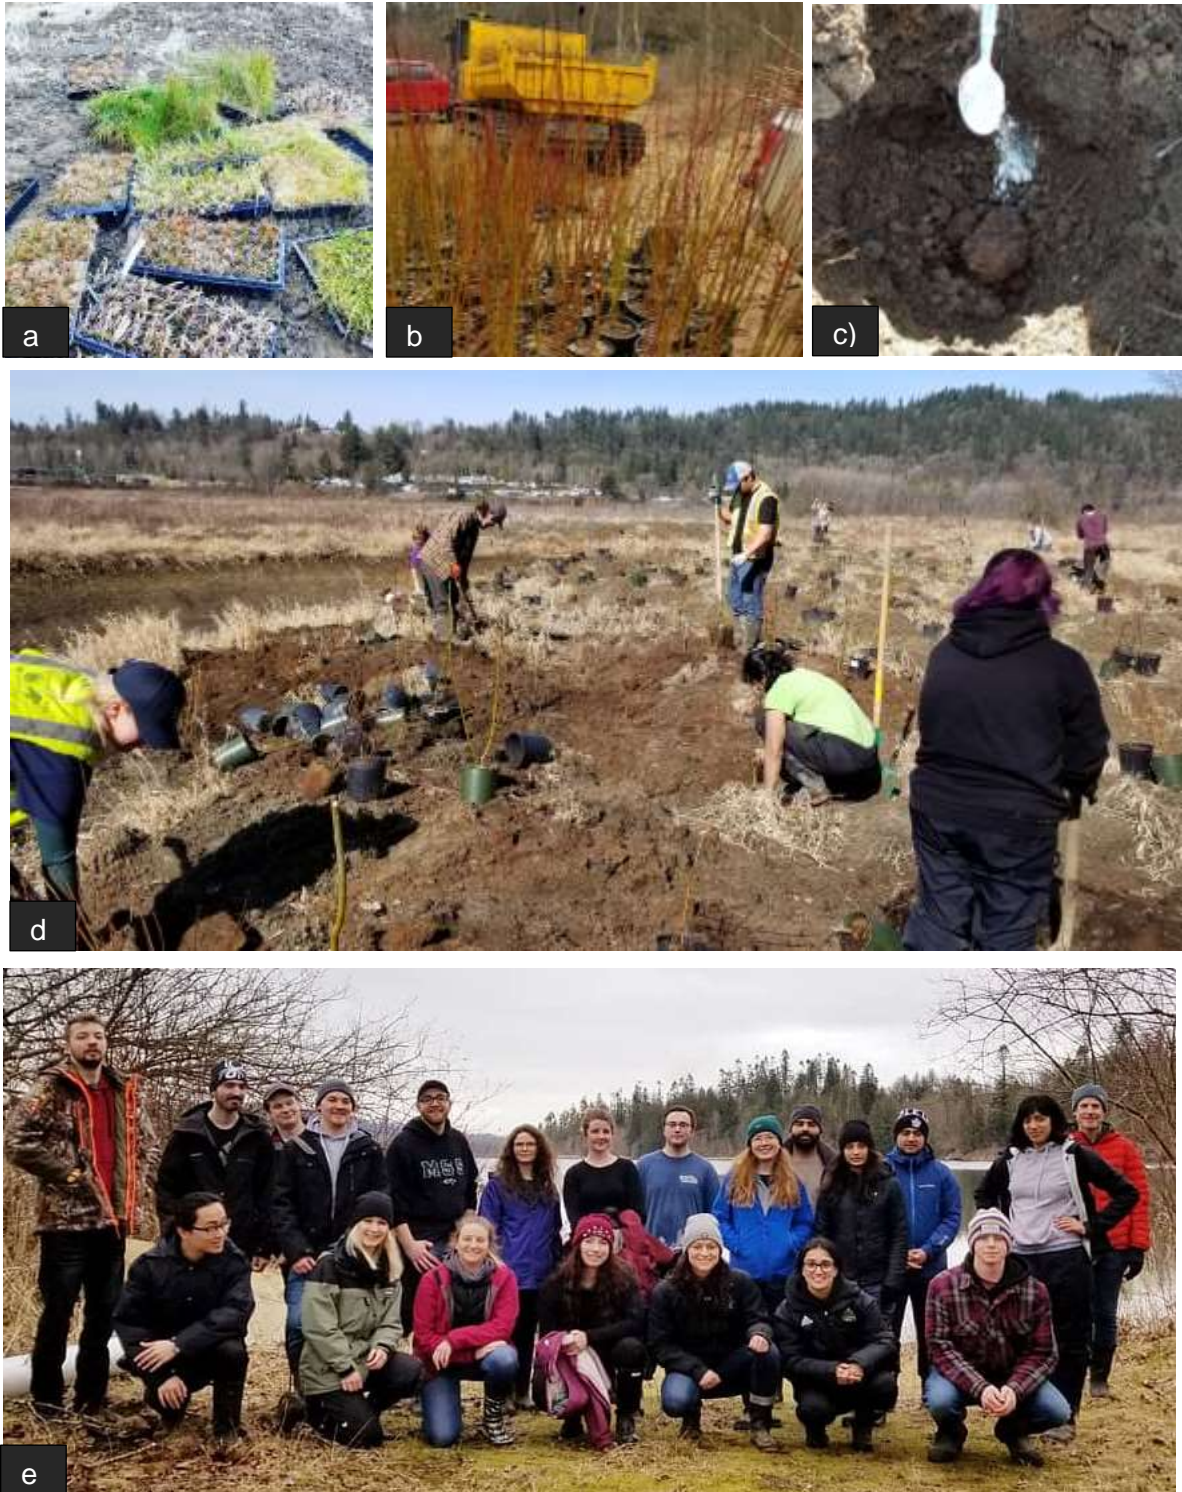
Figure 1. Planting Stave Site 2. a) Sedge mats b) muruca volvo to haul plants and herbivory guards to the floodplain c) adding mycorrhizal fungi to the soil d) volunteer planting event e) University of Fraser Valley - geography volunteer planting event

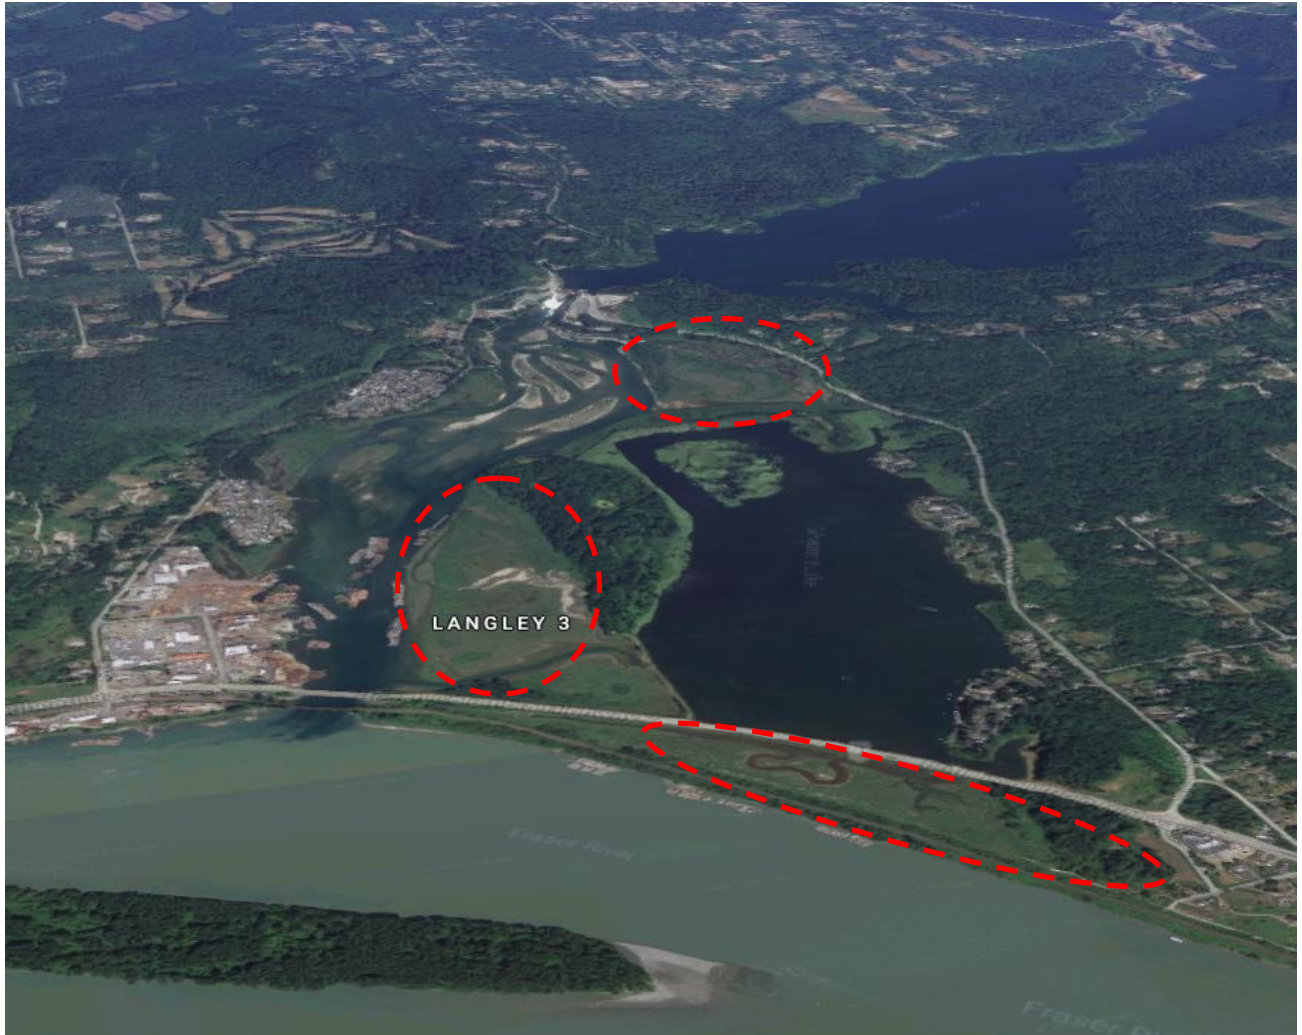
Figure 1: Overview of restoration and survey areas

As part of a larger biodiversity and restoration study on the Lower Stave River, a visual ground survey was undertaken in the Lower Stave watershed in 2017, 2018 and 2019 to detect the presence of overwintering or staging Sandhill Cranes. This site is part of a restoration project being undertaken by the Fraser Valley Watershed Coalition (Figure 1) and other partners to improve the lower portion of the river to create new spawning and rearing habitat for both anadromous salmon and other resident fish species (pers. comm. N. Cox; see Figure 2).

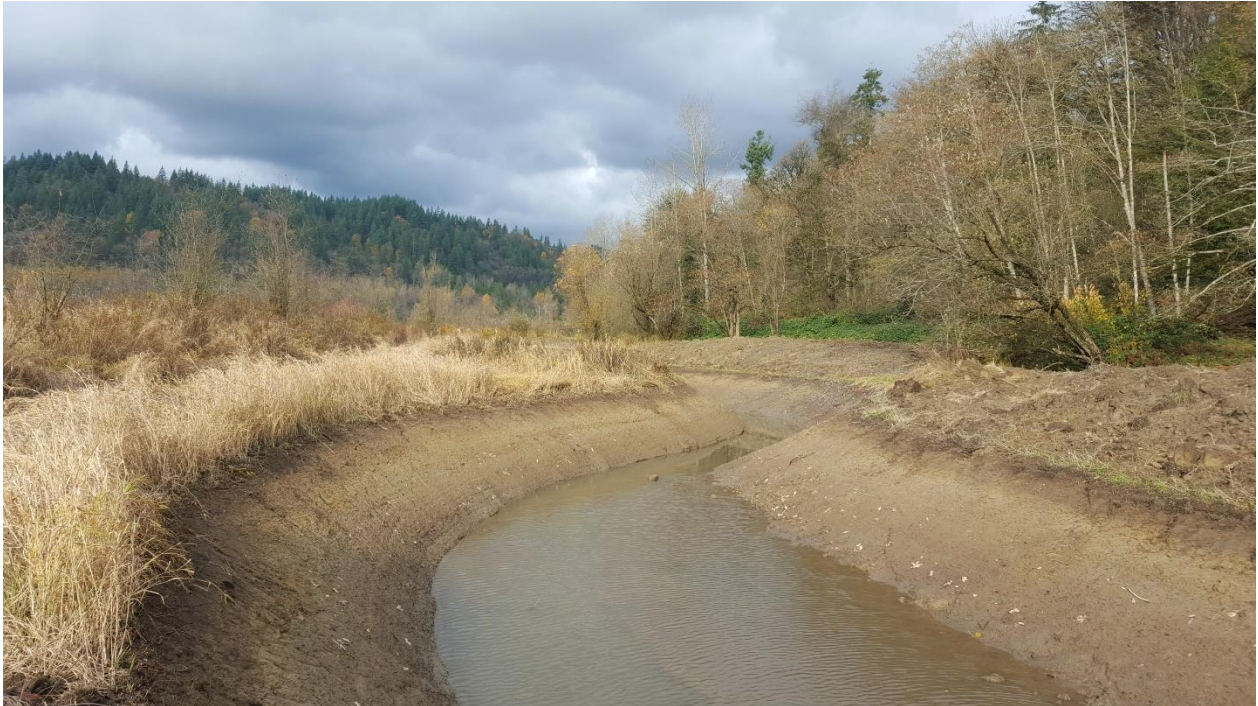
Figure 2: Photograph of part of the restoration project to provide additional salmon rearing habitat (which by association was also observed to provide excellent foraging opportunities for snipe, dabbling ducks and herons)

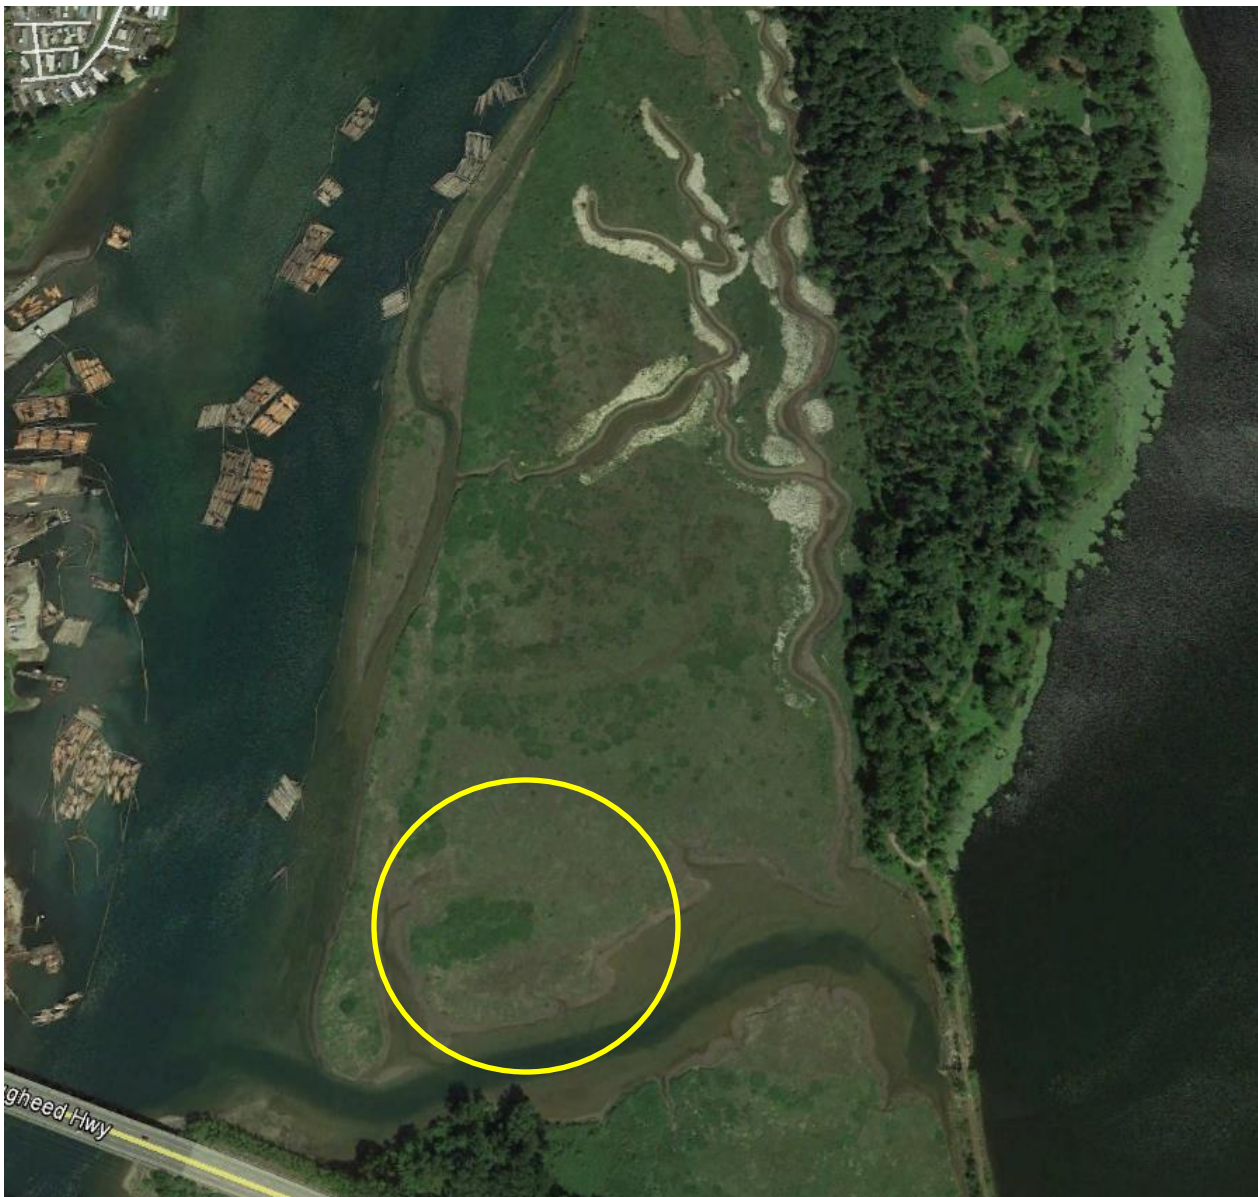
Figure 5: Potential location for the creation of small, nesting islands for Sandhill Cranes and the creation of a potential site for the growth and harvesting of wapato

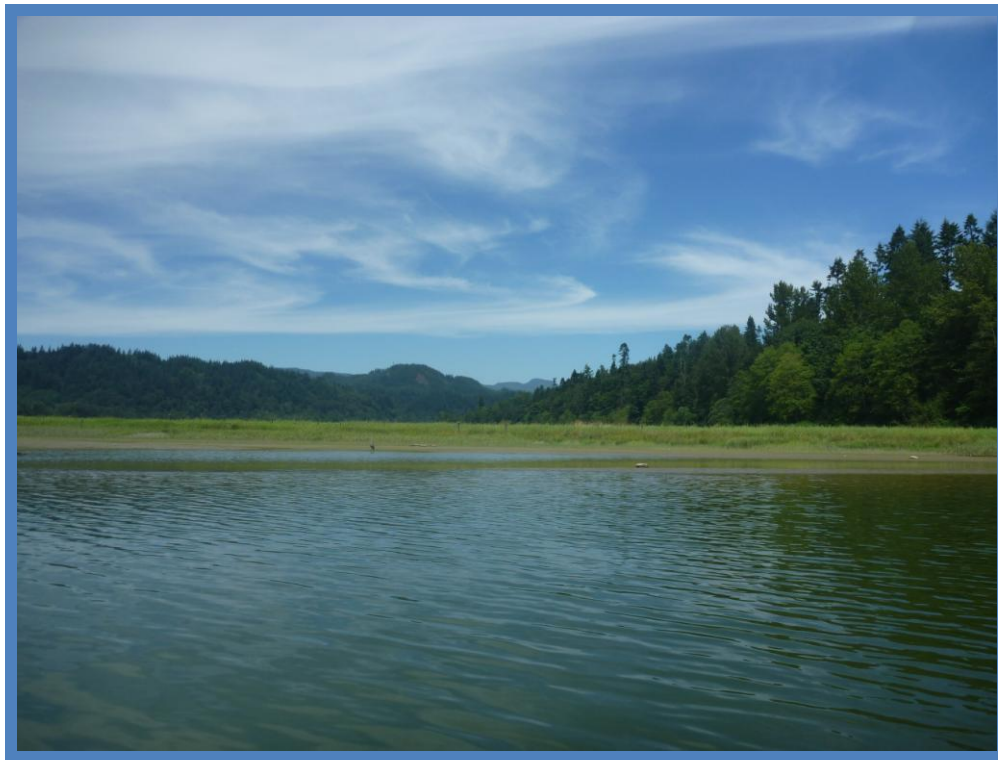
View from south of Stave Site 2 (looking north)– August 2015. Photo by Aimee Mitchell.

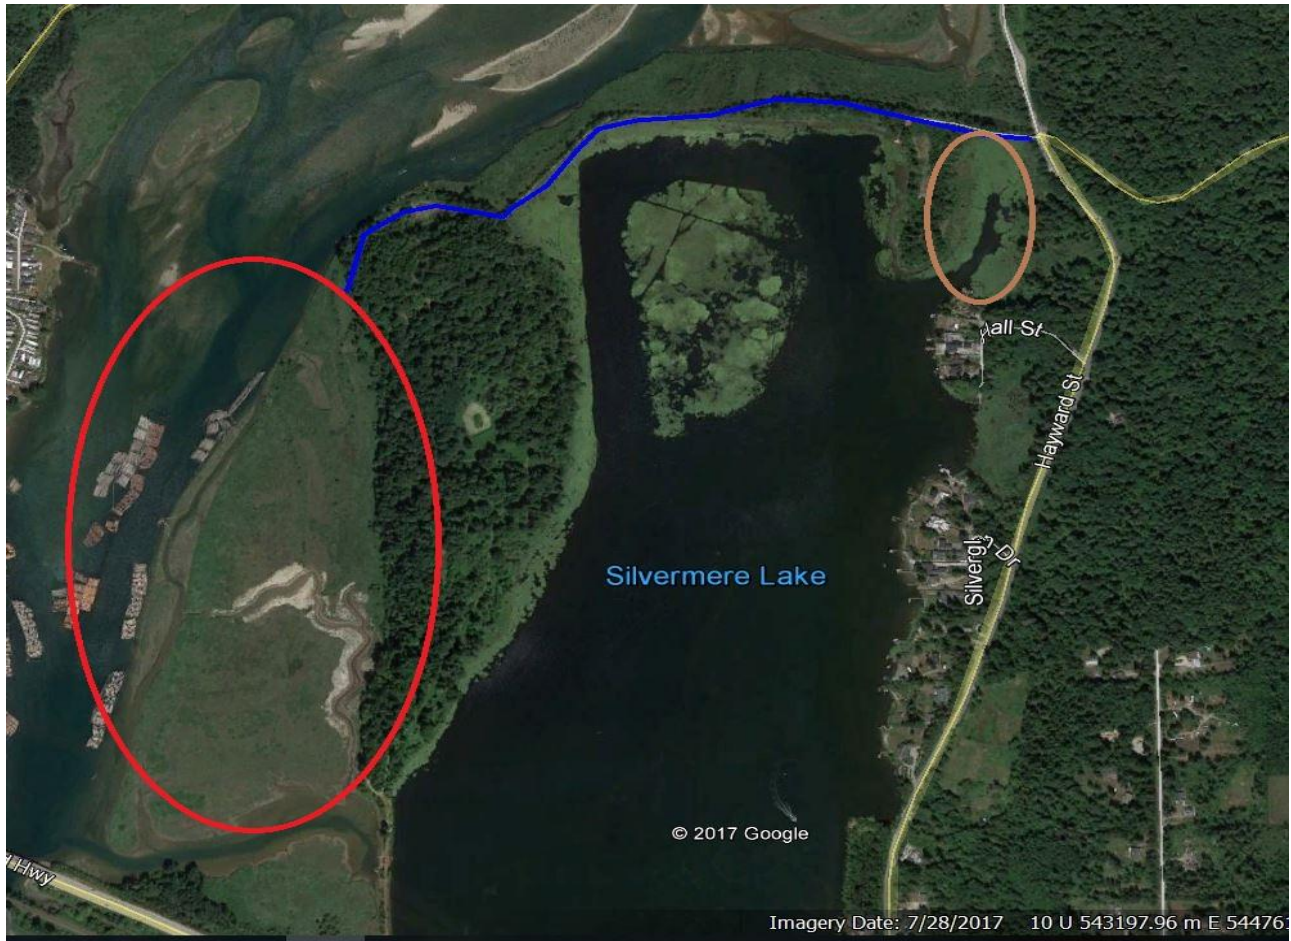
Figure 1. Stave Site 2 (red circle), path of machinery (blue line) in September 2017 and turtle basking habitat enhancement area of Silvermere Lake (brown circle) that was enhanced in August 2016.

Introduction: Members of the Coastal Painted Turtle Project (CPTP) visited and monitored sites of historic nesting observations in the path of the Stave Site 2 restoration works in May through July 2018 (Fig. 1).

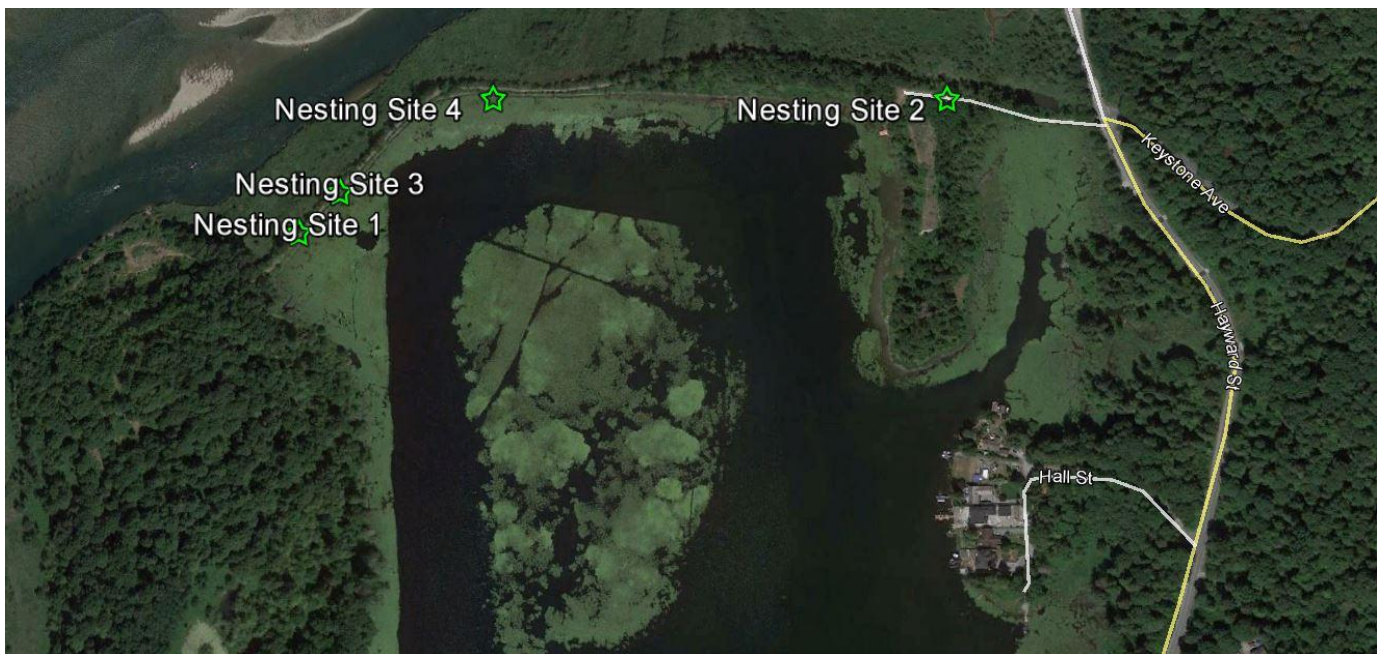
Figure 2b. Western Painted Turtle nesting activity observations in 2017.

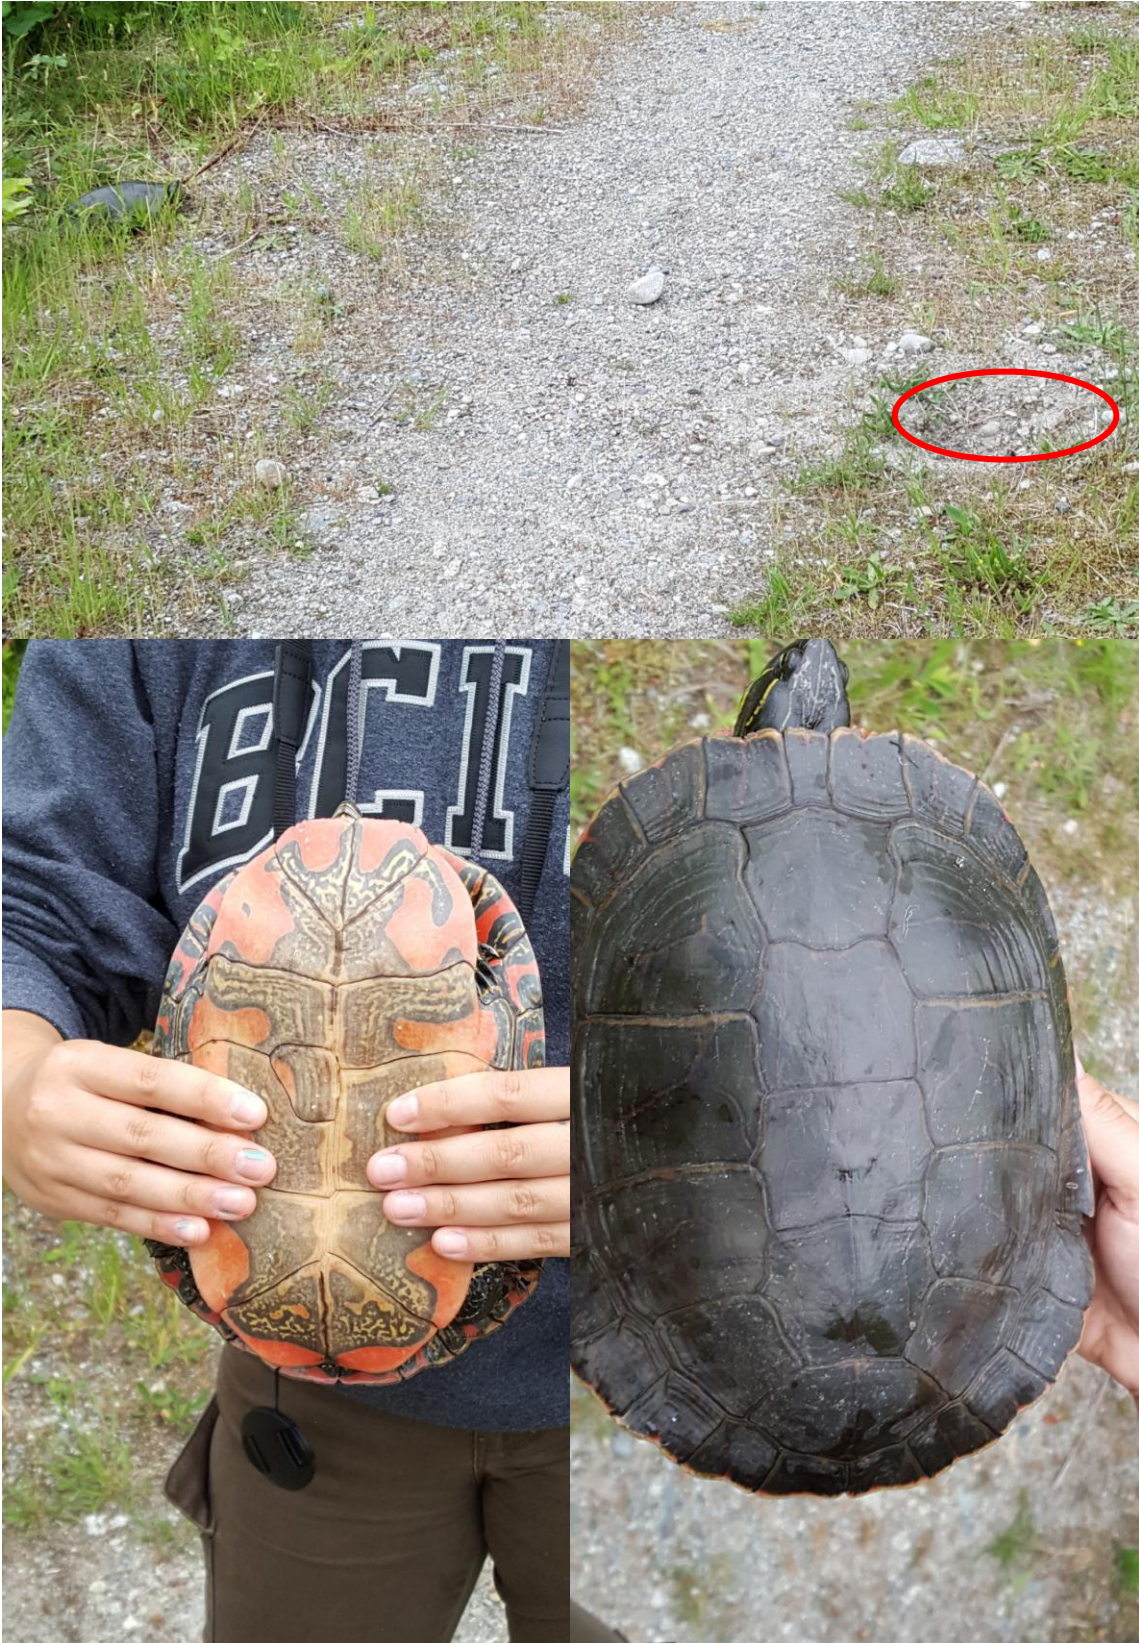
Figure 3. Female Western Painted Turtle on land at Nesting Site 1 on June 7th, 2017. One test pit highlighted with red circle in right of first photo. Photos by Aimee Mitchell.

Summer Nesting Activity Monitoring: During the turtle nesting season (May to July) this area was visited four times by CPTP member, Aimee Mitchell. Areas surveyed were based on past observations of signs of nesting (Fig. 2a). During one session on June 7th, 2017, while out with Fraser Valley Conservancy interns, one unmarked female turtle was captured on land near a minimum of four test pits (Nesting Site 1) (Fig. 3.). No nests were confirmed to have been laid at this time, however, due to the observation of test pits and a female turtle on land at this location it is highly likely that nests were/are present.

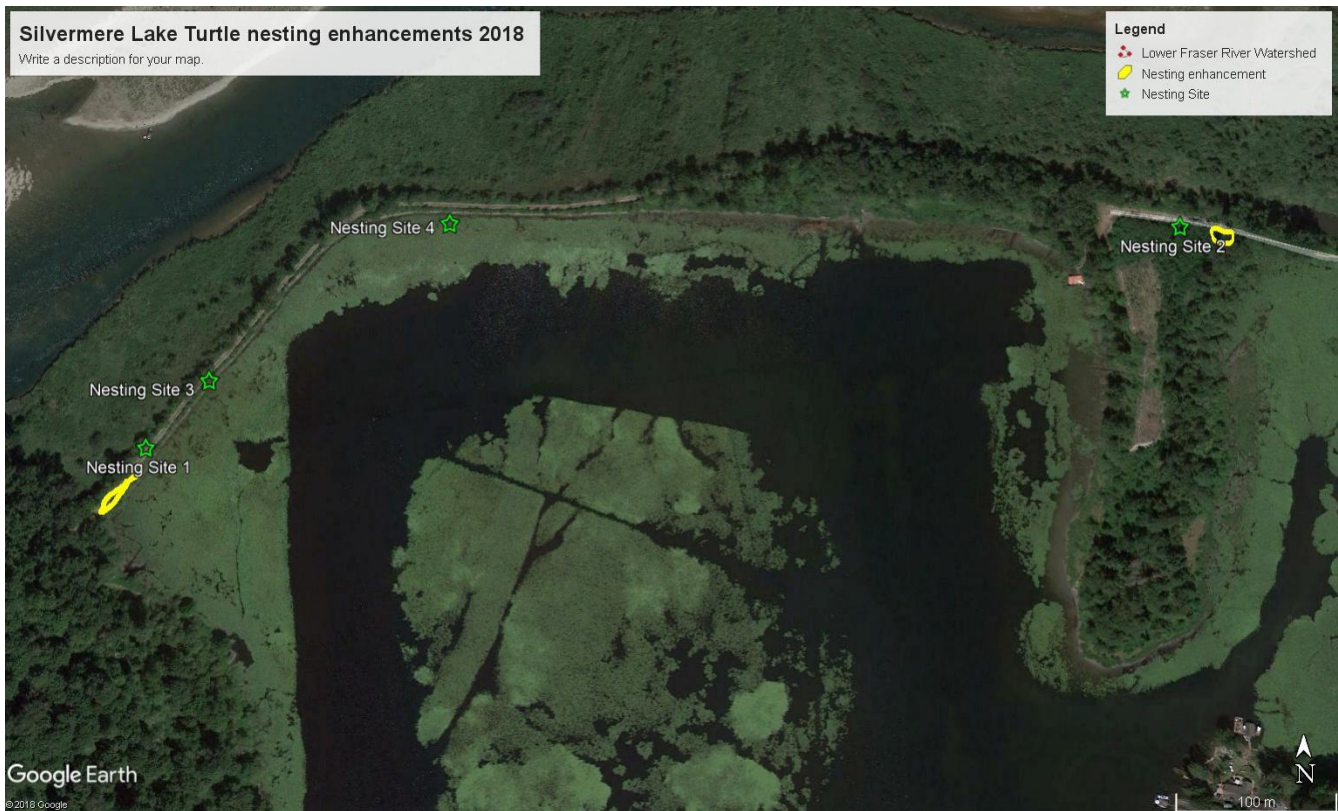
Figure 4. Sites of observed turtle nesting activity (Nesting Sites 1-4) and nesting enhancement locations planned for late September 2018.

At enhancement site 1 (near nesting site 1) an excavator will be used to remove the top layer of plants and substrate to expose the sandy edge of the lake. This area is already quite sandy, but is overwhelmed with plants so no additional substrate is needed at this location. At enhancement site 2 (near nesting site 2) the excavator will dig shallowly to remove the top substrate before installing the new sand.

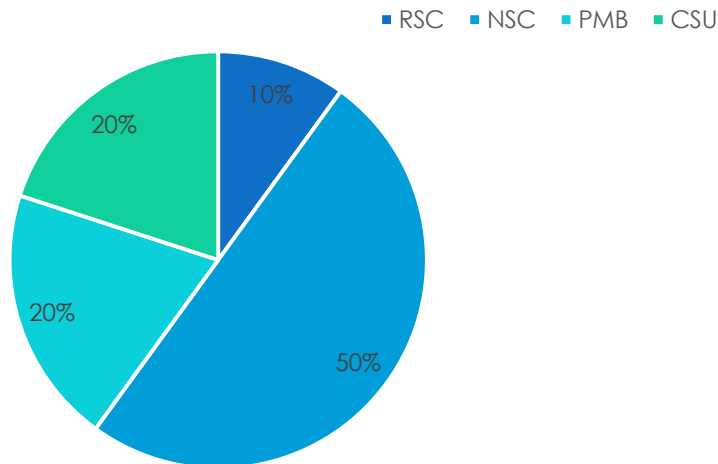
Figure 1. Fish Monitoring by Species Caught at Stave Site 2 across all monitoring stations (Dec 2018- Mar 2019). No salmonids caught at Stave site #2.

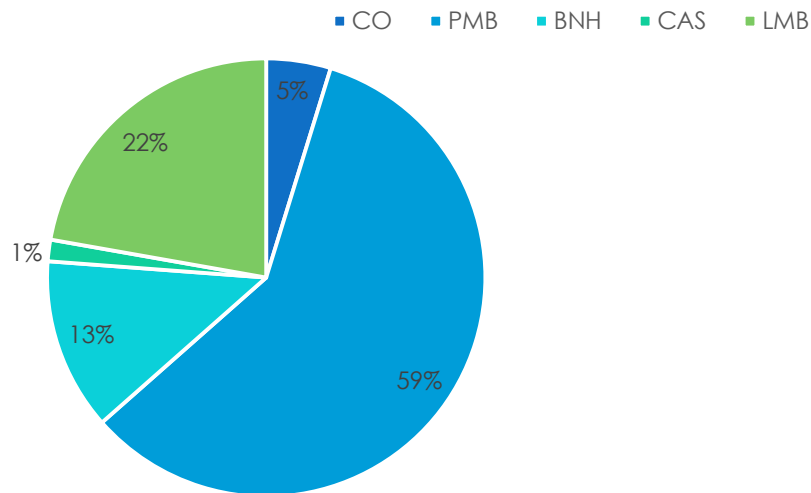
Figure 3. Fish Monitoring by Species Caught at Stave Site 3 across all monitoring stations (Sept 2018- March 2019). Juvenile Coho Salmon accounted for five percent of fish caught at site #3.

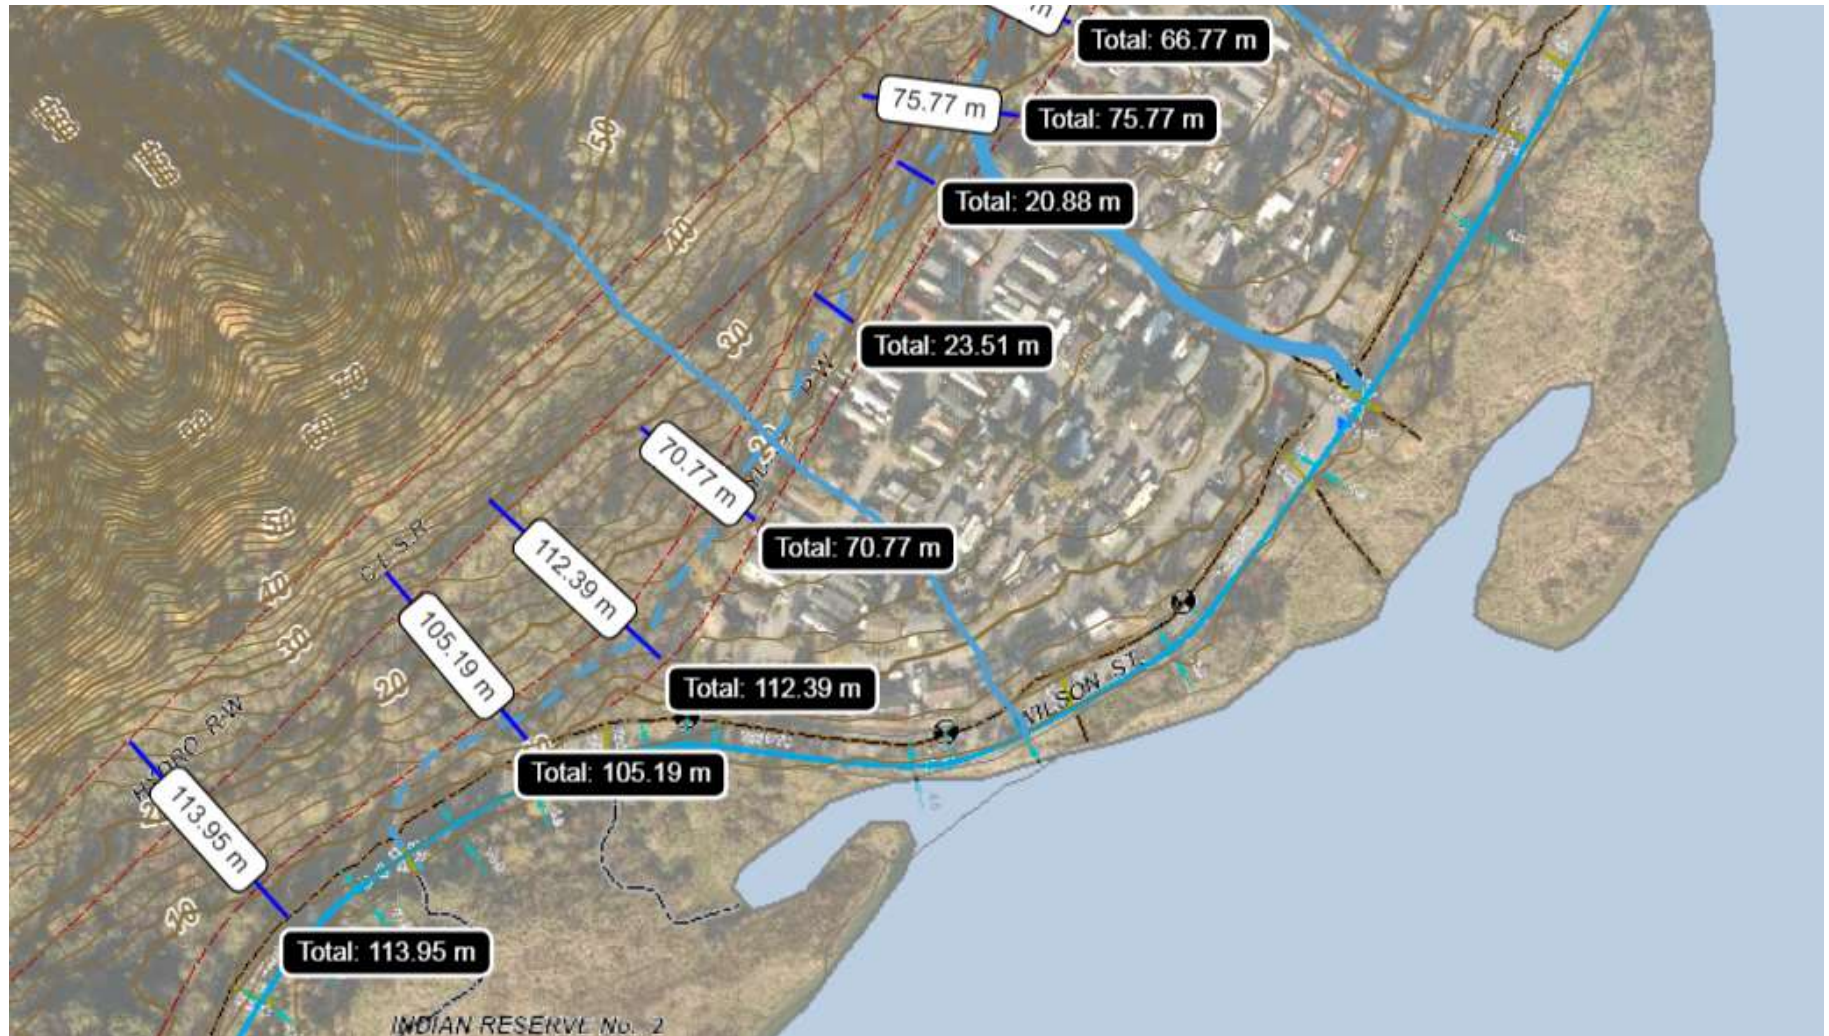
Ranges from roughly 66 m to 113 m wide Right of Way that follows the toe of slope, captures the mountain streams and may provide opportunity for capturing seepages, surface water, and groundwater for the creation of additional off-channel habitat, and tie in to existing infrastructure.

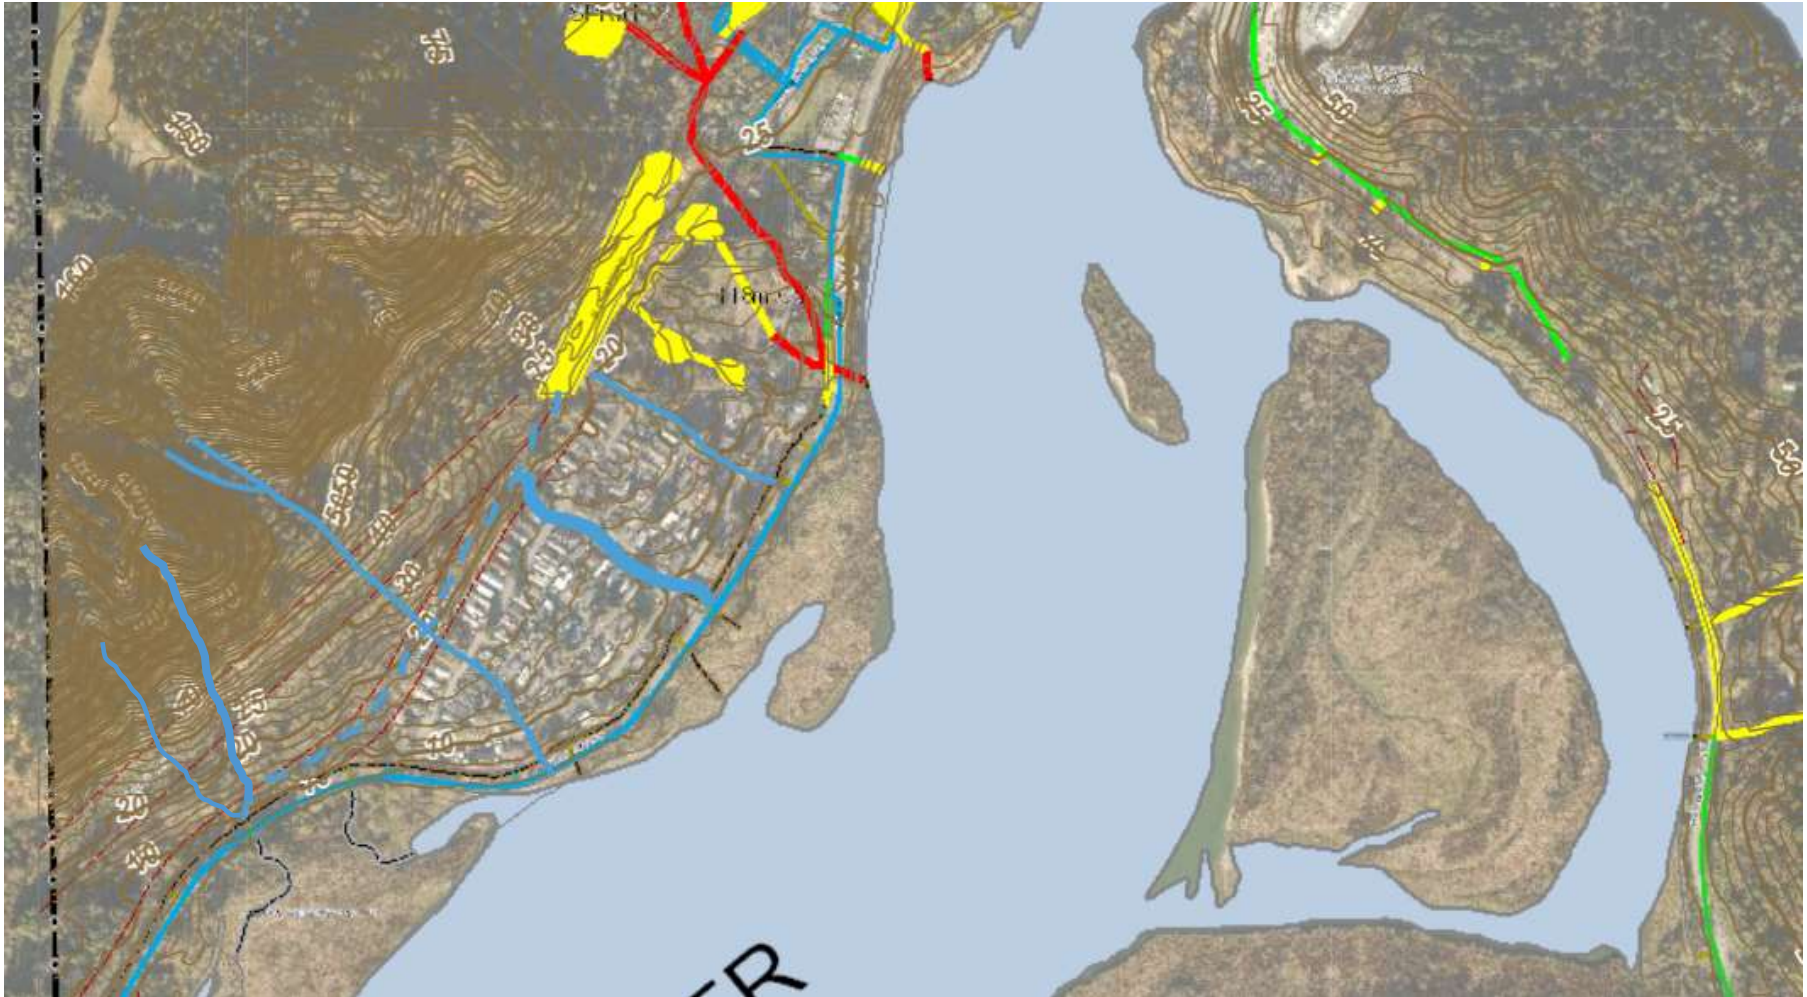
Inferences for stream locations using image interpretation and elevation contour lines. Dashed blue lines represents potential opportunity to construct habitat within toe of slope to collect surface, groundwater and tie into existing waterways and infrastructure and expand off-channel habitats in the Lower Stave.

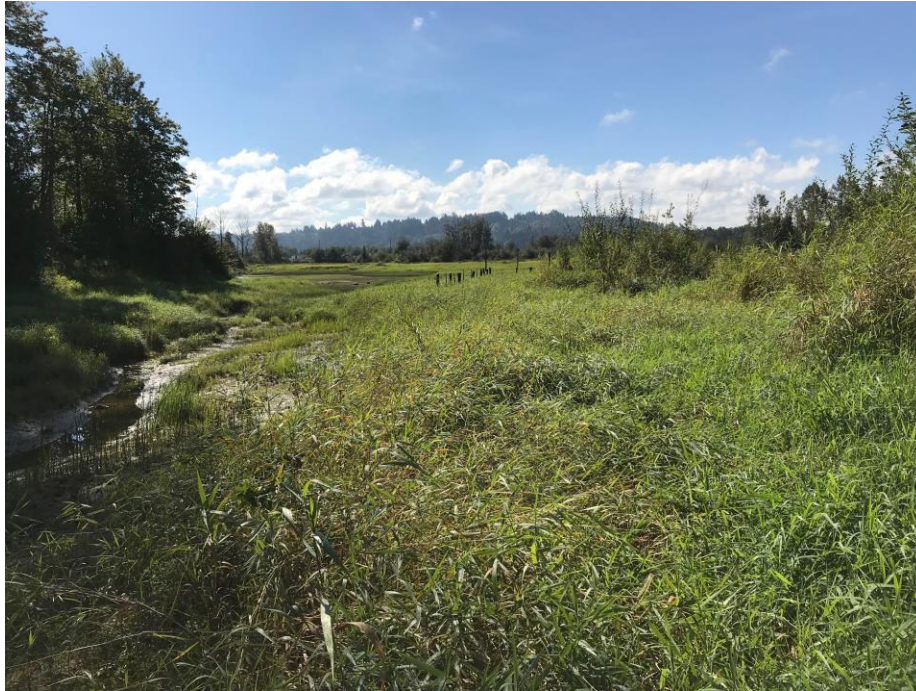
Figure 1. Plantings of trees and shrubs are visible on the right side of the photo. A relatively large area between the plantings and the channel allows reed canarygrass to invade.

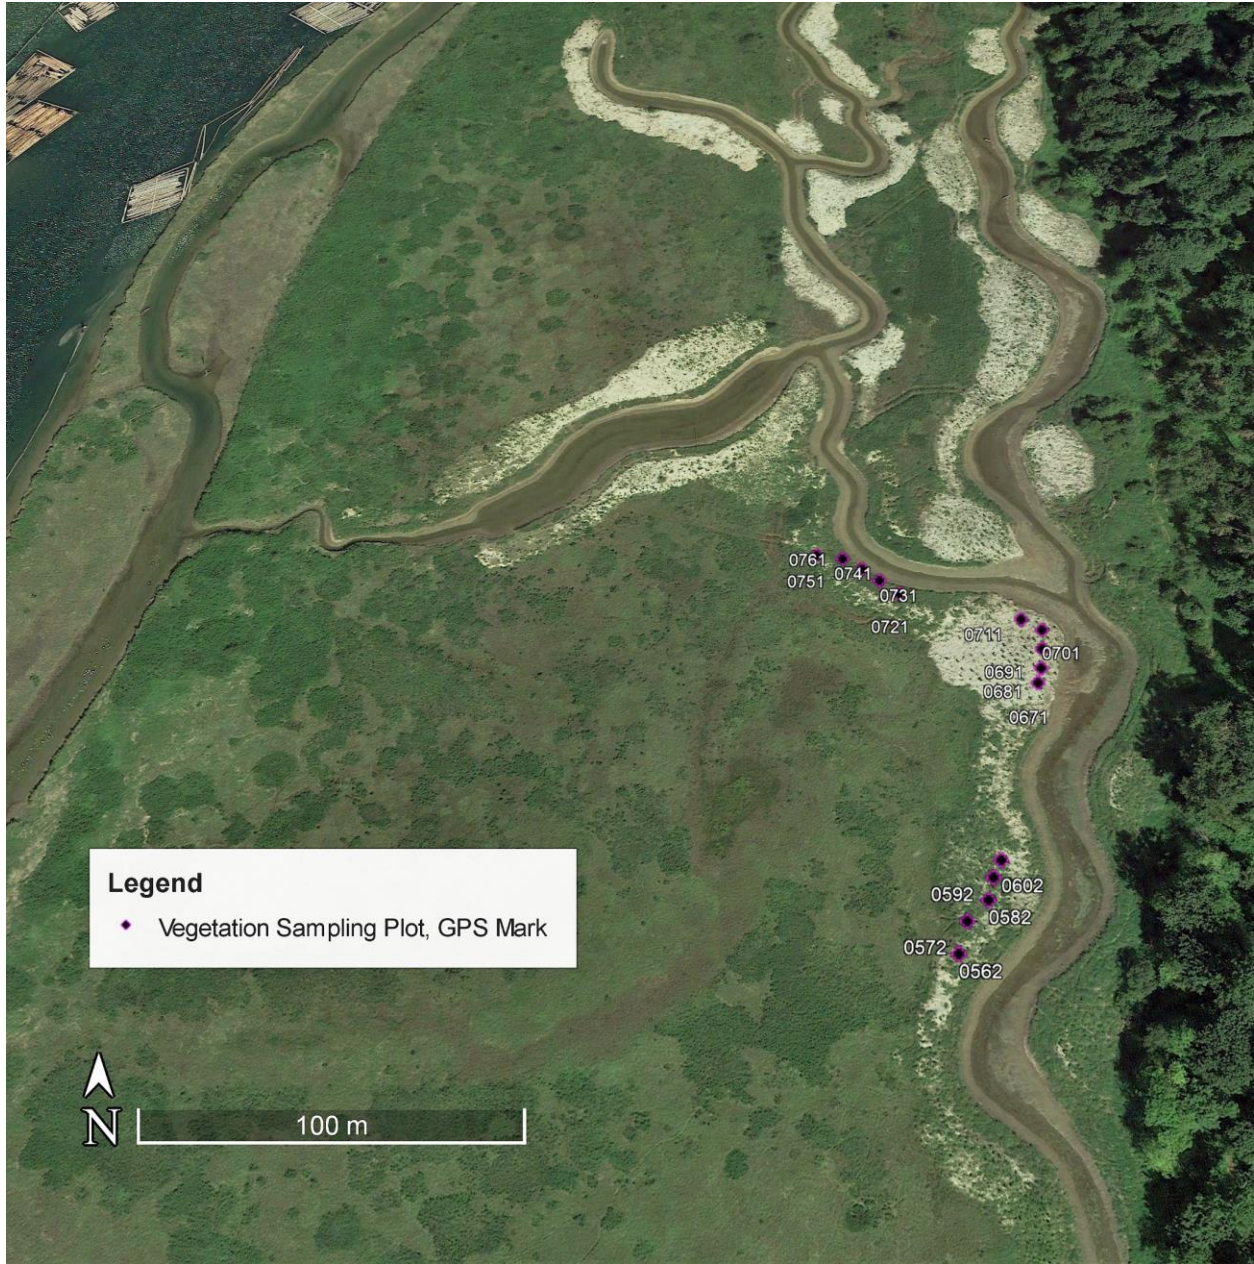
Appendix 1. Map of the vegetation assessment plots sampled in September 2018 at Stave River Site 2.
