Project Title: Lower Stave River- Restoring and Enhancing Freshwater Tidal Floodplain Habitats

FWCP Project No. COA-F19-2720

March 27, 2019

Prepared by: Natasha Cox and Rachel Drennan Fraser Valley Watersheds Coalition

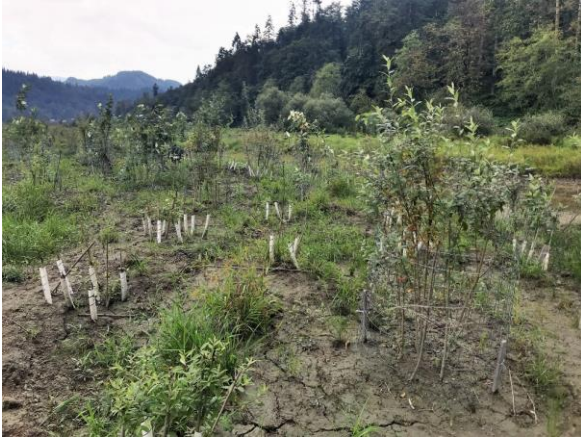
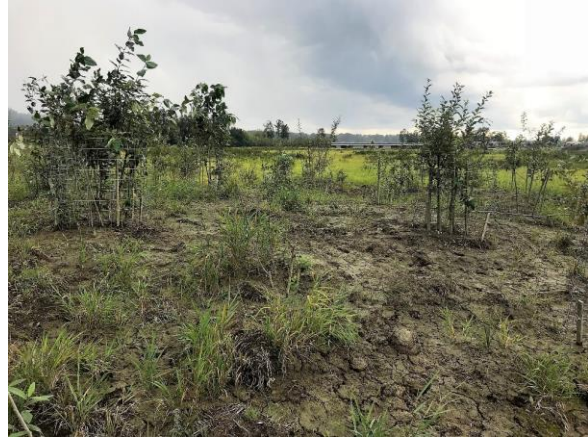
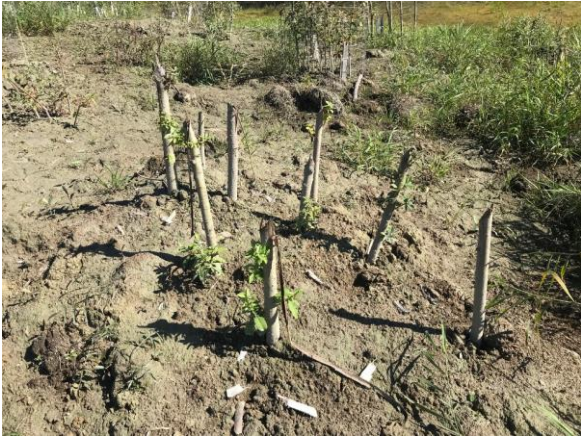
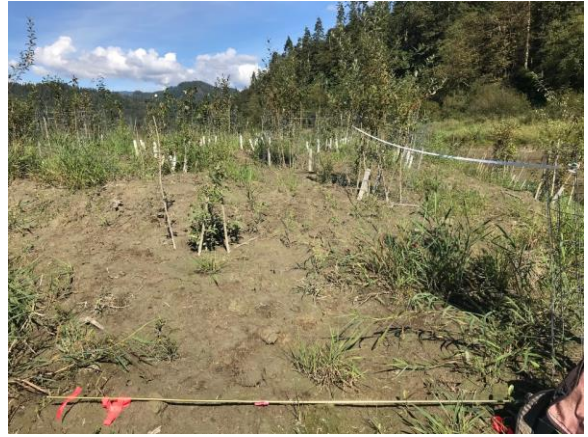
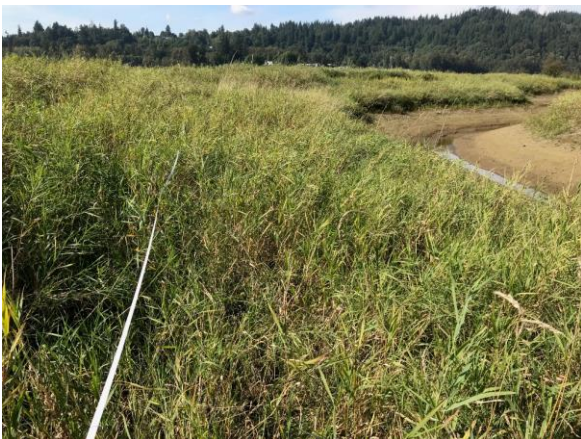
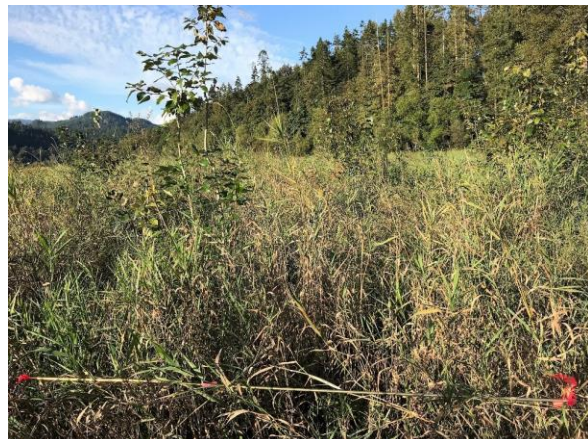
Photographs from the study area: a) and b) examples of a planted site adjacent to a channel; c) a willow whip planting without much growth but likely to be more successful next year as roots become better established; d) example of a planted area where denser planting is advised to reduce the chance that reed canarygrass will invade; e) randomized transect through unplanted area, post-construction disturbance; f) example of a plot in a planted area (note the abundance of reed canarygrass despite it being an enhanced site).

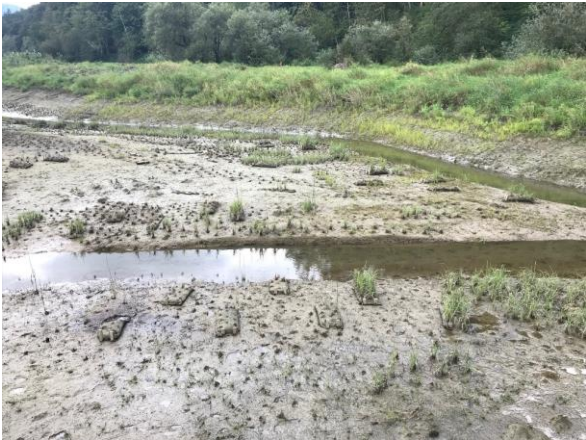
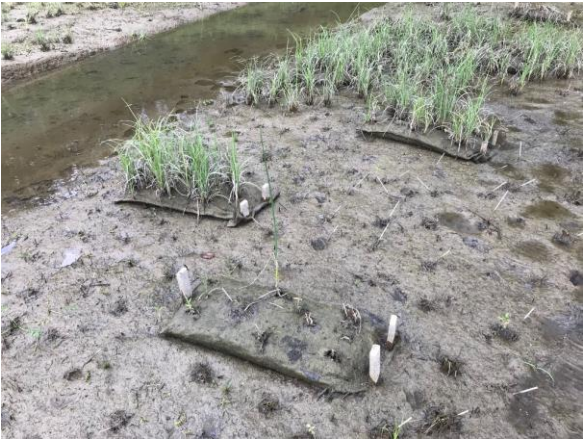
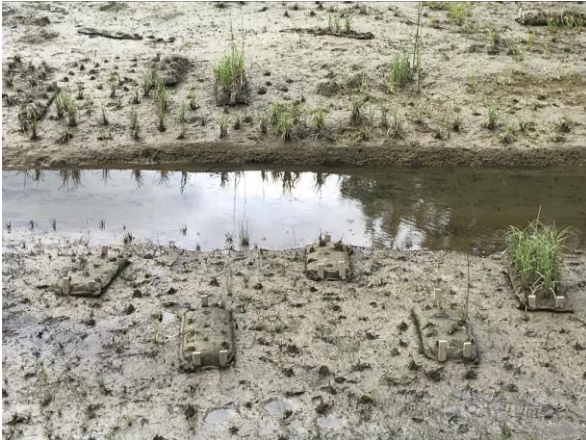
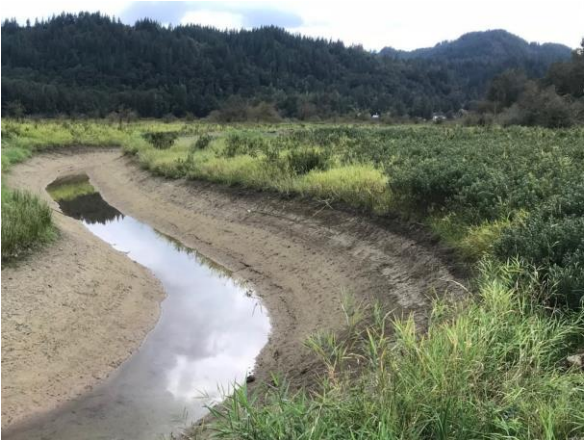
Photographs from the study area (continued): g) overview of plantings in a channel bottom; h) and i) emergent plant species mats and plugs with variable survival rates after the first season; and j) an excavated channel where existing hardhack shrubby vegetation (dark green, right side of photo) was left undisturbed and intact.
