**IDENTIFYING FOREST ROADWAYS FOR  
REHABILITATION WITHIN THE CHASE CARIBOU HERD  
RANGE BOUNDARY  
PEA-F19-W-2650**

PREPARED FOR: FISH AND WILDLIFE COMPENSATION PROGRAM  
PREPARED BY: CHU CHO ENVIRONMENTAL LLP  
STUDY PERIOD: MARCH 2018 – FEBRUARY 2019

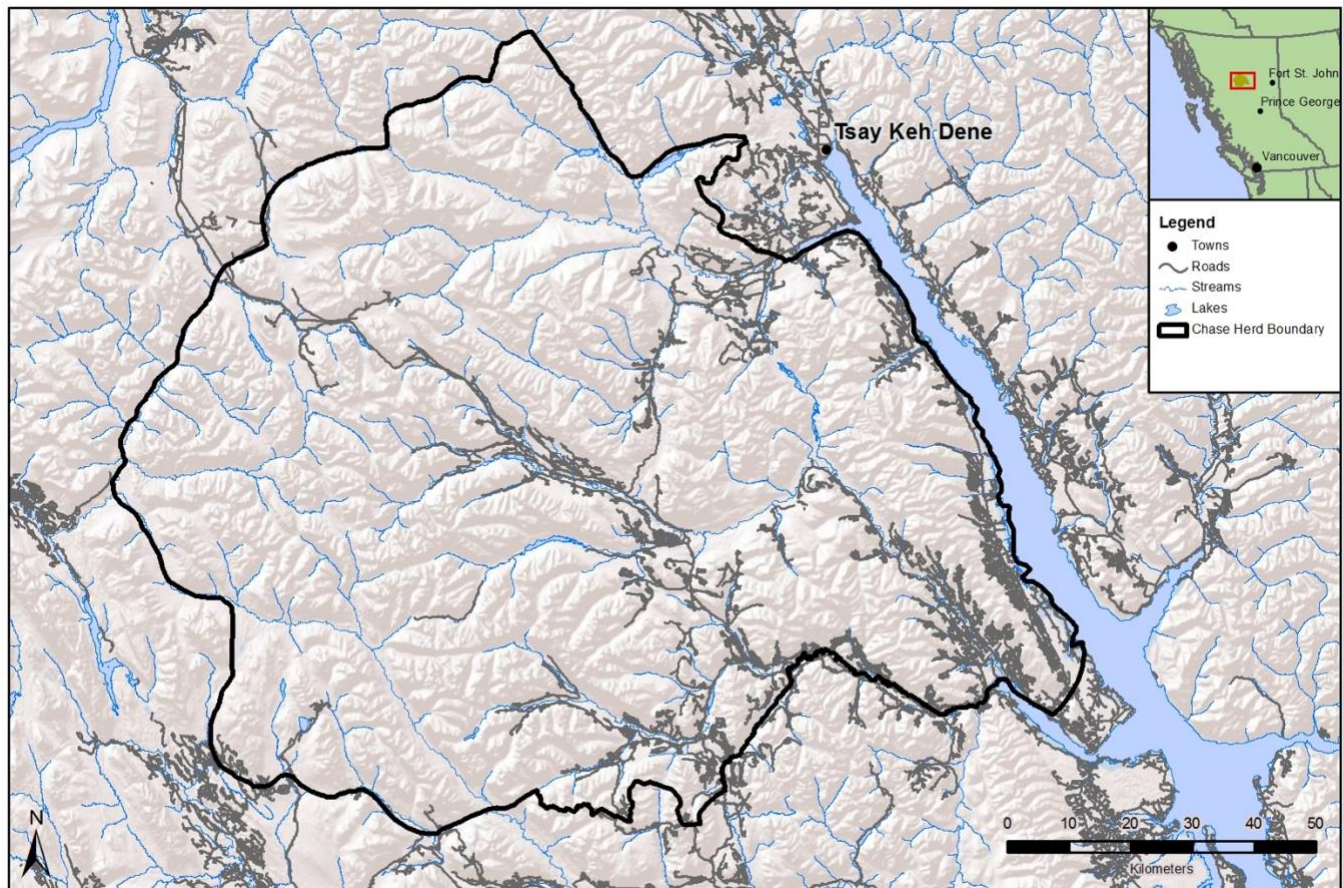
**Figure 1.** Chase caribou herd boundary (black) and roads (gray) located west of Tsay Keh Dene, and the Williston Reservoir.

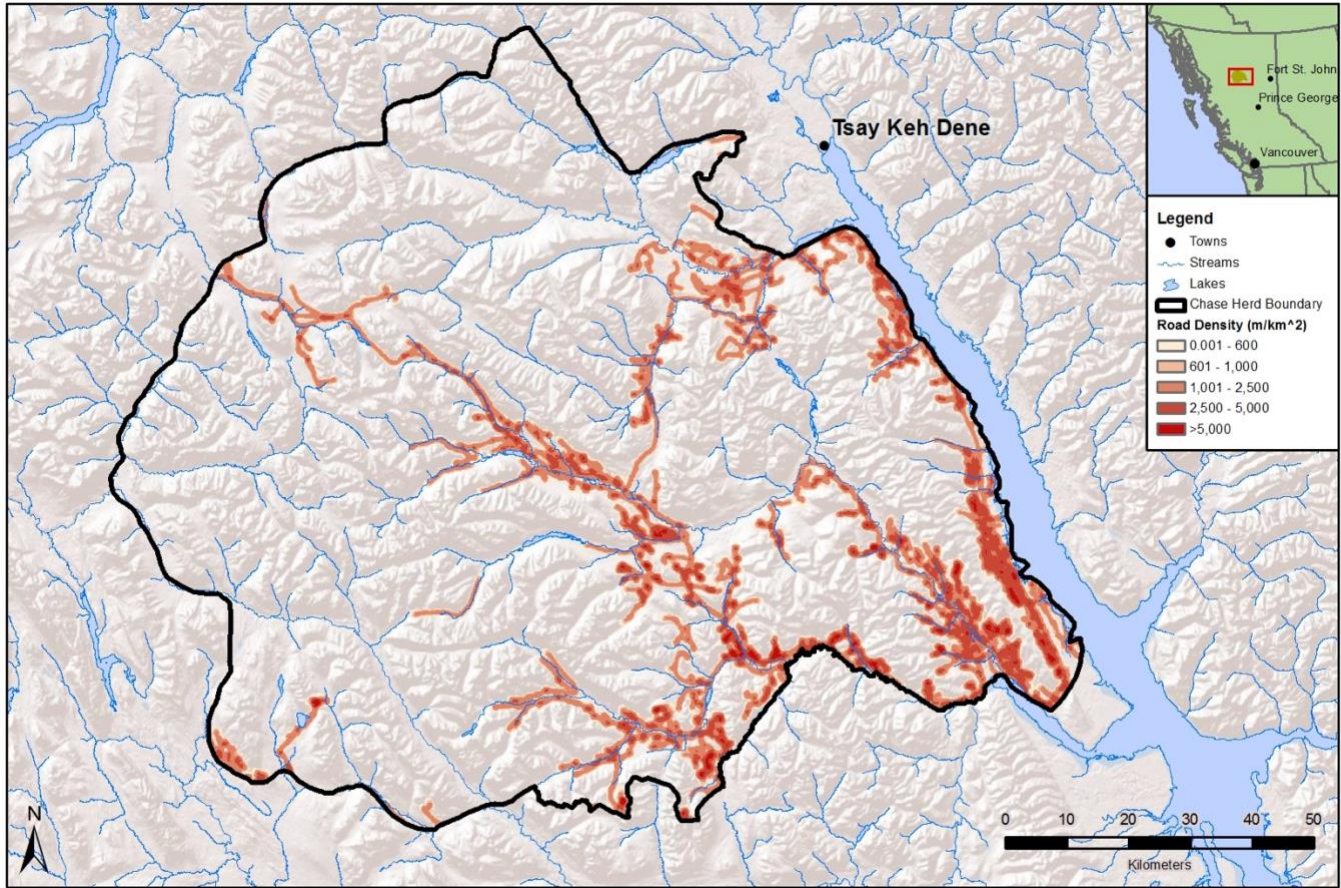
**Figure 3.** Road density within the Chase caribou herd using a moving window analysis. The threshold of .6 km/km<sup>2</sup> is considered detrimental to caribou.

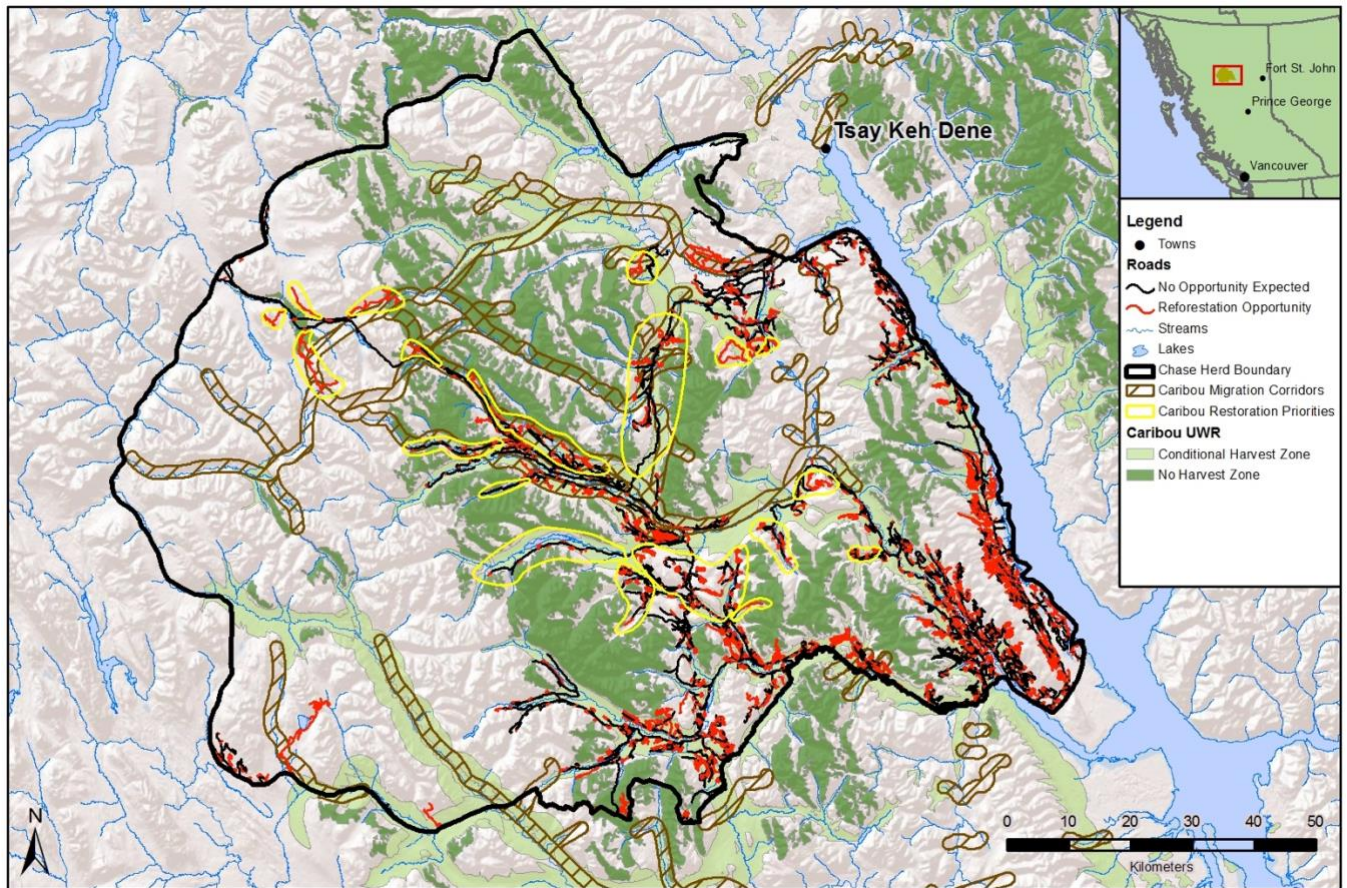
**Figure 4.** Final recommendations for road restoration priorities based on considerations for caribou are highlighted in yellow circles. Roads shown in red were identified by licensees as roads available for reforestation.

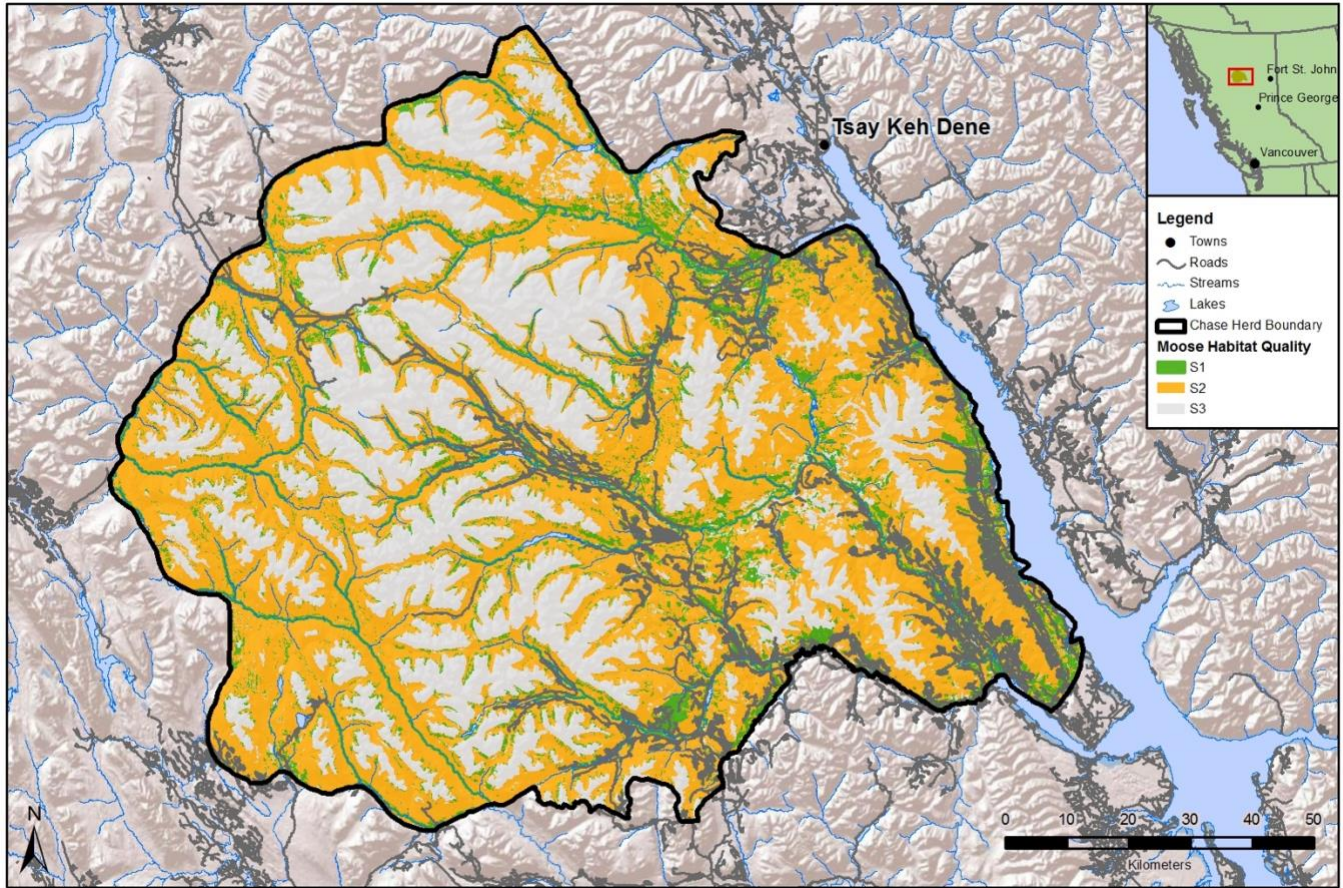
**Figure 5.** Modeled moose habitat quality within the Chase herd. S1 = high quality (green); S2 = moderate quality (yellow); S3 = no value (grey). All roads are shown in dark grey.

Not surprising, moose habitat is ubiquitous throughout low elevations within the Chase caribou herd range boundary (Figure 5), with S1 (high quality habitat) representing 202,017 ha and S2 (moderate quality habitat) representing 628,160 ha. Being cognizant of the potential overlap with caribou and moose, and to reduce this conflict when possible, when roads are selected for restoration and enhancement, this mapping will be used to inform the restoration techniques applied. For example, if the road is directly adjacent to or connects moose and caribou habitat, reforestation techniques may try to incorporate species that are unpalatable to moose in an attempt to limit or reduce that potential for conflict.

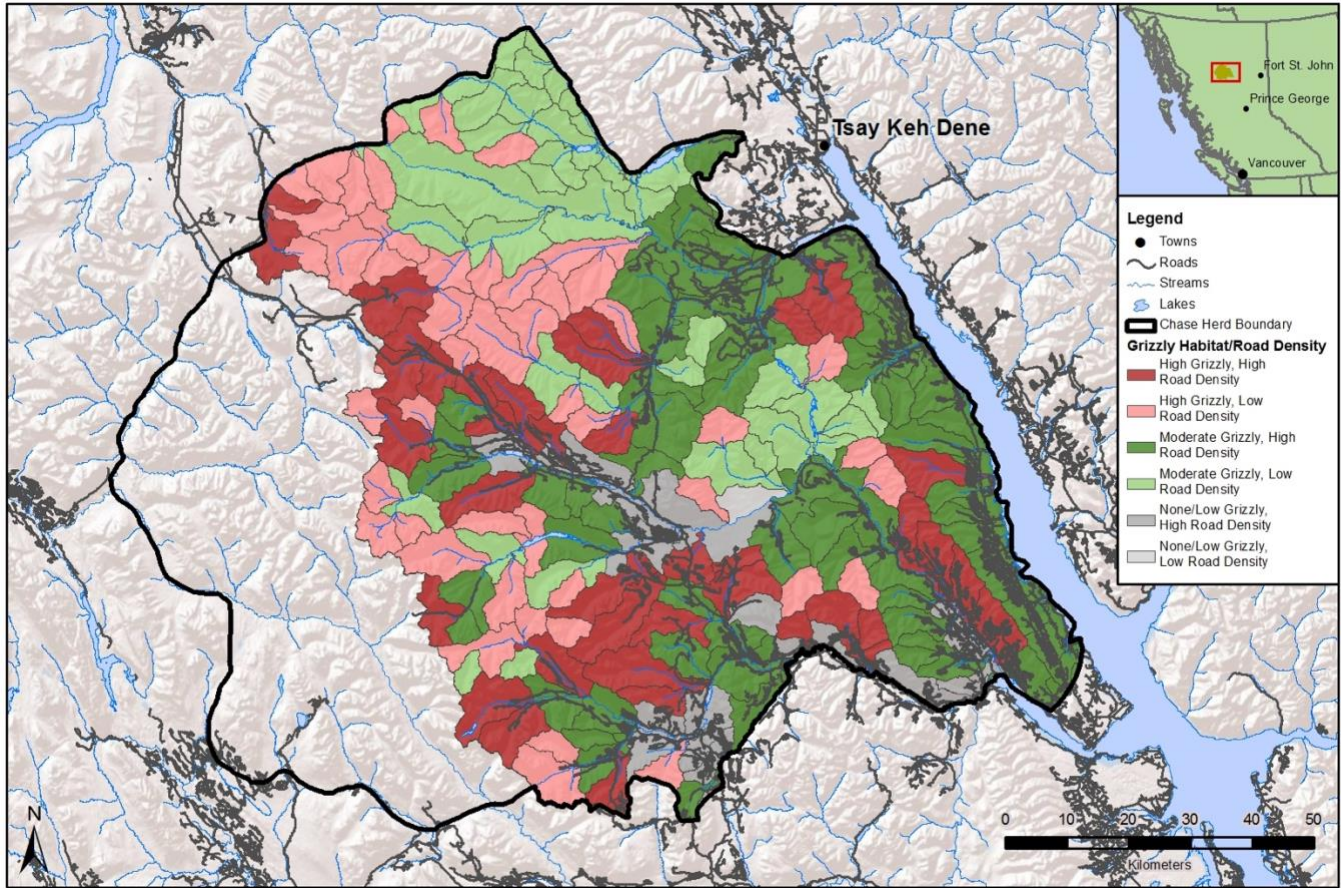
**Figure 7.** Grizzly bear habitat quality and road density. High grizzly bear habitat with high road density (dark red); high grizzly bear habitat with low road density (light red); moderate grizzly bear habitat with high road density (dark green); moderate grizzly bear habitat with low road density (light green). All roads shown in dark grey.

Grizzly bear habitat quality within the Chase herd is highly correlated with mountainous regions that provide high berry production, and many of these areas (shown in red in Figure 7) also overlap with core caribou areas. Of the areas where data is available, a total of 857,262 ha is considered high-moderate quality for grizzly bears and 58% of this area is within high road density areas.

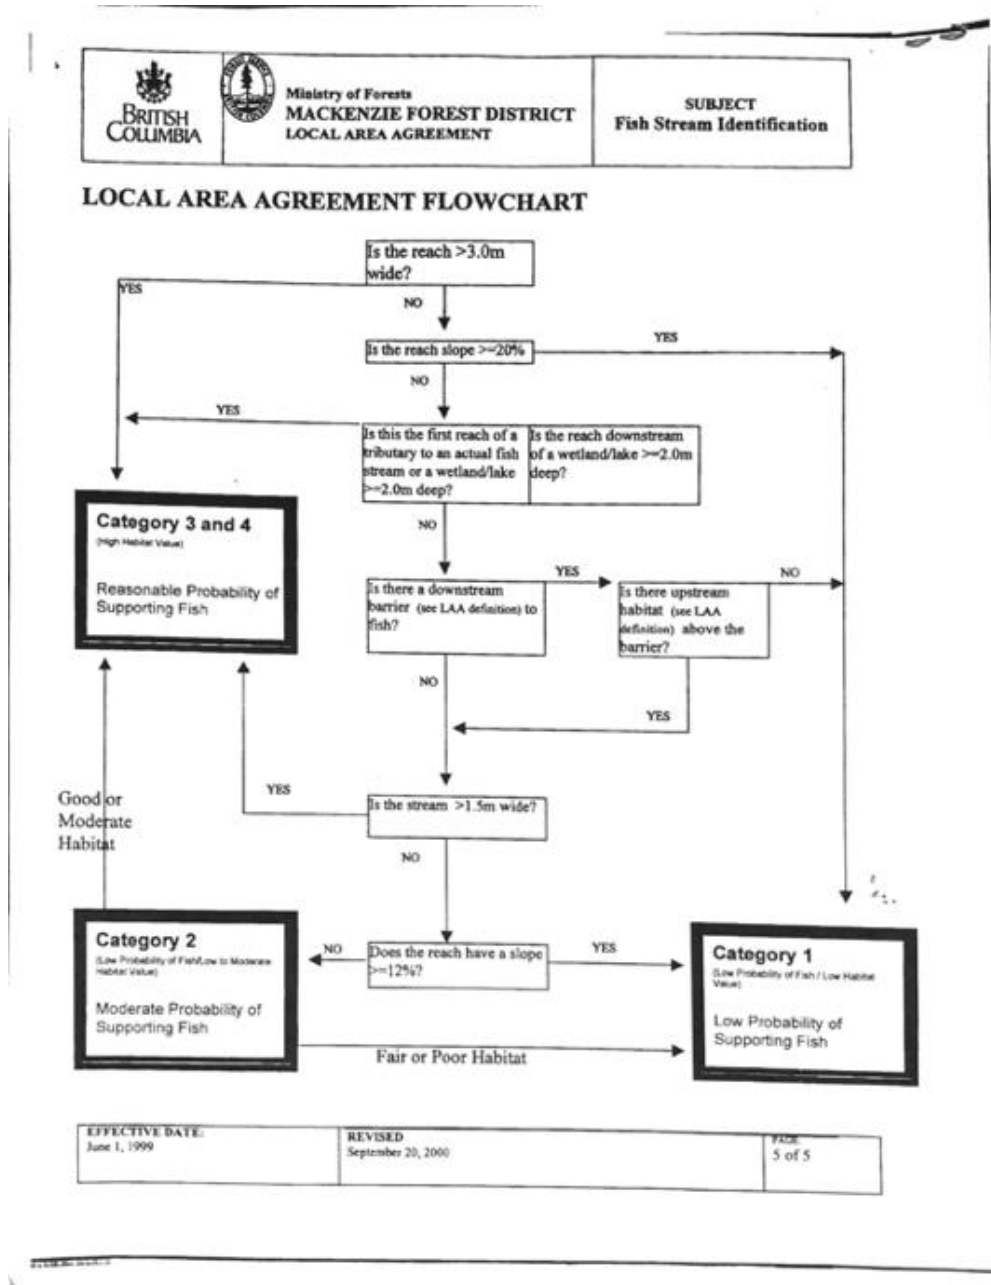
Figure 8. Mackenzie Forest District (now the Mackenzie Natural Resource District) local area agreement fish stream identification flow chart.

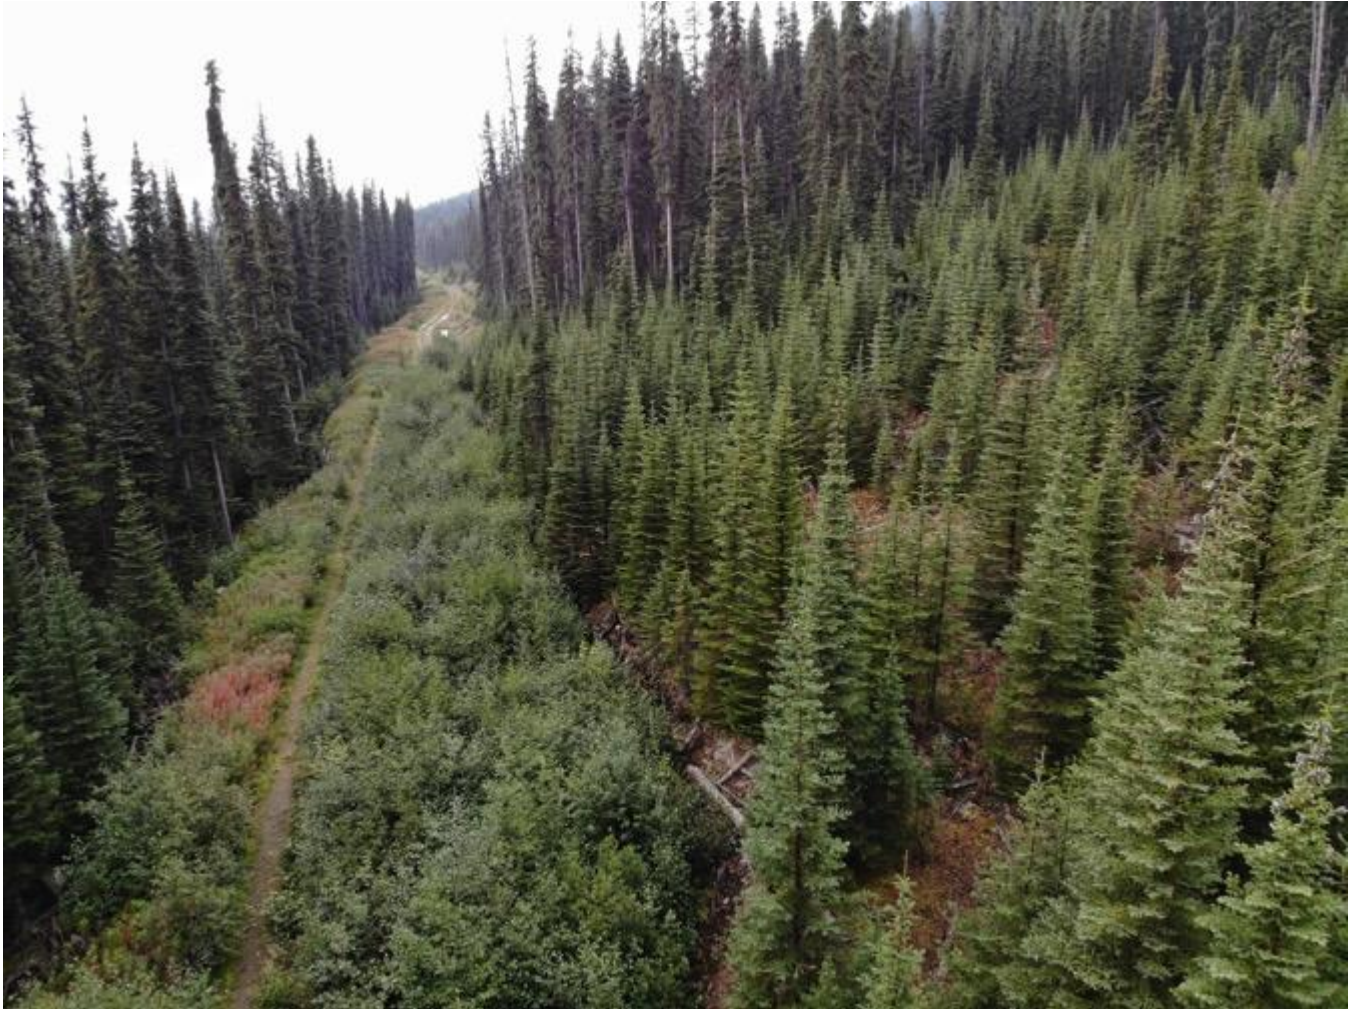
**Figure 11.** Road 1 brushed in with willow and alder.

This road is located in a high elevation (1300 m) area, is isolated from other road networks, and leads to alpine areas. Access management is recommended along with culvert removal and planting. A large portion of the road is maintained by repeated truck access, and so it will require appropriate mechanical site preparation before planting. There is an opportunity to remove a bridge over a large creek approximately 2.5 km before the road, which could accelerate revegetation on the entire 3-4 km road segment.

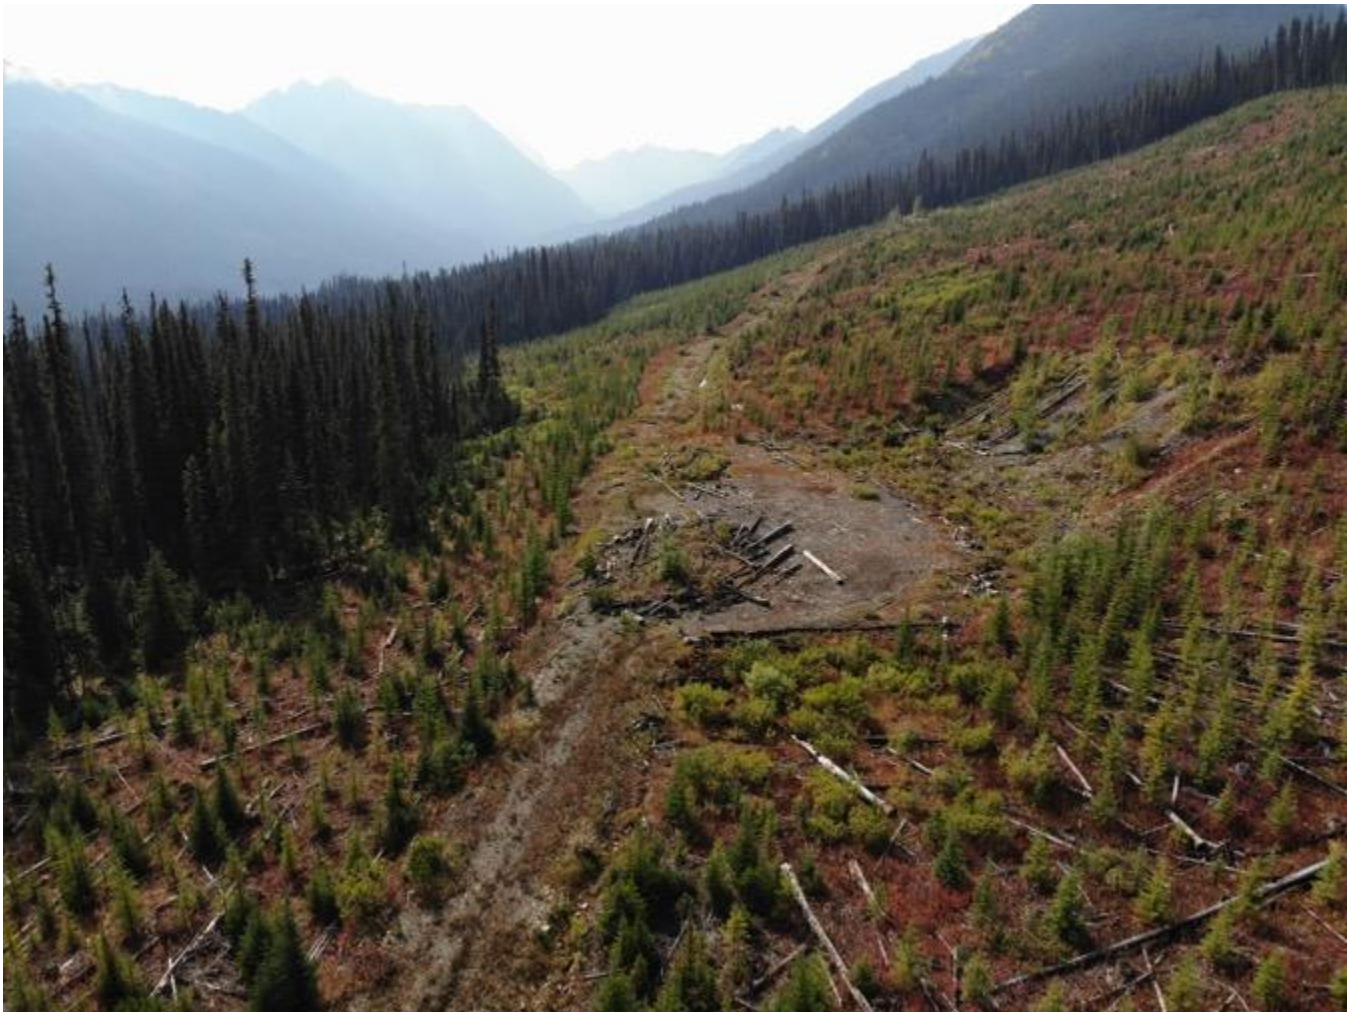
Figure 12. Landing near the end of Road 1.

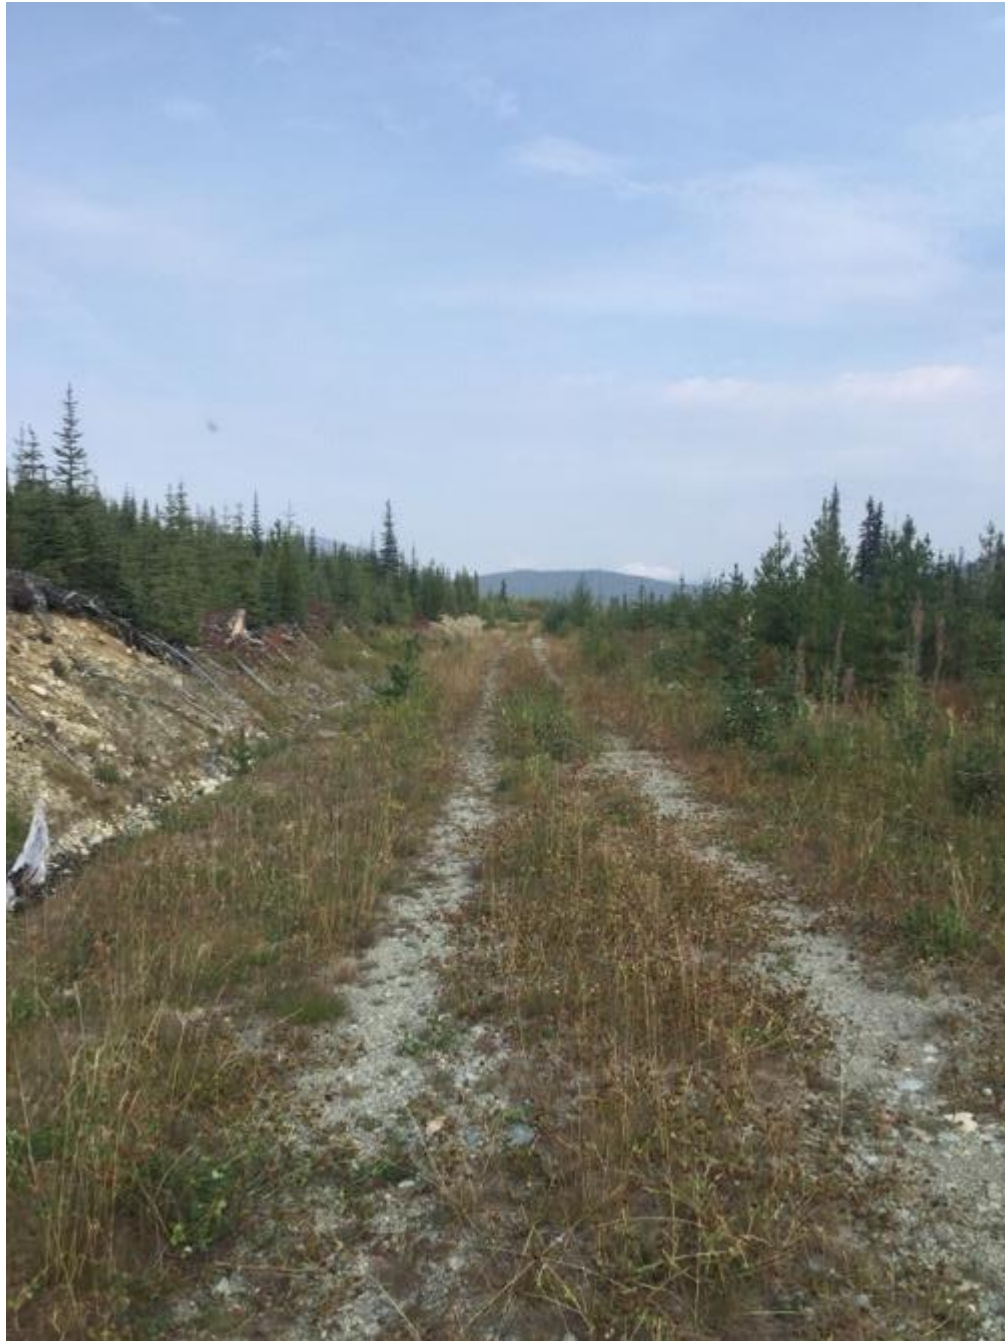
The road surface is well compacted and is a mixture of gravel, moss and grasses with some natural regeneration of grass and red clover (*Trifolium* spp.; Figure 13). Natural regeneration of the alder and willow saplings is less than 1.5 m in height and less than 700 stems per hectare (sph). Average road width is 3.5 m and average road grade is < 5 %. There is more than 200 m of eligible road, over 4 m wide and not restocked, available for rehabilitation. The cut blocks have been replanted and are at the 'free-to-grow' stage. The road is located on a slope with a + 10 % and - 5 % grade. The average road grade is 2 % while the stream crossings are approximately -3 %, most flowing through a culvert. The streams have an average width of 0.86 m and the largest culvert is 0.9 m in diameter. There are no classifiable streams crossing the road. Several existing culverts have been left in place, providing drainage. Horse droppings and hoof prints were visible along the road indicating potential use of this road by Guide Outfitters. Bear, wolf, and moose scat were also observed.

**Figure 13.** Compaction preventing natural regeneration on Road 1.

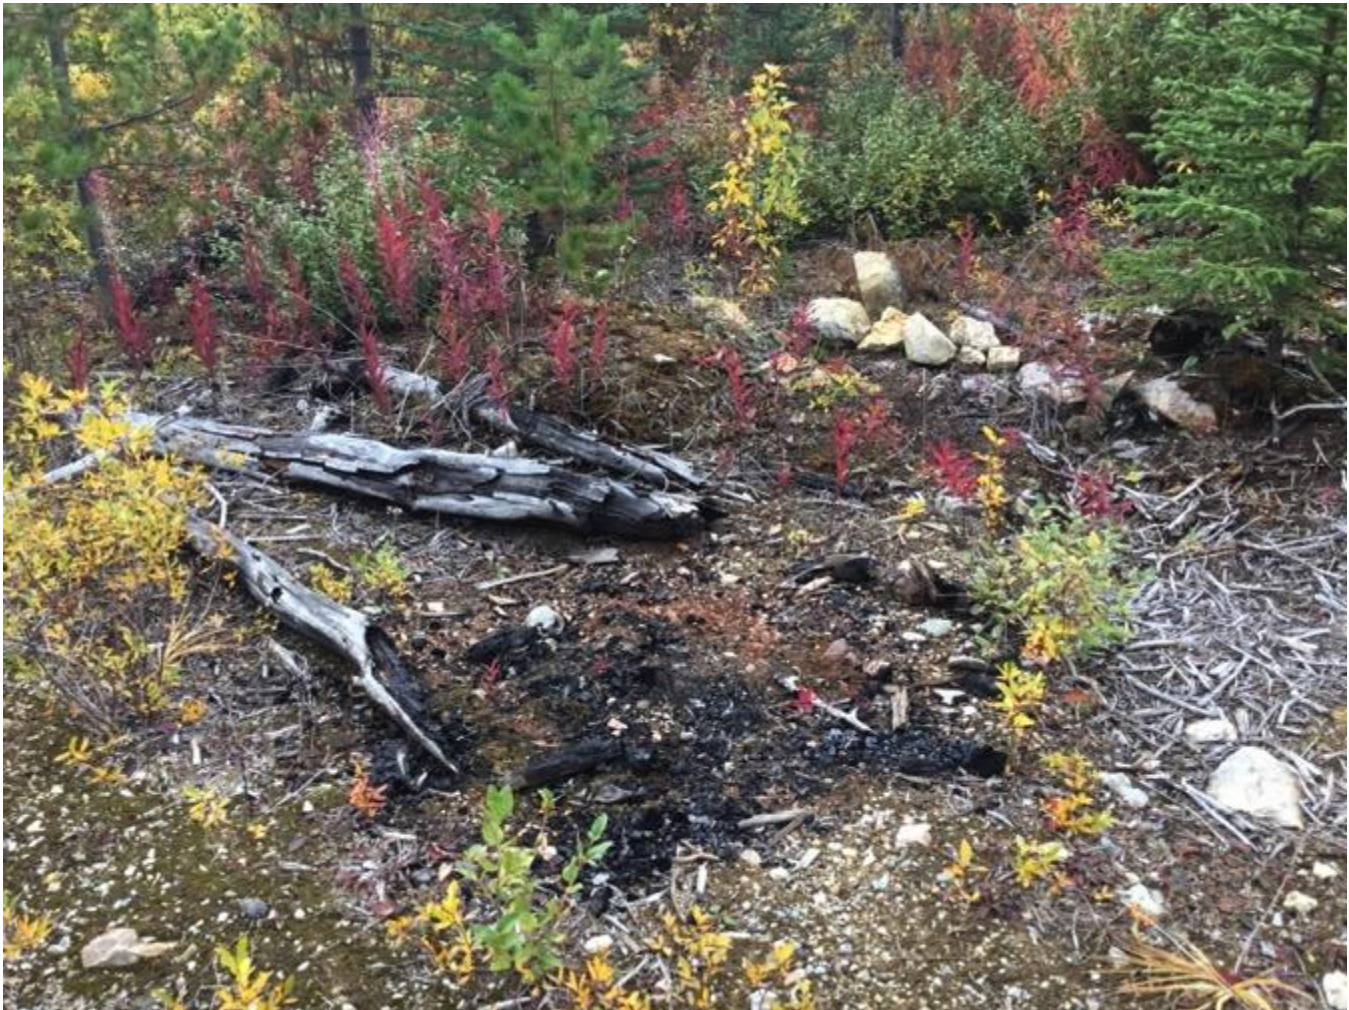
Figure 14. Evidence of recreational use on Road 2.

The road surface is well compacted and will require appropriate site preparation before planting. Discouraging access to the road within the first 200 m would help prevent the further compaction of the road base.

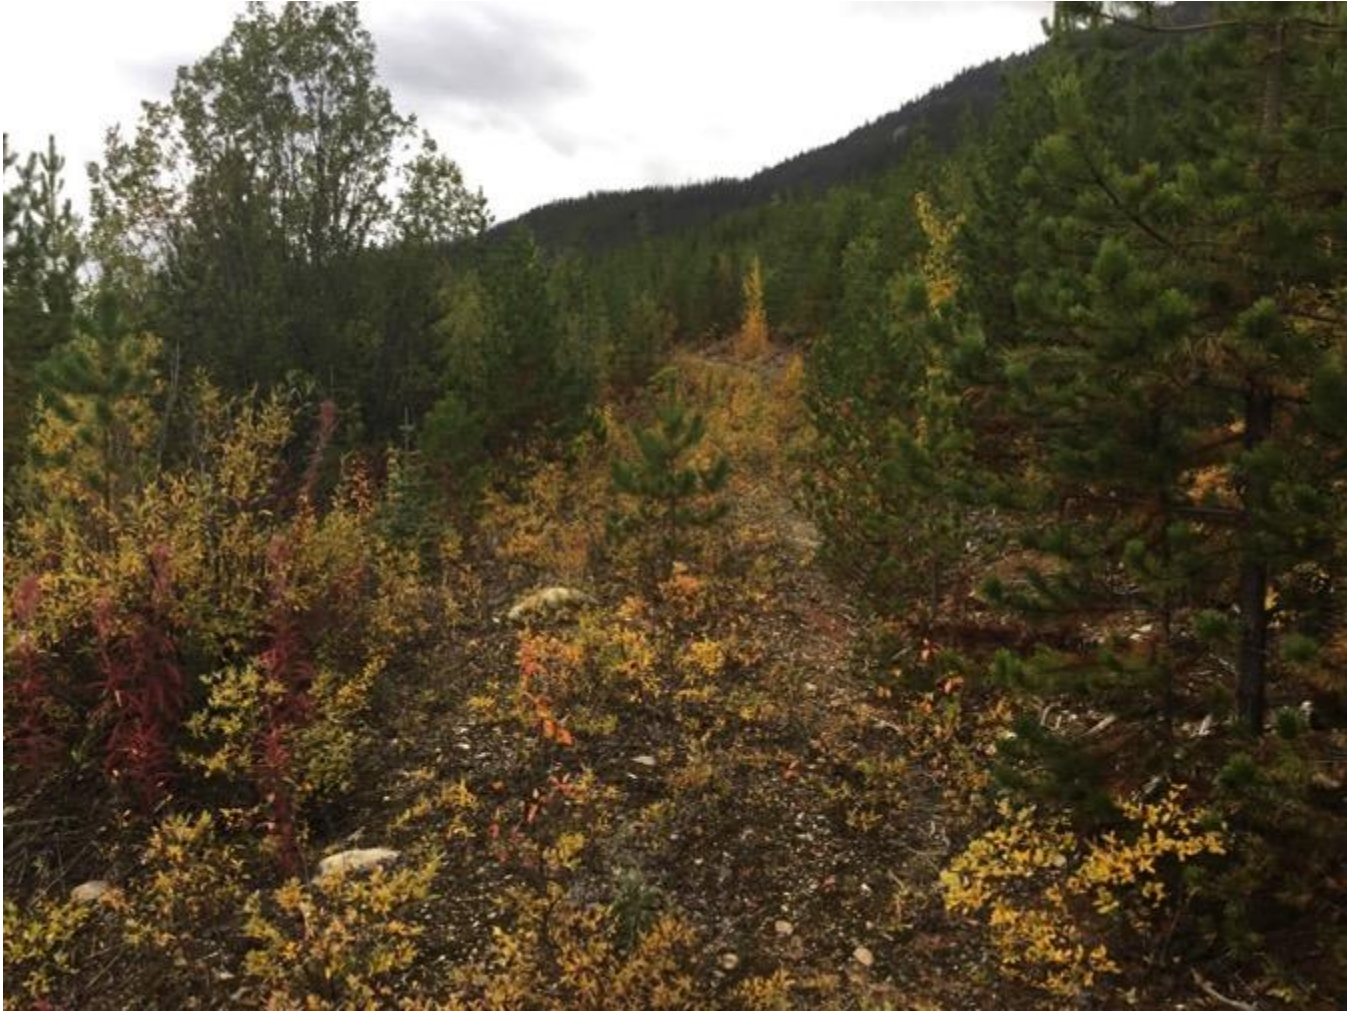
**Figure 15.** Mixed pine and spruce plantation adjacent to Road 2.

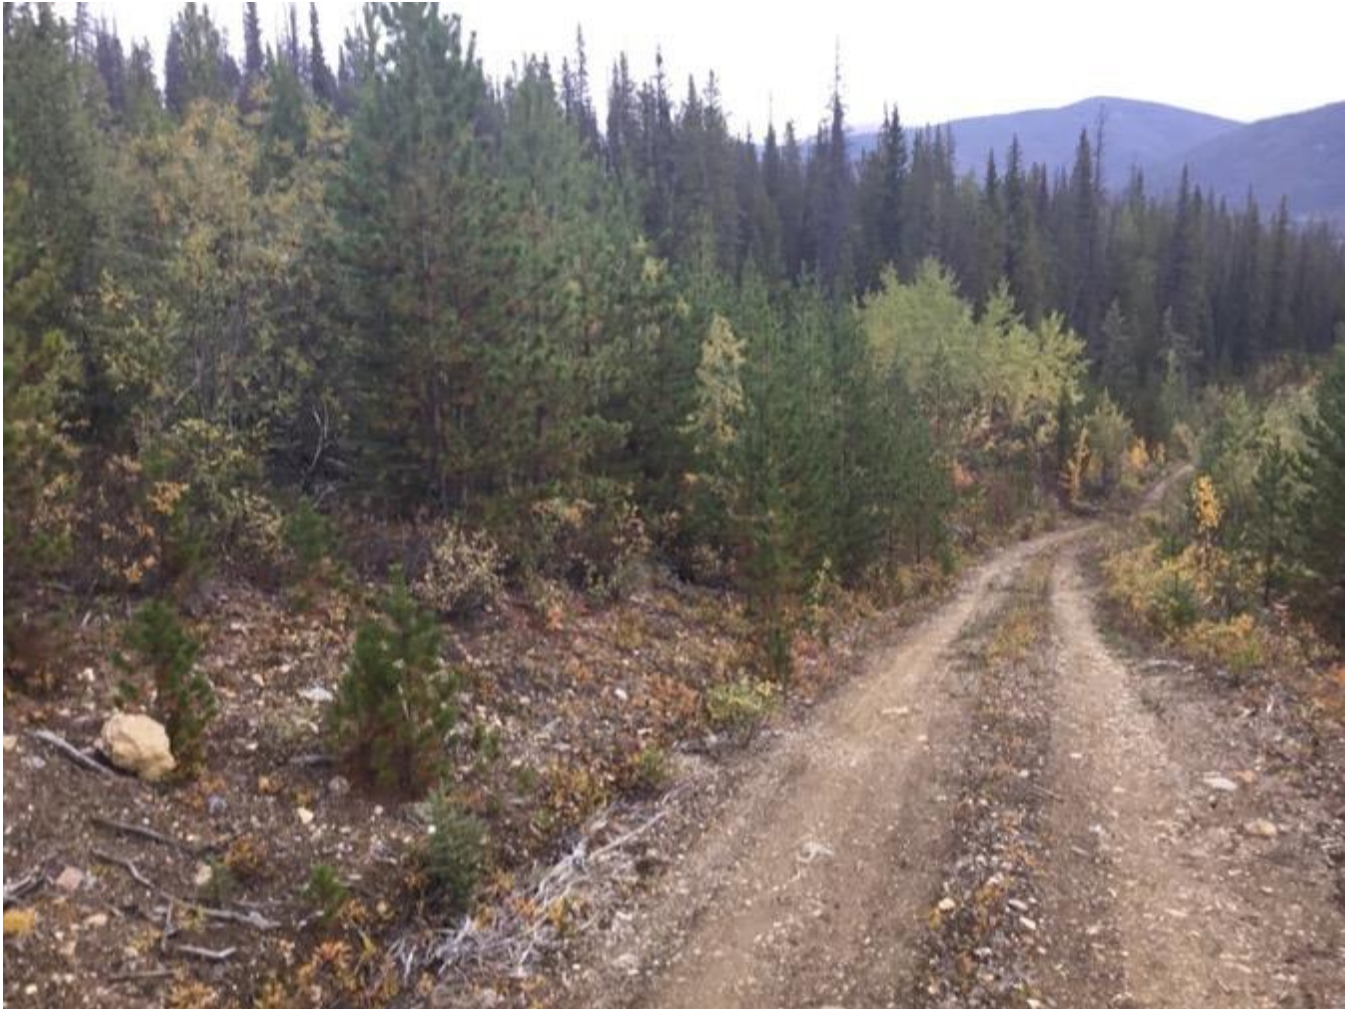
**Figure 16.** Heavy recreational use maintains the compacted road, slowing natural regeneration on Road 2.

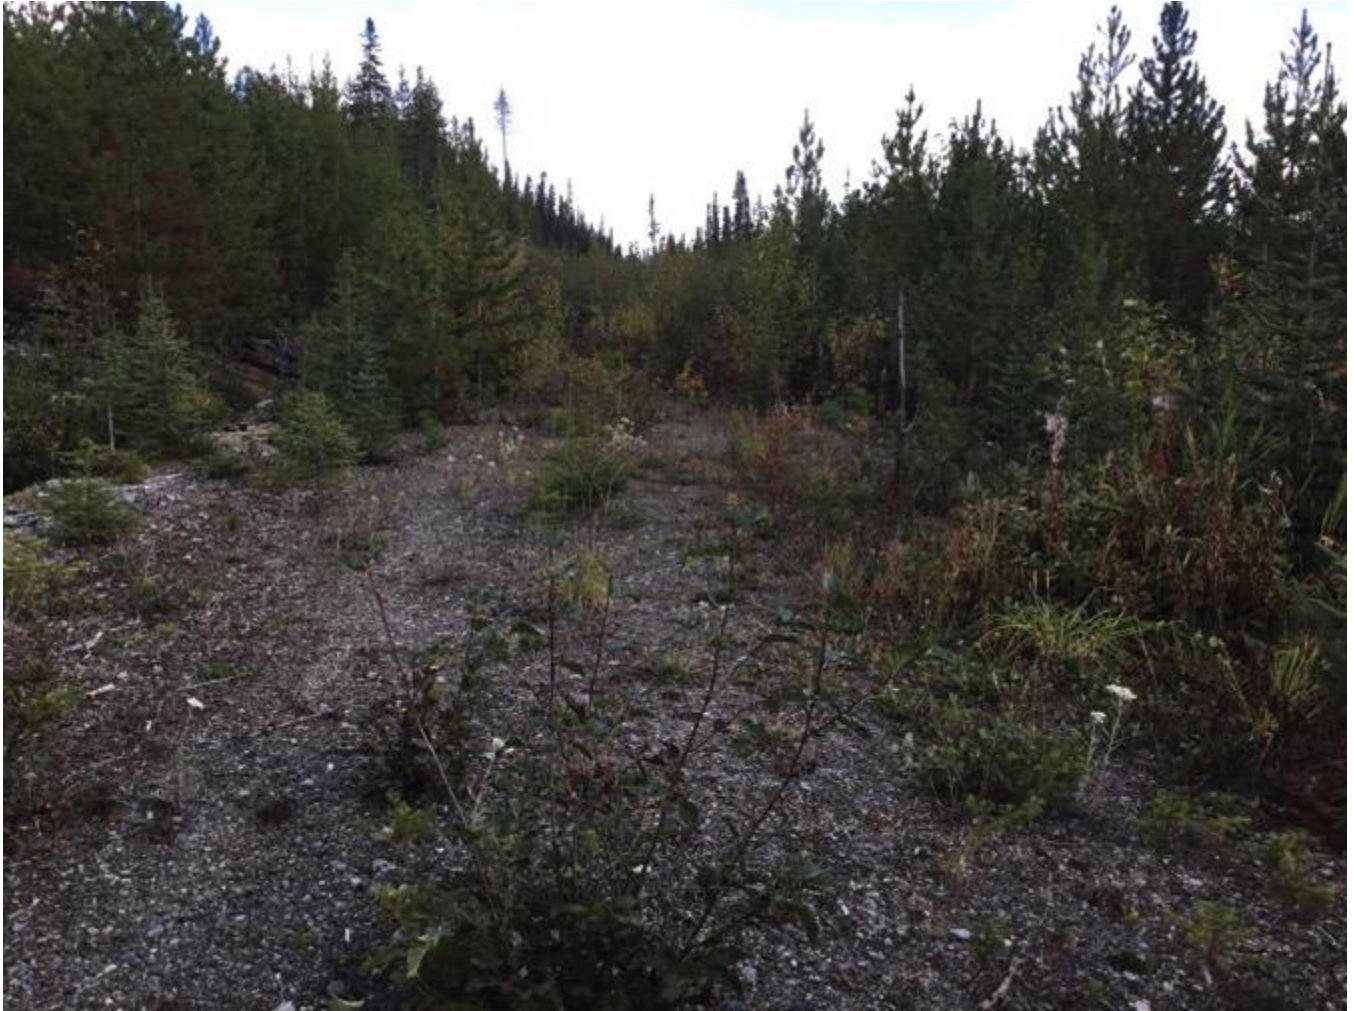
**Figure 17.** Road 3 showing adjacent plantations.

The average road width is > 4 m and over 200 m is eligible for rehabilitation. The compacted road is not surfaced, but has coarse texture and no organic matter. Willow, alder, fir, pine, and spruce are naturally regenerating with fir, pine and spruce greater than 700 sph. The road is also regenerating grasses, moss and clover. The slopes are gentle at - 4 % and + 6 %, with a road grade of - 3 %. The road does not cross a classifiable stream and has no erosion issues. Bear and moose scat were observed on the road during surveys. There is also evidence of recreational activity up to the first ditch. The road surface is well compacted and will require appropriate mechanical site preparation before planting the area that is not regenerating.

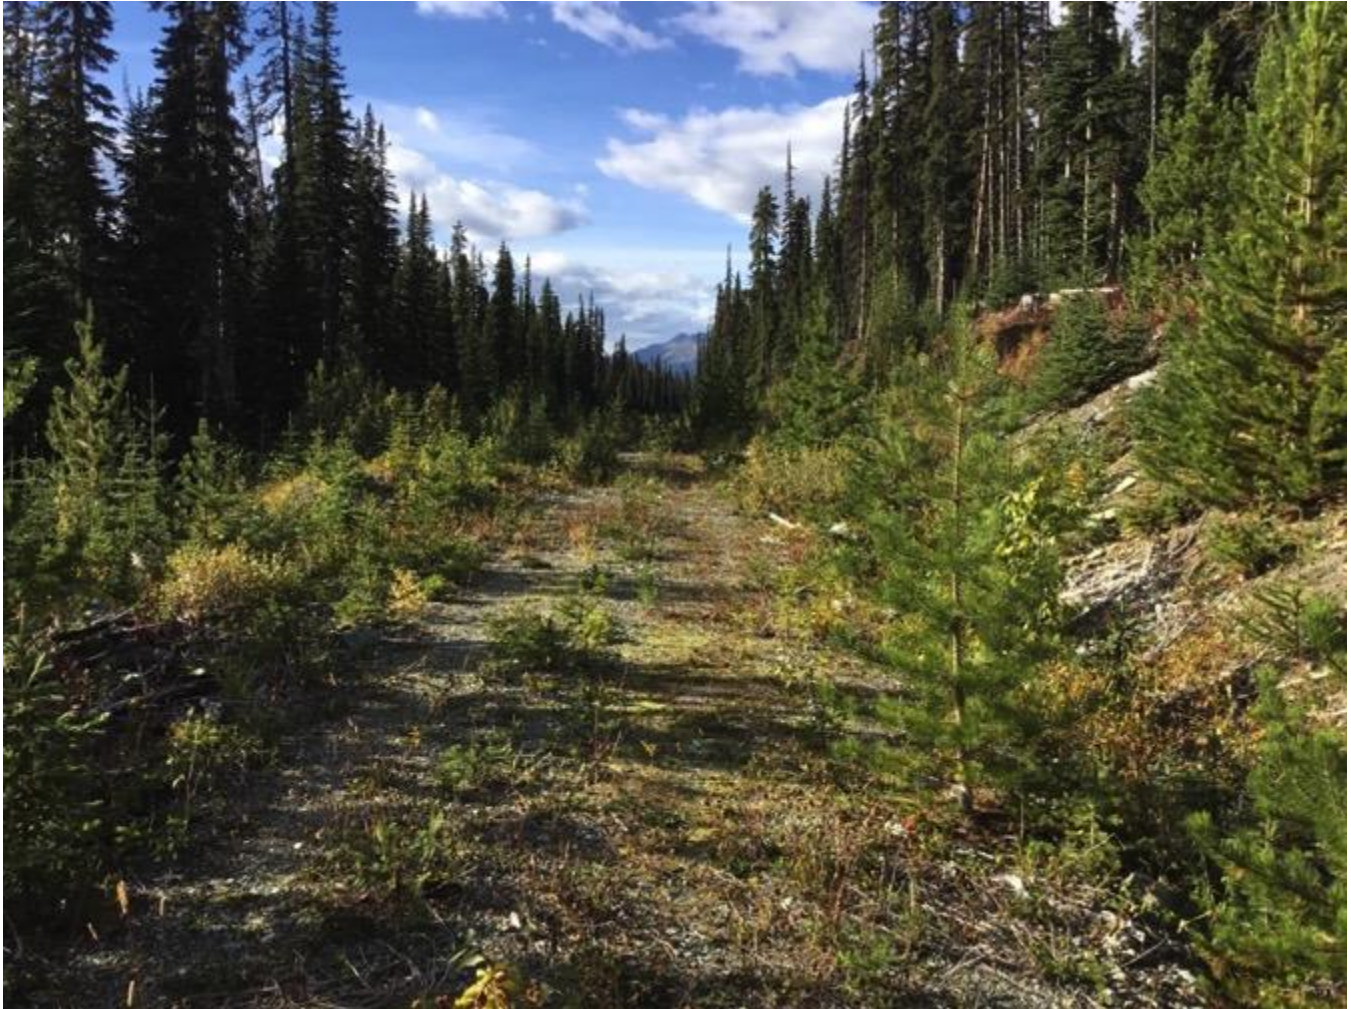
Road 3 runs parallel to the Tenakihi FSR, on the slopes of the mountains to the north-east. The road is located within a caribou migration corridor. The road gradually gains elevation, passing two plantations along the way, and ending in a third. These plantations are composed of 65 % pine and 35 % spruce (Figure 17). The mature adjacent stands are pine leading with a component of spruce (Figure 18).

**Figure 18.** Road 3 showing adjacent timber stands.

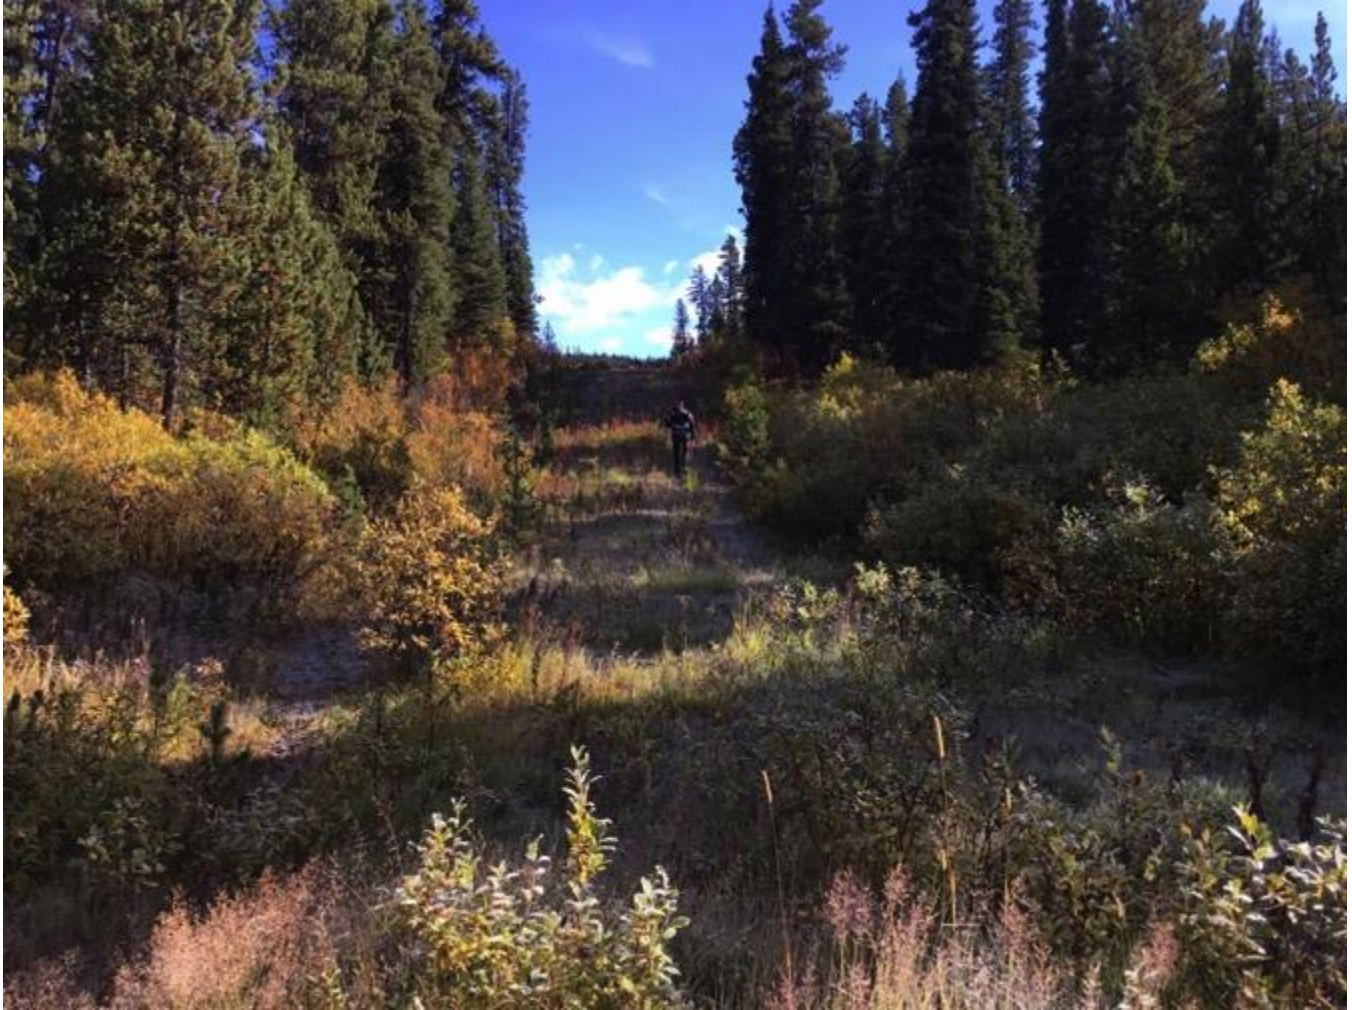
**Figure 19.** Road 4 showing adjacent timber stands.

before planting is the recommended treatment to ensure tree establishment and growth. Given the recent tracks, it would be advantageous to restrict access of ATVs using a barrier.

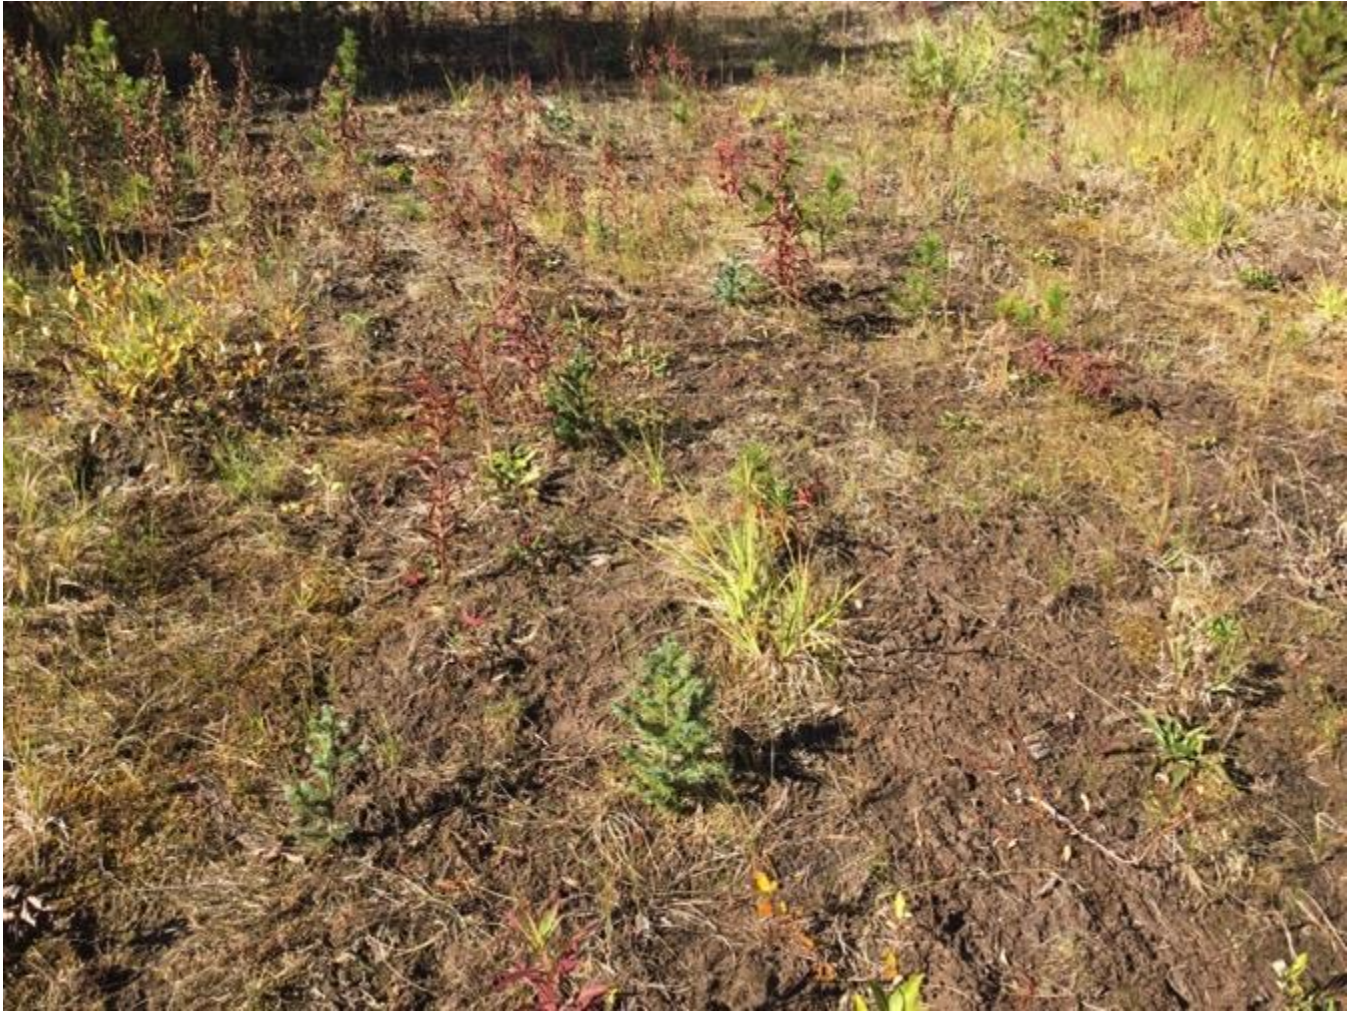
**Figure 20.** Less compaction on the running surface of Road 4.
