**IDENTIFYING FOREST ROADWAYS FOR  
REHABILITATION WITHIN THE CHASE CARIBOU HERD  
RANGE BOUNDARY  
PEA-F19-W-2650**

PREPARED FOR: FISH AND WILDLIFE COMPENSATION PROGRAM  
PREPARED BY: CHU CHO ENVIRONMENTAL LLP  
STUDY PERIOD: MARCH 2018 – FEBRUARY 2019

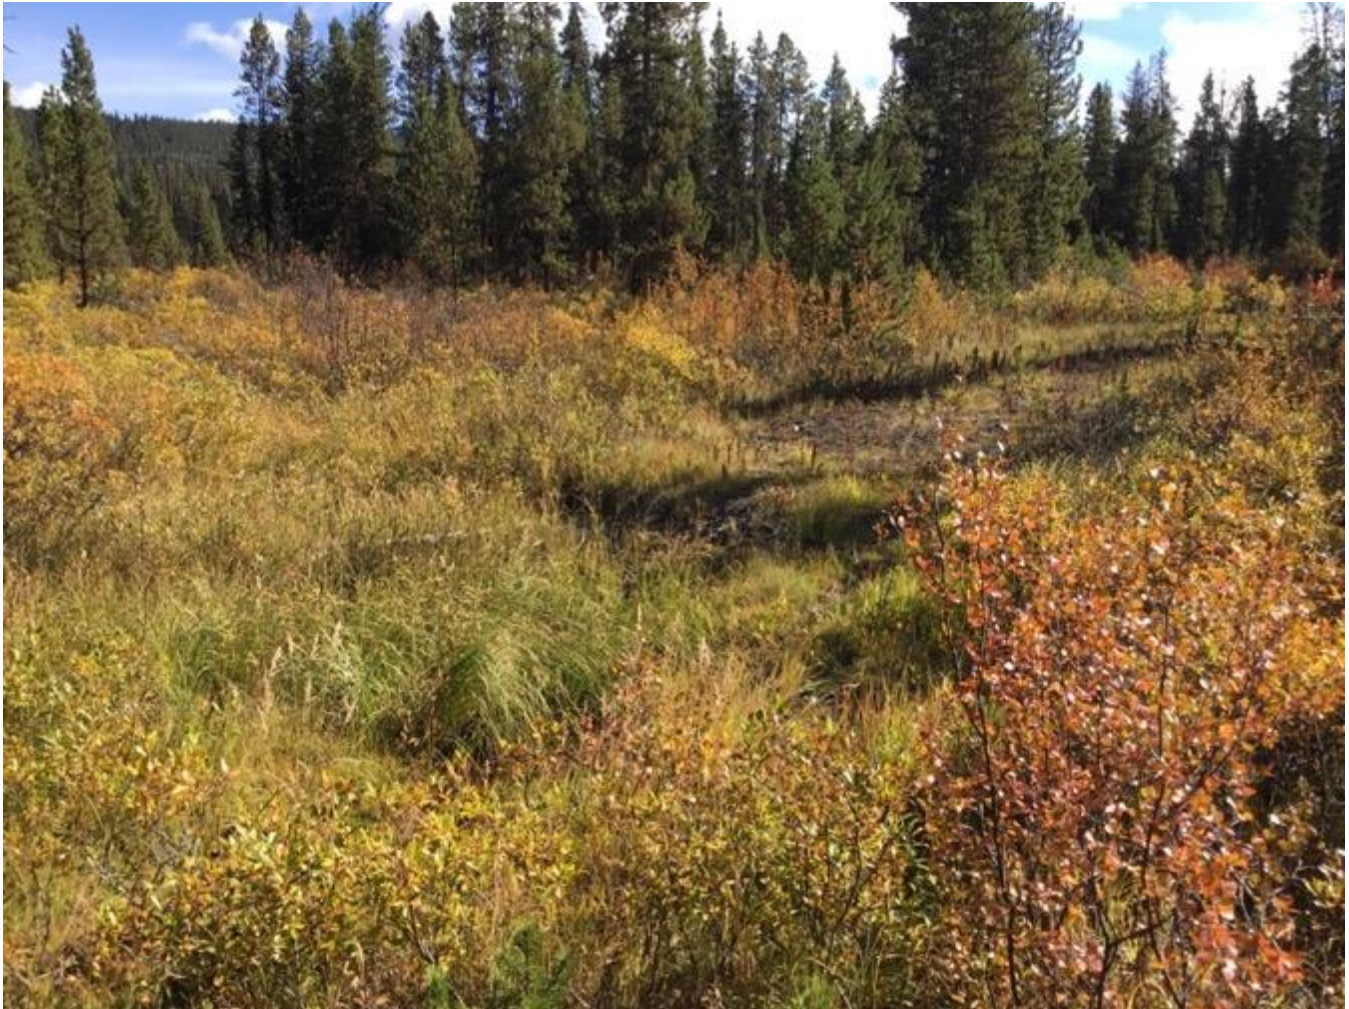
**Figure 21.** Natural regeneration of grasses, willow and fireweed on Road 4.

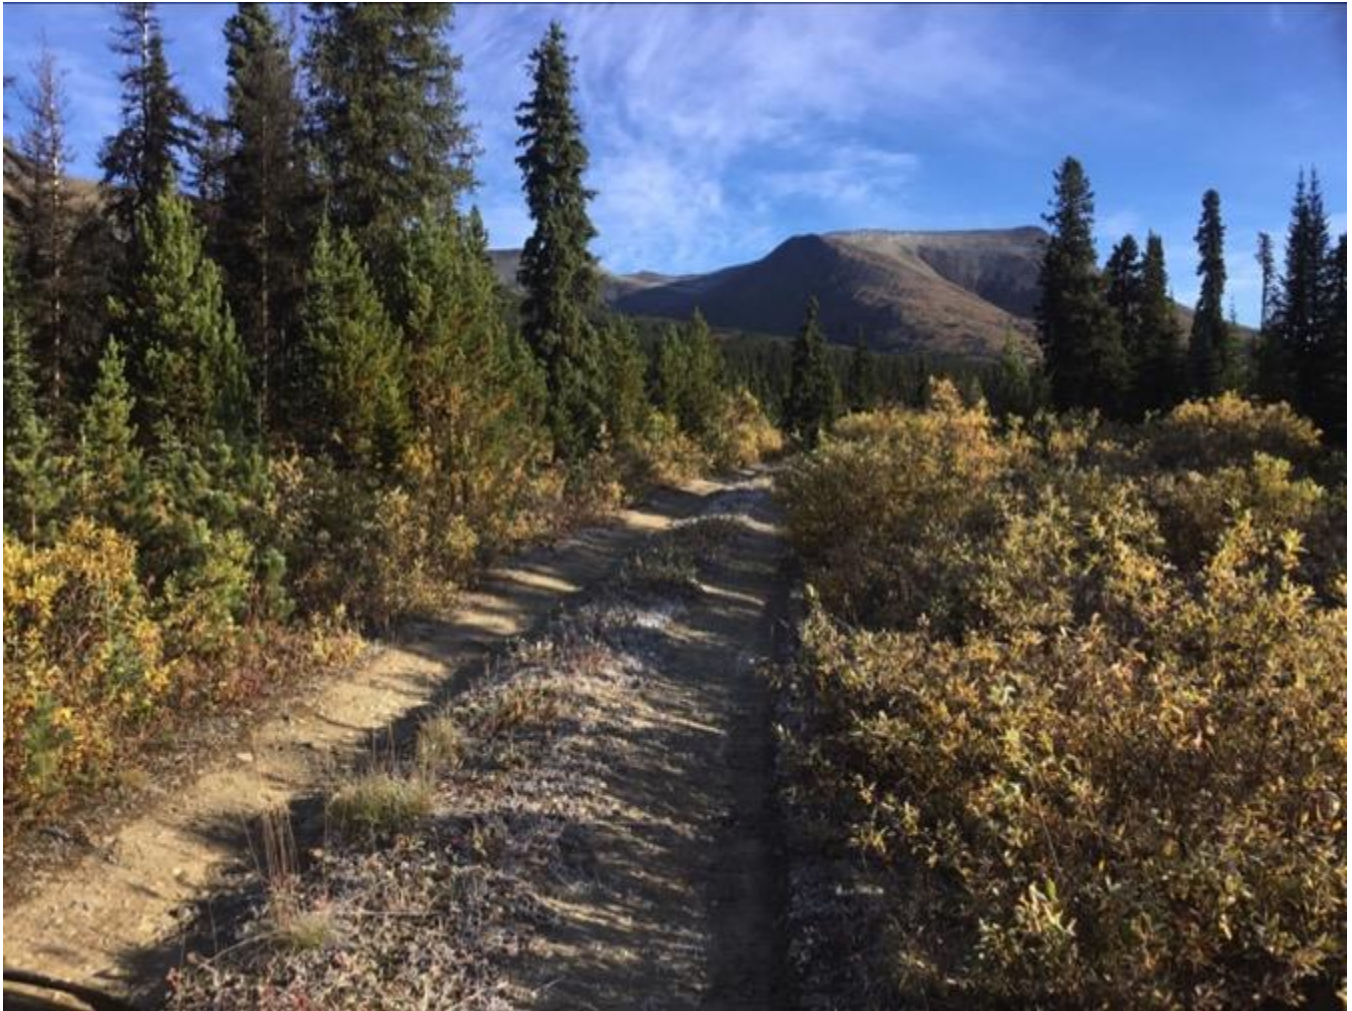
Figure 22. Road 5 showing adjacent stands.

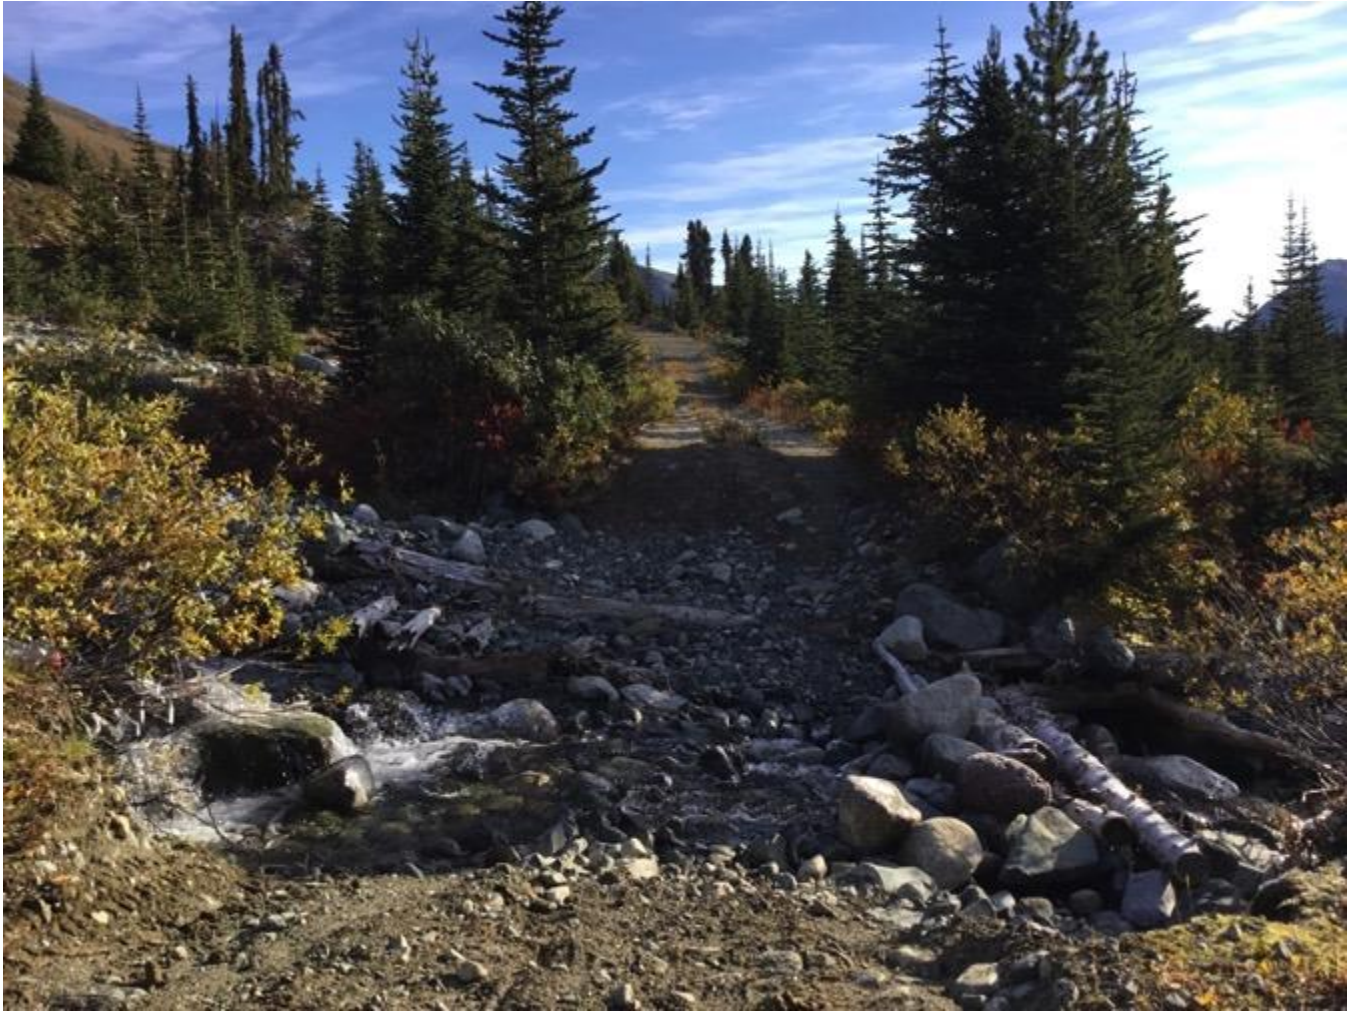
The road is compacted and has a coarse soil texture. The road has an average grade of – 11 % with a ditch slope of – 18 % and + 8 %. The road crosses a 3 m wide creek with a rocky creek bed and no culverts or cross ditching are present (Figure 23). Along the uncompacted areas of the road, lichen, moss and grasses are naturally regenerating. Ungulate tracks are evident along the road, possibly from a caribou.

Figure 23. Stream crossing on Road 5.

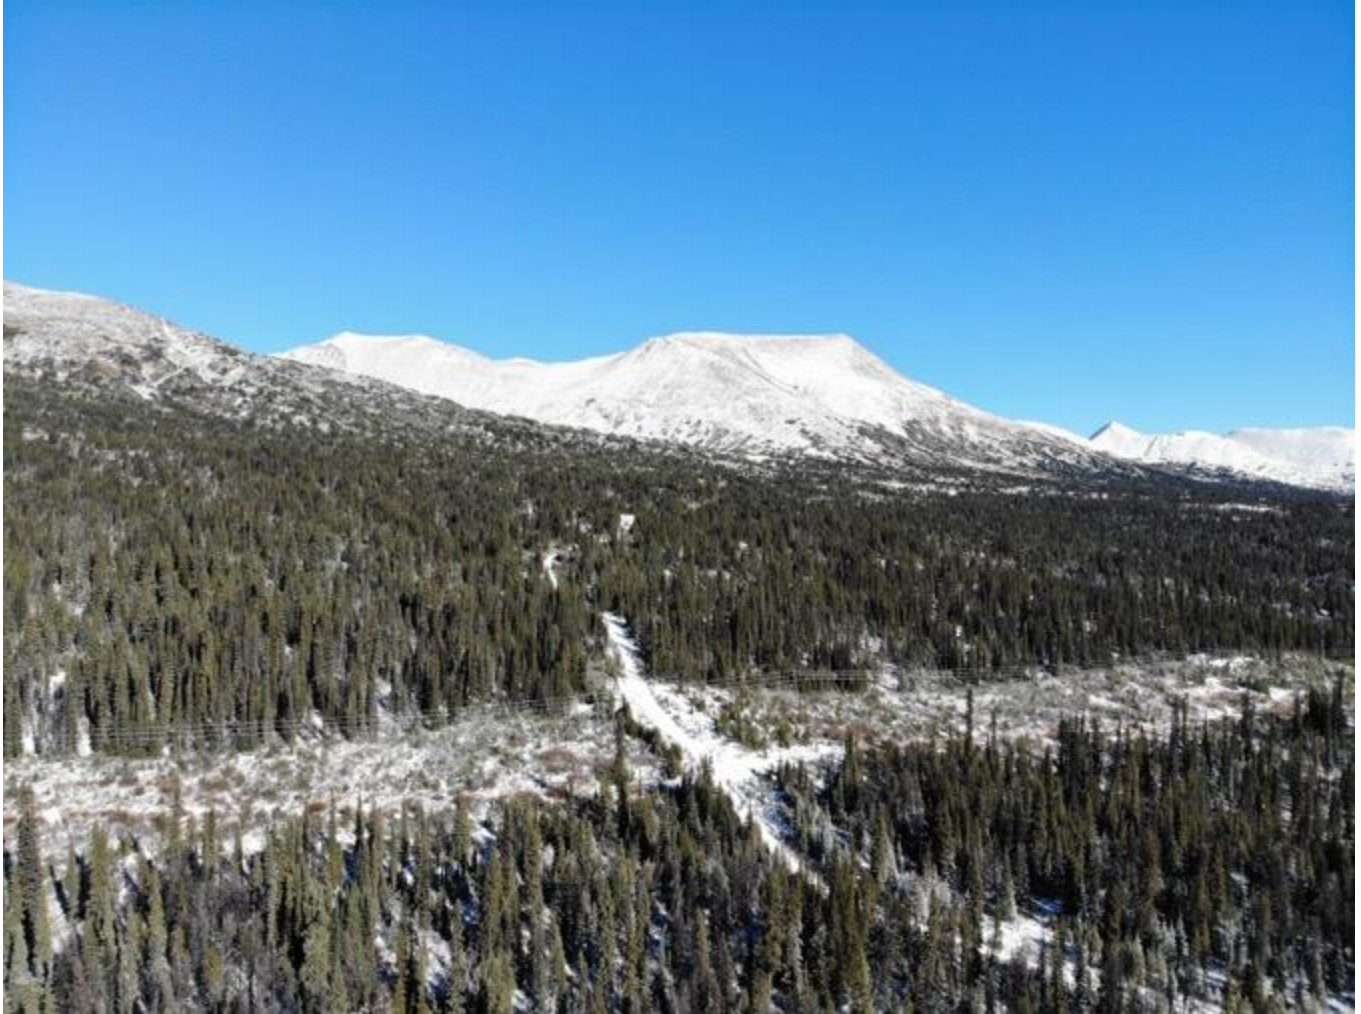
This road provides access to high elevation caribou winter range, and to the powerline (Figure 24). There is the possibility of winter recreational use of this roadway and powerline. The road surface is well compacted and will require appropriate site preparation before planting. Access should be restricted to prevent access into the alpine, a caribou migration corridor and high elevation caribou winter range.

**Figure 24.** Road 5 leading into alpine.

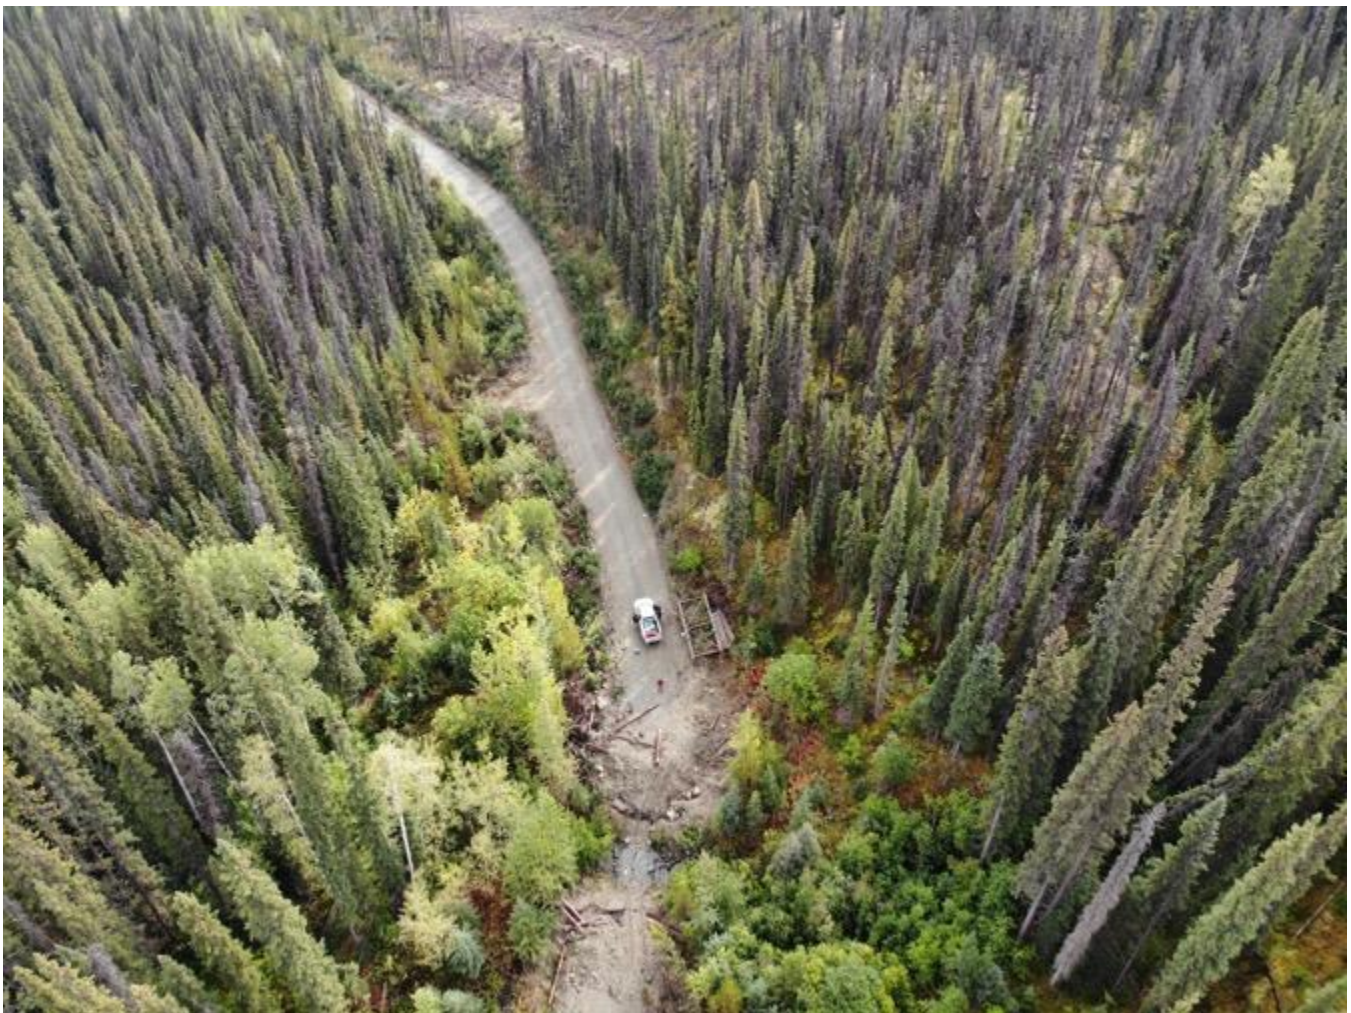
**Figure 25.** Access control on Tutizzi Lake road (bridge removed).

Since this road already has creek crossings removed, it is recommended that the remainder of the road is ripped and planted. The road is compacted and surfaced, and will require a ripper to facilitate new seeds and plant establishment and growth. It is also recommended that culverts be removed and barrier puts in place at the beginning of the road to prevent road access. This road has not been identified by the licensees for rehabilitation, perhaps due to the several newly harvested cut blocks that have likely not met silvicultural obligations yet.

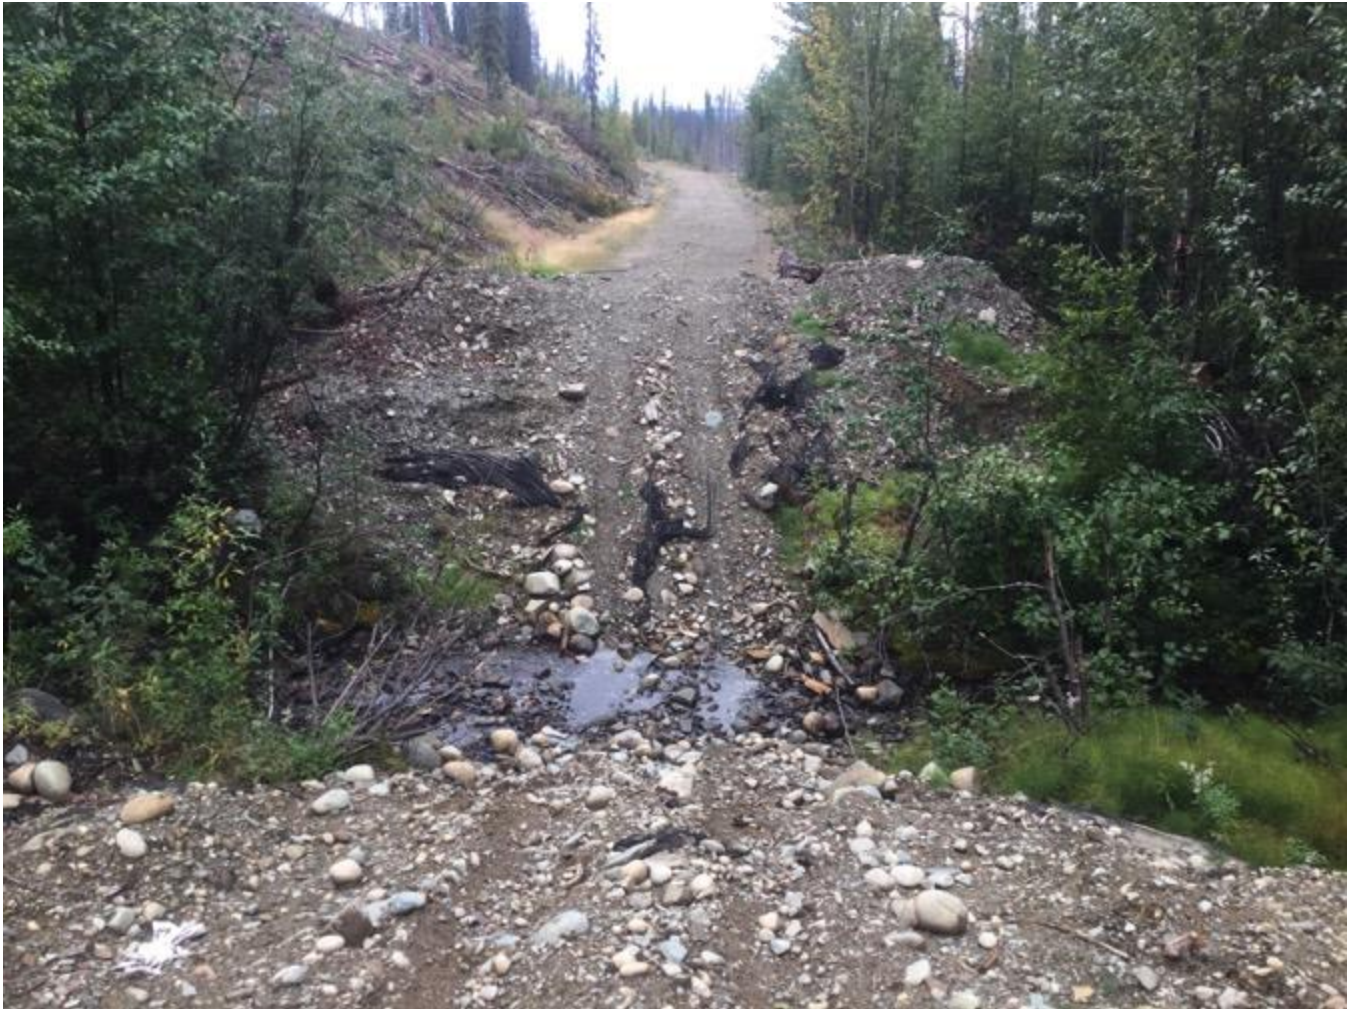
**Figure 26.** Road to Tutizzi Lake ditched to prevent pickup truck access.

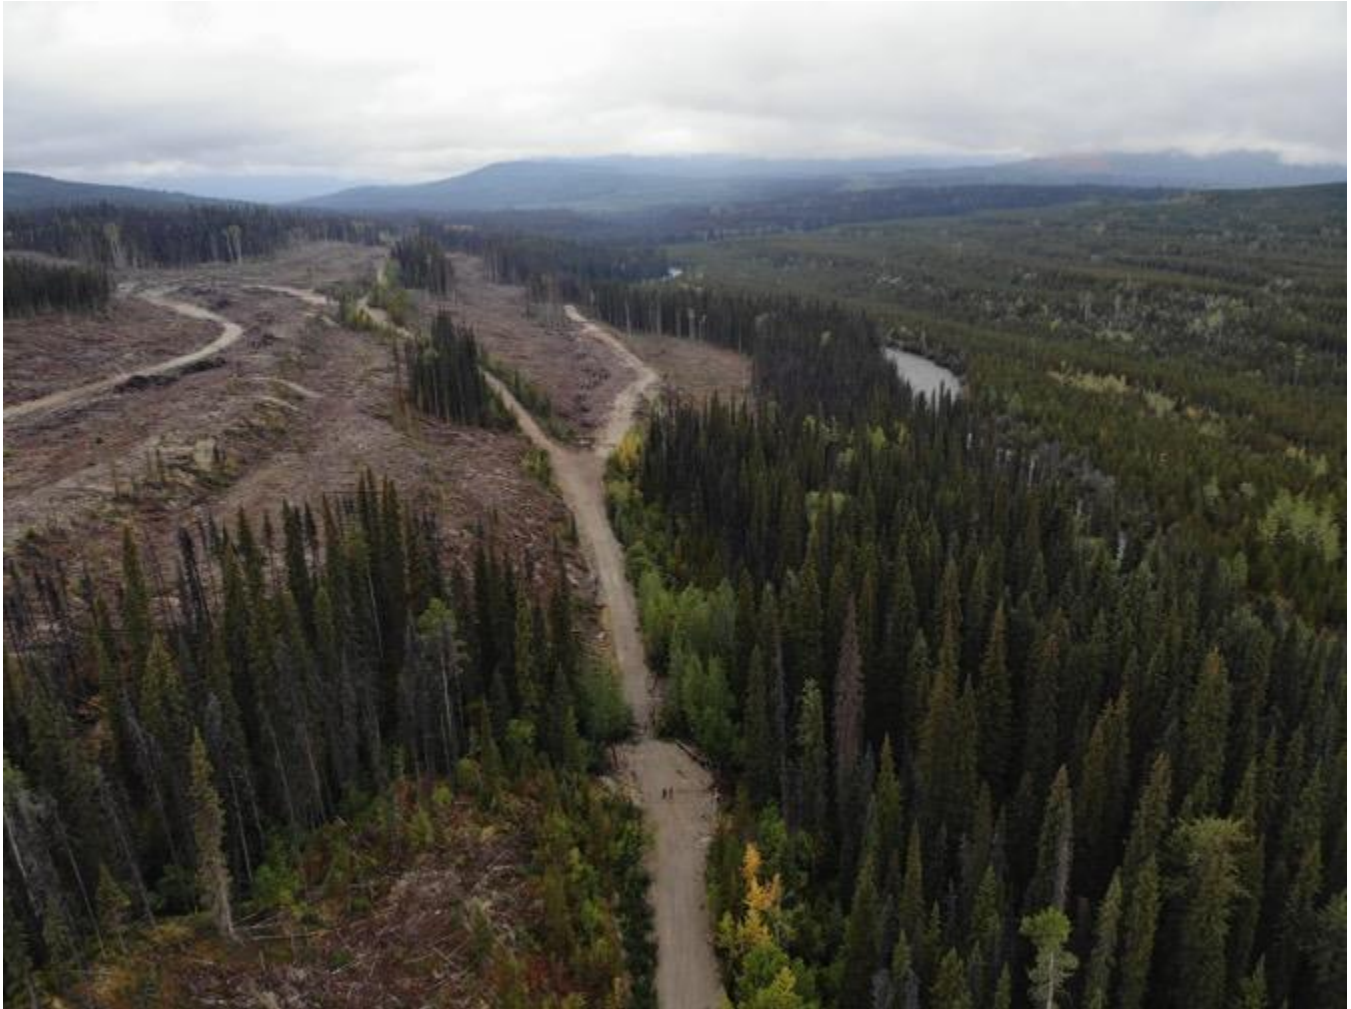
**Figure 27.** The road to Tutizzi Lake west of the deactivation.

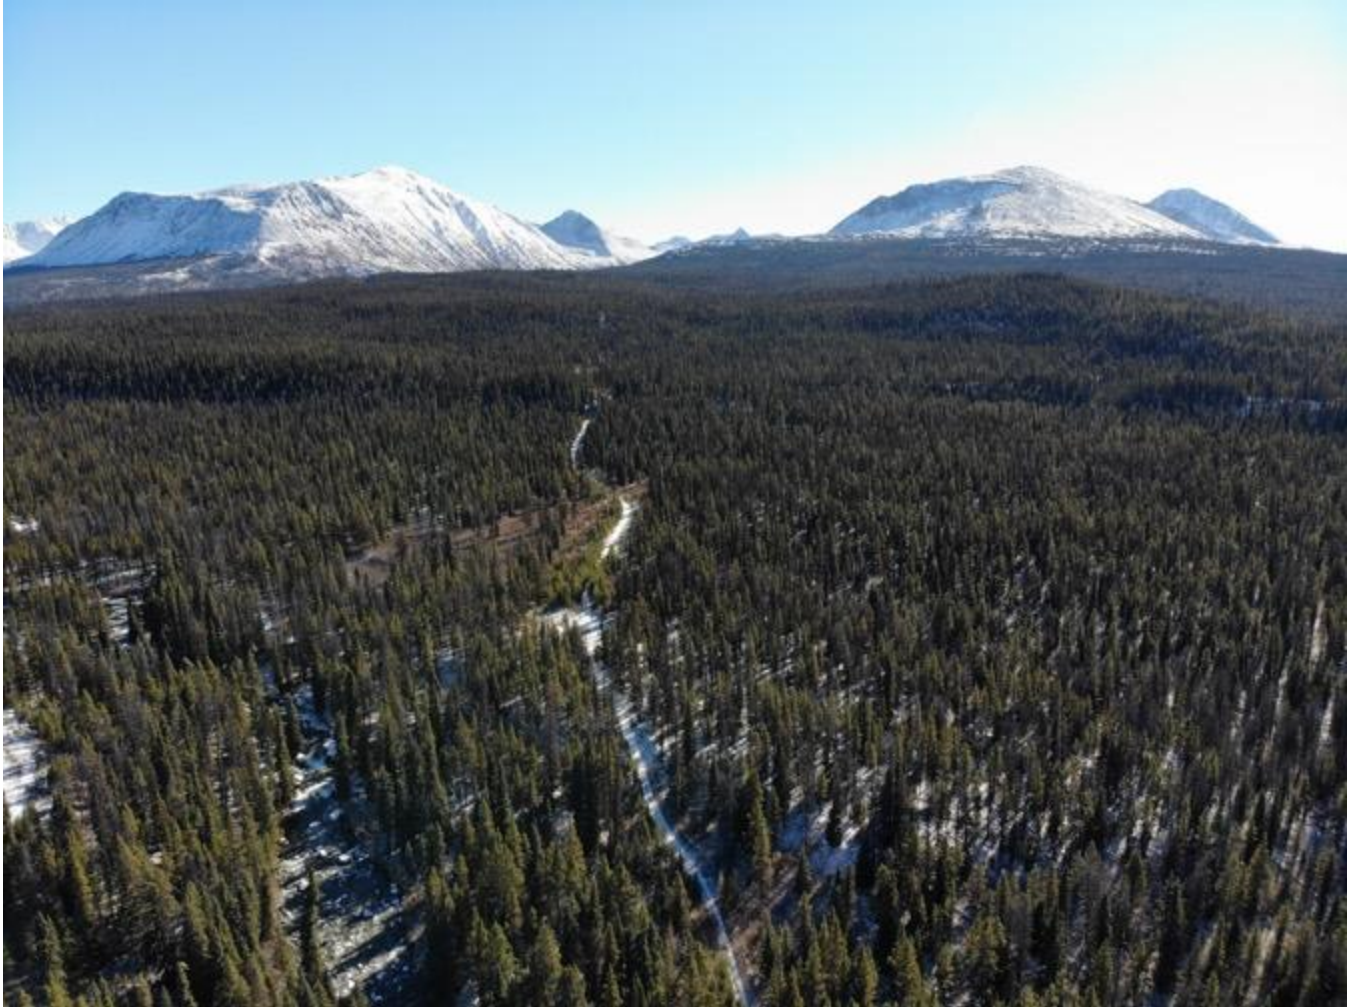
Figure 28. Adjacent stand of spruce and pine on Road 21.

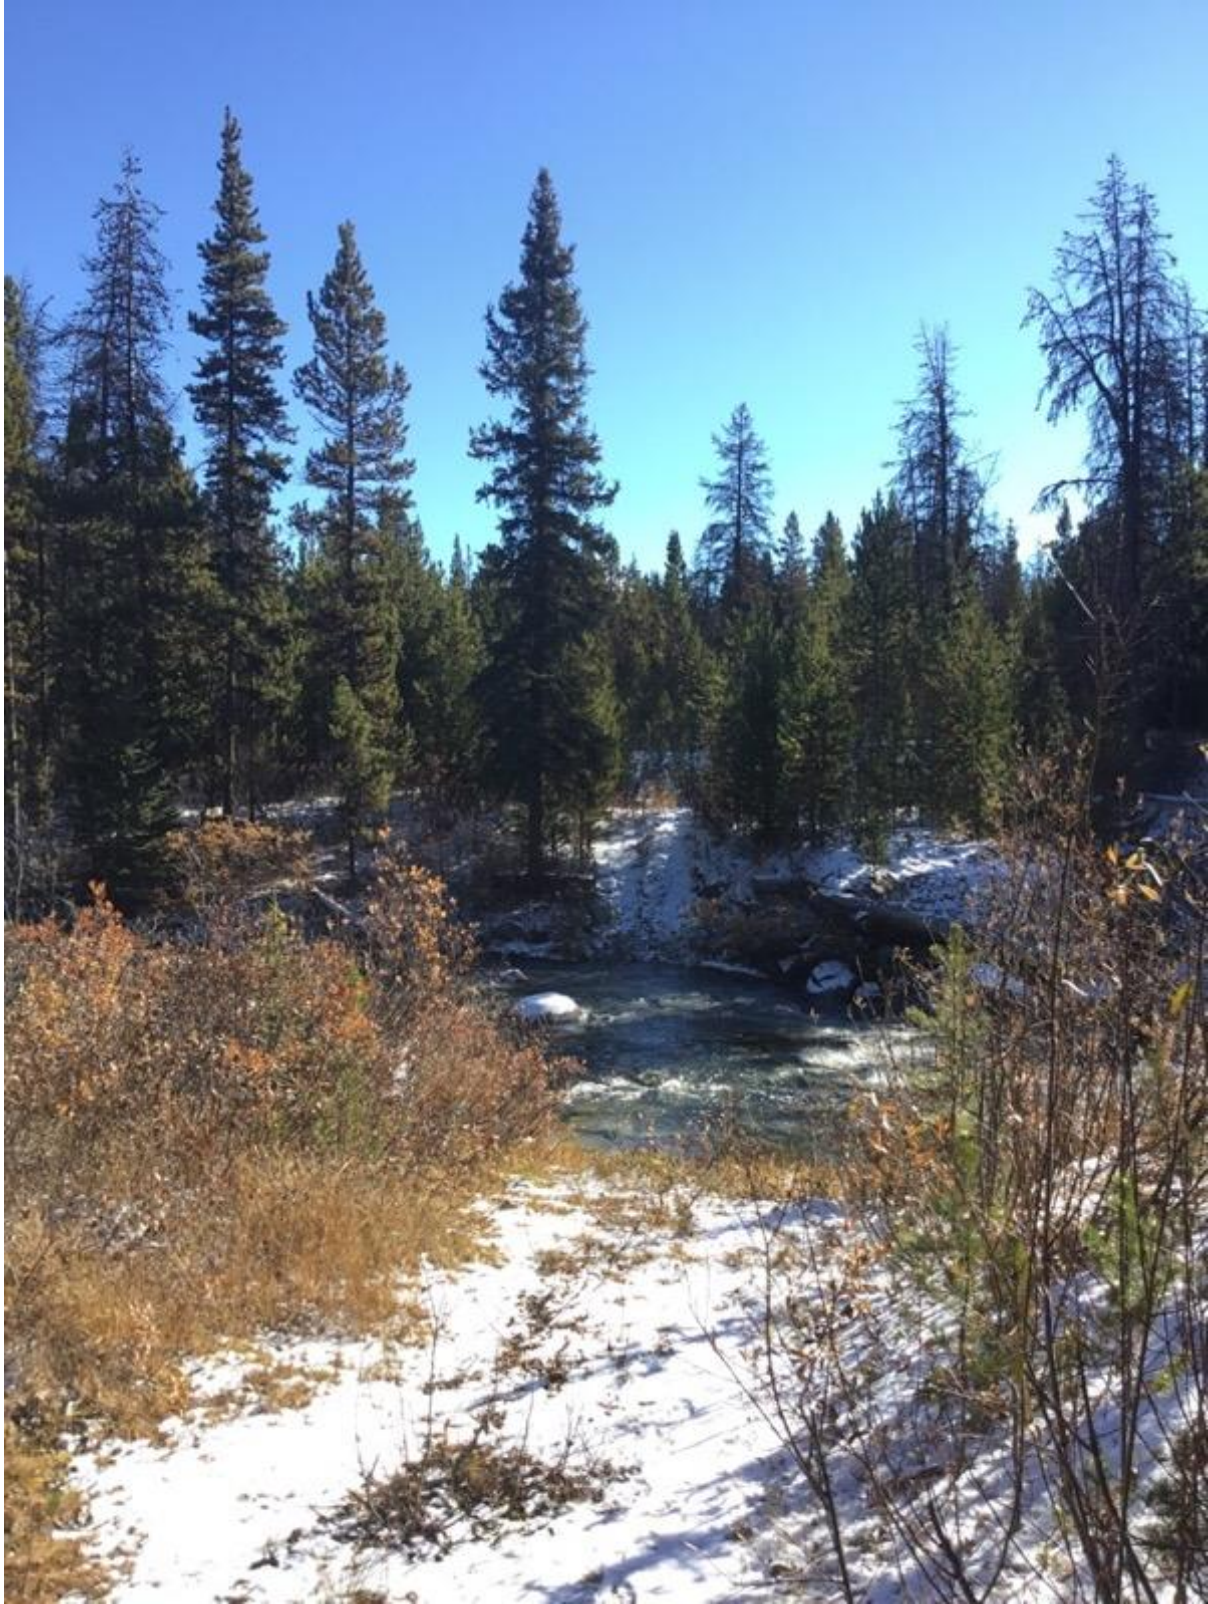
There is a creek crossing at the beginning of the road that is crossable by ATV's (Figure 29). Access control measures are recommended to prevent the continue access and crossing of the stream by ATV's.

Figure 29. Stream crossing at the beginning of Road 21.
