Restoration of Carex marsh habitat in the K'omoks Estuary

2019 Final Report

Project Number: COA-F19-F-2784

Guardians of Mid-Island Estuaries Society

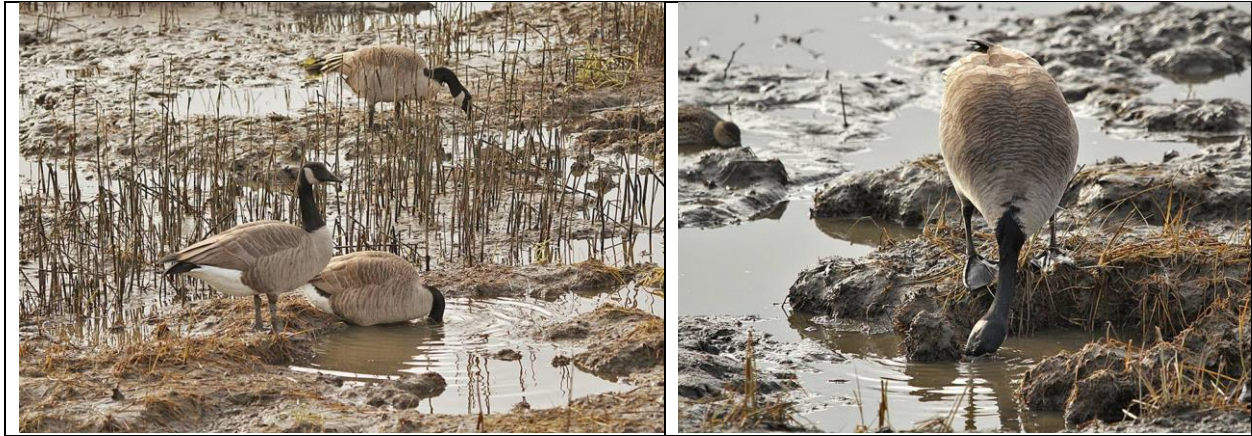
Figures 1 and 2. Canada Geese grubbing *Carex* rhizomes which led to marsh platform erosion at the K’omoks Estuary, January 2018.

Year-round resident CAGO and a variety of “visiting” sub-populations (Clermont, H. 2015), have been directly linked to over-grazing and grubbing of channel edge vegetation dominated by species such as the highly productive Lyngbye’s Sedge (*Carex lyngbyei*), leading to the erosion of productive sediment/soils and the collapse of marsh benches on most estuaries found along the east coast of Vancouver Island. Since 2015, the Guardians of Mid Island Estuaries Society (GoMIES) have worked closely with the K’omoks First Nation (KFN) Guardians to address a new emerging issue that is severely impacting estuaries within the KFN traditional territories. Overabundant resident Canada Geese (CAGO) have over-grazed estuarine marshes in the K’omoks estuary which has caused erosion of significant marsh and beach structure in the estuary. The greatest loss of *Carex* channel edge communities in the K’omoks Estuary occurs in the Dyke/Comox Slough off Comox Road. Several other locations are at risk with over 1200 resident Canada Geese observed feeding on the K’omoks estuary in August, September, and October 2017 and 2018. The photos below are Canada Geese feeding in the K’omoks estuary in January 2018.

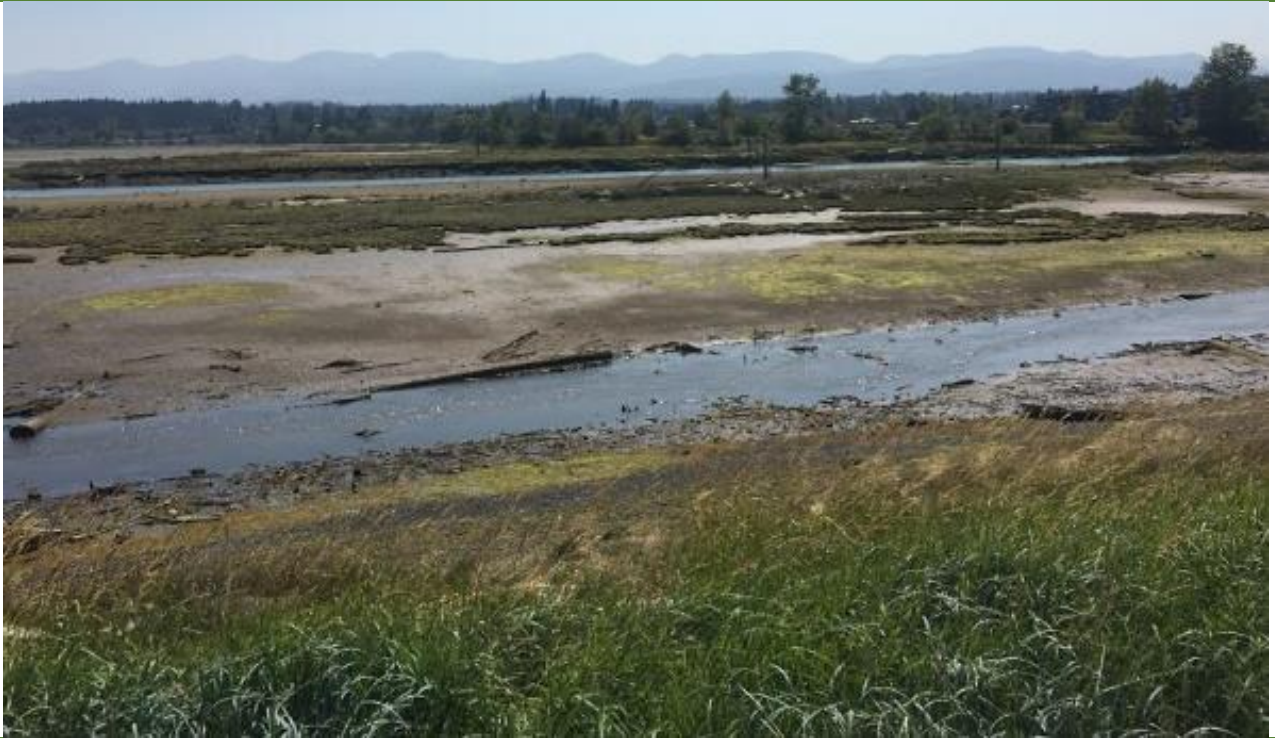
K'omoks Estuary marsh platform degradation adjacent to the Courtney River, July 2018.

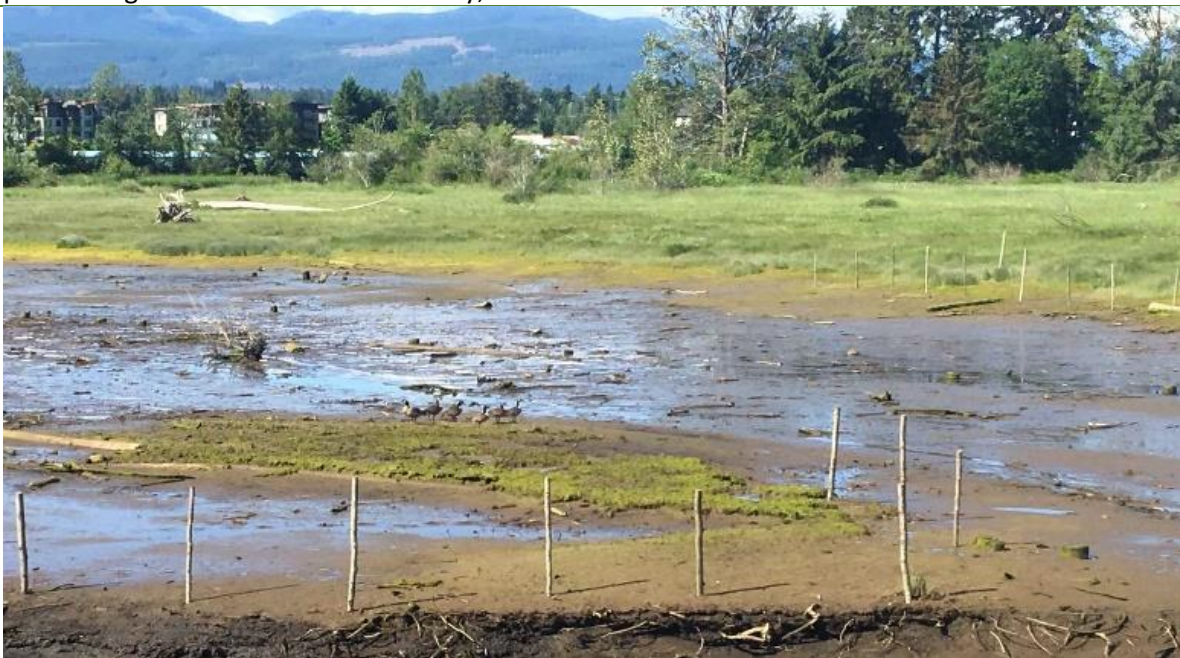
Early stages of restoration fencing being installed to protect remaining platform, transplants were later introduced to this site, May 2018.

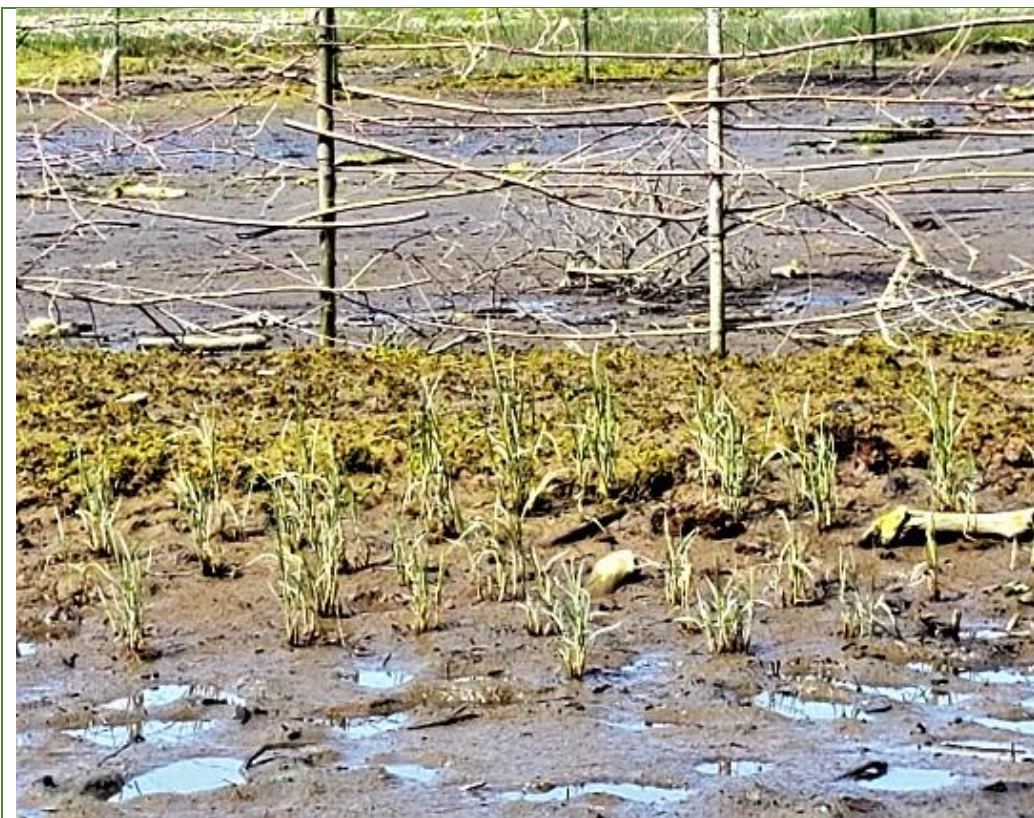
Same platform as previous photo after Eco-Cultural fencing installed and *Carex* plugs transplanted, May 2019.

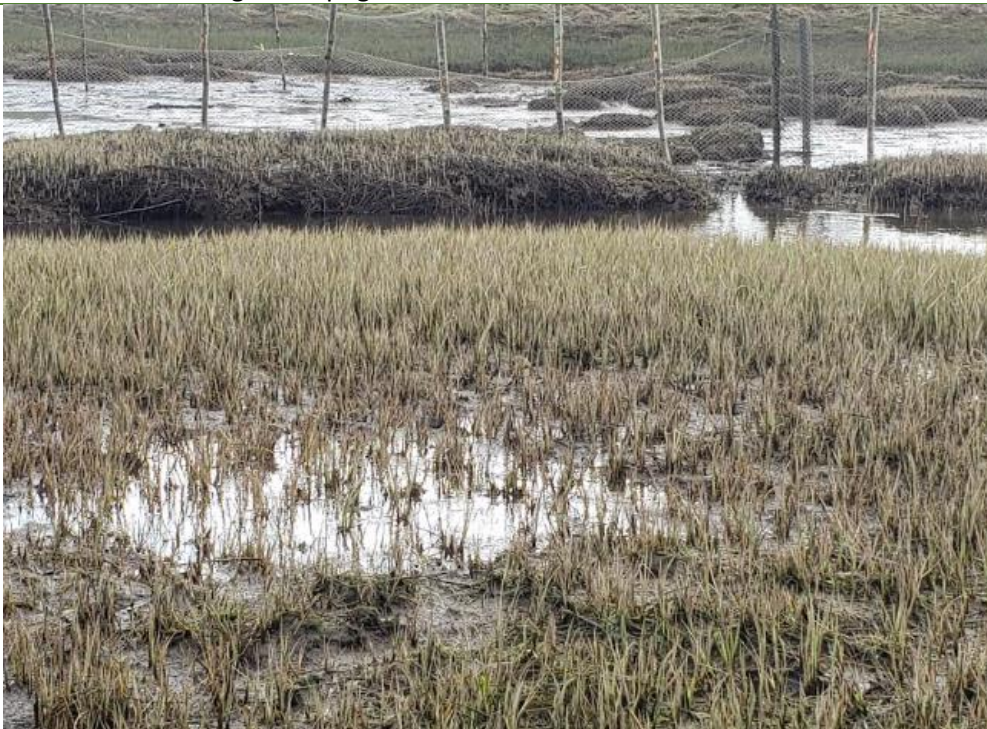
Previously degraded *Carex* stands recovering due to restoration fencing protecting from Canada Goose herbivory. March 2019.

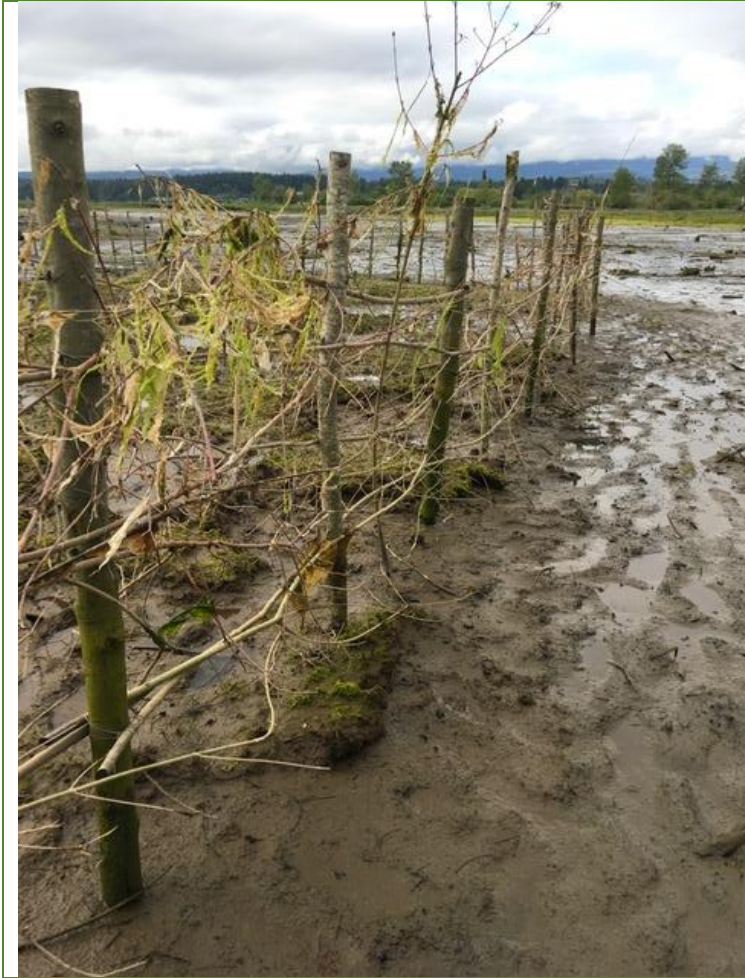
Example of eco-cultural fencing, no plastics or metals involved in the construction process.

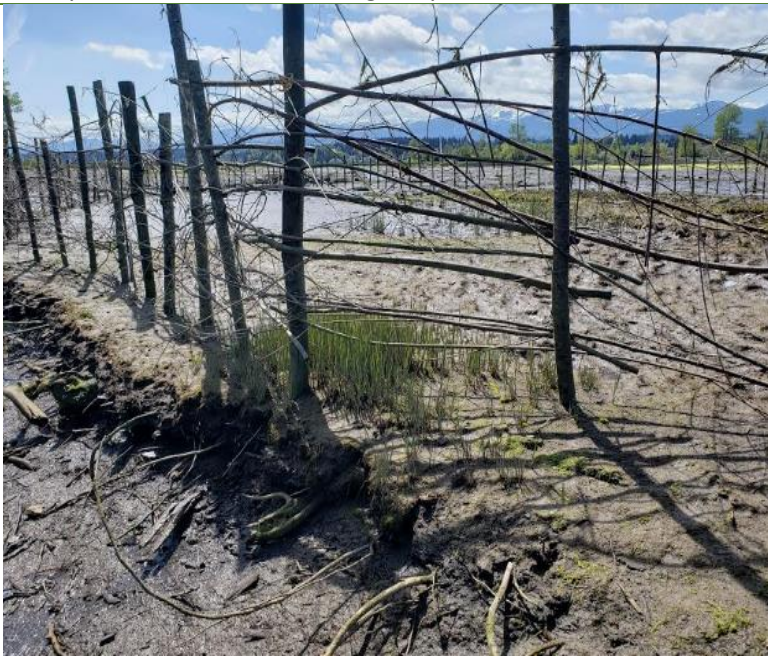
Site protected with eco-cultural fencing, 100s of *Carex* transplant plugs introduced, March 2019.

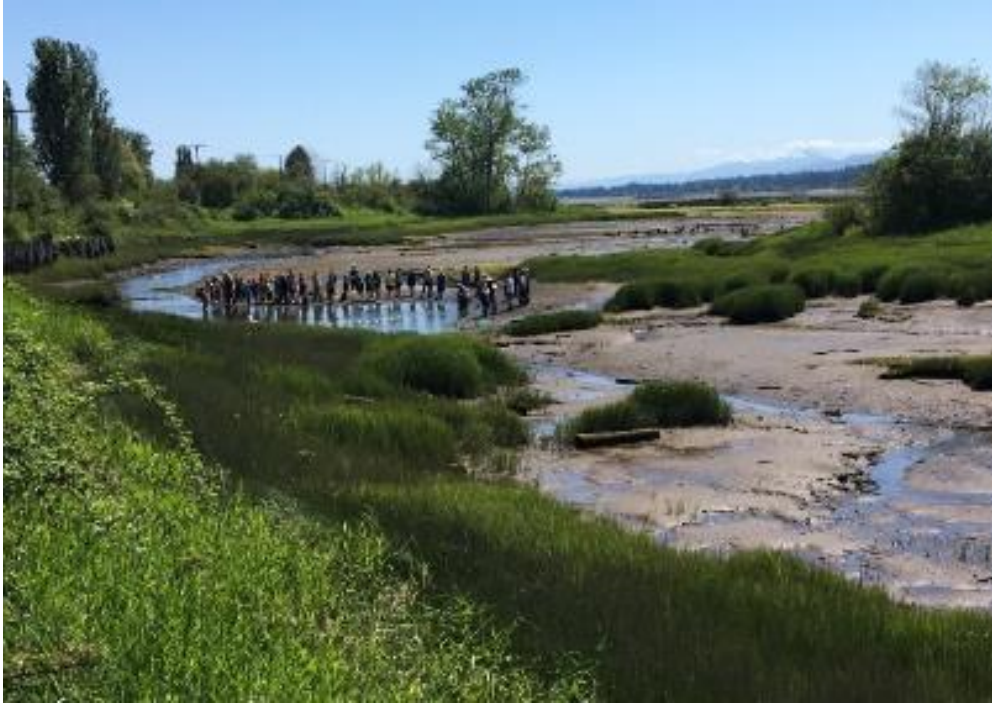
Denuded mudflats, exposed to erosion, prior to 2018 restoration fencing. School group seining fry with DFO and PW volunteers.

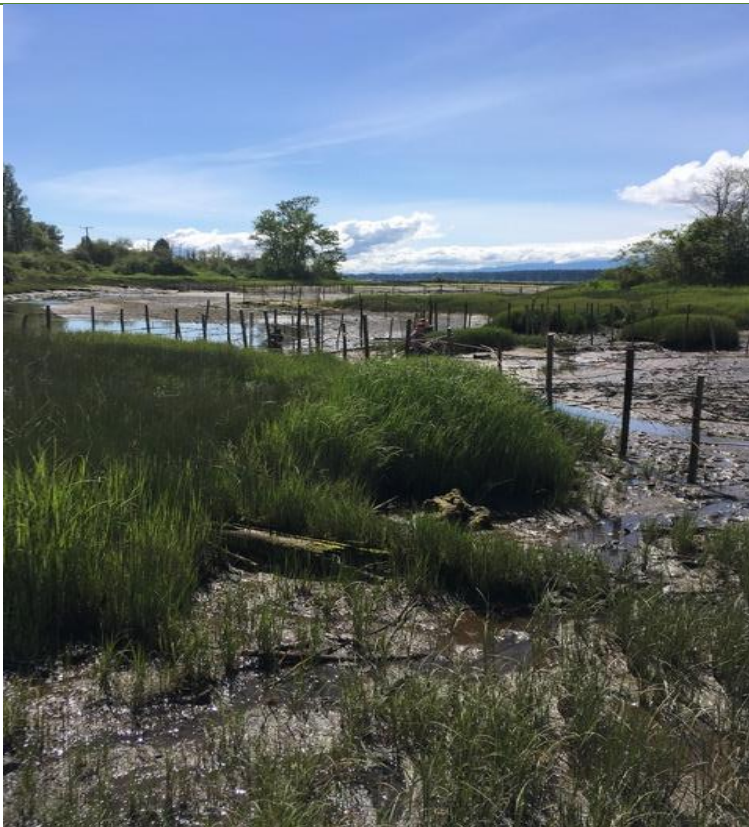
Carex rhizomes spreading over previously denuded area, May 2019. Improved eco-cultural fencing in progress.

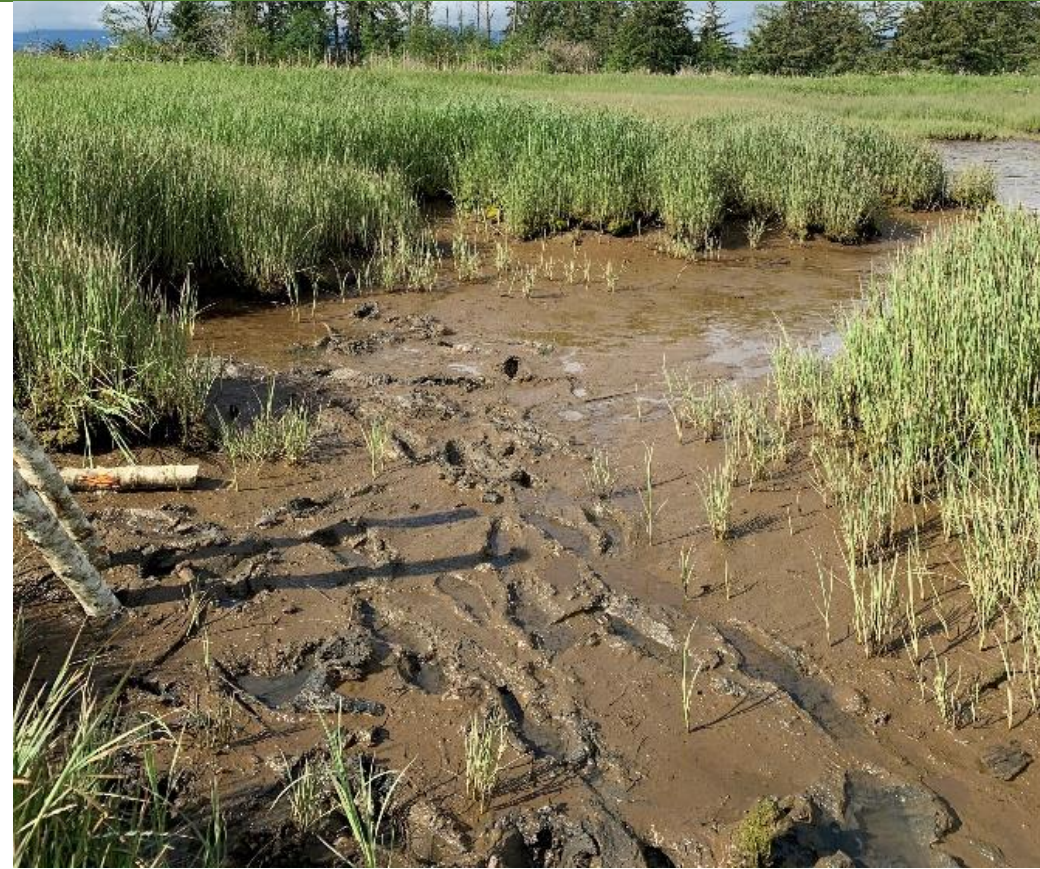
Rhizomal spread of *Carex* now possible after exclosure protection from Canada Goose herbivory. Comox Slough/Hollyhock flats, May 2019.

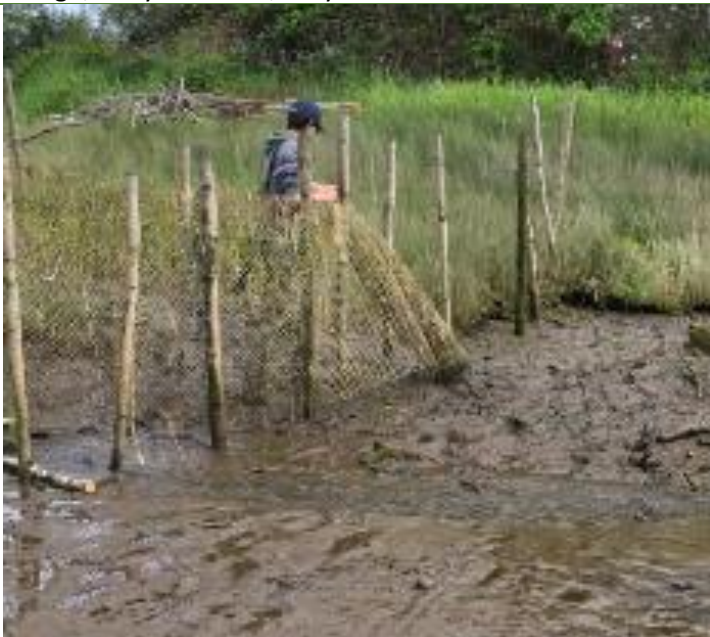
Temporary plastic “snow fencing” coming down to be replaced by 100% natural eco-cultural fencing, constructed of alder, willow, and hemp, May 2019.

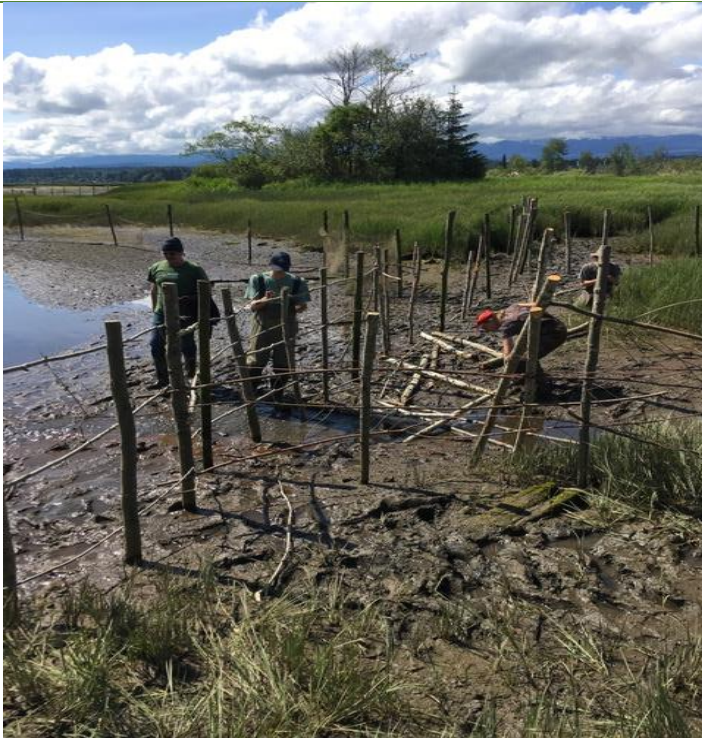
Eco-cultural fencing going up in the spring of 2019.

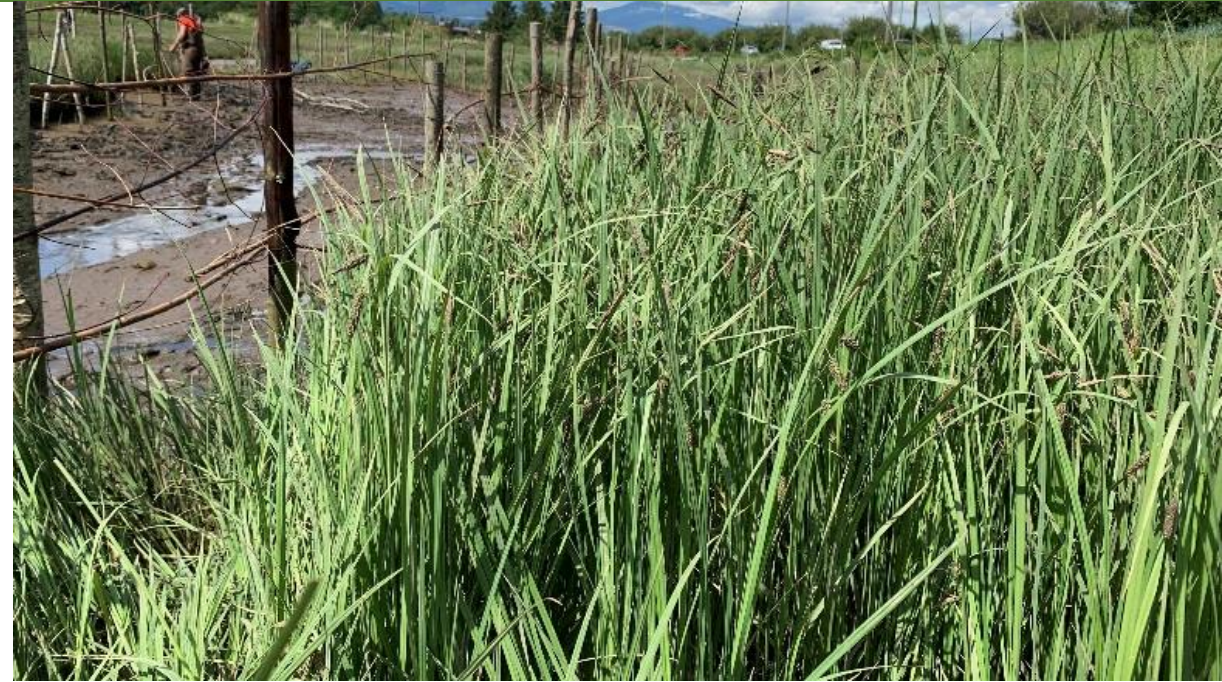
2019 *Carex* growth flourishing under the protection of eco-cultural fencing.

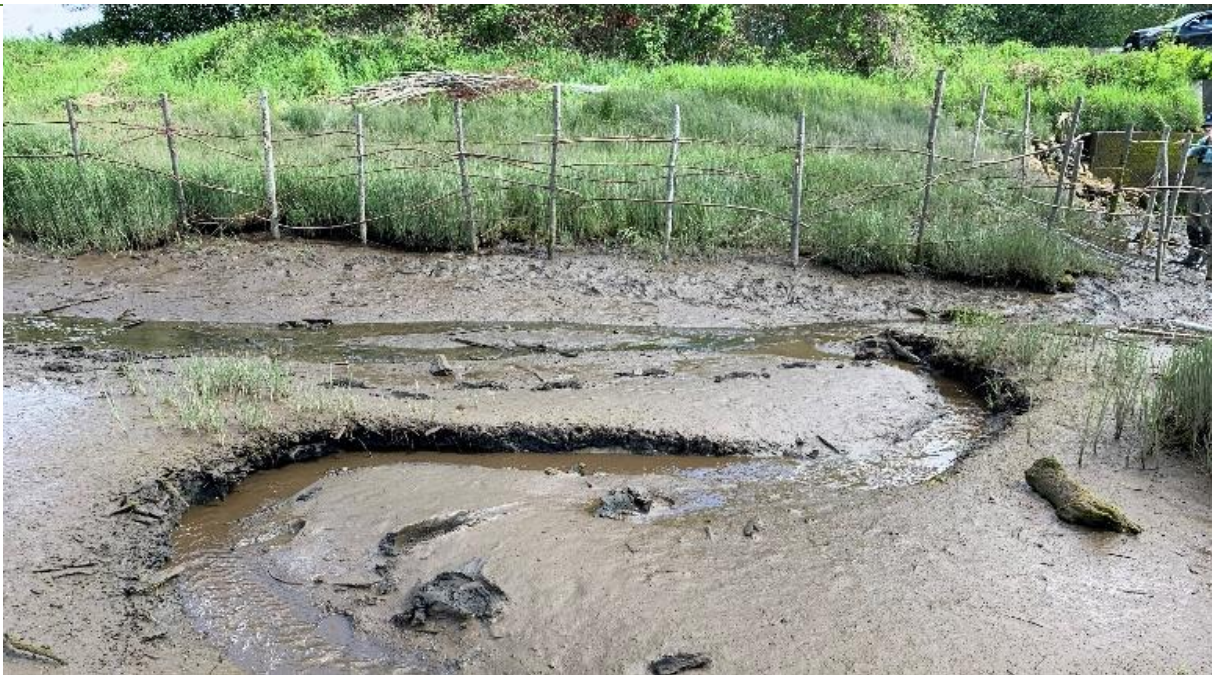
Carex flourishing behind the protective eco-cultural fencing and beginning to re-establish along the dendritic channel, Comox/Dyke Slough, May 2019.

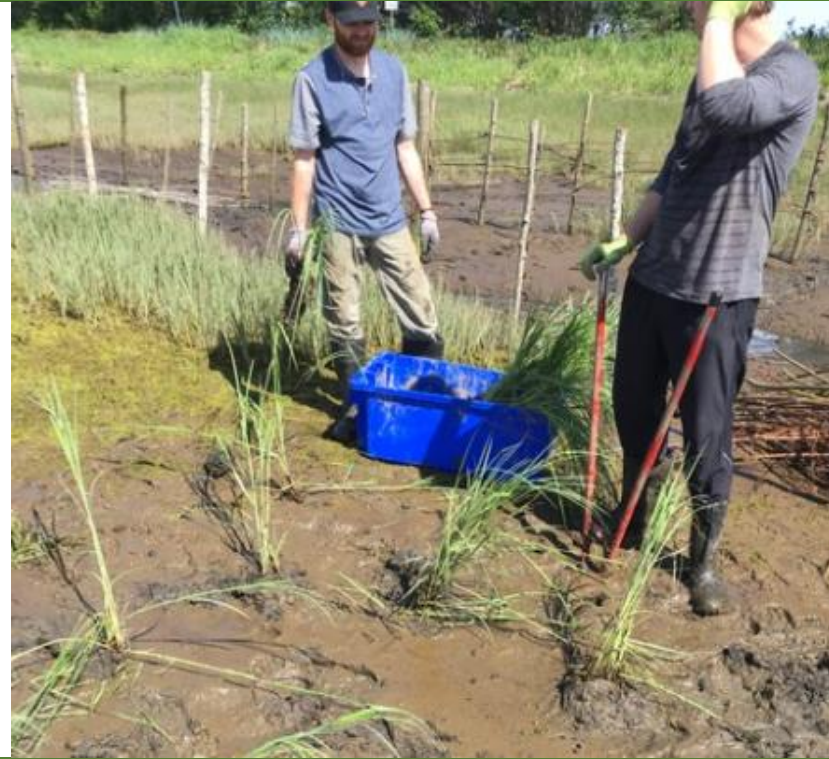
The *Carex* plug transplanting process, Comox Slough, May 2019.

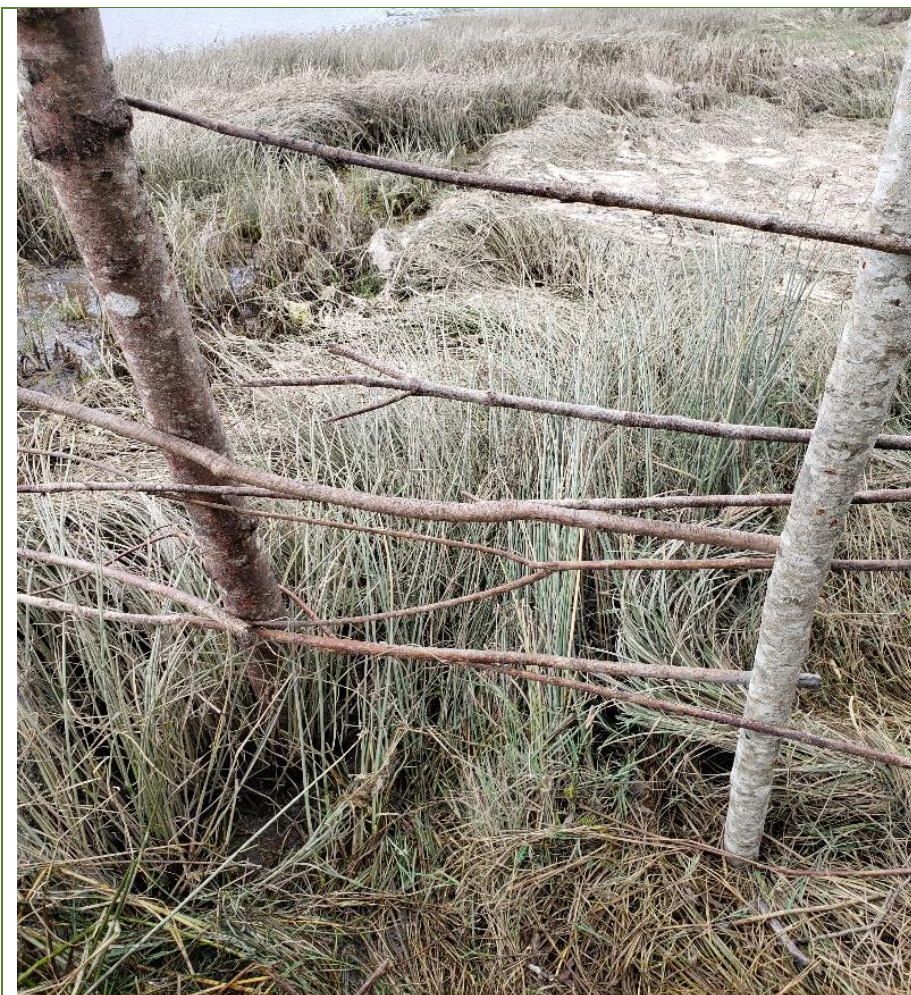
Eco-cultural fencing up in the "lagoon." August 2019.

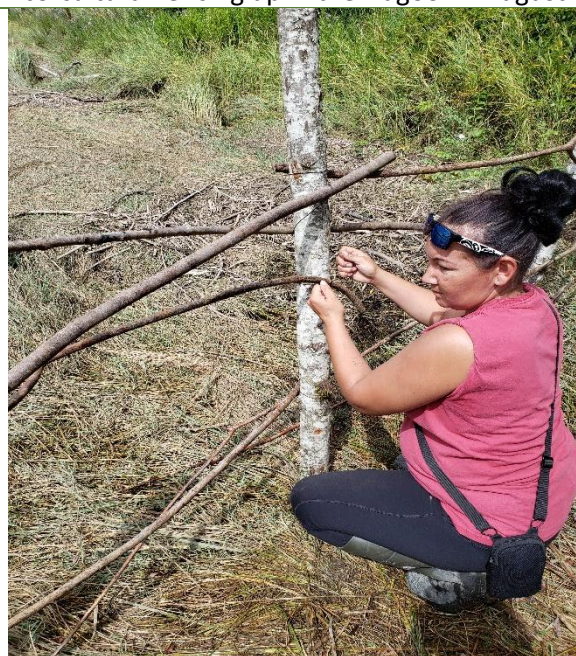
Krissy Brown in August 2019, tying in Willow to the new Air Park Lagoon eco-cultural fence.
