**Reeve Slough Feasibility Assessment 2019  
Final Report**

FWCP Project ID# COA-F20-F-3083

Prepared for Fish & Wildlife Compensation Program

Prepared by North Fraser Salmon Assistance Project Society

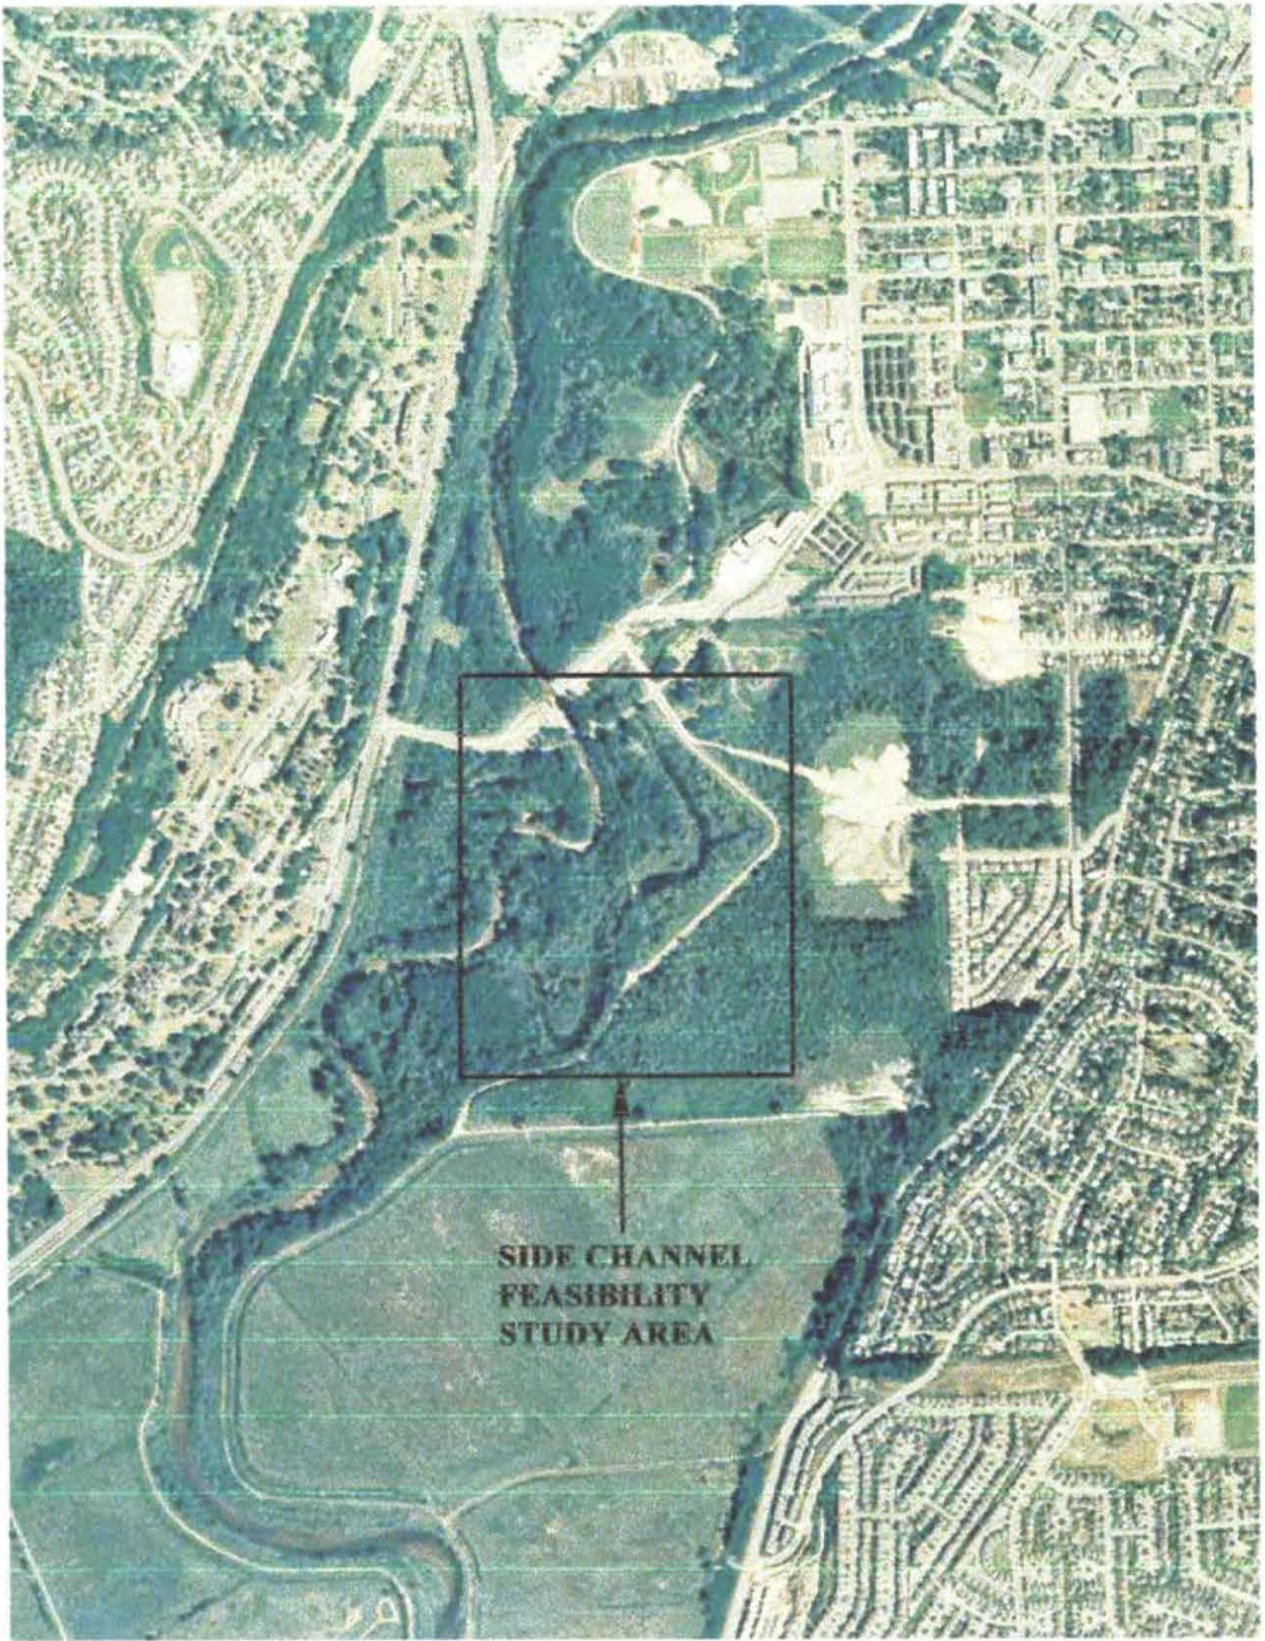
**Figure 3.1.** 1996 aerial photograph of lower Coquitlam River showing urban interface with side channel area. Coquitlam City boundary to left, Port Coquitlam boundary to right.

Figure 3.1, a 1996 color aerial, provides the general inter-urban landscape context surrounding the study area. As is evident, land development is predominant, and very little undeveloped lands remain in the lower reaches of the Coquitlam River. To the immediate right and east of the side channel site, and outside the boundaries of Kwikwetlem Reserve No.2, is the large up-slope Mary Hill urban residential complex within the municipal boundaries of Port Coquitlam City. This interface, as described by the consultants, creates an important concern in their recommended water quality infusion option for the proposed side channel rehabilitation site.

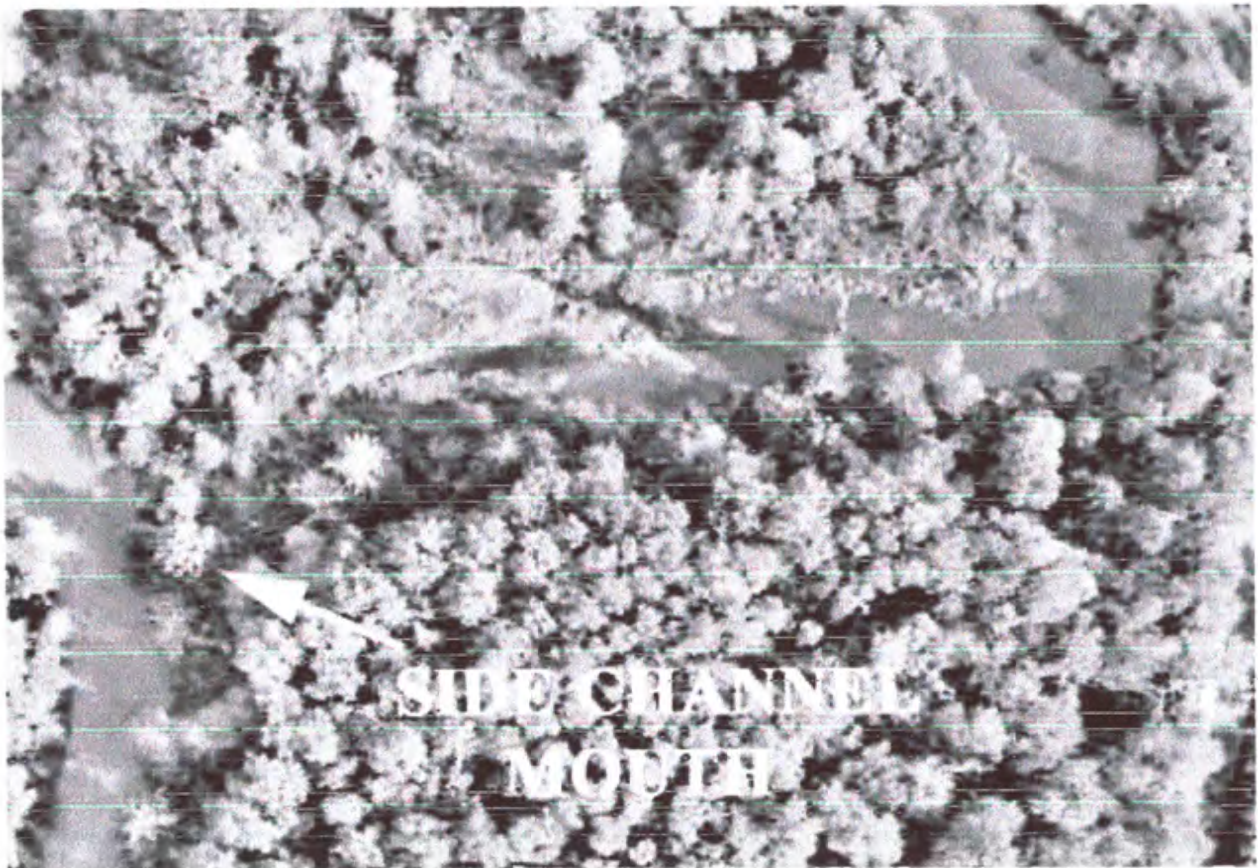
**Photo 4.1.** Location of Coquitlam River and side channel mouth.

At low water, the Coquitlam River is now one meter lower than the side channel, therefore water flow connectivity may be absent at critical times of the year for coho salmon migration and movement. This may necessitate engineering to lower the bottom side channel. By doing so, this may significantly impact the side channel by reducing “pool depth due to dewatering,” necessitating the possibility for lowering much, or all, of the remaining side channel. The consultants recommend a “bathymetric survey of the channel should be completed to determine if pool depth would be significantly impacted by lower water levels.”

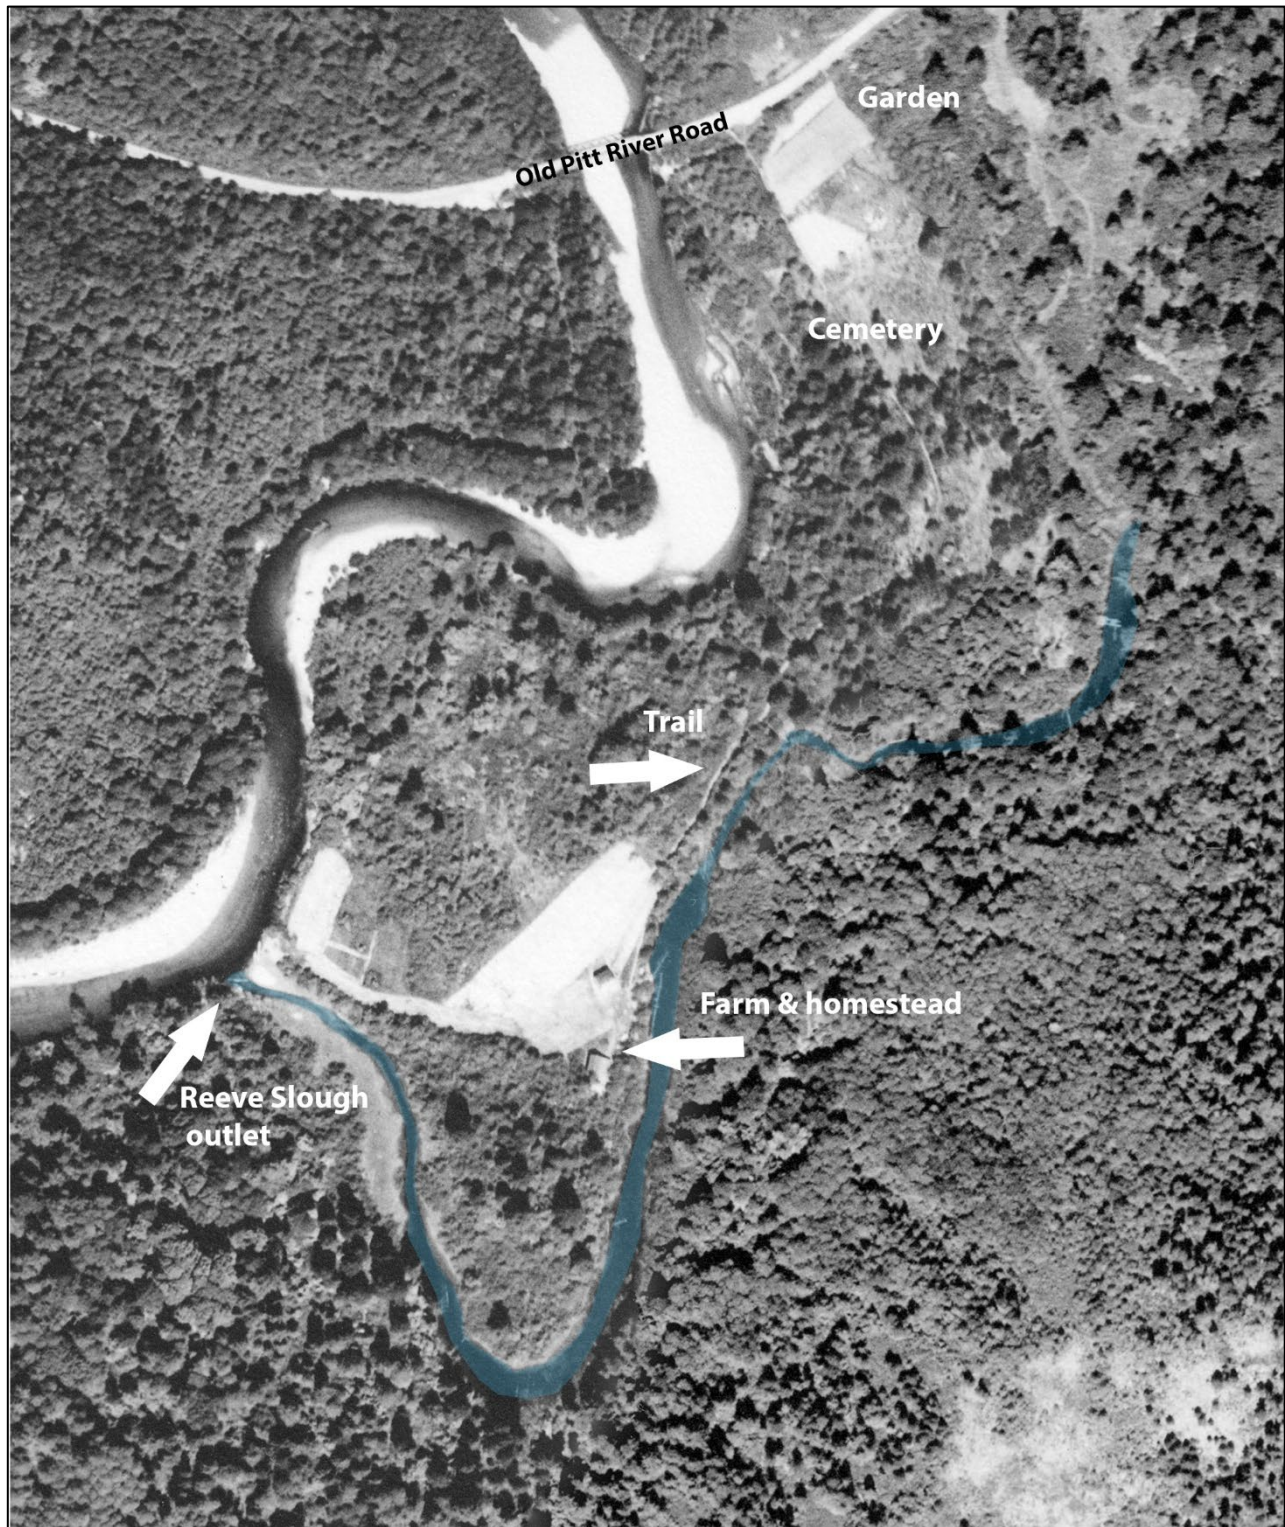
**Figure 3.** Historic 1938 air photo compilation (UBC, Geographic Information Centre).

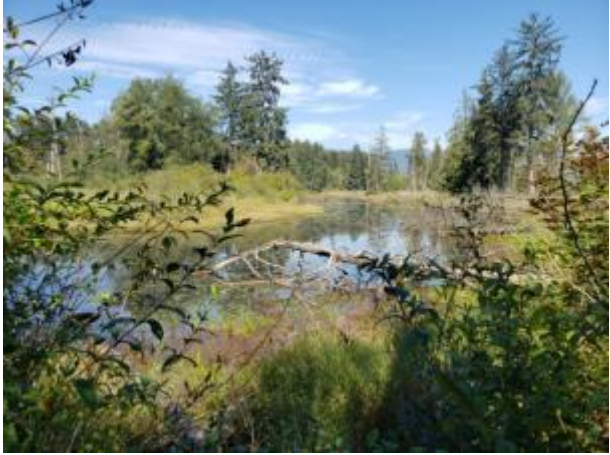
Topography is generally flat (<2% gradient) apart from the dyke itself. The project area encompasses what appears to be a dry, elevated channel bed that may contain water during periods of wet weather or periodic flooding. At its eastern most point, at the channel's confluence with Reeve slough, the channel bed was approximately 0.5 metres higher than the water surface in the slough.

**Confluence of dry channel bed and Reeve slough**

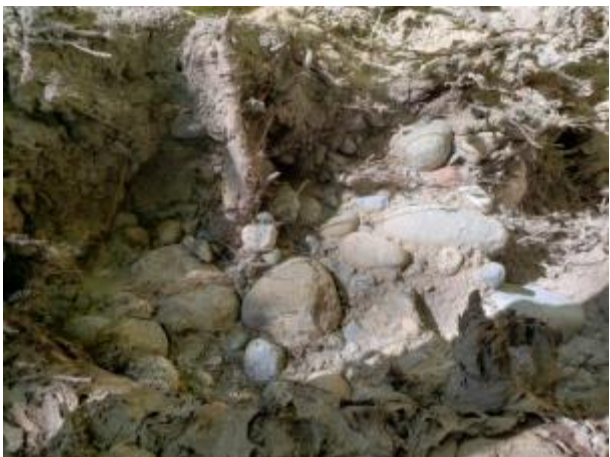
Soil tests were not conducted as part of this assessment; however, soil in the dry channel appears to have a high sand content (sandy loam) with presence of rounded gravels and cobbles. These soil characteristics are indicative of fluvial (i.e., river or stream) processes.

**Rounded cobbles in substrate (west side of project area)**

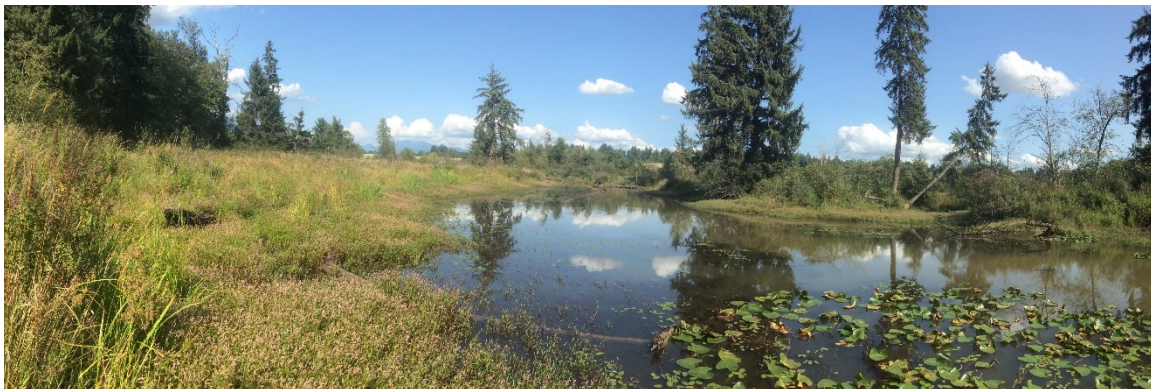
Photograph 1 - Upstream view of Reeve Slough from location of historic dyke crossing.

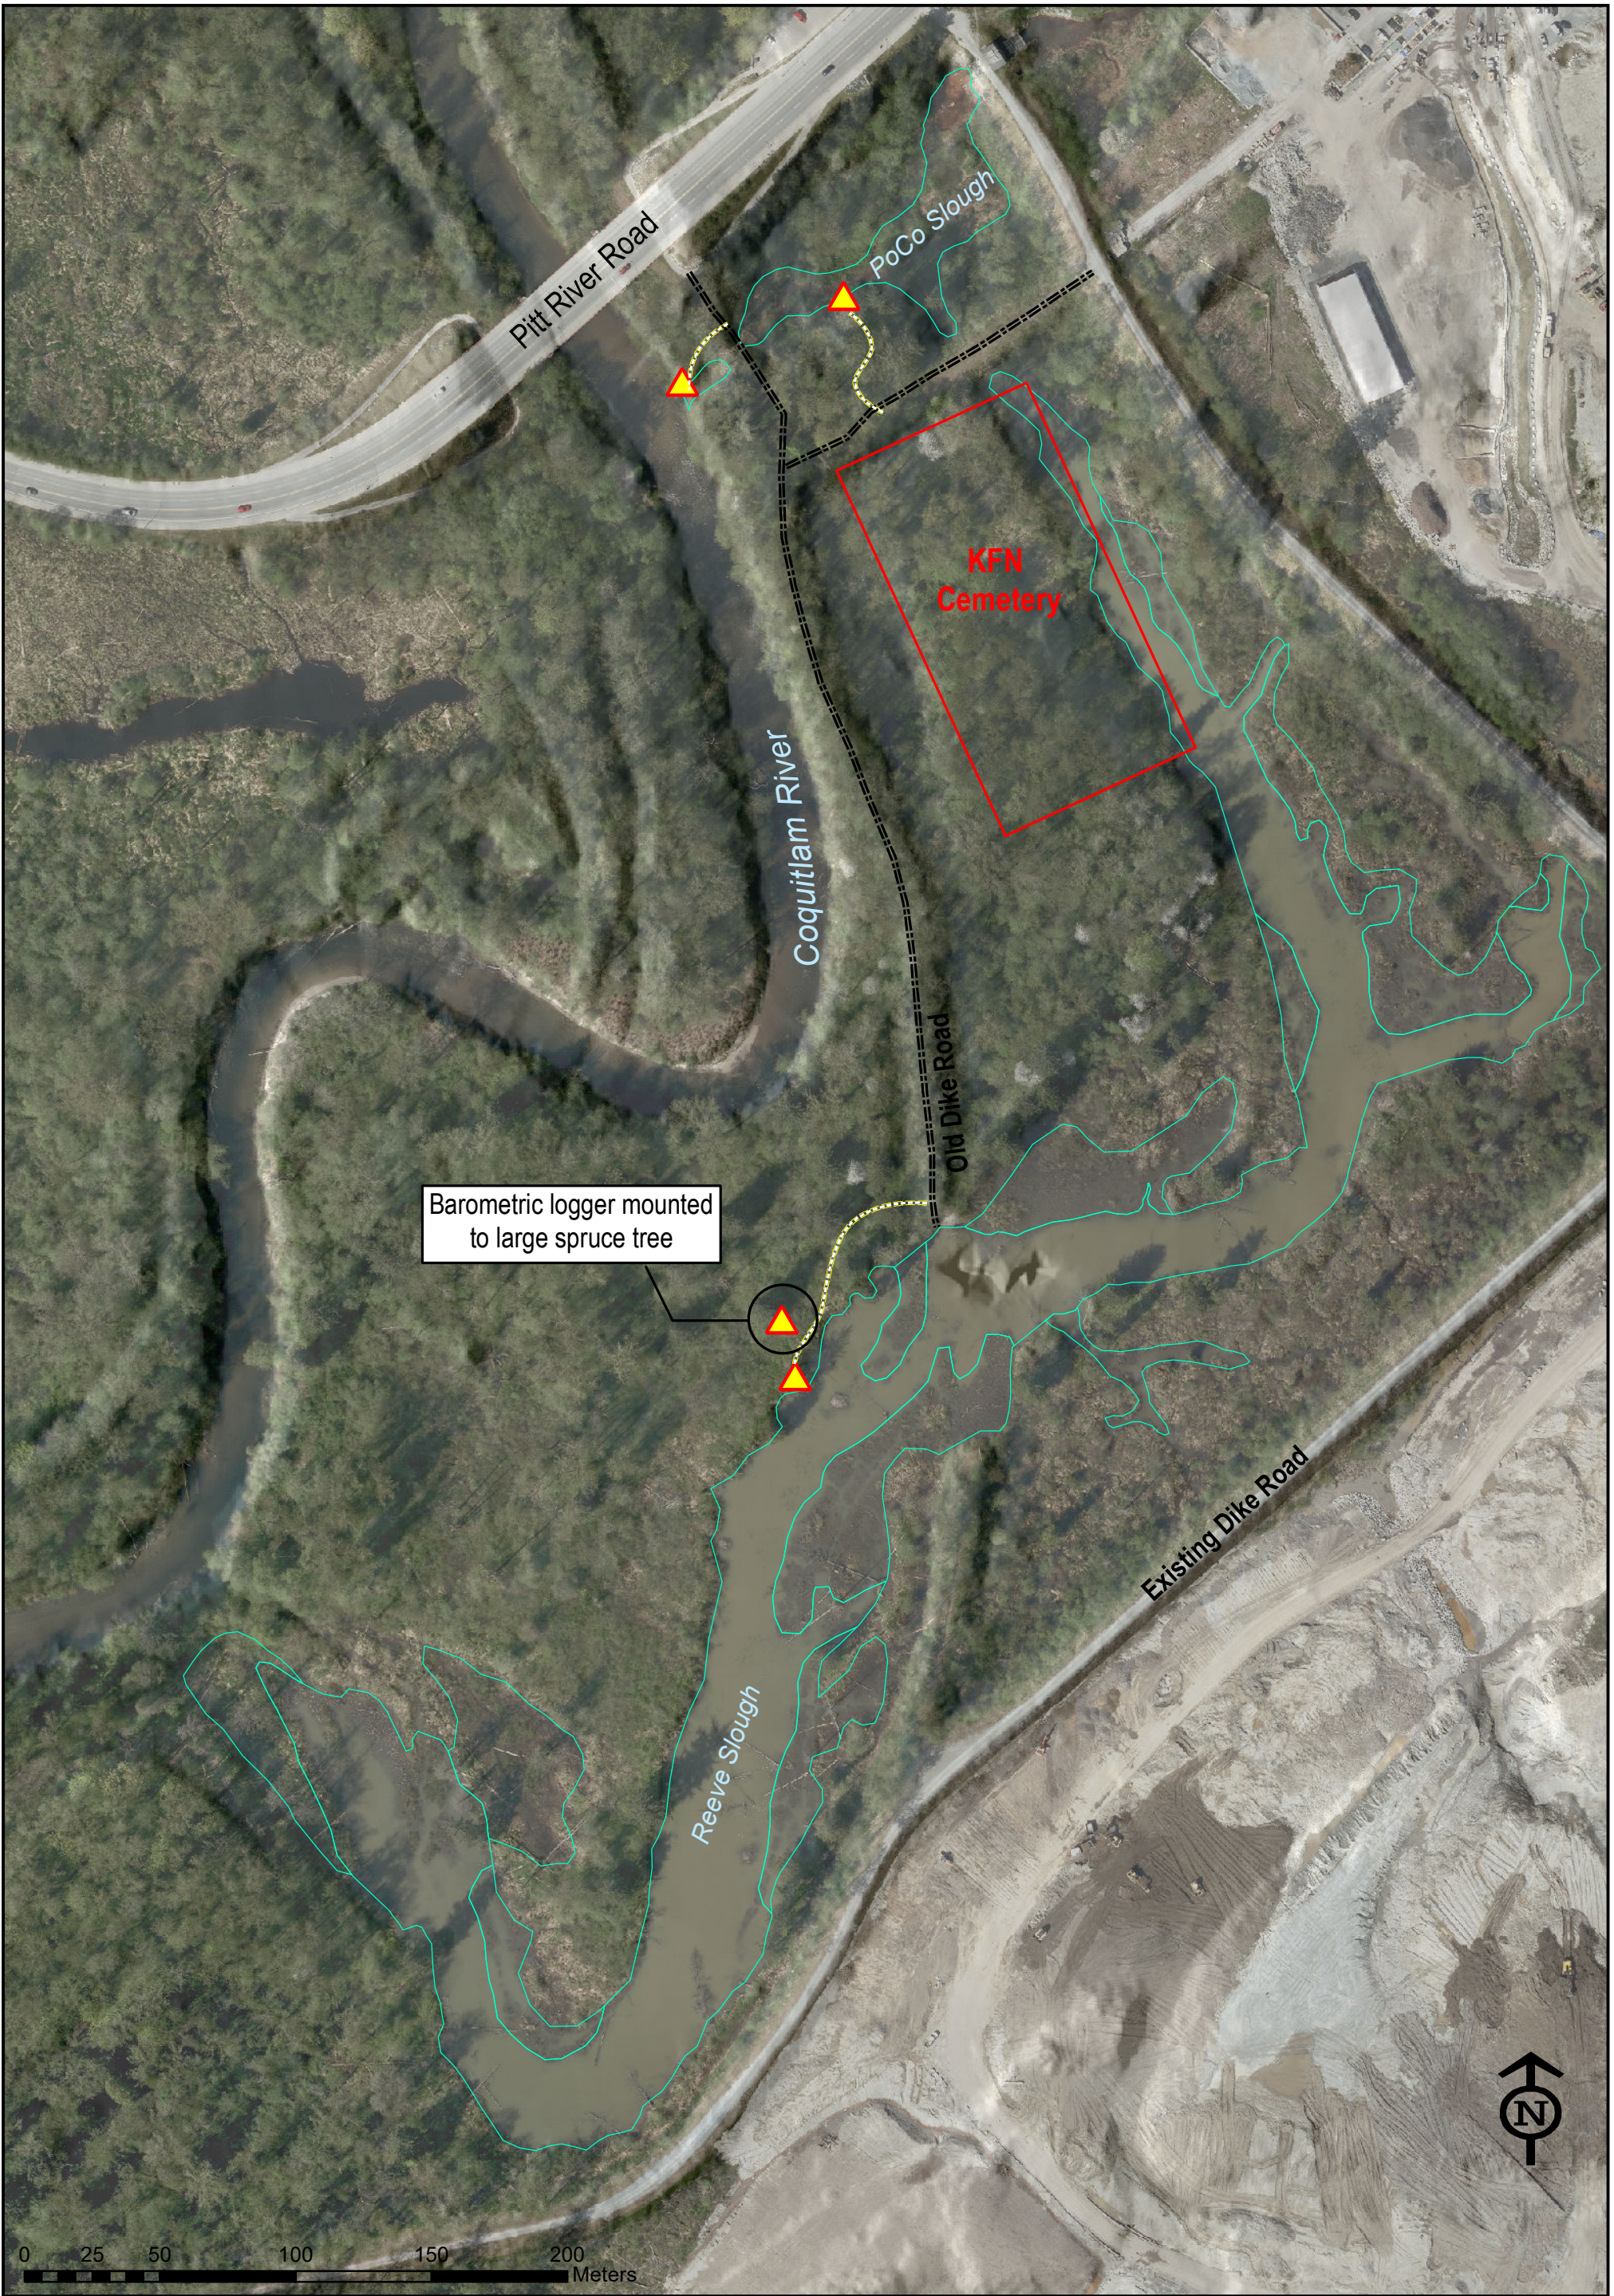
<b>Legend</b> Level_Logger Slough Natural Boundary Access (Road Surface) Foot access route		 Prepared by: <b>ENKON</b> Environmental Ltd. Map Created: 2020-02-03 by: R. Preston NAD 83, Zone 10N	<b>Reeve Slough Level Logger Locations</b>
			<b>Figure 2</b>
			<b>Fisheries &amp; Oceans Canada</b>

Data acquisition has been completed via manual downloading of the data loggers utilizing specialized equipment provided by ENKON. ENKON has been deploying the use of a Solinst direct read to optical adapter paired with a Levelogger App Interface unit to facilitate blue-tooth data collection to smart device (Appendix A).

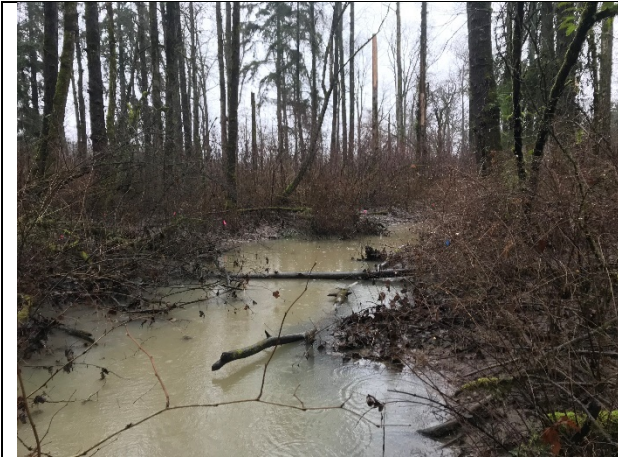
Photograph 2 – Upstream view of Reeve Slough drainage channel along approximate alignment of the LiDAR modeled flow path following Feb 2020 storm event.

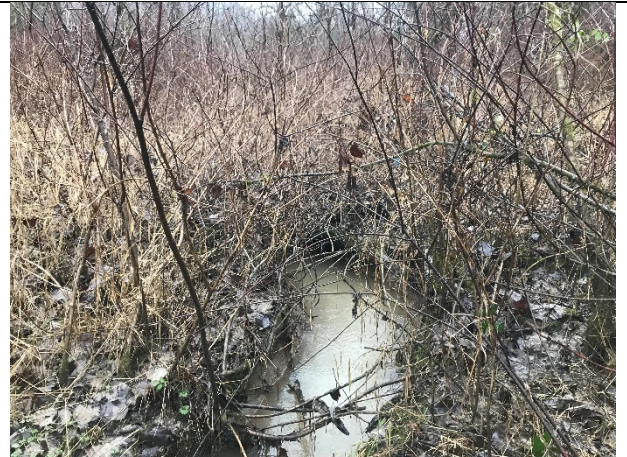
Photograph 3 – Reeve Slough drainage channel nearing confluence with Coquitlam River left bank following Feb 2020 storm event.

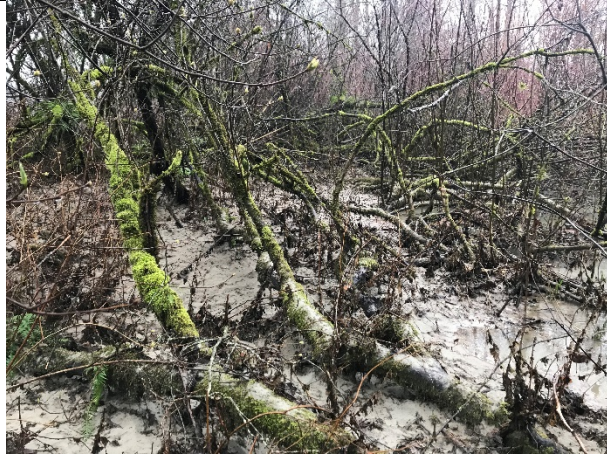
Photograph 4 - Veneer of sand deposited as a result of flood event in early February 2020 confirms overbank flooding and direct hydrologic connection between Coquitlam River and Reeve Slough.

Field assessments coinciding with the early February 2020 storm event confirmed direct evidence of floodplain inundation with a ubiquitous veneer of sand deposits on the immediate floodplain surfaces confirming the direct inundation of the northwestern areas of Reeve Slough (Photograph 4 & 5).

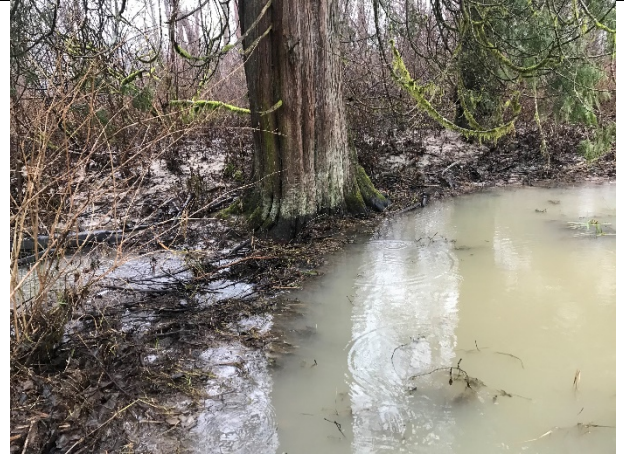
Photograph 5 - Illustration of visible floodplain inundation at NW limit of Reeve Slough illustrating slough water level, floodplain sand veneer, and visible staining on Cedar stem indicating recent flood inundation. Note nominal beaver dam obstruction at edge.

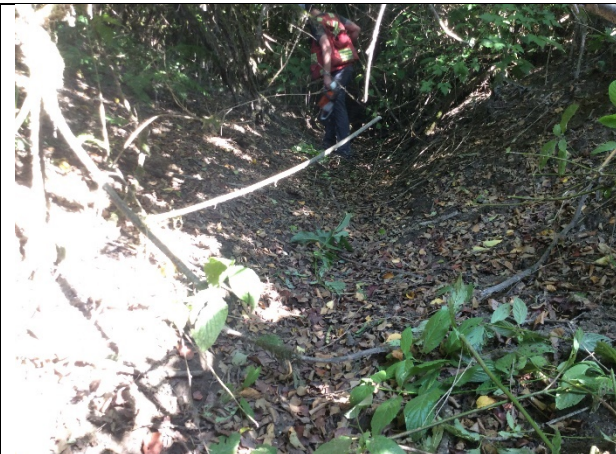
Photograph 6 – Upstream view of dry linear channel connecting Reeve Slough to Coquitlam River (July 2019)

A secondary drainage feature was originally identified as a potential drainage outlet. The identification of a discrete linear drainage feature is evident from terrain modeling results and was verified during dry weather field reconnaissance (Photograph 6). The linearity of the feature suggests a potential anthropogenic origin. Drainage function was confirmed during high water conditions (Photograph 7). However, the ditch feature is concluded to be insignificant in comparison to the main flow path mapped from the northwest terminus of the slough as discussed above. The ditch connection does not interface with the main open water boundary of the slough and drains a limited volume flow and would not afford potential fish access.

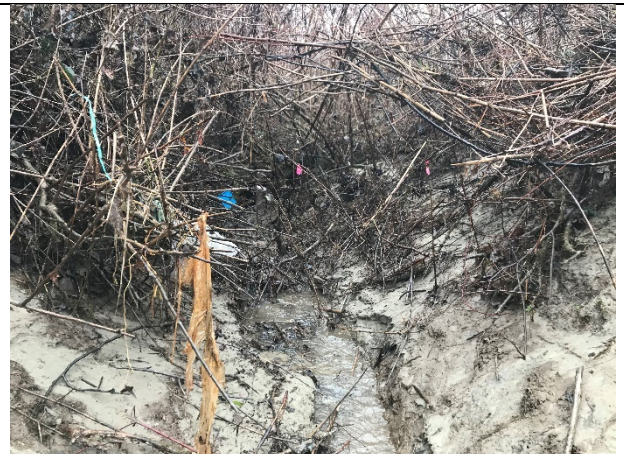
Photograph 7 – Upstream view of nominal drainage function through recently deposited floodplain sand veneer following February peak flows.

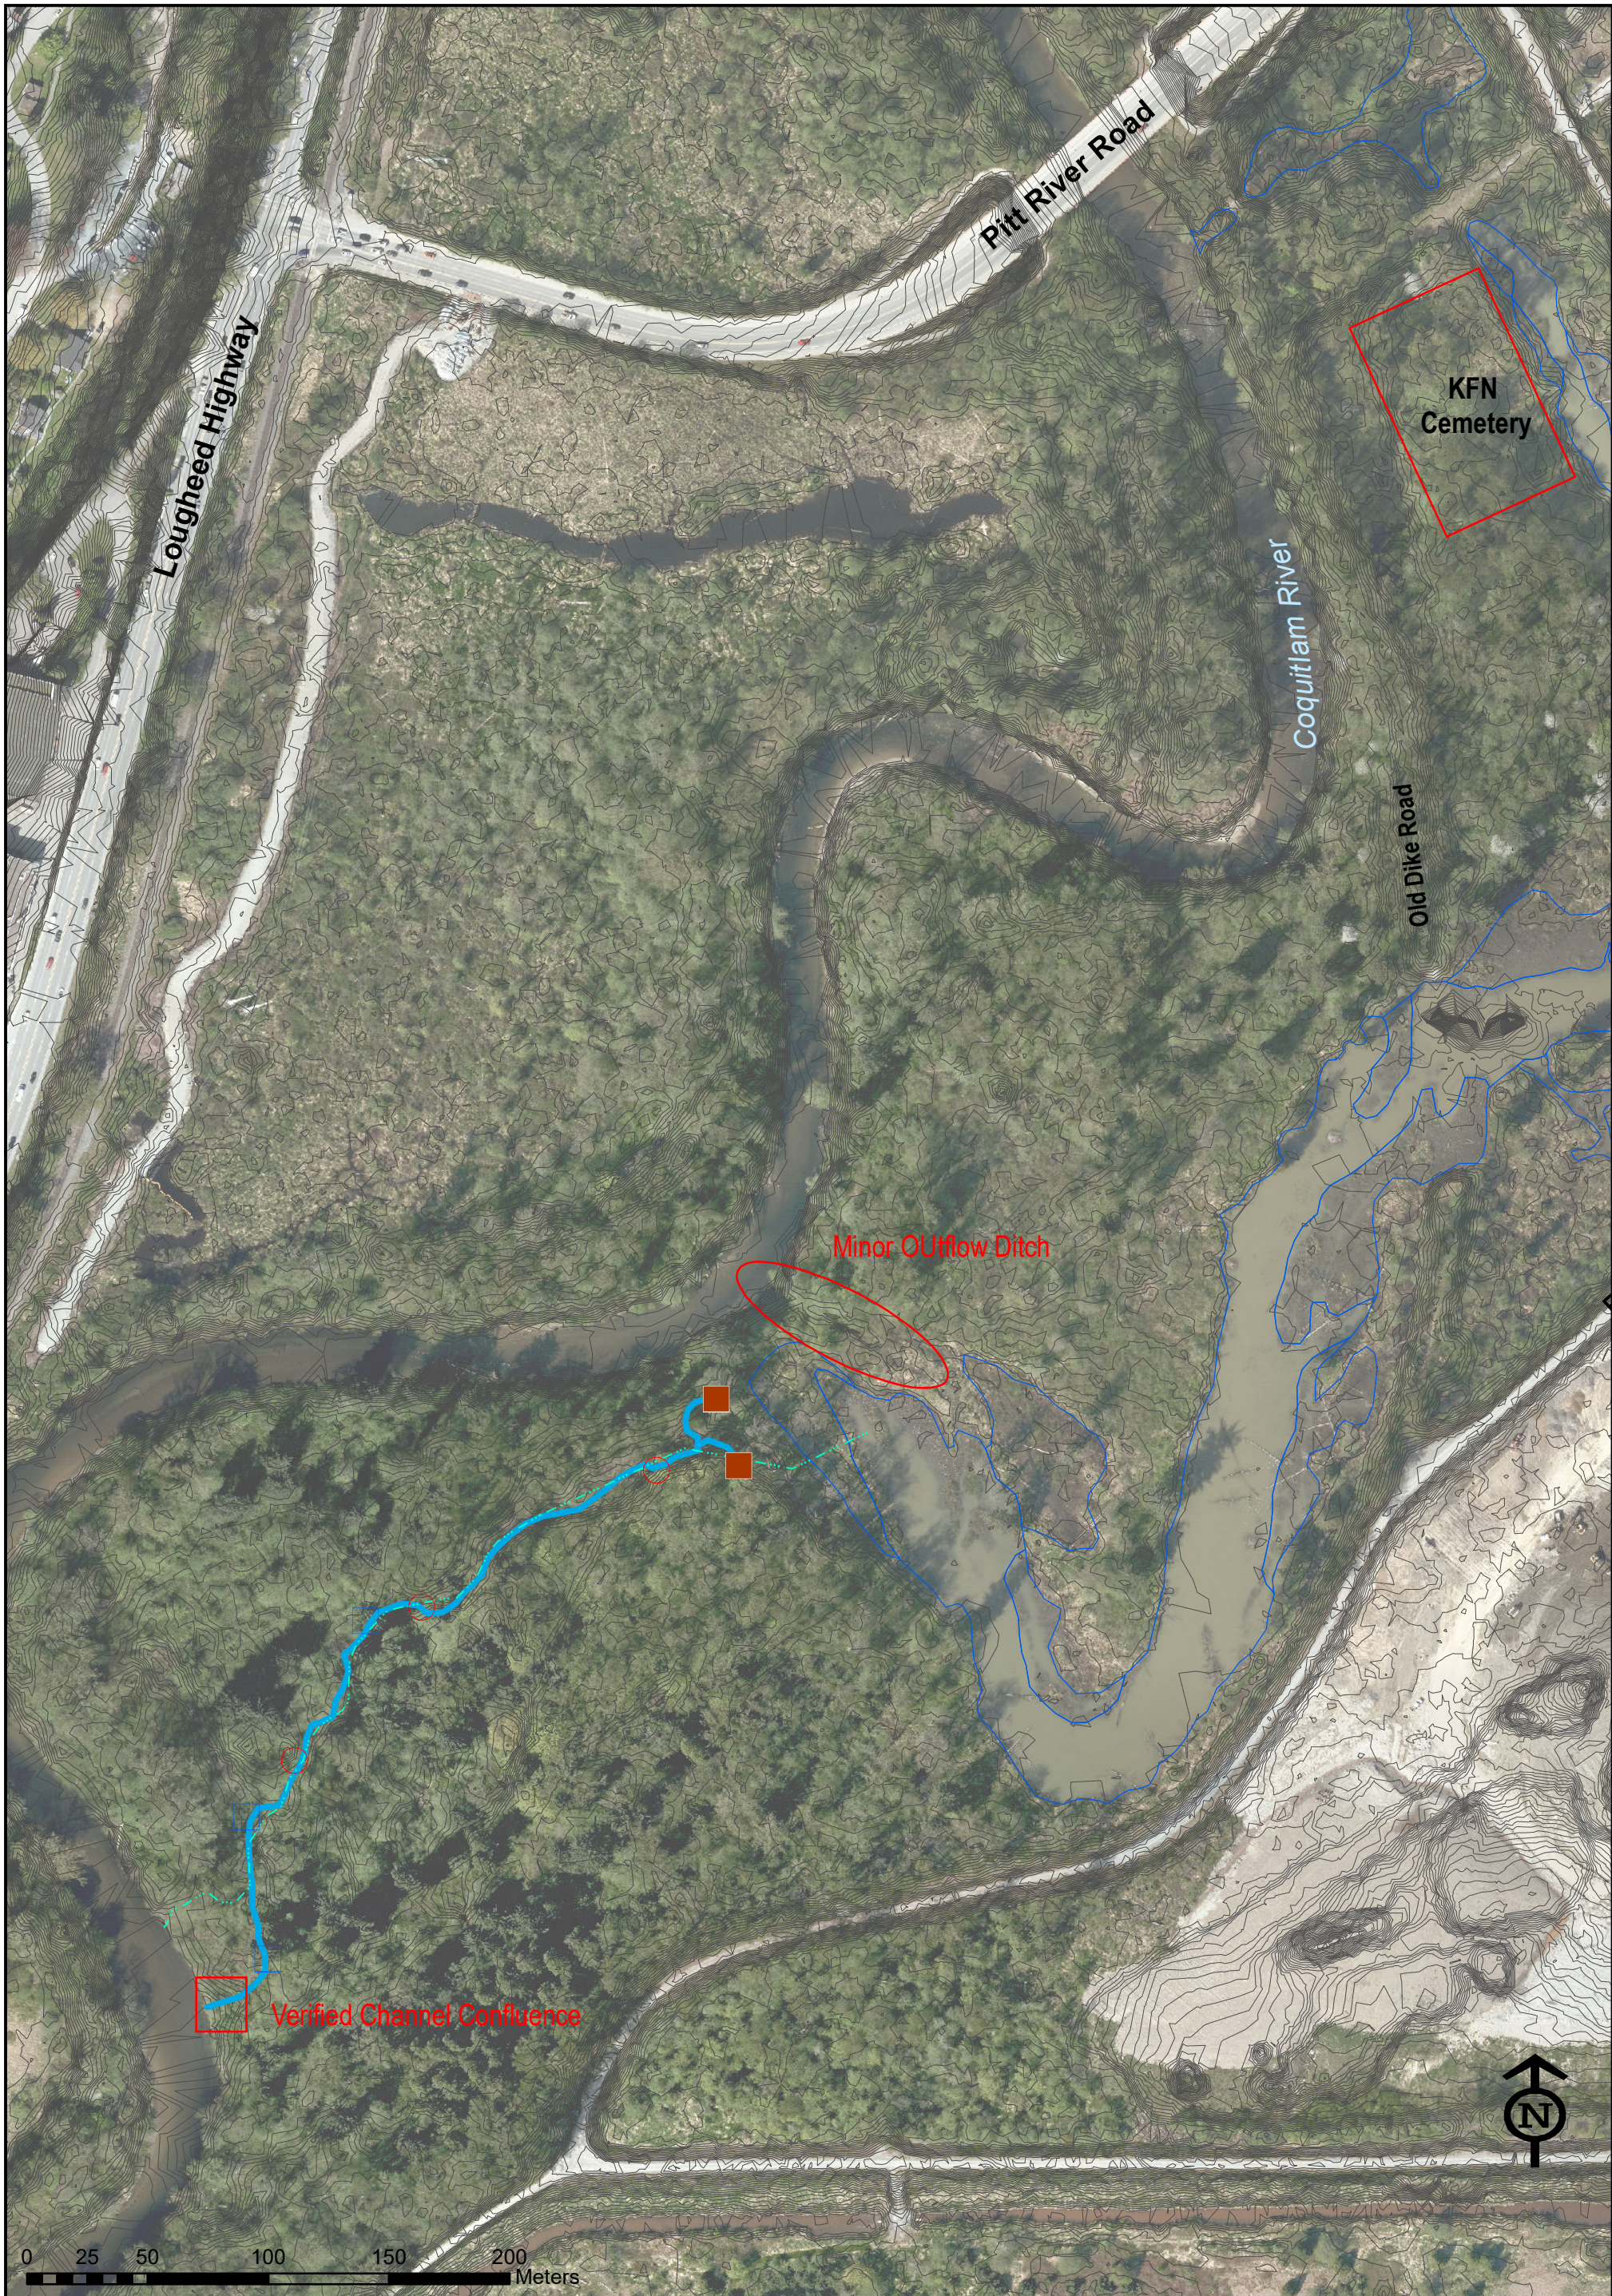
<p>Prepared by: <b>ENKON</b> Environmental Ltd.</p> <p>Map Created: 2020-02-25 by: N. Lamarche NAD 83, Zone 10N</p>	<p><b>Reeve Slough Outflow Channel Mapping</b></p> <hr/> <p><b>Figure 3</b></p> <hr/> <p><b>Fisheries &amp; Oceans Canada</b></p>

Flow direction and flow accumulation algorithms were employed to interpolate the preferential flow-path (e.g. drainage network) from the 0.5m DEM surface. The drainage network analysis yielded a drainage flow-path through the floodplain with connectivity to the Coquitlam Rivers left bank located approximately 400m from the slough boundary (Figure 3).

7. The point of confluence between the seasonal flow path and Coquitlam River is approximately 1m elevation.

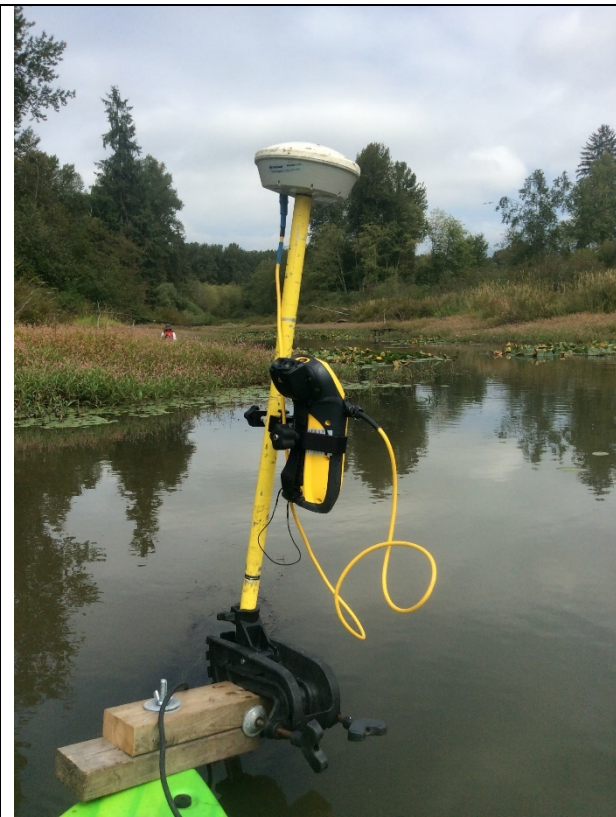
Photograph 8 – Bathymetric survey transducer and GNSS equipment mounted to a kayak at Reeve Slough

The instrumentation approach included the mounting of the transducer and GNSS data collector to a single-person kayak (Photograph 8). The transducer based bathymetric survey results provided poor spatial coverage of the wetland and no useable information with respect to a typical bathymetric map to understand the subsurface profile of Reeve Slough. The significant variability of the bed of the slough coupled with the manufacturers requirement for a minimum 0.4 m depth of insertion for the SonarMite transducer, coupled with the significant density of aquatic weeds (Photograph 9) precluded assessment of all but the central portion of the slough (Figure 4).

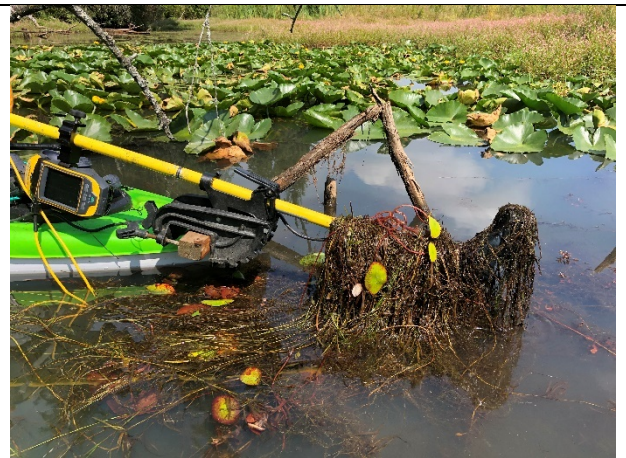
Photograph 9 - Illustration of typical transducer fouling resulting from extensive aquatic weed presence within Reeve Slough.

Result of the bathymetric instrumentation was the interpretation of maximum slough depth which was recorded as 1.92m with an average of 0.7m for the accessible areas of the slough. The result is limited due to fouling from aquatic plants which precluded the possibility of the development of bathymetric mapping. Any future detailed bathymetry requirements should be pursued only under winter high water conditions. Even then, the expectation of detailed bathymetric datasets should be tempered due the prevalence of obstructions, aquatic weed fouling, and relatively shallow depths. The manual bathymetric analysis facilitated by the sampling at 69 stations increased the mapped area, thus providing additional detail of the depth to benthic surface material which ranged from 0.4 to 2.1 m, with an average slough depth of 1.28 m.

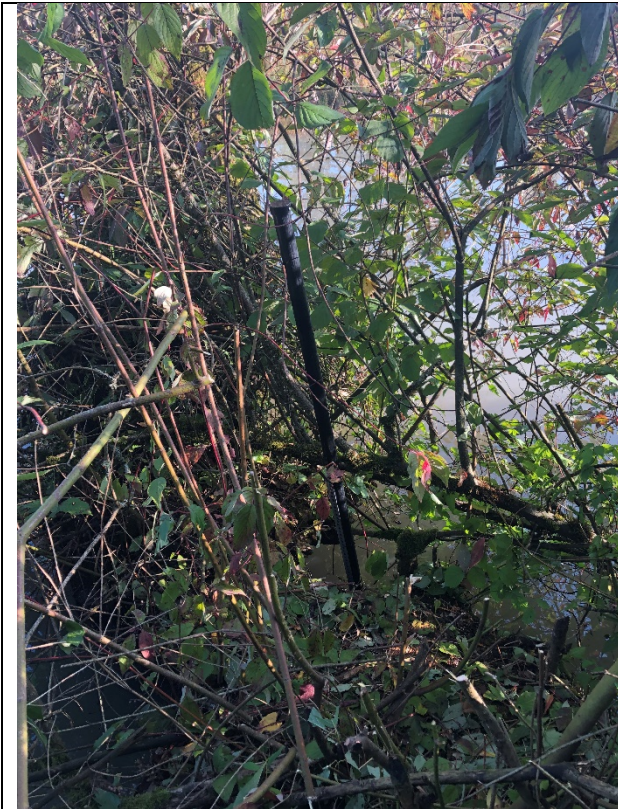
Photograph 10 – PVC deployment for Levelogger at Reeve Slough.

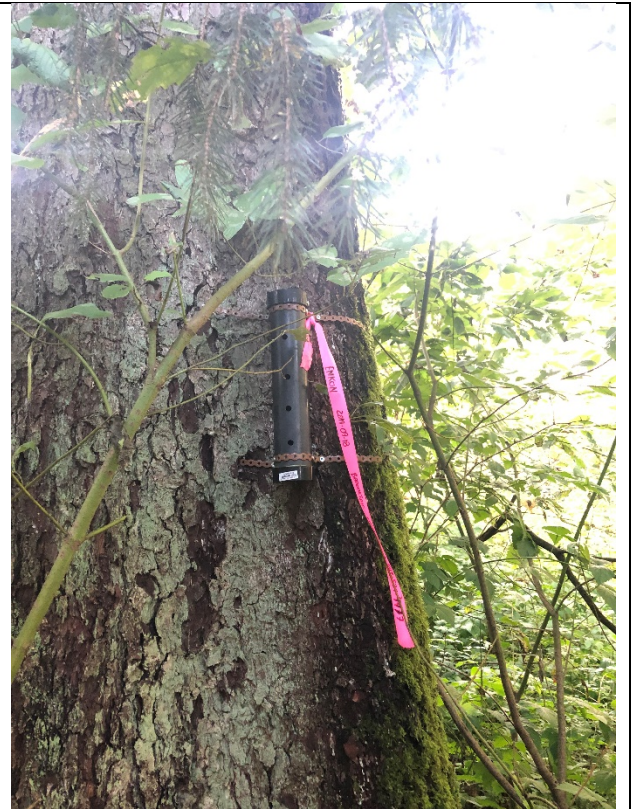
Photograph 11 – Barometric datalogger deployment installed above limits of potential floodplain inundation.

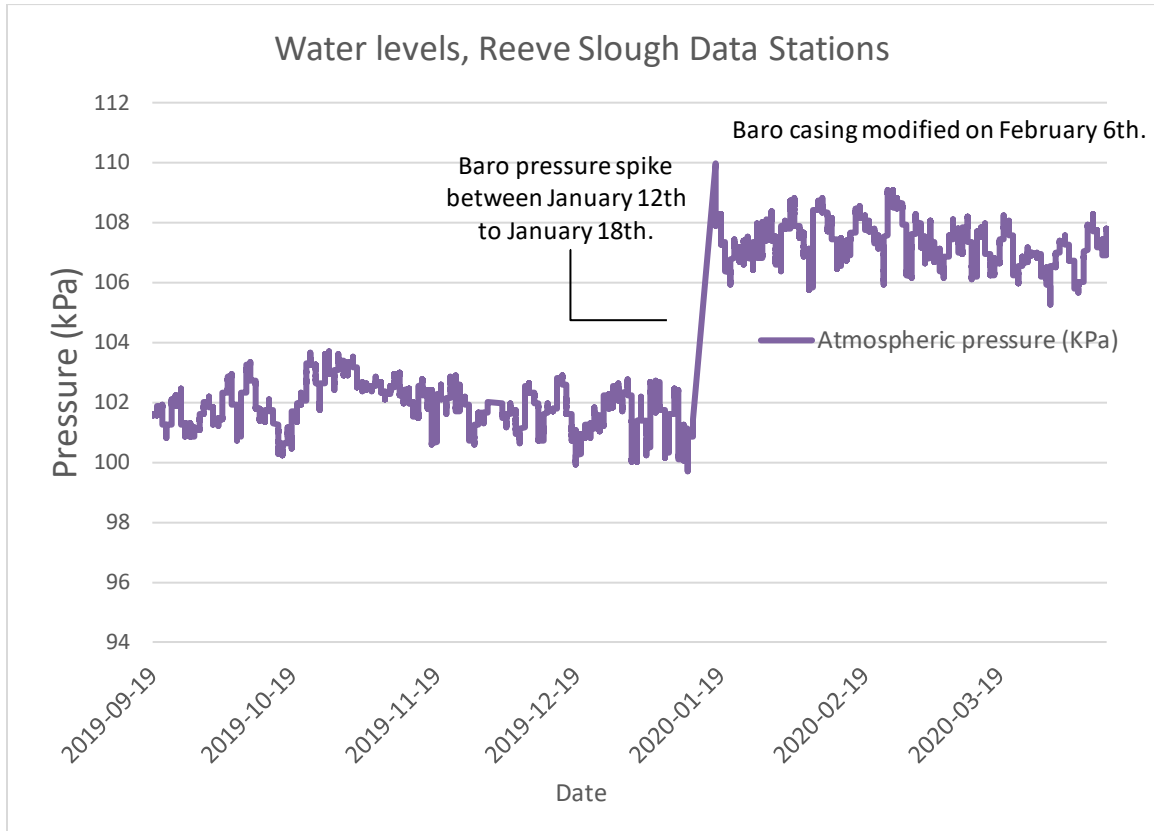
Figure 6 – Consolidated barometric compensation dataset

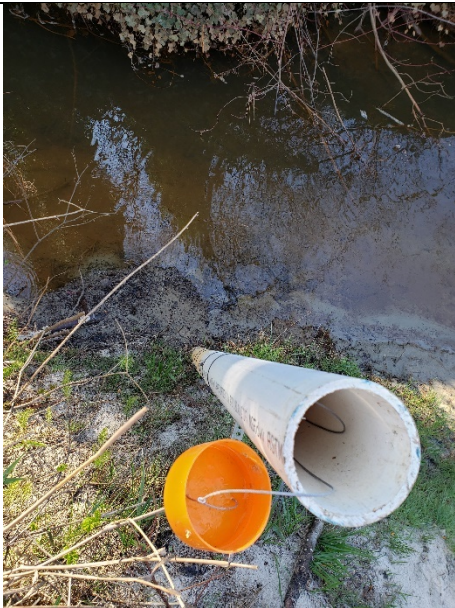
Photograph 12 – Illustration of observed April 2020 conditions at Coquitlam River Levellogger deployment illustrating equipment above low water level.

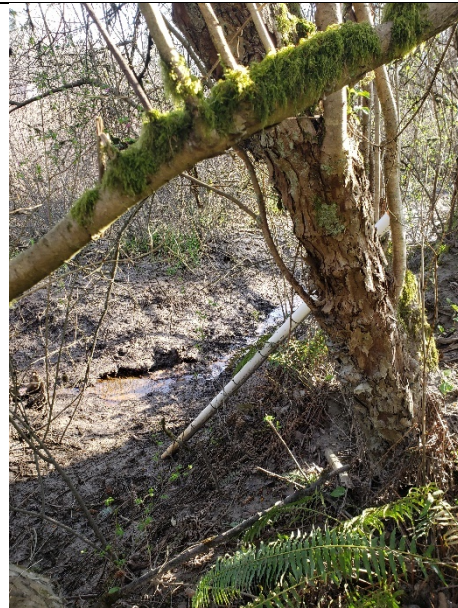
Photograph 13 – Illustration of PoCo Slough Levellogger conditions following Coquitlam River flow reduction and dyke culvert maintenance.

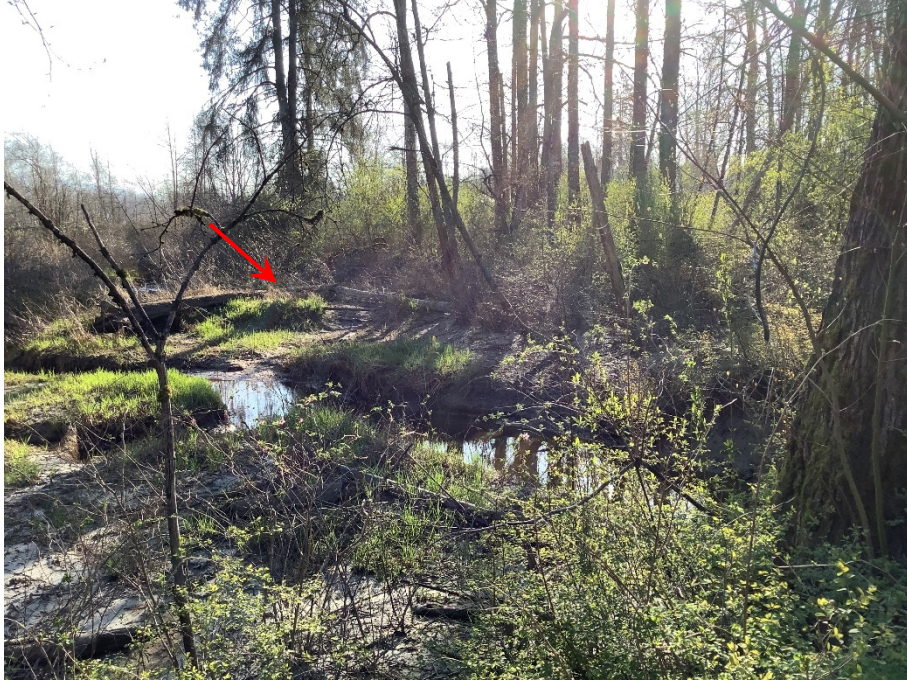
Photograph 14 - Upstream view of PoCo Slough illustrating channel thalweg vs. left bank conditions at location of Levelogger deployment – arrow indicates original deployment site under prior inundation conditions.

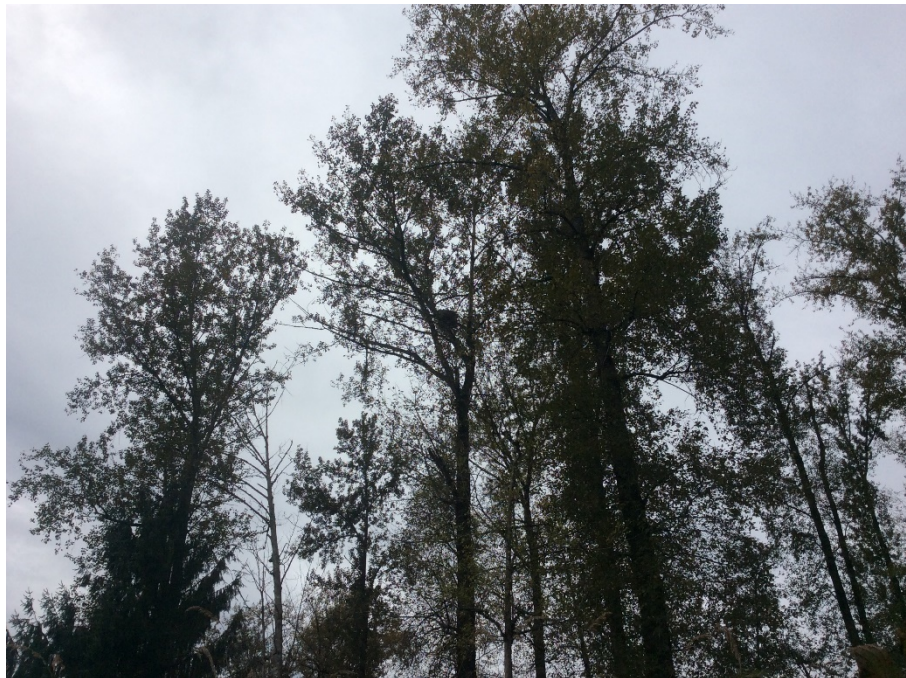
Photograph 15 - Bald eagle nest located within floodplain habitat between Reeve Slough and left bank of Coquitlam River.

Birds are known to use Reeve Slough for breeding habitat. Inactive nests were observed in the forest and along the edge of the slough. A Bald Eagle's nest in a cottonwood was observed in the forest (Photograph 15) (See Figure 1). Its proximity to Coquitlam River and the slough is ideal given the availability of fish, waterfowl, herons and beavers as prey. Its presence may have deterred Great Blue Herons from selecting Reeve Slough as a potential breeding colony; otherwise the forest habitat and prevalence of large cottonwood trees at Reeve Slough would provide an ideal location for a heron colony if it were not for the eagles' nest.
