**Reeve Slough Feasibility Assessment 2019  
Final Report**

FWCP Project ID# COA-F20-F-3083

Prepared for Fish & Wildlife Compensation Program

Prepared by North Fraser Salmon Assistance Project Society

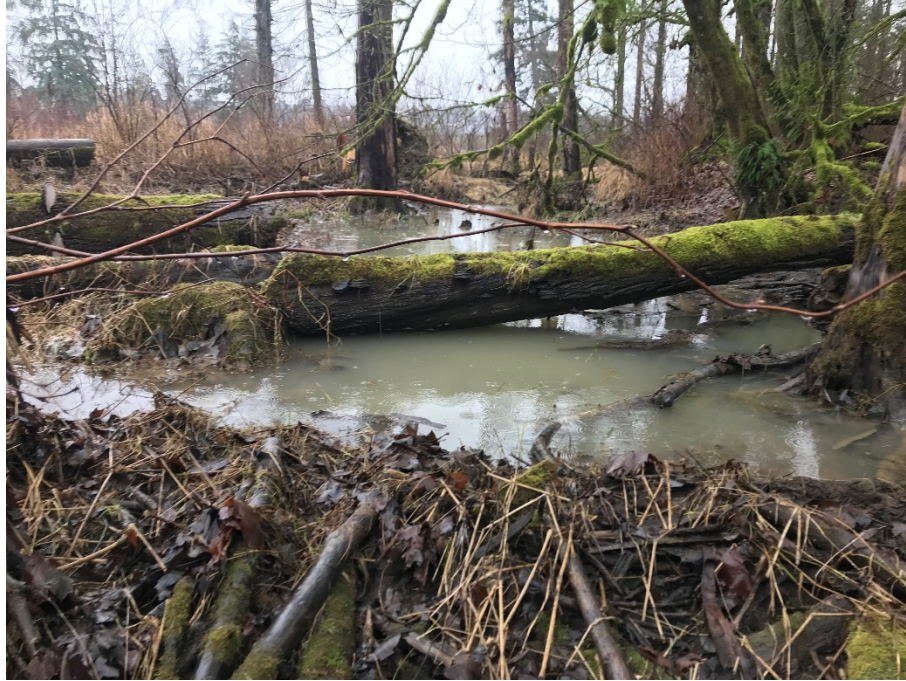
Photograph 16 - Upstream view of minor beaver dams defining base-level control at NW outlet channel.

The project's most significant constraints to the establishment of fish access and egress between the Coquitlam River and Reeve Slough, or the water supply to the slough, is the prevalence of beaver activity. Restoration recommendations will need to consider ongoing maintenance and management of beaver dams to allow for the intended flow paths to function and convey water and mitigate the risk of flood inundation of the Kwikwetlem First Nation Cemetery. Multiple active beaver dens and dam structures are present within the slough.

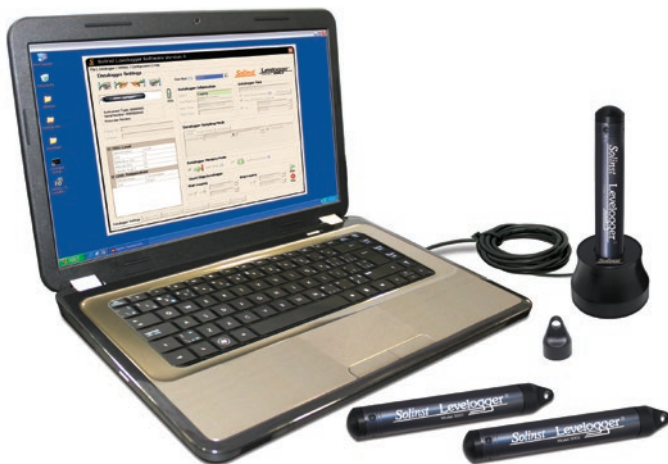
*Fast communication and downloading speeds with a high speed Optical Reader*

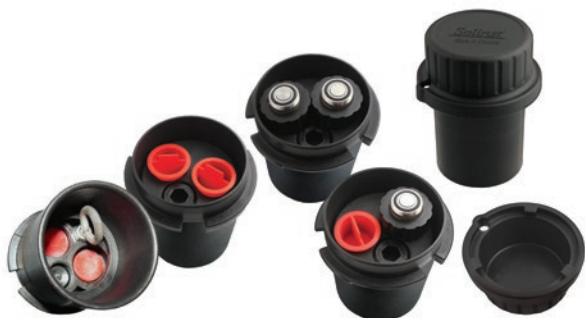
The well cap has a convenient eyelet for suspending Levelloggers using wireline or Kevlar cord. The Well Cap insert has two openings to accommodate Direct Read Cables for both a Levellogger and Barologger. Adaptors are available to fit 4" wells.

The cap is vented to equalize atmospheric pressure in the well. It slips over the casing, and the cap can be secured using a lock with a 3/8" (9.5 mm) shackle diameter.

*Levellogger 2" Locking Well Cap Installations  
(see Well Caps data sheet for more details)*

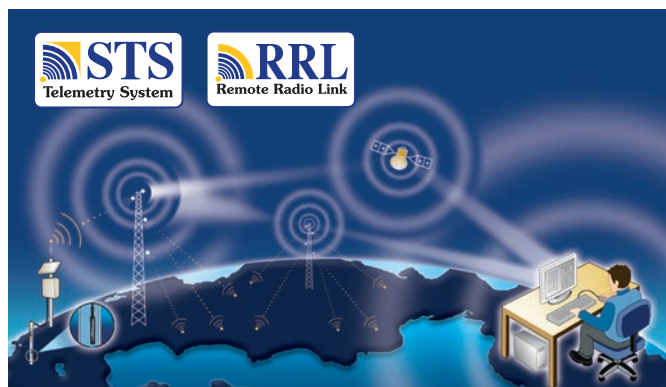
One push-button is used to download all of the data in a Levelogger's memory to a USB device plugged into the DataGrabber. A convenient LED light indicates the operation of the DataGrabber. The data in the Levelogger memory is not erased, and logging is not interrupted if the Levelogger is still running. The DataGrabber uses its own replaceable 9V battery.

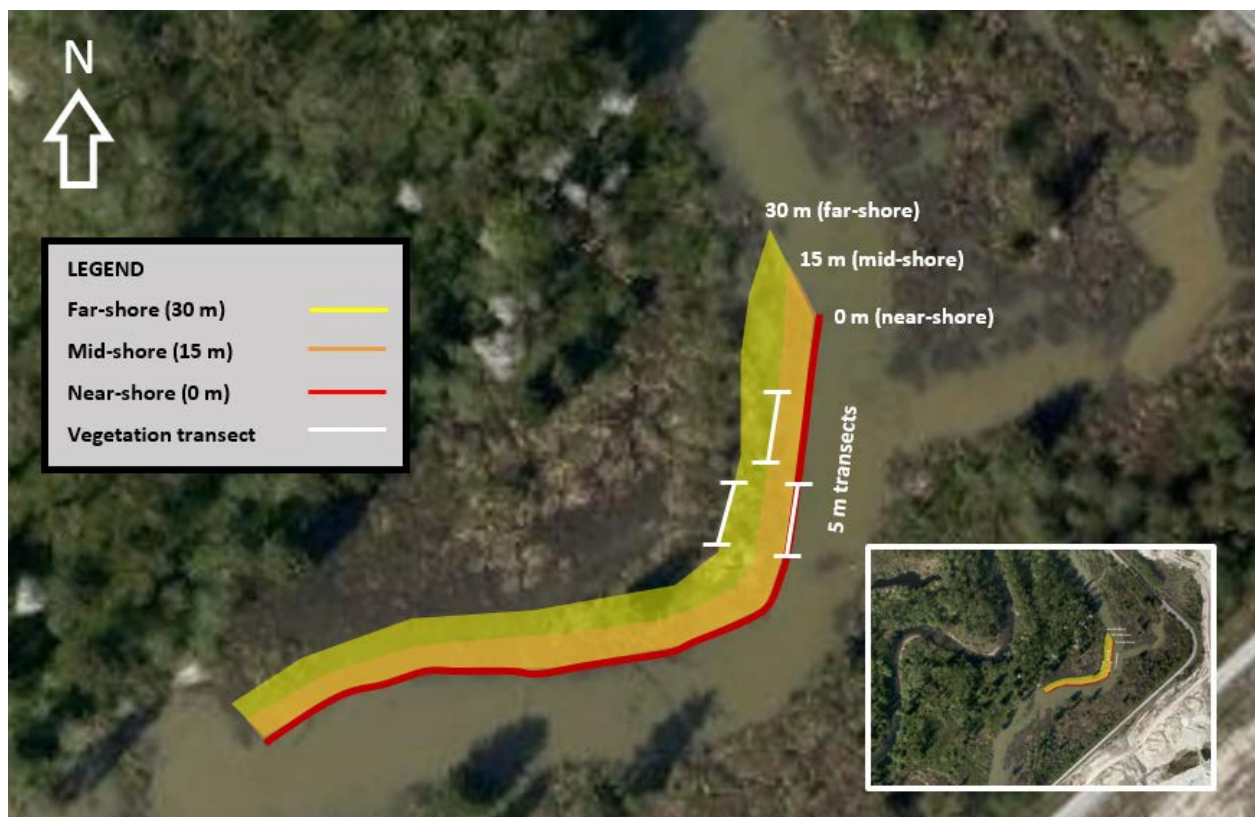
Figure 3. An example of near-shore, mid-shore, and far-shore distances used during our vegetation sampling at Reeve Slough on 19 October 2019. For the survey our 10 transect locations were at randomly selected locations around Reeve Slough.

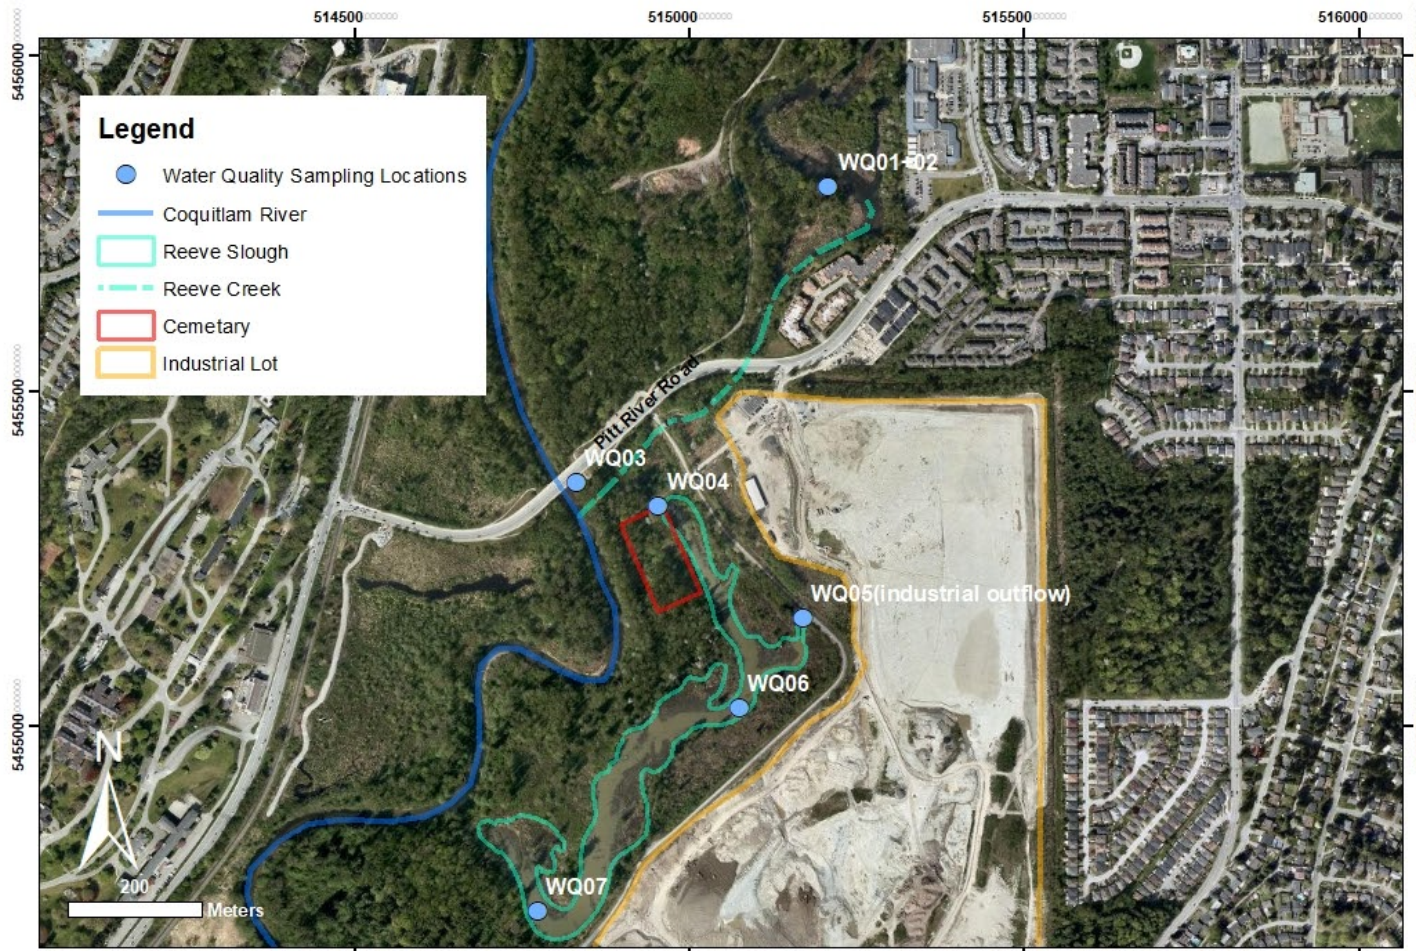
Appendix D: Water quality sampling locations from 18 October 2019.

**Reeve Slough Water Quality Sampling Locations**
