**Kus-kus-sum Land Restoration Phase I: Unpaving Paradise**

**COA-F21-F-3270**

**DRAFT Final Report**

Prepared by: Jennifer Sutherst and Caitlin Pierzchalski (Comox Valley Project Watershed Society)

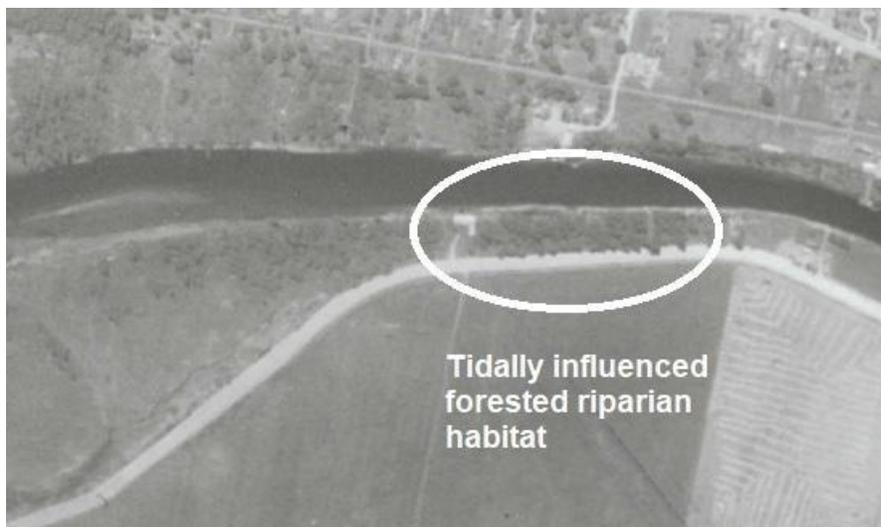
*Figure 2: 1946 Aerial image of Kus-kus-sum site*

Historical air photos from 1946 and 1951 show that the area was forested and indicate that one or more channels crossed the property and connected to the Dyke Slough (Figure 1). These channels would have provided brackish off-channel habitat for salmonids, a type of habitat that is lacking in the K'ómoks Estuary. Off-channel habitat allows juvenile salmonids to escape high river flows and seal predation, as well as providing holding areas to allow for forage, growth, and acclimatization to increasing salinities before they migrate to the marine environment (Beechie et al. 1994) (Sommer et al. 2001) (Ebersole et al. 2003).

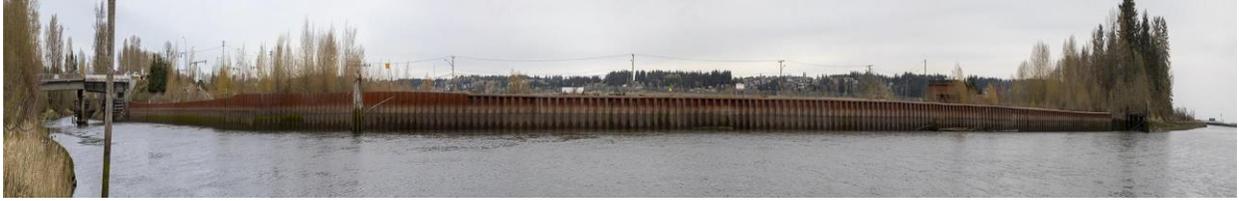
*Figure 4: Panorama of the 440m steel clad retaining wall that separates the current site from Courtenay River.*

A sawmill was built on the Kus-kus-sum site location in 1949. Over the next 50 years, to facilitate industrial sawmill operations, the area was cleared and paved and a steel-clad concrete retaining wall (which encroaches on the river) was erected along the shoreline. These alterations have removed much of the historical fish and wildlife habitat values of the site. A 1977 governmental report on Comox Harbor stated that the estuary is one of the richest in Canada and that the sawmill operations and associated log booming should be relocated, in part due to impacts to these salmon runs (Burns, 1977). The decline of the once bountiful runs of Chinook salmon is one of the legacy impacts from logging and milling activities (Sommer et al. 2001). At the Kus-kus-sum site, seals utilize the steel wall as well as the Dyke Slough, which is

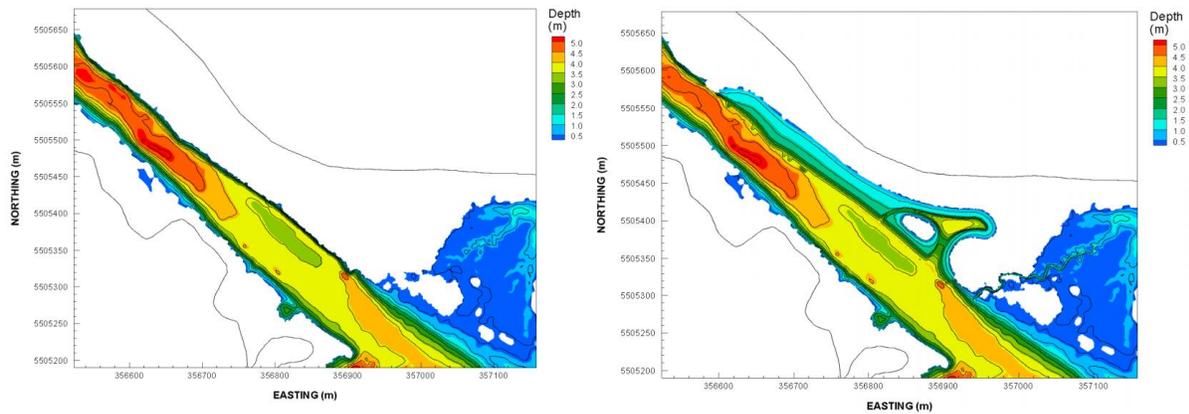
*Figure 6: An example of water distribution on KKS site before and after proposed restoration. Current site is shown on left and proposed site design is shown on right. Prepared by NHC, 2020.*

The hydraulic model aims to illustrate possible water levels and inundation extents at KKS for existing and proposed design under a range of riverine flows and coastal water levels. For full methods behind the numerical model, model validation, and hydraulic analysis, please see Appendix A.
