# Shore-Spawning Kokanee Habitat Restoration & Research Project (Year 2) 2021-2022

COL-F22-F-3482

**Prepared for:** Fish & Wildlife Compensation Program

**Prepared by:** Friends of Kootenay Lake Stewardship Society  
Kayla Tillapaugh, Program Manager

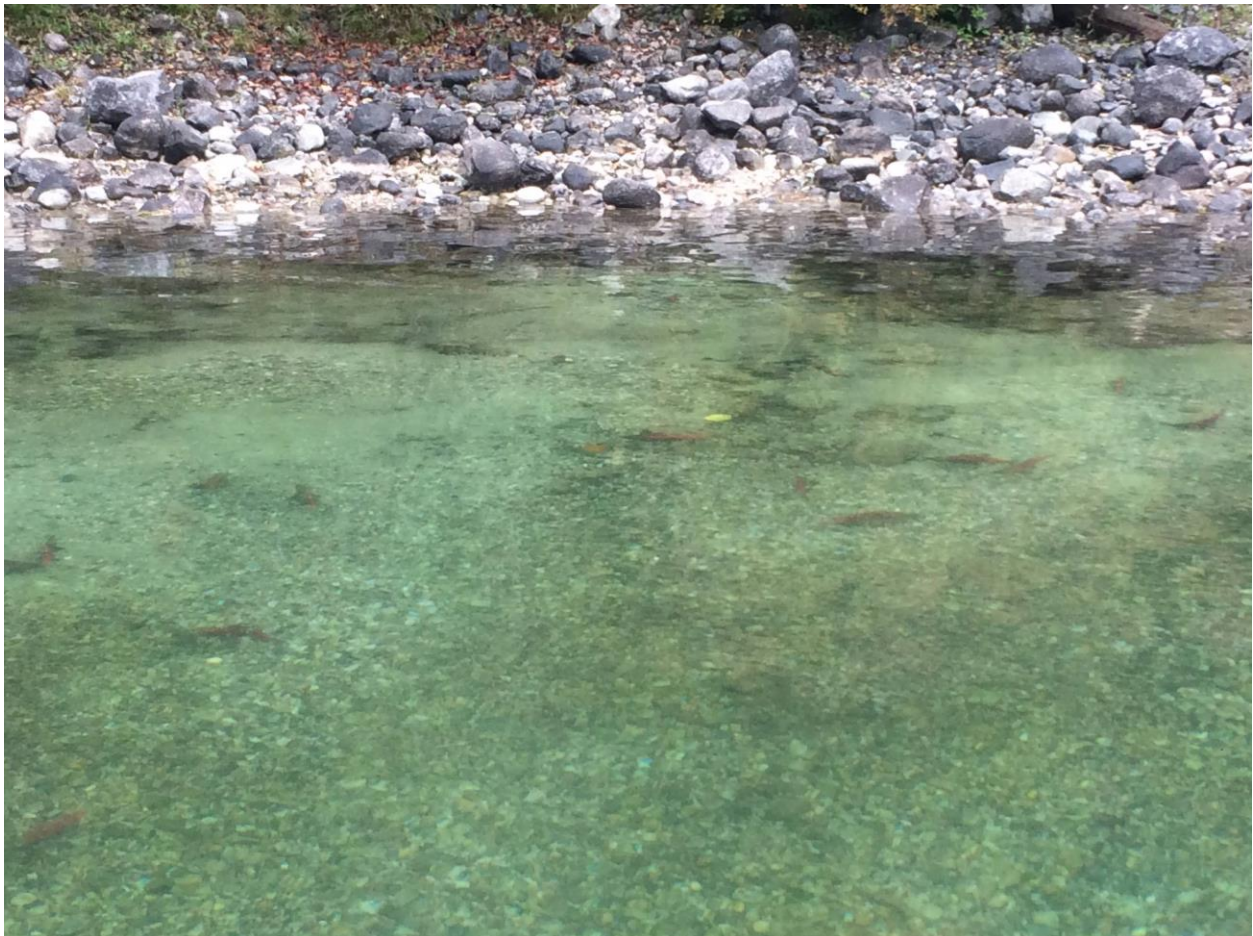
*Figure 2: Oct 4, 2021. Spawning kokanee at McDonald's Landing Regional Park (cleaned areas visible)*

Spawning kokanee numbers were enumerated weekly between September 22 and October 12, 2021 by FoKLSS staff, and weekly between September 23 and October 14, 2021 by Ministry of FLNRORD fisheries personnel. Four monitoring days were completed by FoKLSS in total in 2021. FoKLSS monitoring expeditions were conducted by Jon-style flat-deck boat at coasting speeds across the restoration site. The site was traversed six times for each survey. One monitor counted all kokanee observed, and one monitor counted all kokanee observed above the LWM. Dead kokanee were enumerated, redds were enumerated and marked, and spawning behavior was noted. Spawning behaviour such as guarding, tail digging or visible pairings were recorded. Fish-counters were used to tally counted kokanee and redds and a specific counting method was used to ensure accuracy. A linear object such as a pen or finger was held steady in the middle of the observer's vision. Each kokanee that crossed the line as the observer passed by, or as the kokanee swam by, was counted. Double counting was mitigated by subtracting for each fish that crossed back over the line.

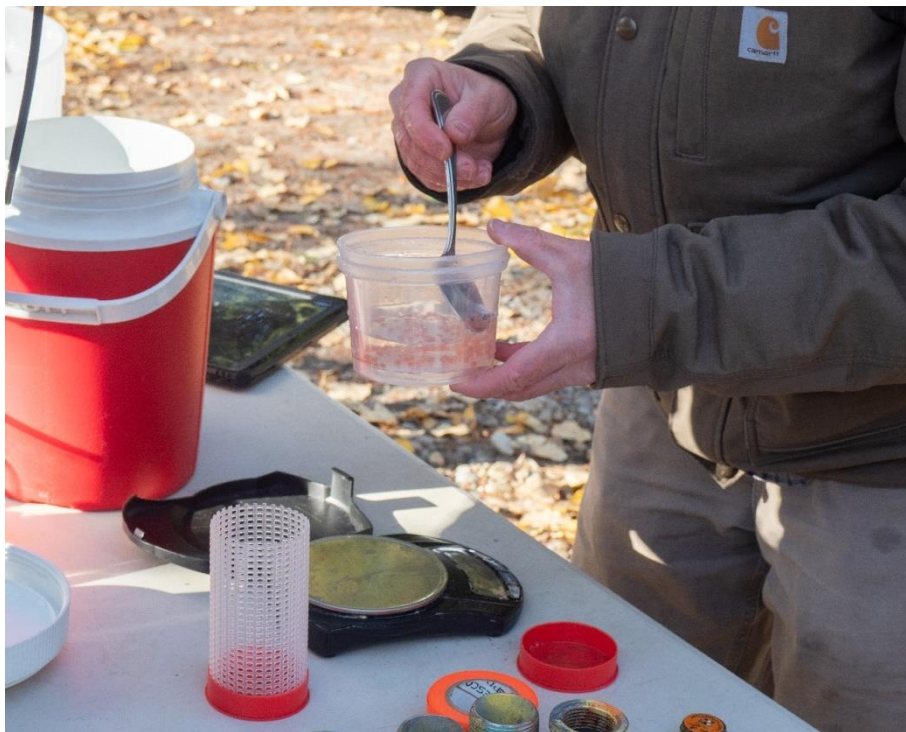
*Figure 3: Nov 1, 2021, Kokanee egg capsule install. Weighing kokanee eggs. Photo credit: Joanne Siderius*

Ten perforated capsules containing kokanee eggs and water temperature data loggers were installed on November 1, 2021 at varying elevations in the control and restored substrate. One-hundred eggs were counted and weighed. Each labelled capsule was loaded with ~200 triploid (infertile) kokanee eggs derived from the BC Freshwater Fisheries Society in Cranbrook, a HOBO Tidbit temperature data logger, and a rock (for extra weight). A length of coloured flagging tape was tied through the tube for easy identification. Each of ten capsules were placed into buckets of fresh lake water and carried to the shoreline. Egg capsules 1-5 were installed within the natural substrate above the LWM in ≈50cm of water in areas of known groundwater upwelling. Egg capsules 6-10 were installed by scuba divers within the restored substrate in ~125-150cm of water. Egg capsules were buried ~10cm below the substrate surface. Data collected included capsule ID, lake level, date, water depth at insertion, time of insertion, weight of eggs, GPS data point ID and additional notes. Temperature data loggers collected a temperature reading once ever four hours from November 1, 2021 to January 28, 2022.

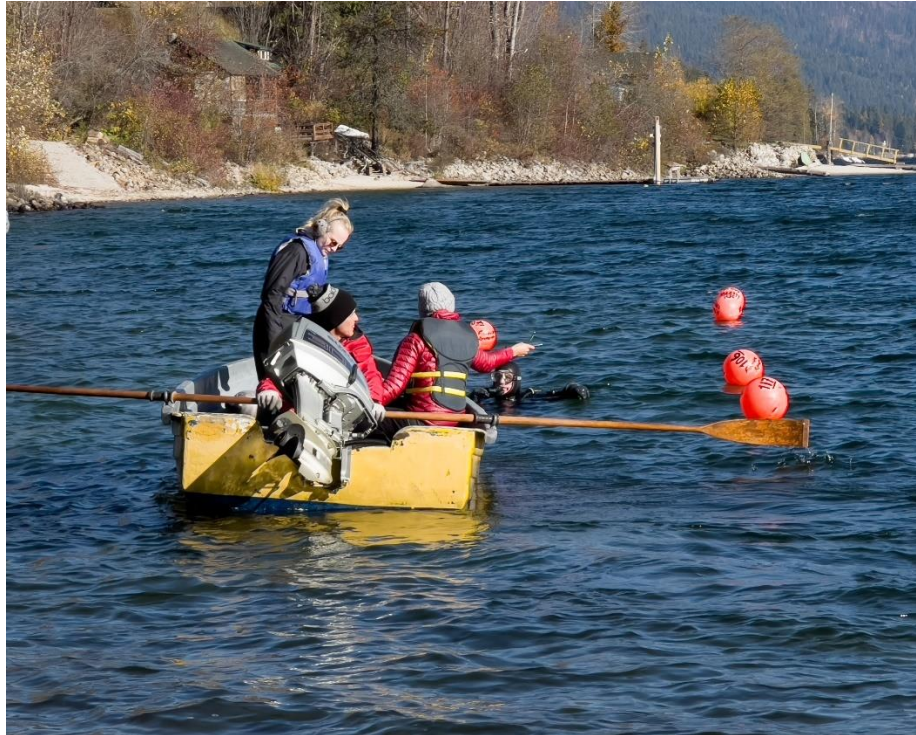
Figure 4: Nov 1, 2021, Kokanee egg capsule install. Divers installing egg capsules. Photo credit: Joanne Siderius

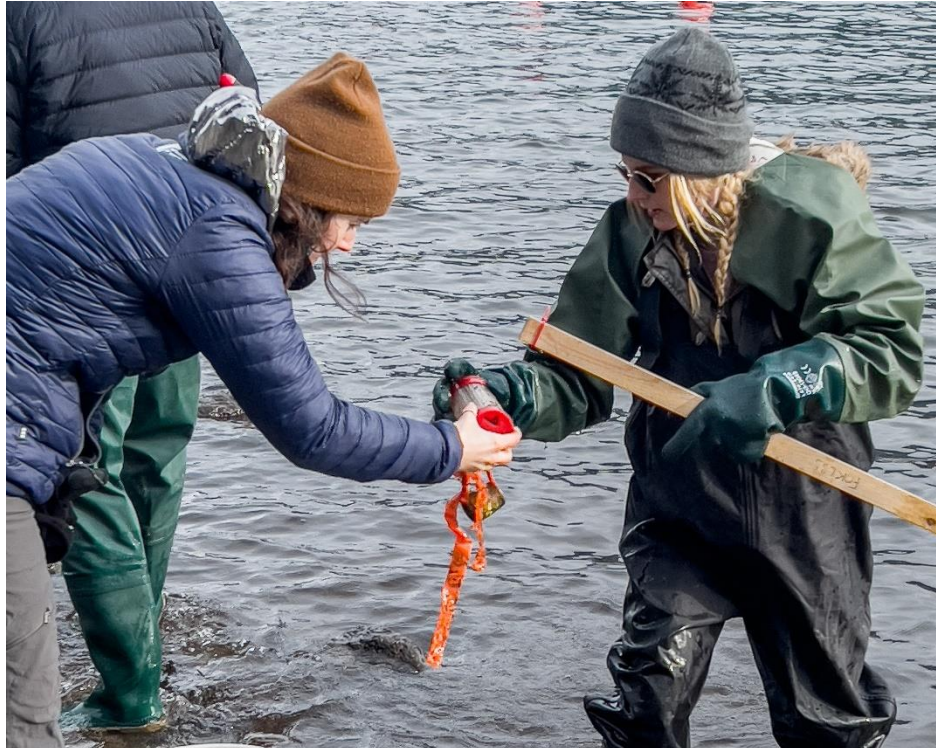
*Figure 6: Jan 28, 2022. Egg capsule retrieval. Removing capsule and inspecting for invertebrates. Photo credit: Joanne Siderius*

Egg capsules were removed from the substrate on January 28, 2022 with support from volunteers and scuba divers; accumulated thermal units (ATUs) were 894 on this date. Egg capsule contents were emptied and assessed by Ministry of FLNORD fish biologists. Data collected included egg tube ID, lake level, water depth at removal, time of removal, GPS data point ID, water temperature, substrate, presence of invertebrates inside and outside the capsule, egg, fry and alevin count, presence of fungus on eggs and additional notes. Photos were taken of the contents of each egg capsule for a more precise count later in the office, and data loggers were offloaded.

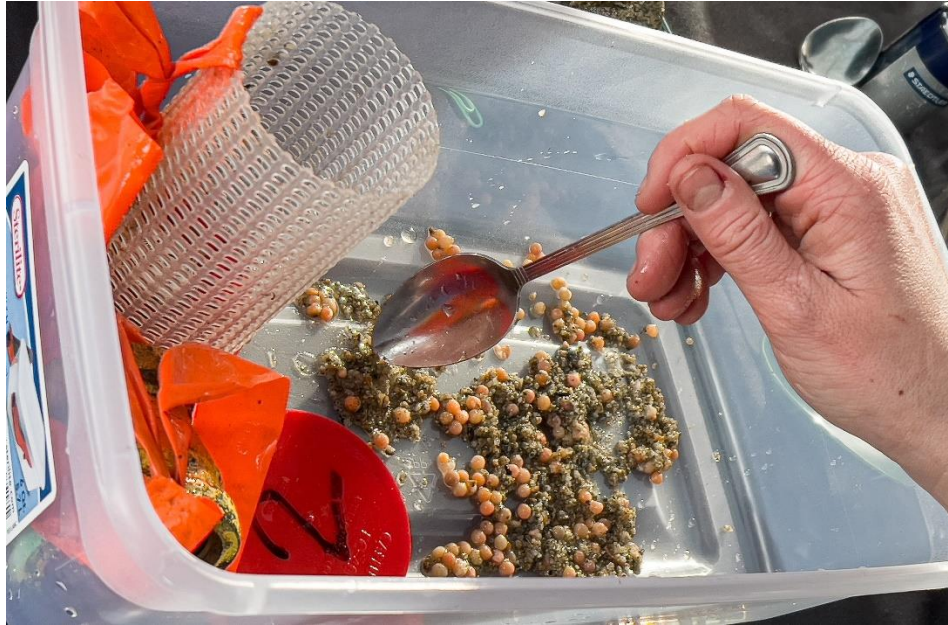
Figure 7: Jan 28, 2022. Egg capsule retrieval. Inspecting capsule contents and counting dead eggs. Photo credit: Joanne Siderius

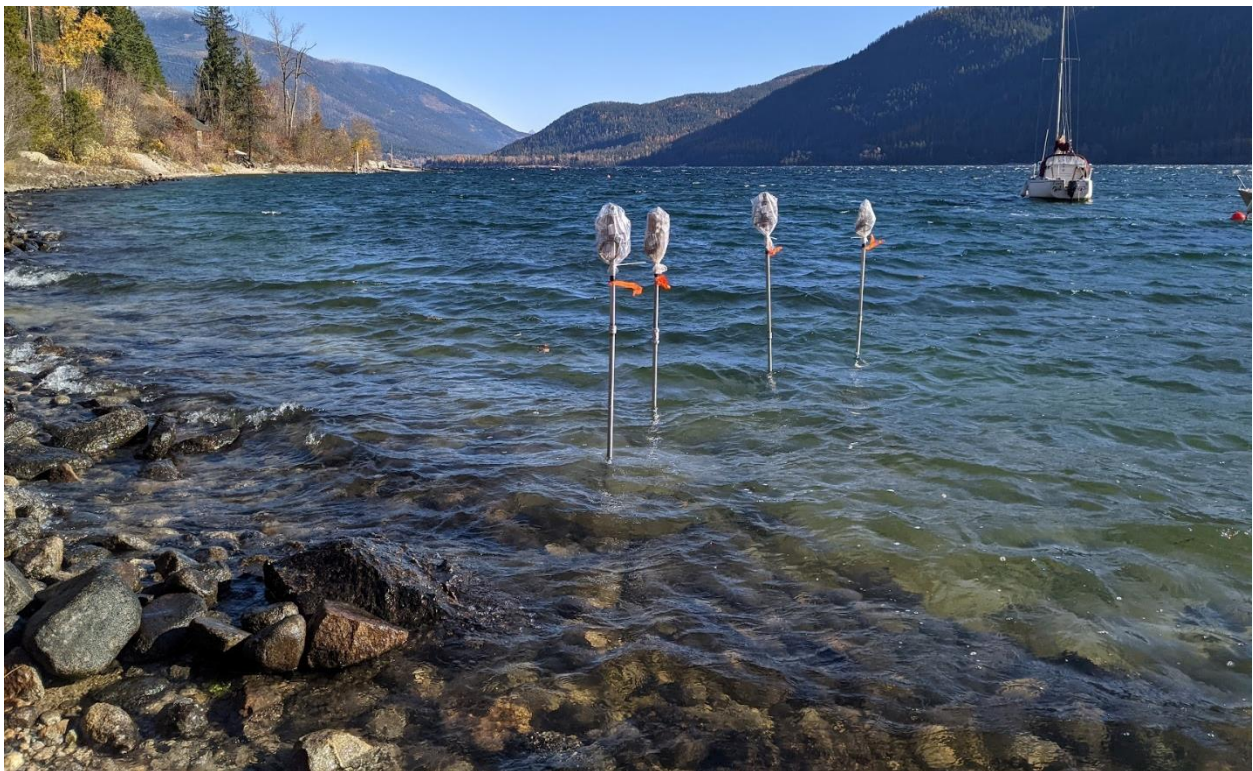
Figure 12: Photo of vertical sediment temperature profiling probes installed at McDonald's Landing restoration site. Photo credit: Cameron Spooner.

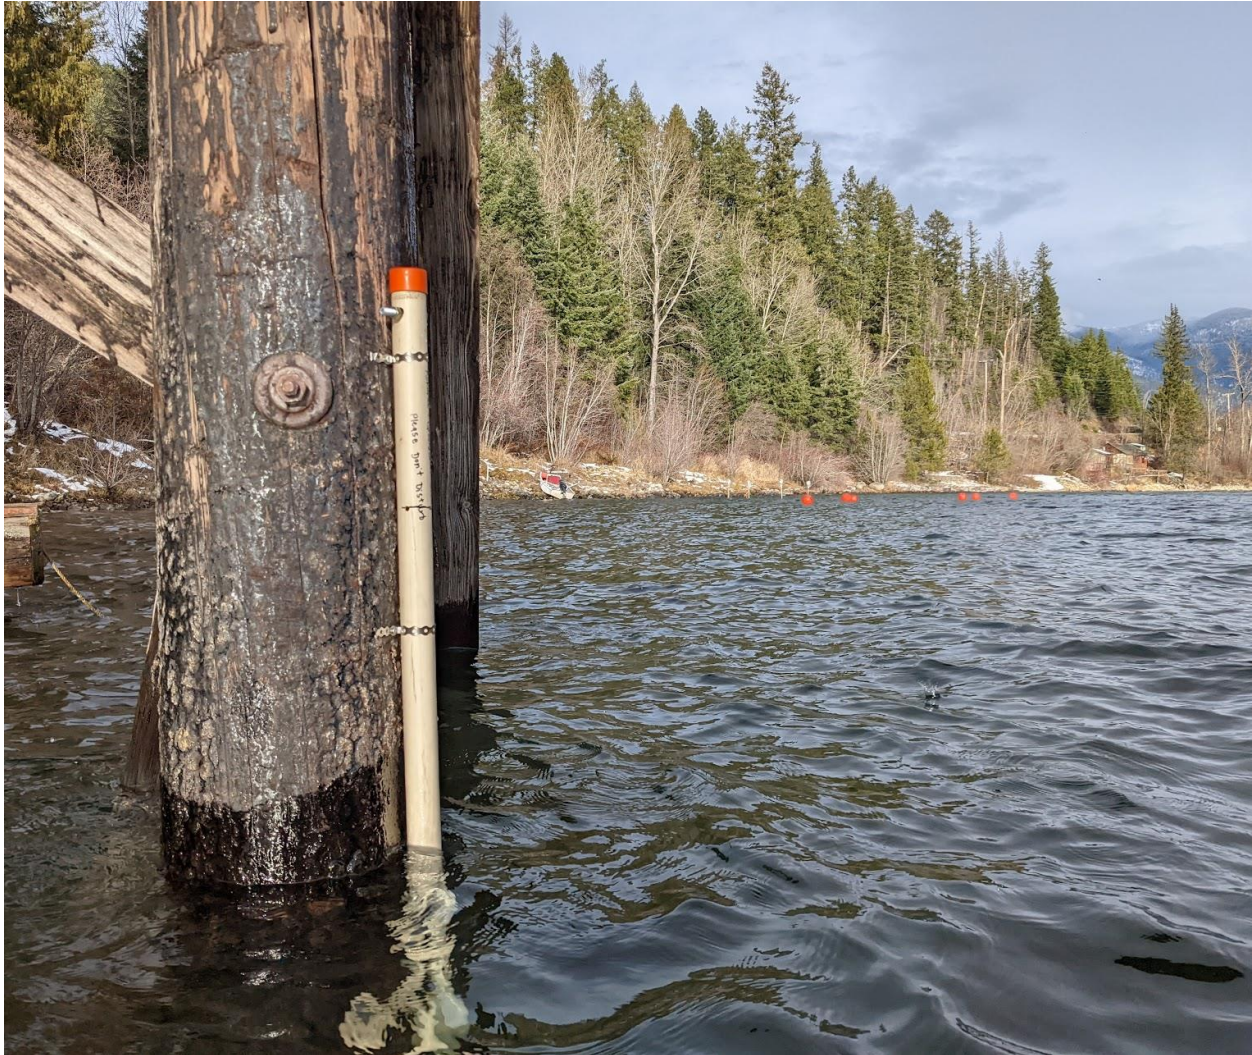
A piezometer was installed to measure the height of the nearshore water table, and a water level logger was installed in the lake to measure lake stage. These loggers collected continuous data on lake stage and water table level which can influence the magnitude of groundwater flow into the lake.

*Figure 13: Photo of water level logger measuring lake stage at restoration site. Photo credit: Cameron Spooner.*

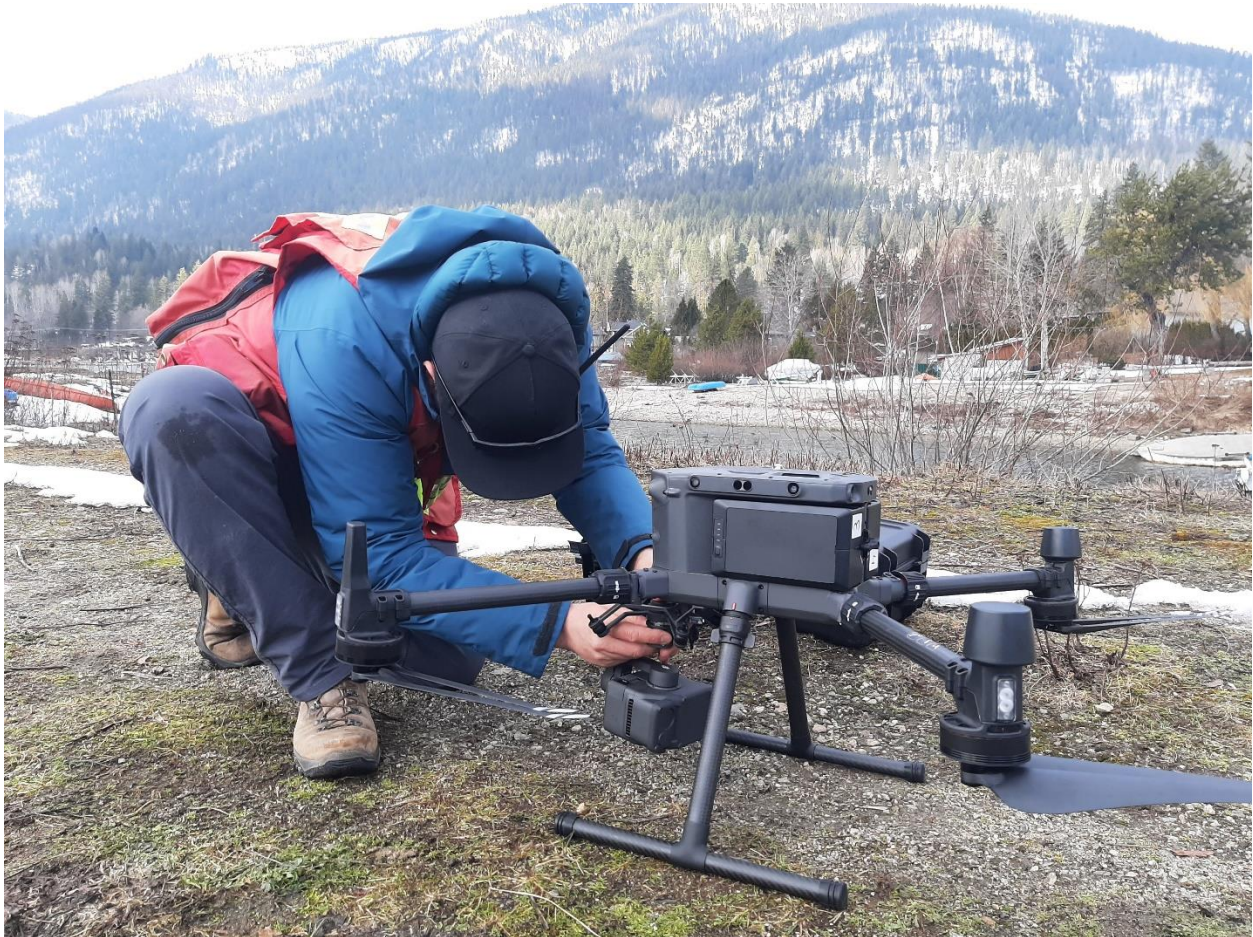
*Figure 14: Feb 15, 2022. Skyeler Folks (ONA) attaching sensor to drone. Photo credit: Kayla Tillapaugh.*

Friends of Kootenay Lake partnered with the Okanagan Nation Alliance to conduct multispectral imaging of shore-spawning habitat at McDonald's Landing and at the Bonaventure Lagoon using a specialized drone. Both spawning sites were imaged on February 15, 2022 and March 23, 2022 to capture high water versus low water states. Three types of images were produced: high-resolution RGB, thermal, and LiDAR. Each drone survey required two flights, one with the thermal/RGB sensor, and one with the LiDAR sensor. Each survey consisted of about 30 minutes of total flight time. A Global Navigation Satellite System (GNSS) was installed at the exact elevation of the lake surface to calibrate elevation readings.

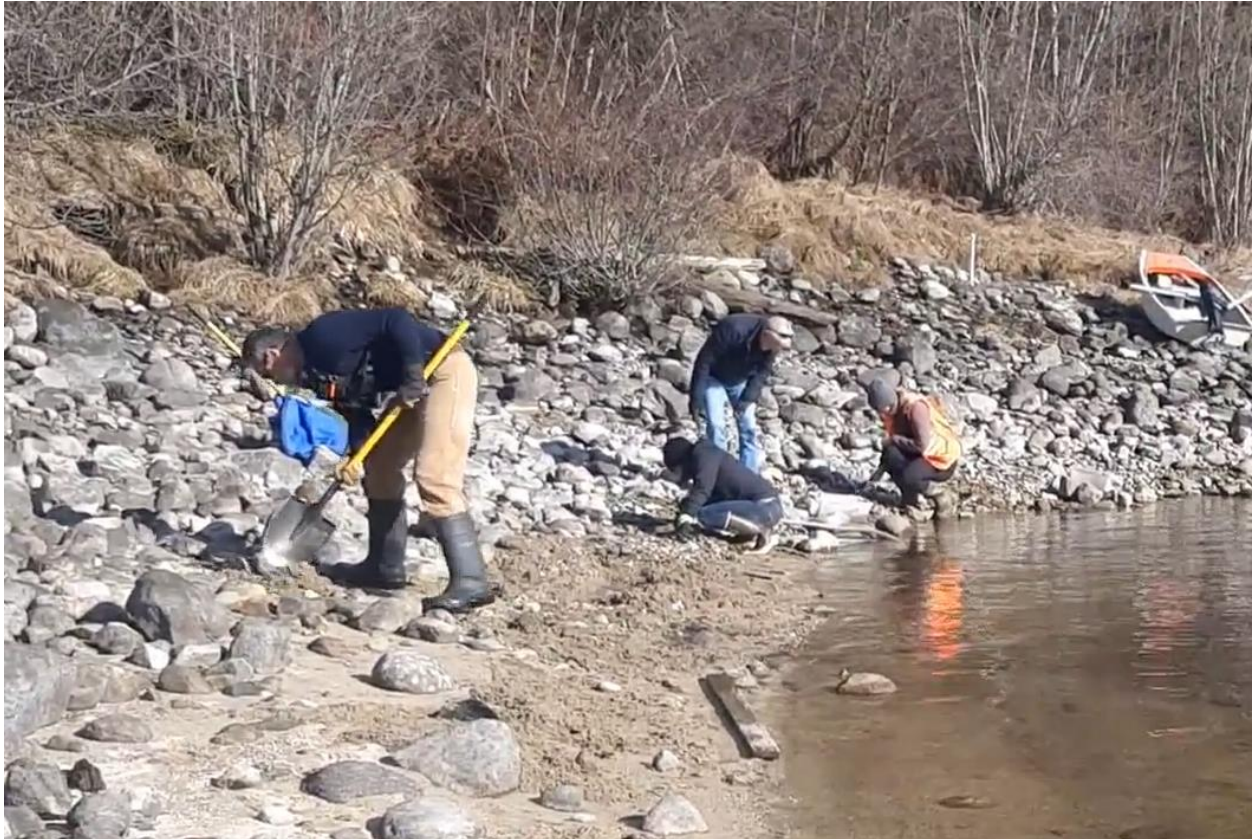
*Figure 15: March 14, 2022. Dewatered redd survey crew locating dewatered redds. Photo credit: Kayla Tillapaugh*

The ground-crew moved along the shoreline to visually identify potential redd locations and then dig them up using a shovel or hand-held trowel. Holes were dug approximately 30-60 cm apart across the

length of the spawning site/ shoreline. Identified redds were geolocated and water temperature was taken. Other data including estimated age, condition, distance from lake, percent mortality etc. were collected for each identified redd. The total number of dewatered redds was estimated based on the number of redds discovered and ground covered. The same process was followed each week as water levels dropped. Sections of redds were flagged and left untouched in March so that they could be assessed with the rising of the water in April. From there, researchers could estimate the probability of redd survival given a specific distance and elevation from the lake.

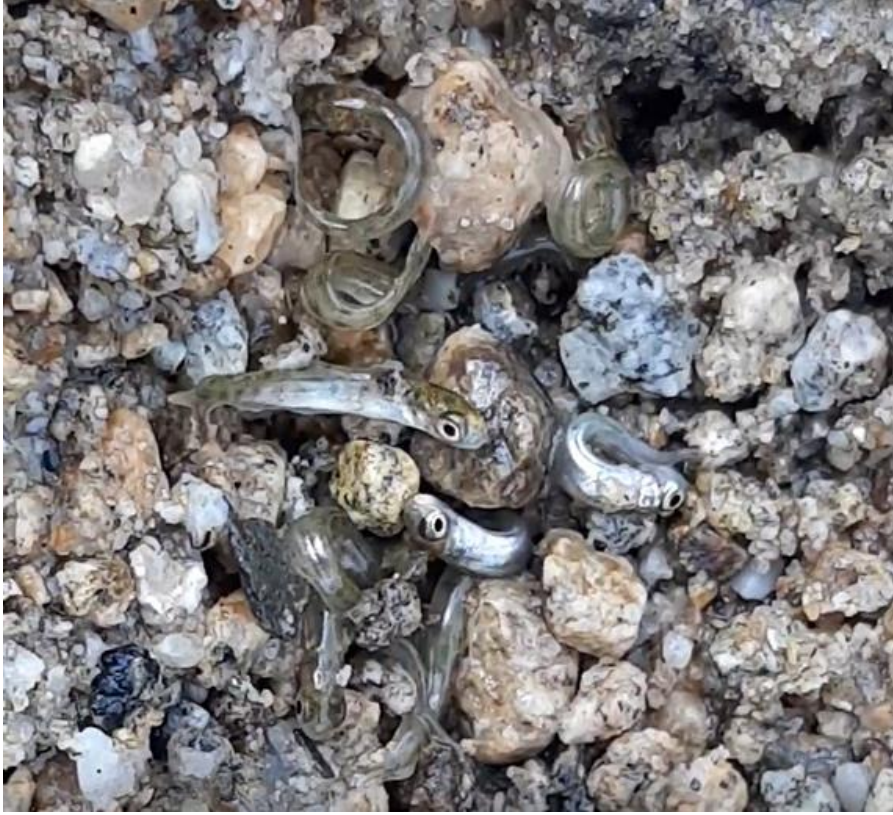
*Figure 16: March 14, 2022. Dewatered redd, live fry. Photo credit: Kayla Tillapaugh*

Live kokanee fry were found within dewatered redds on May 4, 2022. Very few live fry were found, and the ones discovered were skinny and showed signs of starvation. However, these interesting results show that kokanee fry can survive long periods in dewatered redds so long as there is a consistent flow of groundwater.

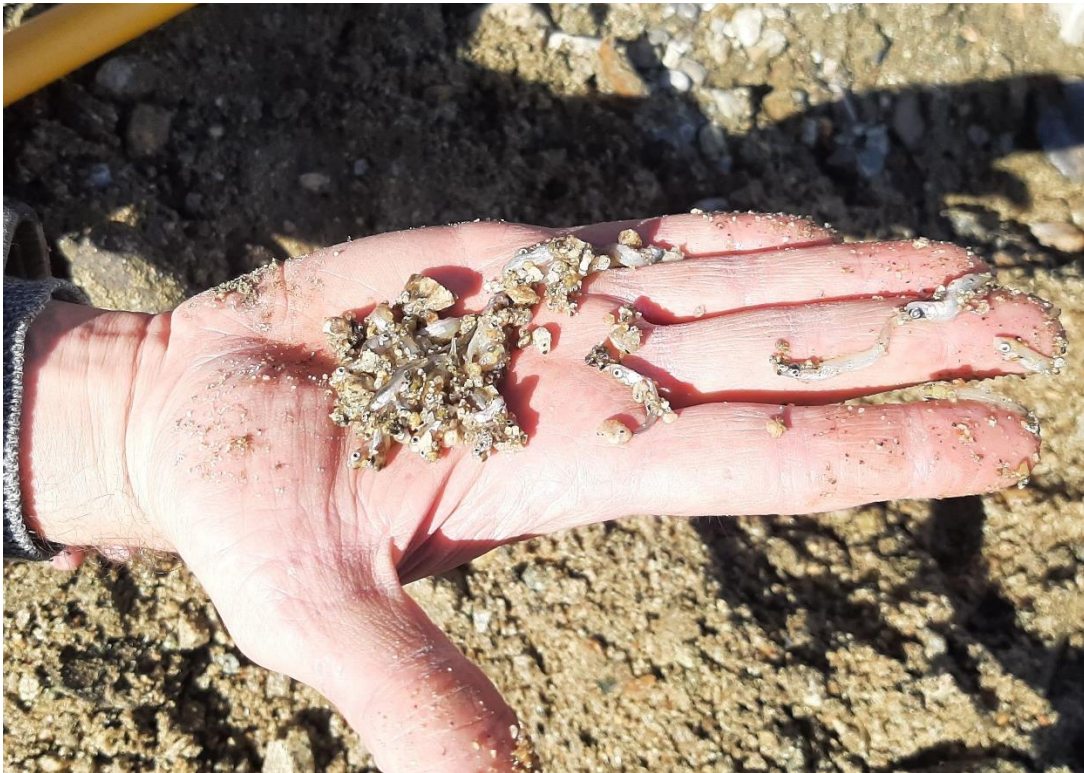
*Figure 17: March 24, 2022. Dewatered redd, dead fry. Photo credit: Kayla Tillapaugh.*

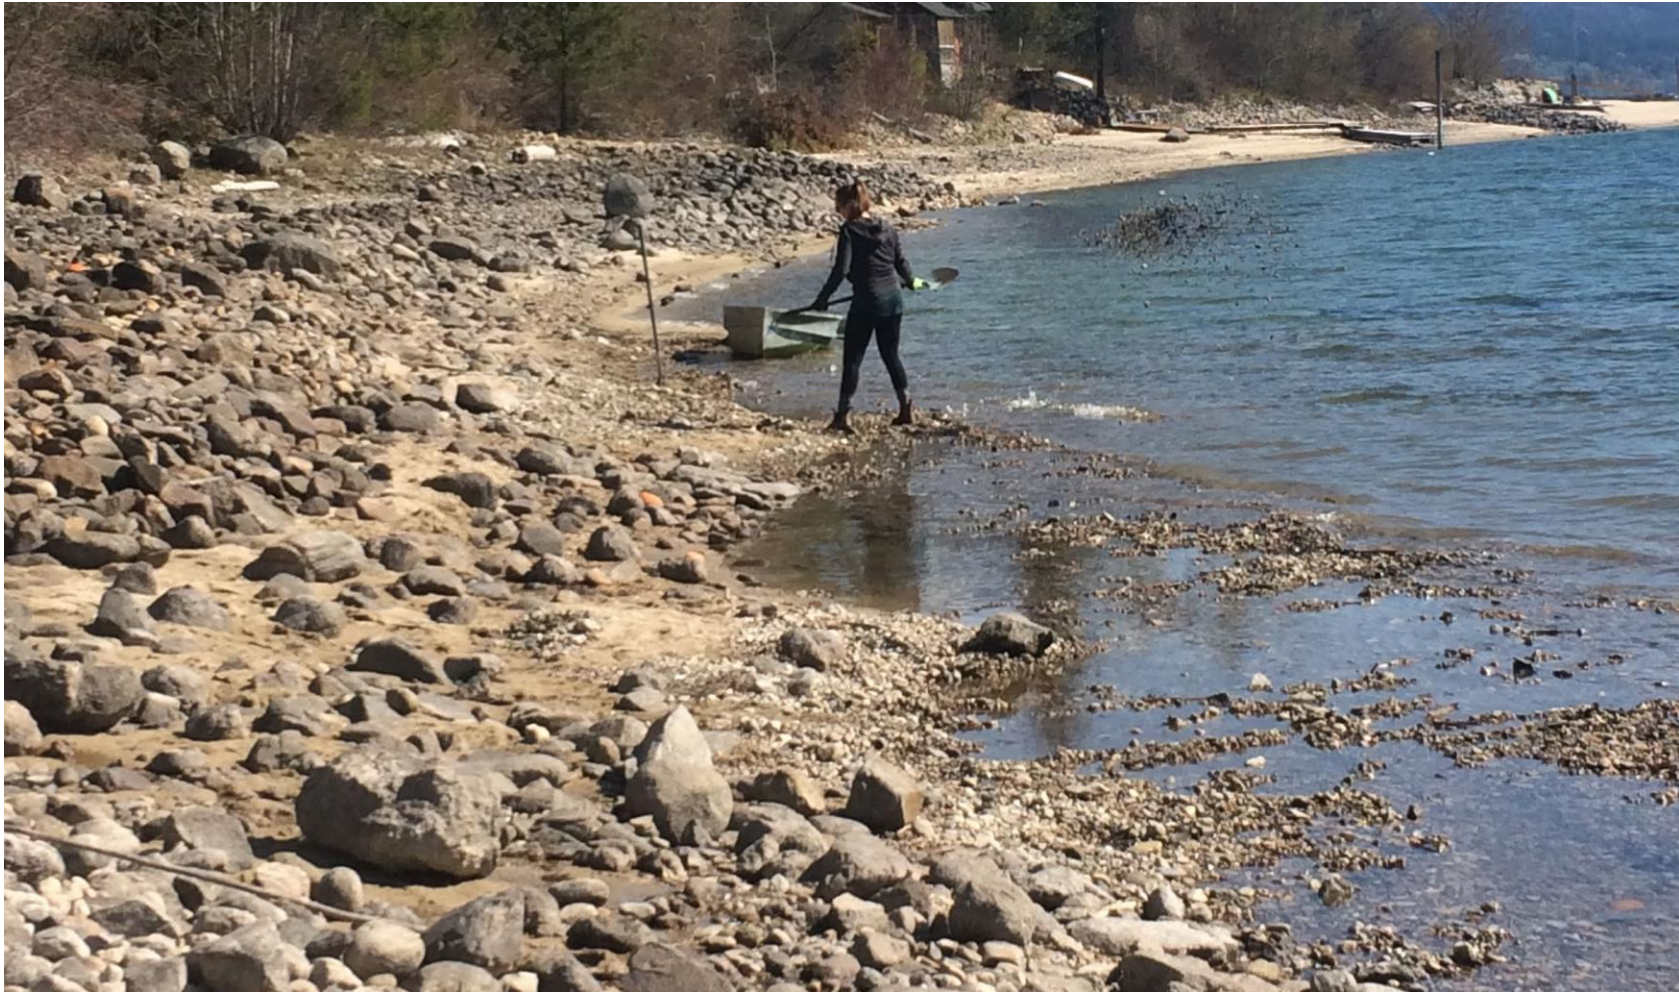
*Figure 18: April 20, 2021 foreshore gravel morphology at McDonald's Landing restoration site (after one previous day of shovelling). Photo credit: Kayla Tillapaugh.*

Gravel maintenance was successful in smoothing out clumps and pushing gravel deeper into the water column. The foreshore elevation was lowered by about 4-inches across the restoration site. This reduced the amount of exposed gravel at low water, which ultimately reduced the elevation at which redds dewater along the LWM. The gravel appearance remained flat and smooth by the fall of 2021 when spawners returned to the site. Evidence of redd-making was apparent, showing the gravel was suitable for building redds. In spring of 2022, there were no gravel

clumps or pileup on the shoreline, showing that gravel maintenance in 2021 had long-lasting results. Figures 16 through 18 below show the results of the maintenance performed.

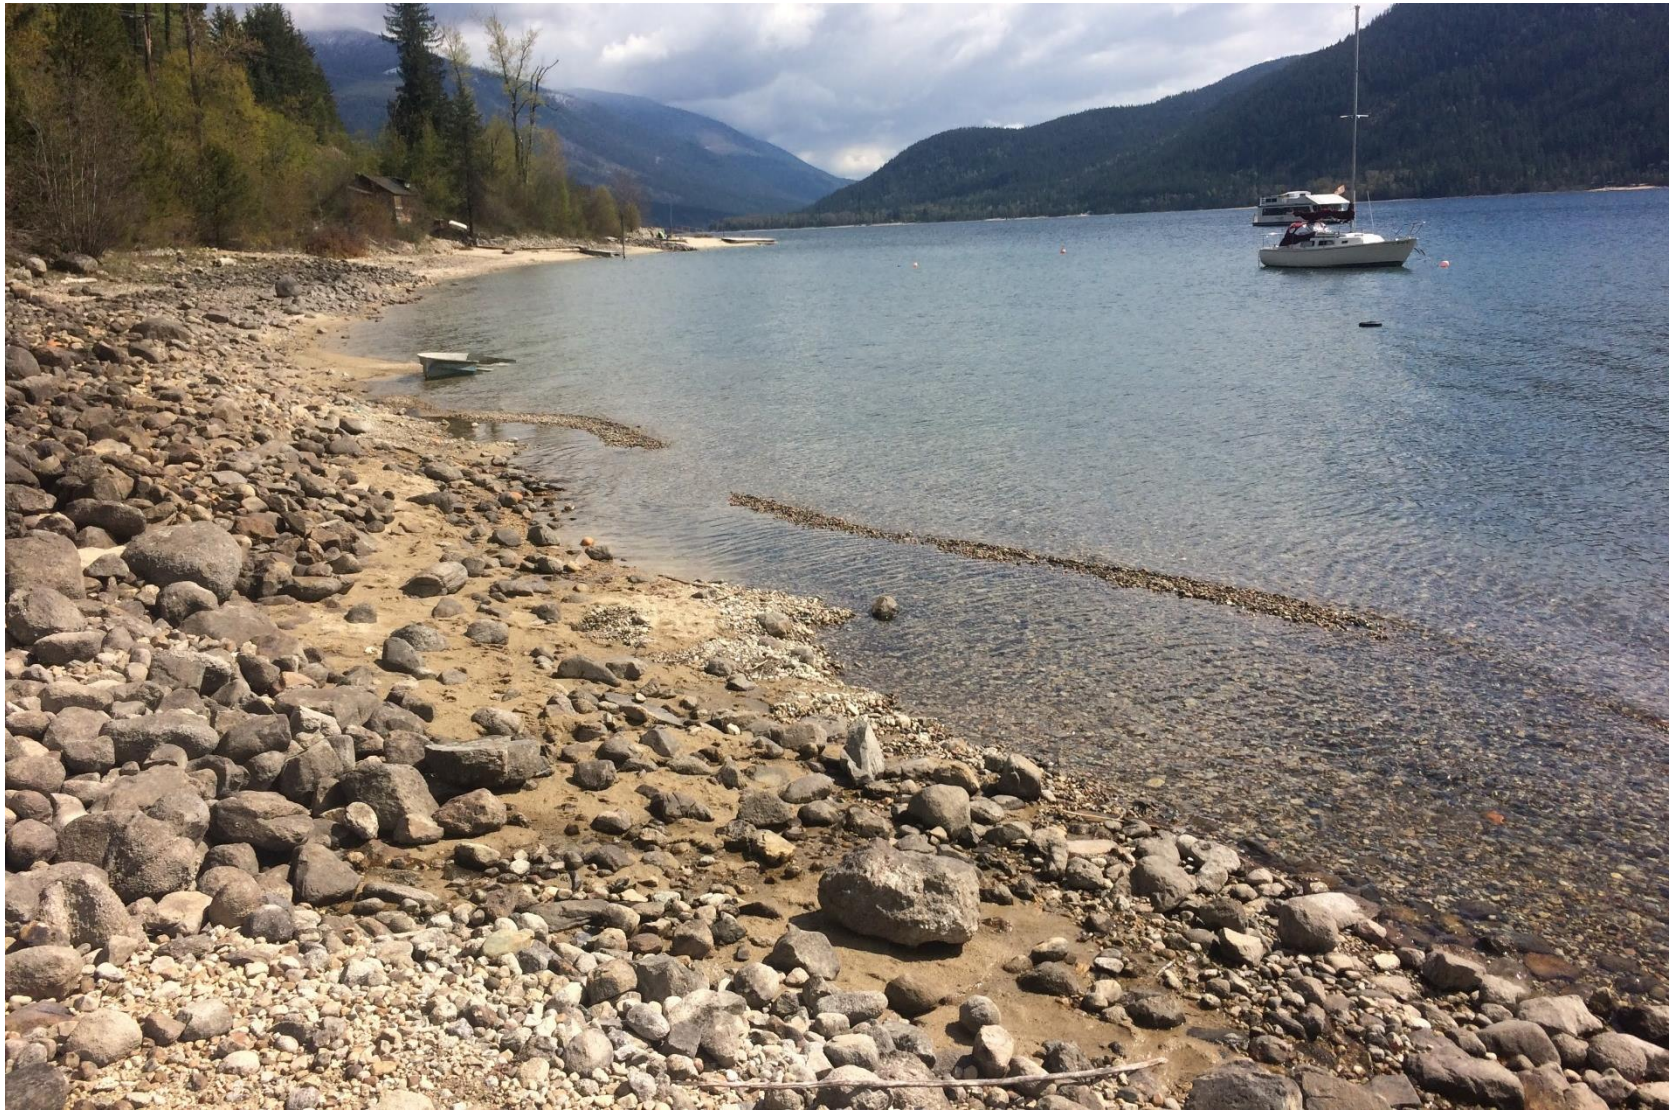
*Figure 19: April 26, 2021. Gravel morphology at McDonald's Landing restoration site (after 2 previous days of shoveling). Photo credit: Kayla Tillapaugh.*

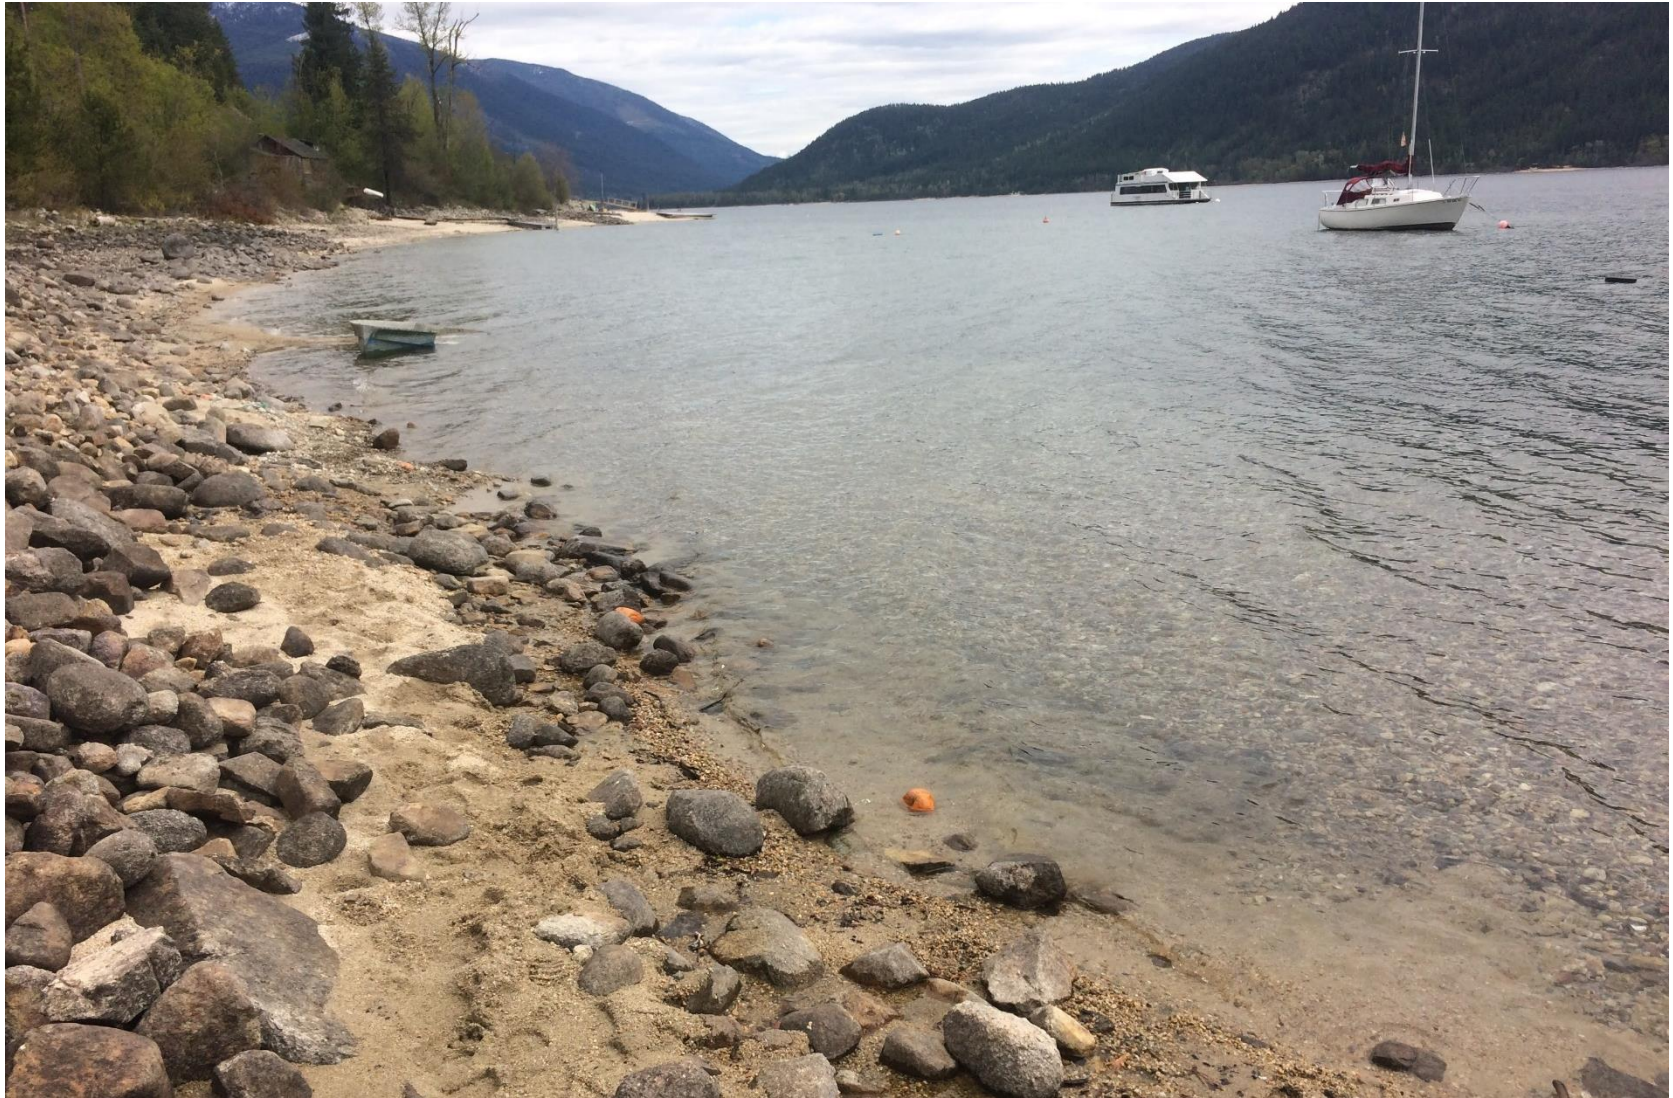
*Figure 20: Apr 28, 2021. Gravel morphology at McDonald's Landing restoration site (after 4 days of shoveling). Photo credit: Kayla Tillapaugh.*

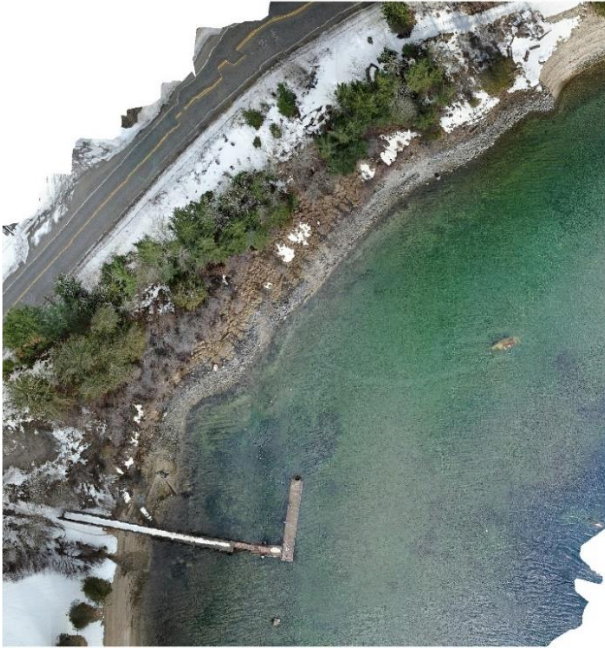
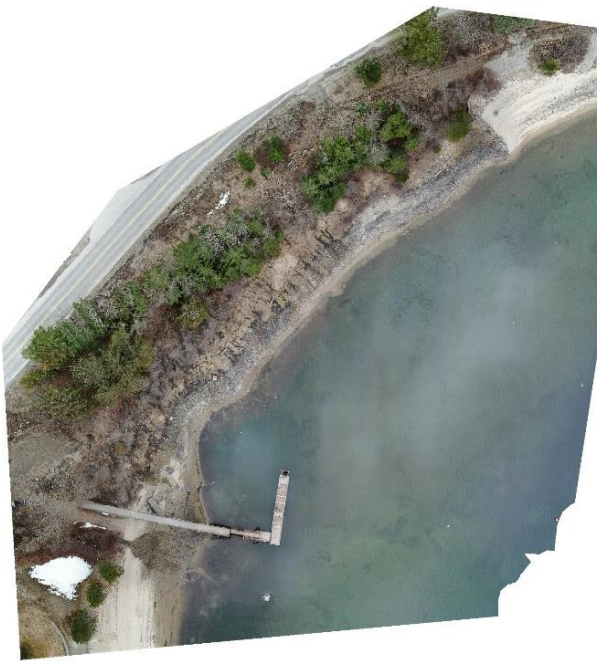
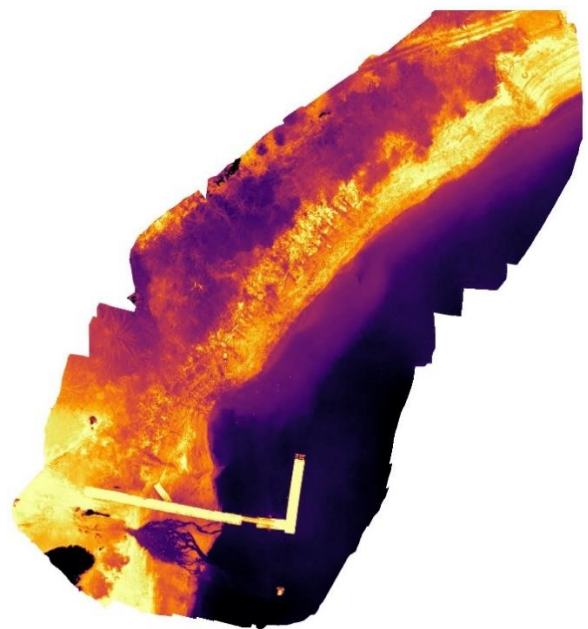
Figures 20 through 26 below show the RGB and thermal drone image outputs from Feb 15 and Mar 24.<sup>1</sup>

Figure 21: Feb 15, 2022. RGB drone imagery of McDonald's Landing

Figure 22: Feb 15, 2022. Thermal drone imagery of McDonald's Landing

Figure 23: Mar 23, 2022. RGB drone imagery of McDonald's Landing

Figure 24: Mar 23, 2022. Thermal drone imagery of McDonald's Landing

At Bonaventure Lagoon on March 23, groundwater is very clearly seen as dark-blue streams and pools contrasted against the orange-yellow mud. On shore at McDonald’s Landing, the groundwater is seen as a darker purple shadowing against the orange/yellow rocks. In the water it is seen as a lighter purple plume over a dark blue-black water. The cold, black-blue surface water of the small stream just west of the dock can also be seen creating a back-eddy and flowing toward the spawning site. Figure 30 below shows four confirmed dewatered redds overlaying thermal imagery. The areas between Redd1 and Redd2, and between Redd3 and Redd4 were identified as the areas with the highest redd density. It is easy to see the correlation between the shadowed blue-purple tones within the areas identified as having high redd density, especially between Redd1 and Redd2.

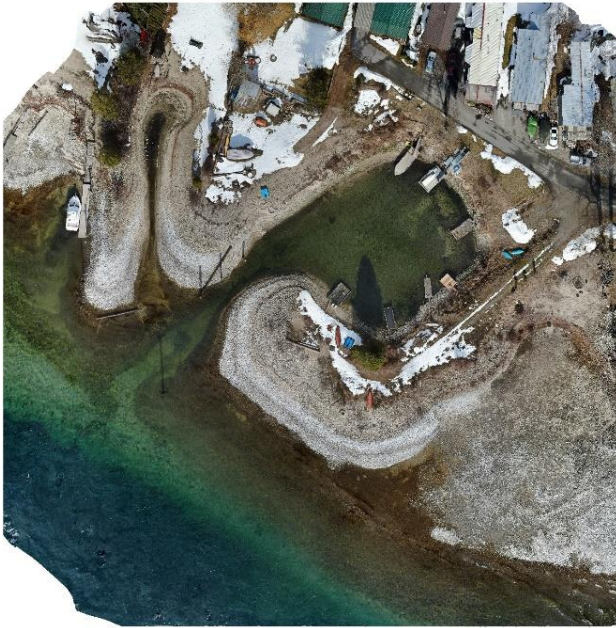
Figure 25: Feb 15, 2022. RGB Drone Imagery of Bonaventure Lagoon.

Figure 26: Feb 15, 2022. Thermal imagery of Bonaventure Lagoon.

Figure 27: Mar 23, 2022. RGB Drone Imagery of Bonaventure Lagoon.

Figure 28: Mar 23, 2022. Thermal Drone Imagery of Bonaventure Lagoon.

The temperature scale is not included in the thermal images at this time because they require calibration and therefore show incorrect temperature values. Figure 29 below shows the colour values of the thermal images from low to high temperature.

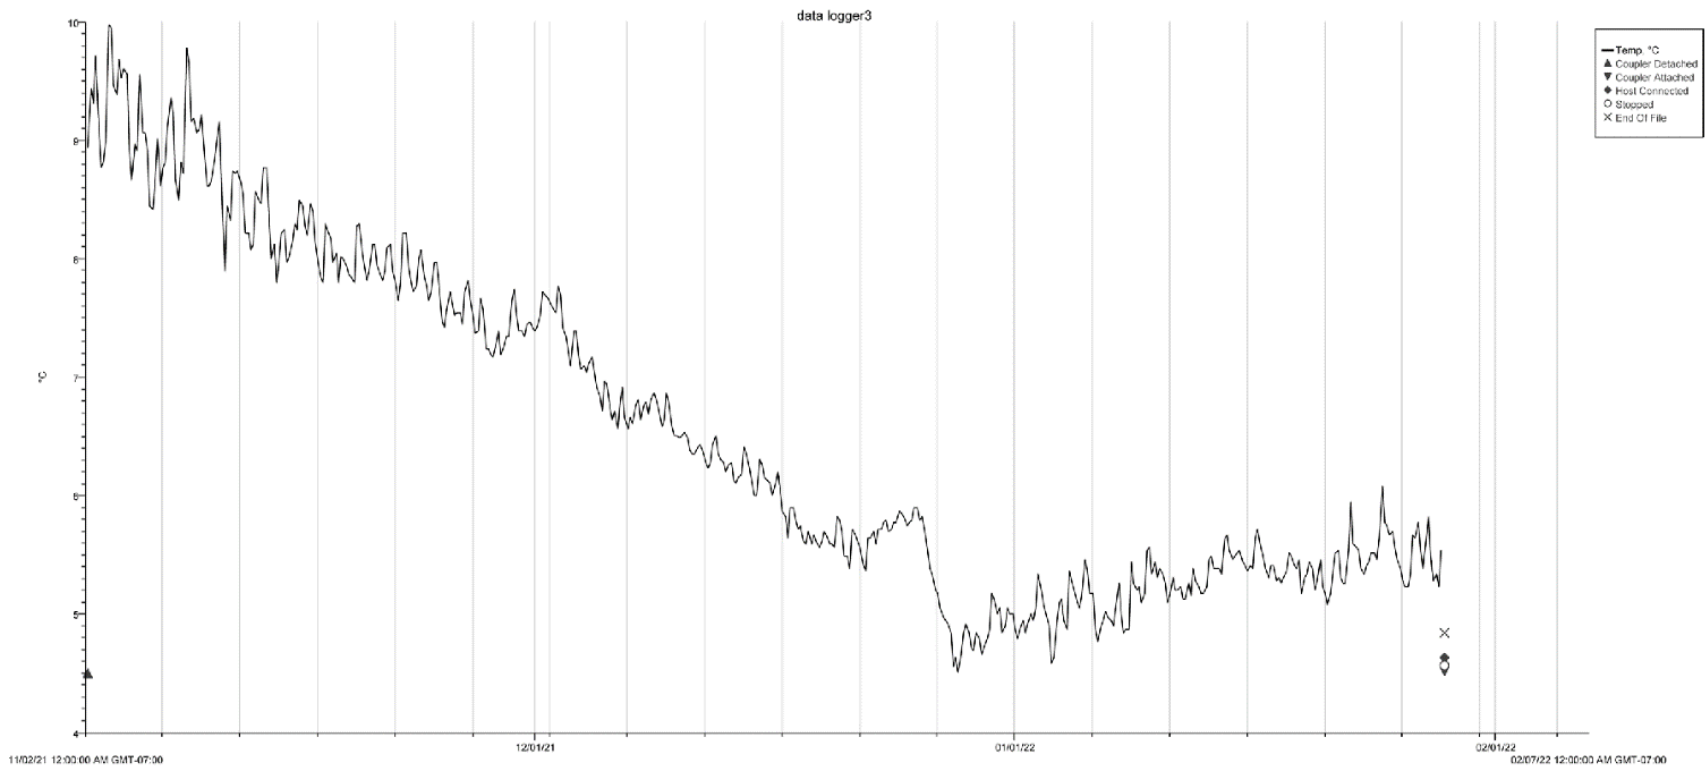
Figure 34: Temperature data from Egg Capsule 2 covering Nov 1, 2021 to Jan 28, 2022

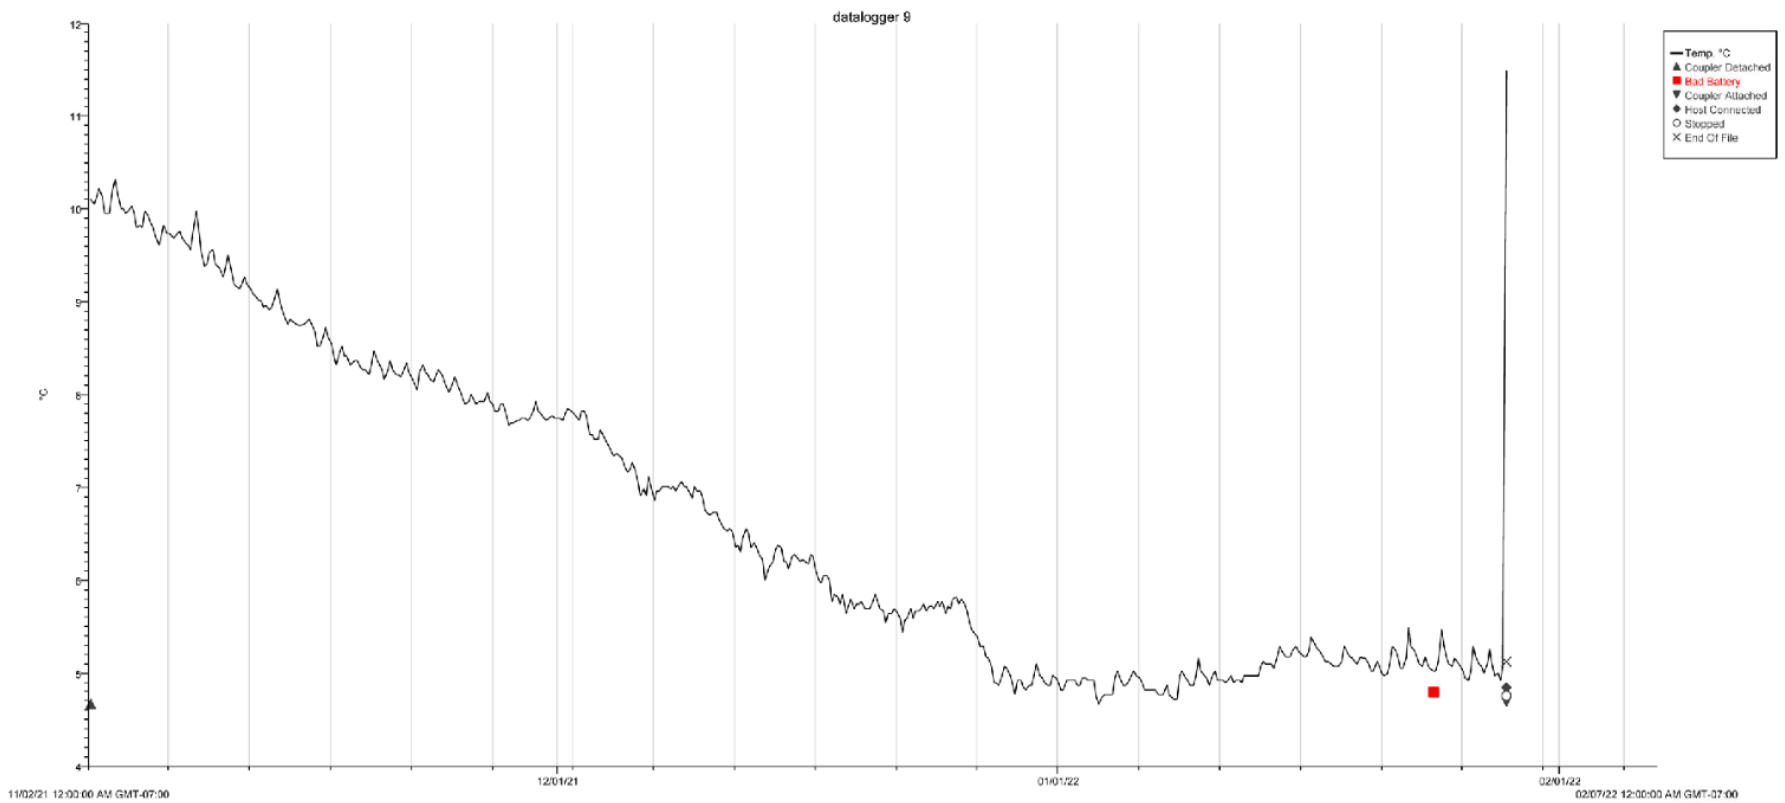
Figure 40: Temperature data from Egg Capsule 9 covering Nov 1, 2021 to Jan 28, 2022
