Kus-kus-sum: Un-paving Paradise Phase I Continued

COA-F22-F-3508

Final Report

Prepared by: Jennifer Sutherst (Comox Valley Project Watershed Society)

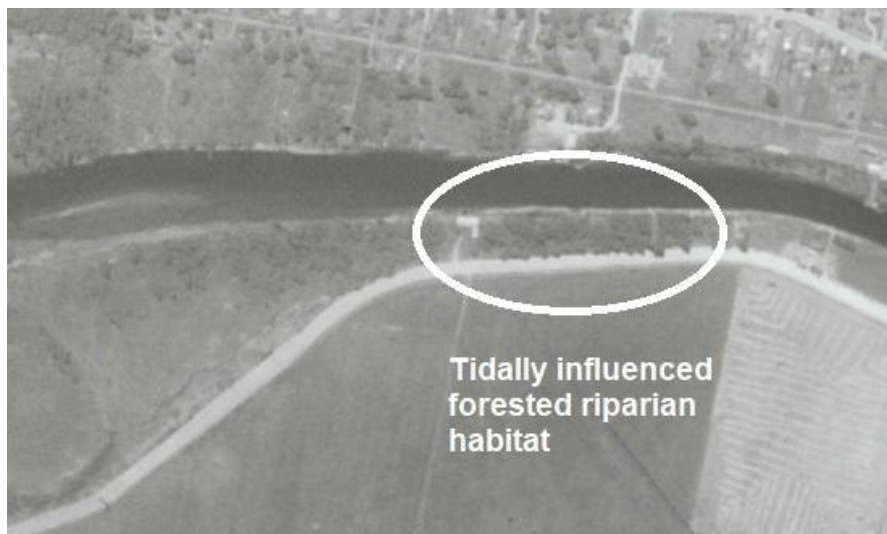
Figure 2: 1946 Aerial image of Kus-kus-sum site

Historic air photos from 1946 and 1951 show that the area was forested and indicate that one or more channels crossed the property and connected to the Dyke Slough (Figure 1). These channels would have provided brackish off-channel habitat for salmonids, a type of habitat that is limited in the K'ómoks Estuary. Off-channel habitat allows juvenile salmonids to escape high river flows and seal predation, as well as providing holding areas to allow for forage, growth, and acclimatization to increasing salinities before they migrate to the marine environment (Beechie et al. 1994) (Sommer et al. 2001) (Ebersole et al. 2003).

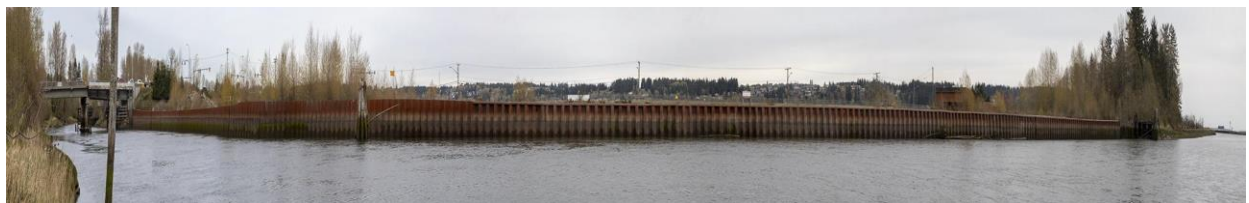
Figure 4: Panorama of the 440m steel clad retaining wall that separates the current site from Courtenay River.

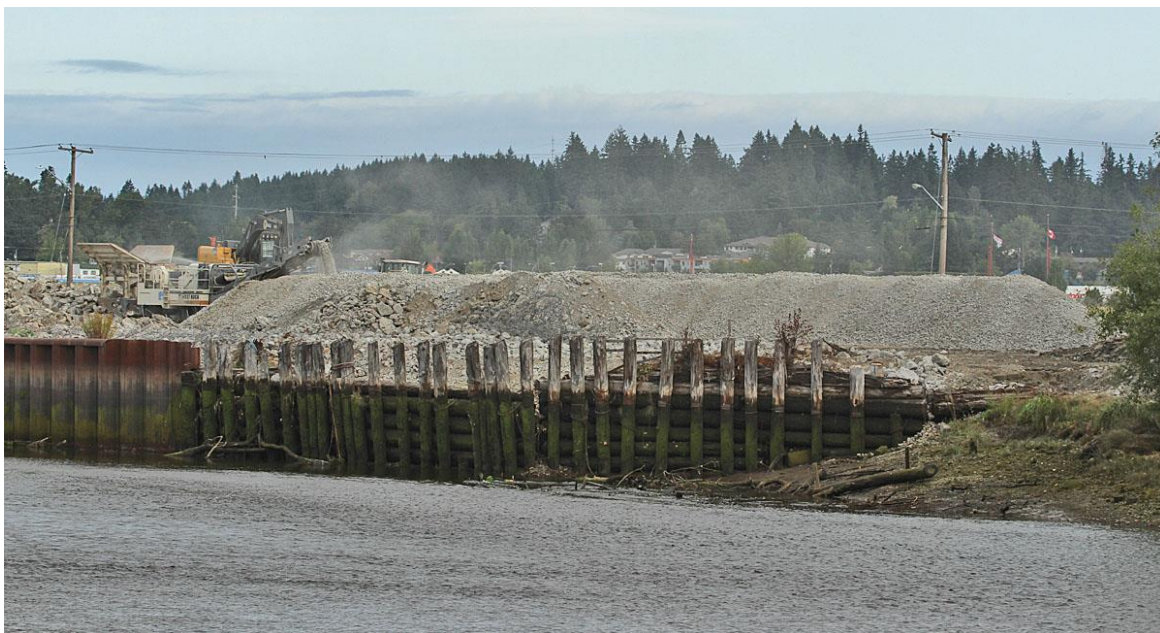
Figure 8- Rock crusher generating windrow piles of crushed concrete.

Towards the end of summer construction season, most of the concrete had been broken and piled up on the site, at which point a rock crusher was brought in to crush all the concrete into the 3"-minus size. The crushing of the material took just over three weeks and large windrows

of the crushed concrete were generated (see Figure 8). Lewkowich Engineering Associates Ltd. came out four times, took samples of the material, graded these samples and certified that they met the standard for reuse as structural fill. Lewkowich generously provided these services pro-bono to the project. The windrows were also surveyed as part of the construction contract with Copcan, which stipulated that they were to be paid \$56.51 per m³ of crush produced. The total volume of material generated was 8,875 m³. This was almost 50% more than the 6,000 m³ that NHC estimated would be taken off the site. The 3"-minus material is a very desirable material for construction and CVPWS advertised that the material would be available for re-use offsite. CVPWS organized to remove the material off the site starting Sept 22, 2021. The recipients had to organize and pay for the trucking of the material and CVPWS paid for the loading and flagging services. The removal of the material went extremely efficiently with an average of 12 trucks hauling per day, and 750 double truckloads of material were removed from the site in five and a half days (see Figure 9).

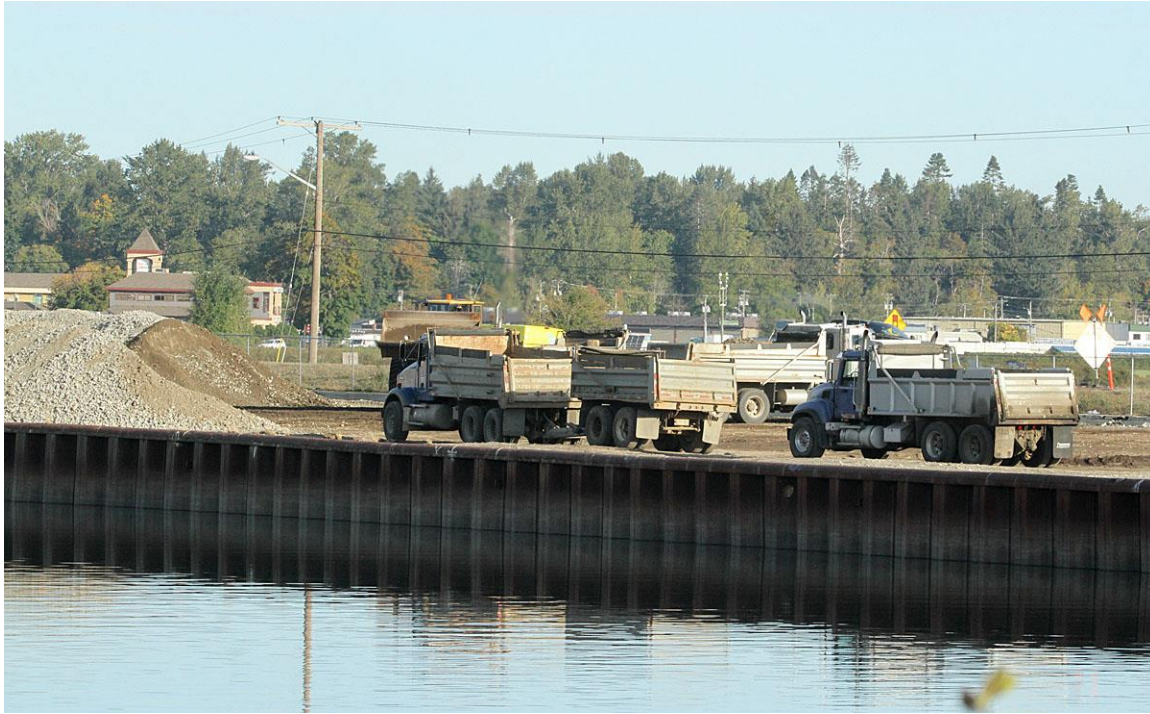
Figure 9 - Trucks being loaded with crushed concrete for distribution to various projects throughout the Comox Valley.

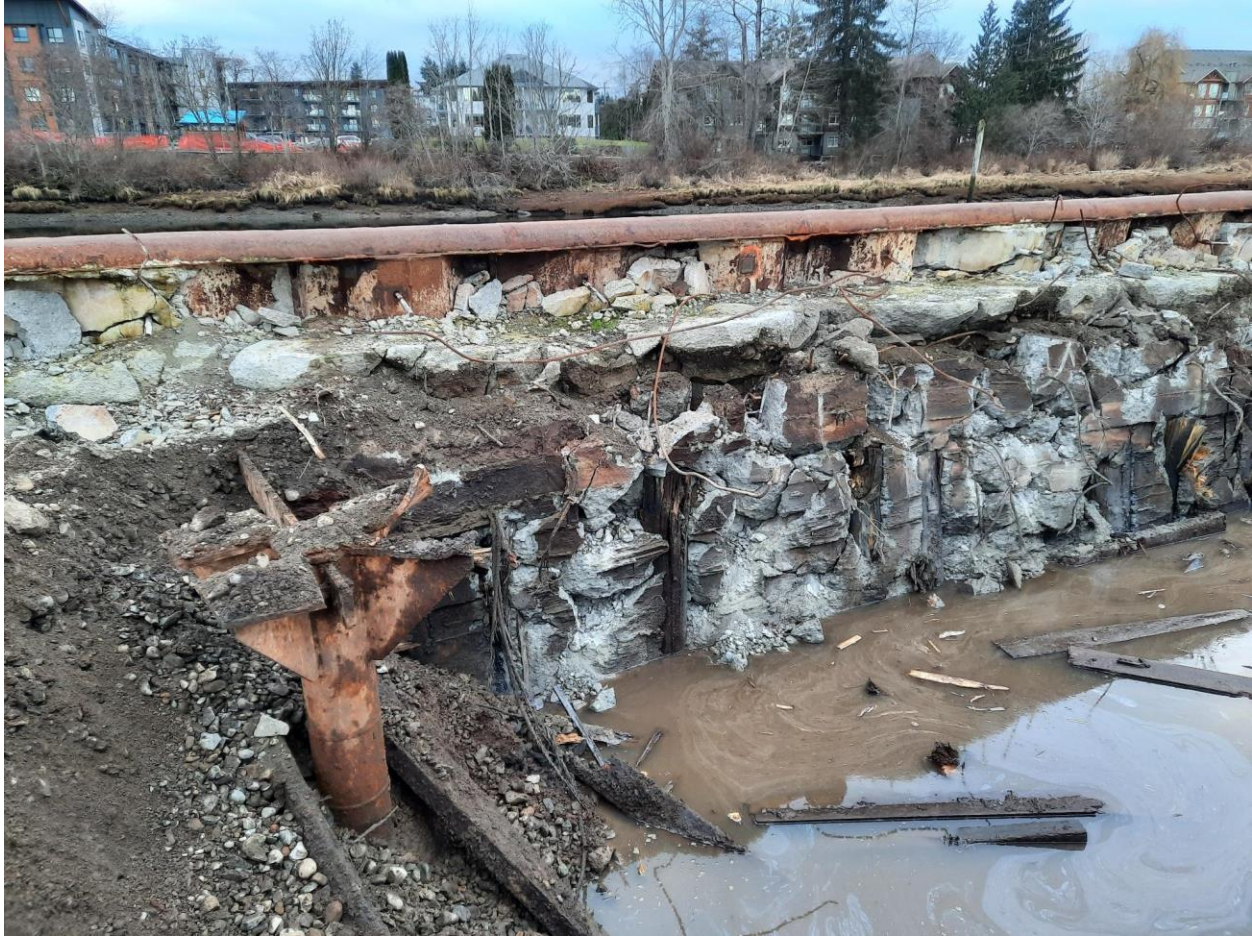
Figure 10 - Cement wall running parallel to the steel sheet piling in the process of being removed.

Work did not resume back on the site until Feb. 03, 2022. The process for the spring work was much the same, digging out and breaking up concrete, extracting the metal from it, digging out asphalt and sorting all the various materials into piles. The one exception was that work in the fall had uncovered a subsurface, reinforced cement wall running parallel to the steel sheet piling wall that was between around 3.6 – 4.8 m deep and ran for 170 m of the site (see Figure 10). This wall was not a known factor when the concrete removal work had been planned. Care had to be taken when removing this wall as we were breaking concrete right next to the river and did not want flying debris or dirty water to enter the river. Furthermore, we had to excavate down to find the base of the wall and this work had to be timed with the low tide. Even so, the water table is high on the site so the excavated areas would start to fill with water at a certain depth. This water had to be pumped out of the area so that the machines could work. The wall had been built using wood forms and had creosote pilings as part of the structure. This woody debris was removed and piled on the site, and the pieces that were contaminated with creosote had to be separate out and handled separately for disposal. Overall, the wall removal was a significant logistical challenge that added an additional two and half weeks onto the project work.

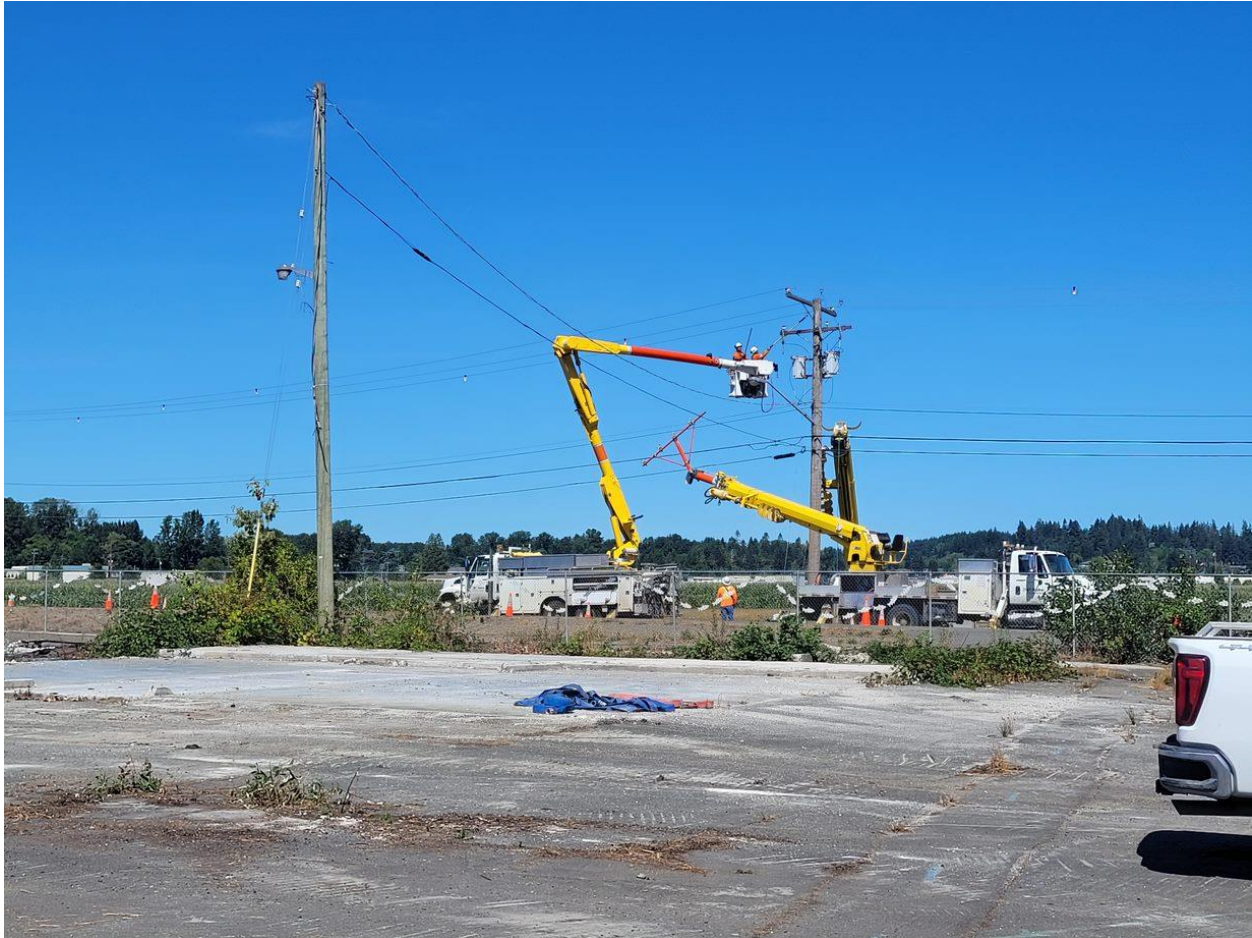
Figure 11 - BC Hydro Crew disconnecting lines to power pole at KKS site in preparation for removing it.

As previously mentioned, a file was started with BC Hydro in the spring of 2021 to have the power pole on the site disconnected from their circuit and removed. It did take some time for BC Hydro to action this request as their crews were quite busy, and this was not a high priority nor emergency task that needed addressing. Luckily, the Copcan crew was able to work around the power pole until it was removed by the BC Hydro crew on August 11th (see Figure 11).

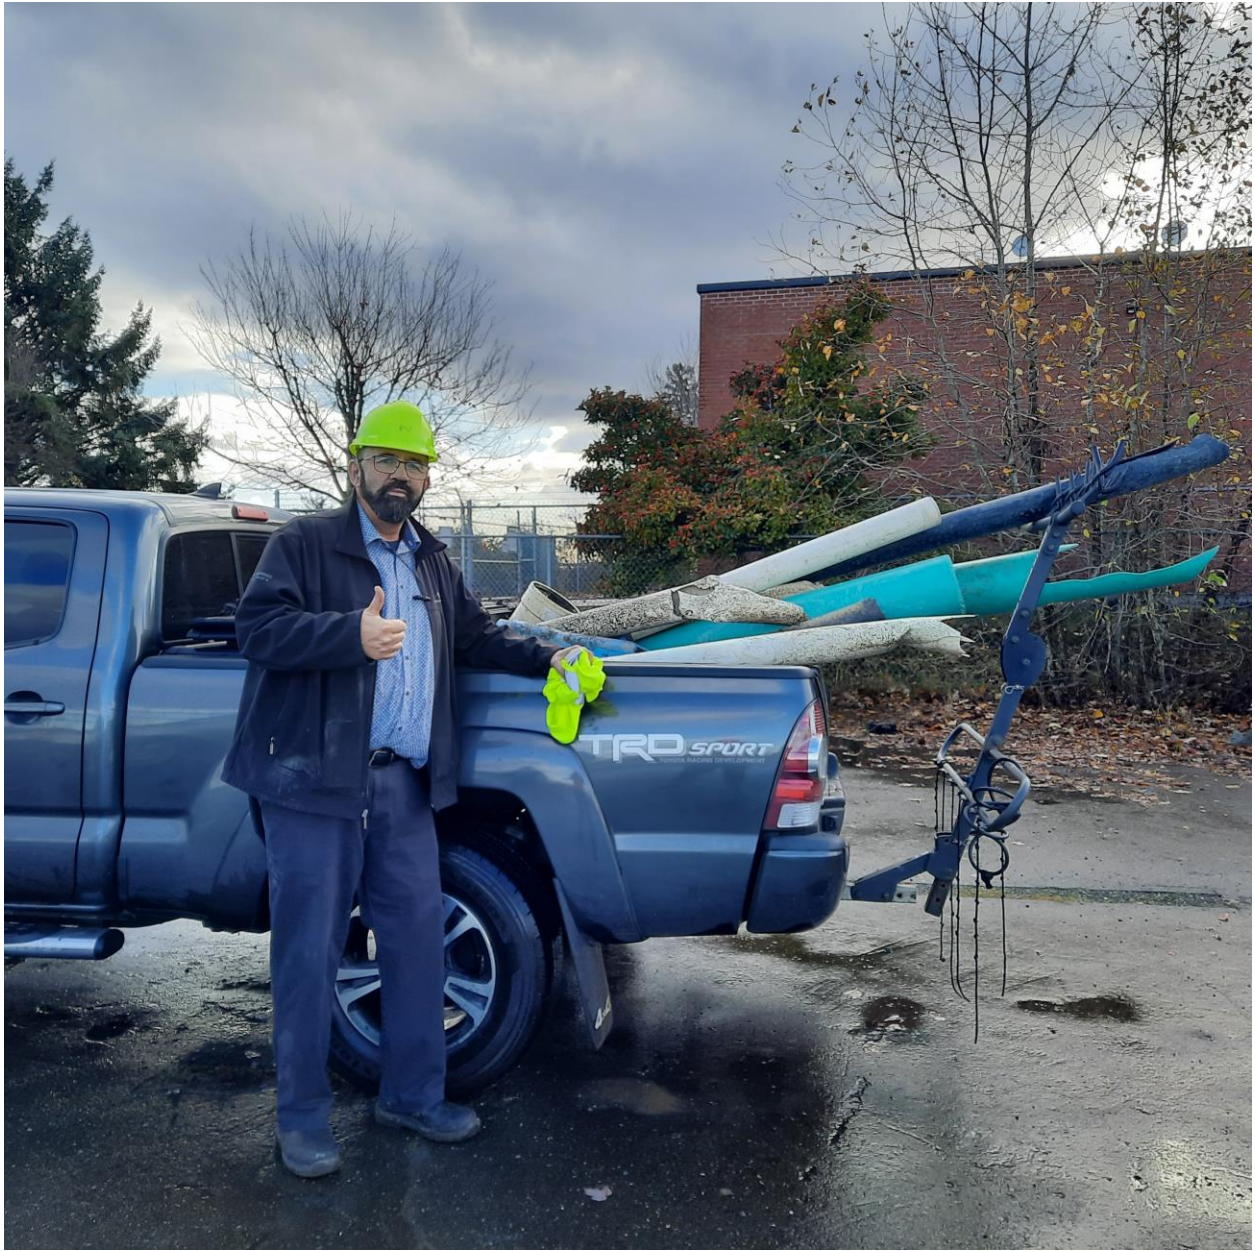
Figure 13 - Gord Nettleton, from United Riders of Cumberland, salvaging PVC pipes from the work site.

Finally, the PVC plumbing pipe extracted from the project was advertised on CVPWS's social media channels and several interested parties came forward to salvage the pipe for drainage projects. Most of the salvaged pipe went to the United Riders of Cumberland (UROC), a registered non-profit mountain biking association, and they reused the pipe for drainage on various local mountain biking trails (see Figures 13 and 14).

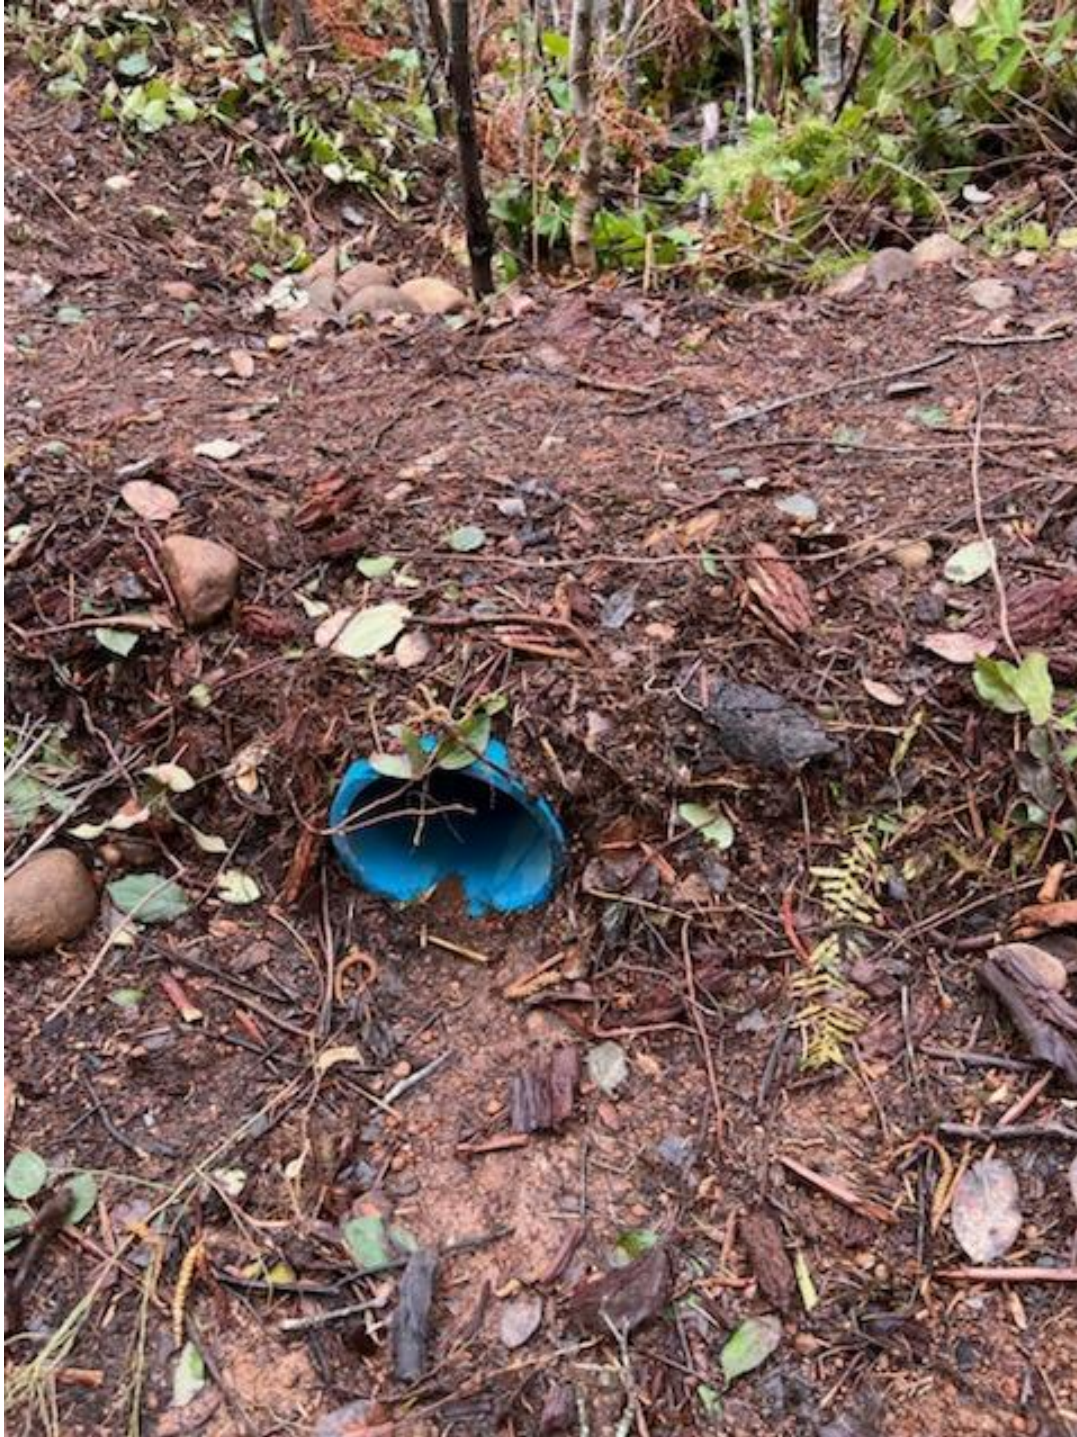
Figure 14 - PVC pipe from the work site installed for drainage in a local mountain biking trail.
