Summary of Minnow trapping component of the SD 91/UNBC eDNA project

2022 Season

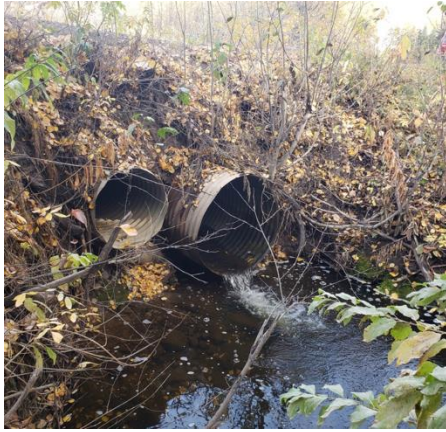
Photo 1. Perched culverts at Dog Creek FSR.

Over three trapping sessions we caught 10 chinook in a small section (~ 130 m) of Dog creek that extends from just above a set of culverts that cross the of Dog Creek Forest Service Road to the confluence with the Nechako River (Appendix 1). Of note in 2022 were the following observations. First, we captured chinook upstream of the perched culverts (Photo 1) and the small chute / waterfall below the culvert (Photo 2). These were thought to be barriers to upstream movement at lower flows in 2021. Clearly, our results this year have indicated that chinook were able to cross these structures during some point prior to our sampling in 2022. Second, we noted cattle activity on the section of Dog Creek above the Dog Creek FSR (Photo 3), and in fact one trap was disturbed by cattle. This activity resulted in a dramatic increase in turbidity of the lower section of Dog Creek in our August trapping session compared to our June and September trapping sessions.

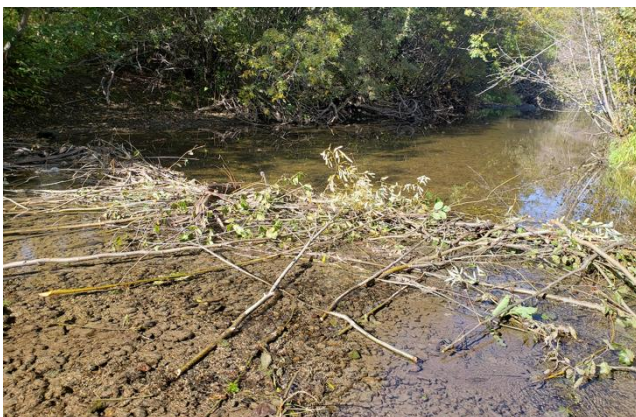
Photo 5. Beaver Dam spanning Ormond Creek.

We noted that a small beaver dam spanning Ormond Creek in the vicinity of where we placed our traps had been constructed between our August and September sampling sessions (Photo 5 & 6). While this beaver dam will not persist on this section of Ormond Creek given width of the creek at this location, and the high flows we have seen in the past, it nonetheless had localized and temporal impacts: water was clearly backing up behind the dam; and a large rainbow trout was seen staging downstream of the dam when we arrived and its upstream movement appeared to be hindered by this small dam (Photos 5 & 6). It was also noted that some attention downstream of the culverts that cross Stella Road may be warranted. We noted that there have been significant alterations to the channel morphology downstream of the culverts. While we did not thoroughly assess the section of Ormond Creek immediately downstream of the culverts for possible fish passage issues, but we feel that this is warranted given the current appearance of the channel (Photos 7-9).

Note water pooling above dam in Photo 5 and large (~ 15 cm) fish that appeared to be a rainbow trout staging at downstream end of dam in the foreground of Photo 6.

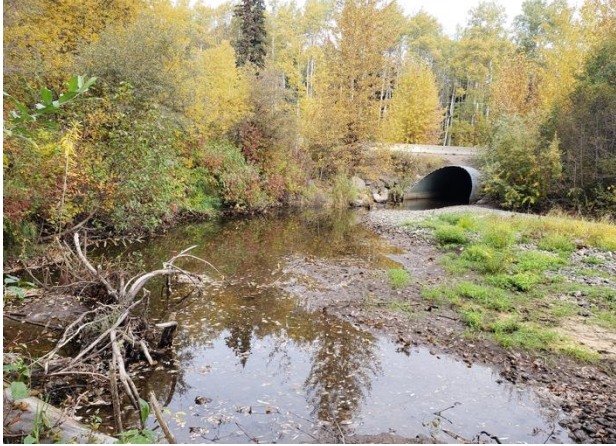
Photo 7. Ormond Creek

This photo is looking upstream to the culvert that crosses Stella Road. Note the sediment wedge on the right-hand side of the photo. This deposition is pushing most of the flow of Ormond Creek through the willows on the river right side of the creek (left hand side of this photo).

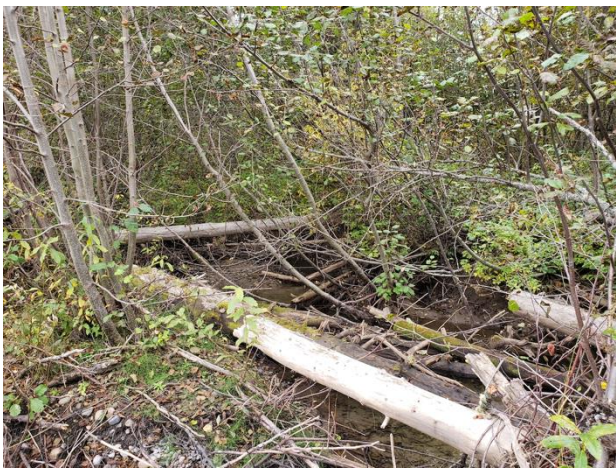
Photo 8. Ormond Creek through willows.

Although difficult to see in the photo, this is one of the paths Ormond Creek takes through the willows on river right. Of importance to note here is that the creek winds through at least one narrow channel that is somewhat clogged with logs and debris.

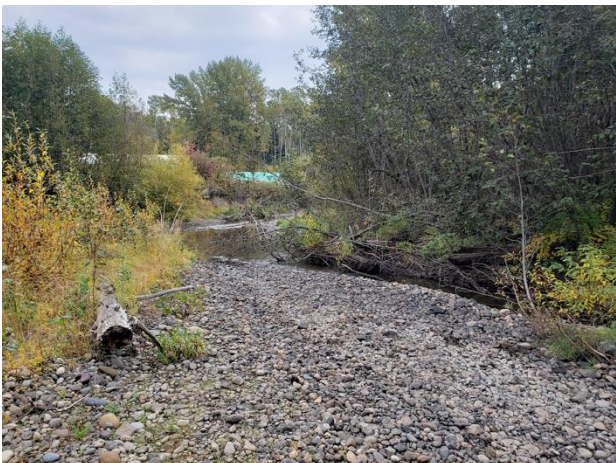
Photo 9. Ormond Creek emerging from path through willows

This photo is looking downstream from Photo 7. One can notice the large accumulation of bedload in the foreground. It can also be seen that the flow of the creek reappears down stream
