Safe Passages for Wildlife in the Southern Canadian Rockies

2022-23 Final Report

Prepared for: Fish & Wildlife
Compensation Program

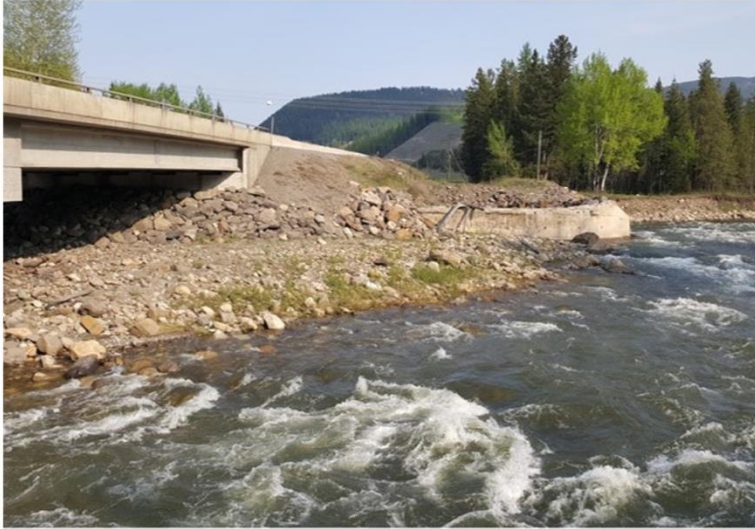
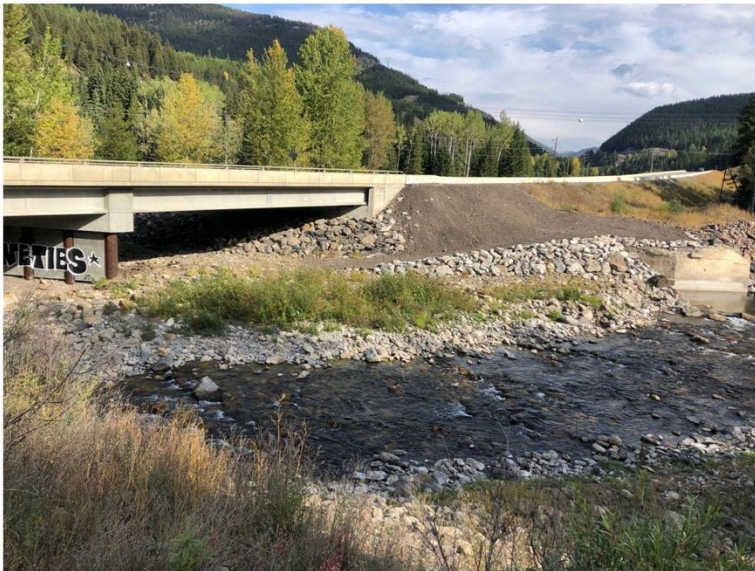
Loop Bridge

Image 2. Example of an underpass retrofit at Loop Bridge. Here a large open span bridge had the potential to provide an effective underpass below the highway, but rip rap and an old abutment blocked animals from easily entering the river edge. We removed a portion of this abutment and created a 10 ft wide path down to the underpass that makes the structure more enticing and safer for wildlife.

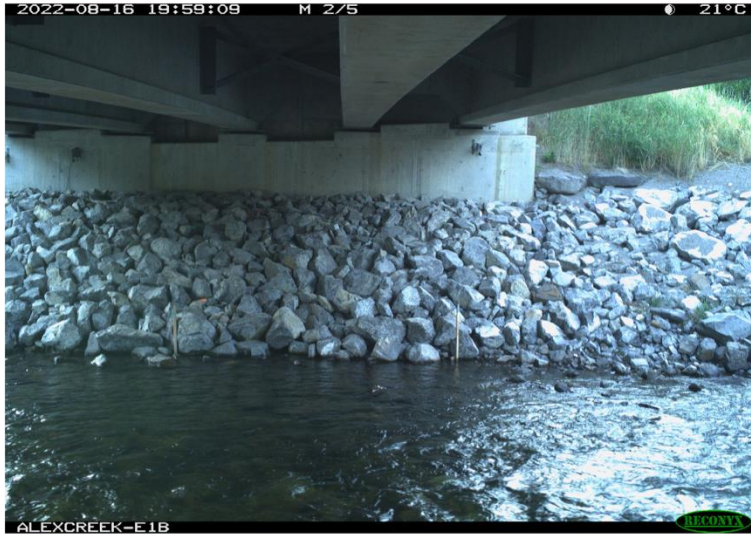
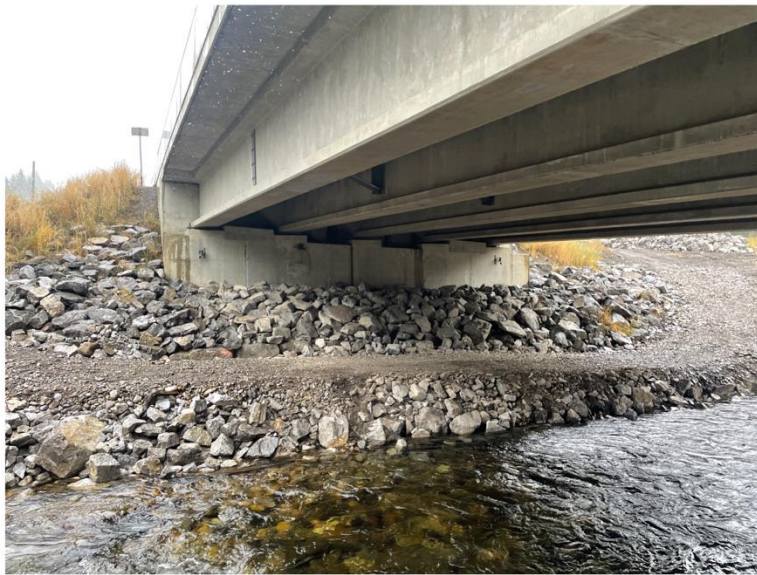
Alexander Bridge

Image 3. Example of an underpass retrofit at Alexander Bridge. Here a large open span bridge is in an ideal crossing location, but due to the rip rap right up to the creek there was limited opportunity for wildlife to cross under the bridge unless they went in the creek. While the creek is passable for some of the year, its is challenging to cross in the spring during high water, and during the winter when the creek is partially frozen. We engineered a solution that allowed a 1.5 m wildlife path through the rip rap while still protecting the infrastructure. In some high water years the smaller gravel from this path will be washed away but it can be replaced by hand when needed.

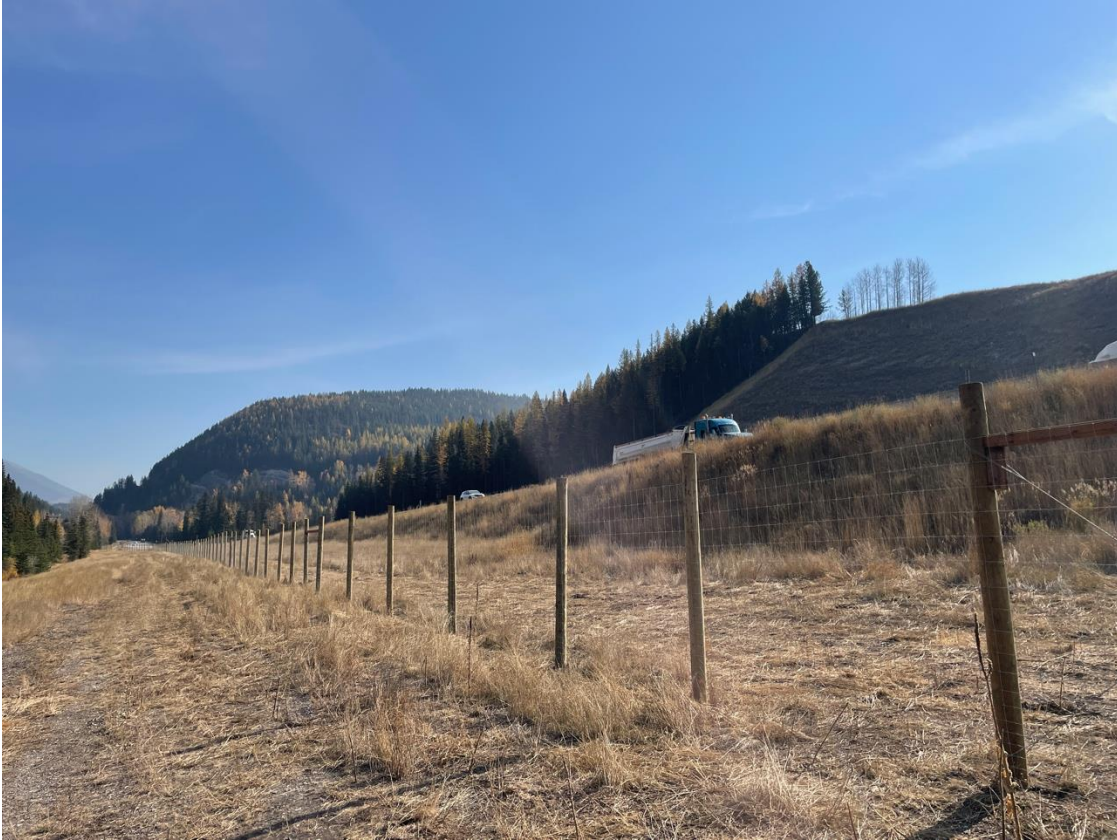
Image 4. Phase one wildlife exclusion fencing between Loop Bridge and Carbon Bridge.

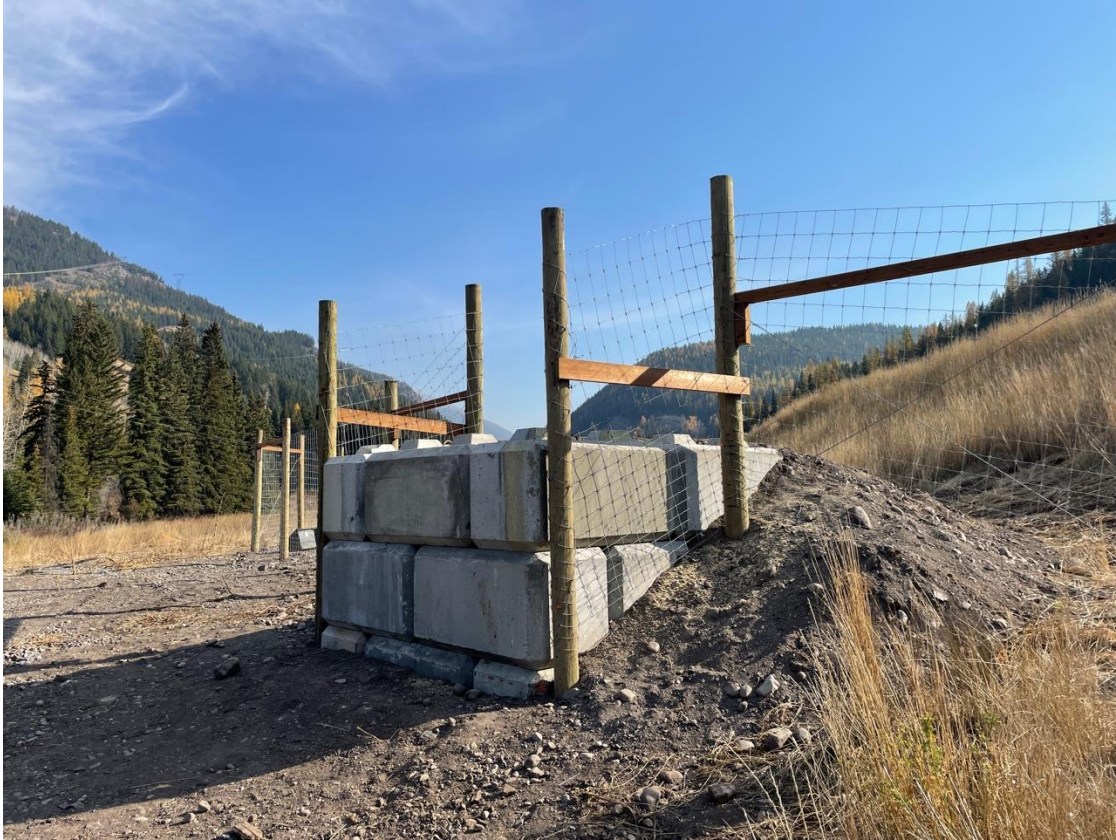
*Image 5. A jumpout along the Phase one fence. The jumpout was designed based on extensive testing from Arizona using elk, bighorn sheep, and deer (Gagnon et al. 2020). This design is simple and allows animals to safely exit the highway if needed, while precluding animals from jumping into the highway right of way in reverse. Where sheep are a concern the grooves between the blocks should be filled.
This image does not show the horizontal bar at 45 cm that was installed after this photo was taken.

We recommend the addition of monitoring cameras at jump outs to monitor use of the structures and assess if animals are accessing the highway through these structures or if they are effective height for animals to be able to get off the right of way .

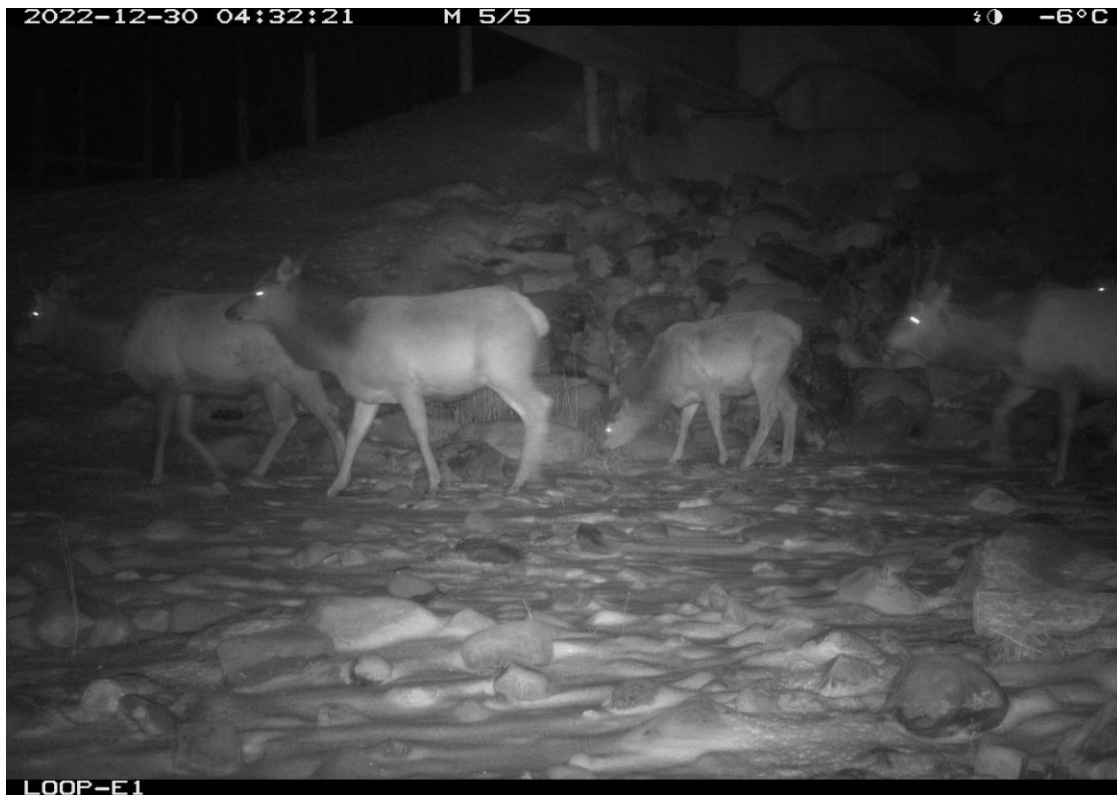
Image 6. An elk herd using the retrofitted Loop Bridge underpass following fence construction.

We have successfully constructed 4 km of fencing (2 highway km's) in 2020-2022 and retrofitted 4 underpasses. The underpasses are all being used by wildlife, and we have observed increased wildlife use of Loop Bridge underpass following the completion of the first section of fence.
