**Reconnaissance (1:20,000) Fish and Fish Habitat
Inventory
of the
Barriere River Watershed
WSC: 129-190100**

Prepared for:
Tolko Industries Ltd.
Louis Creek, BC
VOE 1E0

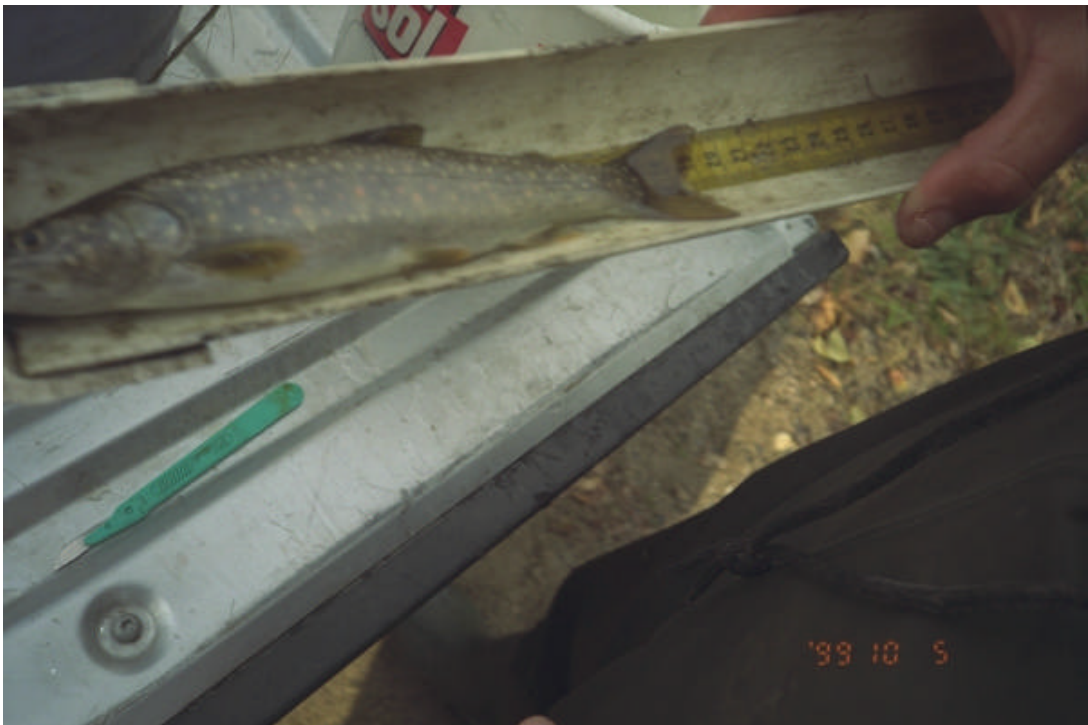
Figure 6. Barriere River watershed: Bull trout captured by electrofishing. Site 148, ILP Map 92P.020, ILP 1, Reach 7, October 5, 1999.

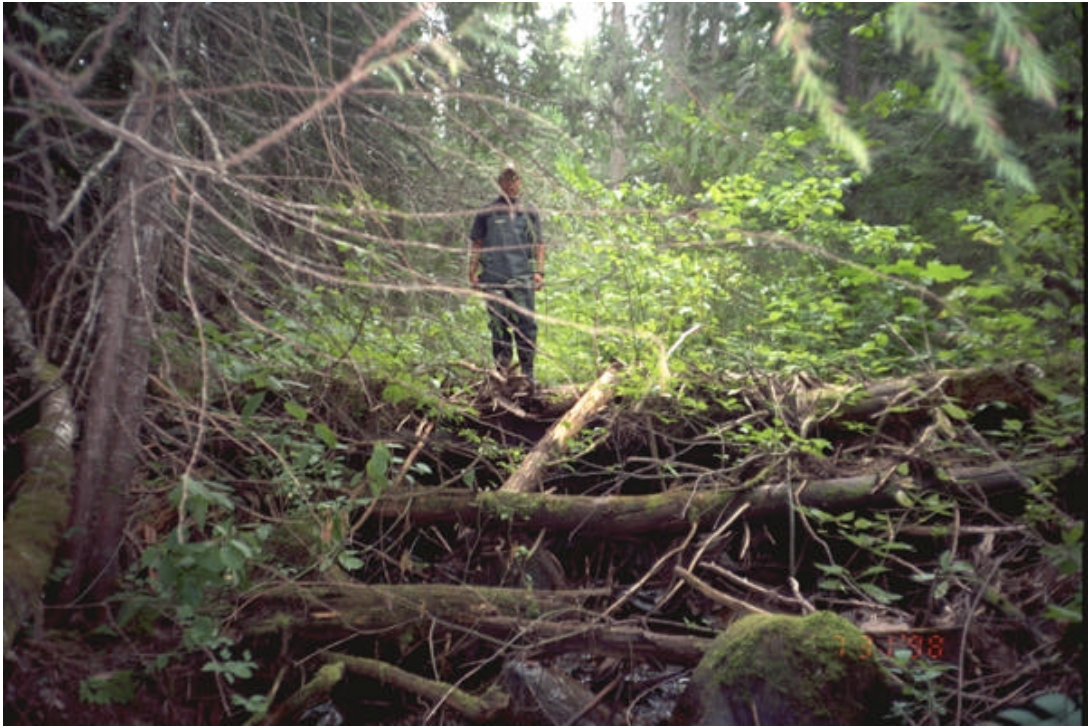
Figure 7. Barriere River watershed: Upstream view of logjam. Site 34, ILP Map82M.031, ILP 10, Reach 1, August 12, 1998.

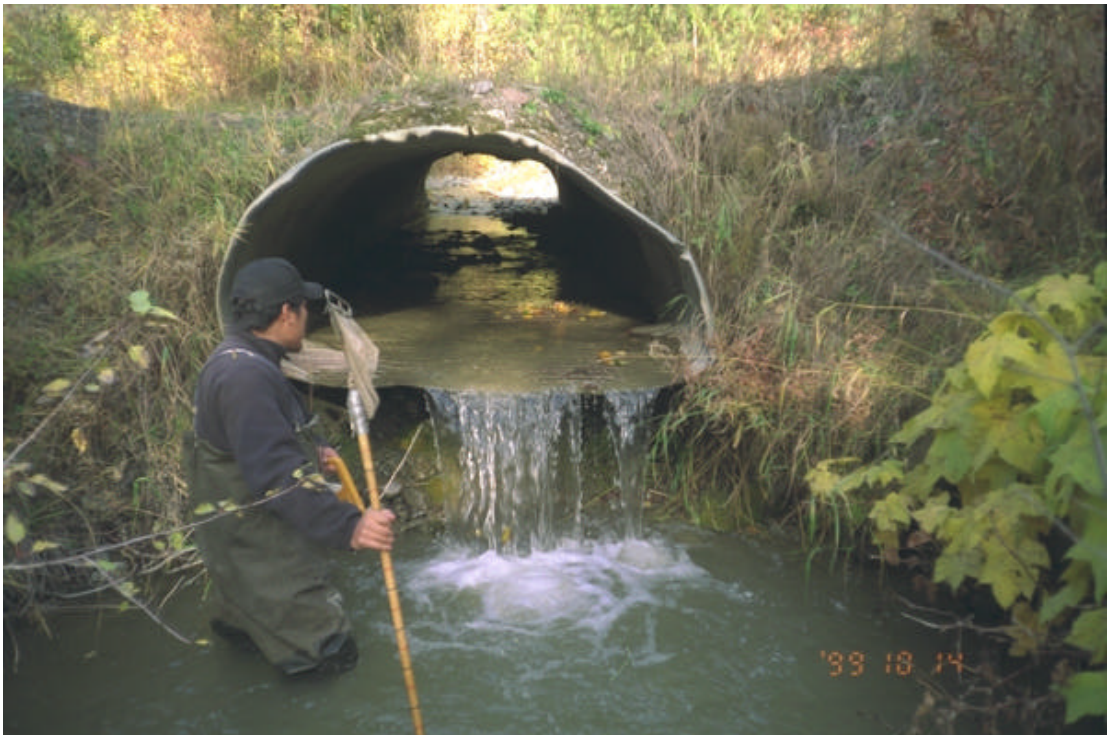
Figure 8. Barriere River watershed: Upstream view of perched culvert. Site 153, ILP Map 82M.021, ILP 56, Reach 1, October 14, 1999.
