Final Report

Shore-Spawning Kokanee Habitat Restoration & Research Project Year 3 (2022–2023)

Prepared for: Fish & Wildlife Compensation Program

Prepared by: Friends of Kootenay Lake Stewardship Society
Kayla Tillapaugh, Program Manager (previous)
Moriah Tanguay, Stewardship Coordinator

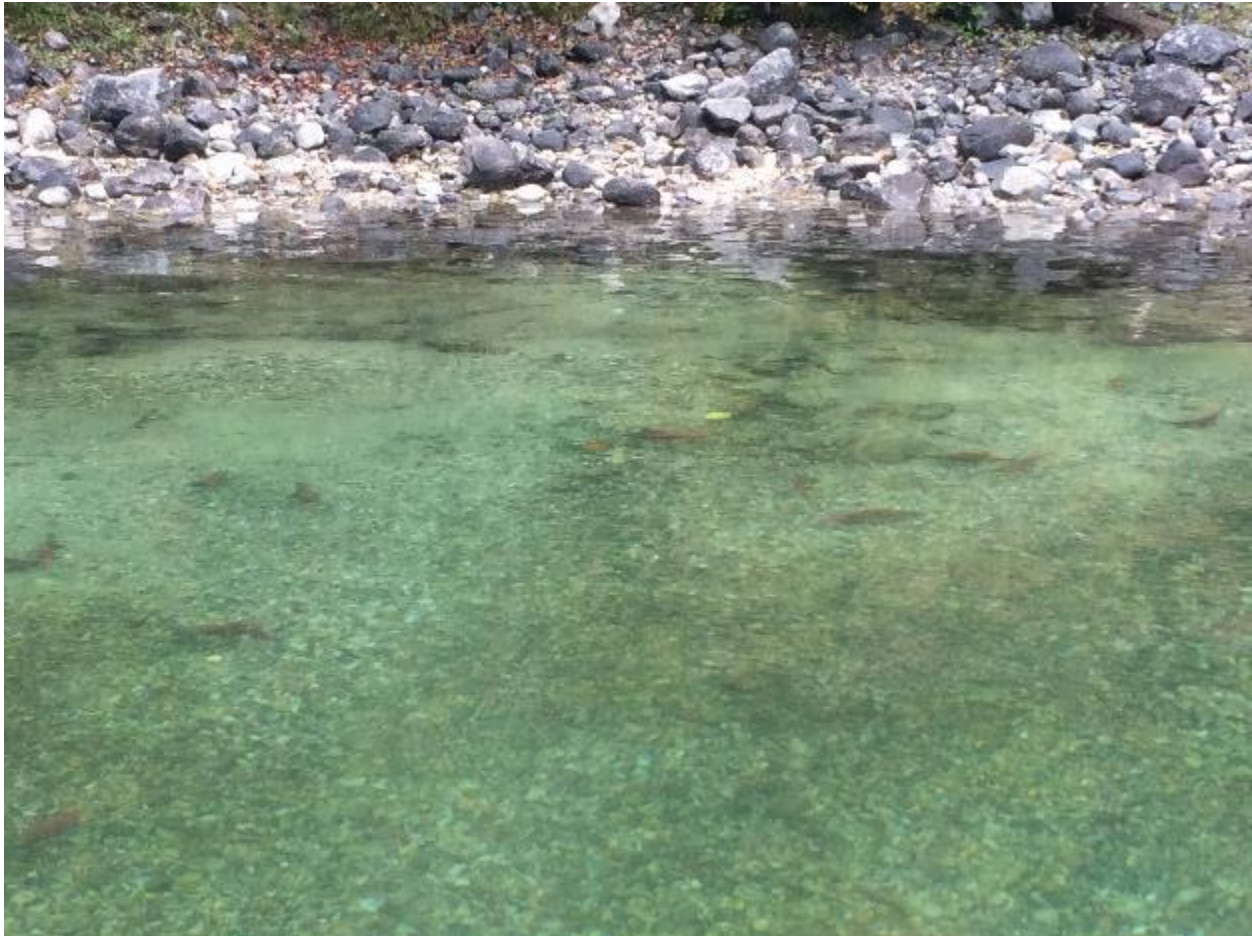
Figure 2: Oct 4, 2021. Spawning kokanee at McDonald's Landing Regional Park (cleaned redd areas visible)

Spawning kokanee numbers were enumerated weekly between September 28 and October 19, 2022 by FoKLSS staff. Five monitoring days were completed by FoKLSS in total in 2022. FoKLSS monitoring expeditions were conducted by boat at coasting speeds across the restoration site. The site was traversed one to six times for each survey. One monitor counted all kokanee observed, and one monitor counted all kokanee observed above the LWM. Both redds and dead kokanee were enumerated using fish counters.

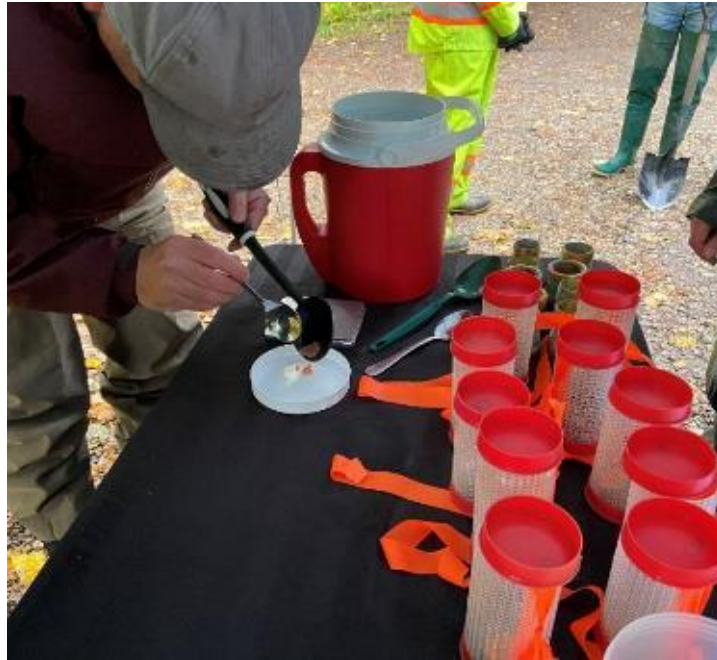
Figure 3: Oct 28, 2022, Kokanee egg capsule install. Counting and weighing kokanee eggs. Photo credit: Moriah Tanguay

A fish transfer permit and a Section 11 Water Sustainability Act (Changes In And About A Stream) notification were obtained. Ten perforated capsules containing kokanee eggs and water temperature data loggers were installed on October 28, 2022 at varying elevations in the control and restored substrate. One-hundred eggs were counted and weighed. Each labelled capsule was loaded with ~200 triploid (infertile) kokanee eggs from the BC Freshwater Fisheries Society in Cranbrook, a HOBO Tidbit temperature data logger, and a rock (for extra weight). A length of coloured flagging tape was tied through the tube for easy identification. Capsules were placed into buckets of fresh lake water and

carried to the shoreline. Egg capsules 1-5 were installed directly adjacent to naturally created redds in ~100-150 cm of water in areas of known groundwater upwelling. Egg capsules 6-10 were installed within the restored substrate by scuba divers, directly adjacent to naturally created redds, in 165-180 cm of water. Egg capsules were buried horizontally ~10cm below the substrate surface. Data collected included capsule ID, lake level, date, water depth at insertion, time of insertion, weight of eggs, GPS data point ID and additional notes. Photos were taken of the contents of each egg capsule for a more precise count of eggs later in the office. Temperature data loggers collected a temperature reading once every four hours from October 28, 2022 to January 20, 2023.

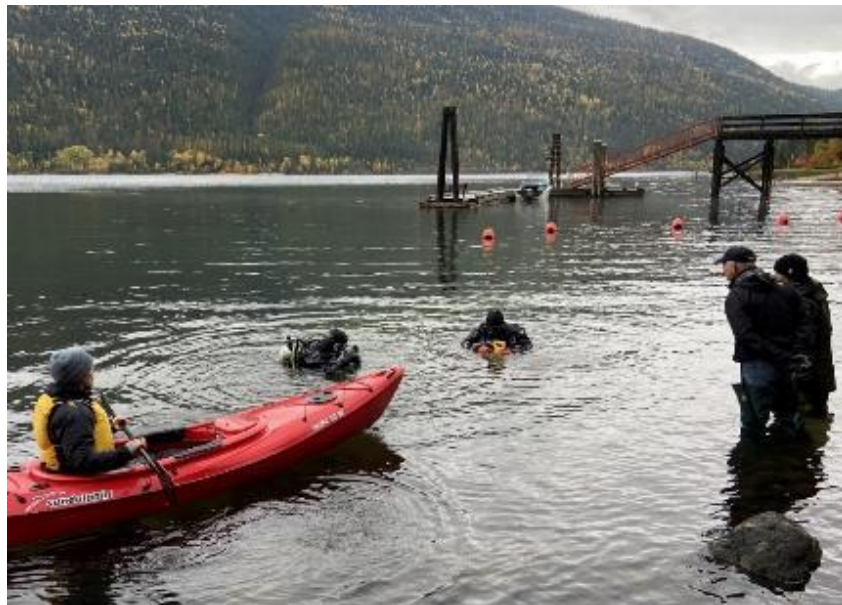
Figure 4: Oct 28, 2022, Kokanee egg capsule install. Divers installing egg capsules. Photo credit: Moriah Tanguay

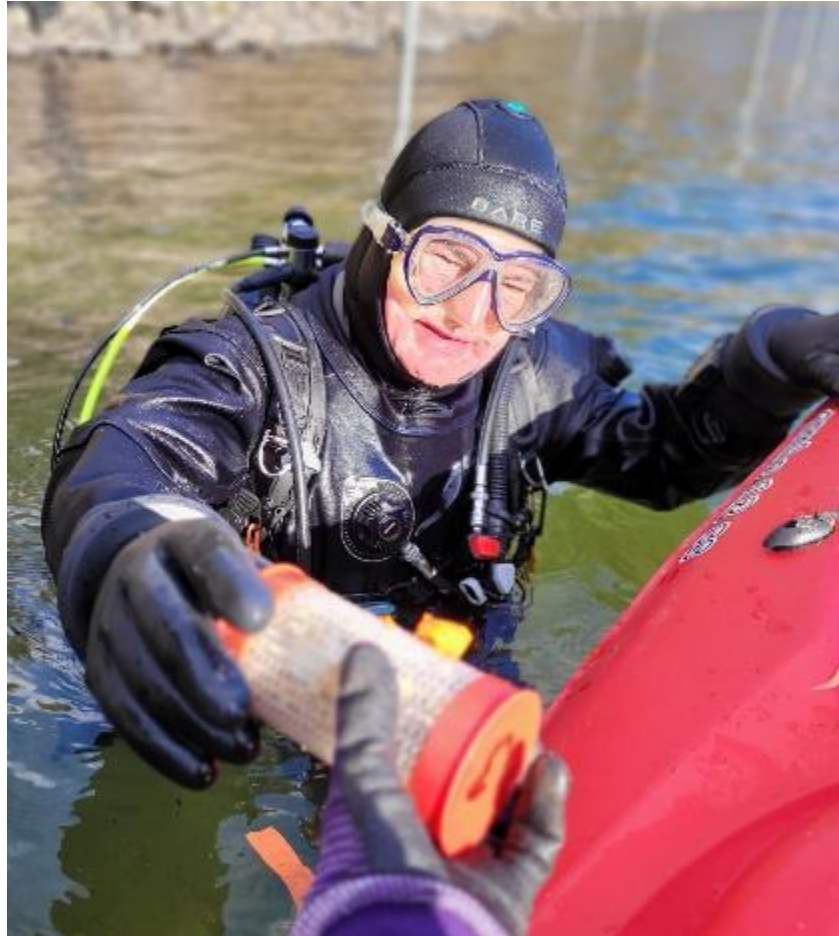
Figure 5: Jan 20, 2022. Egg capsule retrieval. Removing capsule from substrate. Photo credit: Kayla Tillapaugh

Egg capsules were removed from the substrate on January 28, 2022 with support from volunteers and scuba divers; accumulated thermal units (ATUs) were approximately 864.4 on this date. Egg capsule contents were emptied and assessed by provincial fish biologists. Data collected included egg tube ID, lake level, water depth at removal, time of removal, GPS data point ID, water temperature, substrate, presence of invertebrates inside and outside the capsule, egg, fry and alevin count, presence of fungus on eggs and additional notes. Photos were taken of the contents of each egg capsule for a more precise count later in the office, and data loggers were offloaded.

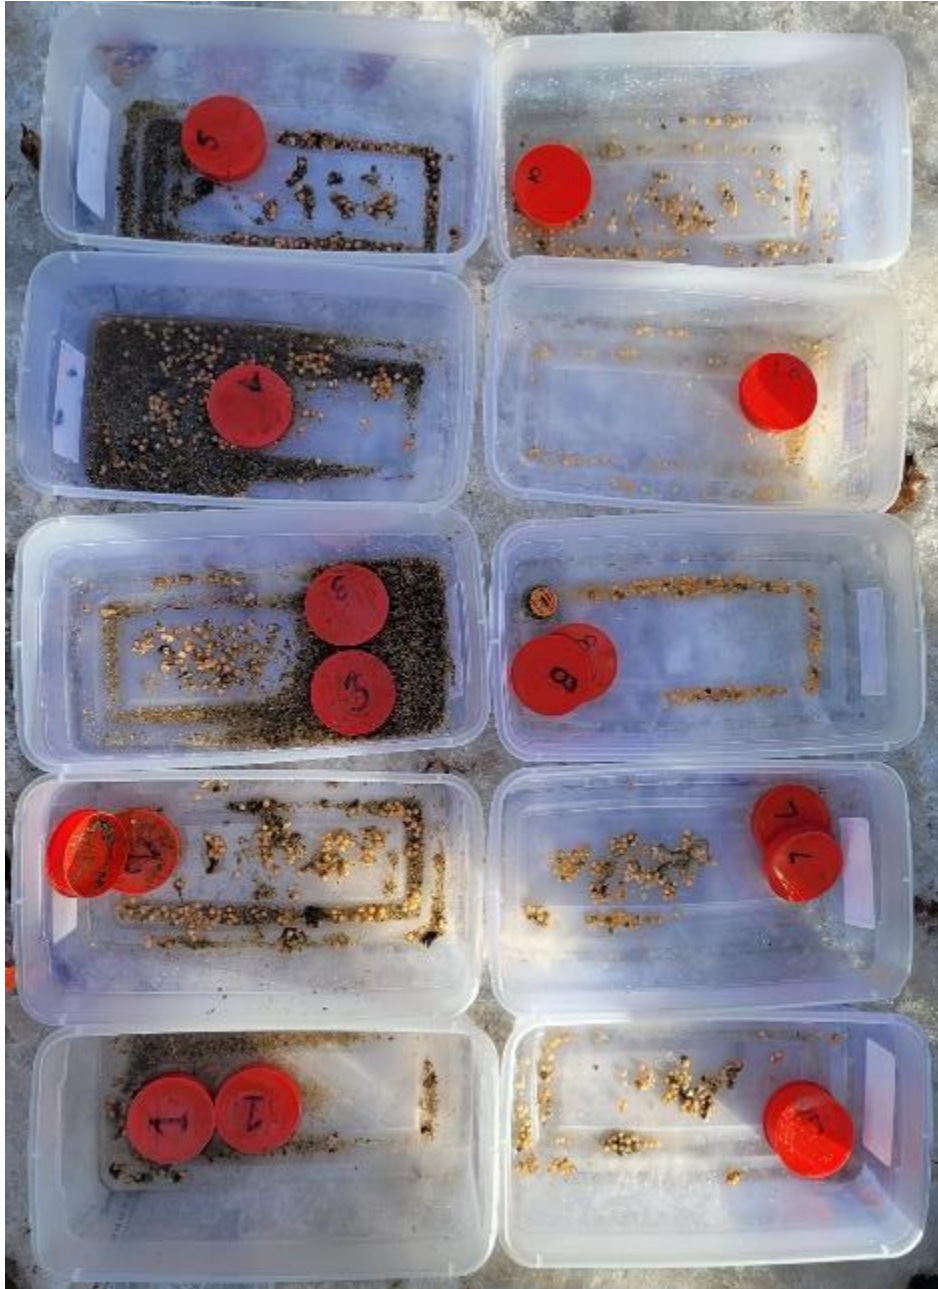
Figure 6: Jan 20, 2023. Egg capsule retrieval. Inspecting capsule contents and counting dead eggs. Photo credit: Kayla Tillapaugh

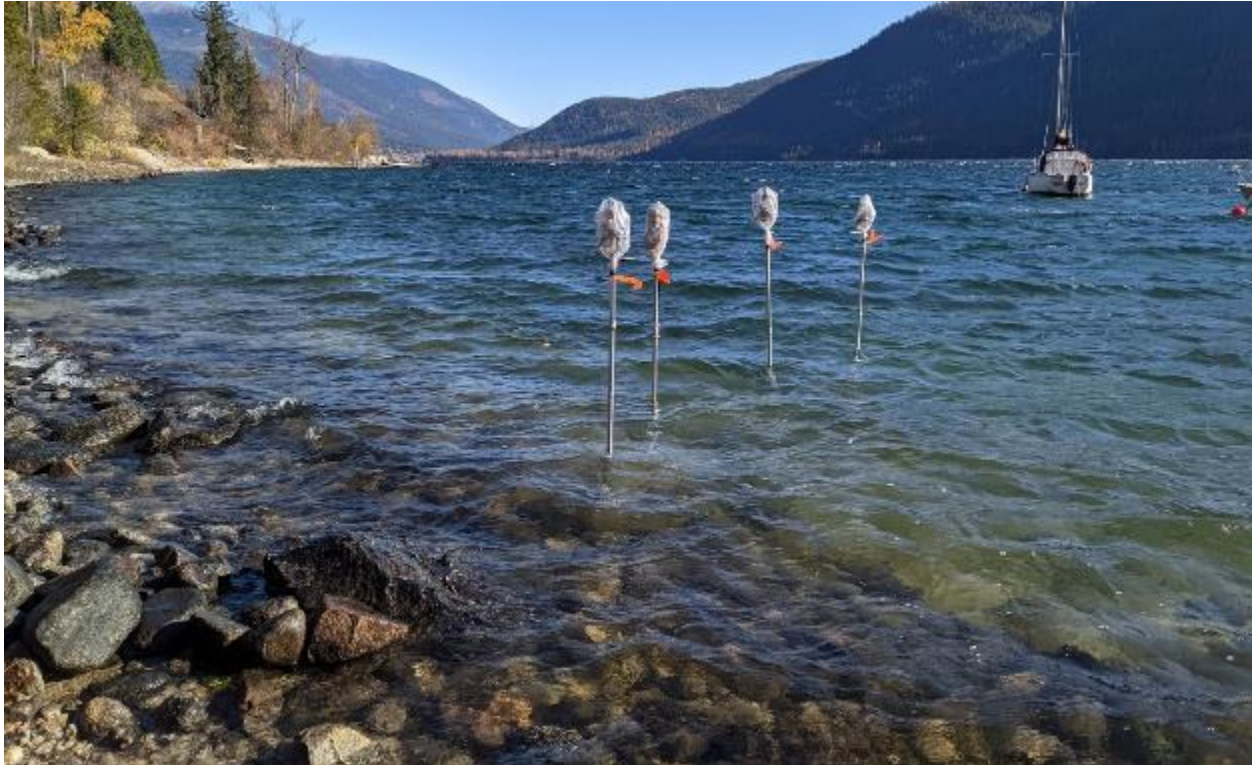
Figure 10: Photo of vertical sediment temperature profiling probes installed at McDonald's Landing restoration site. Photo credit: Cameron Spooner.

Four vertical sediment temperature profiles were installed using steel pipes and a set of 4 thermistors or Tidbit loggers. The goal was to measure sediment temperature and use it to model vertical groundwater flow. The pipes were driven into the substrate and the temperature probes were placed inside - one 30 cm below the lakebed, one 20cm below the lakebed, one 10cm below the lakebed, and one at the lakebed (0cm). Surface water and groundwater temperature signals were acquired from the water level loggers in the lake and lakebed (60cm below the lakebed). Temperatures were recorded every 30 minutes from November – April of 2021 – 2023. Vertical groundwater flow was then modelled using 1DTempPro, a USGS graphical user interface (GUI) for the VS2DH model.

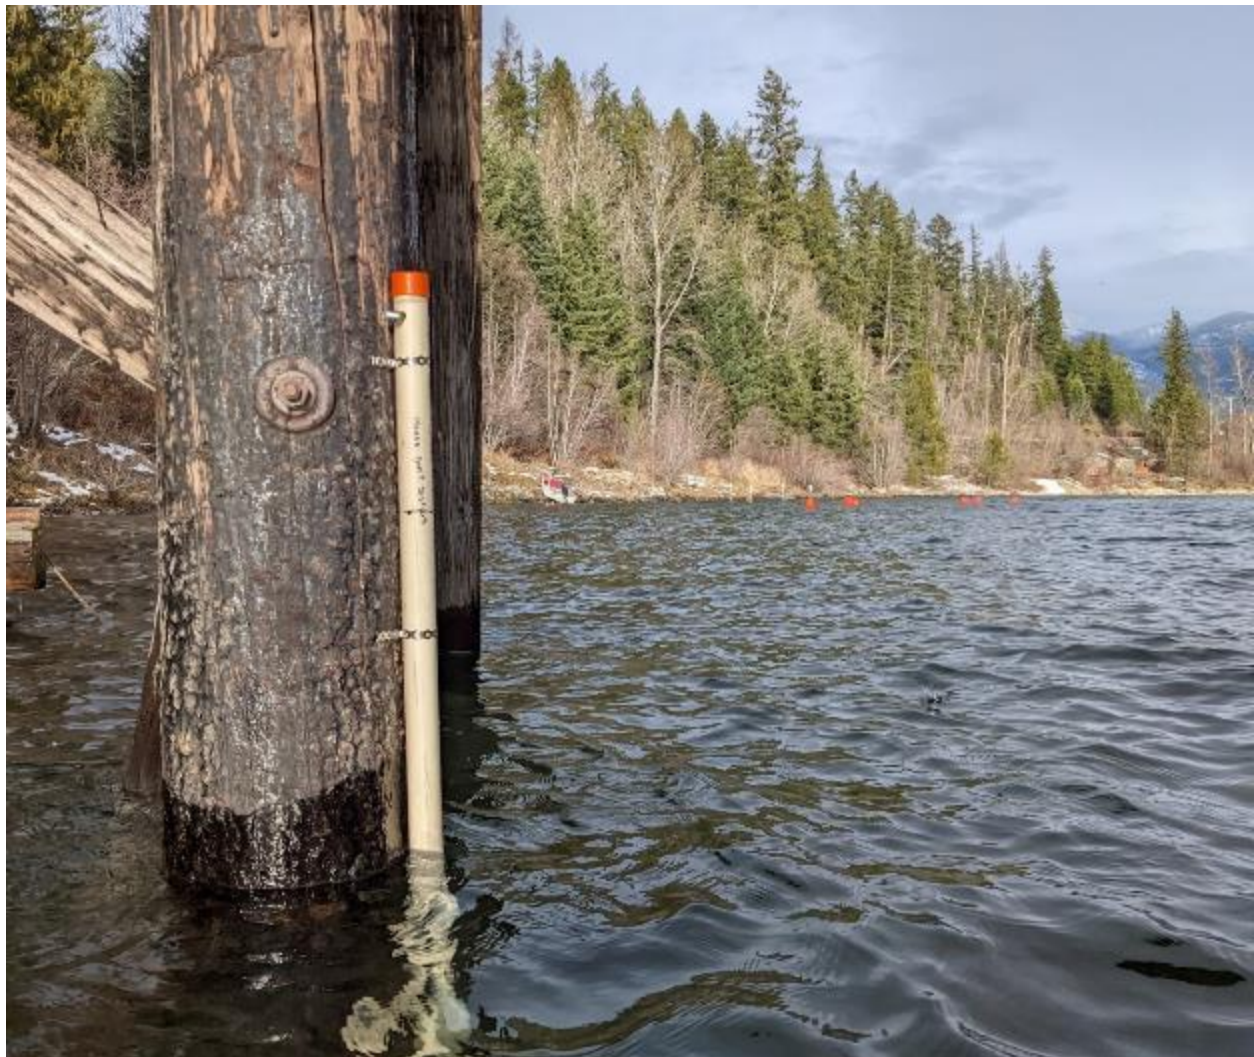
Two piezometers were installed, one to measure the height of the nearshore water table and another to measure the groundwater head at 0.6m depth below the lakebed. One stilling well with a water level logger was installed in the lake to measure lake stage. These loggers collected water level and temperature data on a 30-minute interval. This can be used to infer the magnitude of groundwater flow into the lake and monitor any changes to groundwater flow potential. The lakebed piezometer was also used to perform slug tests to analyze the hydraulic conductivity of the lakebed sediments.

Figure 11: Photo of water level logger measuring lake stage at restoration site. Photo credit: Cameron Spooner.

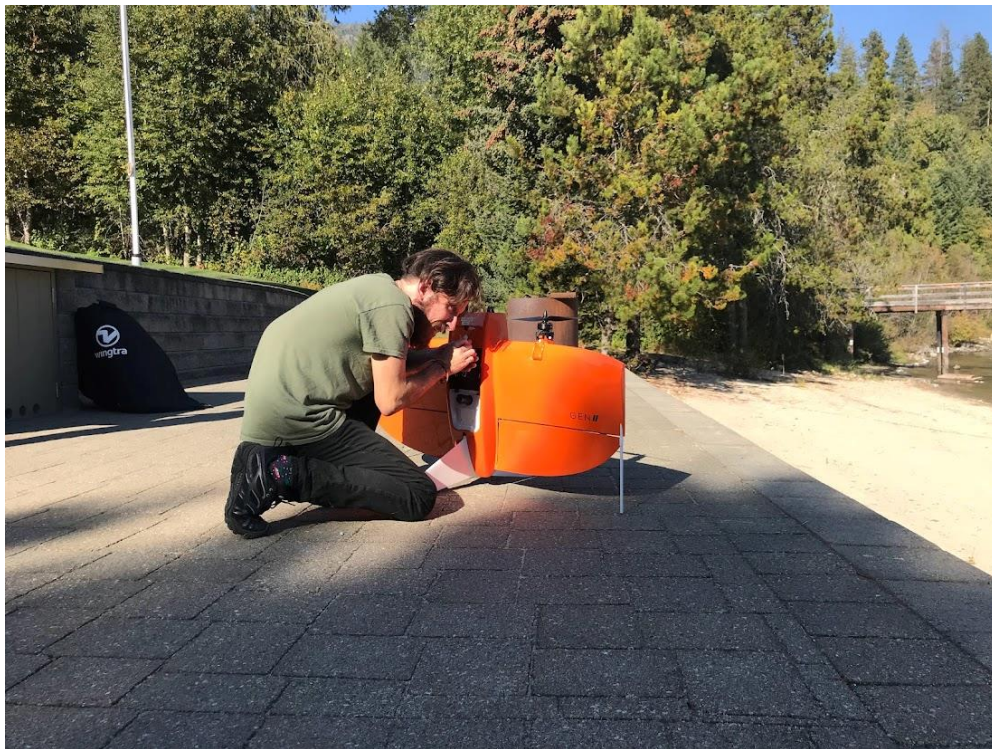
Figure 12: Oct 15, 2022. Santiago Botero (Above Sensing) preparing drone for flight at McDonald's Landing. Photo credit: Kayla Tillapaugh

Friends of Kootenay Lake contracted the Okanagan Nation Alliance to conduct multispectral imaging of shore-spawning habitat at McDonald's Landing and Bonaventure Lagoon using a specialized drone. The imagery was collected during spawning (October 15, 2022) and during low water (April 6, 2023). Three types of images were produced: high-resolution RGB, thermal, and LiDAR. Each drone survey required two flights, one with the thermal/RGB sensor, and one with the LiDAR sensor.

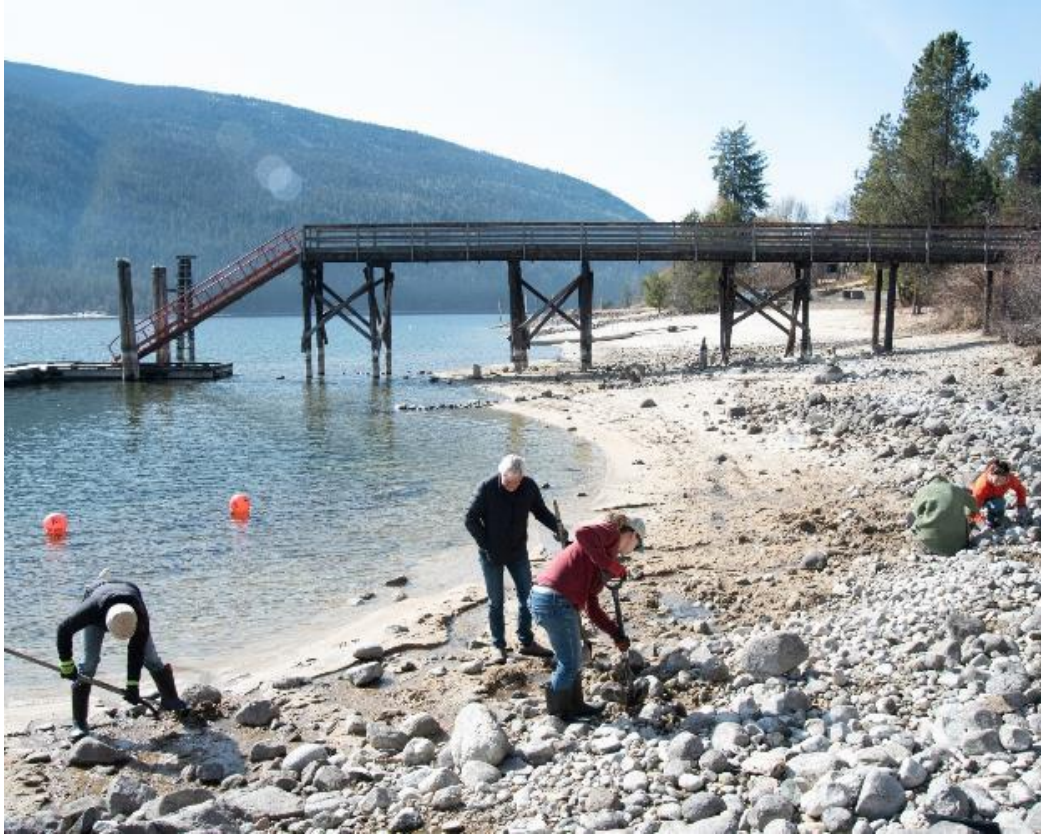
Figure 13: March 30, 2023. Dewatered redd survey crew locating dewatered redds. Photo credit: Joelle Burnie

On March 30, 2023, FoKLSS assisted BC fisheries technicians with a dewatered redd survey at McDonald's Landing and Bonaventure Lagoon. The ground crew moved along the shoreline to visually identify potential redd locations and then dig them up using a shovel or hand-held trowel. Identified redds were geolocated and water temperature was taken. Other data including egg and fry condition and temperature were collected for each identified redd.

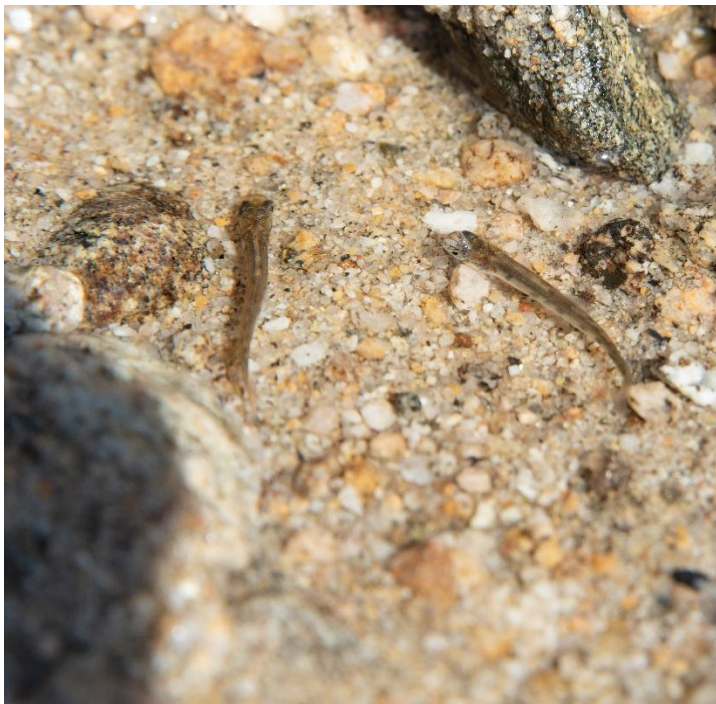
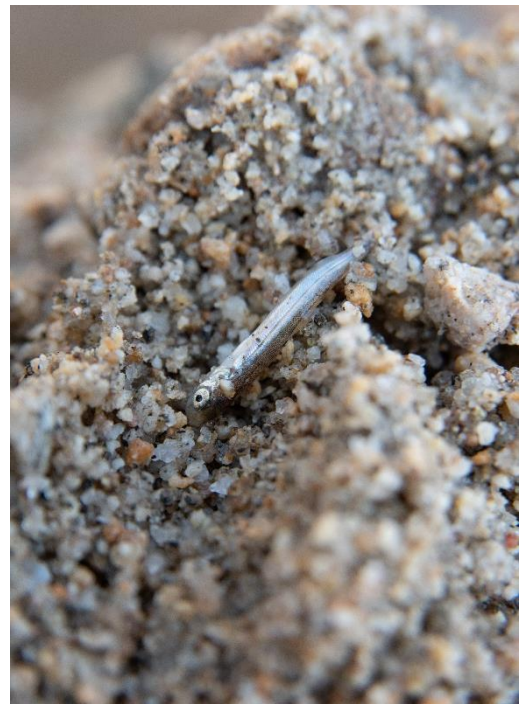
Figure 14: March 30, 2023. Dewatered redds containing live fry (left) and dead fry (right). Photo credits: Kayla Tillapaugh

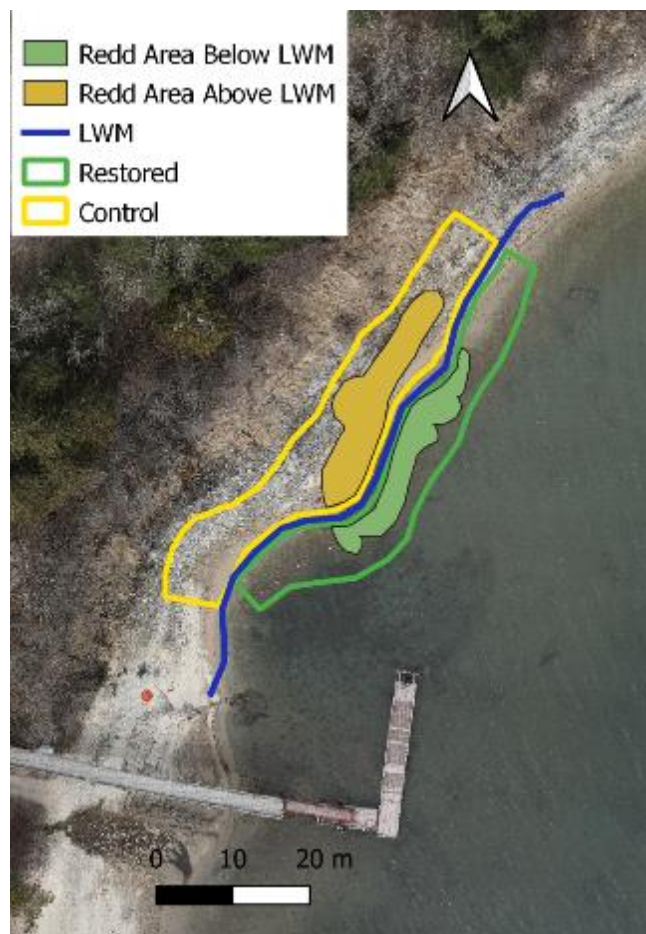
Our highest spawner count for the entire McDonald's Landing site was 39 fish, observed on October 12, 2022. Spawners were observed in roughly equal proportions in the control and restored sites. However, redds are better indicators of fine-scale habitat use than spawners, as kokanee are highly mobile and wary of the motorized monitoring boat. Early redd observations were all in the control site (Sept 28 - Oct 15). But by the final count (Oct 19), we observed a total of 65 redds in the entire McDonald's Landing site, 23% (n = 15) of which were in the restored area. The redd areas observed on October 19, were identified as circular depressions of cleaned gravel. These areas, where the majority of redds were observed, are approximated in Figure 15 below.

Figure 15: Estimated redd areas in the control and restored areas of McDonald's Landing, as observed on October 19, 2023

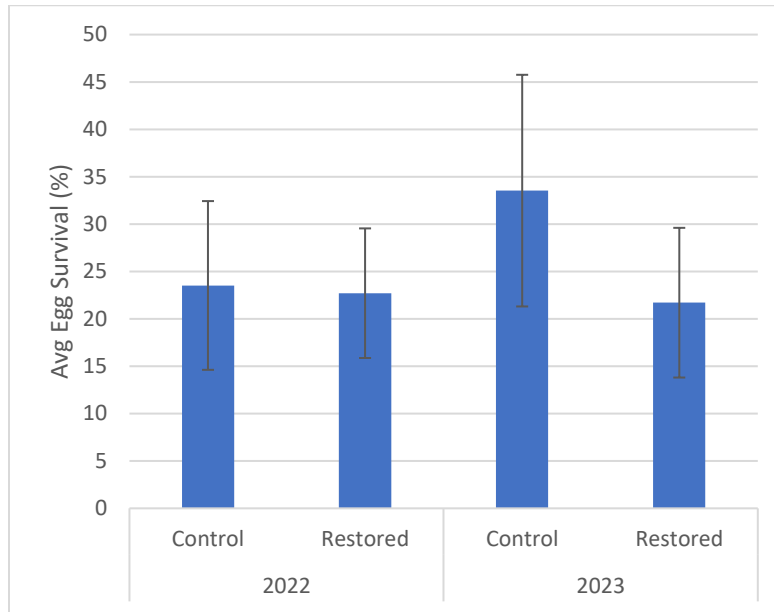
Egg-to-fry survival rates were similar in the control and restored areas (Figure 16). Eggs in the control area (egg capsules 1-5) averaged $33\% \pm 12.3$ survival (range of 21–46%); those in the restored area (egg capsules 6-10) averaged $22\% \pm 7.9$ (range of 14–30%). The average water temperature associated with the egg capsules was $6.47\text{ }^{\circ}\text{C}$, the median was $6.41\text{ }^{\circ}\text{C}$, and the range was $2.77\text{--}12.07\text{ }^{\circ}\text{C}$. The kokanee eggs were reported at 310.4 Accumulated Thermal Units (ATUs) on October 28, 2022 when they were

installed. With an average water temperature of 6.4 °C throughout the incubation period, the eggs were estimated at 864.4 ATUs upon extraction (January 20, 2023). Fry emergence can be expected any time after 850 ATUs.

Figure 16: Comparison of average egg-to-fry survival rates (%) in the control and restored areas of McDonald’s Landing, winter 2022 and 2023.

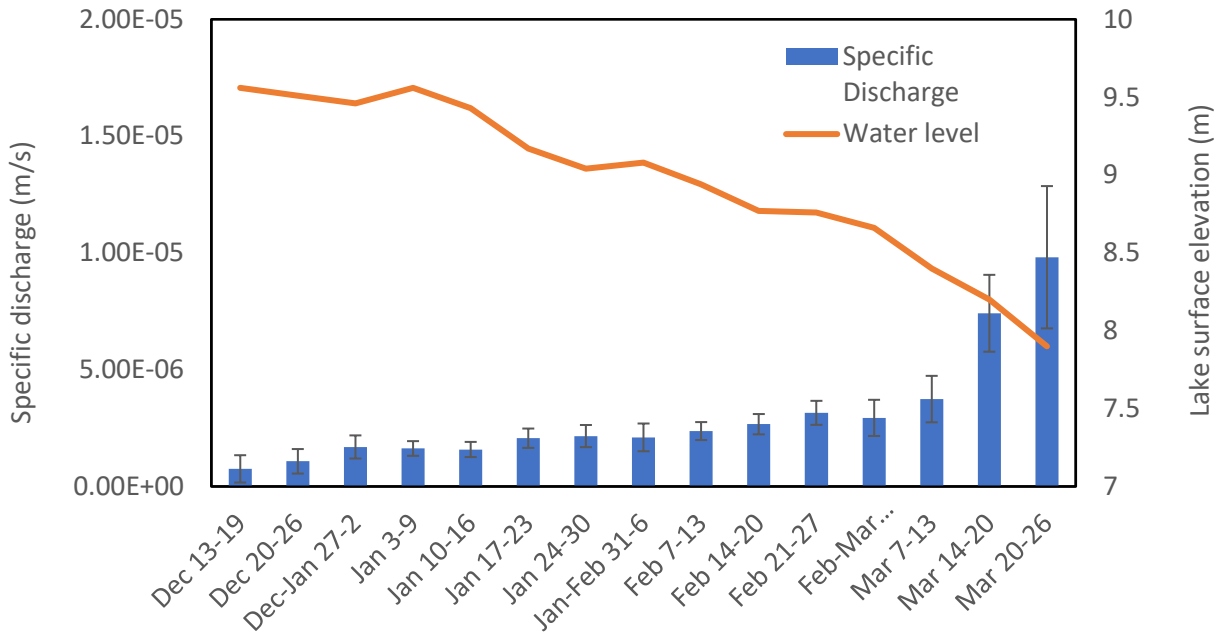
Early sediment temperature modelling shows a clear increase in vertical groundwater flow as the lake level drops in the spring (Figure 17). Preliminary radon and water isotope samples also indicate that the lakebed porewater is strongly connected to the local groundwater at McDonald’s Landing (Figure 18). This data is still under review and the results are expected to be published in late 2023 to early 2024.

Figure 17: Modelled specific discharge and changes in lake level from December 2021 to March 2022. C Spooner, presented at the CGU 2023 Annual Meeting.

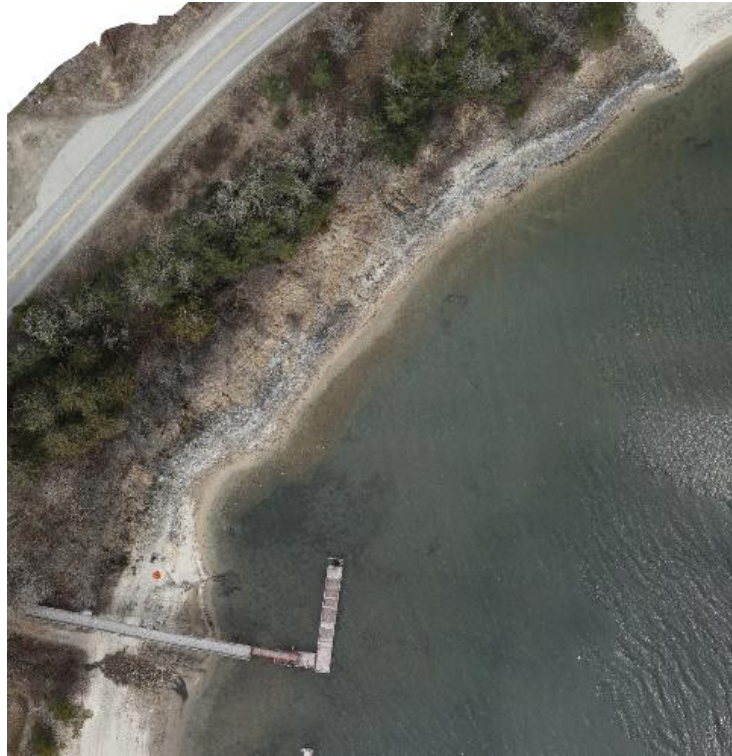
Figure 19: Aerial photo of McDonald's Landing Regional Park, April 6, 2023

Aerial images, including regular, thermal and LiDAR photographs, were successfully collected during spawning season (October 15, 2022) and during low water (April 6, 2023) at McDonald’s Landing and Bonaventure (Figure 19–Figure 28).

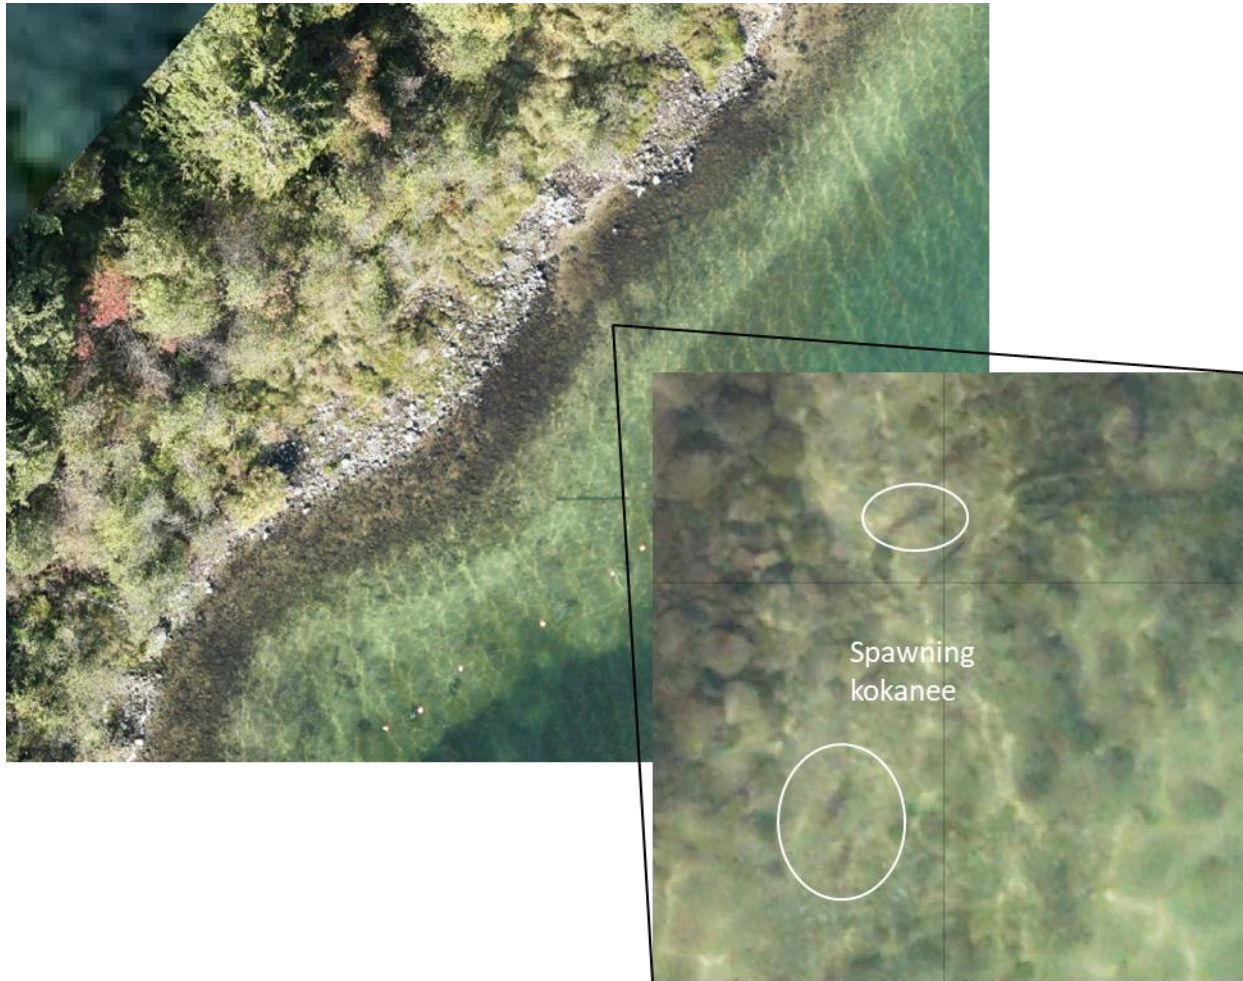
Figure 21: Aerial photo of McDonald's Landing Regional Park, October 15, 2022, with inset map showing kokanee spawning in cleaned redd area

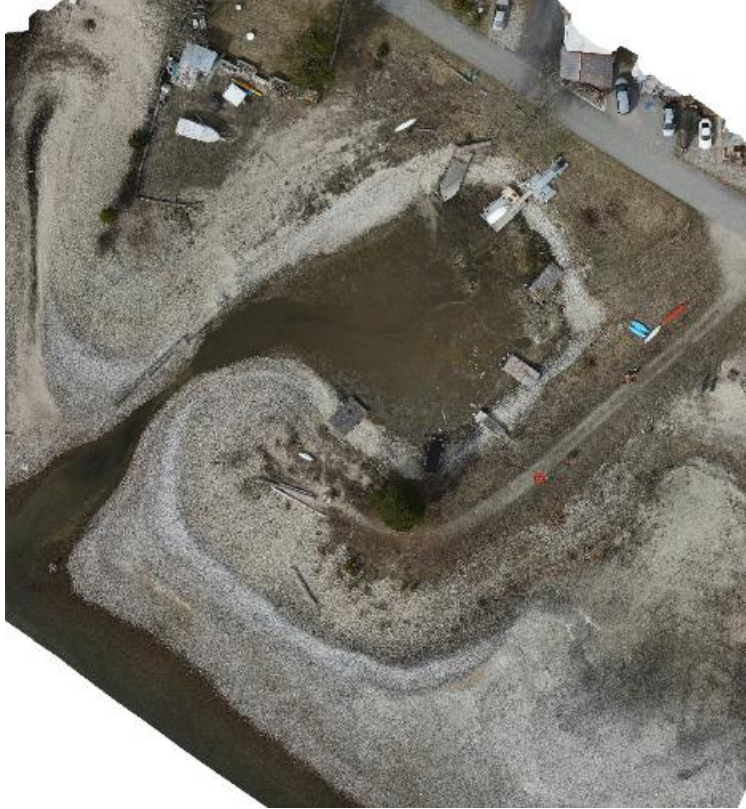
Figure 24: Aerial photo Bonaventure Lagoon, April 6, 2023

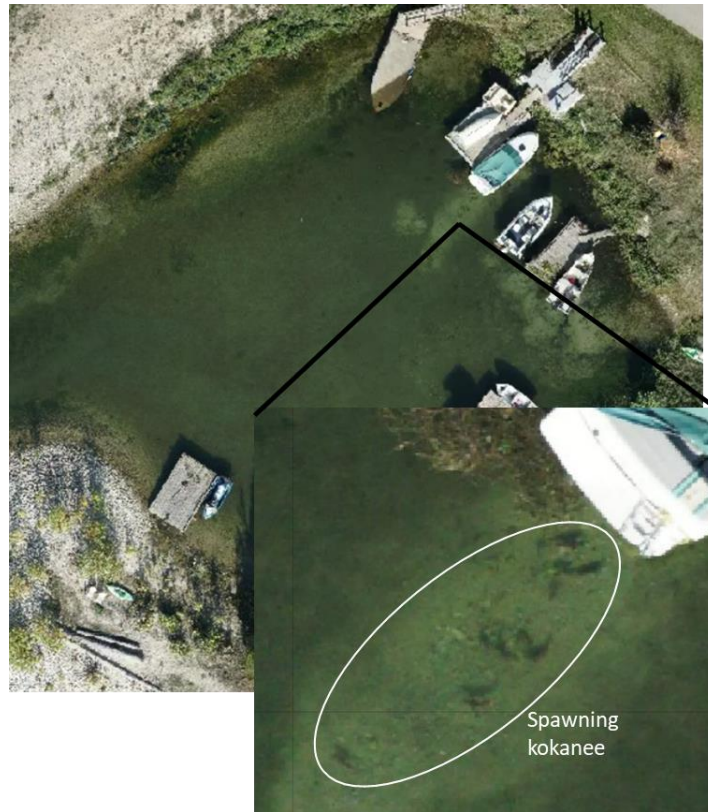
Figure 26: Aerial photo of Bonaventure Lagoon, October 15, 2022, with inset map showing kokanee spawning in cleaned redd area

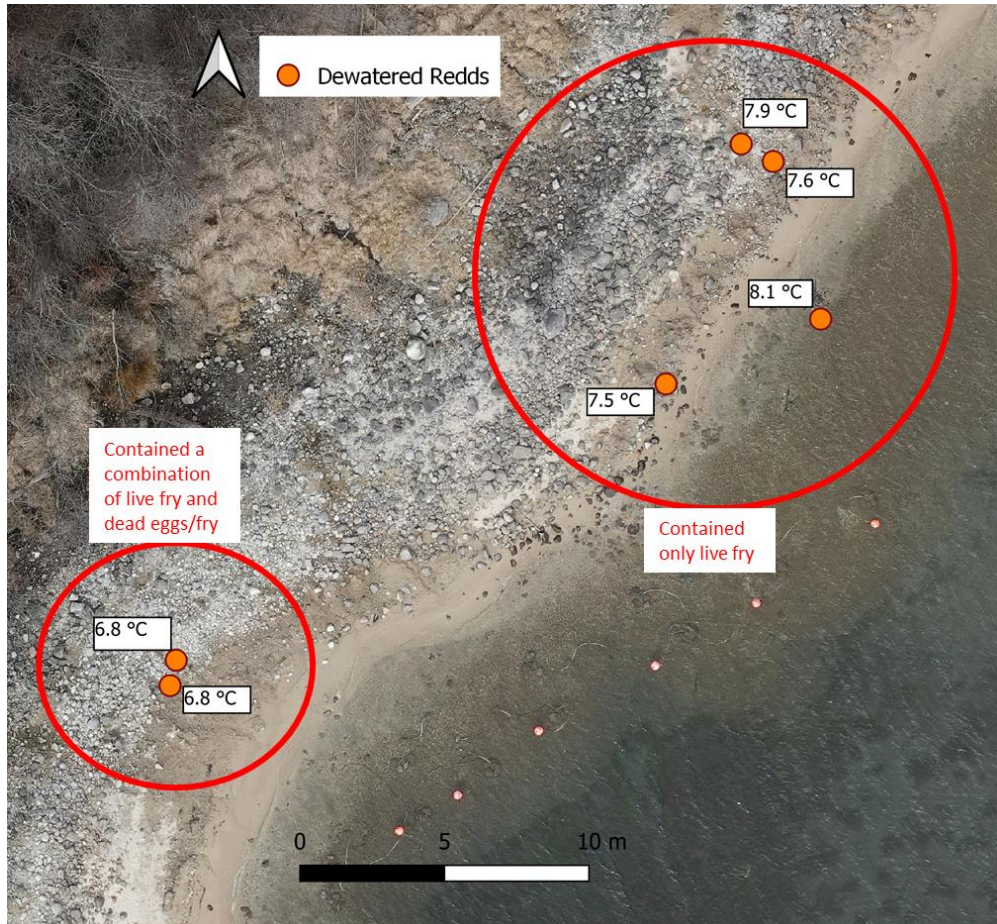
During an informal dewatered redd survey at McDonald's Landing on March 30, 2023, we located six redd locations above the low water mark, some containing multiple redds. All redd locations contained live fry; only the two most southern redd locations contained a combination of live fry and dead eggs/fry (Figure 29). We also located a dewatered redd area at Bonaventure Lagoon (Figure 31). Environmental consultants recently performed detailed dewatered redd surveys at both sites on behalf of BC Hydro, FortisBC and Columbia Power Corporation. Results are available from them on request. Redds at both McDonald's Landing and Bonaventure were associated with locations of upwelling groundwater (dark purple streams in thermal imagery; Figure 30, Figure 31).

Figure 29: Contents and temperatures of dewatered redds at McDonald's Landing, as observed on March 30, 2023

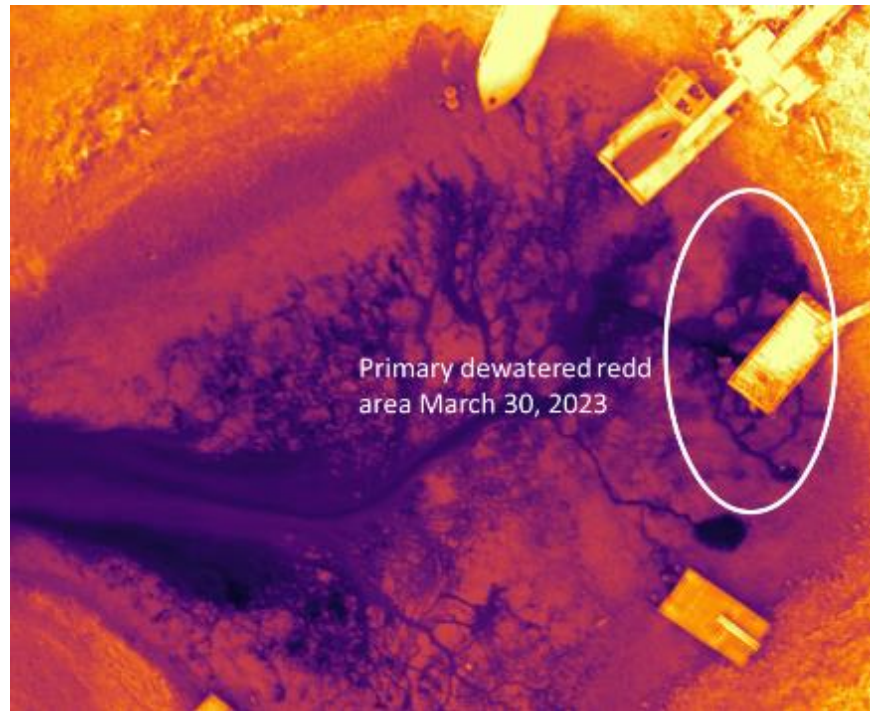
Figure 31: Association between redd area (white circle) and upwelling groundwater (dark purple streams) at Bonaventure Lagoon, spring 2023

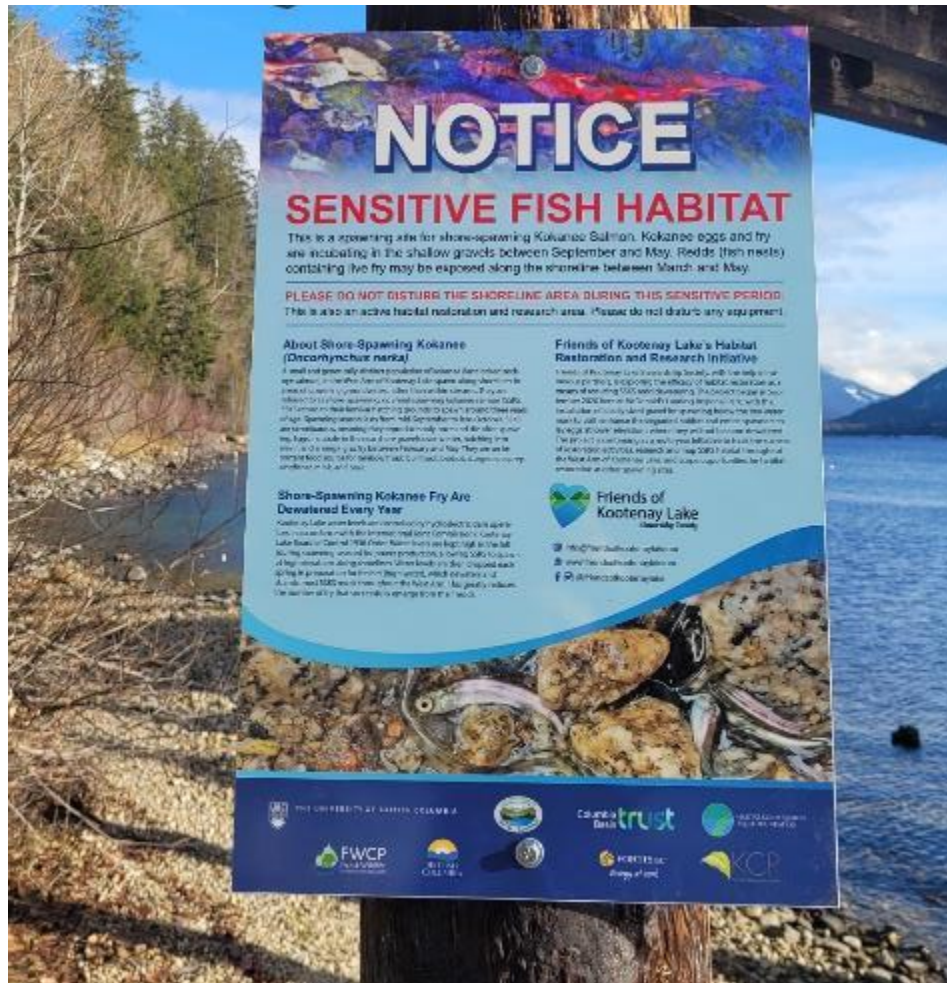
Figure 33: SSKS informational sign installed January 20, 2023 at McDonald's Landing research site. Photo credit: Kayla Tillapaugh. Original file provided in Appendix (Figure A.1)

The informational SSKS sign (Figure 33) was installed on January 20, 2023. The sign provides background on SSKS on Kootenay Lake, describes the research and restoration project, and discourages trampling/interference at the sensitive site.
