Elk Valley Cottonwood Conservation and Restoration Strategy

(FWCP#: COL-F23-W-3698)

PREPARED BY: THE ELK RIVER ALLIANCE, FERNIE BC

November 2023

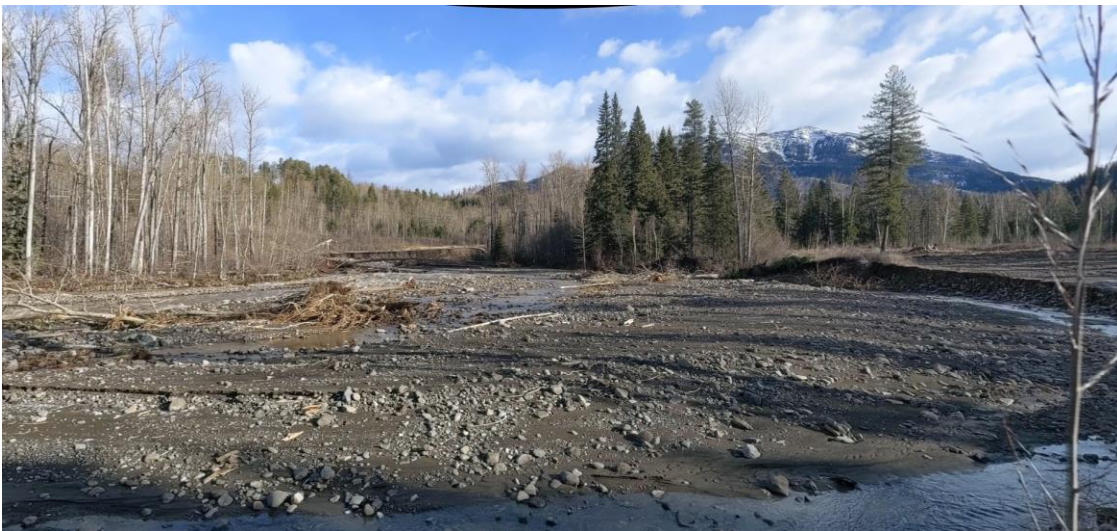
Figure 1: Flood damage to an Elk Valley watercourse (Coal Creek) during the November 2021 flood event.

Foreground: The unvegetated field in the foreground experienced extensive scouring and erosion. Background: Thick cottonwood vegetation on a right angle 'dog l

In addition to providing habitat, cottonwoods also offer green infrastructure protection from high water and flood events (Walker et al. 2016). The roots of large trees such as cottonwoods anchor stream banks, preventing streamflow from moving rocks and soil (which erodes the stream bank), while also slowing the shifting position of watercourses more effectively than forbs and grasses (Rood et al. 2015). Additionally, cottonwood habitats naturally mitigate downstream flood risk. The water velocity of overland flooding that flows through cottonwood habitat is dampened significantly more than if water flowed through forbs and grasslands. This decrease in floodwater velocity, as well as the natural capacity for cottonwood habitat to flood without damage to these flood-adapted landscapes, helps mitigate the downstream potential for damage related to flooding.

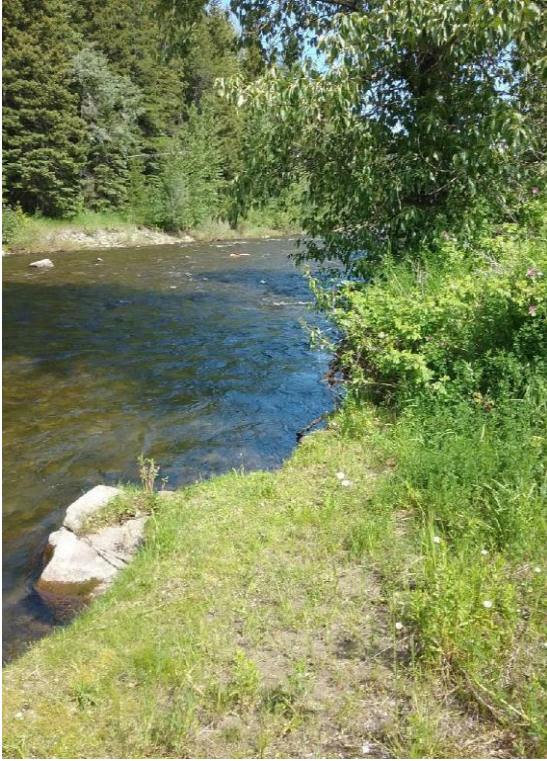
Figure 4: Small rehabilitation site where a detailed site inspection was not completed.

If a site was small (e.g., 400m² or less), yet an on-site visual assessment determined the site would benefit some level of rehabilitation (e.g., small-scale and no site preparation required), a detailed site inspection was not completed at this time. These sites were marked as 'potential rehab site' with a low-medium priority. Figure 4 demonstrates an example of a site that could receive minimal rehabilitation efforts, however, did not warrant a detailed site inspection to be completed.

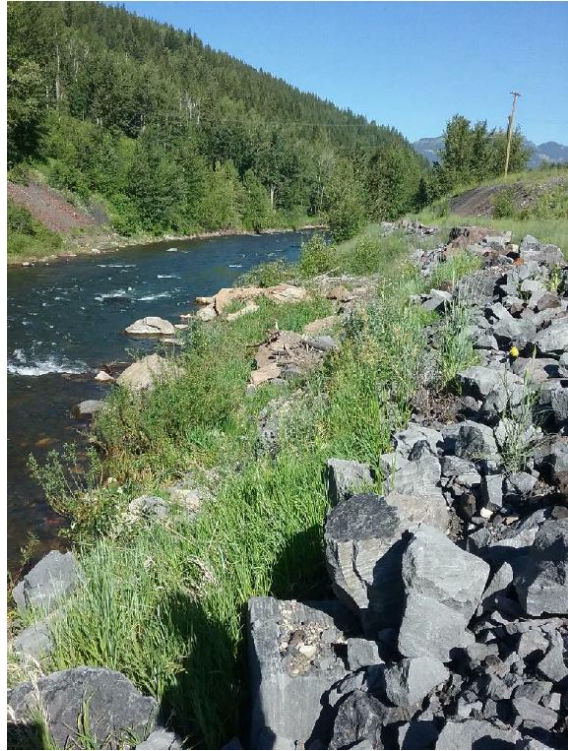
Figure 5: Example of site where rehabilitation has been determined not possible or necessary.

Alternatively, where crews could access the site, however due to current work, rip rap, or adjacent stands only containing spruce species, rehabilitation was determined not possible or necessary and simply marked 'no rehab potential'. Figure 5 demonstrates an example of these sites.
