SOCIETY FOR ECOSYSTEM RESTORATION  
IN NORTHERN BRITISH COLUMBIA

## Restoring Fish Passage in the Peace Region - 2023

Prepared for  
Fish and Wildlife Compensation Program  
and  
Fish Passage Technical Working Group

Prepared by  
Al Irvine, B.Sc., R.P.Bio. and Mateo Winterscheidt, B.Sc.  
New Graph Environment Ltd.  
on behalf of  
Society for Ecosystem Restoration in Northern BC

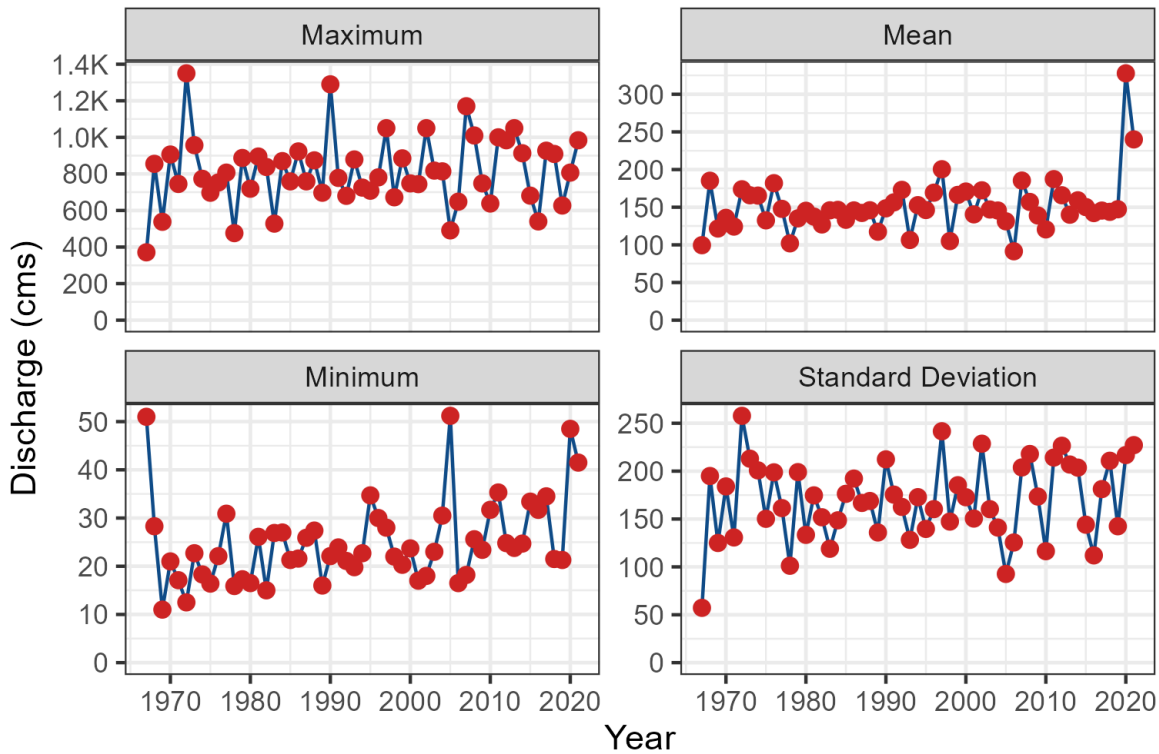
Figure 2.3: Summary discharge statistics (annual maximum, minimum, mean and standard deviation) for Parsnip River at hydrometric station #07EE007.

the northern Rocky Mountains which receive large amounts of precipitation as snow leading to peak levels of discharge during snowmelt, typically from May to July (Figures [2.2](#) - [2.3](#)).

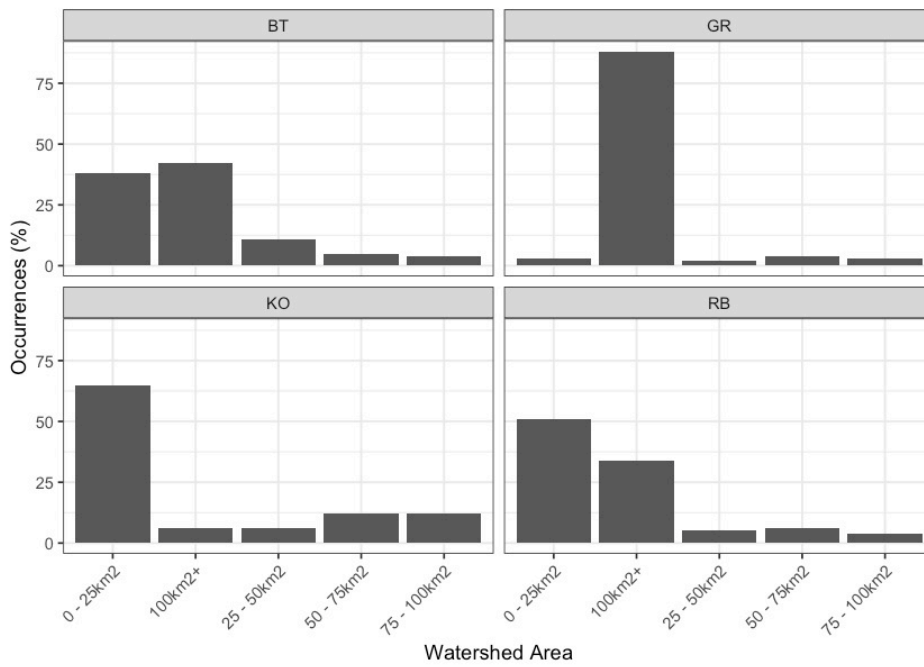
Figure 2.6: Summary of historic salmonid observations vs. watershed size category for the Parsnip River watershed group.

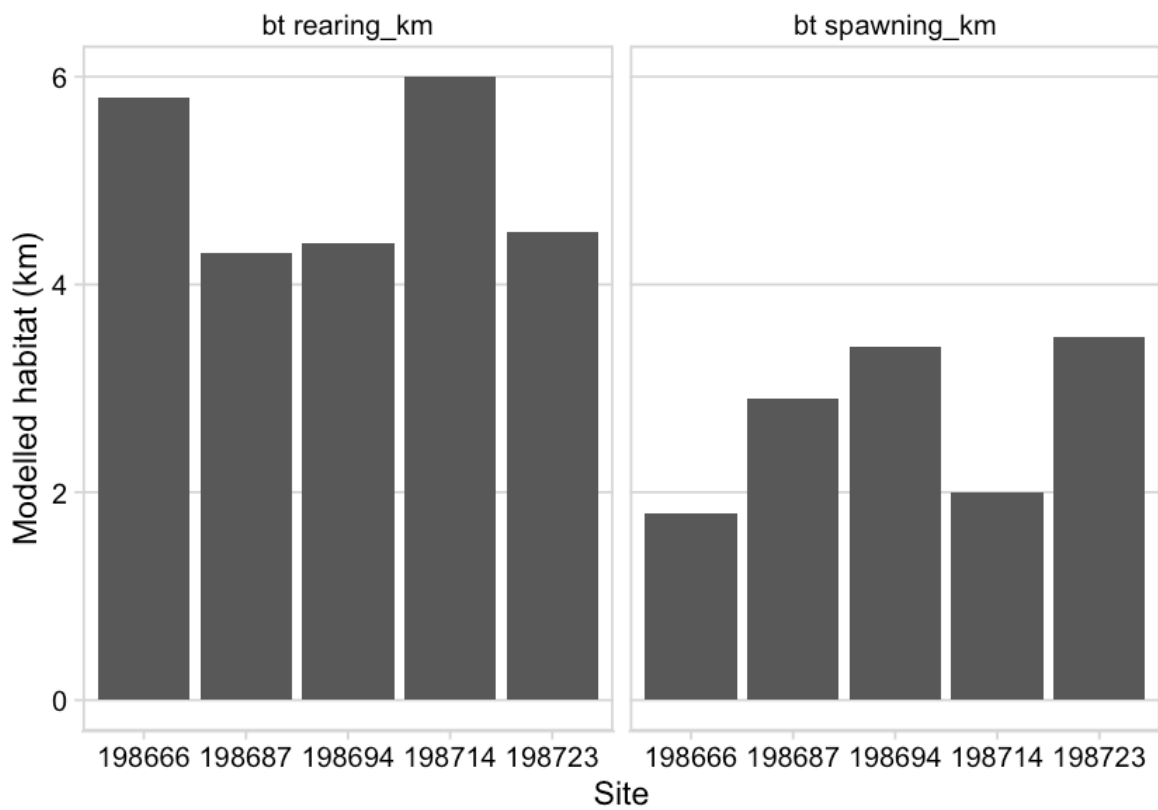
Figure 4.1: Summary of potential habitat upstream of habitat confirmation assessment sites estimated based on modelled channel width and upstream channel length.

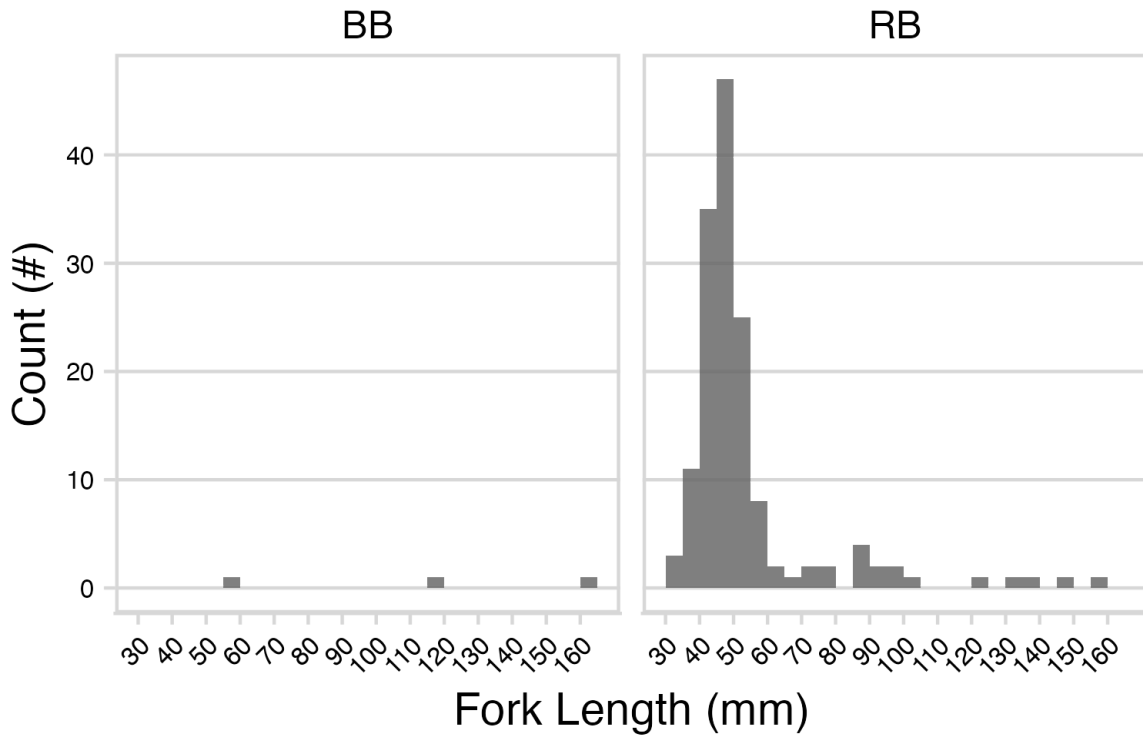
Figure 4.2: Histograms of fish lengths by species. Fish captured by electrofishing during habitat confirmation assessments.

Electrofishing was conducted at 12 sites with a total of 171 fish captured. Fork length data was used to delineate rainbow trout based on life stages: fry (0 to 65mm), parr (>65 to 110mm), juvenile (>110mm to 140mm) and adult (>140mm) by visually assessing the histograms presented in Figure [4.2](#). A summary of sites assessed are included in Table [4.8](#) and raw data is provided in [Attachment 3](#). A summary of density results for all life stages combined of select species is also presented in Figure [4.3](#).

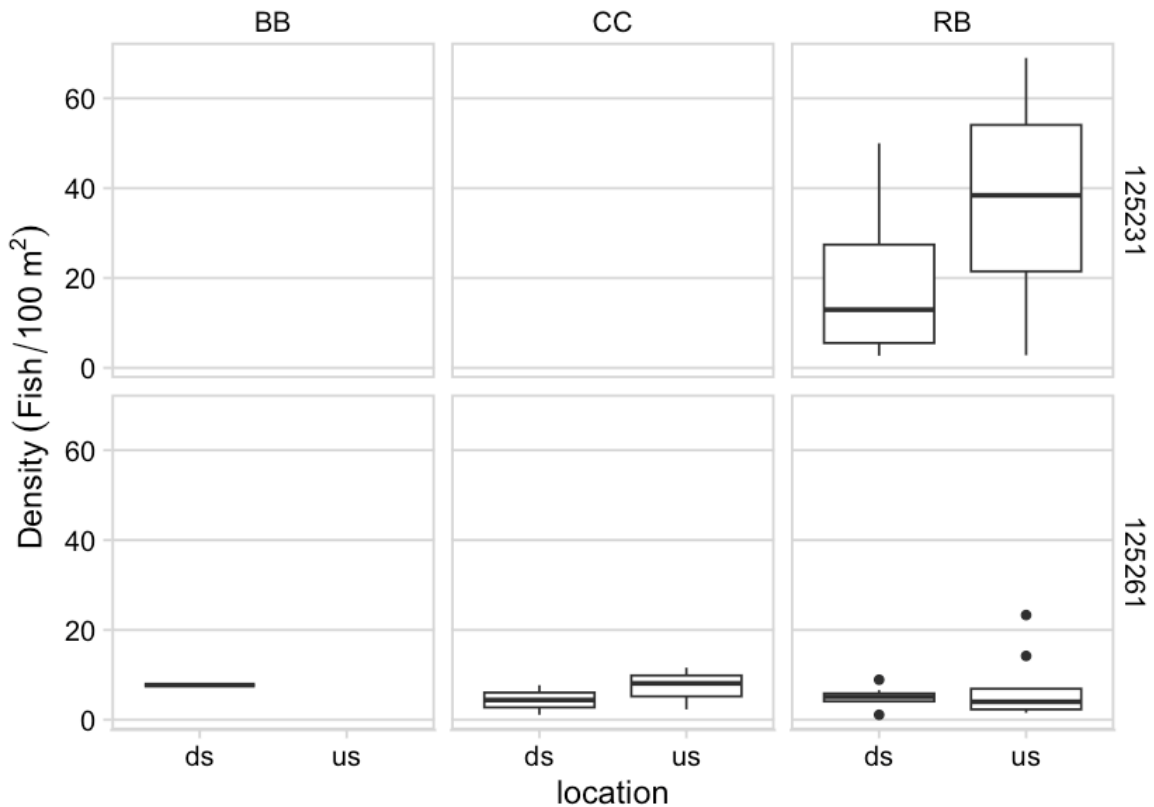
Figure 4.3: Boxplots of densities (fish/100m<sup>2</sup>) of fish captured by electrofishing during habitat confirmation assessments.

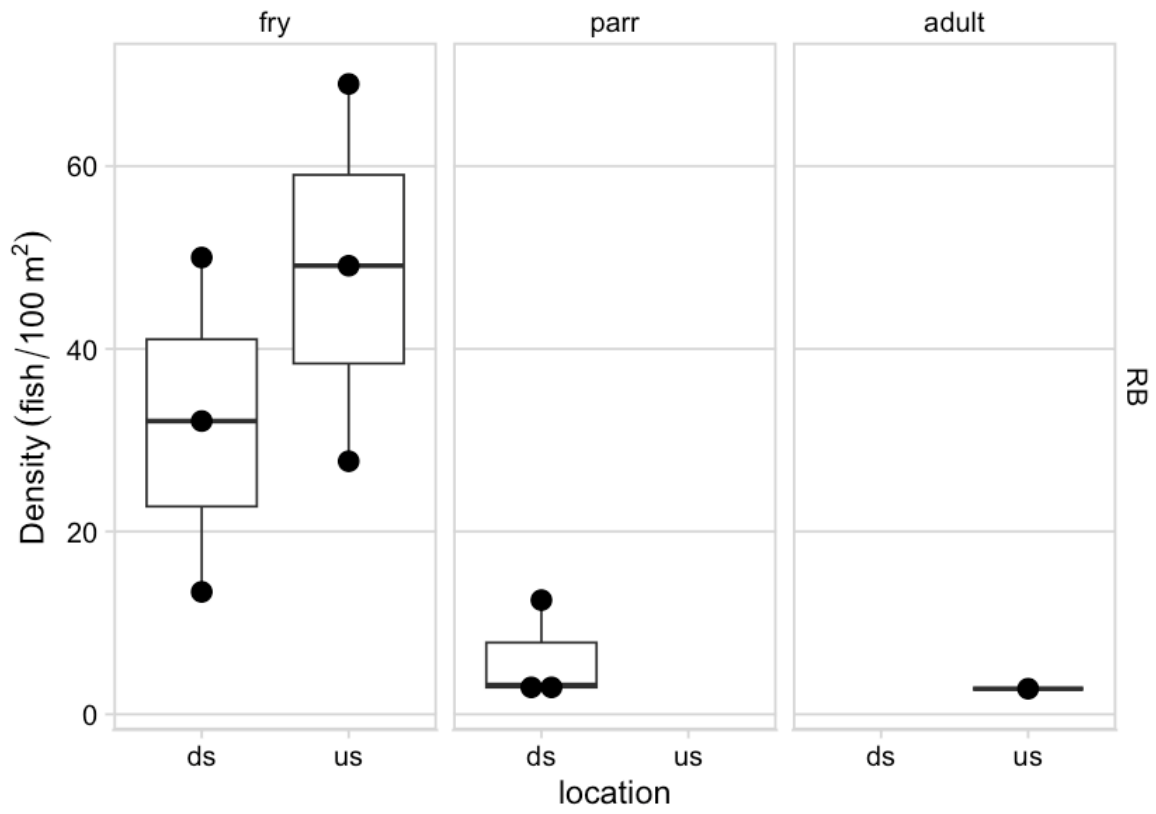
Figure 5.1: Densities of fish (fish/100m<sup>2</sup>) captured upstream and downstream of PSCIS crossing 125231.

Restoration of fish passage at crossing 125231 is lined up for the summer of 2024 with a design specifications to replace the two 1.2m round pipes (outlet drops of 0.65m) with a 12.2m steel girder/timber deck bridge on spread footing. Replacement of the crossing will provide access to habitat blocked to upstream migrating fish for likely 10 - 20 years (timeline depending on the rate of down cutting caused by the outlet drops) and the stream has no other anthropogenic obstructions to fish passage. The presence of burbot in the system is of particular interest as this fish provides good food values and in general, compared to numerous other species (ex. steelhead and coho), burbot are documented as less capable swimmers considering time-to-fatigue versus swim speed (Katopodis and Gervais 2016). The presence of burbot downstream of the crossing and absence in sample sites above could indicate that the crossing is preventing some migration of this species however sample areas were small and the habitat presence/preference may have been more a determinant of presence than the passability of the crossing.

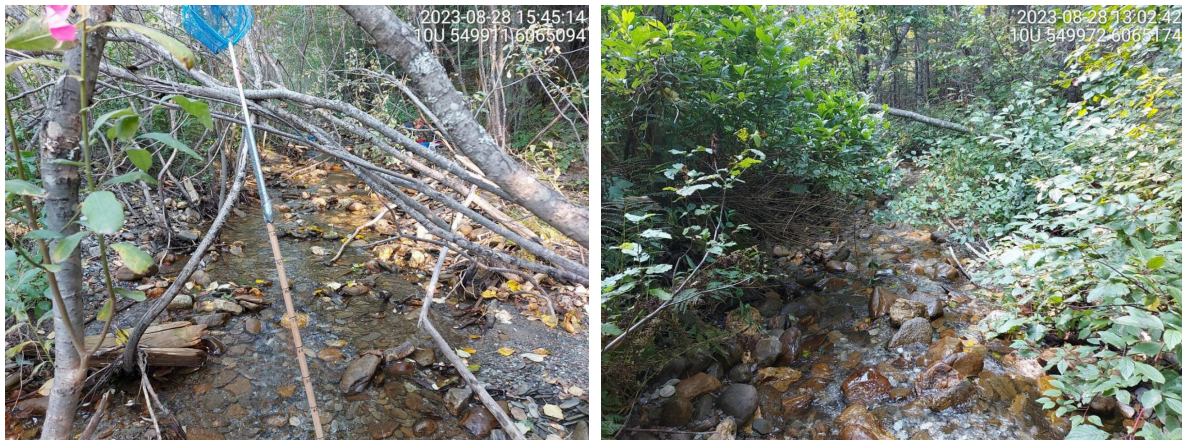
Figure 5.2: Left: Habitat electrofished downstream of PSCIS crossing 125231. Right: Habitat electrofished downstream of PSCIS crossing 125231.

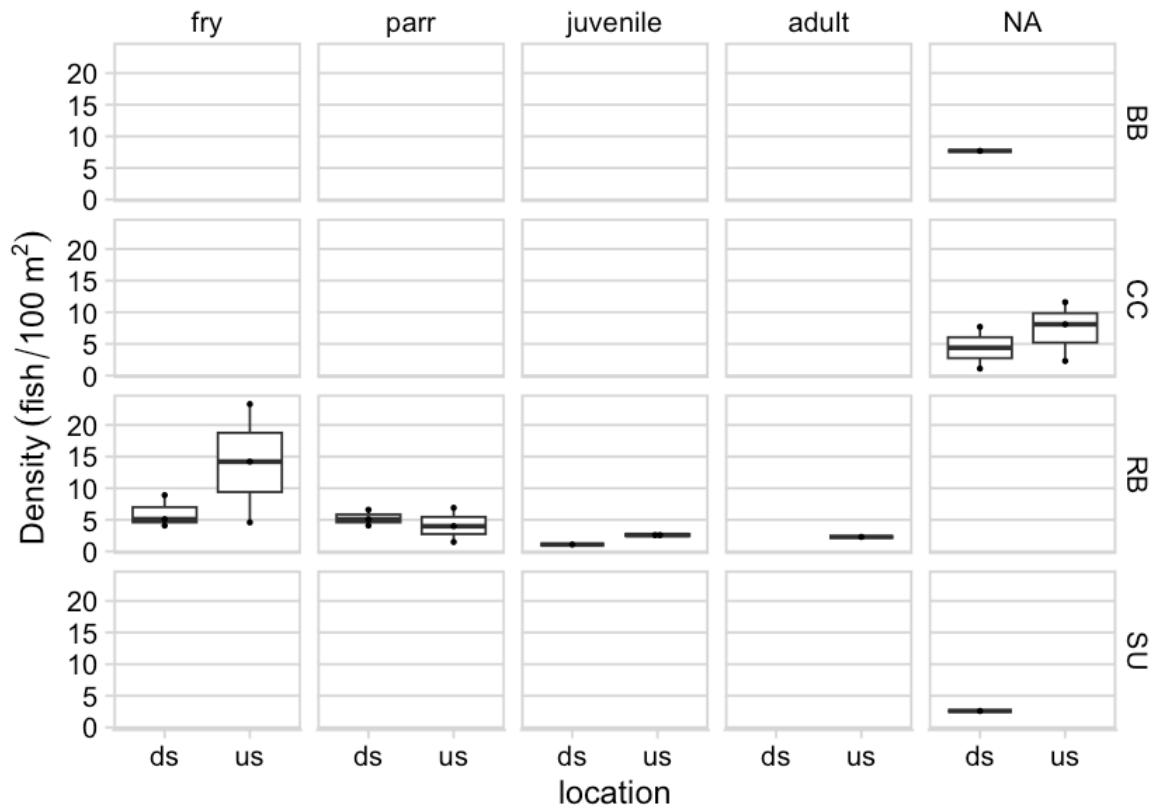
Figure 5.4: Densities of fish (fish/100m<sup>2</sup>) captured upstream and downstream of PSCIS crossing 125261.

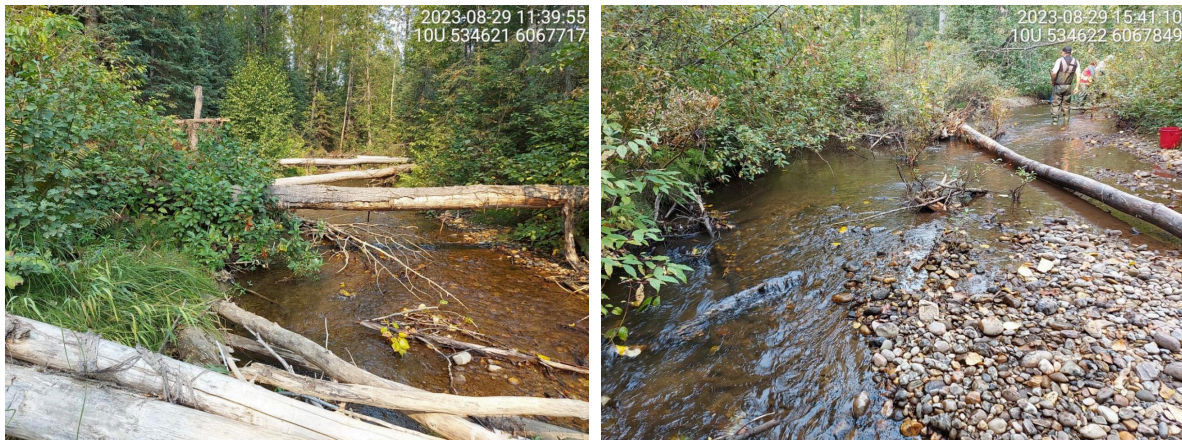
Figure 5.5: Left: Habitat electrofished downstream of PSCIS crossing 125261. Right: Habitat electrofished upstream of PSCIS crossing 125261.

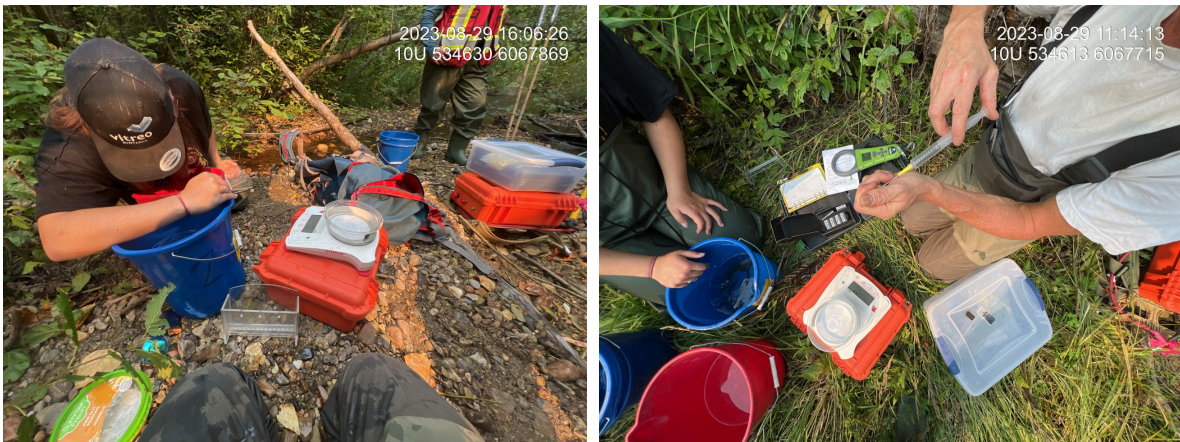
Figure 5.7: Left: Collecting length and weight of all fish captured at Fern Creek. Right: PIT tagging rainbow trout and burbot >60mm fork length at Fern Creek.

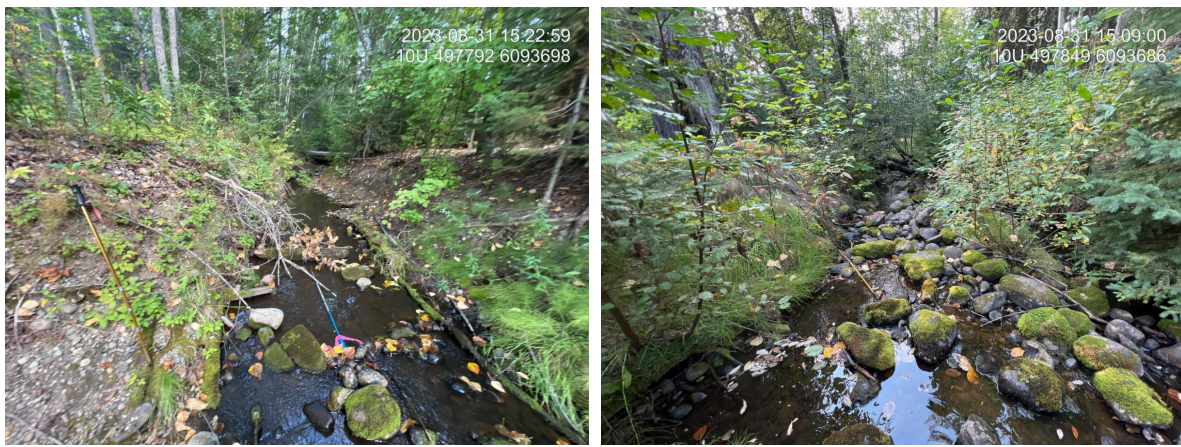
Figure 5.8: Left: Typical habitat downstream of PSCIS crossing 198714. Right: Typical habitat downstream of PSCIS crossing 198714.

The stream was surveyed upstream from crossing 198714 for 250m (Figure 5.8). In the area surveyed, the stream was noted as having good flow and abundant gravels suitable for rainbow trout spawning. The dominant substrate was gravels with cobbles sub-dominant. Total cover amount was rated as moderate with overhanging vegetation dominant. Cover was also present as undercut banks. The average channel width was 2.8m, the average wetted width was 1.9m, and the average gradient was 2.7%. The habitat was rated as medium value with habitat present suitable for salmonid rearing and spawning.

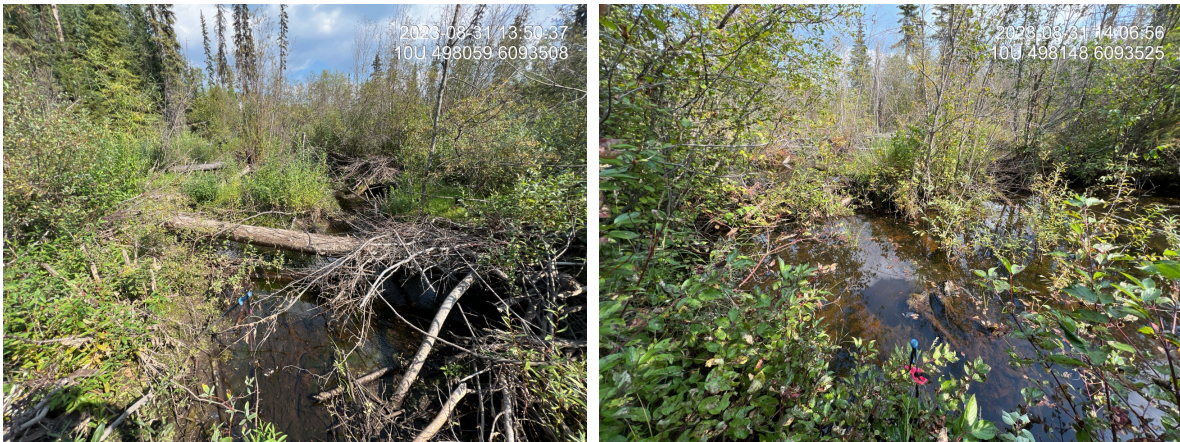
Figure 5.10: Left: Typical habitat upstream of PSCIS crossing 198714. Right: Typical habitat upstream of PSCIS crossing 198714.

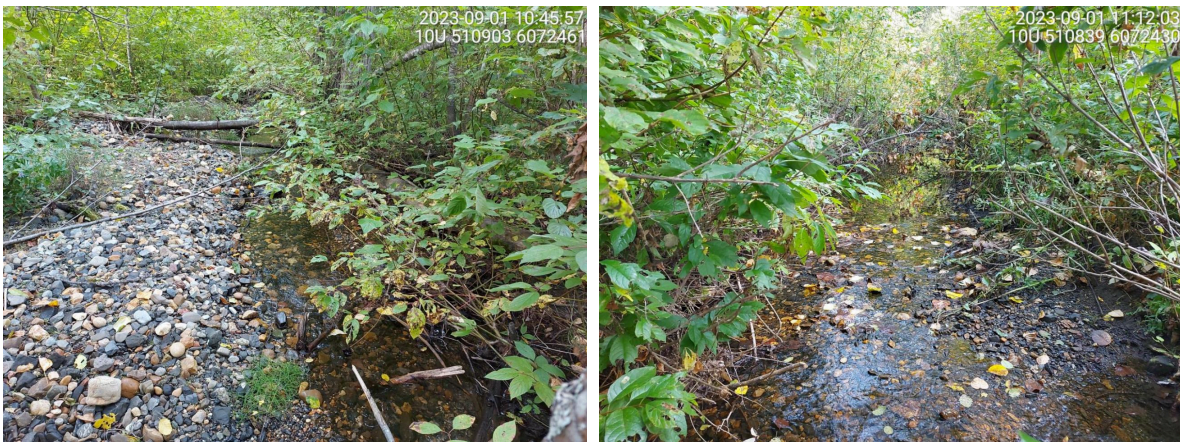
Figure 5.11: Left: Typical habitat downstream of PSCIS crossing 198687. Right: Typical habitat downstream of PSCIS crossing 198687.

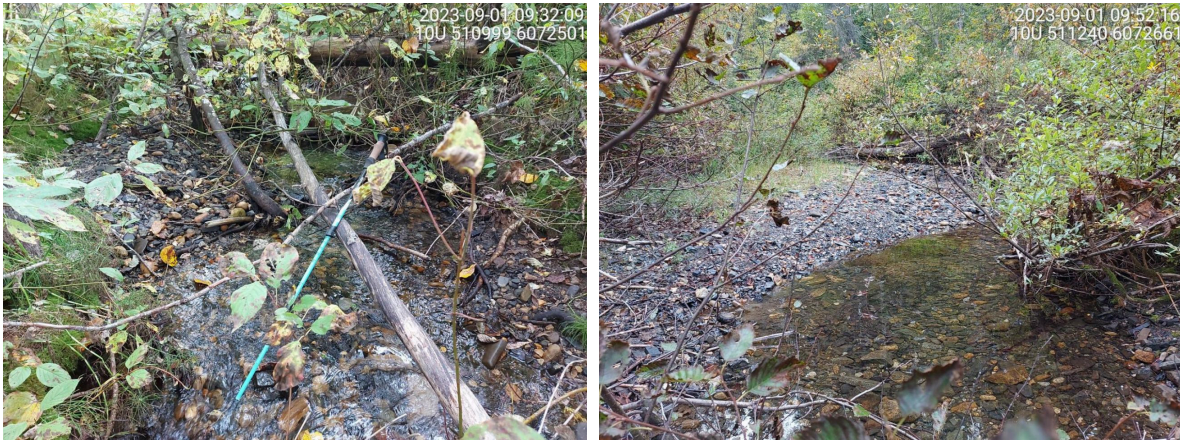
Figure 5.12: Left: Typical habitat upstream of PSCIS crossing 198687. Right: Typical habitat upstream of PSCIS crossing 198687.

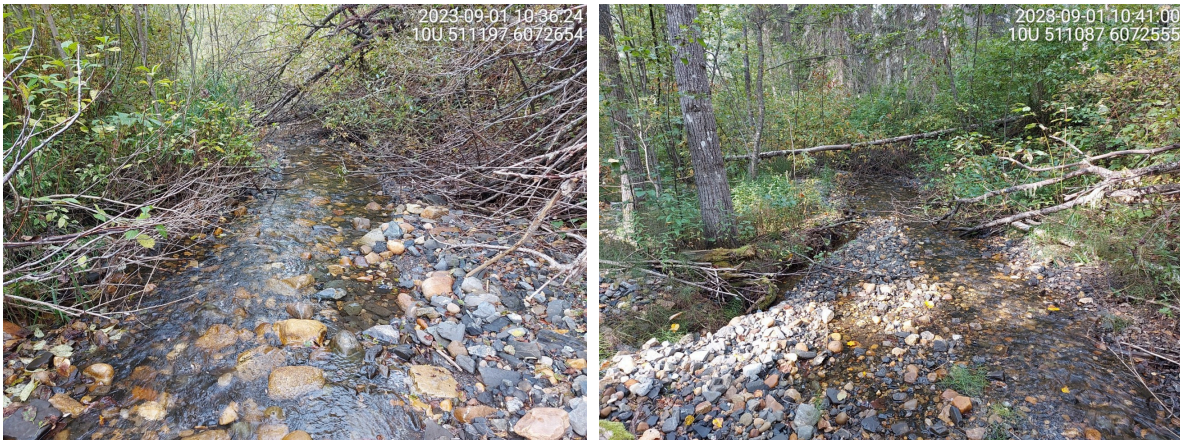
Figure 5.13: Left: Typical habitat upstream of PSCIS crossing 198687. Right: Typical habitat upstream of PSCIS crossing 198687.

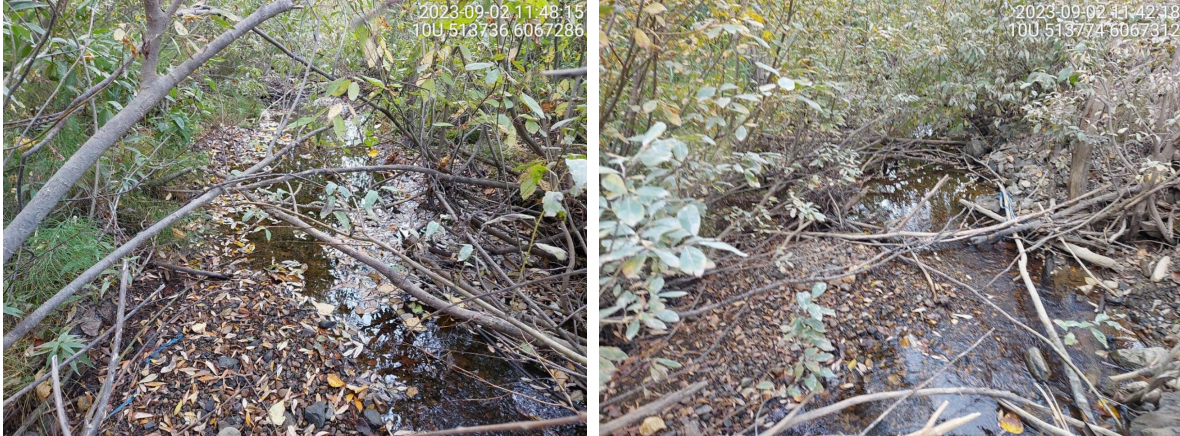
Figure 5.14: Left: Typical habitat upstream of PSCIS crossing 198723 and downstream of 198694. Right: Typical habitat upstream of PSCIS crossing 198723.

The stream was surveyed upstream from crossing 198723 for 110m to the location of 198694 (Figure 5.14). Total cover amount was rated as moderate with small woody debris dominant. Cover was also present as large woody debris and overhanging vegetation. The dominant substrate was gravels with fines sub-dominant. The average channel width was 2.4m, the average wetted width was 1.5m, and the average gradient was 1%. Abundant gravels suitable for salmonid spawning were noted as present within the area surveyed. The habitat was rated as value for salmonid rearing.

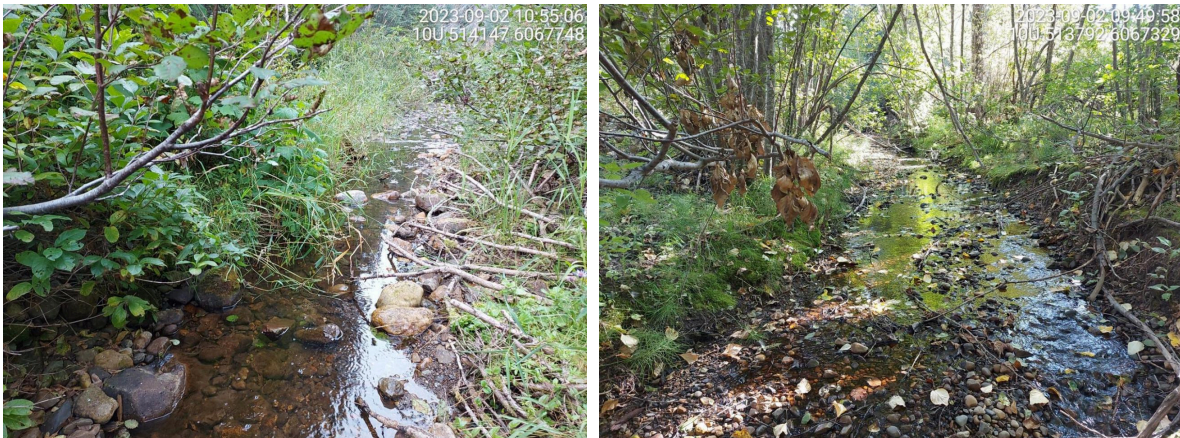
Figure 5.15: Left: Typical habitat upstream of PSCIS crossing 198694. Right: Typical habitat upstream of PSCIS crossing 198694.

The stream was surveyed upstream from crossing 198694 for 650m (Figure 5.15). The average channel width was 2.7m, the average wetted width was 1.9m, and the average gradient was 2.8%. The dominant substrate was cobbles with gravels sub-dominant. Total cover amount was rated as abundant with large woody debris dominant. Cover was also present as small woody debris and overhanging vegetation. Small fish were spotted periodically throughout survey and significant blowdown created large woody debris cover - particularly for the first 250. Some deep pools suitable for overwintering were noted along with pockets of gravel suitable for spawning. The habitat was rated as medium value as an important migration corridor containing habitat suitable for rearing.
