# Restoration Following the Re-Watering of Little Bear Slough

## FINAL REPORT

Prepared For: Fish & Wildlife Compensation Program

Prepared By: Laura Holt and Claire Ethier

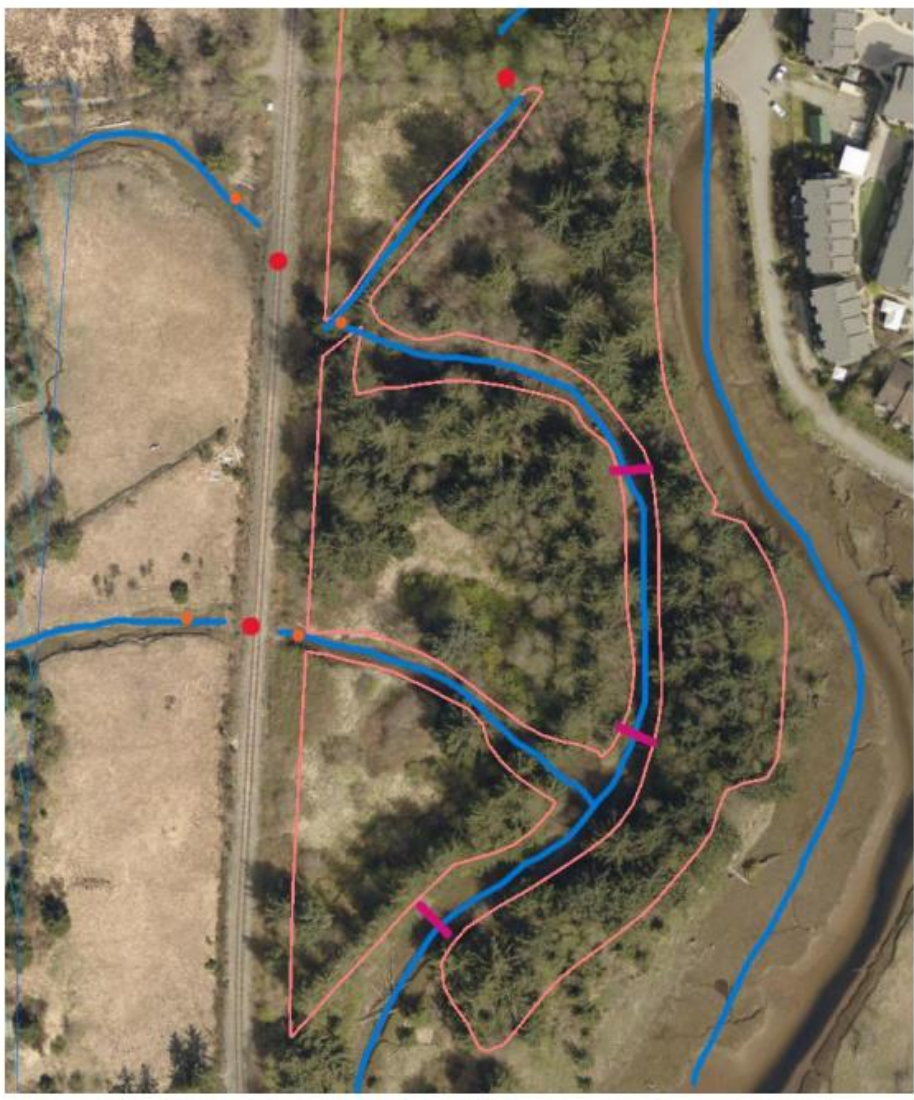
Figure 5. Map of current and remnant channels on the South side of the NTBC conservation area (red outline). Proposed connection points for re-watering remnant channels are shown along with survey locations.

Map of remnant tidal channels, reconnection points, and survey sites in 2024.

Surveys were completed by NTBC on September 9th and November 6<sup>th</sup>, 2024 at high tide. Measurements were taken at 6 locations on either side of the 3 main reconnection points (see Figures 4 and 5) and recorded in a table.
